TOWN HEAD, NEWBY BRIDGE, CUMBRIA

Archaeological Building Recording

July 2020

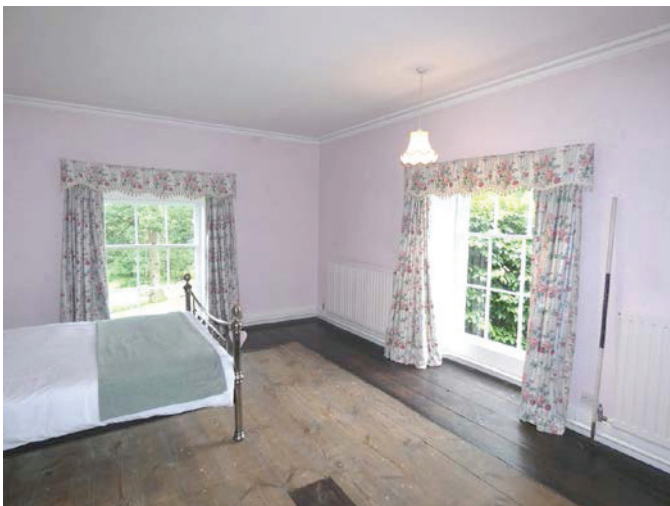
Plate 90 (left): Windows in the north and west elevations of Room F4, viewed from the south-east

4.3.23 **First Floor Room 4:** this has also been subdivided into three spaces, including a small lobby on the south-east corner. The floor is timber boards, which are relatively wide and the plaster ceiling has a simple cornice. There are windows to the north and west, all three over six lights with panelled shutters (Plate 90) and there is a hearth stone on the east side. The doorways have six panel doors (Plate 91) and there is a bannister with square section balustrades in the opening overlooking the stairs, the jambs of which are at an odd angle.

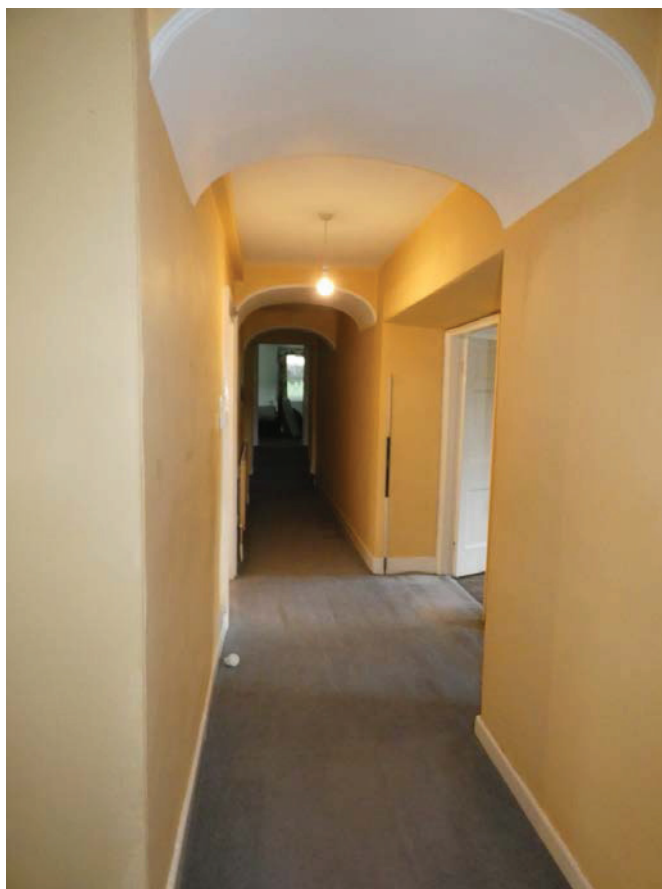
Plate 93 (right): Arched openings along the east/west arm of Room F5, viewed from the west

4.3.24 **First Floor Room 5:** this comprises a corridor, primarily linking the first floor rooms to the main staircase. It has a moulded cornice where it opens out into the main staircase on the west side. The staircase is as per the ground floor with square section balustrades and a simple hand rail (Plate 92) and there are three round headed arches over the east/west section (Plate 93). There is a tall stair window in the north elevation that illuminates the main stairs, and numerous doorways to the north and south all with six panel doors. Two in the south elevation are set back within a large opening in the main wall. At

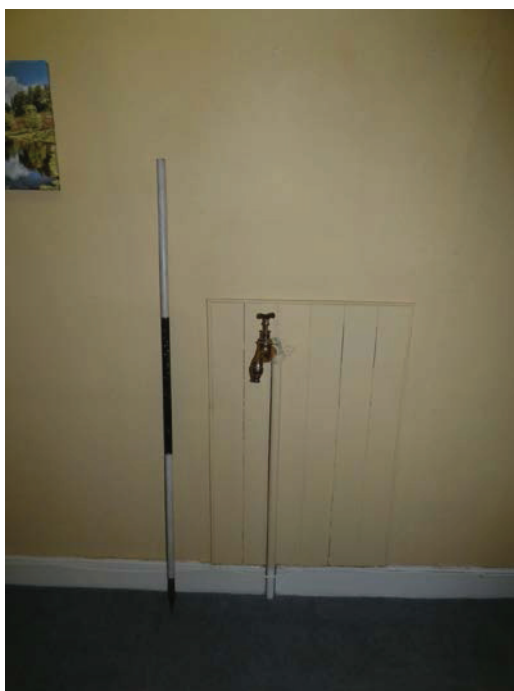
Plate 94: Brass tap and panelling at the north-east end of Room F5, viewed from the north

the far east end of the east/west arm there is a large brass tap fixed to an area of tongue and groove panelling (Plate 94), presumably part of an early fire-fighting system.

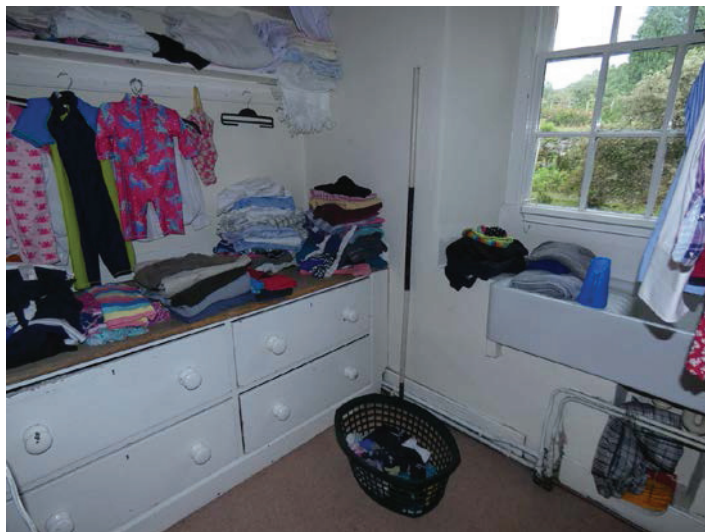
Plate 95: The storeroom forming the east part of Room F6

4.3.25 **First Floor Room 6:** this comprises a bathroom to the west and small storeroom to the east. The bathroom has been totally modernised, with a three over six light window to the north and an alcove with a three panel door to the east. The storeroom has an original or early fitted cupboard along the west side and a window to the north with a Belfast sink below (Plate 95). Immediately to the south of the store is a small room leading to the stairs to the second floor, which are timber and fairly plain.

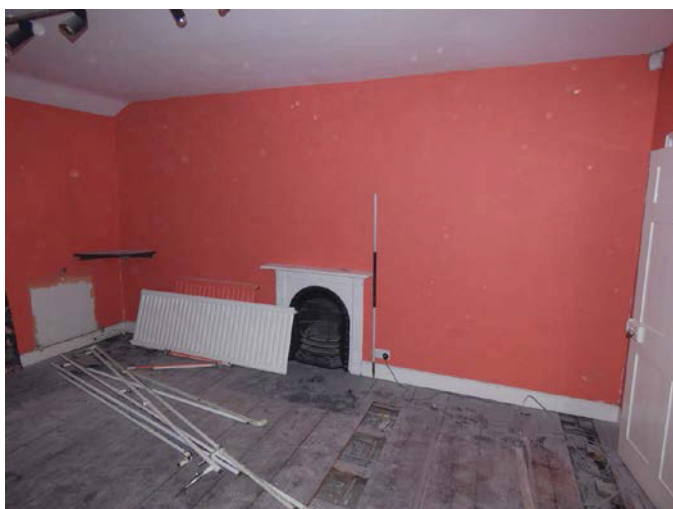
Plate 96 (left): Fireplace in the south elevation of Room F9, viewed from the north

4.3.28 **First Floor Room 9:** this has a timber floor, the boards relatively wide and plaster ceiling. The walls are mostly plain; there is a window to the east with a six over six light casement and a fireplace to the south with a floral iron surround and insert (Plate 96). There is a doorway to the west and a relatively modern two-light window with a fixed casement to the north (Plate 97). A new door has now been cut through the east side of the north elevation, which is a stud partition wall.

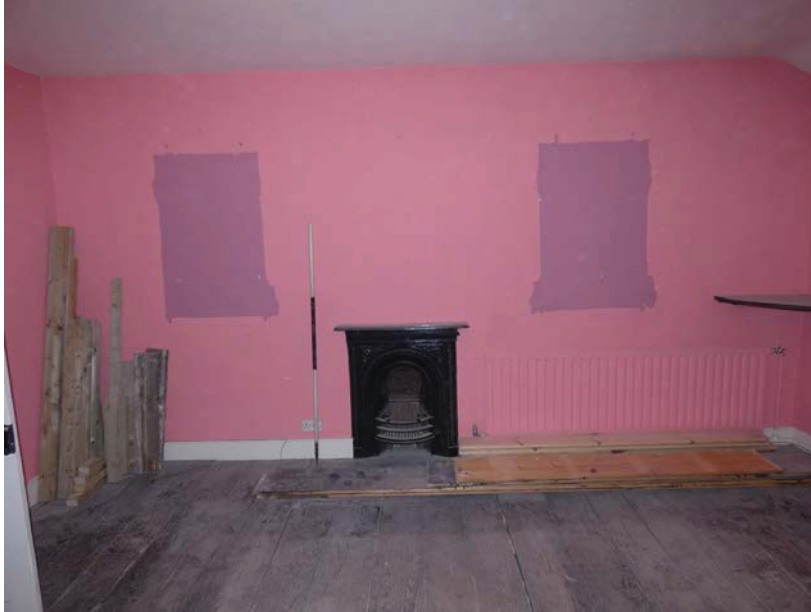
Plate 98: The north elevation showing the fireplace in Room F10, viewed from the south

4.3.30 **First Floor Room 11**: this also has a timber floor of wide boards. There is a fireplace to the north with a floral iron insert (Plate 98), window to the east with a six over six light casement, and doorway to the west with a six panel door.

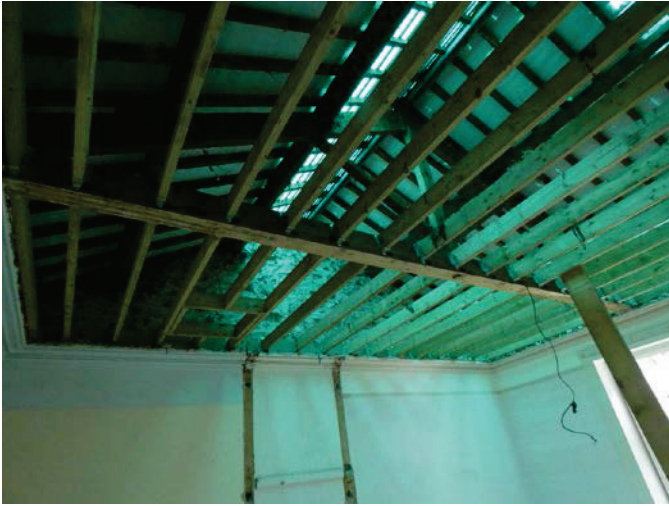
Plate 99 (left): The truss in Room F12, viewed from the south-west

4.3.31 **First Floor Room 12**: this has a timber board floor with narrow boards, although a large section was missing during the work on site on the north side where a staircase was removed and there are corresponding scars in the north elevation. The ceiling had also been removed revealing a single king post truss with angled struts (Plate 99). The walls had been stripped to the original plaster, which was topped with a deep cornice (Plate 100), although it was evident that this hadn't been cut through for the installation of the stairs on the north side, which indicates that they were a later addition. The east elevation has a large window 10 over 10 light sash casement with a smaller window to the south with a two over four light casement (Plate 101). This is located in what was evidently originally a small toilet as there are more scars for stud walls in this area. The south elevation has a hearthstone in the floor and a doorway with moulded surround and a six-panel door to the west, covered by hardboard on the north side. The wall above the removed ceiling is rough stone and mortar with throughstones in the south elevation and projecting stones marking the line of a flue (Plate 102).

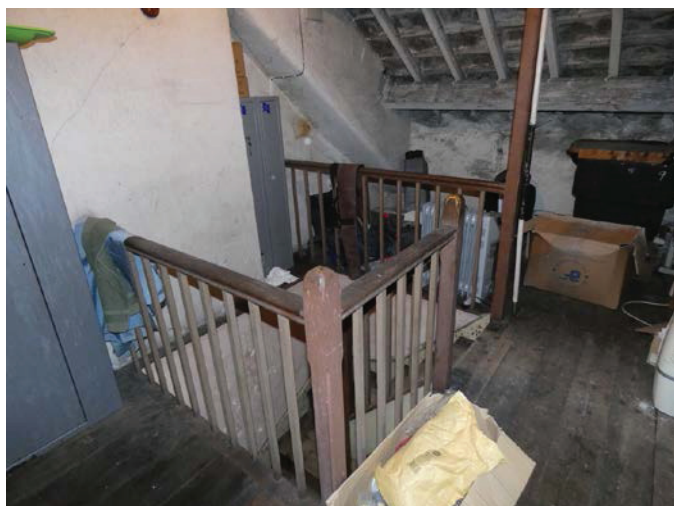
Plate 103 (left): The stairwell in Room S1, viewed from the south-east

4.3.32 **Second Floor Room 1:** this has fairly irregular and wide floorboards orientated north/south, with a stairwell on the west side with square balusters, dome-topped and stop chamfered newel posts and a fairly plain handrail (Plate 103). The walls are all finished with rough limewash and the room is open to the roof, which has three purlins, evidence for two blocked skylights, and the slates are finished with plaster parging (Plate 104). The north elevation is essentially plain while the east has a small window on the north side with splayed jambs, a two-light hinged timber casement, a timber sill plus a lower level window seat (Plate 105). The south elevation is a stud partition, with a central doorway with a timber surround but no door. There is a window to the east with a top opening six-light timber casement with bars across the top part (Plate 106). The west elevation is infill below the east truss, with a space below the principal rafter forming an alcove on the north side (Plate 103).

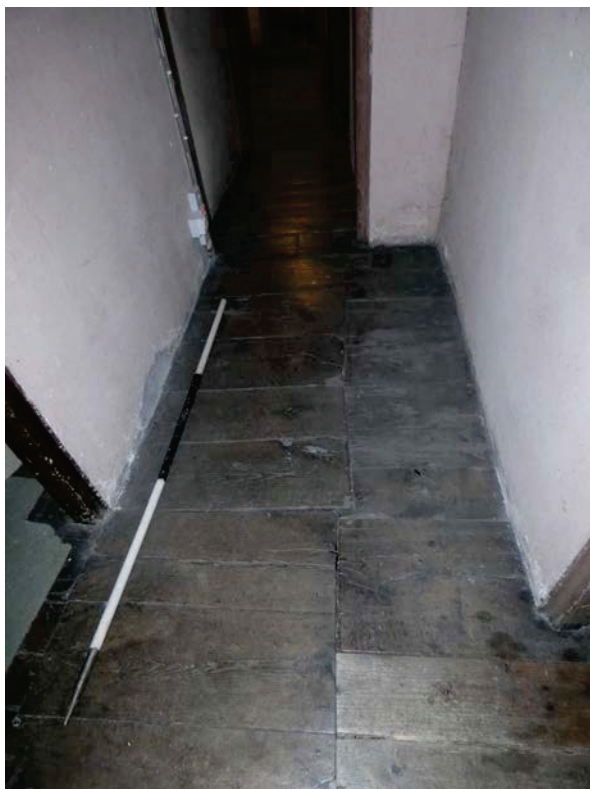
Plate 107: Floorboards in Room S2, viewed from the east

4.3.33 **Second Floor Room 2:** this is essentially just a corridor linking rooms on this floor formed between stud walls. The floor is essentially a continuation of that in Room S1, with some very wide and irregular boards (Plate 107). The east has had an additional modern partition added, and there are doorways to the north, west, and south with moulded surrounds but no doors.

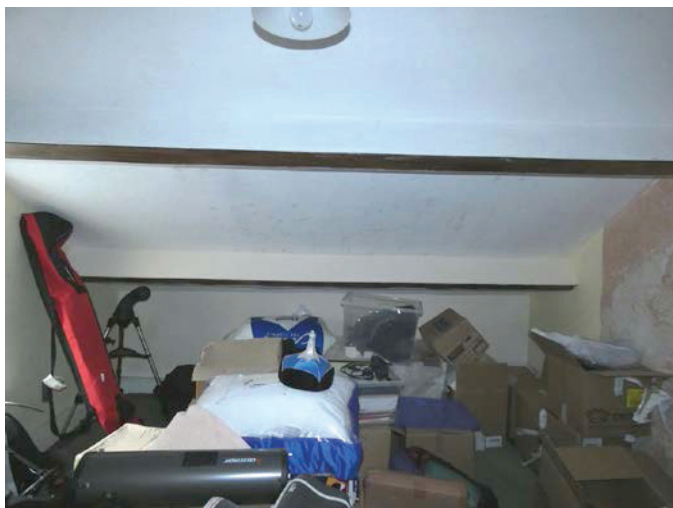
Plate 108 (left): The south side of Room S3, viewed from the north

4.3.34 **Second Floor Room 3:** the floorboards are similar to those to the north, and the ceiling is plastered and becomes flat on the north side but two purlins are visible (Plate 108). The walls are plastered and painted, and a mid-20th century painting of ladies' shoes on shelves has been added to the east elevation (Plate 109). This also has a window with a three over three light top-opening casement, with the bottom two panes on the south side angled to follow the adjoining roofline. It has splayed jambs and a timber lintel and window seat. The room is otherwise plain, with a doorway to the north.

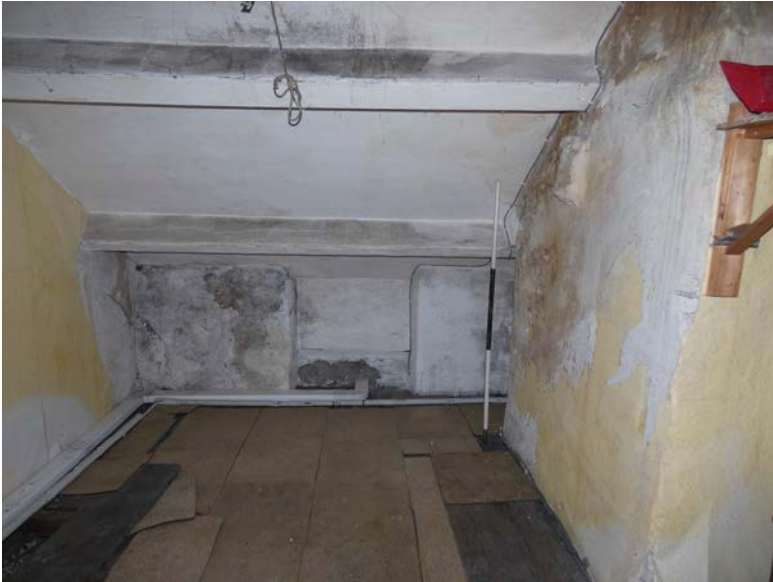
Plate 110 (left): The north elevation of Room S4, viewed from the south

4.3.35 **Second Floor Room 4:** this has similar floorboards orientated north/south and a pair of purlins exposed across the north side with a skylight with a two-light iron casement. A flat plaster ceiling has been created on the south side. The north elevation has a tall alcove in the centre, perhaps a blocked former window (Plate 110). The east elevation is stepped out on the north side and a much thicker section of masonry, with the principal rafter of the truss exposed in the elevation proper. The south

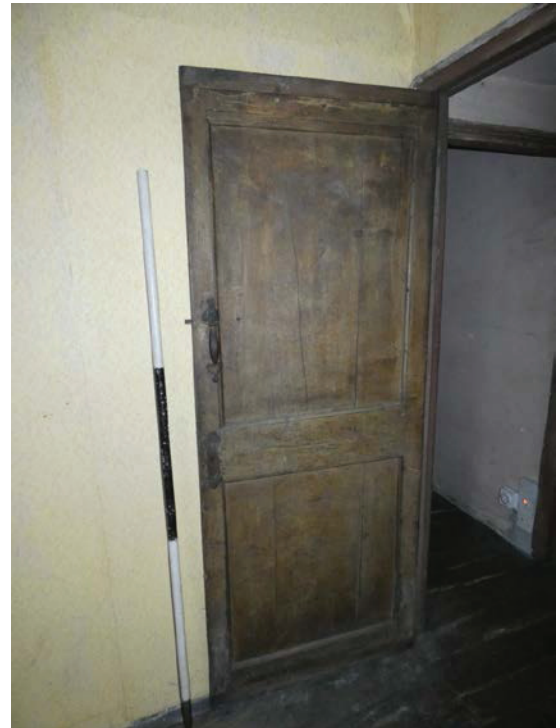
Plate 111 (right): The door in the south elevation of Room S4, viewed from the west

elevation is a stud partition with a doorway on the east side with a moulded surround and early two-panel door with decorative latch (Plate 111).

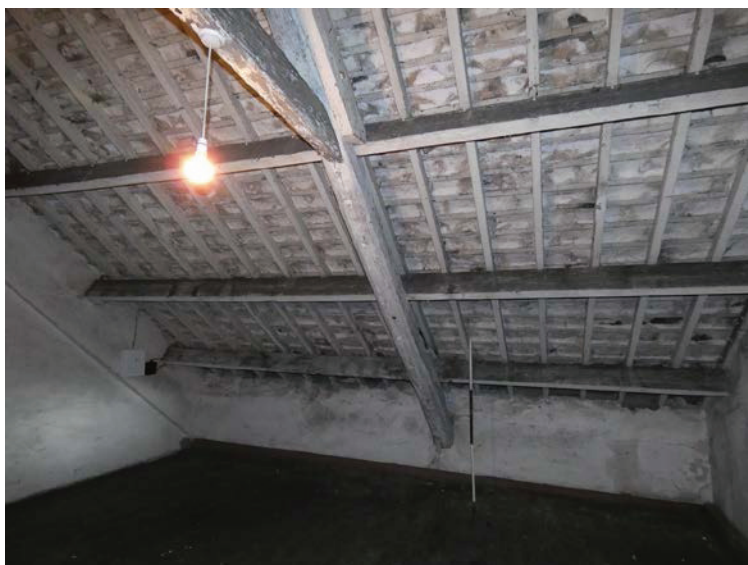
Plate 115 (right): The south side of Room S5, viewed from the north-west

4.3.36 **Second Floor Room 5:** this too has relatively wide and irregular floorboards orientated north/south, with additional boxing for the service bell cables attached to the west elevation and along the bottom of the south (Plate 115). It is open to the roof and there are three purlins per pitch plus the ridge, all of which are hand finished or sawn; the remains of a now blocked skylight are also visible (Plate 113). The two trusses supporting the roof are visible, in both cases they form part of an elevation on the east side. They are tie beam type, with thick principal rafters and a collar, with further bracing attached to the west truss forming an additional collar (Plate 112). The principals overlap west on east where they meet and the whole thing is held with timber pegs. The back of the slates is finished with plaster parging and all of the elevations are finished with rough plaster and limewash. The north elevation has a small opening leading into a small void below the roof (Plate 113). The east elevation is a stud partition and steps round to the east where there is an early two-panel doorway on L-shaped hinges (Plate 114). The south side of the elevation fills in the space below the collar of the western truss. The south elevation is plain and only really the wall top (Plate 115), while the west has a window on the south side with a six-light casement, the lower part of which has been modified to match the slope of the roof to the west (Plate 116), and has a timber window seat. To the north is a fireplace with a plain square stone surround and iron hob grate and hearthstone, with the boxing for the bell cables to the south of this (Plate 117).

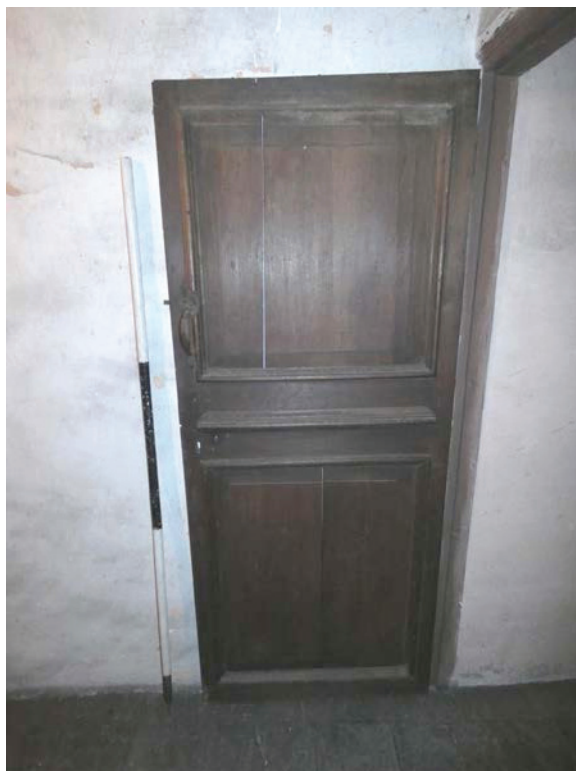
Plate 118: Early door as viewed in Room G6

4.3.37 **Second Floor Room 6:** this is essentially little more than a lobby between other rooms. It has a suspended plaster ceiling and is plastered and painted throughout. There are doorways to the north and west with moulded surrounds and containing two early doors with raised and fielded moulded panels a central moulded rail (Plate 118).
