# MARSH GRANGE BARN, DUNNERHOLME, ASKAM-IN-FURNESS, CUMBRIA

## Heritage Statement

December 2020

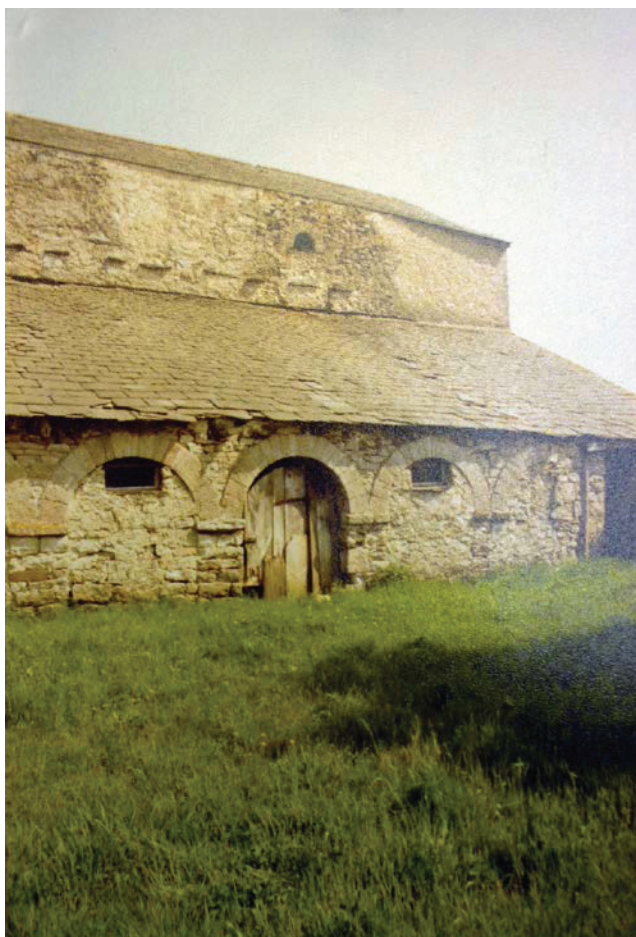
3.2.6 **Photograph, 1983:** this photograph (CAC(B) BDP/137/15/2 1983) shows the south end of the west external elevation, at which point the monopitch outshut with decorative arched windows was still extant (Plate 5).

Plate 5: Photograph of 1983

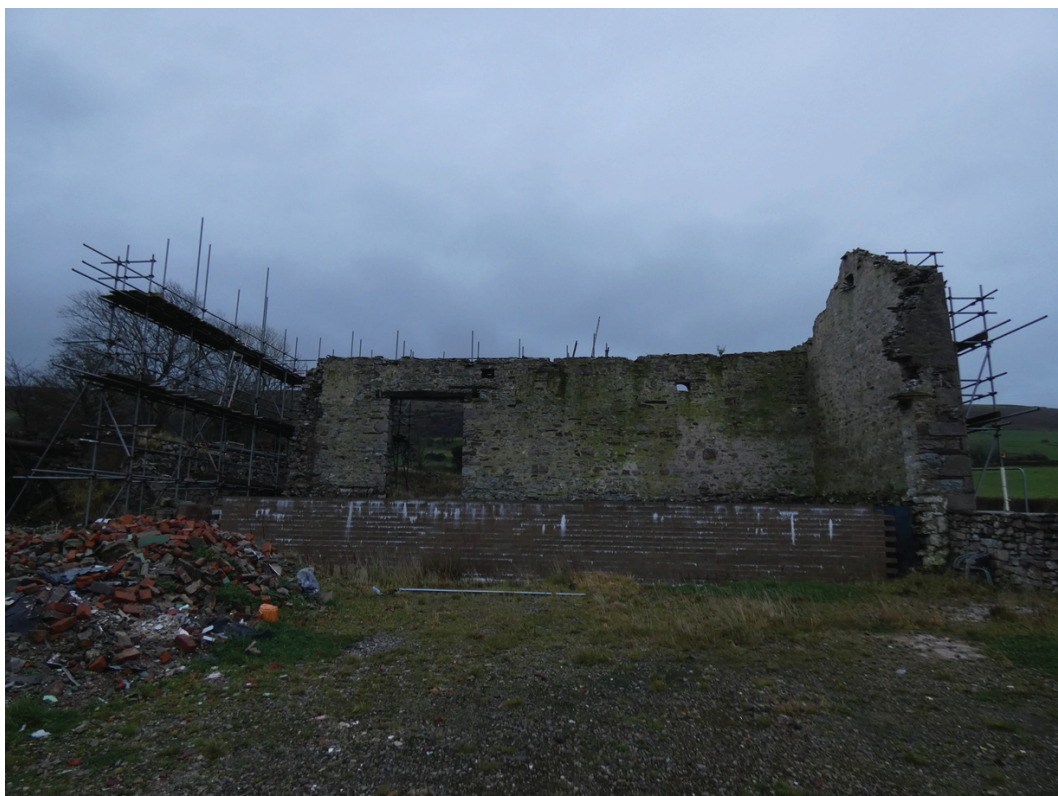
3.5.1 The site visit revealed that since the completion of the previous archaeological building recording in 2015 the barn had been partially redeveloped and was still partially scaffolded. The west side of the main part, and the monopitch outshut, had been demolished and new foundations put in place (Plate 6), while the southern wall of the open-fronted extension to the east had been totally rebuilt and a new concrete floor installed (Plate 7 and Plate 8). Throughout the roof had been removed, although the trusses and slates were still stored on site (Plate 9); however, the iron columns that supported the roof of the eastern outshut were not visible.

**Plate 6: The main barn viewed from the west, showing the missing west wall and new foundations**

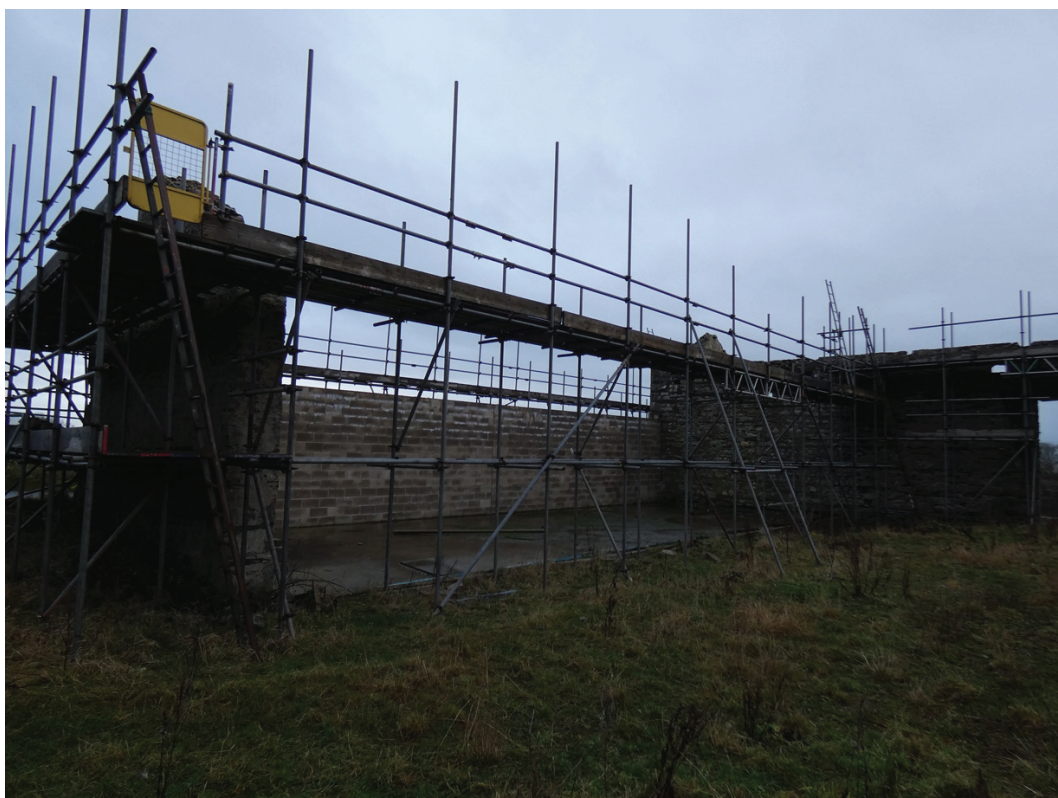
**Plate 7: The outshut to the east, viewed from the north-east, showing the new wall and concrete floor**

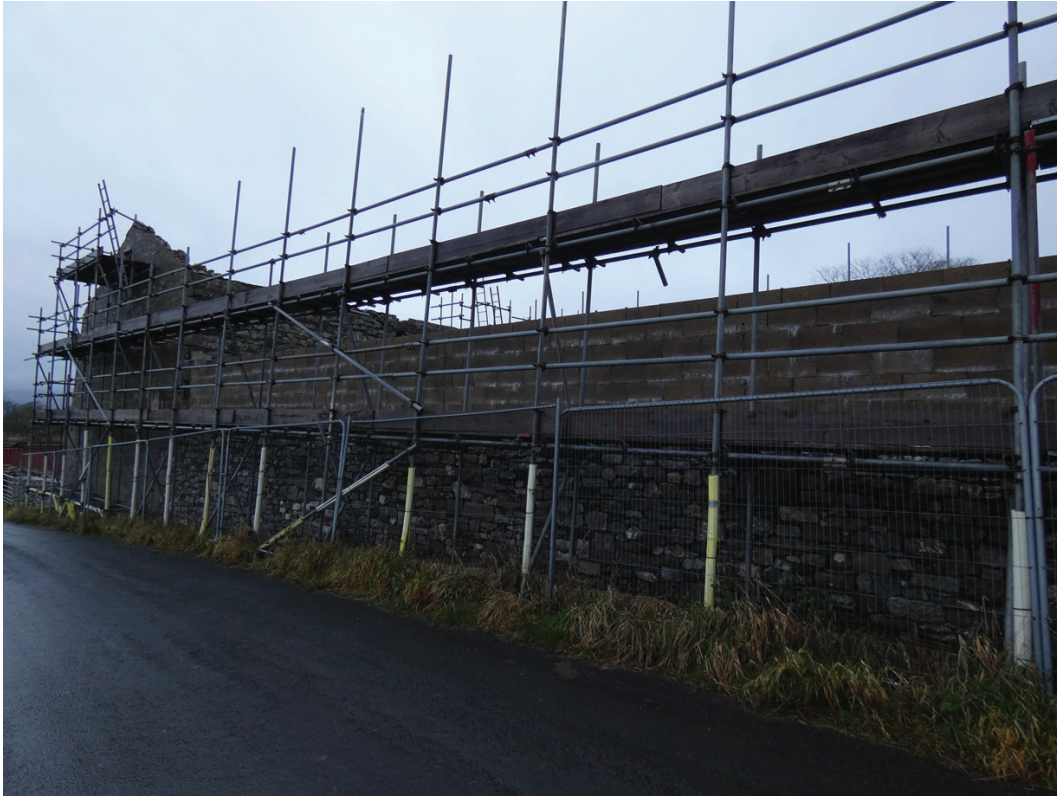
**Plate 8: The rebuilt south wall of the eastern outshut, viewed from the south-east**

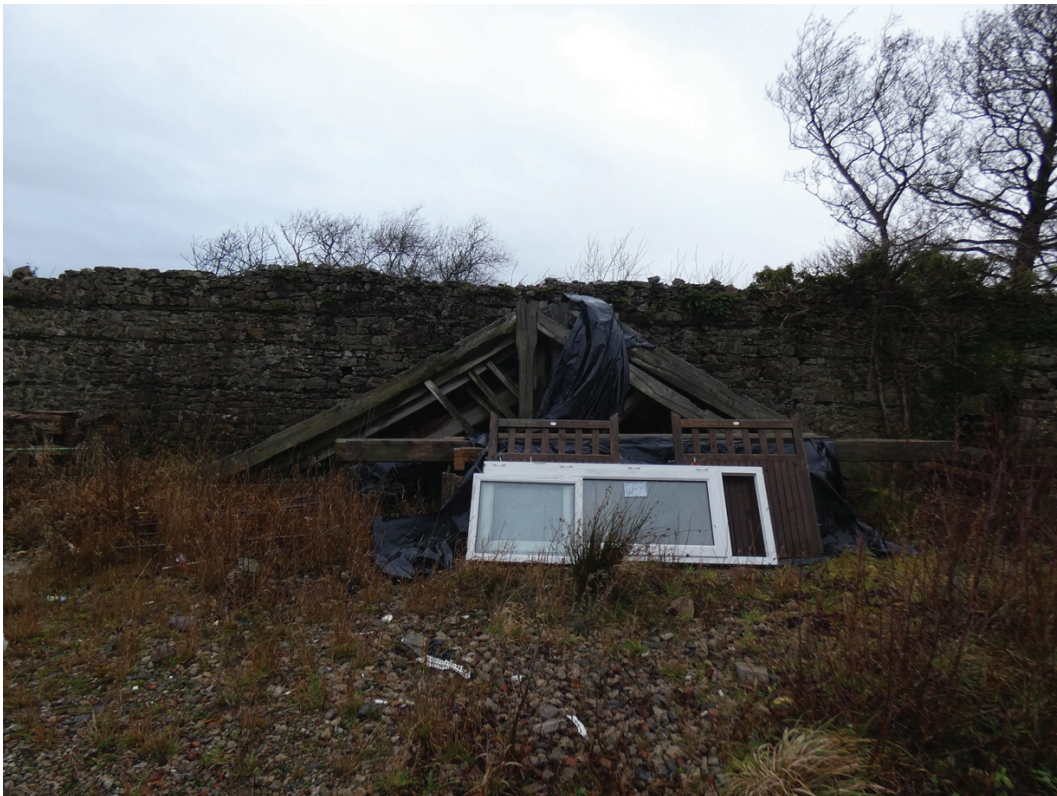
**Plate 9: Roof trusses lose on site against the west boundary wall, viewed from the east**

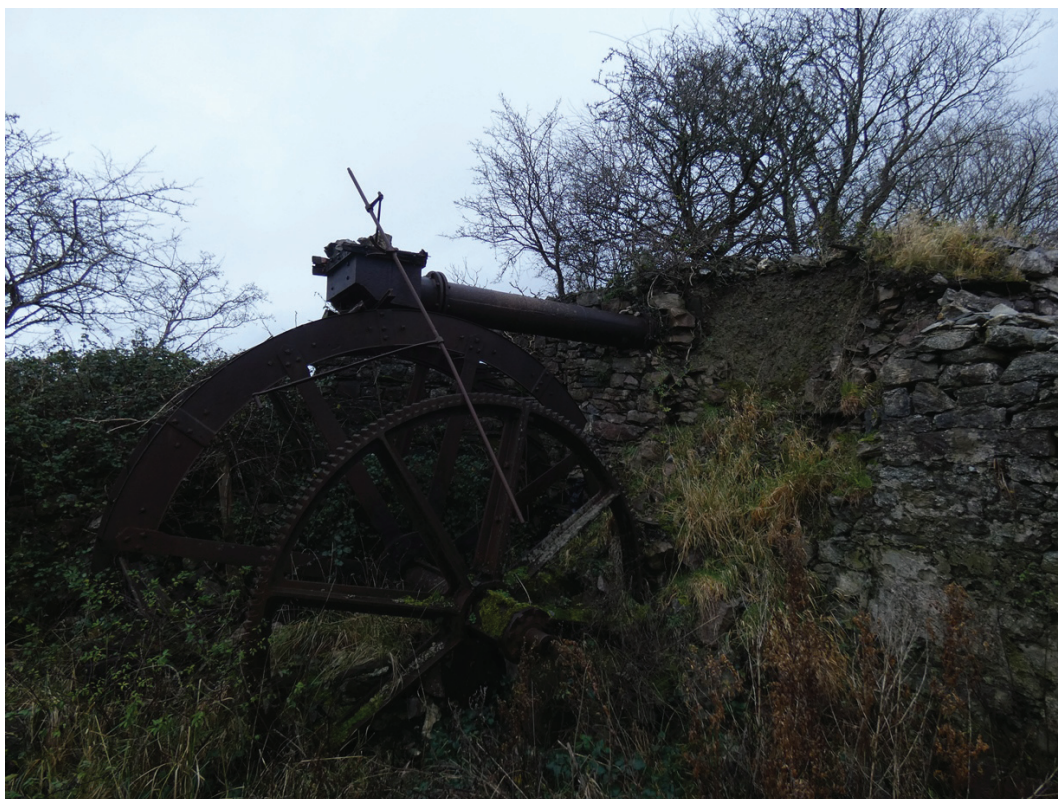
3.5.2 The iron waterwheel to the north was still extant, although the timber starter box on top was missing (Plate 10) and the wall dividing the wheel from the gears to the south had collapsed or been removed, leading to active erosion of the bank containing the water feed pipe coming from the east (Plate 10). The retaining wall to the east was also evidently in poor condition (Plate 11).

**Plate 10: Water wheel to the north of the main building, viewed from the south-west**

4.4.1 The proposed development would be ultimately beneficial in giving the remains of the building a new lease of life and therefore preserving them. It also provides an opportunity to carry out suitable work to consolidate the waterwheel – this could be as little as clearing it of vegetation, cleaning the metalwork of the most severe corrosion and coating it with a suitable preservative, and stabilising the associated walls. It is not clear from the earlier building recording whether the waterwheel would have originally been internal and so protected from the elements, but this seems unlikely. Therefore, if it was preserved and left uncovered, essentially as a garden feature, it would ideally require some ongoing maintenance. More concerning is the evident erosion to the bank housing the water feed pipe, probably caused by the loss of part of the adjoining wall, and to a lesser extent the associated retaining wall to the east. If this is

not addressed it is possible that parts of the bank could collapse, causing considerable damage to the waterwheel. In addition, some mitigation, ideally through suitable design and the positioning of a protective layer, might also be necessary in order to protect any features present in the original north end of the main part of the building (now external to the north wall) that would be affected by the construction of the access ramp to the garden. More generally, sympathetic design of any new build elements would be particularly important in terms of the over all impact on the surviving original fabric, and could be carried out through the reuse of materials on site such as the original grey roofing slate, and use of matching stone and mortar where there are repairs and additional stone walls, to that already present in the building.

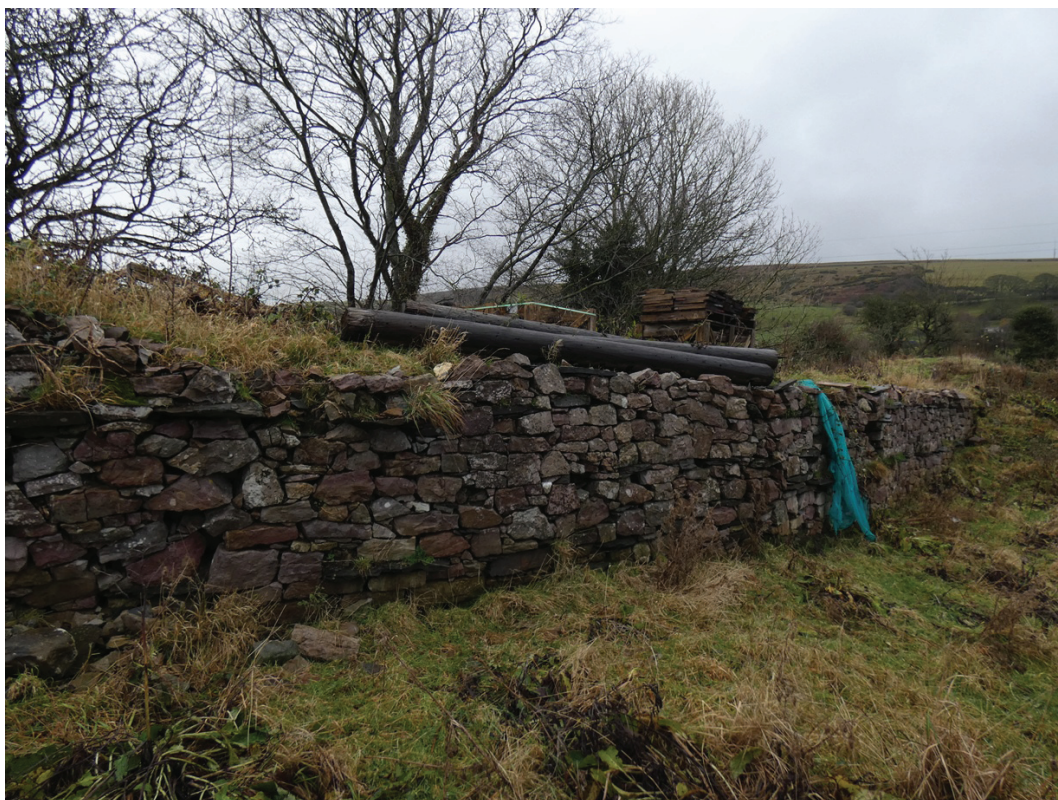
**Plate 11: Retaining wall to the east of the water wheel, viewed from the south-west**
