PRIORY CHURCH OF ST MARY AND ST MICHAEL, CARTMEL, CUMBRIA

Archaeological Evaluation

Client: PCC Cartmel Priory

March 2021

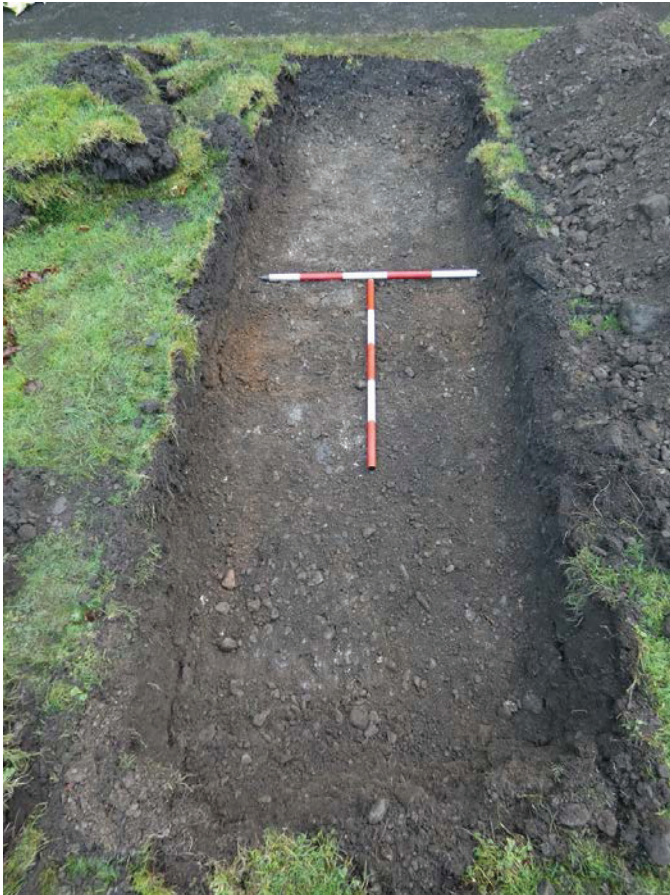
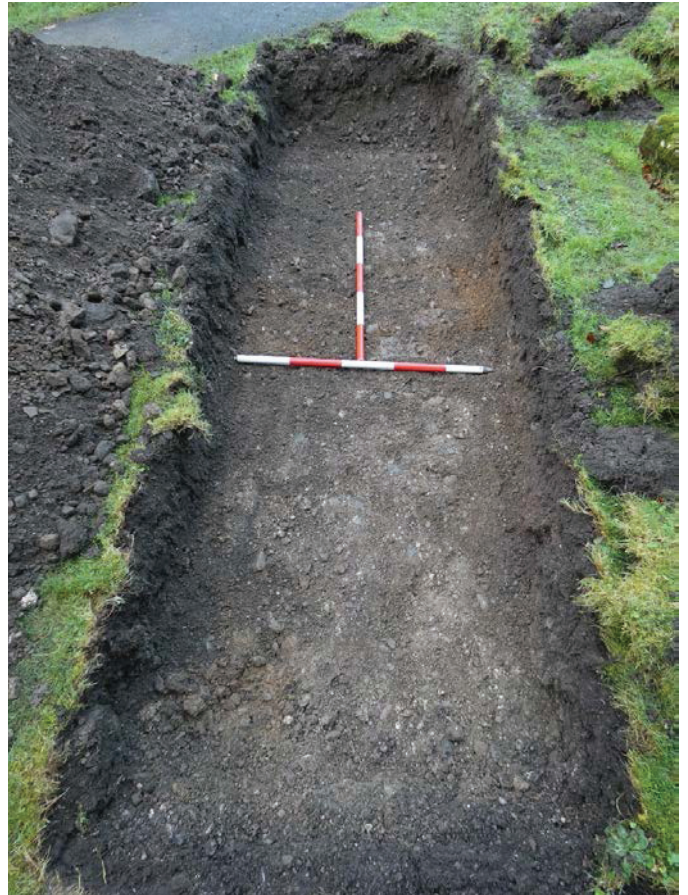
4.1.1 This trench was approximately 3.8m long by 1.1m wide and orientated approximately north/south. The topsoil comprised a dark greyish black loose gritty silt between 0.25m and 0.3m thick, and with a large lense of dark purple ash on the south-east side. Below this the natural, comprising a loose mid-orangey brown gritty clay with 20% rounded pebbles (**106**), was encountered, into which was cut two features. At the north end of the trench was a linear feature orientated approximately east/west ranging from 1.3m wide at the top to 0.7m wide at the bottom, with an initial shallow sloping cut on the south side coming to a step and then a vertical cut, while the north side had a near vertical cut from the top (**103**). The base was not definitely reached due to the difficulties of keeping the loose fill from collapsing. The upper fill comprised a loose mid-greyish-brown gritty/sandy clay with lots of lime mortar and 20% angular pebbles and was up to 1.25m wide and 0.5m thick (**101**). Below this was a softer deposit of dark greyish-brown silty clay with 20% rounded pebbles, 0.7m wide and at least 0.5m thick (**102**). Part of a tree root was present near the base of the feature. At the south end of the trench there was a second linear feature extending out of the south end of the trench. This too was orientated approximately east/west and at least 1.7m wide and 0.5m deep, with a near vertical side to the north and a flat base (**105**). It had a single fill comprising a loose mid-greyish-brown sandy/gritty clay with 30% angular and sub-angular cobbles and other inclusions such as slate and lime mortar (**104**) and filled all of cut **105**.

Plate 7 (left): Trench 1 after initial cleaning revealing features **103** and **105**, viewed from the north

Plate 8 (right): Trench 1 after initial cleaning revealing features **103** and **105**, viewed from the south

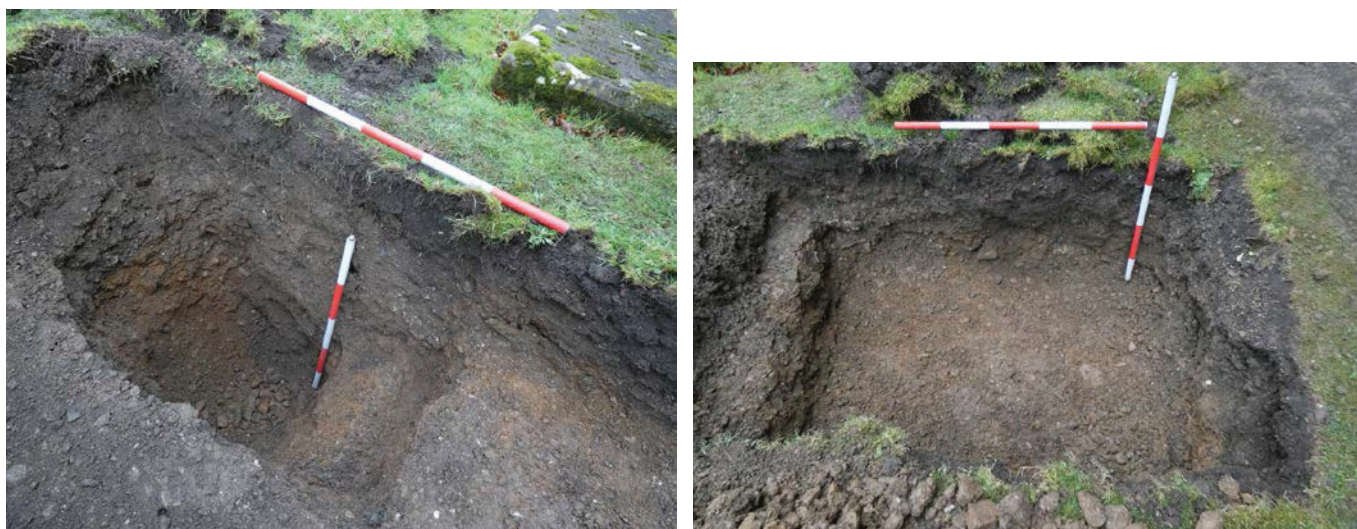
Plate 9 (left): Section through feature 103, viewed from the west

Plate 10 (right): Section through feature 105, viewed from the west

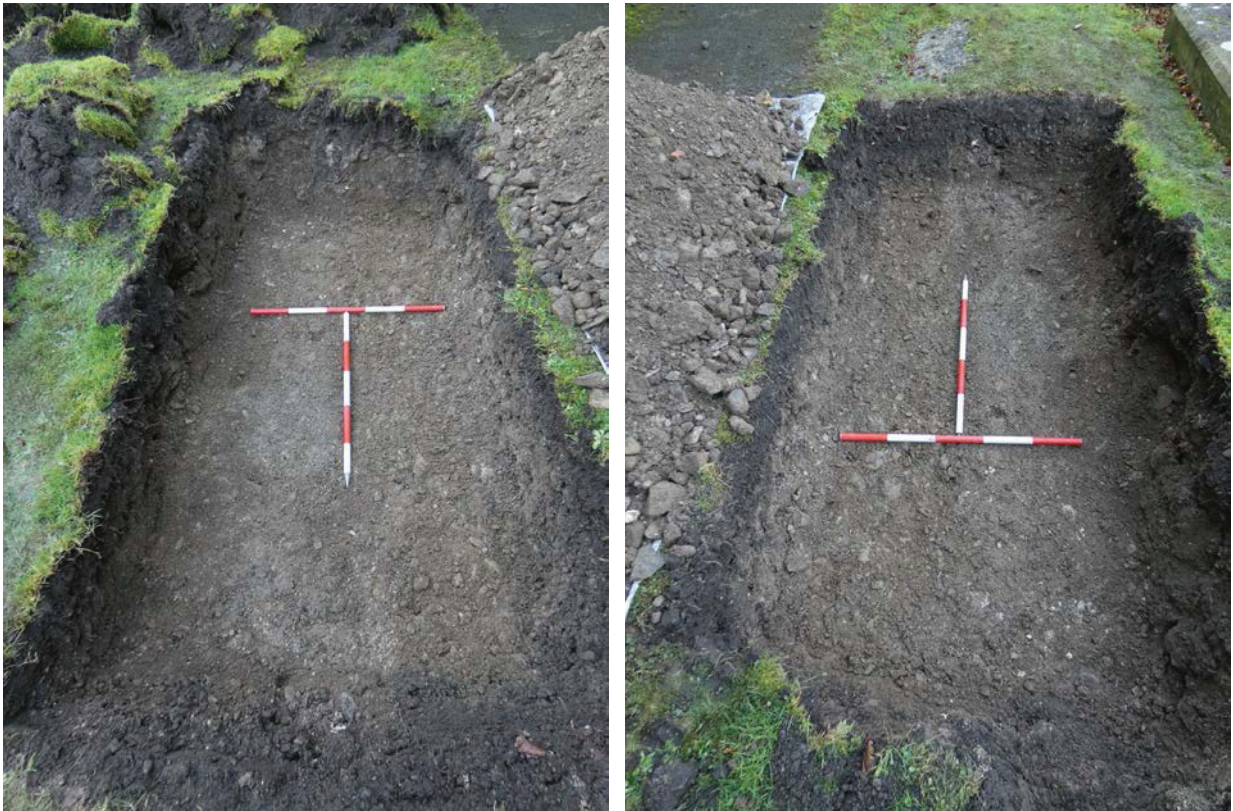
4.2.1 This was approximately 3.1m long by 1.4m wide and orientated approximately east/west. The topsoil comprised a loose dark greyish black gritty silt, 0.25m to 0.3m thick (**201**). Below this was a deposit of loose pale greyish brown gravelly clay with lots of lime mortar and 25% angular and sub-angular cobbles (**201**). Below this a large linear feature was encountered, cut into the natural, which comprised a loose mid-orangey-brown sandy/gritty clay with 10% rounded cobbles and 10% rounded gravels (**204**). The linear was orientated essentially east/west and at least 1.2m wide at the top, although extending outside the trench to the south, with a steep cut on the north coming to a step after which it was only 0.9m wide, the total depth being at least 0.7m (it was not fully excavated due to collapsing sides; **203**). The feature had a single fill comprising a loose mid-greyish brown gritty sandy clay with 40% rounded and sub-angular stones (**202**) and this filled the whole of feature **203**.

Plate 11 (left): Trench 2 after initial cleaning, showing deposit 201, viewed from the west

Plate 12 (right): Trench 2 after initial cleaning, showing deposit 201, viewed from the east

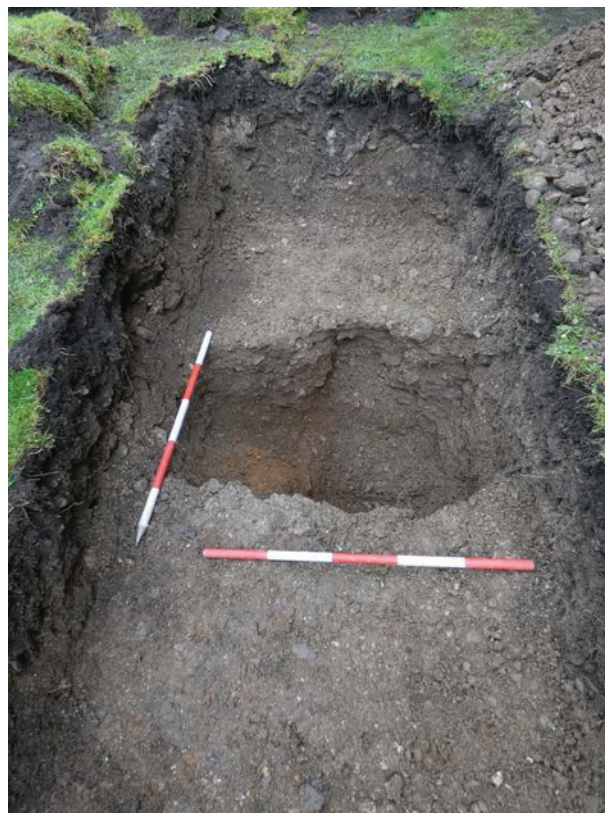
Plate 13: Section through feature 203, viewed from the east

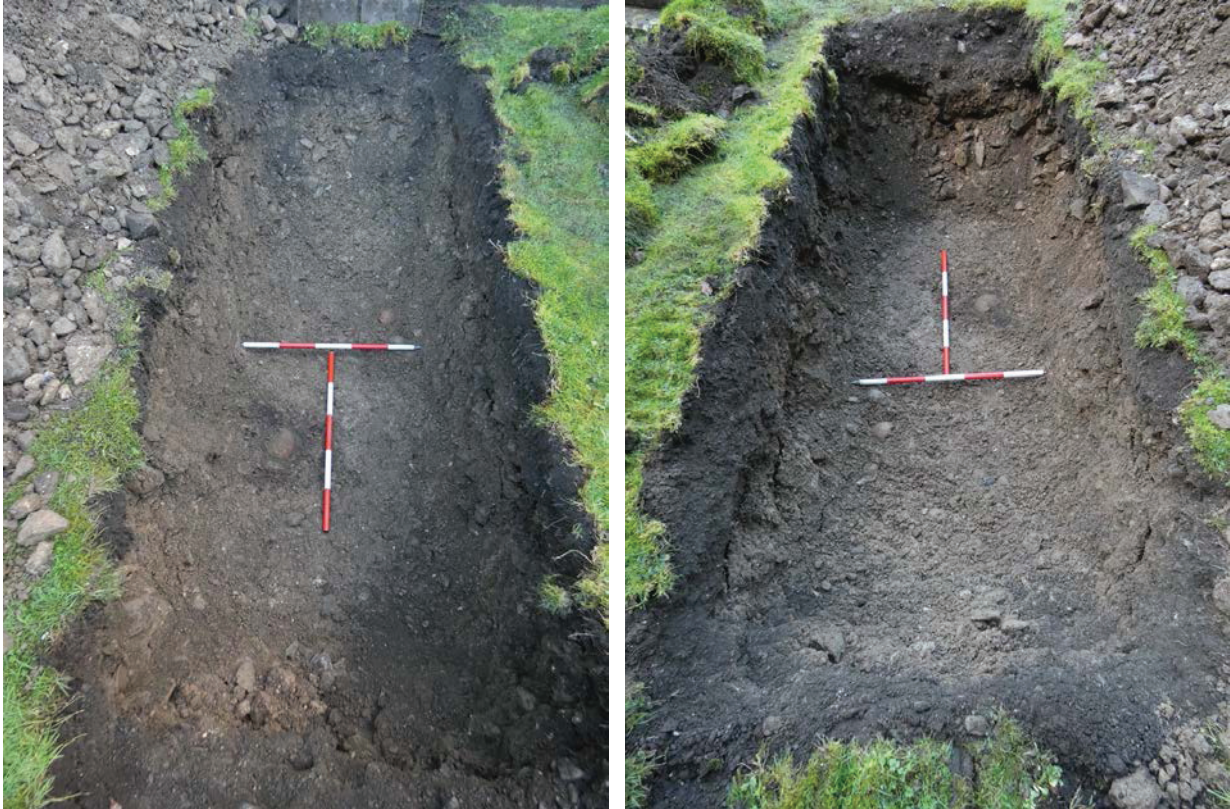
4.3.1 This was approximately 3.8m long by 1.1m wide and orientated north-west/south-east. The initial deposit comprised a very dark grey loose gritty sandy-silt topsoil up to 0.2m thick (**300**). Below this was a pale brownish grey gritty clay with 60% rounded and sub-angular cobbles and other inclusions such as roofing slate, lime mortar, brick, pottery and animal and human bone, including four complete skulls (**301**). This deposit was at least 0.6m thick but not fully excavated because of the danger of collapse; two of the skulls were left *in situ* at the limit of excavation (these were covered with boards for protection before backfilling).

Plate 14 (left): Trench 3 at limit of excavation, viewed from the north-west

Plate 15 (right): Trench 3 at limit of excavation, viewed from the south-east

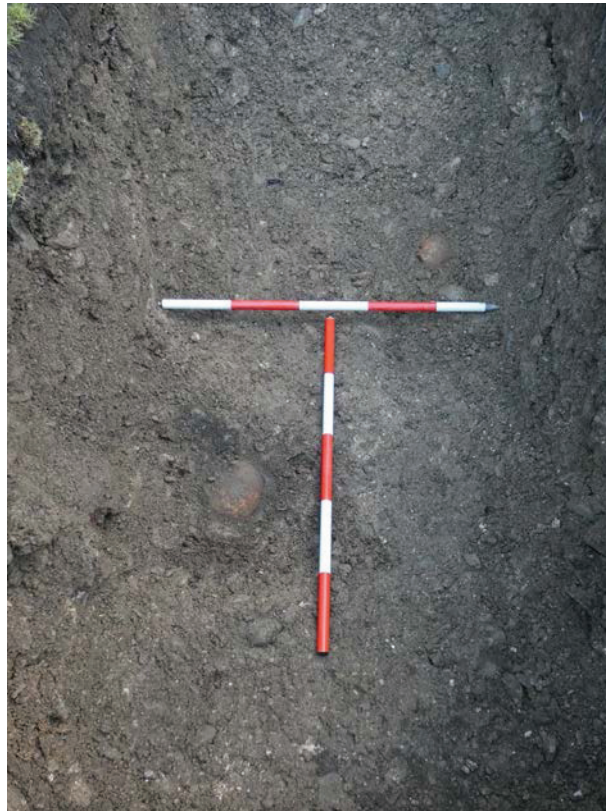
Plate 16: Human skulls left *in situ* in Trench 3, viewed from the north-west

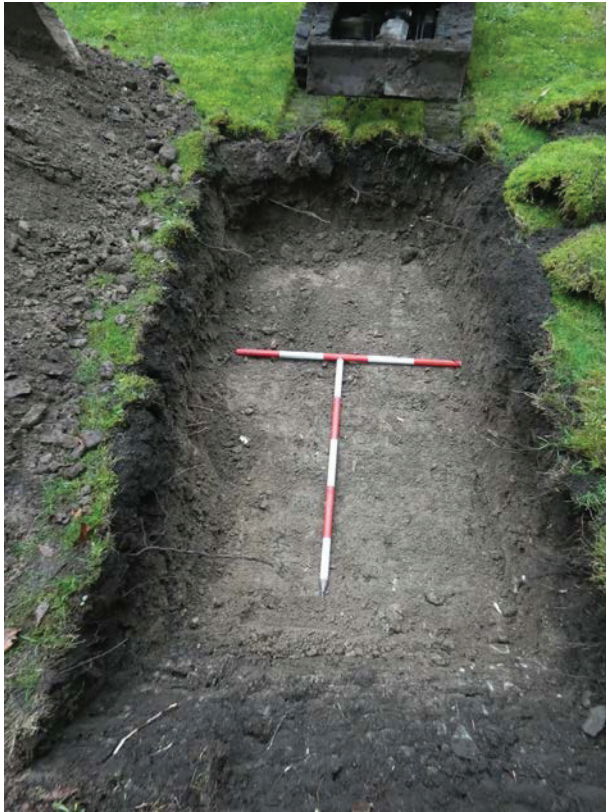
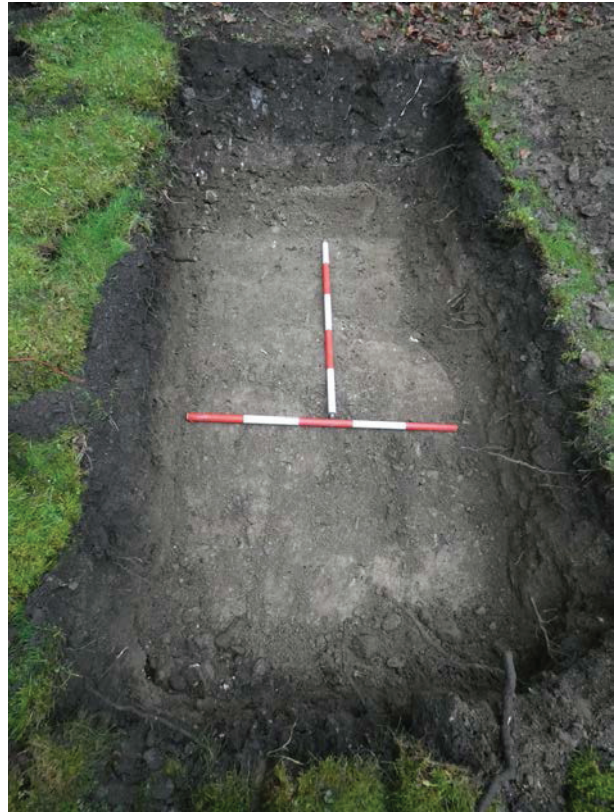
4.4.1 This was approximately 2.5m long by 1.1m wide and orientated approximately north-west/south-east. The topsoil comprised a dark grey or black loose gritty clay 0.2m thick (**400**). Below this were a series of dumped deposits. The uppermost comprised a loose mid-brown gritty clay with 20% angular pebbles, probably repositioned natural (**401**). Below this was a loose pale brown gritty clay with 20% angular cobbles, up to 0.2m thick (**402**). Below this was a firm pale brown clay with few inclusions, 0.2m thick (**403**). This deposit sealed two features. The southernmost of which comprised a linear feature orientated essentially east/west, 0.6m wide and at least 0.6m deep (it could not be fully excavated due to the depth and loose nature of the fill; **405**). It was filled by a single deposit, which comprised a soft pale brown silty clay with 10% rounded cobbles and some slate and was 0.6m wide and at least 0.6m deep (**404**). To the north of this feature was a pit, which was essentially oval in plan (although it extended out of the north end of the trench) orientated east/west, 0.8m wide east/west, at least 0.6m north/south, 0.2m deep and with shallow sloping sides (**407**). It had a single fill, comprising a soft pale brown silty clay with 10% angular cobbles, some slate and brick, and large amounts of post-medieval pottery, bone, and marine shells (mostly cockle but with some mussel) (**406**).

Plate 17 (left): Trench 4 cleaned to deposit 403, viewed from the north-west

Plate 18 (right): Trench 4 cleaned to deposit 403, viewed from the south-east

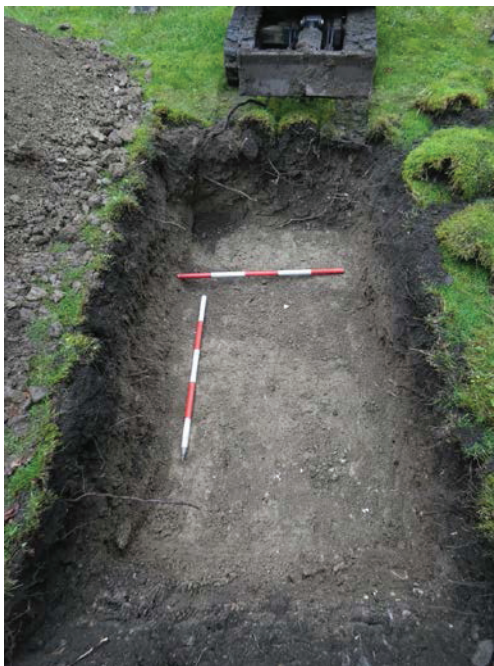
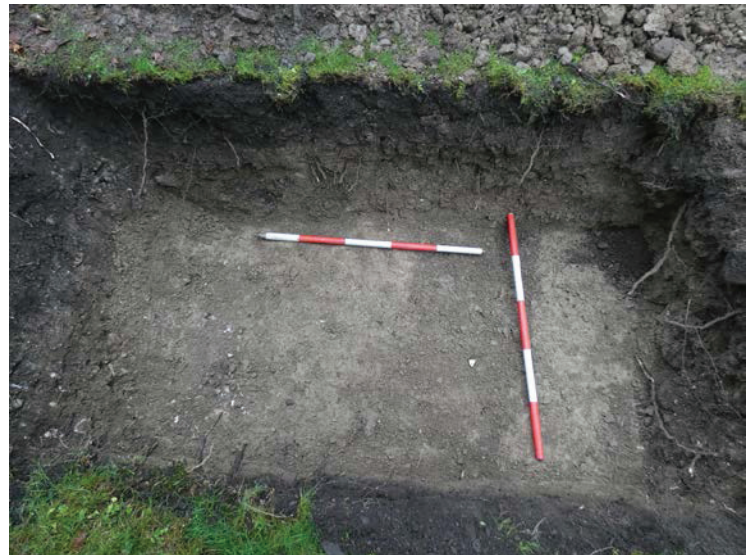
Plate 19 (left): Trench 4 following the removal of deposit 403, showing features 405 and 407, viewed from the north-west

Plate 20 (right): Trench 4 following the removal of deposit 403, showing feature 405 and 407, viewed from the south-west

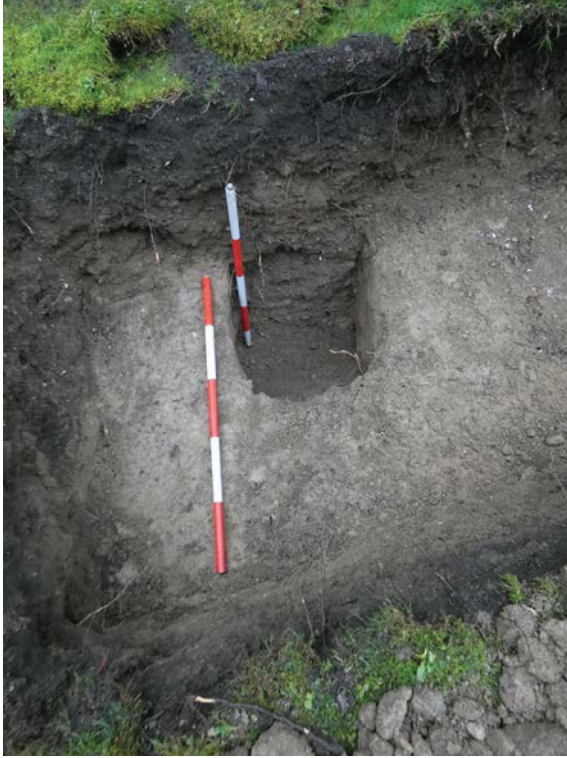
Plate 21 (left): Section through feature 405, viewed from the north-east

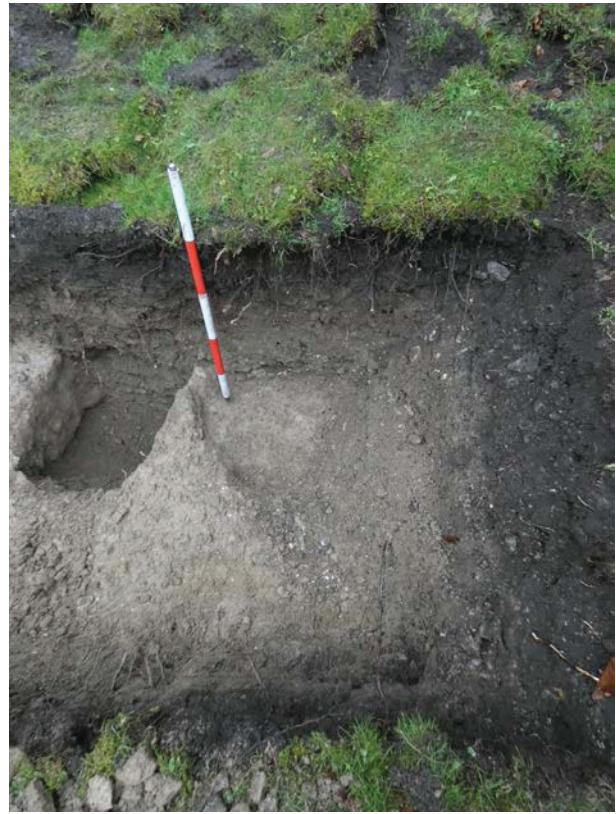
Plate 22 (right): Section through feature 407, viewed from the north-east

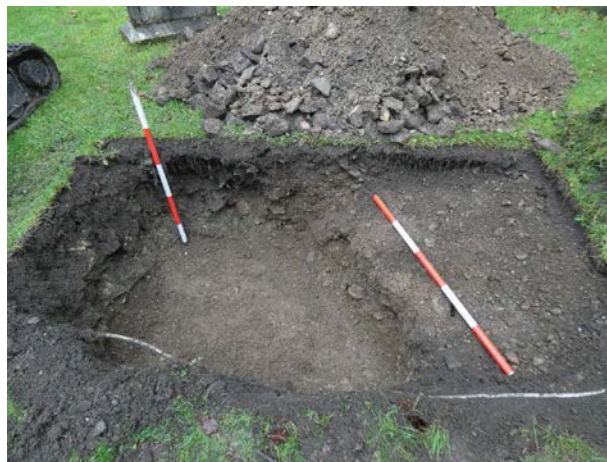
4.5.1 This was approximately 2.4m long by 1.2m wide and orientated approximately north-east/south-west. The topsoil comprised a loose dark greyish-black gritty clay, 0.2m thick (**500**); along the north-west side of the trench a disused telephone cable was exposed just below the turf and so a narrow strip of the trench was left unexcavated along this side. Below this the natural was exposed, comprising a loose dark orangey brown gravelly clay with 30% rounded pebbles (**504**). Cutting into this was a linear feature running across the centre of the trench, essentially east/west (**503**). This had a near vertical cut on the south-west side but extended beyond the north-east end of the trench and was 0.45m deep and at least 1.5m wide. The upper fill comprised a loose mid-greyish-brown gritty clay with 75% angular cobbles (**501**), which filled most of feature **503**. However, against the cut was a small deposit of pale brown firm clay with 10% rounded gravel (**502**).

Plate 23: Trench 5 excavated, showing feature 503

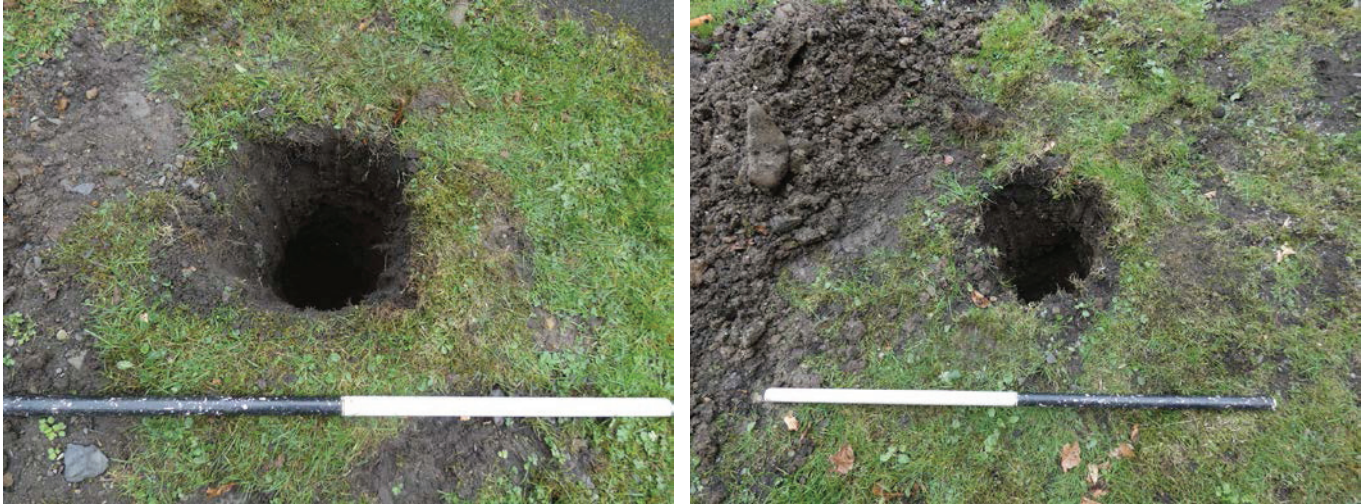
4.6.1 **Window Sample 1 (WS01)**: this comprised the hand-excavation of an initial pit c0.3m square to a depth of c0.7m through the north end of evaluation Trench 1 (Plate 24). Below the turf was an initial topsoil deposit of loose dark grey gritty clay 0.2m thick, which was on top of a loose mid-brown sandy clay containing some small bone fragments and lime mortar, beneath which was the mid-orangey brown gritty sandy clay natural. Given its location it seems likely that this pit caught the north edge of feature **103**.

Plate 24 (left): WS01 following excavation, viewed from the east

Plate 25 (right): WS02 following excavation, viewed from the south-west

4.6.2 **Window Sample 2 (WS02)**: this comprised the hand-excavation of an initial pit c0.3m square to a depth of c0.8m through the centre of evaluation Trench 2 (Plate 25). This revealed a deposit of loose greyish brown sandy clay with lots of angular cobbles.

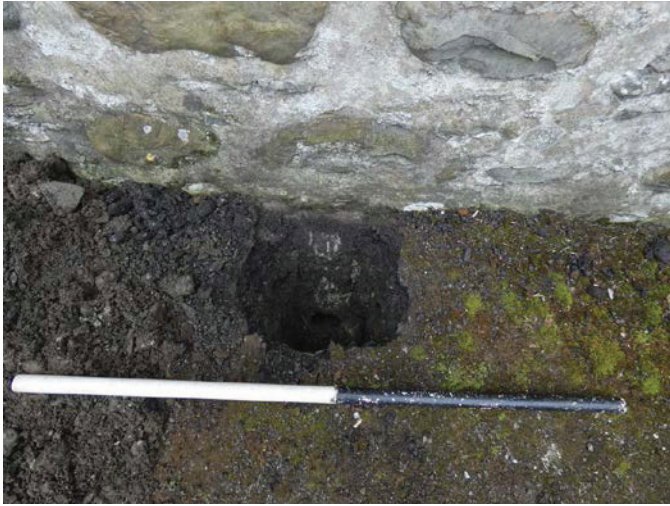
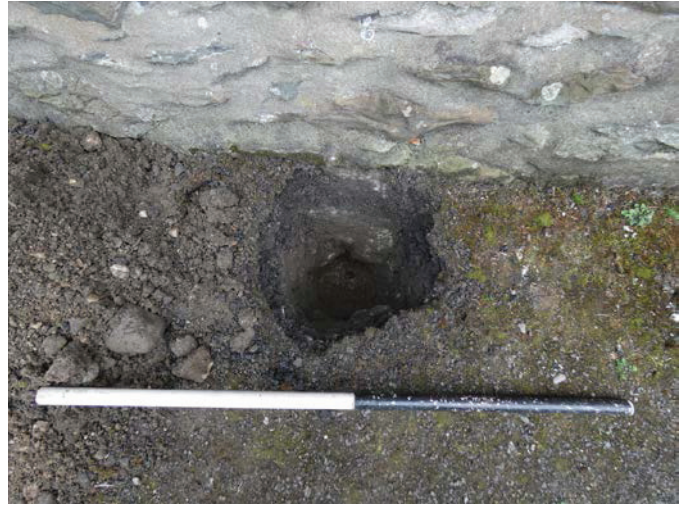
4.6.4 **Test Pit 1 (TP1)**: this comprised the hand-excavation of a pit c0.3m square to a total depth of c0.4m. The initial deposit comprised the tarmac path surface, which was 0.1m thick. Below this was a mid-greyish brown sandy clay with some fragments of roofing slate and lime mortar 0.2m-0.3m thick. The footing of the priory church wall projected to the north by c0.1m at a depth of 0.4m, shortly after which was the base of the footing was encountered (Plate 26).

Plate 26 (left): Test Pit 1 excavated, showing projecting base of footing, viewed from the north

Plate 27 (right): Test Pit 2 excavated, viewed from the north

4.6.5 **Test Pit 2 (TP2)**: this comprised the hand-excavation of a pit c0.3m square to a total depth of c0.5m. The initial deposit comprised the tarmac path, which was 0.1m thick, beneath which was a mid-greyish brown loose sandy clay with 10% rounded cobbles and some lime mortar. At a depth of 0.4m the footing of the church wall widened slightly and at 0.5m a pale brown sandy clay was encountered, presumably the natural (Plate 27).

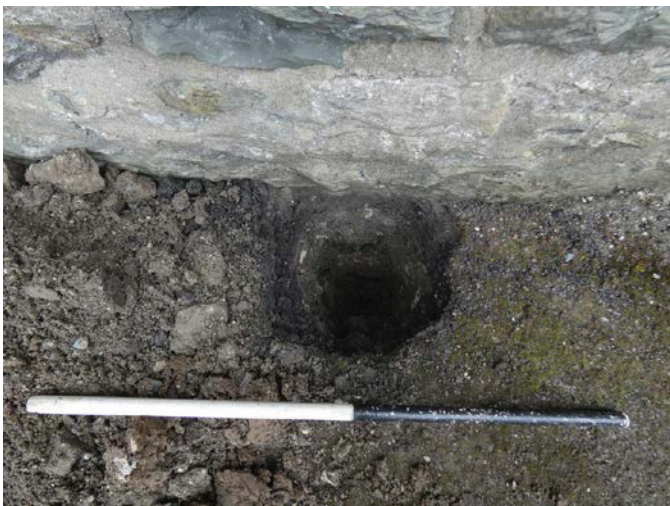
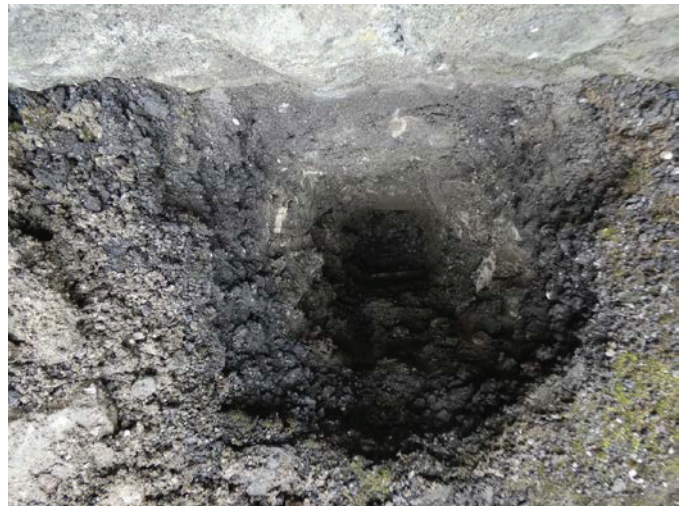
4.6.6 **Test Pit 3 (TP3)**: this comprised the hand-excavation of a pit c0.3m square to a total depth of c0.7m. The initial deposit comprised the tarmac path, which was 0.1m thick, beneath which was a mid-greyish brown loose sandy clay with rounded and angular cobbles, including some fragments of thick roofing slate, and lumps of lime mortar. At a depth of 0.5m the foundations became slightly wider and at c0.7m the base of the foundations was reached (Plate 28). An iron pipe was revealed on an east/west alignment, along the north side of the trench (Plate 28).

Plate 28 (left): Test Pit 3 excavated, viewed from the north

Plate 29 (right): Close up view of Test Pit 3 showing the pipe, from the north
