WENNINGTON OLD FARM, TATHAM, LANCASTER, LANCASHIRE

Heritage Assessment

June 2021

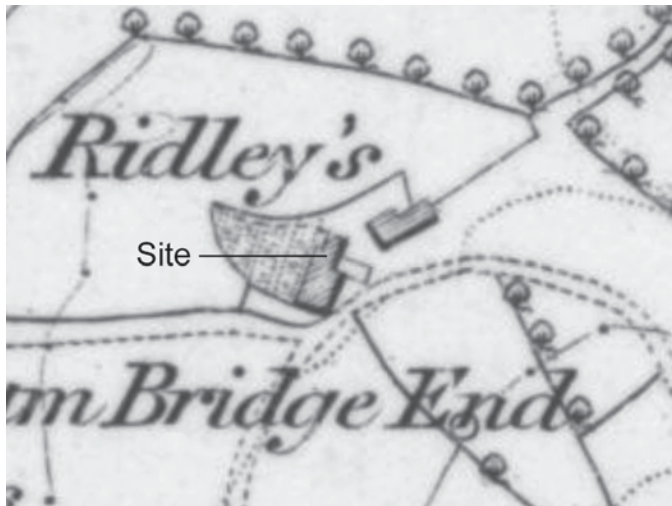
Plate 1 (left): Extract from the Ordnance Survey map of 1847

3.2.1 **Ordnance Survey, 1847:** the building is clearly shown at this date as a single north-east/south-west orientated structure (Plate 1). The south-west end is evidently much wider and there is a suggestion of a smaller outshut or outshuts being present at the north-east end. The core of the building is essentially much as it is today.

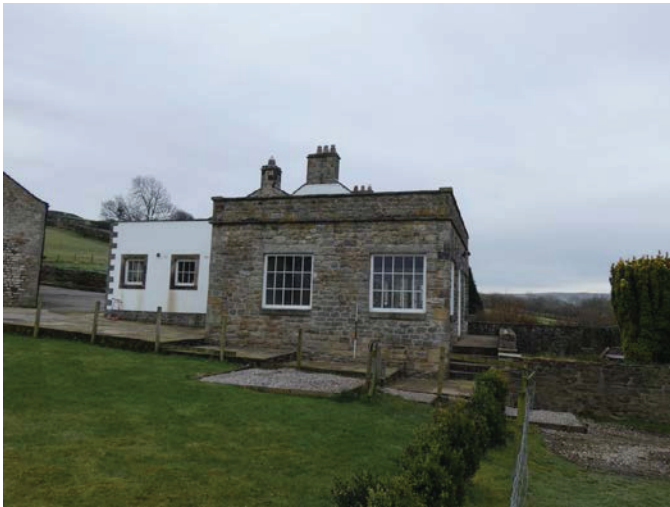
Plate 11 (left): The west side of the north external elevation, viewed from the north

3.4.2 North external elevation: the west side comprises the flat roofed modern extension with a string course below the parapet. The corner has dressed stone quoins. There are two large windows in this section, both with fixed 15-light casements and stone sills and lintels (Plate 11). The return to the east has a double doorway, each with eight lights and with a stone lintel. The east end has a row of three windows each with dressed square stone surrounds and hinged six-light casements and this section is also finished with render scored to give the appearance of ashlar blocks but with projecting stone quoins at the east end. (Plate 12) Above this lower section is the raised gable of the main part of the building to the south, which is constructed from roughly coursed stone and has a small chimney with stone water tabling and a single ceramic pot. Beyond this, to the south, is the gable of the central part of the house,

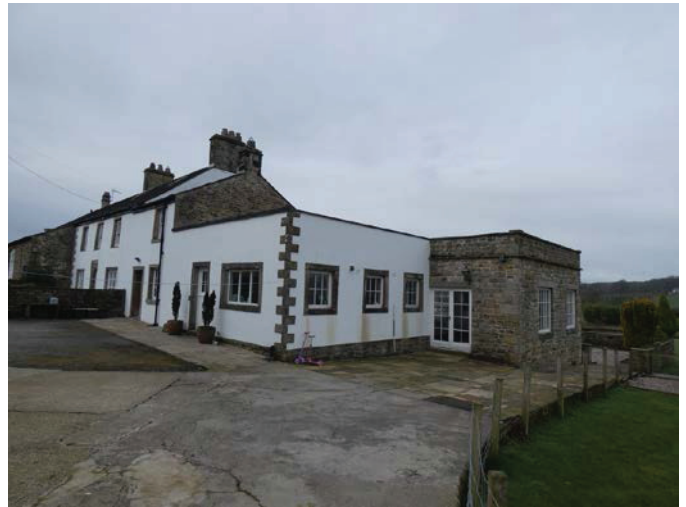
Plate 12 (right): The east side of the north external elevation, viewed from the north-east

which is finished with smooth render apart from the chimney, which is constructed from ashlar stone work with water tabling and three ceramic pots.

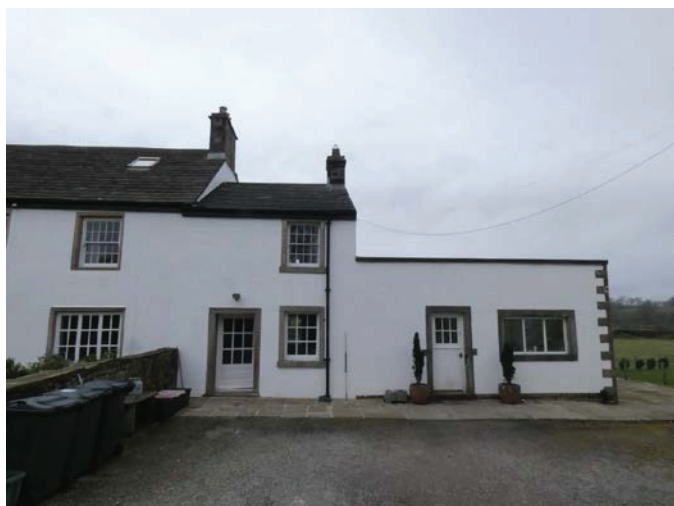
Plate 13 (left): The north end of the east external elevation, viewed from the east

3.4.3 East external elevation: the north end is part of the single storey extension with a flat roof and plain parapet. It is rendered with scored ashlar blocks and projecting quoins at the north end (Plate 13). There is a long low window on the north side with square stone surrounds and a fixed three-light casement. To the south is a doorway also with square stone surrounds, although with central projecting keystones in the jambs, and a split door, the top half with six lights the bottom plank and batten. To the south of this the elevation raises to two stories. The ground floor has a window with a square stone surround with a fixed nine-light casement. To the south is a doorway with nine lights in the top and a fielded panel below. At first floor level is a window, again with square stone surrounds and a 16-light sash casement with horns. To the south the elevation is raised again at the centre of the house (Plate 14). There are a pair of wide windows on the ground floor with narrow dressed stone surrounds with a steep chamfer and three part six-light casements, hinged in the centre (Plate 15). These are either side of a central doorway with moulded quoined jambs and an embattled lintel with the date '1688' and initials 'RM' carved in relief (Plate 16). The door has nine lights above a moulded panel. The first floor has three more windows again with narrow dressed stone surrounds with a steep chamfer and modern 20-light sash casements with horns. At the south end there are ashlar V-jointed quoins against a return in the wall to the east, which is plain but has ashlar dressed stone quoins where it returns to the south. There is a small doorway immediately after this with square surrounds and a modern glazed 12-light door (Plate 17 and Plate 18). To the south is a large wagon doorway with ashlar quoins and a flat voussoir arch. The door has been infilled with large panelled double doors with 16 lights over and four lights in flanking panels either side. There is a further doorway at the south end blocked with stone and with a square surround and ashlar quoins at the south-east corner.

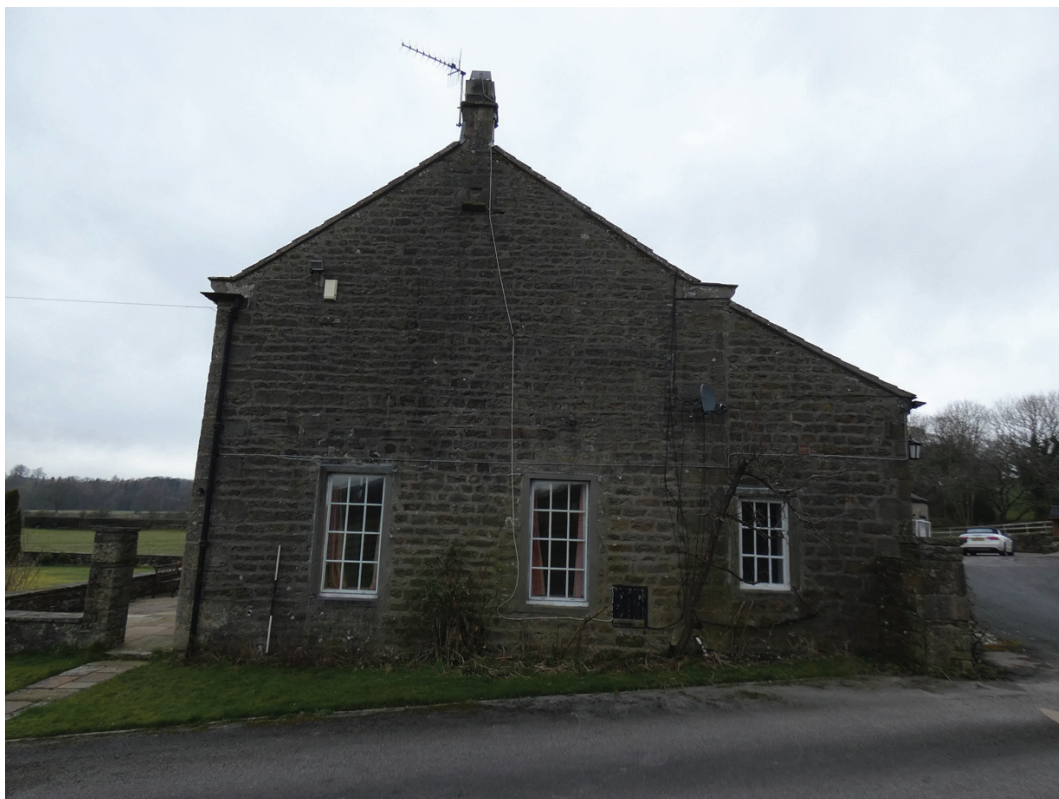
Plate 19: The south external elevation, viewed from the south

3.4.4 South external elevation: this comprises the gable end of the building, with a continuous outshut extension clearly added to the east side (Plate 19). It is all exposed stone laid in rough courses with a small chimney on top of ashlar stone. There are dressed quoins at either end with ovolo-moulded kneelers on top, although the eastern one is partially hidden by the outshut roof. Below the chimney is a former owl hole, blocked with stone but leaving a small recess, and with a projecting stone sill. At ground floor level there is a pair of windows that are evidently inserted and have thin band surrounds in concrete and lead over the lintels, extending to either side, and 12-light casements (Plate 20). Low to the east of these is a further small opening with a plank door. The outshut extension to the east also has a small window with square stone surrounds and a nine-light fixed casement (Plate 21).

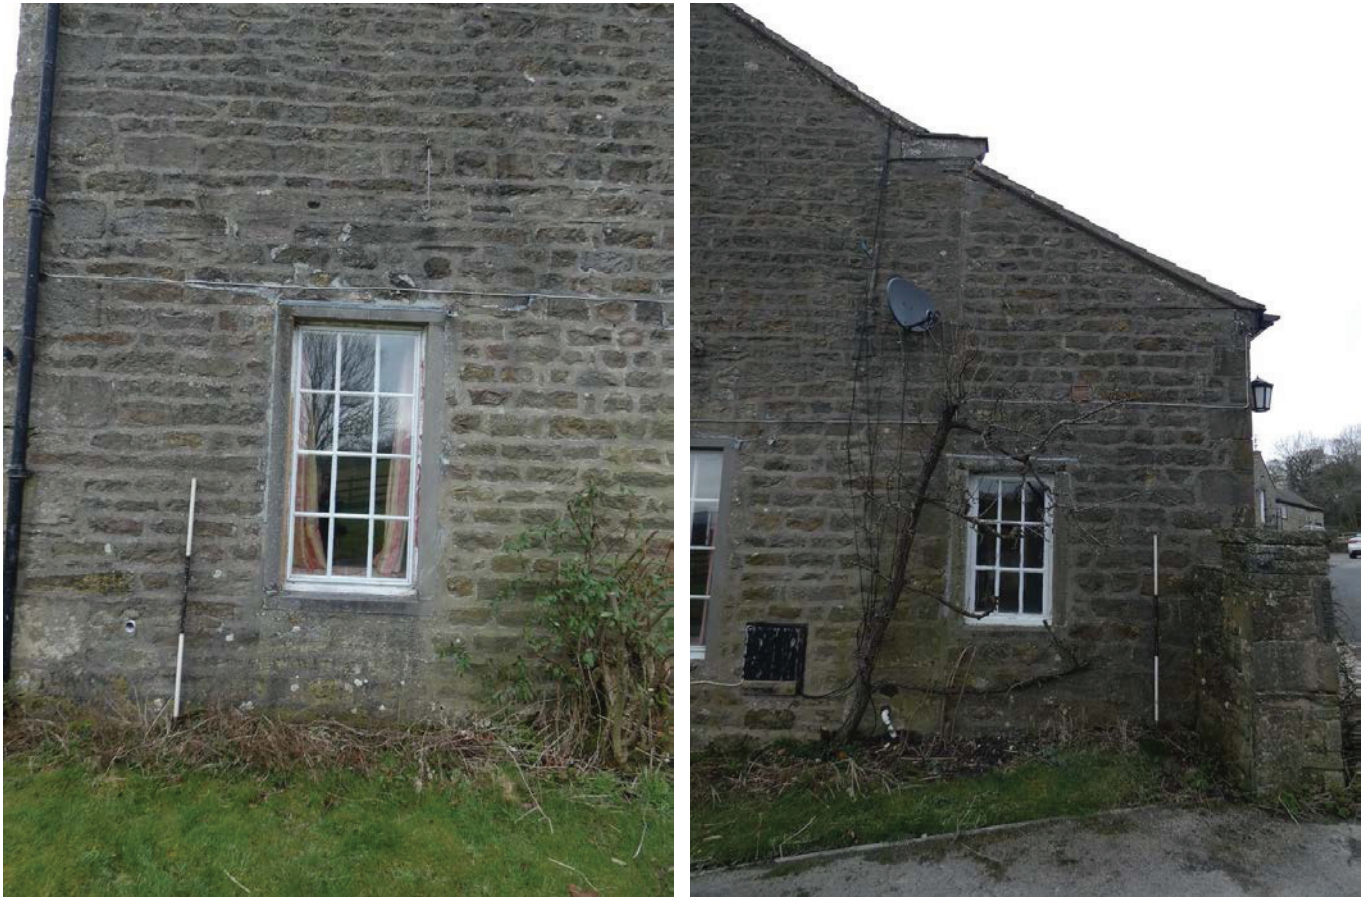
Plate 20 (left): Detail of inserted window in the south external elevation, viewed from the south

Plate 21 (right): Outshut extension on the east side visible in the south external elevation, viewed from the south

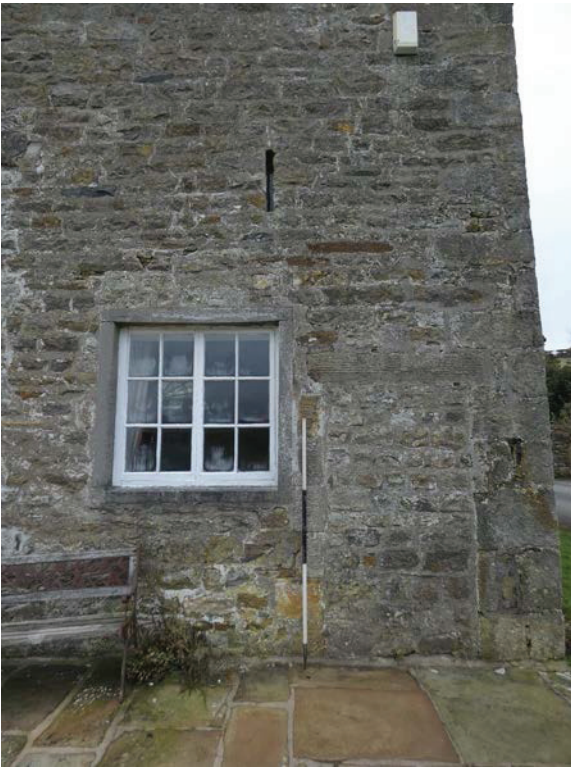
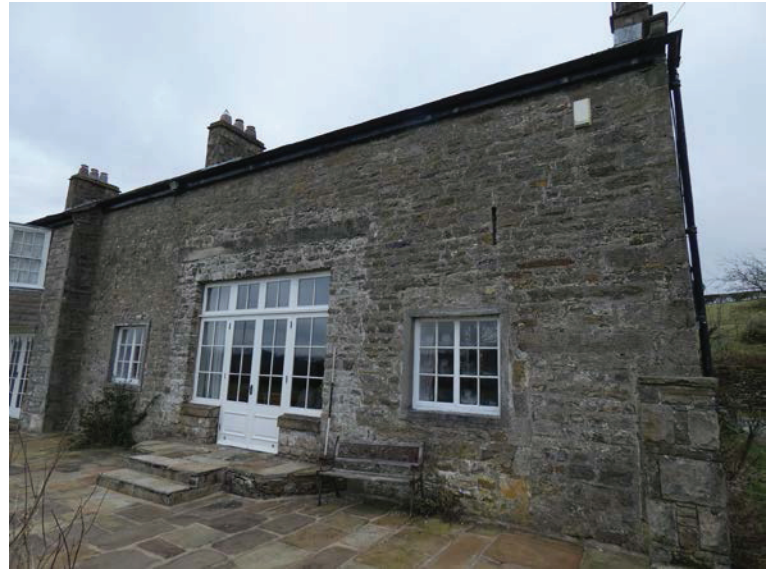
Plate 22 (left): The blocked doorway and inserted window in the south end of the west external elevation, viewed from the west

Plate 23 (right): General view of the south end of the west external elevation, viewed from the south-west

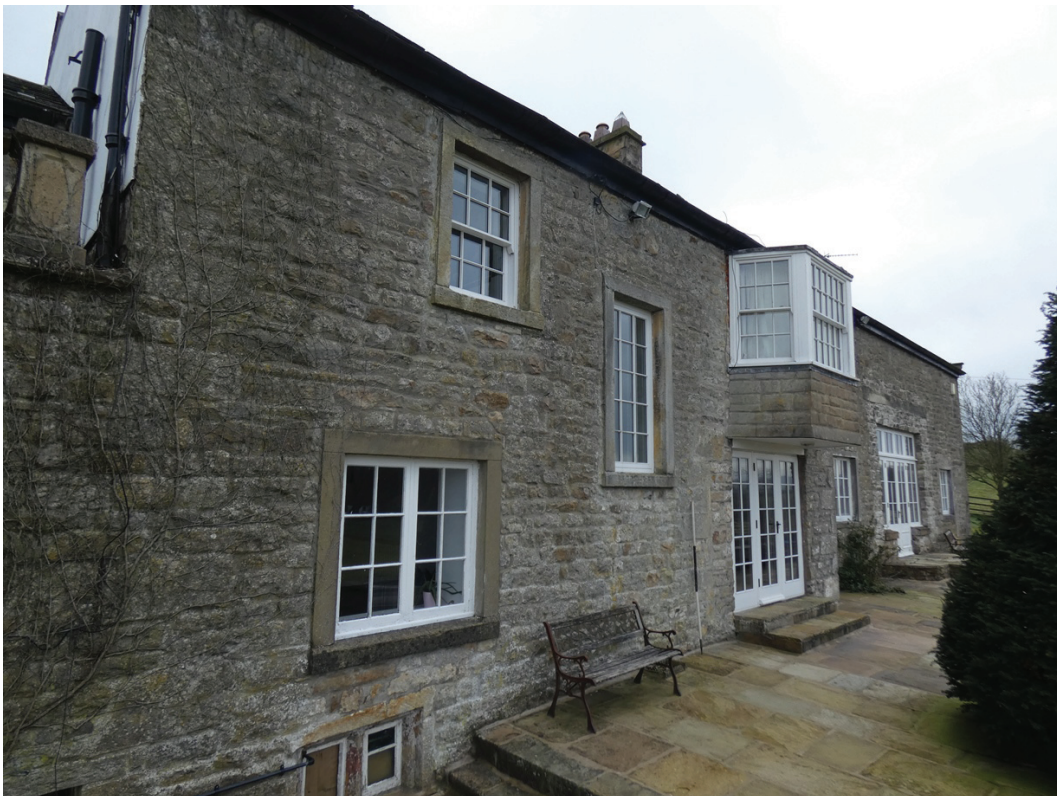
Plate 24: General view of the central part of the west external elevation, viewed from the north-west

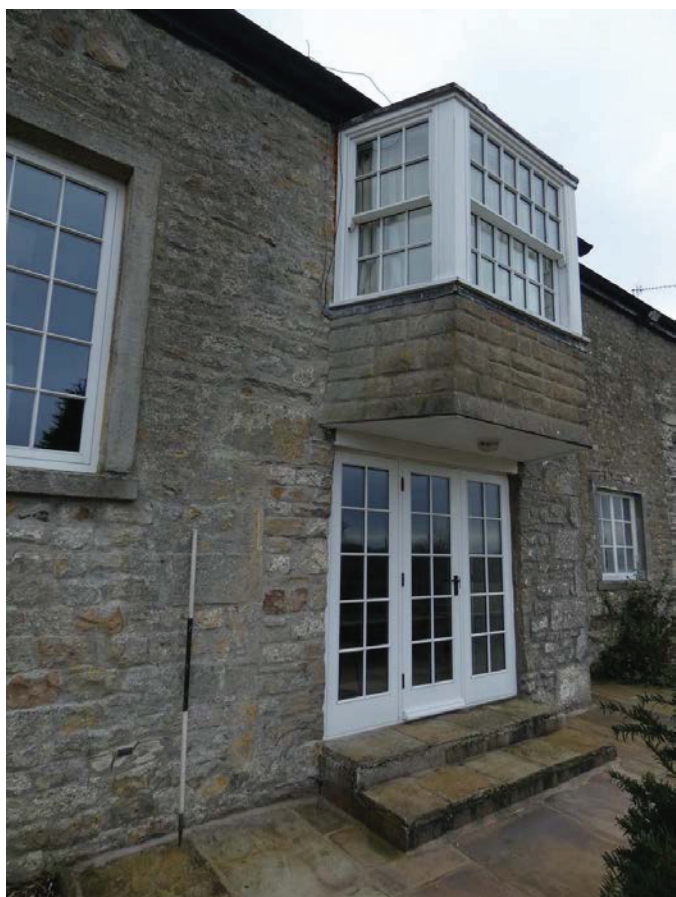
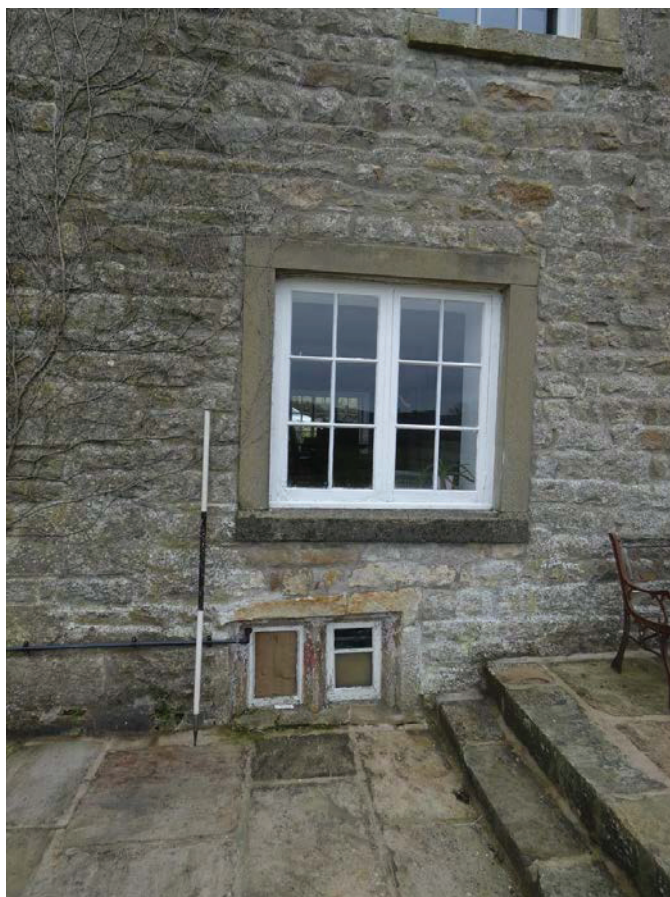
Plate 25 (left): Blocked former door, French door and bay window on the south side of the central section, viewed from the north-west

Plate 26 (right): Ground floor and cellar windows on the north side of the west external elevation, viewed from the west

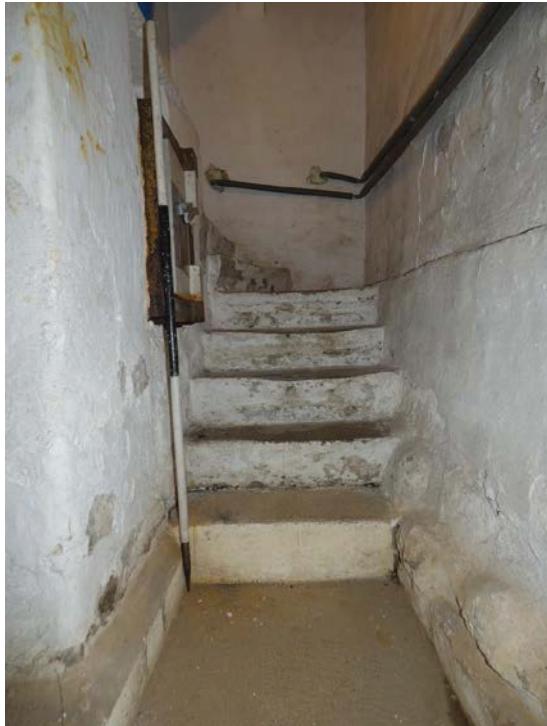
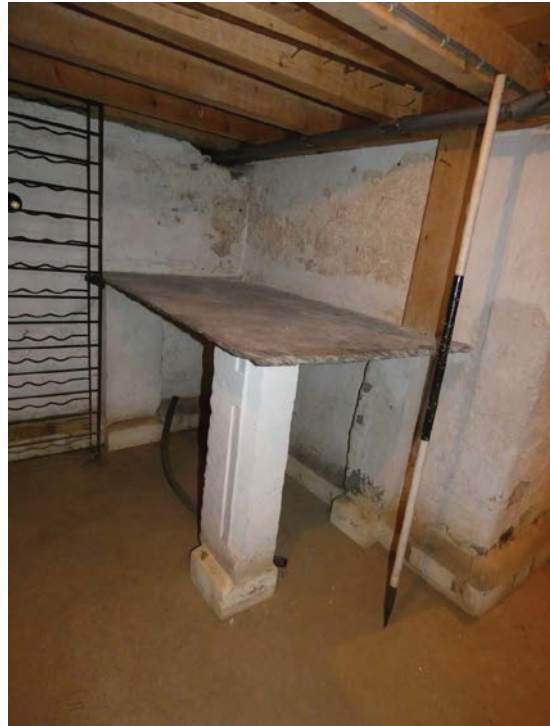
west are plain, although the underside of the stairs is visible in the east, which has thick boards some of which with Baltic timber marks and chamfered supporting pieces (Plate 31). There is a stone shelf below this and a modern safe set into the wall. To the south of this is a doorway, the door of which has six plain panels. The west elevation has a small window with a central chamfered stone mullion, stone sill and splayed jambs (Plate 32).

Plate 29 (left): Stone steps on the south-west side of Room B1, viewed from the north

Plate 30 (right): Stone bench in Room B1, viewed from the north-west

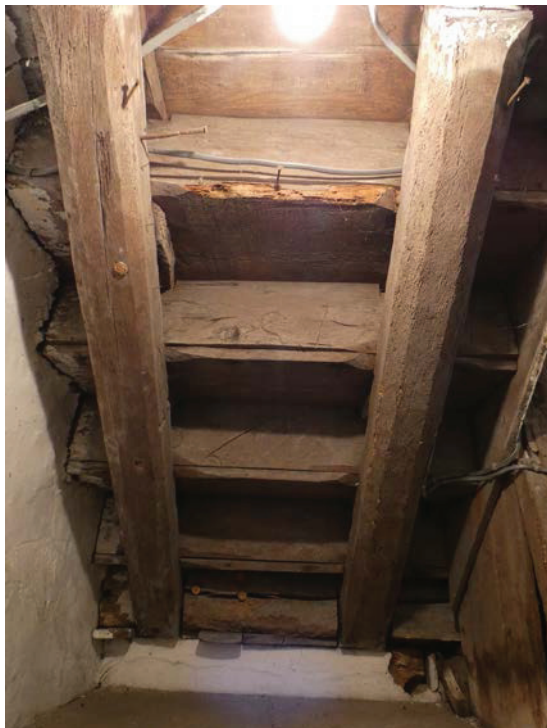
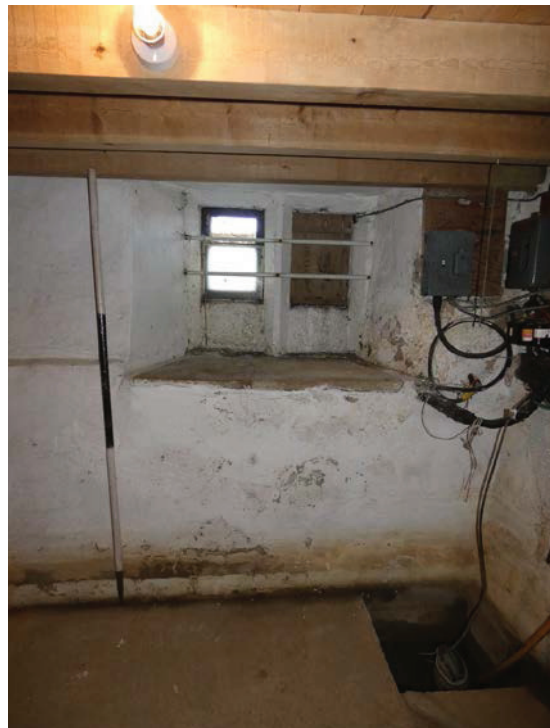
Plate 31 (left): Underside of the stairs on the east side of Room B1, viewed from the west

Plate 32 (right): Mullion window in the west elevation of Room B1, viewed from the east

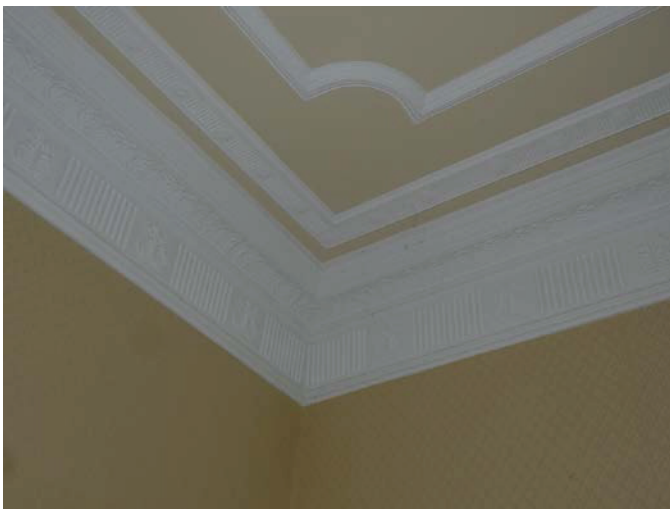
Plate 33 (left): Detail of the cornice in Room G1, viewed from the south-west

3.4.7 Internal detail – Room G1: this comprises a large function room at the south end of the building. The floor is finished with carpet and the ceiling is plaster with applied Georgian-style cornice and decorative including floral swags and fluting (Plate 33 and Plate 34). The walls are also finished with plaster, wallpaper and a denticular dado rail, and the whole room has been extensively modernised. The north elevation is plain apart from a wide doorway with double doors, each with five panels. The east elevation has a large doorway near the centre with elaborate glazed infill comprising glazed double doors with a massive fan light above and flanking lights to either side (Plate 35). There is a low cupboard set in an alcove to the north containing a heater. The south elevation has a central fireplace with a decorative surround comprising a polished stone insert and elaborately carved timber and houses a woodburning stove (Plate 36). Either side of the fireplace there is a window with a window seat and at either end of the elevation the walls have been built out to form large cupboards with double doors each with a pair of eight lights and panelling. The large alcove that the fireplace sits in has scrolled kneelers decorated with acanthus leaves at either end. The west elevation has a large central doorway with French doors (Plate 37), either side of which is a window with splayed jambs finished with panels and a timber sill (Plate 38). The lower part of the winnowing slots visible externally are just evident at the top of the wall, continuing behind the cornice and ceiling.

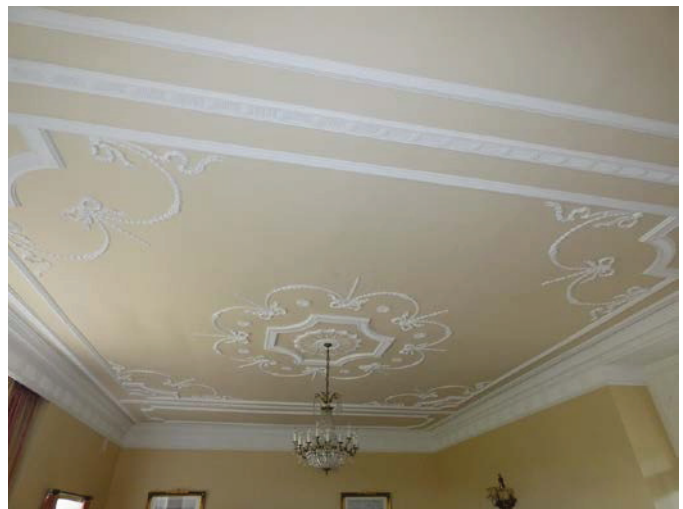
Plate 34 (right): The ceiling in Room G1, viewed from the south

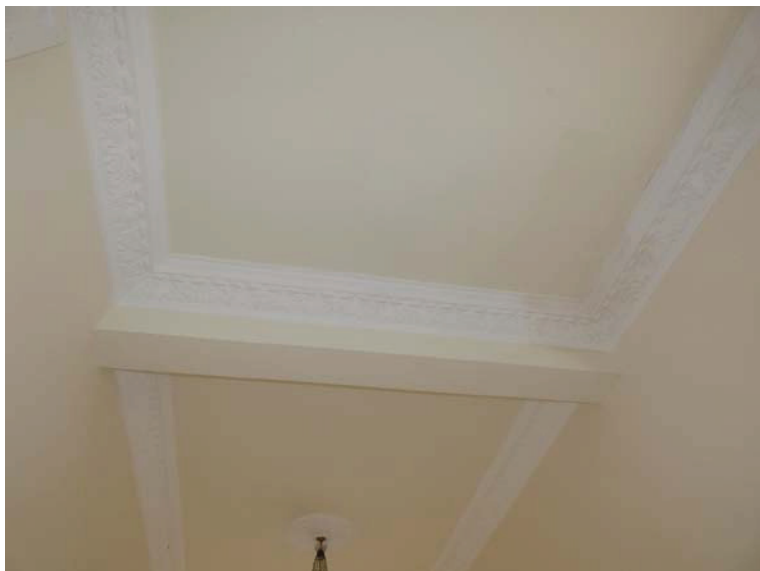
Plate 39 (left): The cornice in Room G2, viewed from the south

3.4.8 Internal detail – Room G2: this comprises a long ‘lobby’ off the east side of Room G1. The floor is finished with carpet, and raised relative to Room G1, and the ceiling is plaster with an ornate cornice and a single plastered beam orientated east/west (Plate 39). The south end has been partitioned off to form a bathroom and the walls are finished with plaster and paint. The north elevation has a small alcove on the west side with a rough timber lintel and later timber sill, and steps back on the east side to form a larger alcove adjacent to the doorway in the east elevation (Plate 40). The door within this has a glazed 12-light door and to the south there is a large doorway with central double doors each with three panels and an overlight and flanking lights (Plate 41). The south end, inside the bathroom, has been extensively modernised and is tiled throughout. There is an alcove in the south end of the east elevation corresponding with the blocked doorway visible externally (Plate 42). The south elevation, inside the

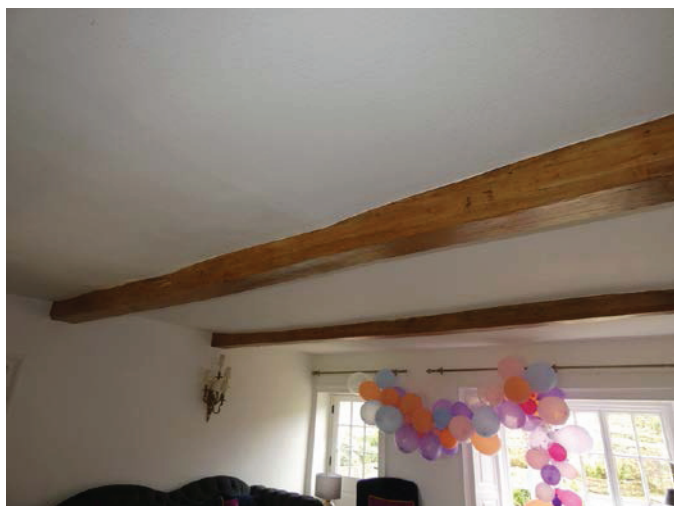
Plate 43 (left): Beams in Room G3, viewed from the south-west

3.4.9 **Internal detail – Room G3:** this comprises the living room within the main part of the house and has a carpet floor and flat plaster ceiling with two exposed timber beams orientated east/west, which are hand-finished and chamfered with stop chamfer detailing at the north end of the eastern one (Plate 43 and Plate 44). There is a further east/west beam in the south-west corner (Plate 49). The walls are finished with plaster and wallpaper and have a moulded skirting board. The north elevation has a modern cupboard built into an alcove on the west side before a return to the north (Plate 45). This contains a doorway to the stairs (Room G4), which has an early surround decorated with fluted columns, mouldings and a rounded arch (Plate 46) but a modern door with six lights in the top. The elevation proper to the east of this has another doorway with a moulded surround and modern door. The east elevation has a doorway on the north side with a moulded surround and modern door (Plate 47). To the south is a window with splayed jambs with bevelled raised and fielded panels and a timber sill seat (Plate 47). The south elevation is plain apart from a doorway with a moulded surround and double doors (Plate 48). There is a vent for a former fireplace to the west. The west elevation has a wide French door on the south side with a moulded surround and panelled jambs, all modern (Plate 49).

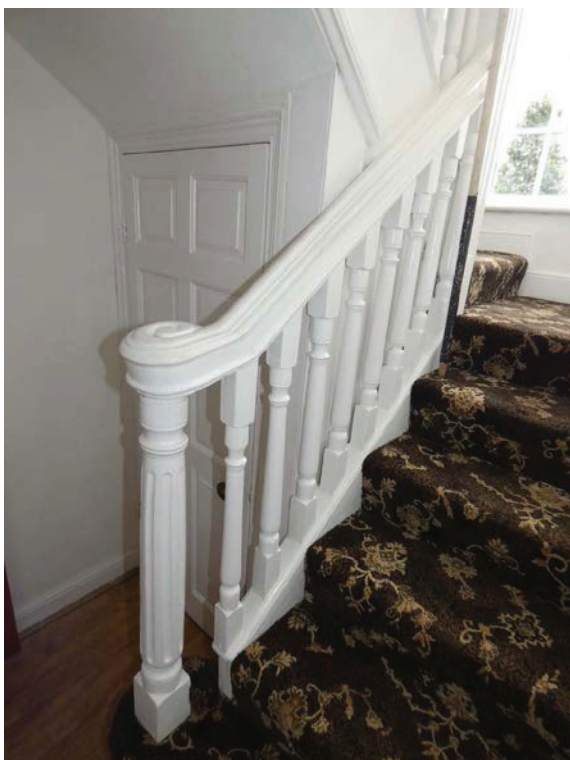
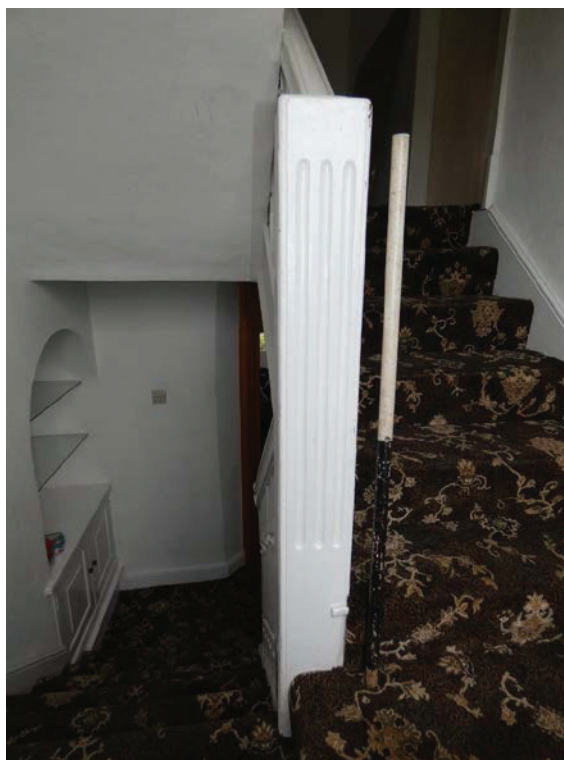
3.4.10 **Internal detail – Room G4:** this comprises the dog-leg staircase within the main part of the house. The staircase has turned balusters on square blocks and a moulded newel post and handrail coming to a scrolled end (Plate 50). At the landing level the newel post is fluted (Plate 51) and there is a tall stair window to the west with splayed jambs and a timber sill seat. At ground floor there is a doorway on the west side leading to the cellar with six bevelled raised and fielded panels and a moulded surround (Plate 52). In the north wall there is an alcove with a rounded head and pair of panelled doors in the bottom (Plate 53).

Plate 50 (left): Staircase in Room G4, viewed from the north-east

Plate 51 (right): Fluted newel post on landing in Room G4, viewed from the west

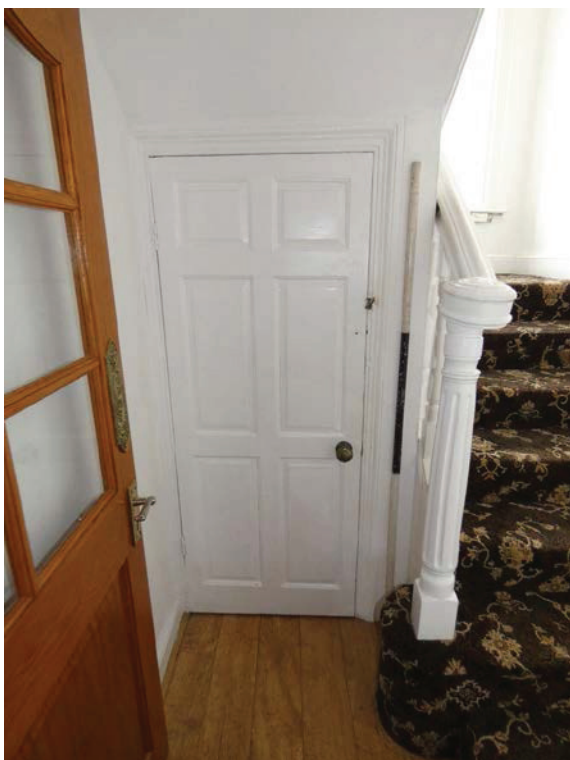
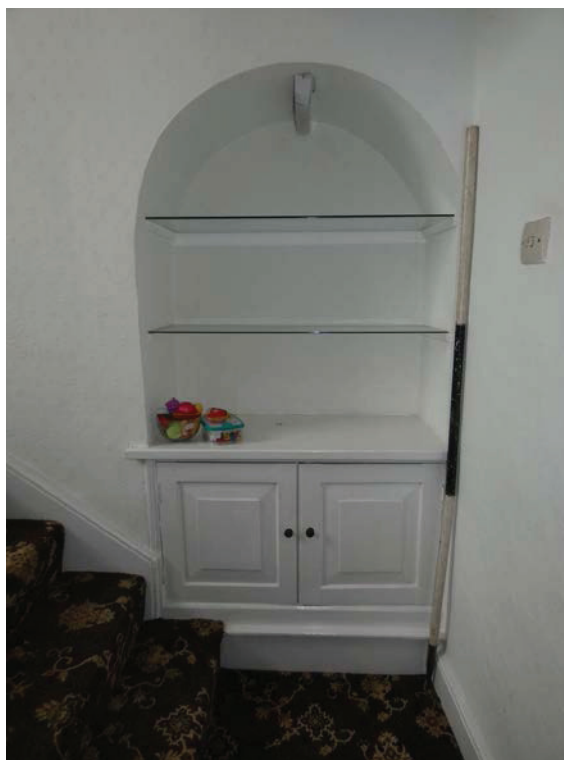
Plate 52 (left): Door to the cellar in Room G4, viewed from the east

Plate 53 (right): Alcove on the north side of Room G4, viewed from the south

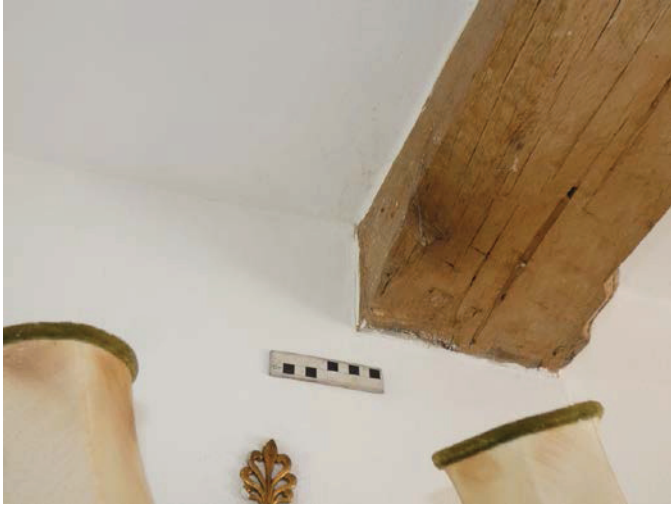
Plate 54 (left): Detail of a chamfered beam in Room G5, viewed from the south-west

3.4.11 **Internal detail – Room G5:** this comprises a dining room and has a carpeted floor and plaster ceiling supported by two beams running north/south, both of which are hand finished and chamfered with runout stops (Plate 54). The walls are finished with plaster and paint and has a tall moulded skirting

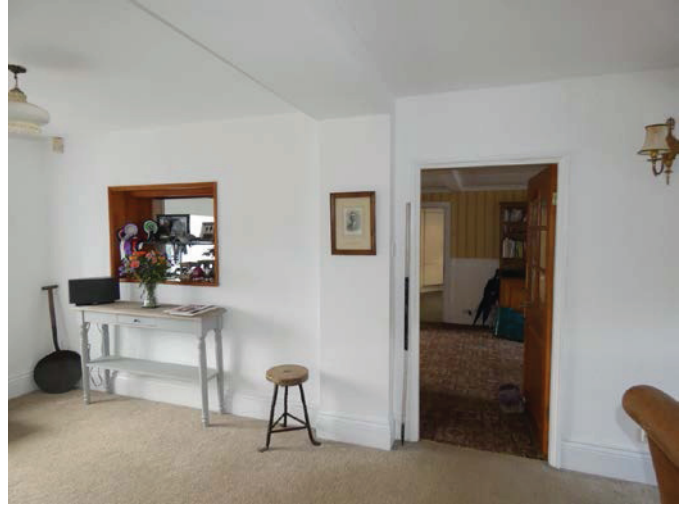
Plate 55 (right): The north elevation in Room G5, viewed from the south-east

board. The north elevation has a long low alcove on the west side, now housing shelving but perhaps originally a window (Plate 55). To the east is a doorway with a moulded surround and modern door with six lights in the top. To the east is a vent for a former fireplace. The east elevation has a large window with splayed jambs with panelling as per Room G3, a timber sill and moulded surround (Plate 56). The south elevation has a tall alcove on the east side, which is largely plain but has bevelled raised and fielded panels in the lower part (Plate 57). To the west is a doorway with a moulded surround and modern door. The west elevation steps out around the staircase (Room G4) and has a window with square jambs, a modern hinged casement, and timber sill seat.

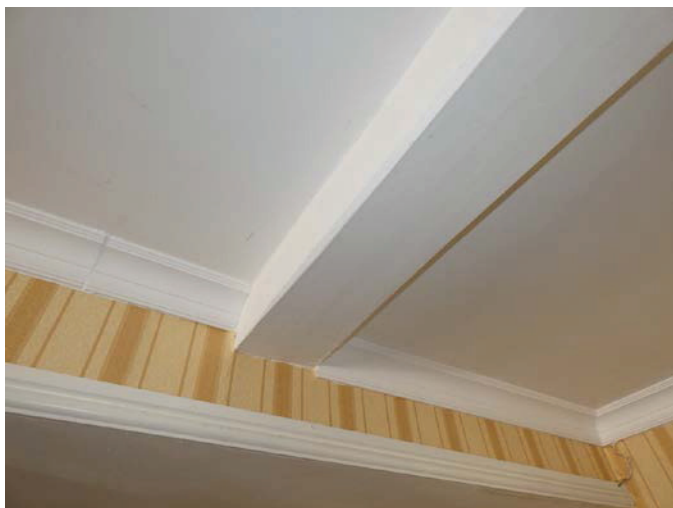
Plate 58 (left): Beam in Room G6, viewed from the south-east

3.4.12 **Internal detail – Room G6:** this forms an entrance hall into the building. The floor is finished with carpet and it has a plaster ceiling with two beams orientated north/south, both very neatly finished and

with a narrow runout chamfer, and there is also a simple modern coving around the whole room (Plate 58). The walls are finished with plaster and wallpaper and the lower part is partially covered by timber-effect panelling. The north elevation has a double doorway, which is glazed, at the west end before a return through a wide opening. There is then another doorway with a plain surround and modern door with six-lights (Plate 59). To the east is a fixed bookcase incorporating a false fireplace with polished stone insert (Plate 60). The east elevation has a window on the north side with splayed jambs, the northern of which is overlong, and a timber sill (Plate 61). There is a doorway to the south in an overlong opening, with a very shallow splayed jamb on the south side (Plate 61). The south elevation has a doorway on the west side, also in an overlong opening with a single step up and a moulded surround around the wider opening and the doorway (Plate 62). The west elevation has a window with a pair of six-light hinged casements and a timber sill (Plate 63).

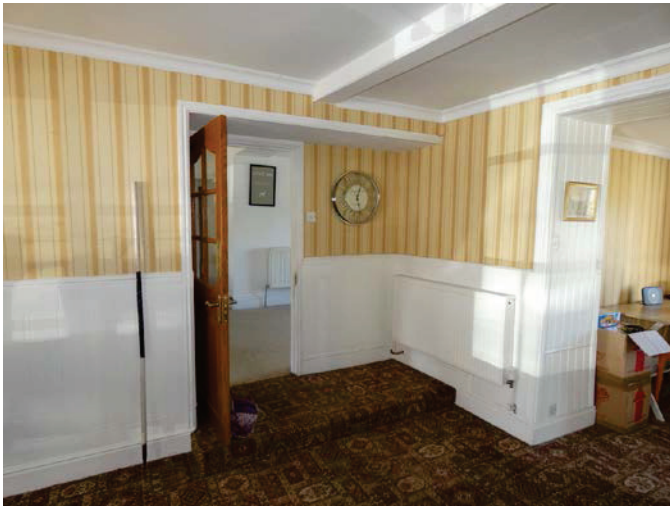
Plate 60 (left): Built in bookcase with false fireplace on the east side of the north elevation of Room G6, viewed from the south-west

Plate 61 (right): Window and doorway in the east elevation of Room G6, viewed from the west

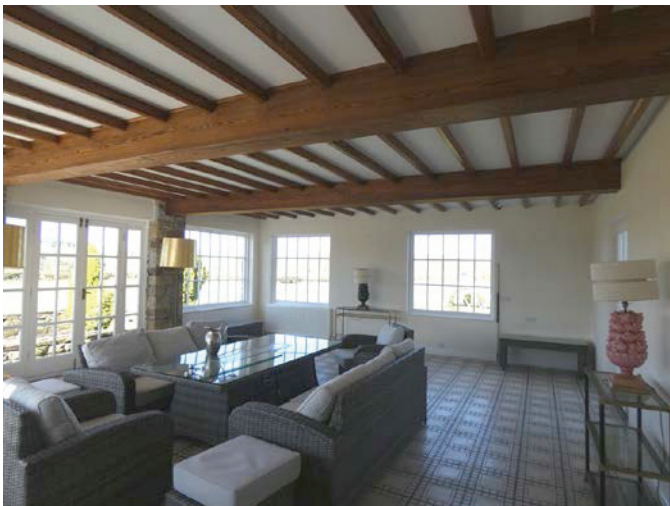
Plate 64 (left): General view of Room G8, from the south-east

3.4.14 **Internal detail – Room G8:** this comprises a garden room within the modern extension. It has a tiled floor and flat plaster ceiling supported by two large east/west beams and chamfered joists (Plate 64). The walls are finished with plaster and paint with a partition on the east side forming a small toilet. The walls are generally fairly plain, with large windows to the north and west and a French door with flanking windows on the west side of the south elevation and double doors up a flight of steps on the east side (Plate 65). The west elevation has two exposed stone buttresses either side of another French door and the east elevation has a doorway into the toilet.

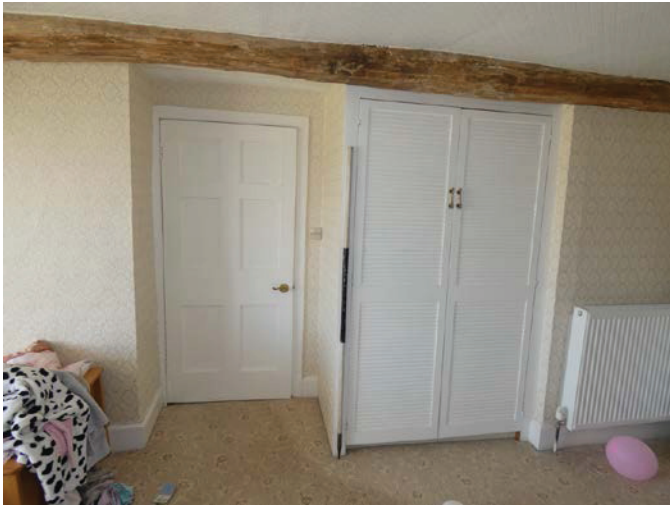
a modern stud partition wall with doorway with an early door with six plain panels and a built-in modern cupboard with double doors to the east of this (Plate 66). The east elevation, within the bathroom, has a window with a modern sash casement and panelling over splayed jambs (Plate 67). The south elevation is plain, and the west has a projecting canted bay window with modern sash casements (Plate 68).

Plate 66 (left): Doors in the north elevation of Room F1, viewed from the south

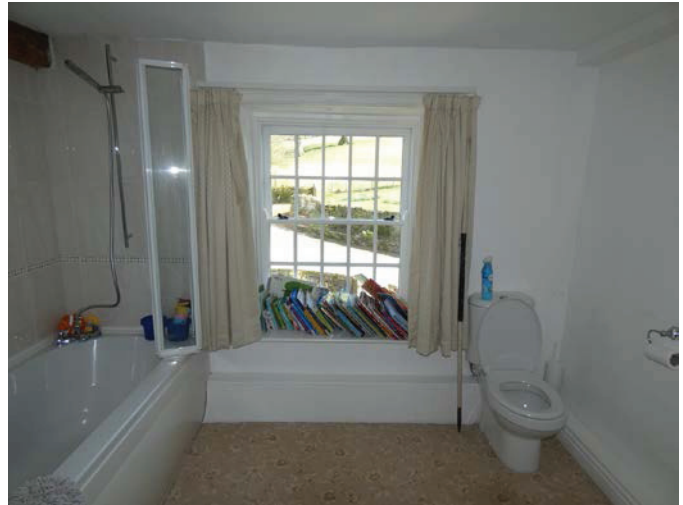
Plate 67 (right): Window in the east elevation of Room F1, viewed from the west

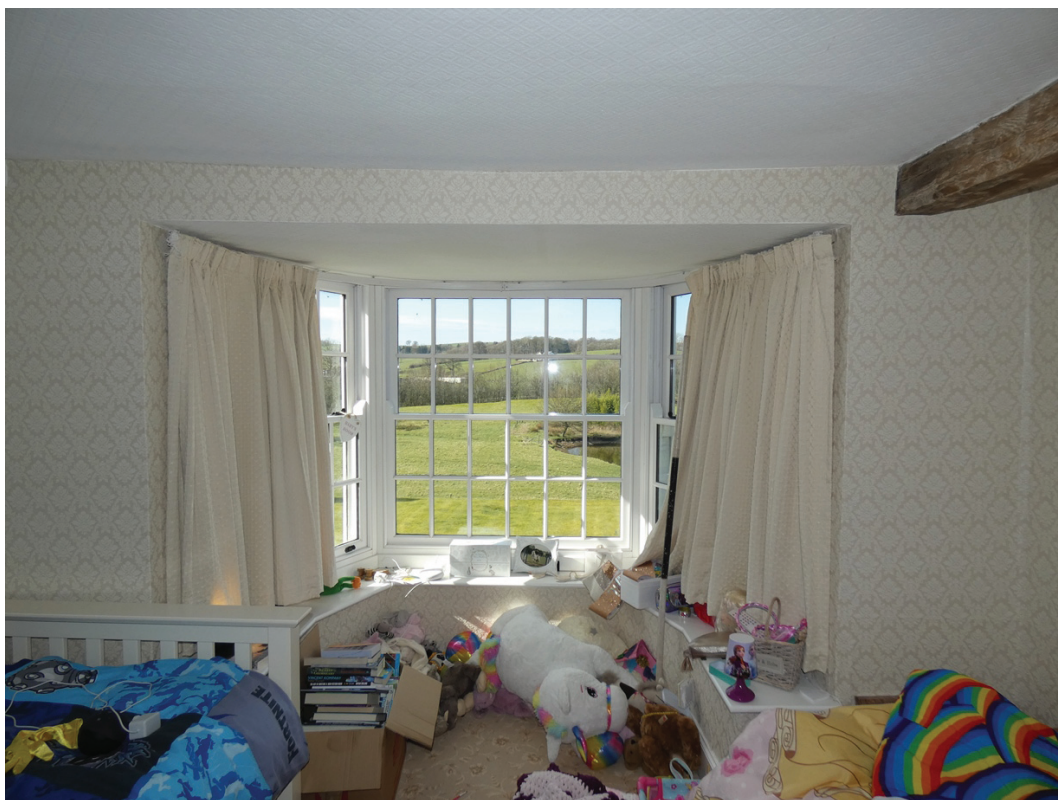
Plate 68 (left): Bay window the west elevation of Room F1, viewed from the east

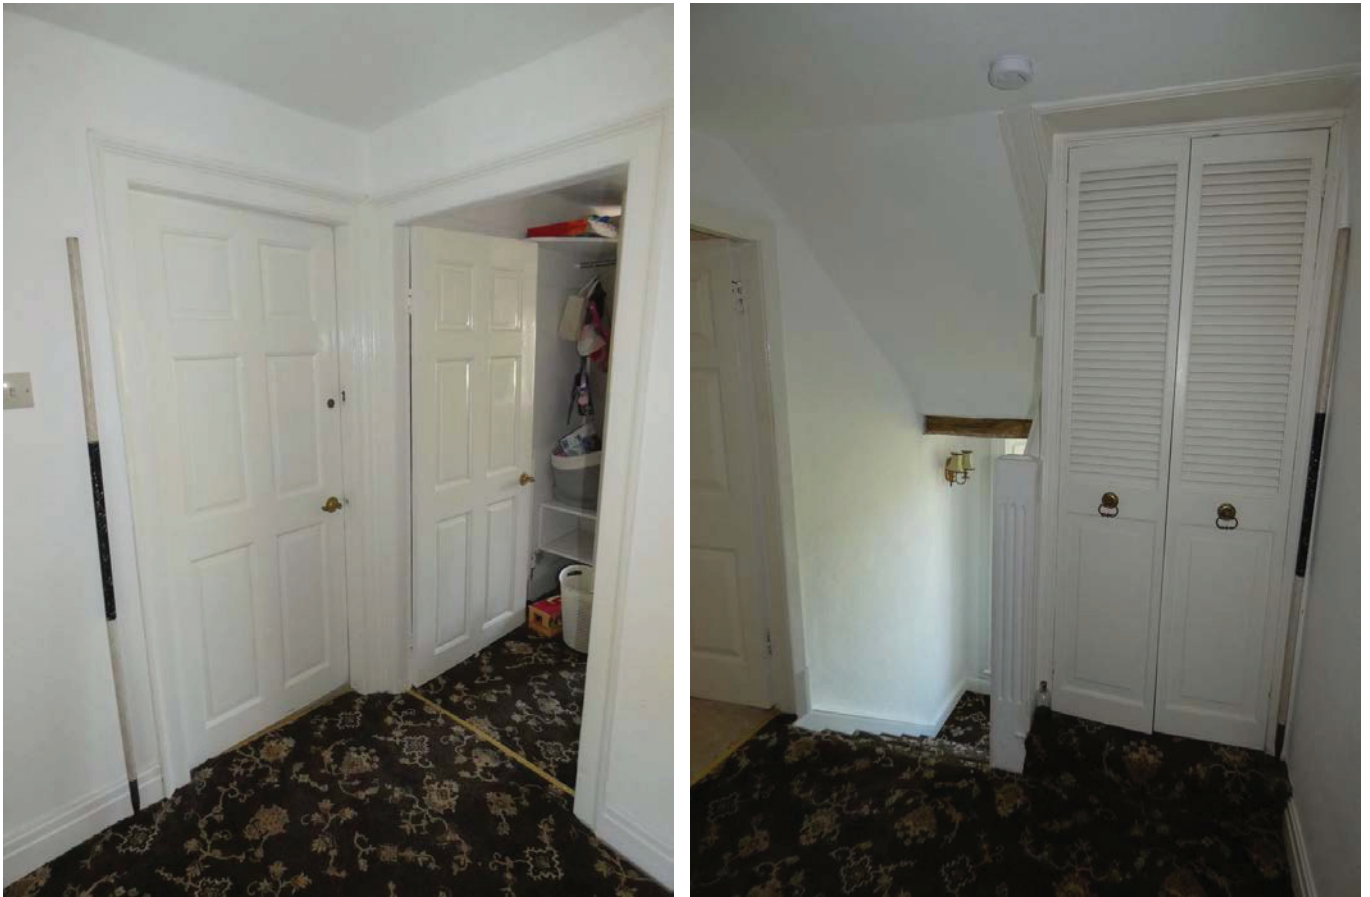
3.4.16 **Internal detail – Room F2:** this forms the landing. The floor is finished with carpet and the ceiling is plaster. The walls are also finished with plaster and wall paper. There are doorways to the north, south and east, all with original six bevelled raised and fielded panel doors and moulded surrounds (Plate 69). There is a narrow double doorway to the west leading to the stairs to the second floor, the top half of the door, which is modern, is vented and the bottom panelled. To the south of this are the stairs down to the ground floor, which have a rectangular section fluted newel post (Plate 70).

Plate 69 (left): Doors to the north and east in Room G2, viewed from the south-west

Plate 70 (right): The west side of Room G2, viewed from the east

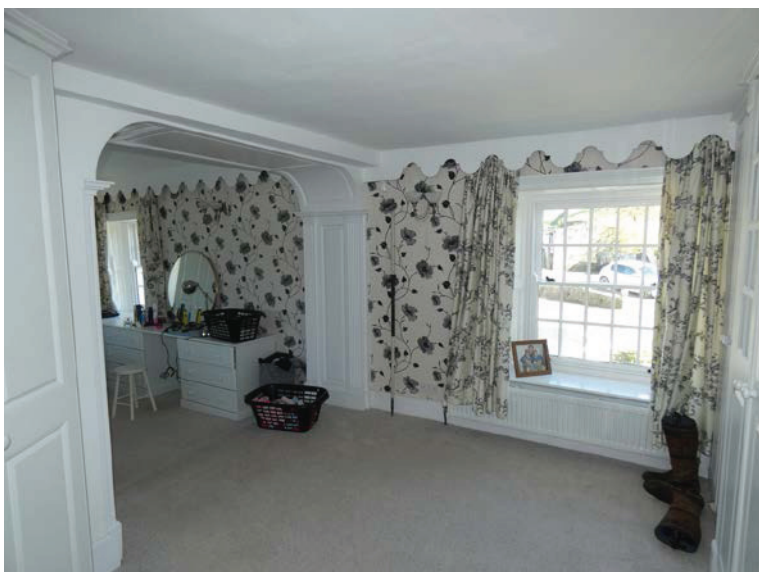
3.4.18 **Internal detail – Room F4:** this has been extensively modernised and the walls are largely covered by fitted cupboards. The floor is finished with carpet and the ceiling plaster. There is a large opening on the east side of the north elevation into Room F5 with a modern arch decorated with panelling and fluted columns (Plate 72). The east elevation has window with a splayed panelled jambs and a modern sash casement (Plate 72), while the south elevation has a doorway on the west side with an early door with six bevelled raised and fielded panels and a moulded surround (Plate 73).

Plate 72 (left): Arch to north and window to east in Room F4, viewed from the south-west

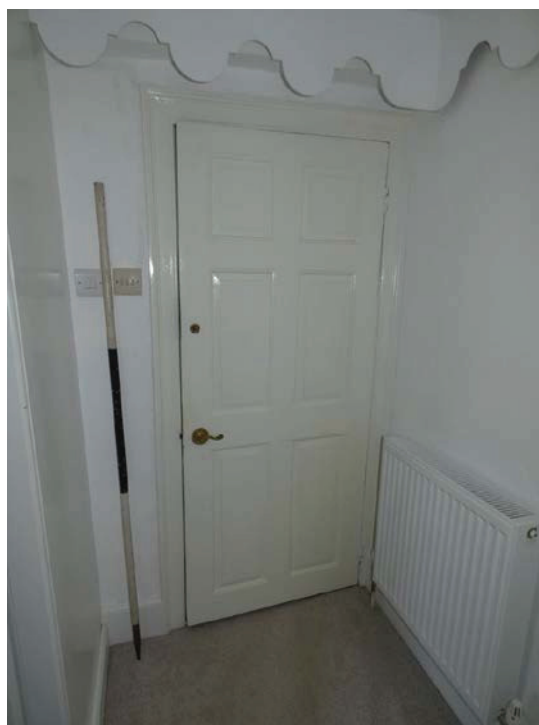
Plate 73 (right): Doorway in the south elevation of Room F4, viewed from the north

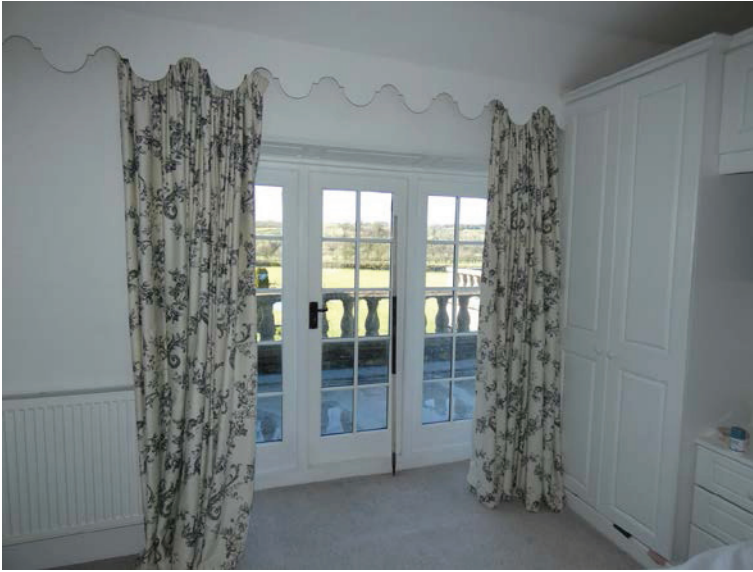
3.4.19 Internal detail – Room F5: this comprises a large bedroom and is accessed through the large arched opening to the south via a single step down from Room F5 to the south. The floor is finished with carpet and the ceiling flat plaster and the walls are finished with plaster and wallpaper, with fitted cupboards to the south and over and around the bed to the north. The room is mostly plain, with a window to the east with a modern sash casement and panelled splayed jambs and French doors to the west leading onto the flat roof (Plate 74). There is a doorway on the west side of the south elevation with an early door with six bevelled raised and fielded panels (Plate 75).

Plate 74 (left): French doors in the west elevation of Room F5, viewed from the east

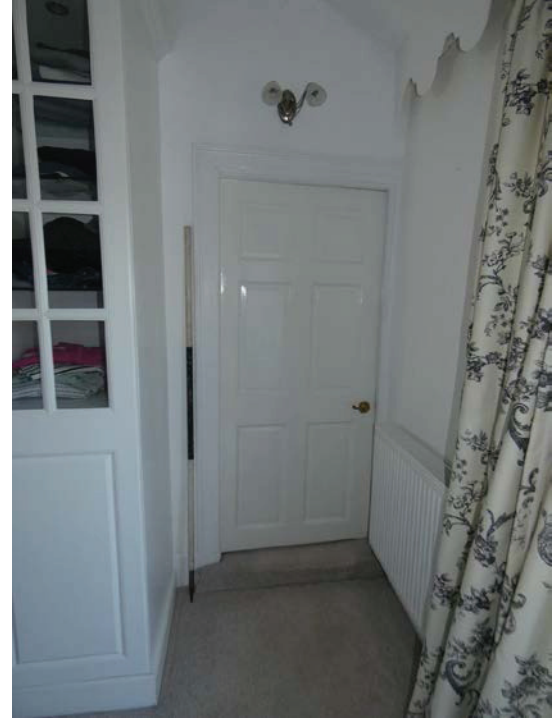
Plate 75 (right): Doorway in the south elevation of Room F5, viewed from the north
