WENNINGTON OLD FARM, TATHAM, LANCASTER, LANCASHIRE

Heritage Assessment

June 2021

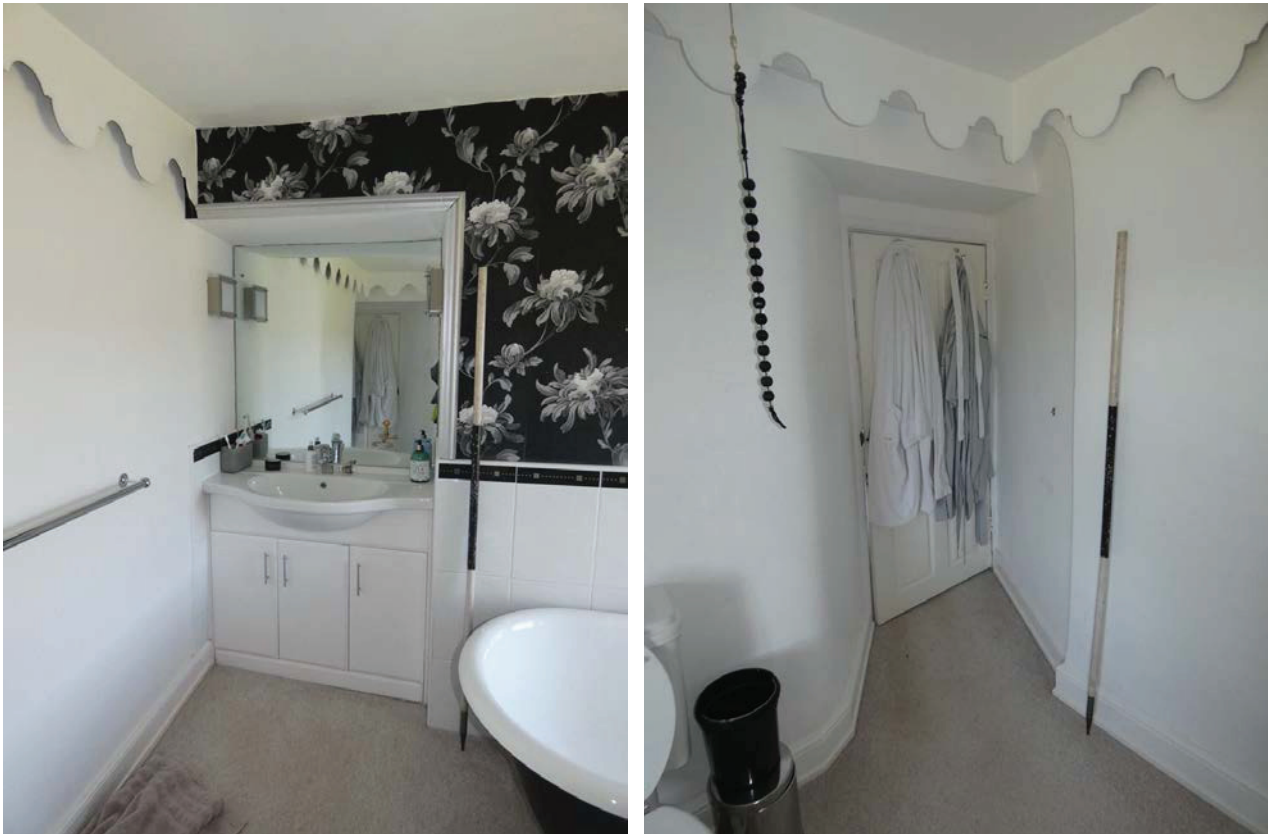
3.4.20 Internal detail – Room F6: this forms a bathroom and is raised up a single step from Room F5. The floor is finished with carpet and the ceiling flat plaster. The walls are finished with plaster and paint and mostly plain, although there is an early six-panel door on the east side of the north elevation, the doorway of which has steeply angled jambs suggesting it was inserted. The south elevation has a tall alcove on the east side, presumably originally a doorway, with some moulded surround remaining (Plate 76), and the west elevation has a window with a modern sash casement and fairly square plain jambs (Plate 77).

Plate 76 (left): Alcove on the east side of the south elevation, viewed from the north

Plate 77 (right): Doorway on the east side of the north elevation, viewed from the south-west

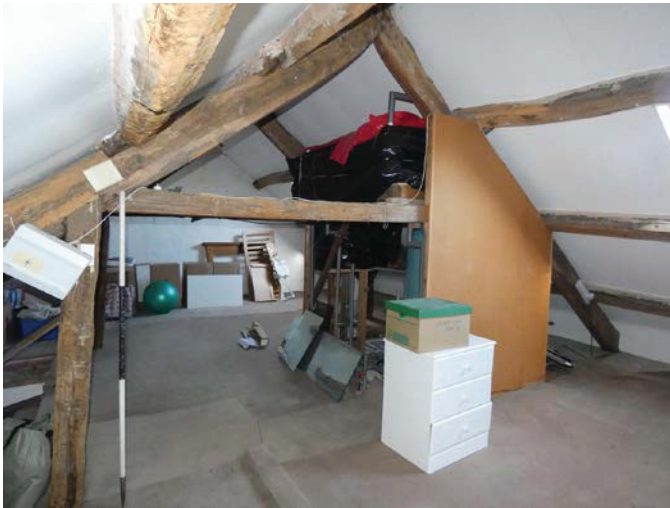
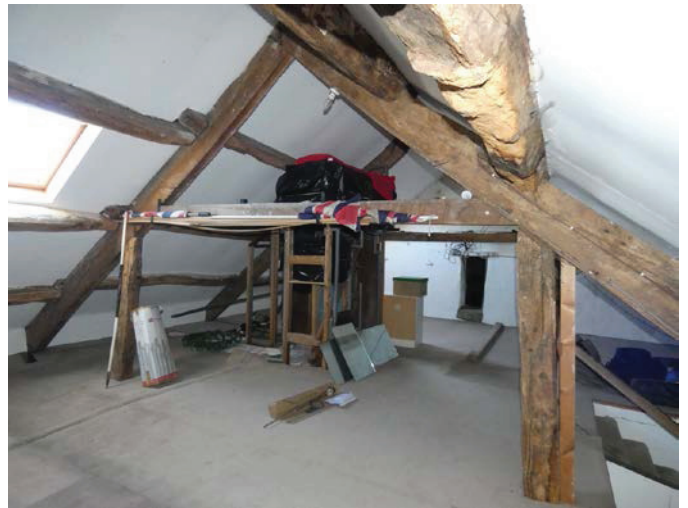
3.4.22 **Internal detail – Room S2:** this comprises a single attic room. It has a carpet floor and is open to the roof, which is backed with modern board. There are two trusses, both of fairly basic tie beam type with lap jointed principals (west on top of east) and pegged. Each has a collar, although this is certainly a modern addition or replacement in the north truss, and each also has a pair of queen posts below the junction between the collar and the principals, although these are probably recent additions or have been more recently moved into this position as both have lots of filler. There are carpenter's marks 'I' and 'II' on the north face of the junction of the principals, from north to south, as well as a 'I' on the east end of the northern principal, again on the north face. In addition, there is an inscribed star on the west end of the south principal and a circle at the west end of the north principal, both also on the north face. The trusses support four purlins per pitch, plus a diagonally-set ridge purlin. All of these are hand-finished and some are evidently reused, probably cruck blades. The east and west elevations are little more than the wall top, although the top of the stairs is on the west side, with a very basic hand rail added between this and the north truss. The north elevation is plain and finished with rough plaster and paint. The south elevation has a similar finish but also a row of through stones and a small doorway providing access to Room S1 to the south. Above this is a modern winch.

Plate 78 (left): The southern truss in Room S2, viewed from the south-west

Plate 79 (right): The northern truss in Room S2, viewed from the north-west

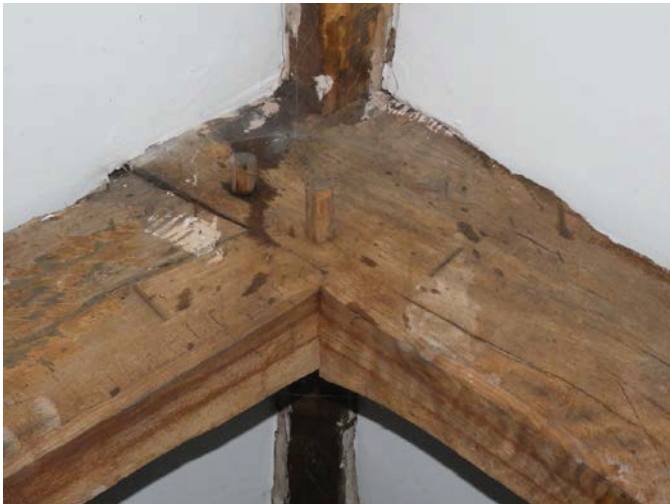
Plate 80 (left): Carpenter's marks 'I' at the top of the north truss, viewed from the north

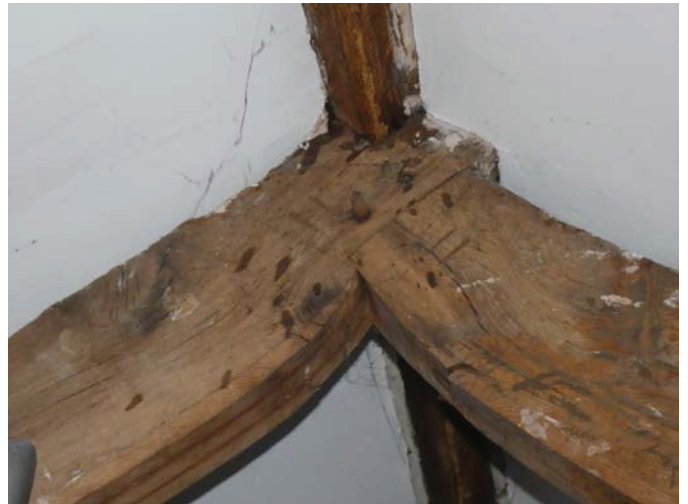
Plate 81 (right): Carpenter's marks 'II' at top of the south truss, viewed from the north

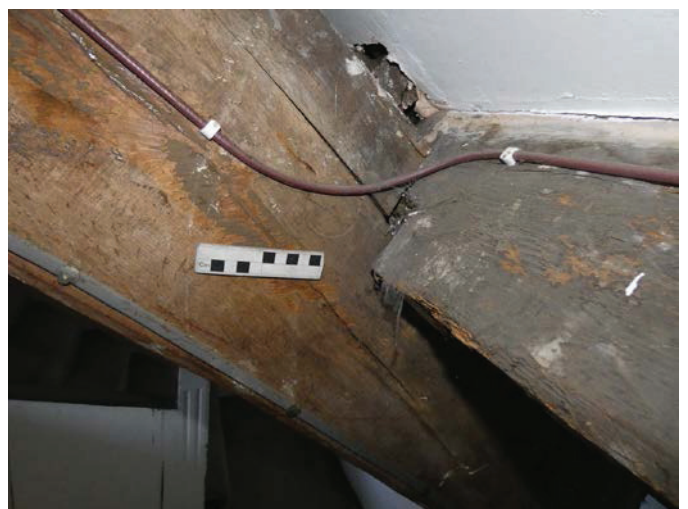
Plate 83 (right): Inscribed circle at the west end of the north truss, viewed from the north
