THE OLD BAR, CAVENDISH STREET, CARTMEL, CUMBRIA

Archaeological Building Recording

The Site	
Site Name	The Old Bar, Cavendish Street, Cartmel
County	Cumbria
NGR	337838 478808
Listing Status and number	Listed Grade II as part of Cavendish Arms, No. 1099113
Brief description of building/buildings to be recorded	Former warehouse between Cavendish Arms and Cavendish Cottage

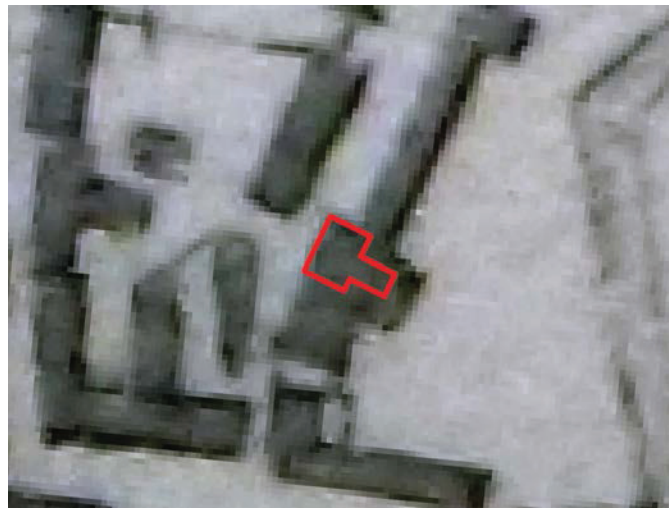
Plate 1: Extract from the enclosure map of 1807

3.1.2 **Enclosure map, 1807:** details of buildings along Cavendish Street and The Square are shown and the block forming The Old Bar is discernible although the scale means that it is shown as just a rectangle (Plate 1).

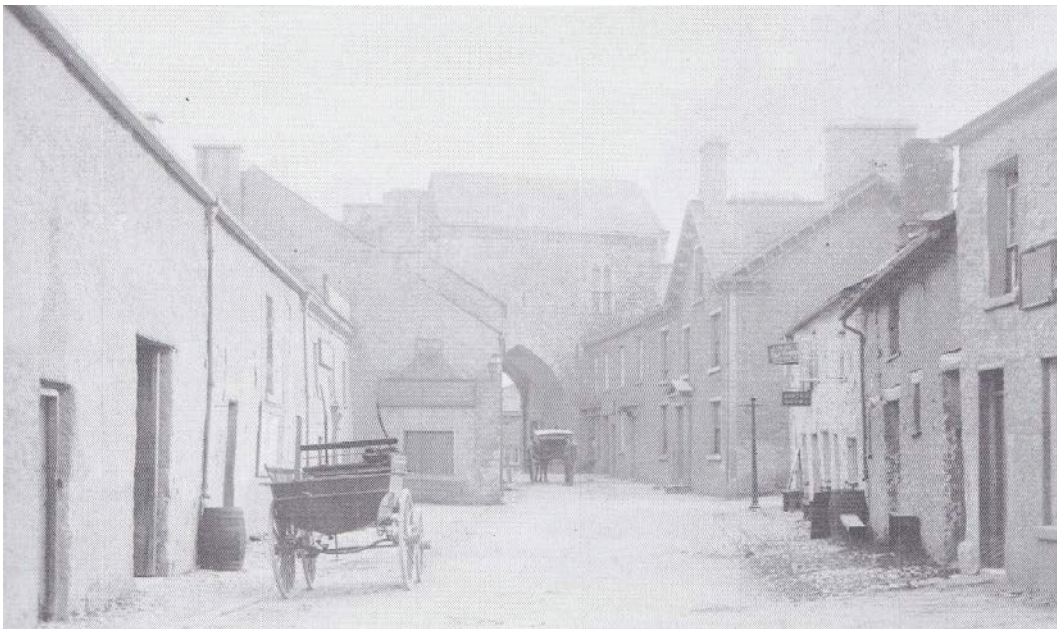
Plate 6: Photograph of Cavendish Street dated c1900 showing the site (from Garbutt and Marsh 1991, 57)

3.1.7 **Photograph, c1900:** a photograph of part of Cavendish Street showing the property thought to date to 1900 is reproduced in Garbutt and Marsh (1991, 57). Although not clear and primarily showing just the north-east external elevation of the building, it demonstrates that a window existed in the elevation at that time, with a sign attached above, although the window casement appears to be covered in some way (Plate 6).

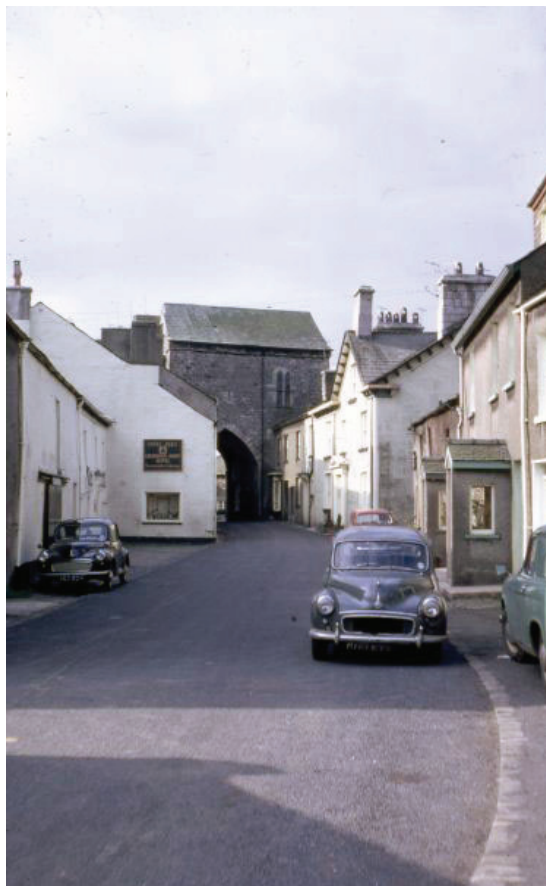
Plate 9: Photograph of Cavendish Street showing the site (Cumbria Image Bank 1970s)

3.1.10 **Photograph, 1970s:** a photograph of part of Cavendish Street again shows the north-east elevation of the building again with a window, apparently with a three-light casement and a sign attached above (Plate 9). This is described as being from the 1970s but may well be from the 1960s.

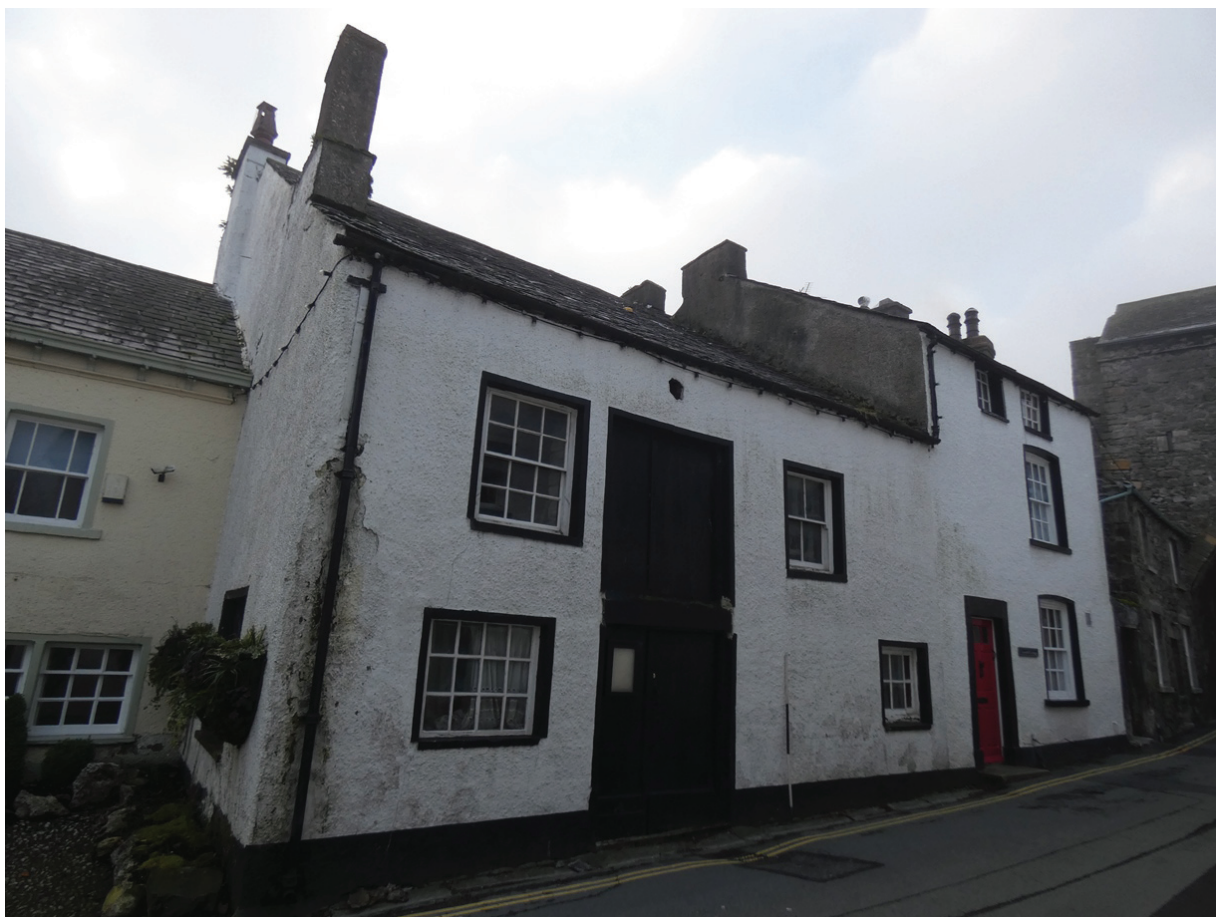
4.2.1 **North-west external elevation:** this is two storeys tall, with loading doorways one above the other north-east of the centre on both floors with plank and batten doors plus a square hole for the hoist boom above (Plate 10). There is a small window on the ground floor on the south-west side with a six-light horizontal sliding sash casement. At first floor level on the same side is a further window with a four-light vertical sliding sash casement with horns. To the north-east of the doors there is a further window per floor, the ground floor with a 12-light fixed casement, and the first floor with a 12-light vertical sliding sash casement with no horns. All of the apertures have a thin rendered band surround and the windows all have thin stone sills, although at ground floor level they are relatively rough.

Plate 10: The north-west external elevation, viewed from the north

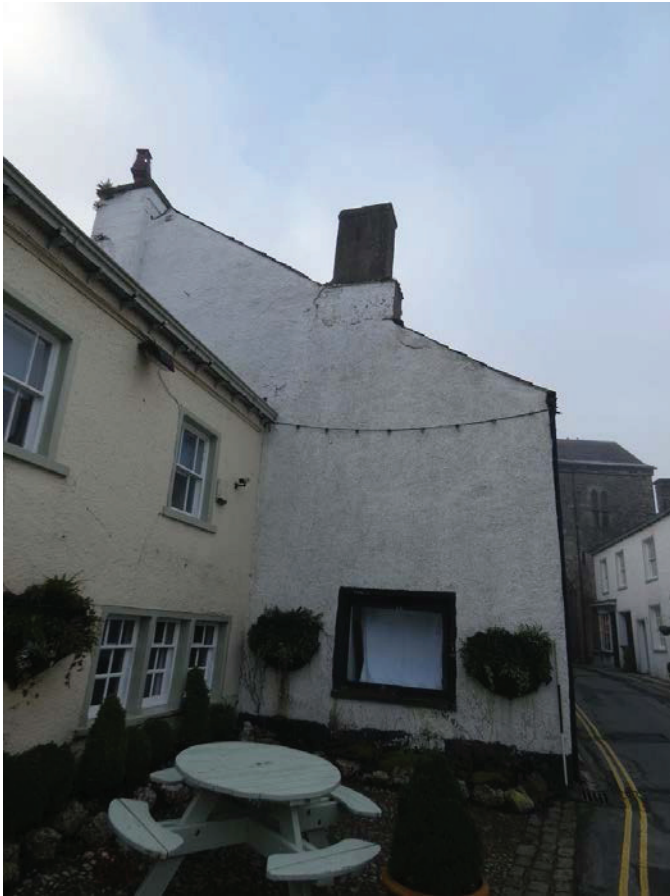
4.2.2 **North-east external elevation:** this comprises less than half of a gable that extends to the south-east and partly forms part of the adjoining property (Plate 11). It is mostly fairly plain, with a projecting chimney with ashlar stone and a single ceramic pot at the top of the gable, and a lower tiered chimney with no pots on the north-west side. There is a single window at ground level with a fixed single-light casement and a thin rendered surround and sill.

Plate 11 (left): The north-east external elevation, viewed from the north-east

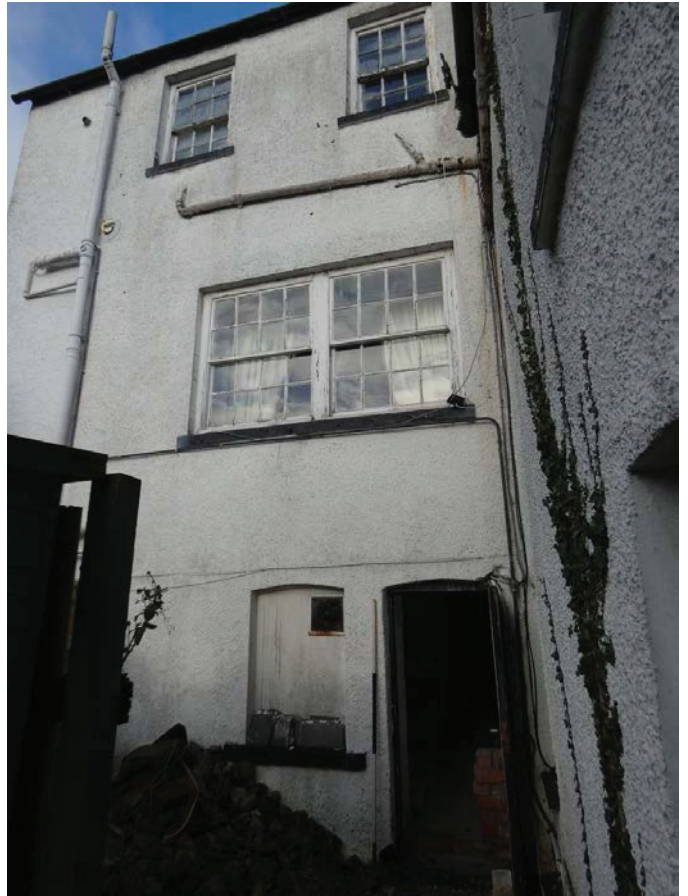
Plate 12 (right): The south-east external elevation, viewed from the south-east

4.2.3 **South-east external elevation:** only a small part of this, the north-east side of the ground floor, forms part of the property (Plate 12). This is roughcast and has a window on the south-west side with a flat arch and thick stone sill. This has been filled with board but incorporates a vent. To the north-east of this there is a doorway, again with a flat arch and plain surrounds and a modern panel door. Above, at first floor level, is a wide window with a pair of 16-light vertical sliding sash casements with no horns and on the second floor there is a pair of windows with plain square surrounds and 12-light vertical sliding sash casements with no horns.

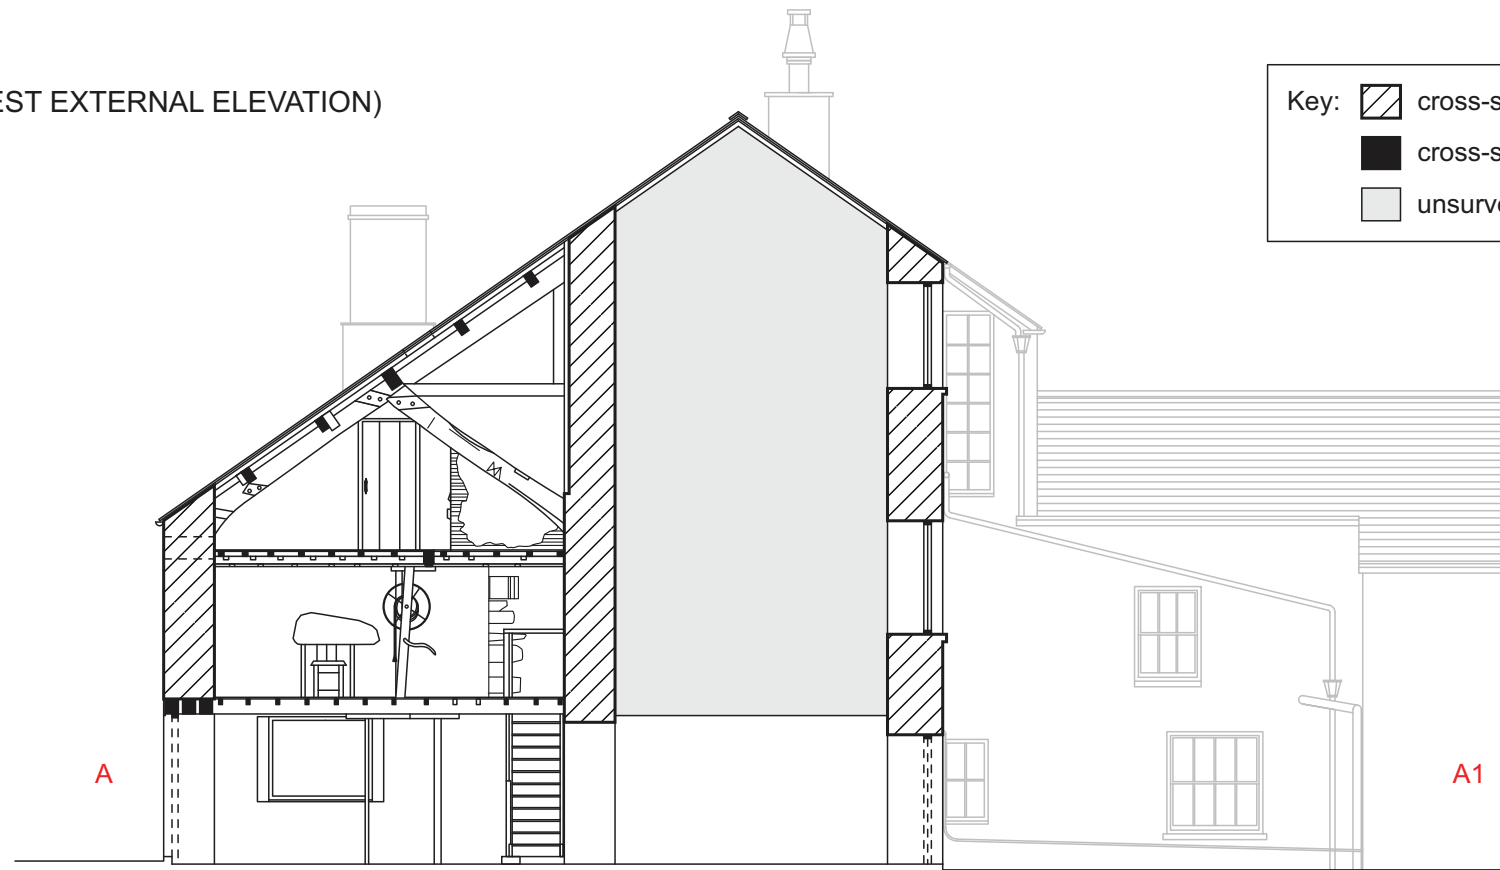
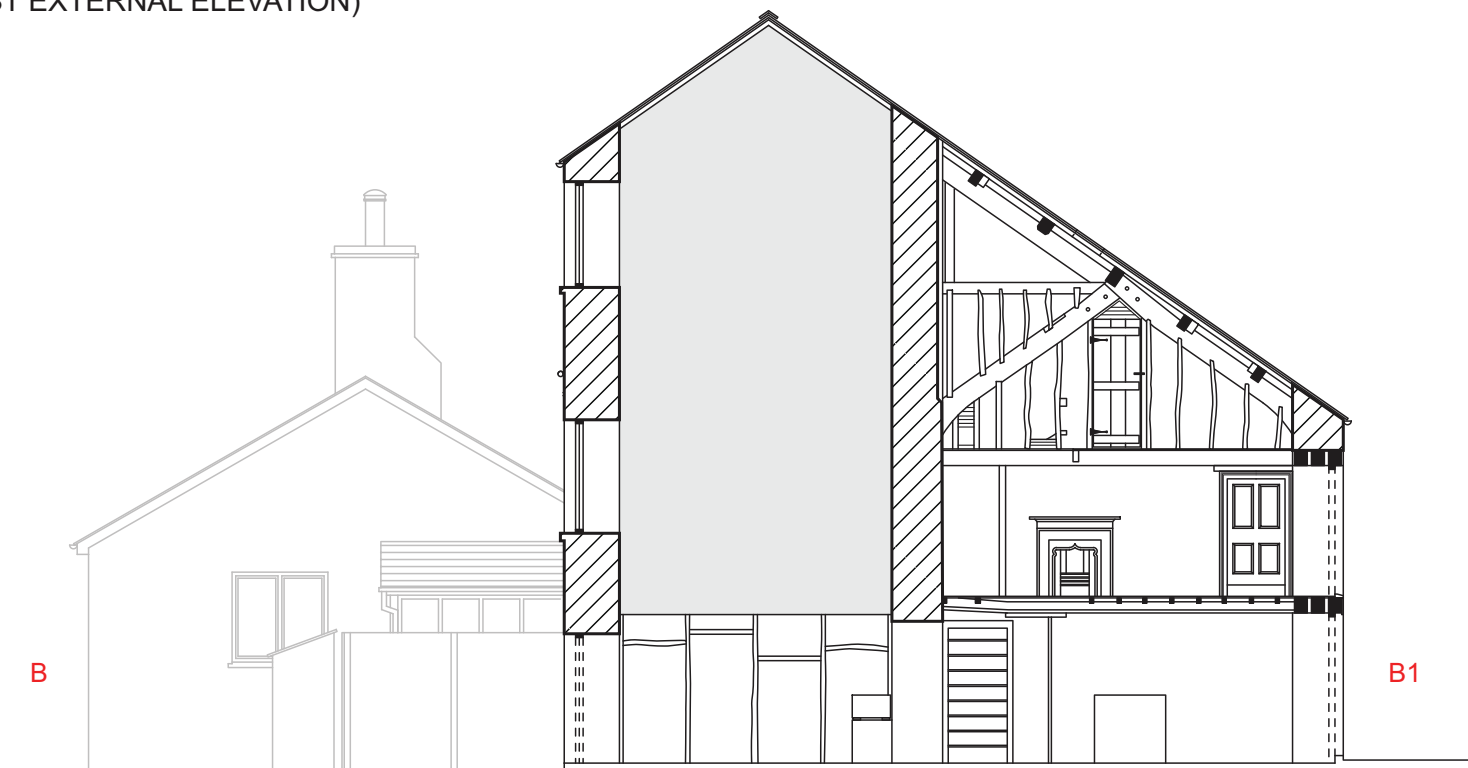
Figure 3: Sections A-A1 and B-B1

SECTION A-A1 (SOUTH-WEST EXTERNAL ELEVATION)

SECTION B-B1 (NORTH-EAST EXTERNAL ELEVATION)

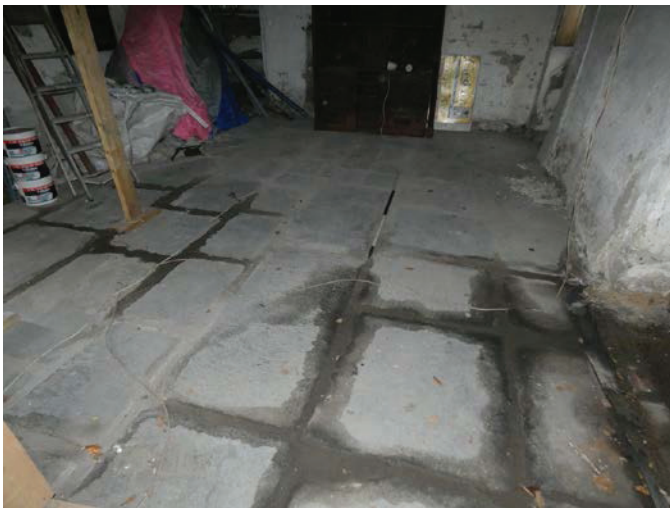
4.3.1 **Ground floor Room 1:** this has a flag floor, which has evidently recently been re-laid (Plate 13). The ceiling, which comprises the floor boards of the room above backed with lathe and plaster, is supported by three beams running north-west/south-east, all hand finished and chamfered (Plate 14 and Plate 15), the north-east with a neat stop chamfer (Plate 16). They all have early iron hooks attached, although not in large numbers, as well as modern fittings. There is a slot in the underside of the north-east beam at the north-west end, filled with timber, and the central beams has numerous peg holes in its south-west face, perhaps suggesting it is reused. The walls are generally finished with early lime plaster and limewash, with some later patching. The north-west elevation has a window on the south-west side with splayed jambs extending to the ground and simple plank shutters on long hinges (Plate 17). To the north-east of this there is an upright timber fixed into the wall with a beaded edge and to the north-east again there is an off-centre double doorway heavy hand-finished timber lintels and a pair of very rough plank and batten doors with very wide planks held by long strap hinges on pintels. To the north-east is another window with a sloping timber sill with a recessed shelf below and plastered fairly square surrounds.

Plate 13 (left): The flag floor in Room G1, viewed from the north-east

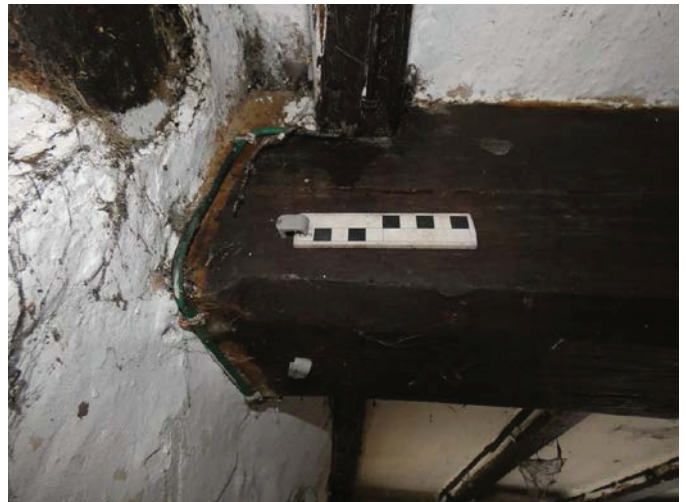
Plate 16 (right): The stop chamfer at the north-west end of the central beam, viewed from the south-west

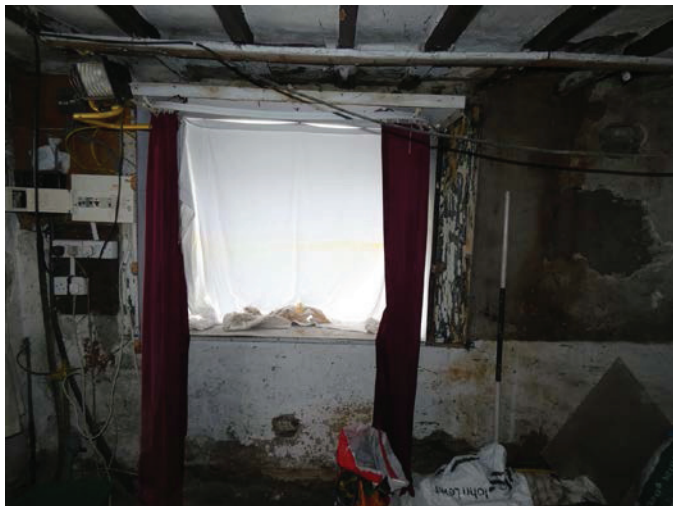
Plate 21 (left): Window in the north-east elevation of Room G1, viewed from the south-west

4.3.2 The north-east elevation has a window on the north-west side with a modern timber sill and timber attached over the jambs connecting to a projecting timber structure holding the curtains (Plate 21). The wall is otherwise fairly plain, apart from some modern patching to the plaster, although there is a rounded projecting section at the south-east end below the steps to the first floor extending onto the south-east elevation (Plate 22). The stairs are set against the north-east end of the south-east elevation, and comprise a very basic timber structure backed with planks and with a square hand rail and newel

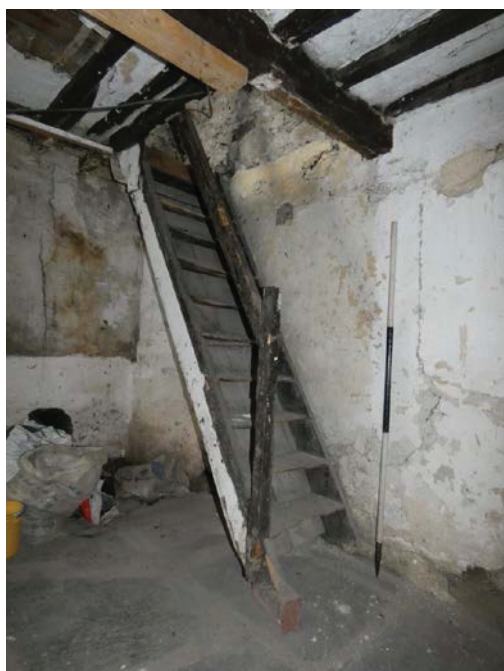
Plate 23 (left): Stairs against the north-east end of the south-east elevation, Room G1, viewed from the west

post (Plate 23). To the south-west of this is a doorway through the thick wall with plain plastered surrounds (Plate 24) and south-west of this is a cupboard built into an alcove in the wall with a plain surround but a moulded entablature and door with two raised and fielded panels and a decorative escutcheon plate on early 'butterfly' hinges, with two further small openings below, presumably for drawers (Plate 26 and Plate 27). The south-west elevation has a tall cupboard in the south-east side with a plain surround and four shelves but no door. In the centre of the elevation is a fireplace with splayed jambs and some bricks in the base (the range in the photographs was loose in the room and does not appear to have originated in this building; Plate 28).

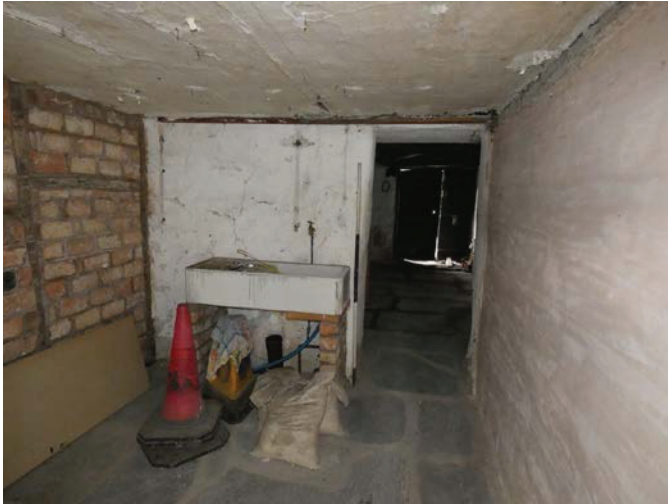
Plate 29 (left): The north-west elevation in Room G2, viewed from the south-east

4.3.3 Ground floor Room 2: this also has a flag floor that has evidently been recently re-laid and has a flat lathe and plaster ceiling. The walls have a mixture of finishes. The north-west elevation has rough original lime plaster and lime wash, with a ceramic Belfast sink set on brick bases on the south-west side and a doorway through to Room G1 with plain plastered surrounds formed through the thick wall to the north-east. The north-east elevation is plain and finished with modern plaster with a hand finished beam running along the top. The south-east elevation is finished with rough original lime plaster, with a doorway on the north-east side with plain plastered square surrounds; the door has a single light in the centre not visible from the outside. To the south-west is an alcove formed within the window filled with board, which has square jambs extending to a slate sill close to the ground. To the south-west is a low alcove with a thin lintel and rounded back, apparently forming a flue although partially blocked by the south-west wall. This is constructed of rough timber stud infilled with edge-laid brick, which has been recently rebuilt or at least cleaned and repointed.

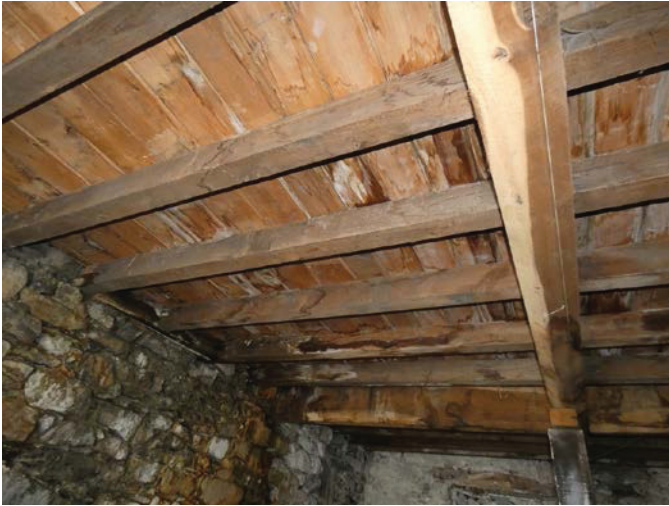
Plate 32 (left): Ceiling at the north-east end of Room F1, viewed from the west

4.3.4 **First floor Room 1:** this has a timber board floor, a mixture of earlier wide boards and later narrow ones, with various holes patched by modern sheet timber. There is a gap in the floor in the east corner for the steps to the floor below. The ceiling is supported by three beams running north-west/south-east, some of which are recent replacements (Plate 32 and Plate 33) while the central one is original but probably reused as it has numerous empty slot holes, although a continuous row along the south-west face evidently relate to a former stud partition wall (Plate 34). The boards of the floor above are relatively late narrow tongue and groove type and are supported on machine cut joists. On the north-west side of the centre of the room there are a pair of upright posts fixed between the floor and the ceiling which hold a winch for the original hoist comprising a timber drum between iron wheels and with a handle on the south-west side (Plate 35 and Plate 36).

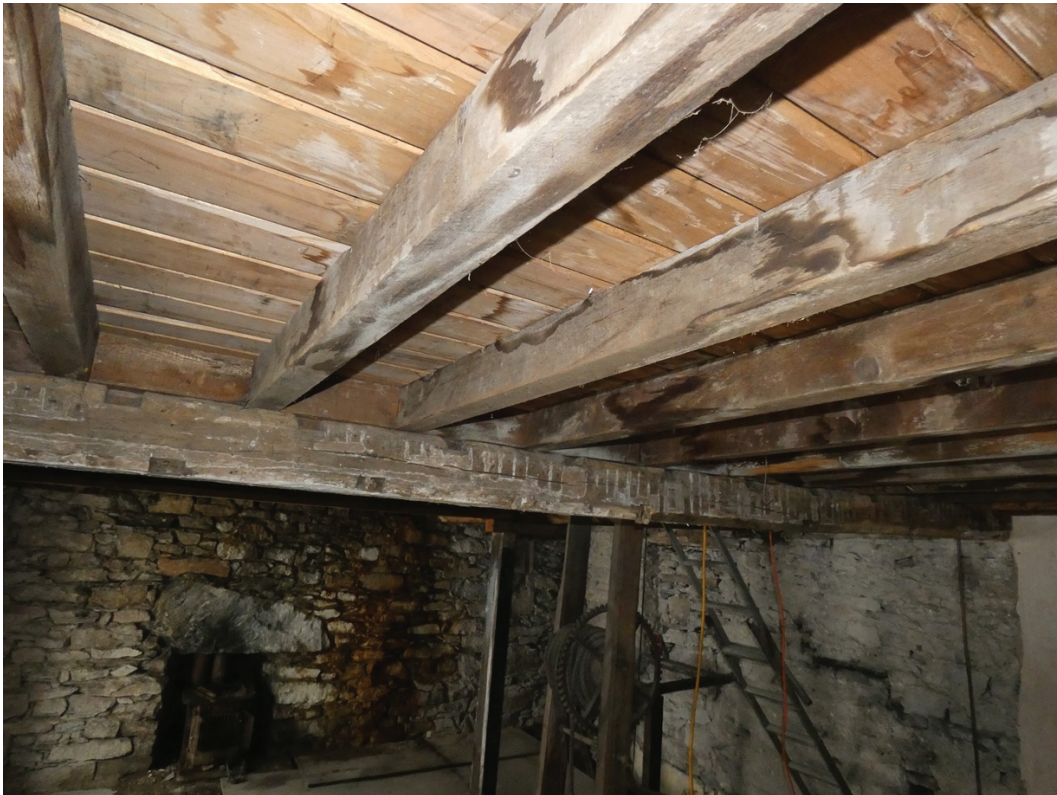
Plate 34: The central beam in Room F1, showing slots, viewed from the south-west

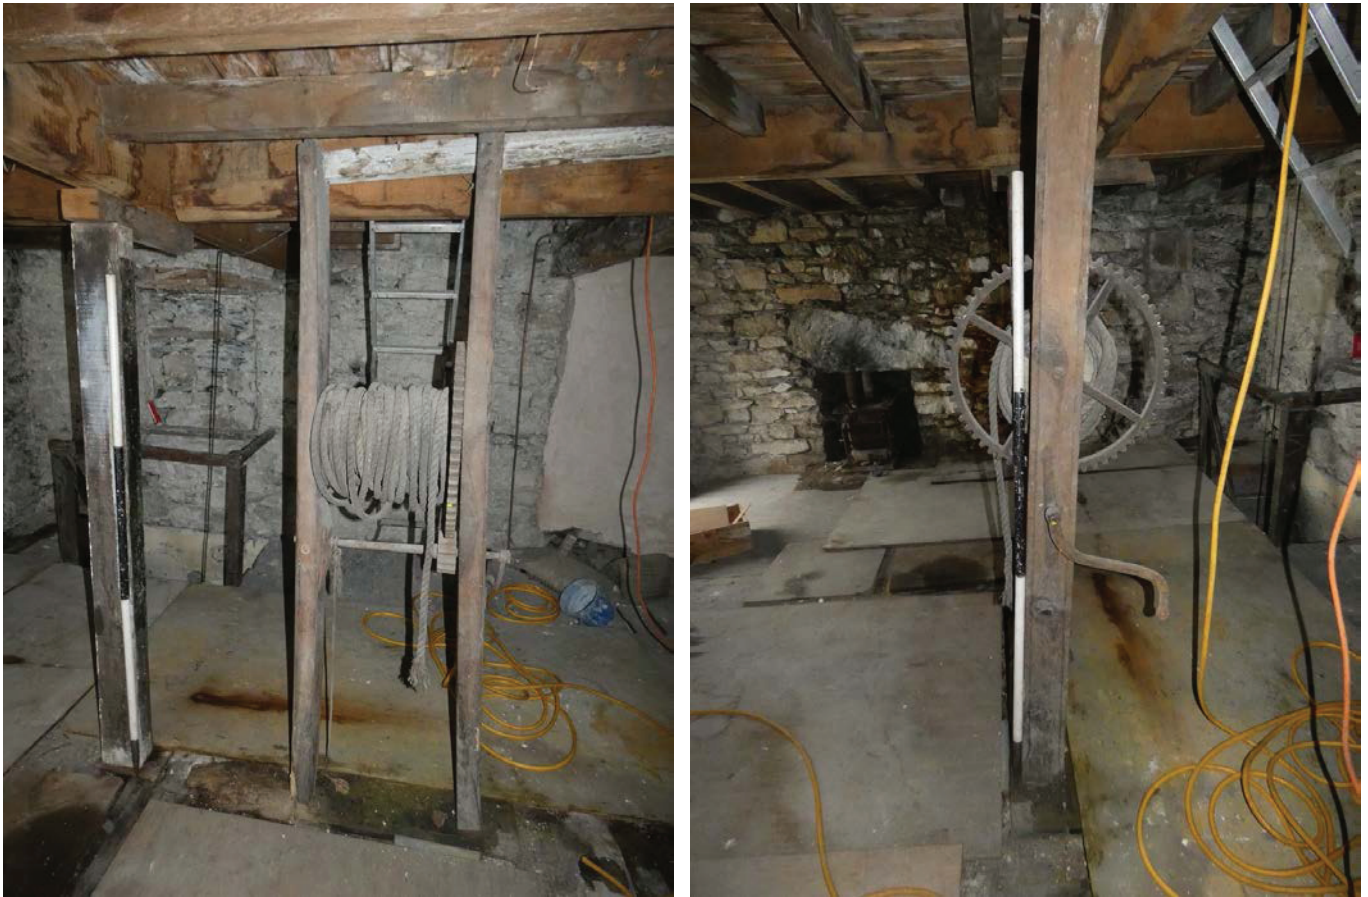
Plate 35 (left): Hoist winch in Room F1, viewed from the north-west

Plate 36 (right): Hoist winch in Room F1, viewed from the south-west

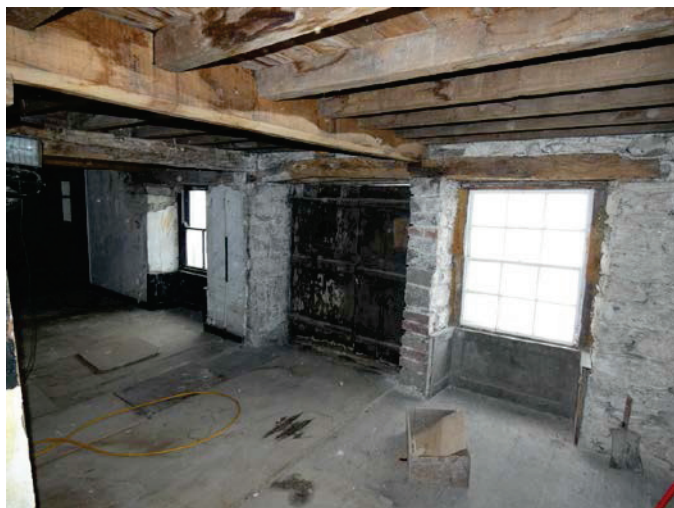
Plate 37 (left): General view of the north-west elevation, Room F1, from the east

4.3.5 The walls have a mixture of finishes, with some original lime plaster and wallpaper, some areas of new plaster, and some stripped to the stone beneath. There is a low beaded skirting board around part of the south-west end of the room. The north-west elevation has old lime plaster finished with flock wallpaper on the south-west side (Plate 37) running up to a window with splayed jambs, with panelling below and over the lower part of the splayed jambs and an inserted modern iron I-beam lintel supporting one of the new beams (Plate 38). To the north-east there is the scar of the stud wall below the central beam, just south-west of a doorway, which has a pair of plank and batten doors with very wide planks held on long strap hinges hung on pintels and heavy hand-finished timber lintels (Plate 39). There is some brick in the bottom of the north-east jamb and the north-east door has chalk tally marks along the top and a poster for the Cartmel Annual Sports for 1897 stuck to it (Plate 40). To the north-east is another window, also with panelling below and over the lower part of the jambs, which are fairly square. The sliding sash casement is apparently quite recent and it has rough hand-finished timber lintels (Plate 41).

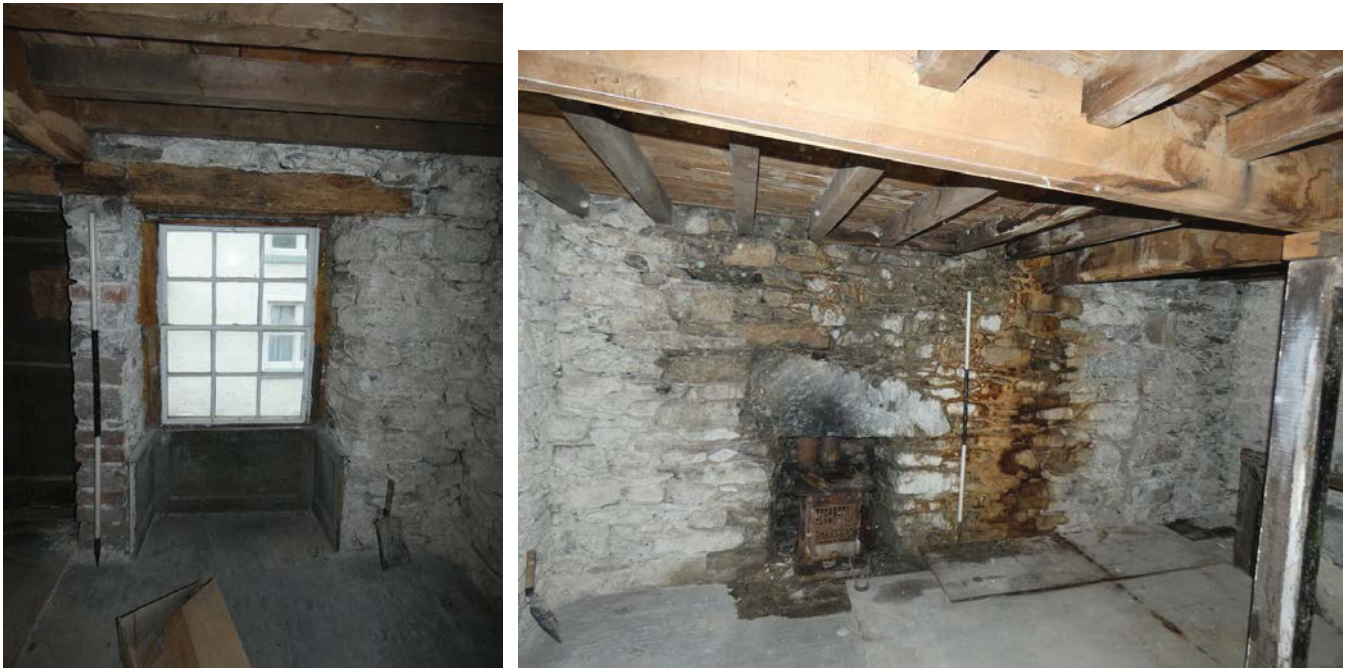
Plate 41 (left): Window on the north-east side of the north-west elevation, Room F1, viewed from the south-east

Plate 42 (right): General view of the north-east elevation of Room F1, viewed from the south-west

4.3.6 The north-east elevation has been stripped back to the stone and has a fireplace in the centre with a large stone lintel and modern stove (Plate 42). To the south-east there is an evident joint where the main part of the wall butts the neighbouring property (Plate 43). The quoins of the corner of the neighbouring property are visible and include a dressed piece of yellow sandstone with moulding that is presumably reused medieval material from Cartmel priory (Plate 44). This seems to have been cut down on damaged on the right hand side, and is likely to have formed part of a door or window surround or a plinth, although its unweathered finish suggests it was originally internal (Richard Wilson pers comm). The south-east elevation evidently butts against this section too and has a blocked window forming an alcove on the north-east side with a rough and reused timber lintel (part of a former cruck blade), a timber sill, and the remains of plaster in the jambs (Plate 45). There is lots of loose grain chaff in amongst the stonework and on the sill. The south-west end of this elevation has been finished with modern plaster and has a full-height recess, now housing a toilet, with a rough timber lintel exposed, which was evidently originally a doorway (Plate 46). The south corner is tiled and houses a shower base, all of which extends round to the south-west elevation. This has a fireplace south-east of the centre with a timber surround with a plain moulding a timber mantel, over an iron insert with decorative floral designs and a pointed arch (Plate 47). To the north-west is a cupboard in an alcove in the wall, with a moulded surround, a four-panel door, and four thick timber shelves inside (Plate 48). A rough timber lintel is also visible where the plaster has been removed.

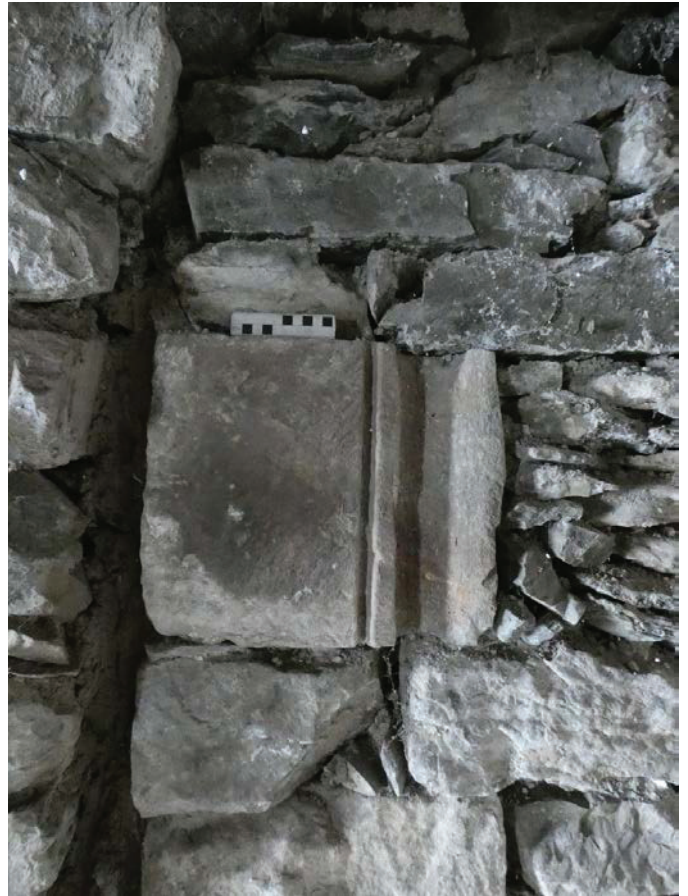
Plate 44 (right): Detail of the reused stone incorporated into the north-east elevation of Room F1, viewed from the south-west

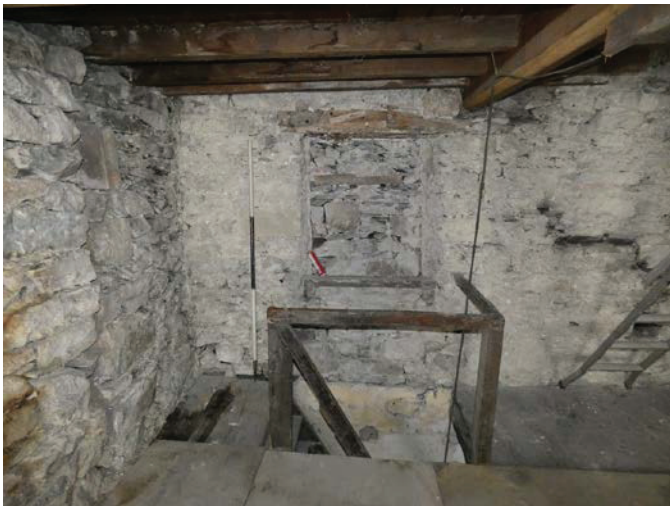
Plate 45 (left): Blocked window on the north-east side of the south-east elevation, Room F1, viewed from the north-west

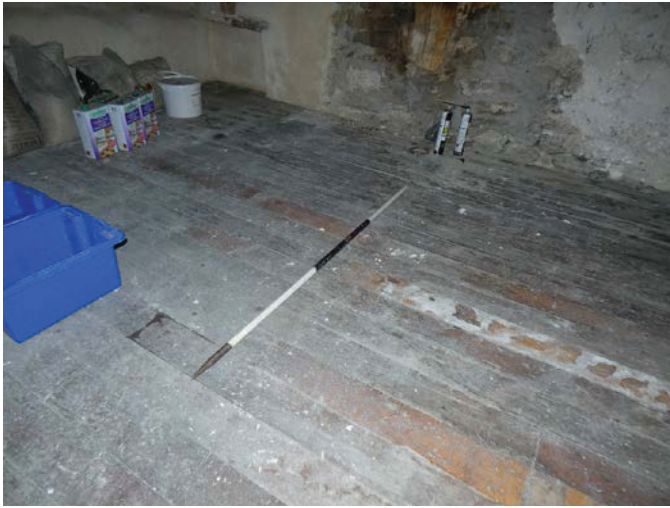
Plate 49 (left): Floor boards in Room S1, viewed from the north

4.3.7 **Second floor Room 1:** this is on the south-west side of the building. It has a tongue and groove board floor, stained mahogany brown and is open to the roof, which is supported by five purlins and has a small single-light skylight. All of these are very rough and hand-finished and at least one has Baltic timber marks, while others are reused and one has a probable carpenter's mark 'IIII'. The rafters are machine cut and there is plaster sarking backing the slates. The walls are a mixture of original and new lime plaster and limewash or exposed stone. The north-west elevation only comprises a small section below the roof, which is exposed stone in very random courses, possibly relatively recently rebuilt. The north-east elevation is a stud wall set beneath the single truss. The north-west side is recent lime plaster, the south-east side original. The truss comprises a half tie beam with the principal curving at the north-west end and evidently part of a reused cruck blade with empty slots. There is a massive angled brace between it and the south-east wall, again reused with a slot and a levelling mark. Above this is a thinner horizontal collar, which supports an upright post at the south-east end. Within this stud wall is a single doorway with a plank and batten door with early strap hinges and latch. The south-east elevation is mostly plain. It steps in approximately 1m above the floor becoming thinner and there are some through-stones above. The south-west elevation has some remnants of original roughcast on the south-east side and recent lime plaster. There is an alcove at floor level with a timber lintel, perhaps originally a window and the wall steps up on the north-west side to a projecting chimney breast.

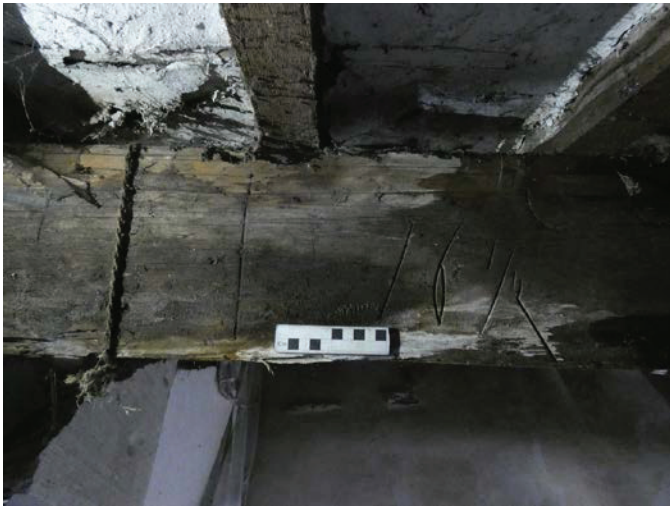
Plate 51 (left): Baltic timber marks in the roof of Room S1, viewed from the north-west

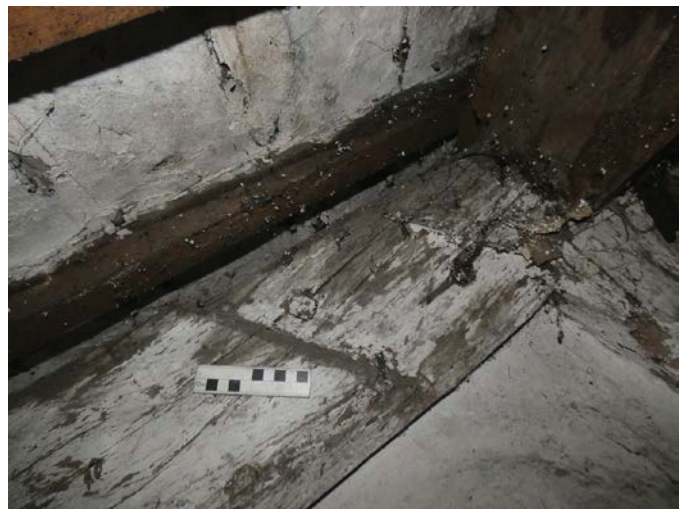
Plate 54 (right): Slot in the truss in the north-east elevation of Room S1, viewed from the south-west

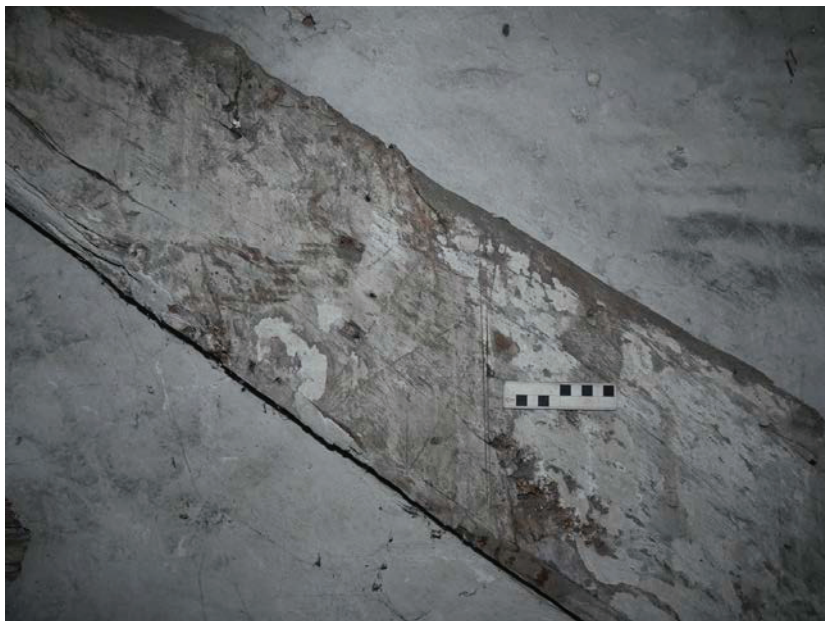
Plate 55: Levelling mark on the truss in the north-west elevation of Room S1, viewed from the south-east

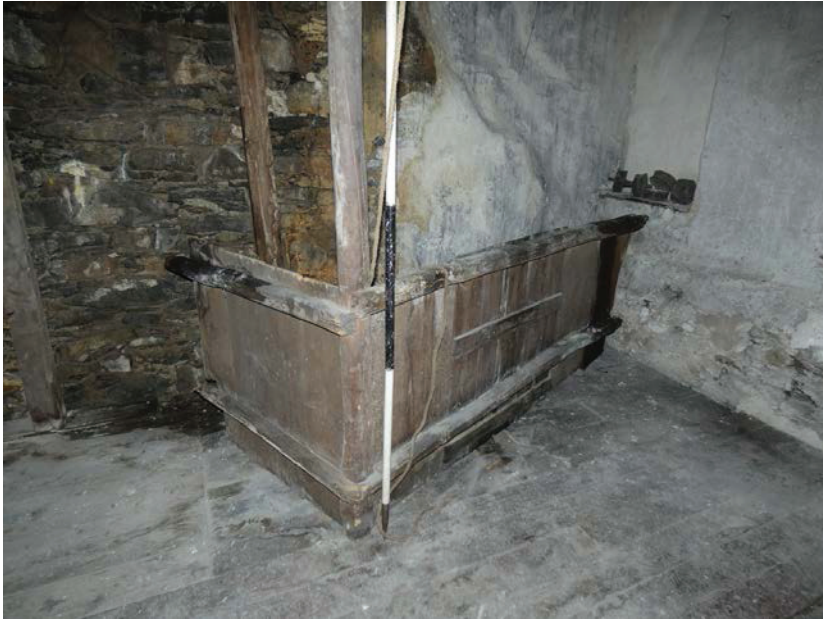
Plate 58 (left): Timber structure in the east corner of Room S2, viewed from the west

4.3.8 **Second floor Room 2:** this is on the north-east side of the building and has the same stained tongue and groove board floor. Sat on this in the east corner is an L-shaped timber structure of plank and batten construction (Plate 58). It is not evidently fixed to the walls or floors, but there is a section of wider boards of approximately corresponding size in the same corner. A hole for access is also present in the south corner of this room. It is open to the roof, which again has five purlins, all of which are hand finished; some are probably reused while others are apparently Baltic pine but do not appear to have any

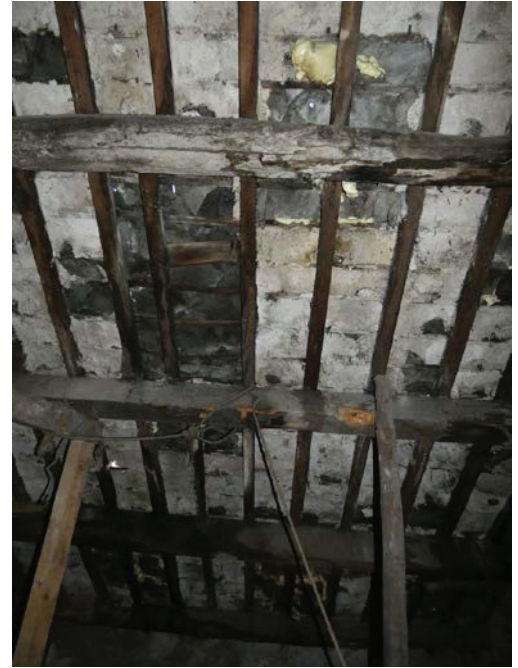
Plate 59 (right): Roof in Room S2, viewed from the south-east

marks (Plate 59). What is thought to be the original hoist boom has been hung by ropes from the roof against the south-east wall (Plate 60). The walls are all finished with lime plaster and limewash. The north-west elevation is low as it is below the roof and plain apart from a hole for the hoist boom, which has a timber lintel. The north-east elevation is quite rough and projects slightly perhaps for the chimney and steps out from the join on the south-east side. The south-east elevation steps back making the wall thinner as in Room S1 and has through-stones high up (Plate 61). There is a tall narrow alcove on the north-east side with a thin timber sill (Plate 62) (with a collection of handmade wheels sat on it, perhaps part of a textile spinning machine as one still has thread wrapped round it; Plate 63). The south-west elevation is the reverse side of the half truss supporting the roof with stud walling below. This is essentially as per Room S1, although the stud wall is covering much of the detail and its studs are exposed (Plate 64). The principal rafter has possibly been sanded on this side.

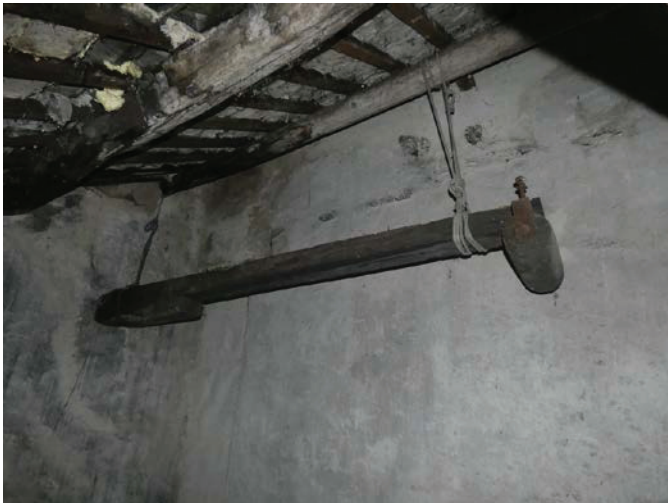
Plate 60 (left): Loose hoist boom in the roof of Room S2, viewed from the west

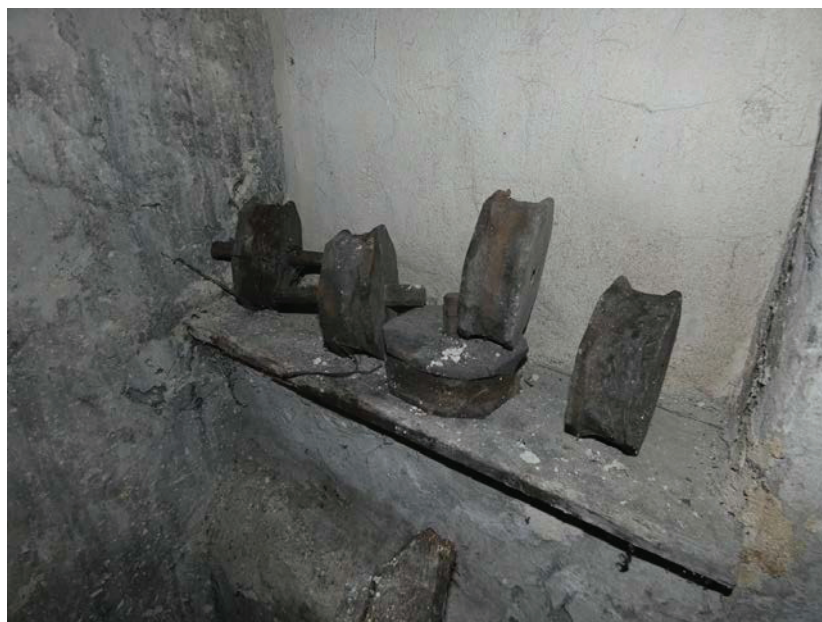
Plate 63 (right): Timber wheels in the alcove in the south-east elevation, Room S2, viewed from the west
