# THE LONSDALE HOUSE HOTEL, 11 DALTONGATE, ULVERSTON, CUMBRIA

## Heritage Assessment

March 2021

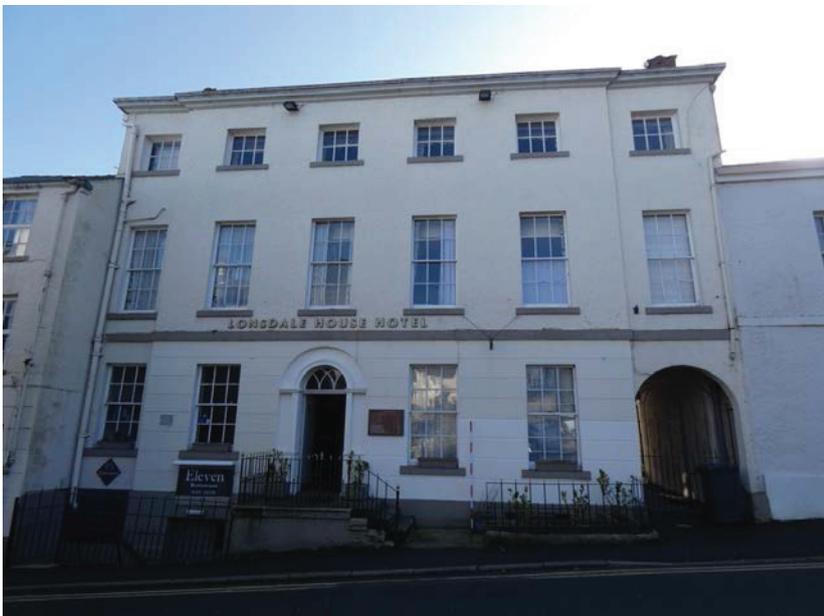
Plate 8 (left): The front (north) elevation, viewed from the north

3.4.2 **External elevations:** the main part of the front elevation presents an impressive broadly symmetrical façade extending over three floors with a projecting central section (Plate 8). The west side extends over a passageway to the rear while the east end is extended by a projecting addition of later date. The main features of interest are the intact sliding sash casements in the windows (which do not have horns and so are likely to pre-date 1840; Wedd 1999, 2) and the front door with its semi-circular overlight and possibly original six-panel door (Plate 8). The east elevation comprises what is clearly an early structure that has been modified, but with a modern flat-roofed extension to the rear (south) (Plate 10). The south elevation is only two stories tall, although with an attic and is also symmetrical but with a central Venetian window, suggestive of an earlier 18<sup>th</sup> century date, flanked by a pair of windows on each floor and an off-centre inserted doorway at ground floor (Plate 11). In the garden to the south of the house forming part of the boundary is a folly comprising a crenelated Gothic-style wall built of ashlar rock faced limestone with various blind arched openings and sham towers (Plate 12). This style of stone work was continued into the boundary wall incorporating the steps up to the garden from the house and an arched entrance into a yard to the west.

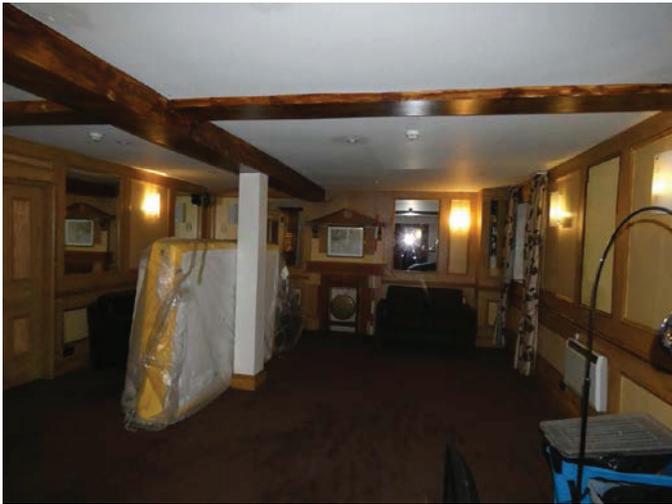
**Plate 13 (left): General view of the main part of the basement, from the east**

3.4.3 **Basement:** the property has been extensively modernised at this level, the rooms most recently used as a restaurant/bar and associated kitchens and toilets, with little or no original fabric remaining (Plate 13 to Plate 16) although a hatch in the east elevation may be relatively early (Plate 15).

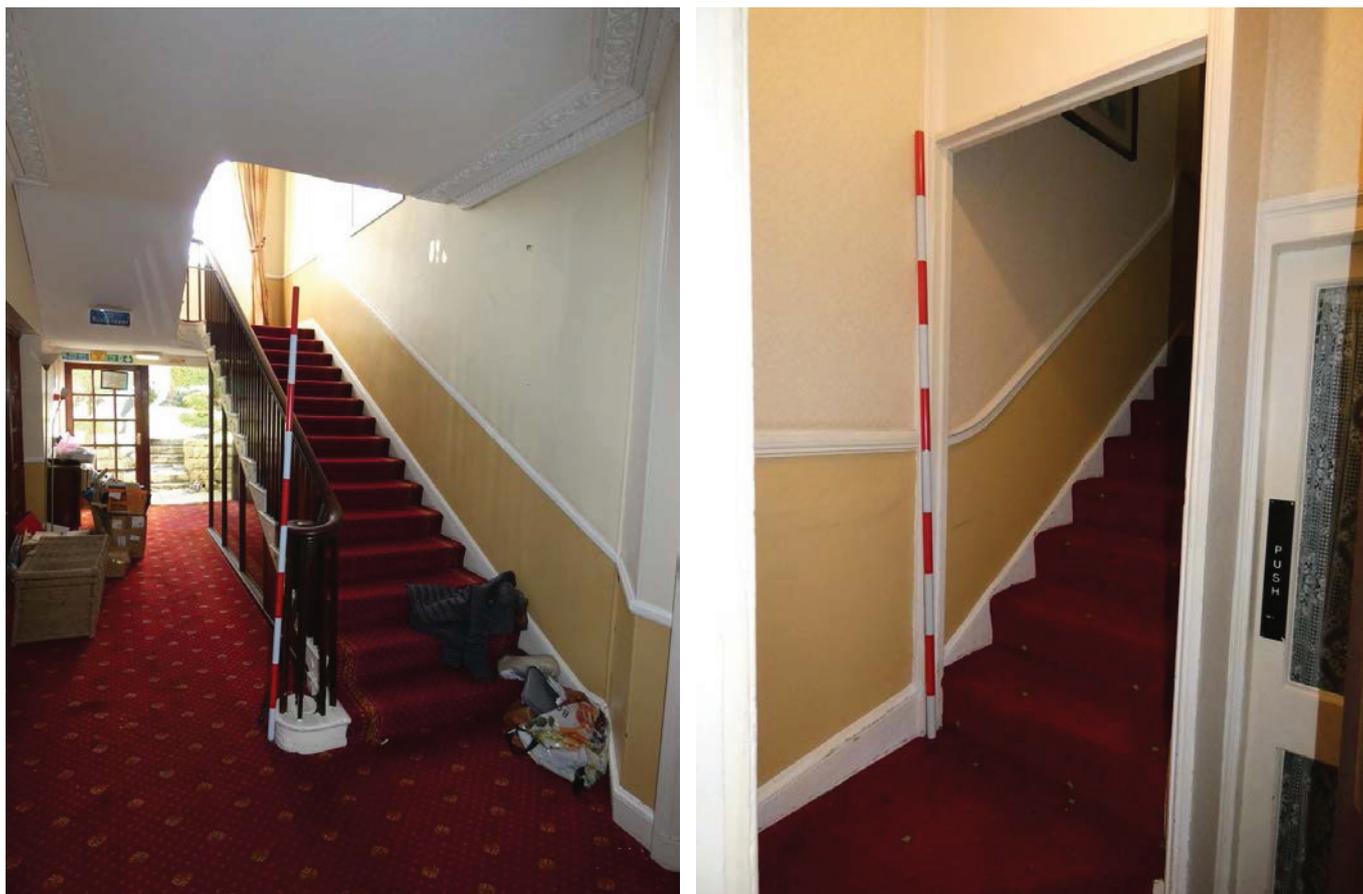
**Plate 17 (left): The main staircase, viewed from the north**

3.4.4 **Ground floor:** at this level the building comprised a mixture of reception rooms, including the main entrance hall connecting to the staircases, and some bedrooms. Again, the space had been extensively modernised, with the only original fabric comprising the staircases (Plate 17 and Plate 18) (including the impressive main stair with its mahogany balusters, although these do not appear to be original), the decorative plaster cornices and ceiling roses, primarily in the main entrance hall (Plate 19 to Plate 21), and the majority of the moulded door surrounds; the doors of probable mahogany are clearly

4.4.1 While details of the proposed alterations to the building are still not known it is unlikely that they will have as large an impact as the work that has already been done, in particular the extensive internal modernisation. Indeed, it is possible that the, arguably harmful, impact of some of these changes could be partly remedied by removing some of the extensive internal partitions, or at least reconfiguring them in a more sympathetic manner, and restoring and opening up important original features such as the staircases and the folly.

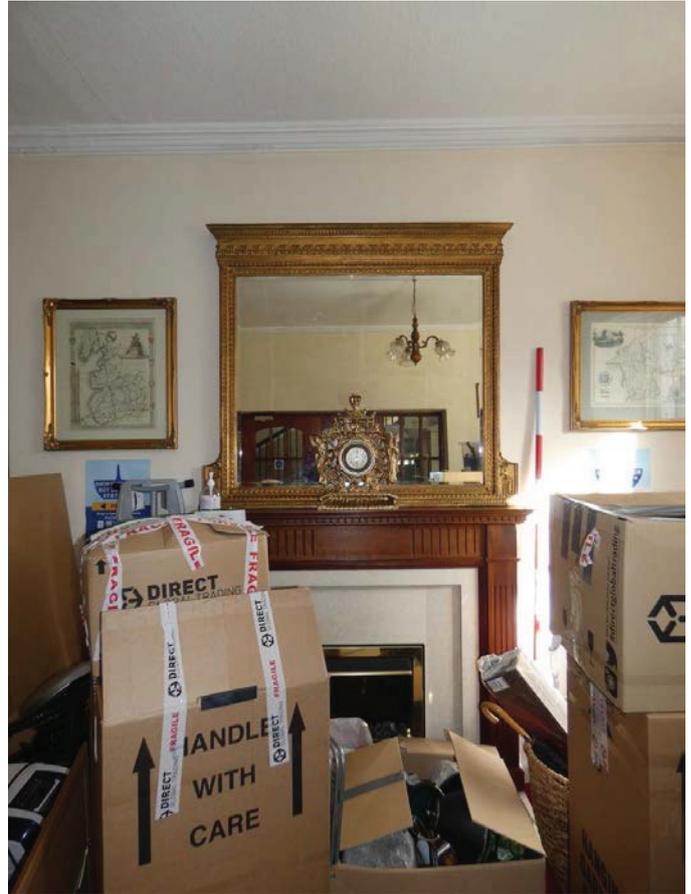
Plate 23 (right): Fireplace in the south-east reception room, viewed from the west

not original. Elsewhere, there is a fireplace with timber surround in the south-east reception room but this is clearly not original, although it could be covering an earlier one.

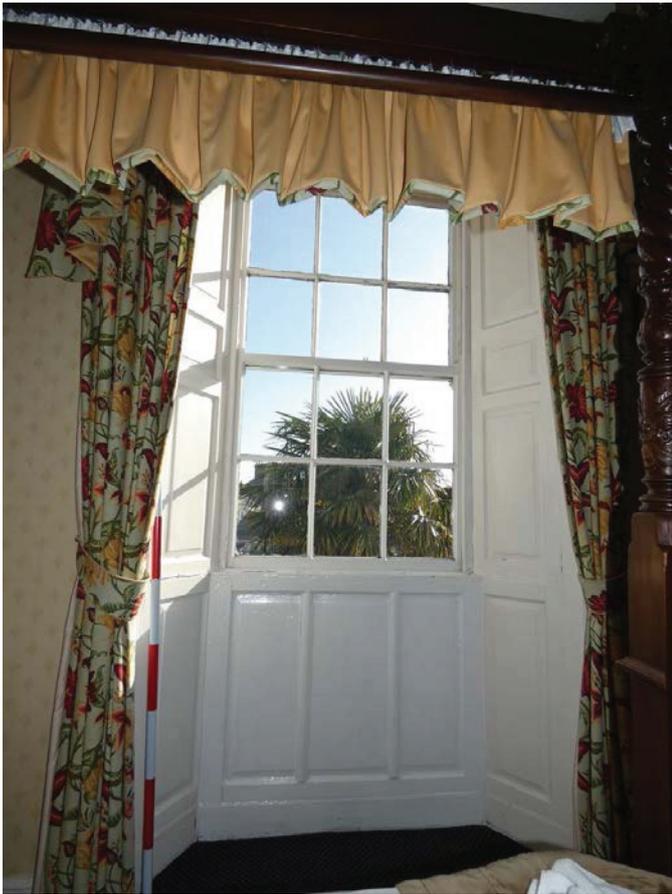
**Plate 28 (left):** Panelling around a window in the south elevation, viewed from the north

3.4.5 **First floor:** this had similarly been extensively modernised, and comprised several bedrooms connected via the main landing and a narrow east/west corridor. The most noticeable piece of historic fabric was again the decorative plaster cornice on the main landing (Plate 24), although a plaster bust was also present within the east/west corridor at the south end of what had evidently originally been a large rounded arch (Plate 25); the north end no longer seems to exist. The main staircase had been partially modified to incorporate a modern glazed partition wall, resulting in the loss of the top hand rail and some of the adjoining door surround (Plate 26). Elsewhere, the back stair retained much of its original structure although the balusters, if these survive, were boxed in (Plate 27). Access to the east end of the building was through an arched opening off these stairs, through what had probably originally been a tall stair window (Plate 27). Within the bedrooms the only feature of interest that survived was the panelling around some of the windows (Plate 28) and a six-panel door that may be original (Plate 29).

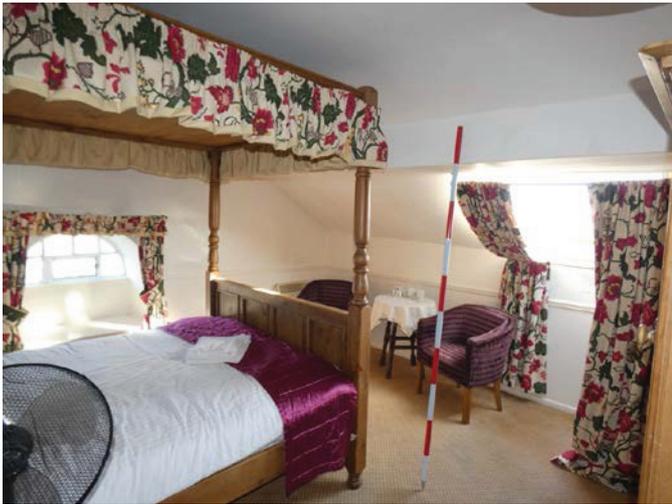
Plate 30 (left): Exposed purlin in the south-eastern room on the second floor, viewed from the north-west

3.4.6 **Second floor:** this too comprised a collection of substantial rooms accessed via the back stairs. Again, this whole floor had been extensively modernised, the most noteworthy feature being the lower level of the south side, which was effectively within the roof space and so the purlins were exposed within the rooms, albeit boxed in and finished with plaster (Plate 30). A small round-headed window was also present in the east elevation of the south-eastern room (Plate 31). The back stair again retained much original fabric, with the balusters boxed in and an inserted glazed partition at the top (Plate 32), with access to the east end of the building also via the former stair window, which had a round head remaining (Plate 33). Within the eastern section a hatch into the roof space showed the original king-post truss of probable mid-19<sup>th</sup> century date was still present with corresponding purlins (Plate 34), and the ends of the tie beams projected into the rooms below (Plate 35). Another window with a round head and early hinged casement was also present in the west elevation (Plate 36) and it is apparent that the windows in the front (north) elevation are central pivoting types rather than sash (Plate 37; these are considered to be 20<sup>th</sup> century in the listing: see *Appendix 1*).

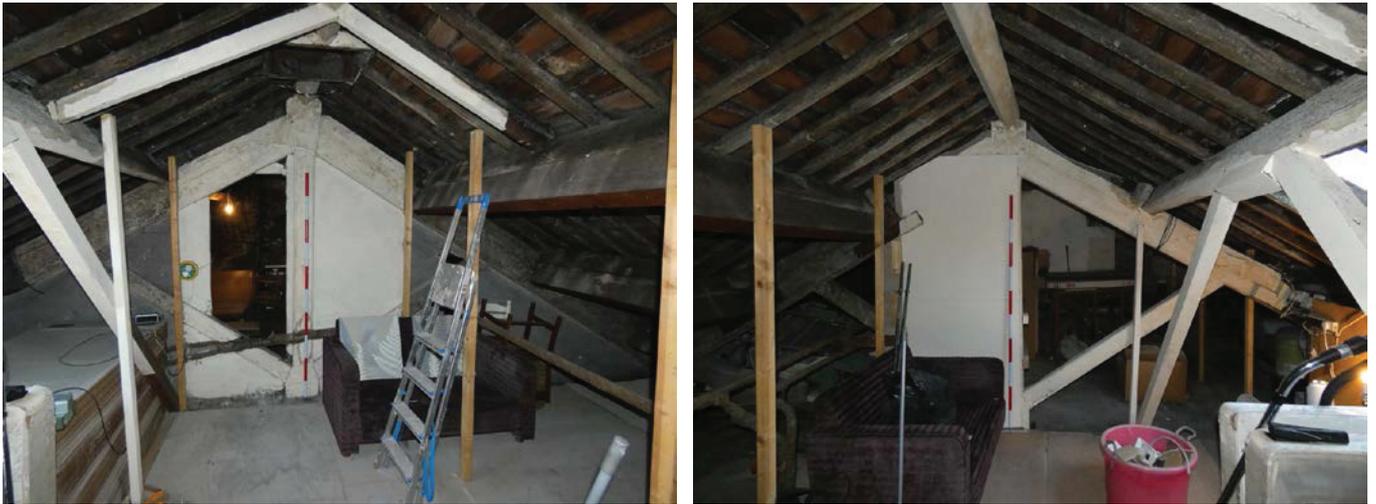
**Plate 38 (left): The eastern truss, viewed from the west**

3.4.7 **Attic:** the attic was only present over the north section of the building and was primarily noteworthy because of a pair of large king post trusses with angled braces (Plate 38 and Plate 39). In addition, the fabric of the eastern elevation was exposed showing the brick structure and chimney breast (Plate 40).
