FURNESS ABBEY, MANOR ROAD, BARROW-IN-FURNESS, CUMBRIA

Archaeological Watching Brief

Scheduled Monument Consent	
SMC No.	S00240689
Works	Excavation of two pits for new signage, cutting back edge of culvert, and exploratory excavation to locate course of drainage pipe

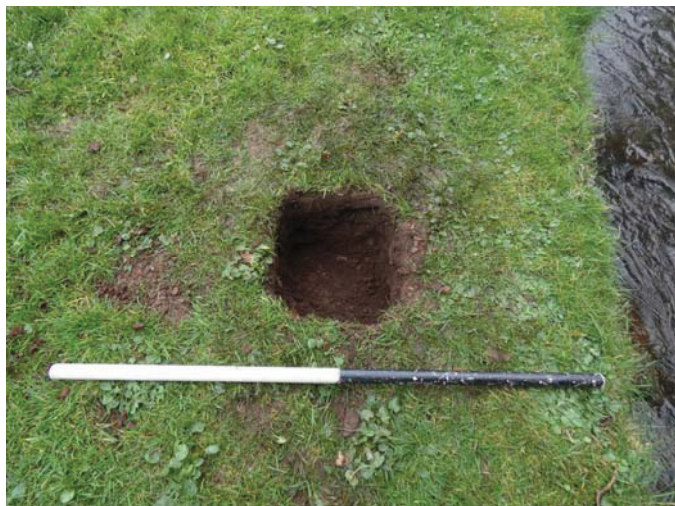
4.1.1 **Signage Pit 1:** this was c0.3m square and below the turf a soft dark reddish brown sandy silt was encountered 0.05m – 0.1m thick (**100**). This was on top of a deposit with a similar matrix but containing 30% angular gravel and 10% angular sandstone cobbles as well as some grey slate and lumps of lime mortar, and was between 0.15m and 0.2m thick (**101**; Plate 1 and Plate 2).

Plate 1 (left): Signage Pit 1 excavated, viewed from the south

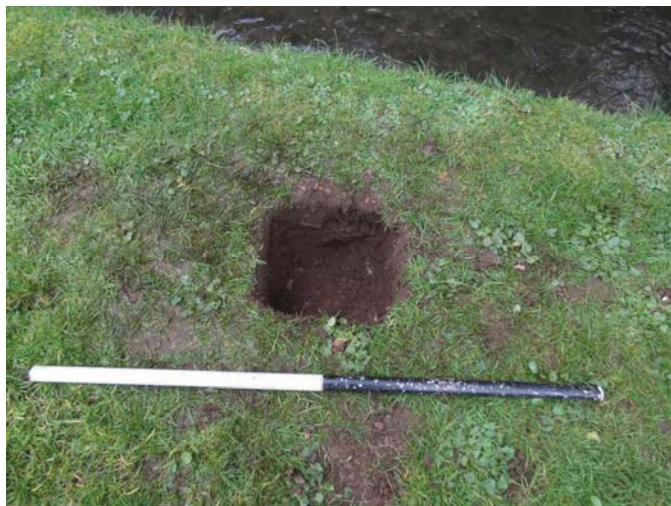
Plate 2 (right): Signage Pit 1 excavated, viewed from the west

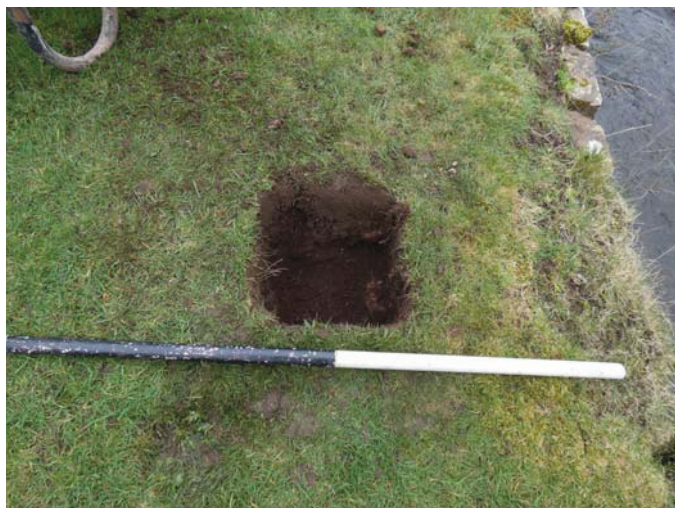
4.1.2 **Signage Pit 2:** this was also c0.3m square and beneath the turf was again an initial layer of soft dark reddish brown sandy silt 0.05m – 0.1m thick (**200**). Beneath this was a similar matrix but 75% angular cobbles, mostly red sandstone, but also some grey slate and lumps of lime mortar, up to 0.2m thick (**201**; Plate 3 and Plate 4).

Plate 3 (left): Signage Pit 2 excavated, viewed from the north

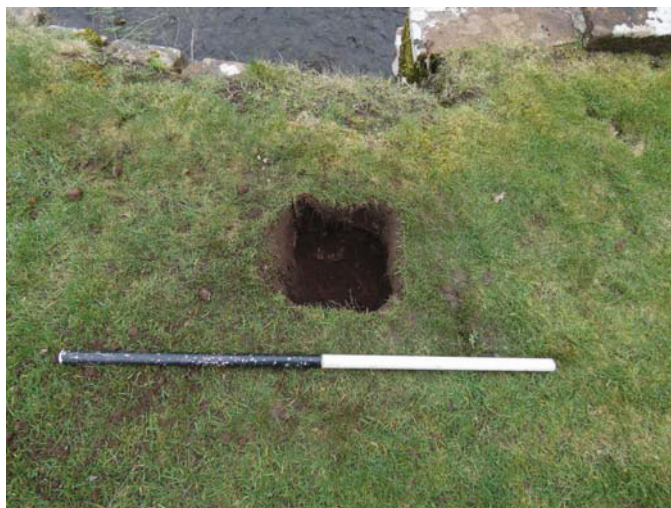
Plate 4 (right): Signage Pit 2 excavated, viewed from the east

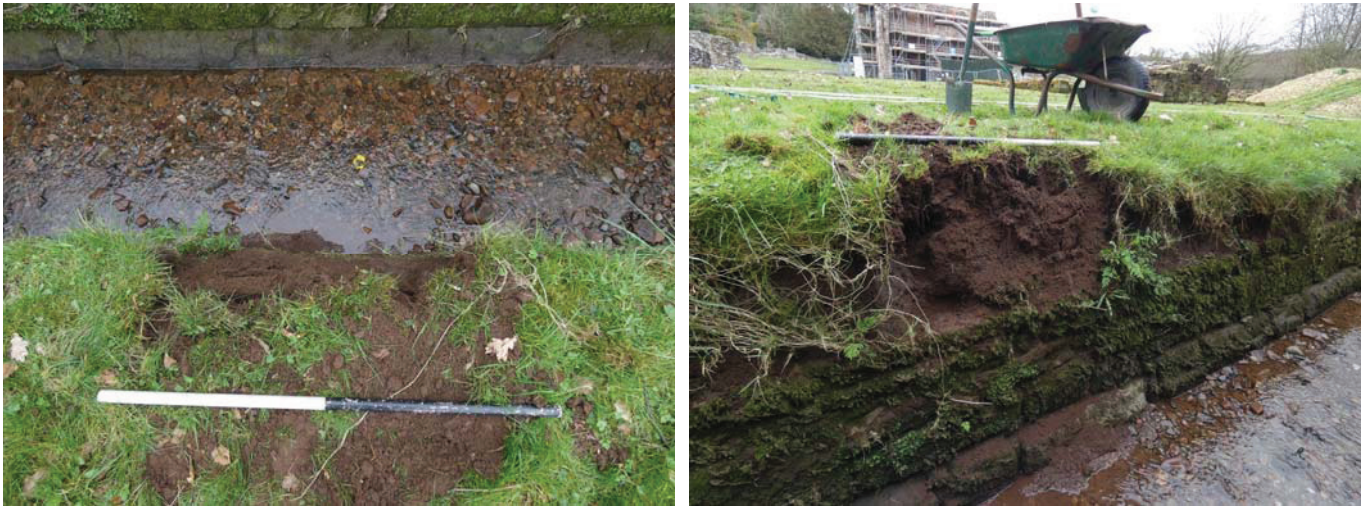
4.1.3 **Overhanging Vegetation Edge Cut:** this comprised the excavation of a small section 0.8m long north/south, cut back less than 0.2m from the edge of the culvert (Plate 5). It was evident from limited excavation and an examination of the side of the culvert, that a firm dark reddish brown silty clay 0.5m to 0.6m thick extended above the top of the east wall of the culvert (**300**; Plate 6).

Plate 5 (left): The edge cut, viewed from the east

Plate 6 (right): The exposed section above the culvert wall, viewed from the north-west

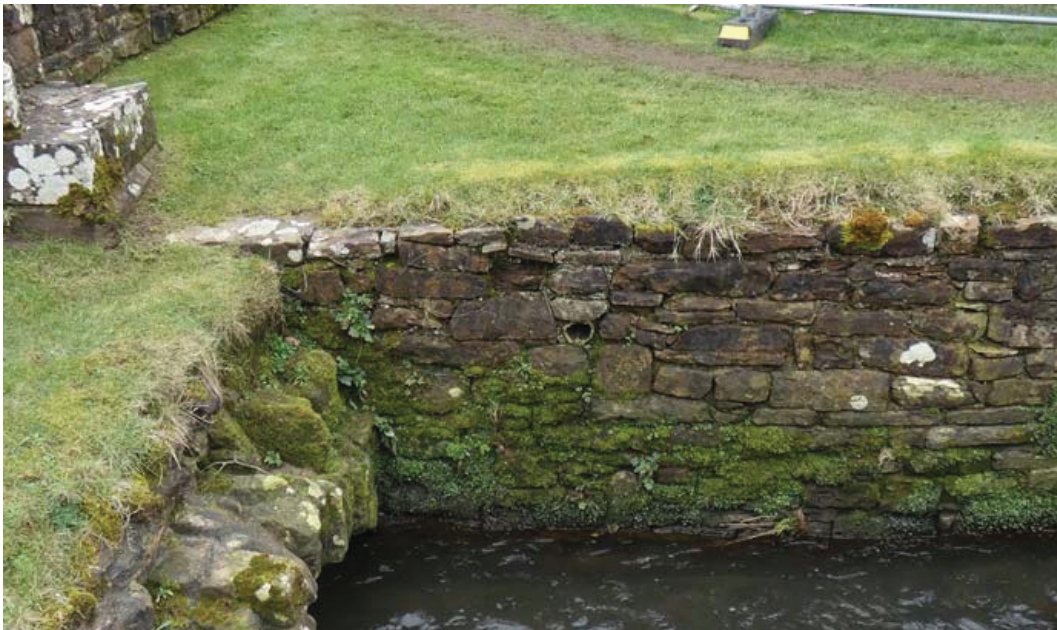
4.1.4 **Drainage Pits:** this comprised the excavation of three pits, each c0.3m square, following the presumed line of a ceramic drainage pipe visible in section c0.5m down the side of the culvert wall to the north-east. The north-easternmost pit, which was close to the edge of the culvert, had a deposit of loose dark reddish brown silty clay, 0.1m thick (**400**) below the turf. Beneath this was a similar deposit but with 30-40% angular cobbles, mostly red sandstone (**401**). The pipe was encountered at a depth of 0.4m below the surface. The second pit to the south-west of the first, had similar deposits (**500** and **501**) and the pipe was again encountered at a depth of 0.4m. It was essentially on the same alignment, although turning slightly to the south. The third pit, to the south-west of the second, had the same general deposits (**600** and **601**) and the pipe was encountered at a depth of 0.4m. At this point it had a large collar and the section fitting into it on the west side had a considerable amount of clay or concrete filler, suggesting the pieces of the pipe were not a good fit.

Plate 7: Pipe visible in section in the culvert wall, viewed from the north-east

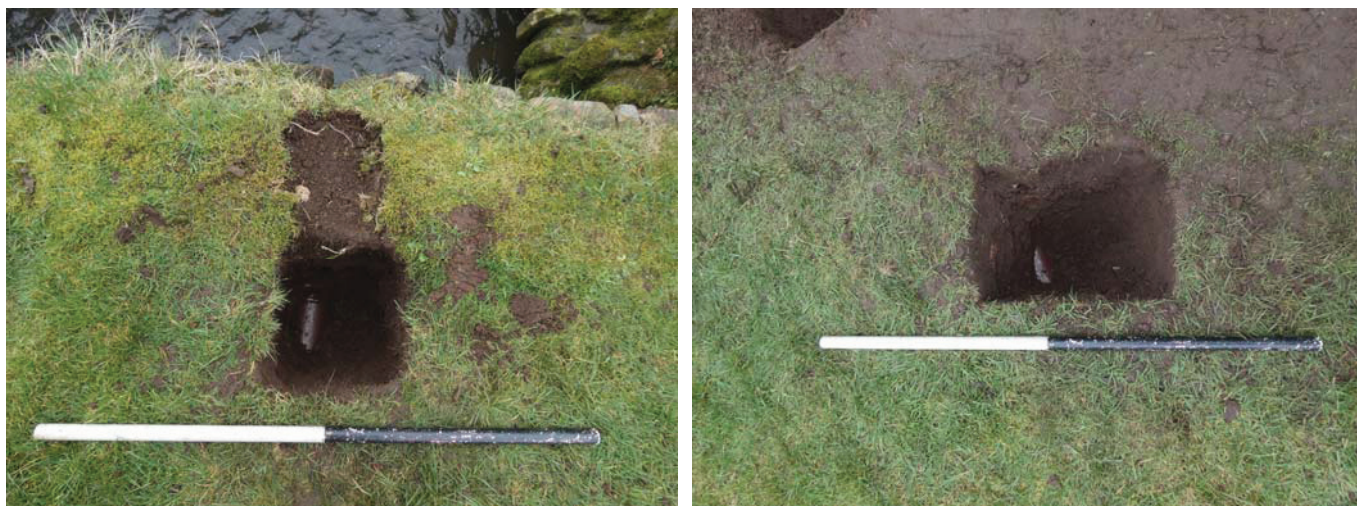
Plate 8 (left): Drainage Pit 1 excavated, showing the pipe, viewed from the west

Plate 9 (right): Drainage Pit 2 excavated, showing the pipe, viewed from the north-east

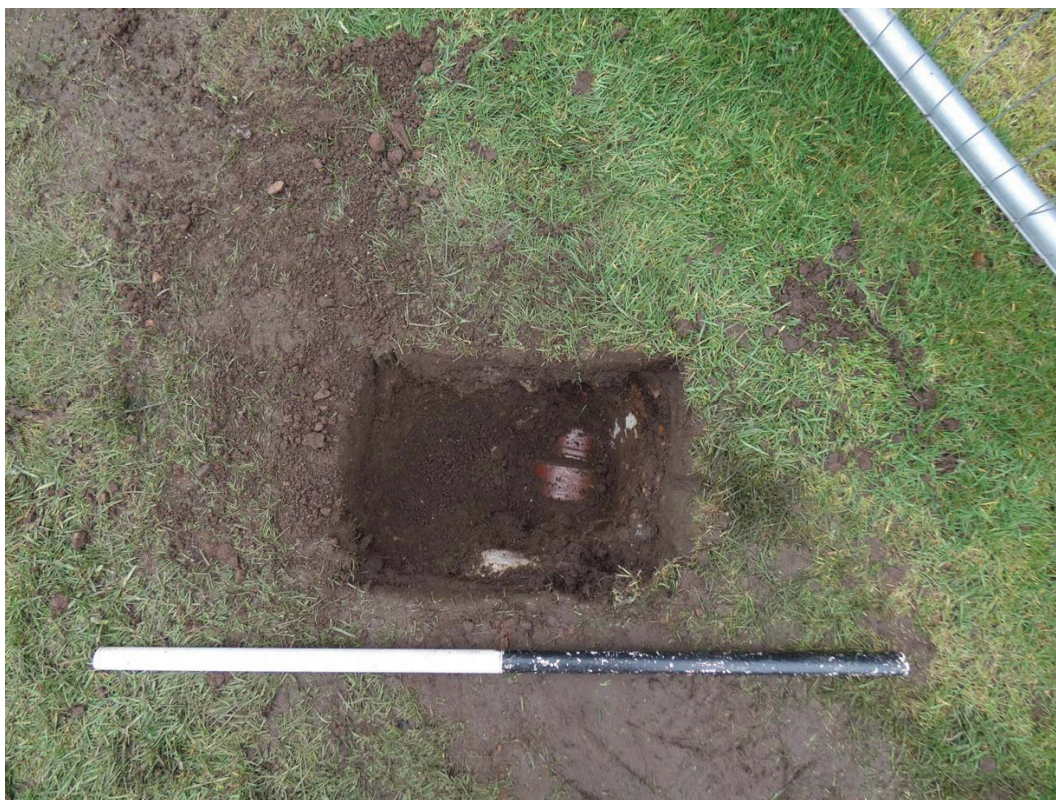
Plate 10: Drainage Pit 3 excavated, showing the pipe, viewed from the north-east

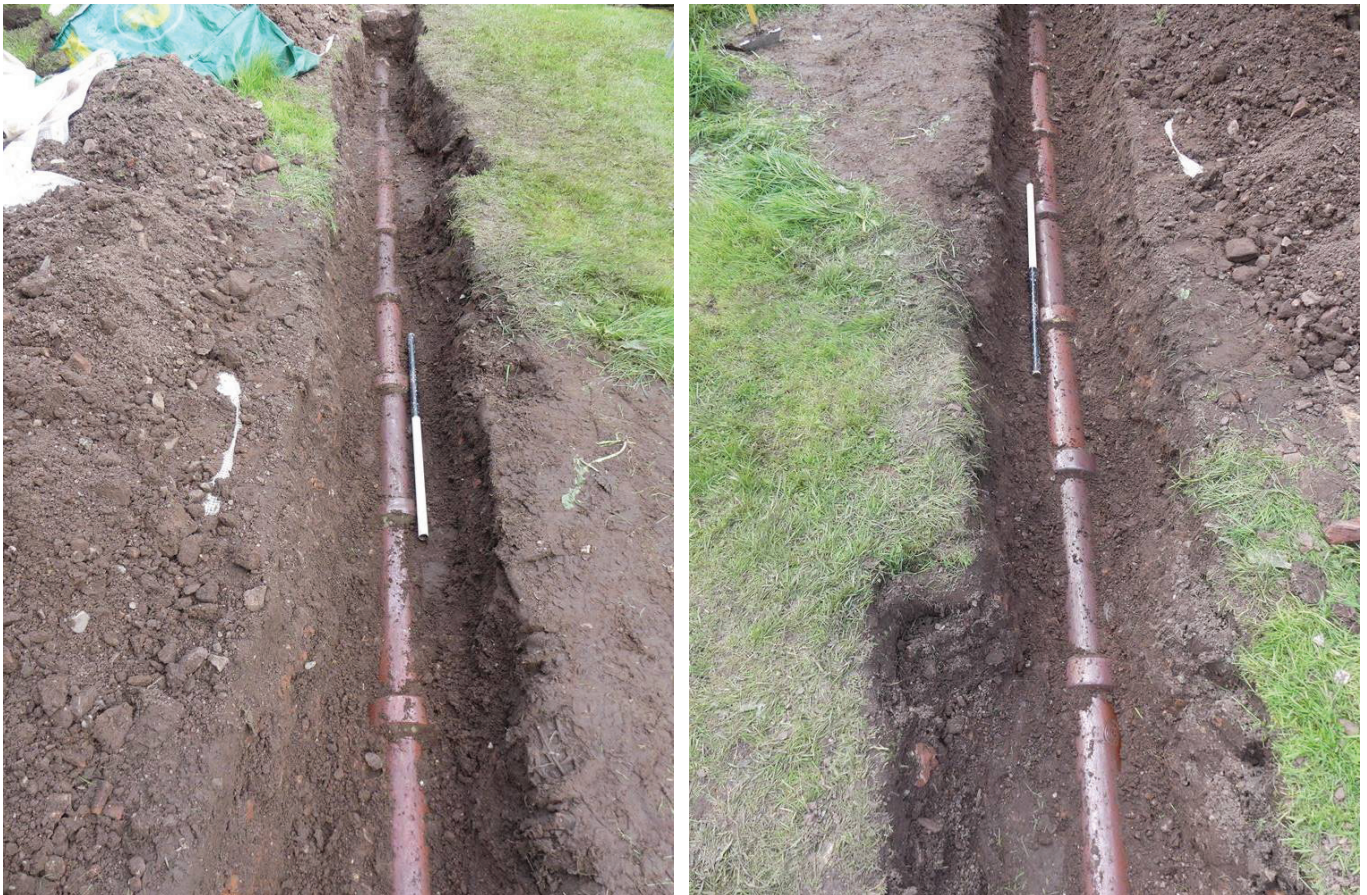
4.1.5 Following the excavation of the three initial drainage pits and the identification of the line of the ceramic drain pipe a trench exposing the whole length of this was excavated by hand on the 25th May 2021. This began from the edge of the culvert at the north-east end and revealed the same deposits as exposed in the original pits: an overlying soft dark reddish-brown silty clay up to 0.1m thick (**700**), over a similar matrix but sandier and with 30-40% angular cobbles, mostly red sandstone at least 0.4m thick and extending to the full depth of the trench. At the base of the trench the ceramic pipe, a dark reddish-brown salt glazed stoneware, was exposed and consisted of 13 sections each approximately 0.6m long including the collars, which were secured with concrete and it noticeably dropped in height from the south-west end to the north-east (Plate 11 and Plate 12). Two sections had a maker's mark visible comprising 'LFC' in three linked circles with 'IW' above (Plate 13). At the south-west end the pipe abruptly stopped. Beyond it a larger area was excavated in the angle formed by the south end of the

Plate 11 (left): The north-east end of the trench, viewed from the south-west end

Plate 12 (right): The south-west end of the trench, viewed from the north-east end

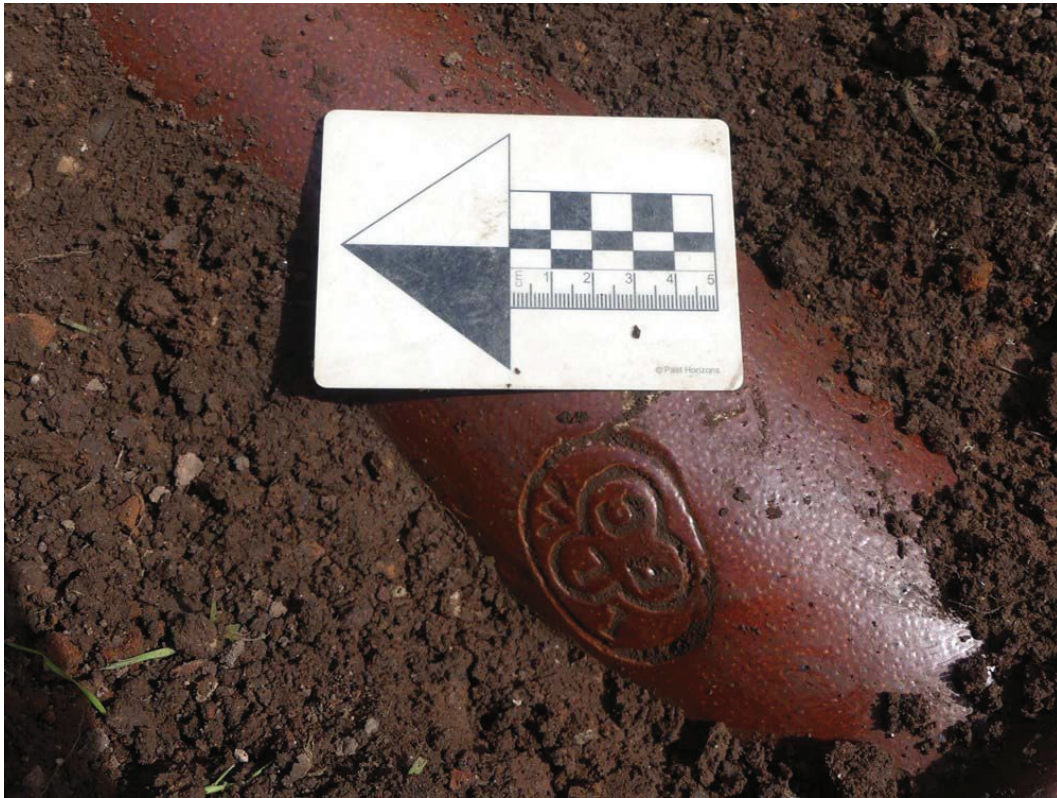
Plate 13: Maker's mark on a pipe section, viewed from the west

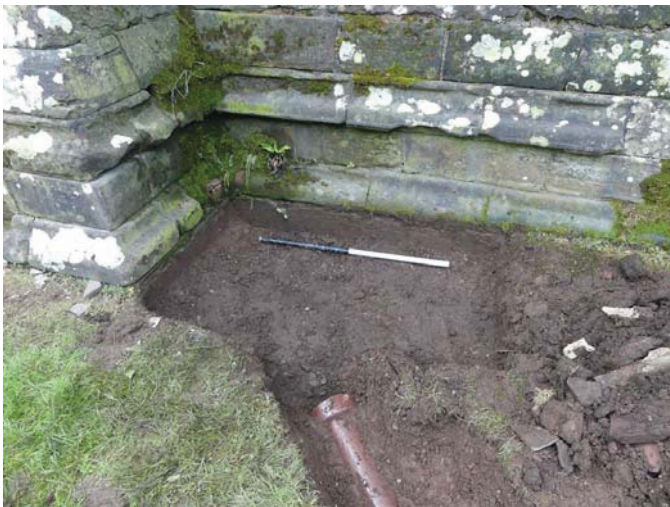
infirmary chapel wall and the buttress in order to form a new soakaway. Within this was an area of large loose angular stones in a similar matrix to **700** but darker and softer due to increased moisture (**702**), but generally only 0.1m thick, although thicker where it met the pipe (Plate 14). This also incorporated a patch of loose limestone gravel against the infirmary chapel wall, approximately 0.3m wide by 0.7m long (**703**) (Plate 14). Excavation through these deposits, to a depth of no more than 0.3m, revealed deposit **701** below, beneath which rough angular boulders were exposed below the dressed plinth of the wall, which were evidently the foundations (Plate 15). In addition, it was observed that the plinth and a moulded rail above had been deliberately removed across an area 2m in from either end, perhaps suggesting a lean-to building. but clearly a later addition, had formerly stood against the east end of the infirmary chapel (Plate 16).

Plate 14 (left): Area excavated against the infirmary chapel wall, showing deposits 702 and 703, viewed from the north-east

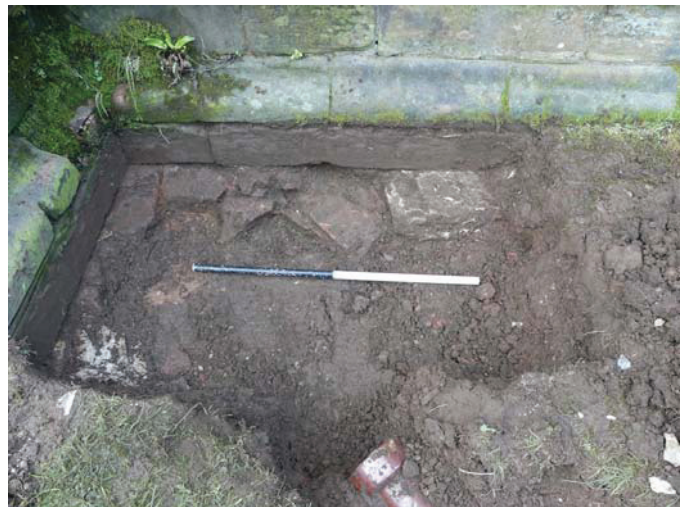
Plate 15 (right): Area excavated against the infirmary chapel wall, showing the foundation boulders, viewed from the north-east

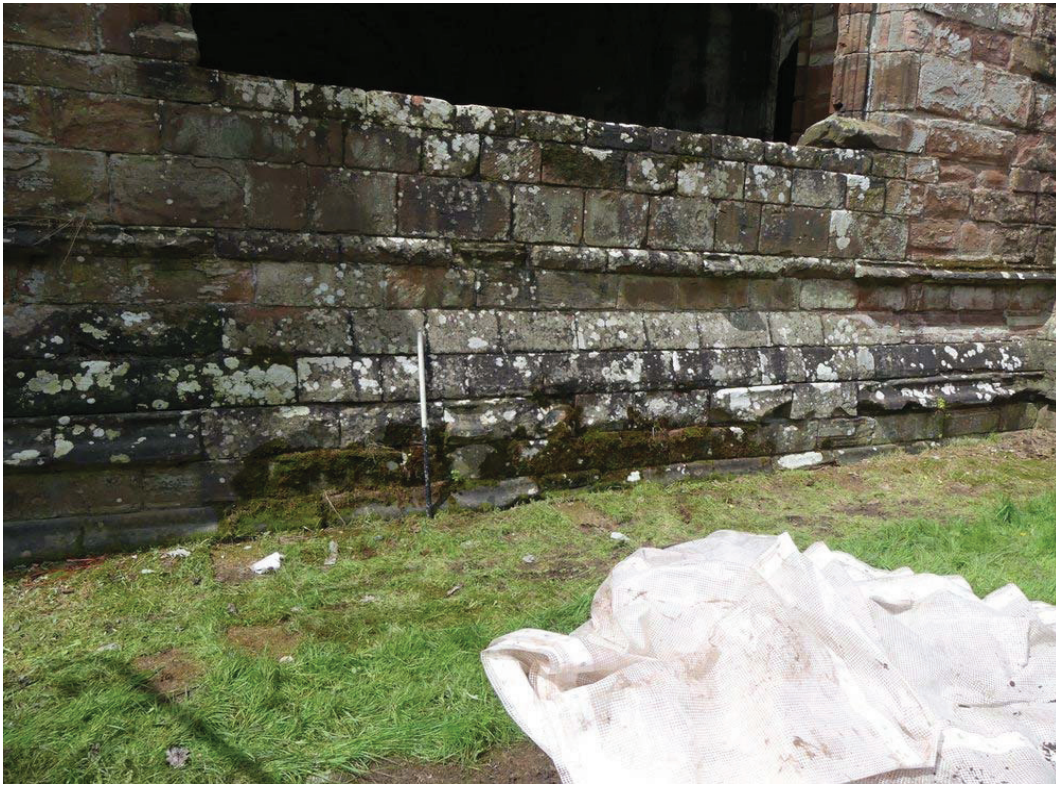
Plate 16: The east end of the infirmary chapel, showing the removed mouldings, viewed from the south-east

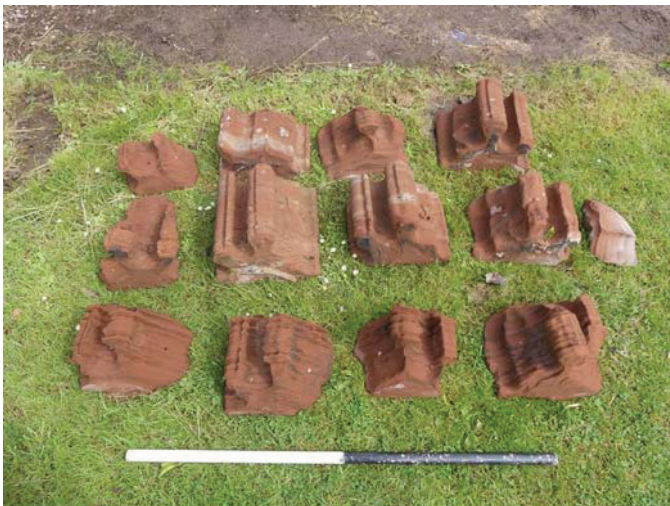
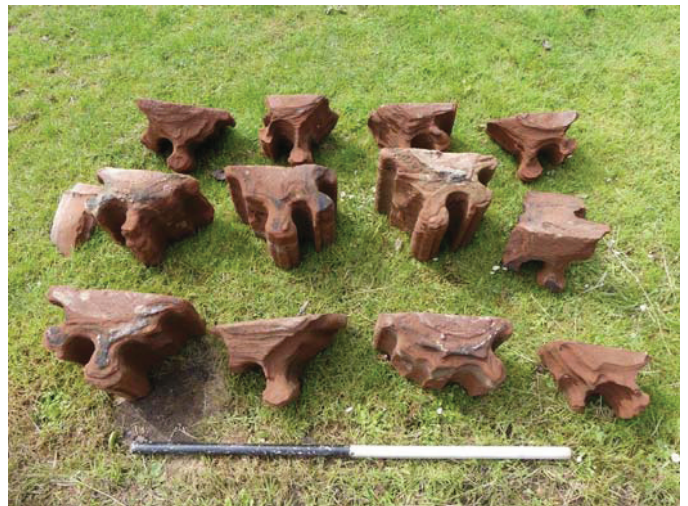
4.1.6 **Additional recording:** at the request of English Heritage photographs were also taken of a collection of loose pieces of moulded stone removed from one of the arches during the renovation work. A section of these is reproduced in Plate 17 and Plate 18.

Plate 17 (left): Loose stones from the arch

Plate 18 (right): Loose stones from the arch

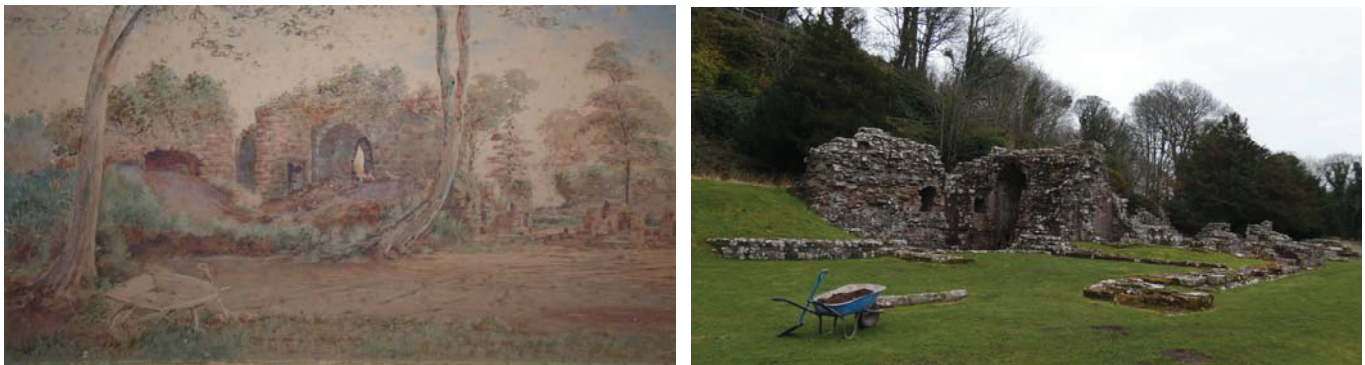
Plate 19 (left): Painting of the area around the Abbot's house during excavation, probably late 19th century (D Elsworth collection)

Plate 20 (right): The present view of the Abbot's house from the location of Signage Pit 2
