LOW LEVENS FARM, LEVENS, KENDAL, CUMBRIA

Archaeological Building Recording and Watching Brief

Client: Dallam Tower Estates

Planning ref: SL/2021/0007 and
SL/2021/0013

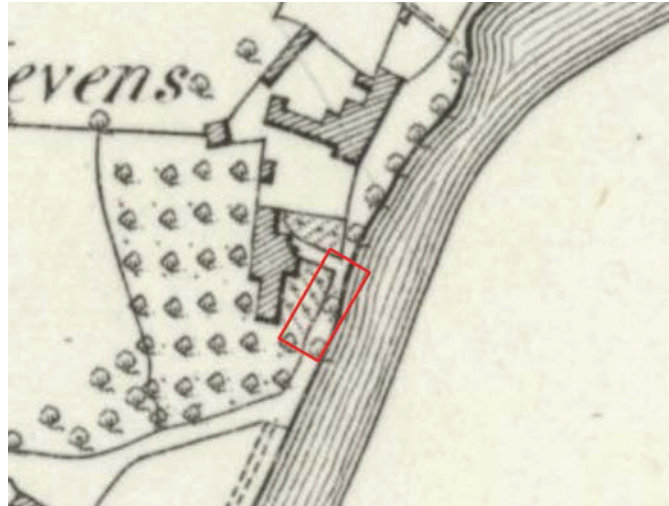
Plate 1: Extract from the Ordnance Survey map of 1862

3.1.2 **Ordnance Survey, 1862:** the first edition 1:10,560 Ordnance Survey map, surveyed in 1858, shows the farm to the west side of the river and the wall along the side of Sampool Lane (Plate 1).

3.1.3 **Ordnance Survey, 1898:** the 1898 edition of the Ordnance Survey map was revised in 1897. This edition, at a scale of 1:2,500, shows slightly more detail than the 1862 edition, including the return of the wall to the west at the south end of the area (Plate 2; cf. Plate 1). The farm at this time was called 'Nether Levens'.

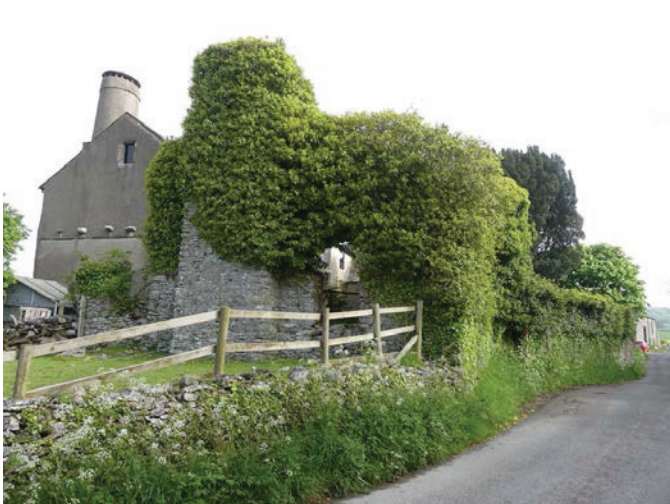
4.2.1 **East external elevation:** this begins at the south end as part of the ruinous adjoining building, the western return of which has a large projecting chimney stack with apertures to either side, probably both windows but the east perhaps a doorway (Plate 9). The return to the wall proper is essentially straight (Plate 10) but with a slight turn to the north-east after the ruinous building ends and a large area of collapse. At the junction with the wall there is a blocked doorway with the remains of a voussoir arch (Plate 11). The rest of the wall is relatively straight, except where the wall turns to form one side of a gate at the lower north end (Plate 12). The undulating top of the parapet was only evident once the ivy had been removed (Plate 13 and Plate 14) and a straight end, although not quoined, also became visible at the change in height at the north end (Plate 15 and Plate 16), immediately before which the upper part of the wall was leaning to the east.

Plate 9 (left): The return into the ruinous building at the south end, viewed from the south

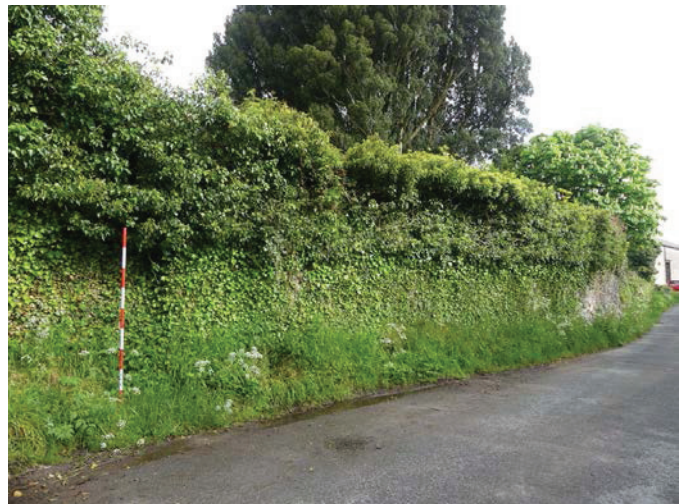
Plate 10 (right): The main part of the wall prior to the ivy being removed, viewed from the south-east

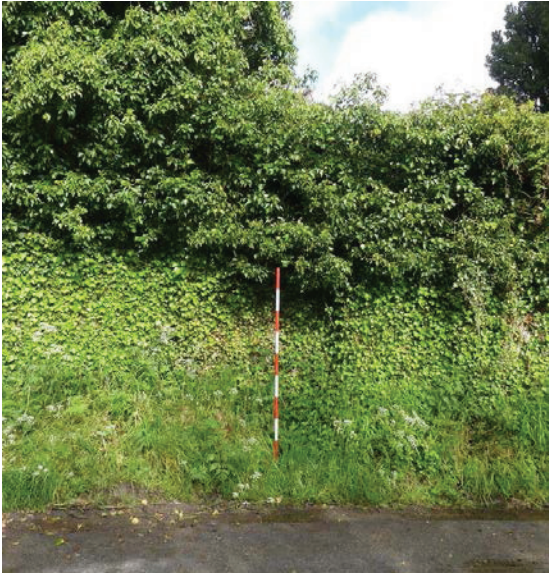
Plate 11 (left): The blocked doorway at the southern end of the wall, obscured by ivy, viewed from the east

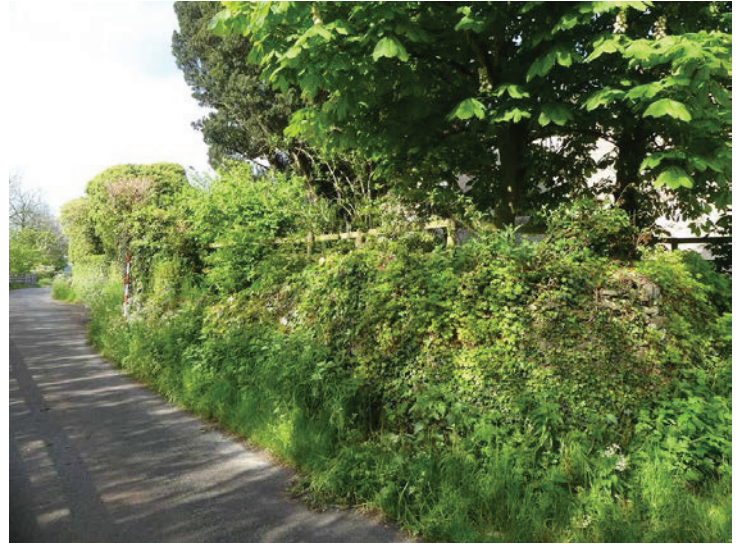
Plate 12 (right): The north end of the wall, obscured by ivy, viewed from the north-east

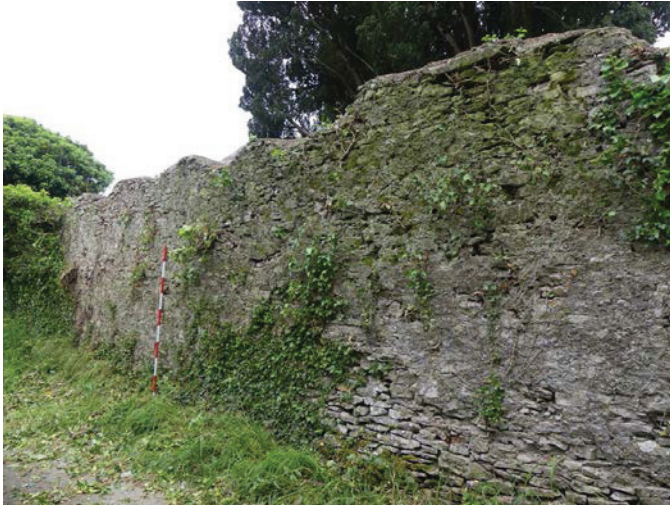
Plate 13 (left): The undulating parapet along the main part of the wall following the removal of the ivy, viewed from the north-east

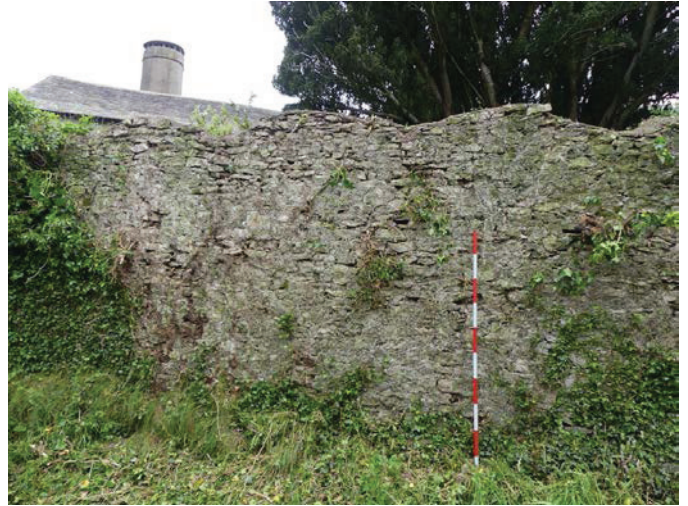
Plate 14 (right): The undulating parapet along the mail part of the wall following the removal of the ivy, viewed from the east

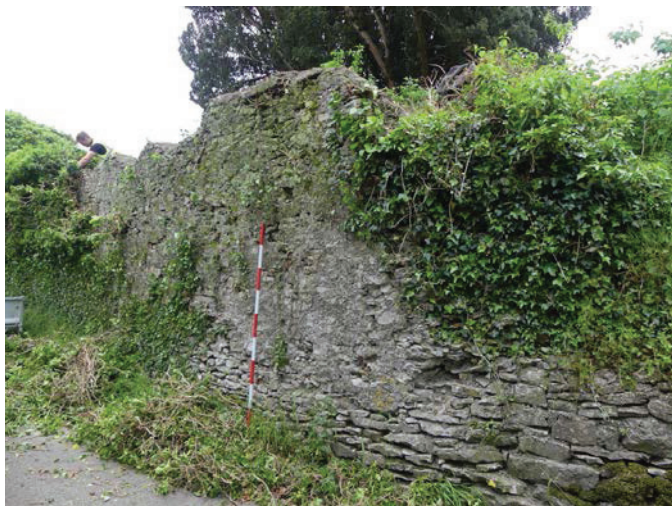
Plate 15 (left): The junction between the main wall and north end, viewed from the north-east

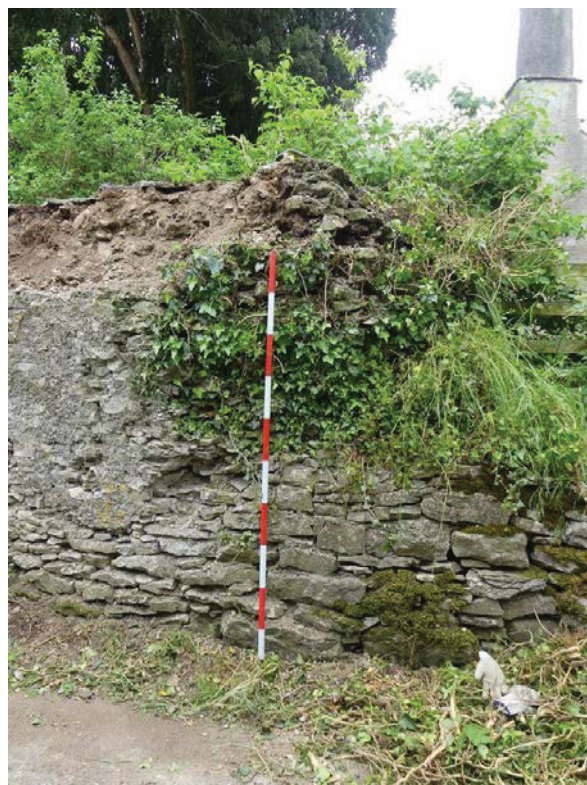
Plate 16 (right): The junction between the main wall and the north end, viewed from the east

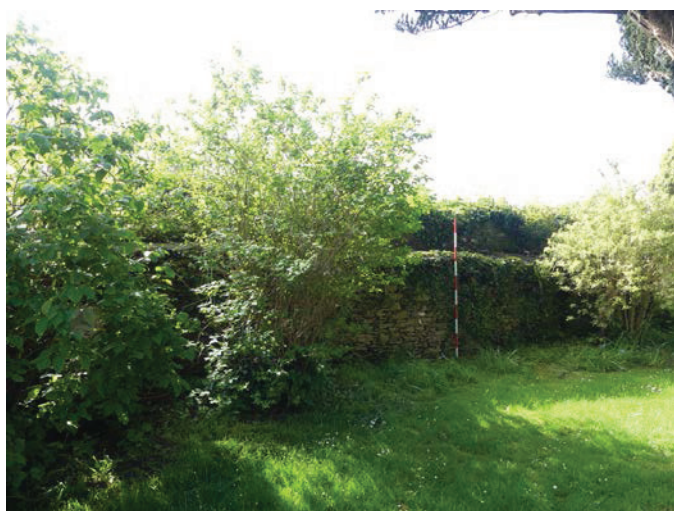
4.2.2 **West external elevation:** the north end of the wall is not visible from the west as it is at ground level and the difference in height is finished with a timber fence. The wall is otherwise fairly unremarkable from this side although the wall-walk was visible (Plate 17 and Plate 18) and at the south end there was a shallow recess 0.3m deep and 0.8m tall with splayed jambs (Plate 19). To the south of this the wall-walk ended before the blocked doorway and the return for the ruinous building to the south was more obvious (Plate 20).

Plate 17 (left): The west elevation of the wall, prior to the removal of ivy, viewed from the north-west

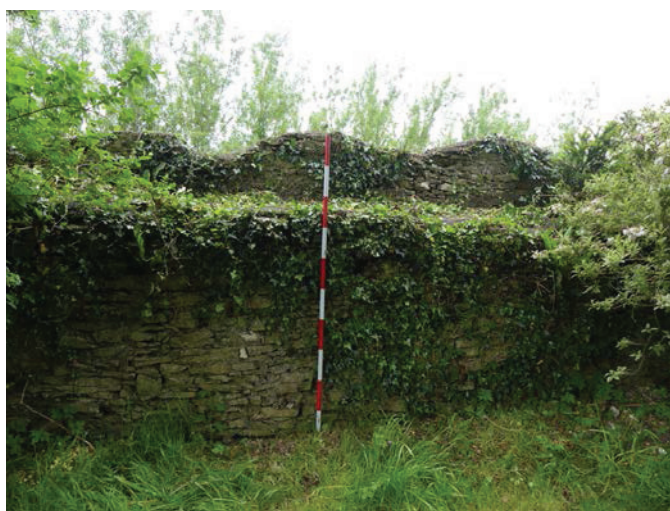
Plate 18 (right): The undulating parapet following the removal of the ivy, viewed from the west

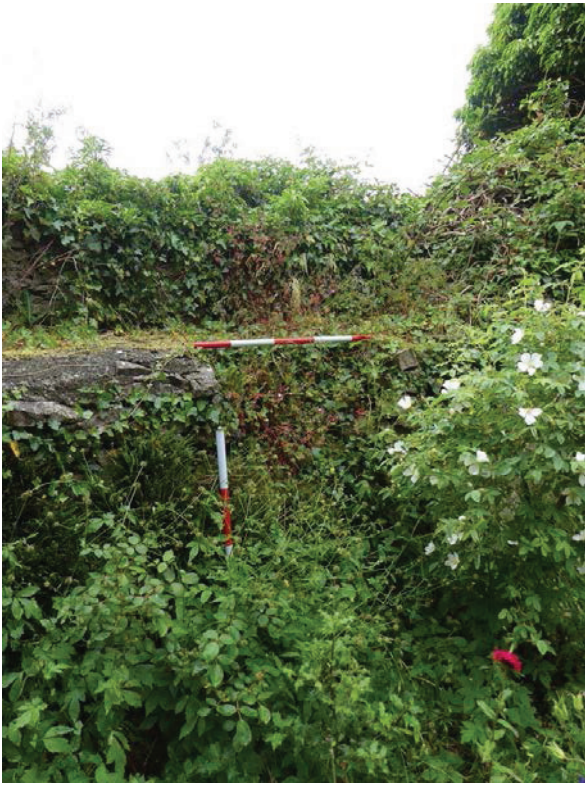
Plate 19 (left): The recess at the south end of the west elevation, viewed from the west

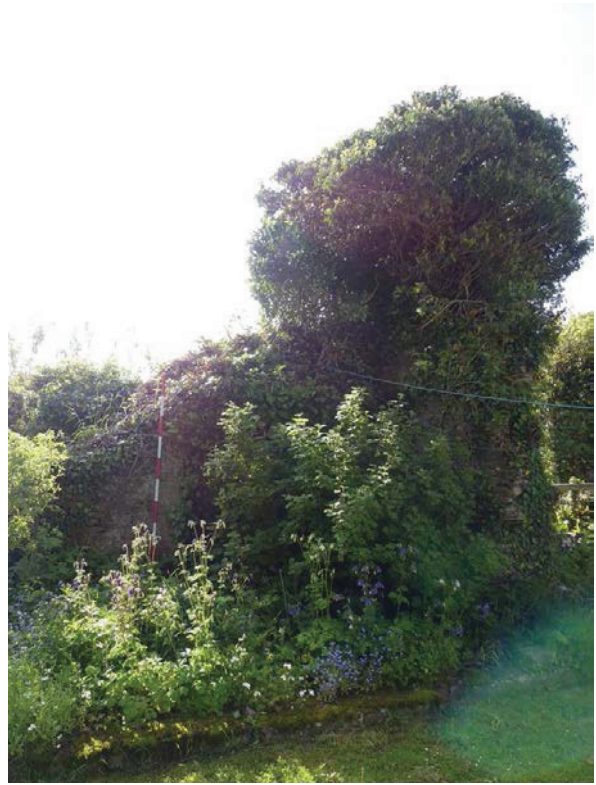
Plate 20 (right): The junction of the west elevation with the ruinous building at the south end and the blocked doorway, viewed from the west

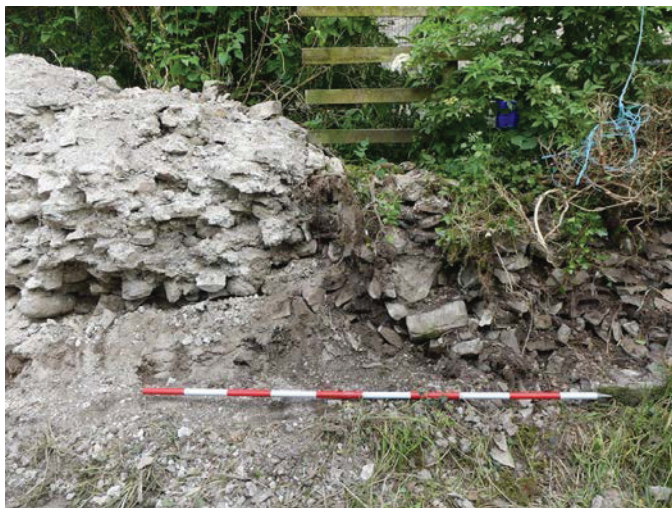
5.2.1 the removal of the ivy initially revealed the form of the parapet and that it and the wall-walk were capped with concrete (**1000**). Demolition revealed that majority of the main part of the wall (**1001**) was of a single build with small angular pieces of limestone set in large quantities of coarse lime-mortar, while the lower section at the north end (**1002**) had some concrete bonding and also incorporated pieces of roofing slate, concrete and dressed red sandstone (Plate 21). As demolition progressed it became apparent that a large section at the bottom of wall **1001**, up to five courses high and over 2.2m long north/south, had been rebuilt as it contained no lime mortar, but some concrete had been used and pieces of concrete slab, roof slate, brick, and dressed red sandstone were incorporated into it (**1003**) (Plate 22). It also projected slightly from the line of the wall above. It was not clear how far this section continued through the wall's thickness, but to the west there was another very loose section within the wall core made up of loose stone in a soft dark brown matrix (**1005**) forming an approximately semi-circular section through the wall, apparently filling a deliberate cut [**1006**] approximately 0.8m wide north/south (Plate 23). Between the main part of the wall (**1001**) and the lower north end (**1002**) there was a smaller patch of lime-rich fabric, approximately 1m wide, that seemed to belong to neither wall (**1007**) (Plate 24). At the base of the whole wall the foundations, which typically comprised larger boulders, especially at the lower north end, were sat on a mid-orangey brown firm sandy clay with 10% angular pebbles, which evidently represents the natural geology (**1004**) (Plate 25).

Plate 21 (left): The junction of the main wall (**1001**) and lower northern section (**1002**) showing the different fabrics

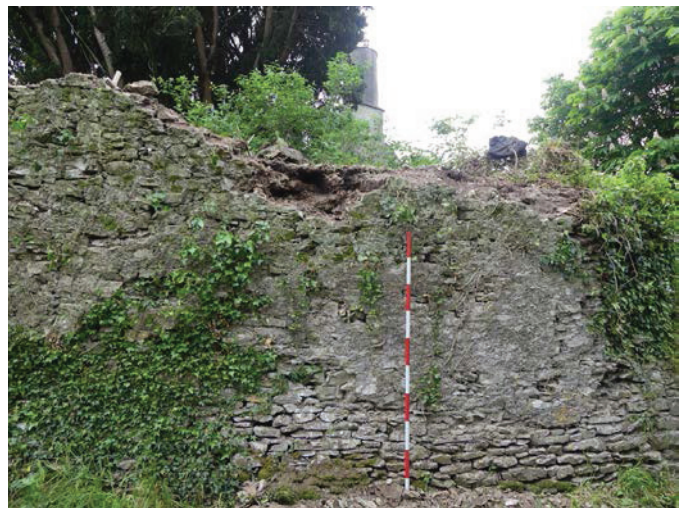
Plate 22 (right): The rebuilt section at the base of the wall (**1003**) revealed during demolition, viewed from the east

6.1.4 **Phase 3 – modern:** perhaps as a result of the excavation of **1006** a section of wall **1001**, low on the east face, was rebuilt (**1003**). Finds recovered from this and the use of concrete in the fill suggest a relatively modern, 20th century date. The section of the wall to the north (**1002**) was also rebuilt, probably several times, with finds of various dates recovered from it. In addition, the top of the main wall **1001** and wall walk were capped with concrete (**1000**). It is conceivable that all of this activity ultimately contributed to the top part of wall **1001** leaning out to the east.

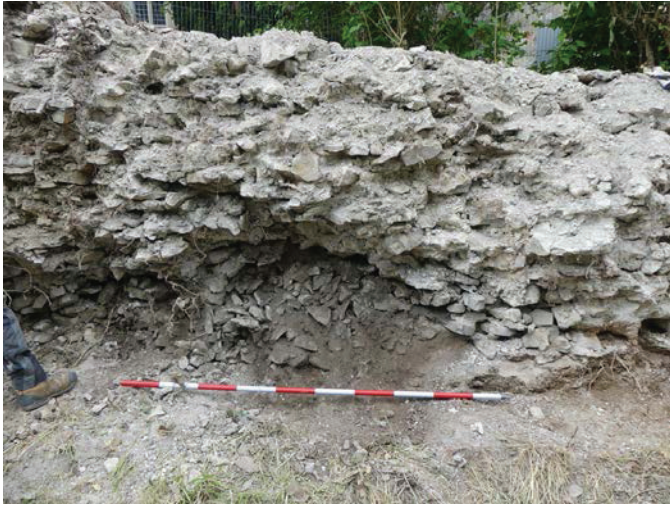
Plate 23 (left): The semi-circular section cut through the lower part of the main wall [1006] filled with (1005), viewed from the east

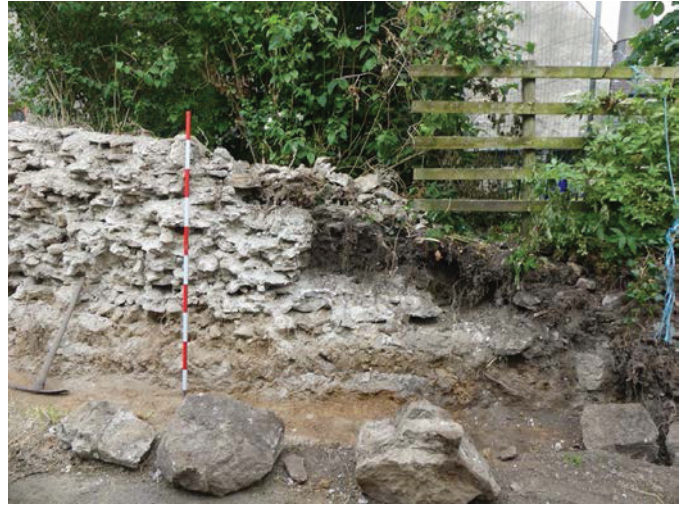
Plate 24 (right): The lime-rich section (1007) between 1001 and 1002, viewed from the east

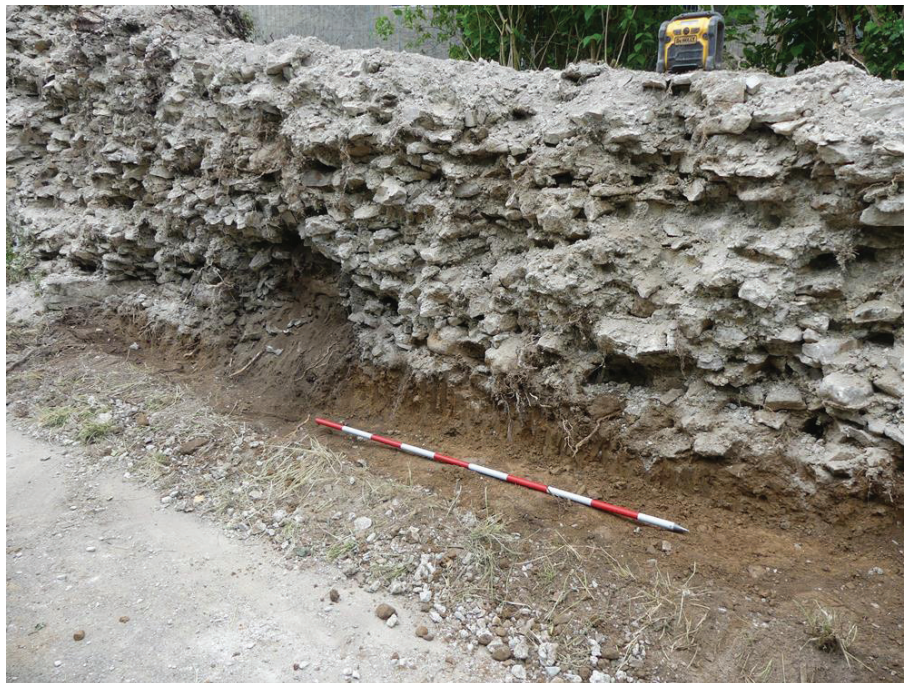
Plate 25: The natural (1004) exposed beneath 1001, viewed from the north-east
