# GREENFIELD LODGE, AYNSOME ROAD, CARTMEL, CUMBRIA

## Heritage Assessment

<b>Planning</b>	
Pre-planning?	No
Planning Application No.	SL/2021/0317
Plans (e.g. conversion, extension, demolition)	Demolition of existing dwelling and construction of replacement building
Condition number	n/a
Local Planning Authority	South Lakeland District Council
Conservation	Libby Mee, SLDC
Planning Archaeologist	Jeremy Parsons, Cumbria County Council

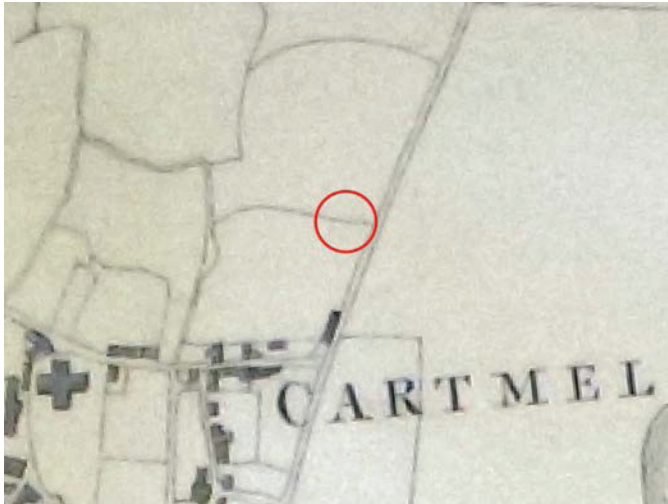
Plate 1 (left): Extract from the enclosure map of 1807

3.1.2 **Enclosure map, 1807:** neither Greenfield House nor the lodge are shown on the enclosure map of 1807 (Plate 1).

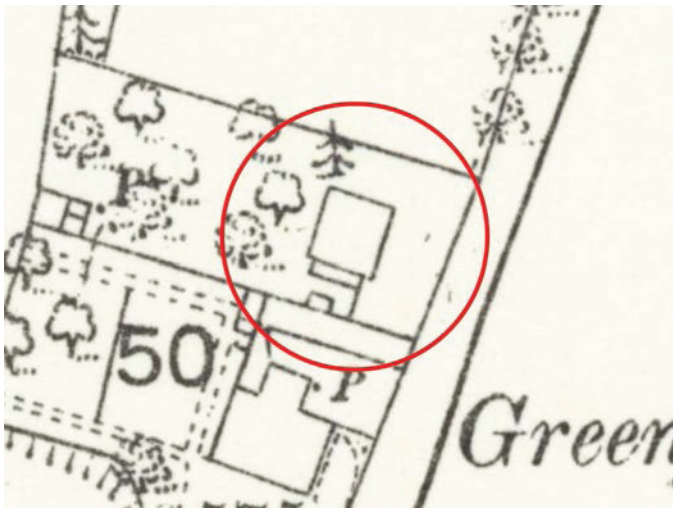
Plate 3 (left): Extract from the Ordnance Survey map of 1890

3.1.4 **Ordnance Survey, 1890:** this is the first edition of the Ordnance Survey map to show the lodge, and, at a scale of 1:2,500, it is much more detailed than the previous map (Plate 3; cf. Plate 2). There is a slight discrepancy in the orientation of the buildings on site between the Ordnance Survey maps and the most recent survey (Plate 3; cf. Figure 4) however, the main structure of the lodge is shown as a square footprint with a narrow, shorter structure to the south side.

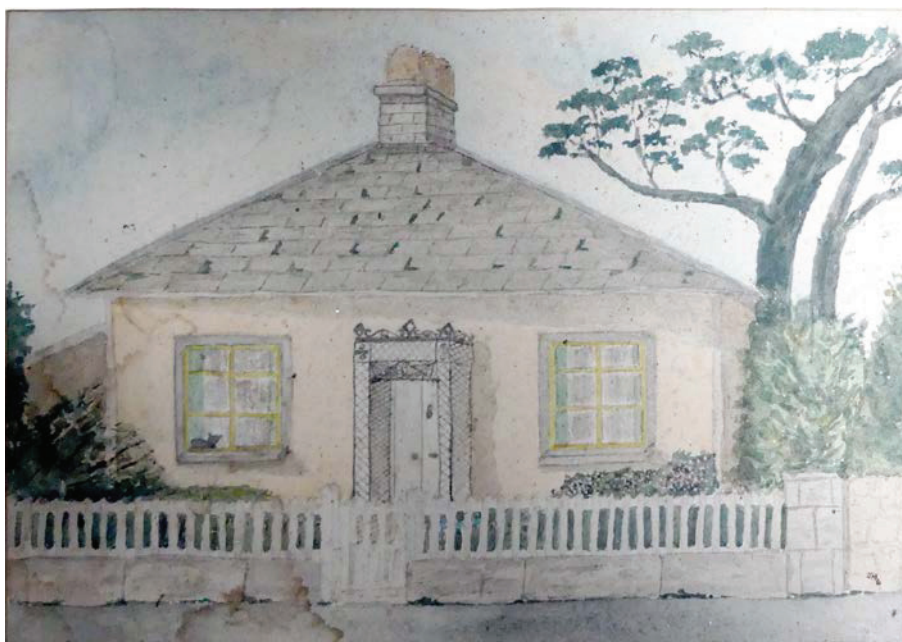
Plate 9: Undated painting of the east elevation of Greenfield Lodge

3.1.9 **Painting, nd:** an undated painting present within the roof space of the building during the building recording depicts the east elevation of Greenfield Lodge prior to the changes of the late 20<sup>th</sup> century. It clearly shows the original hipped roof coming to a central chimney stack, trellis porch around the front door, and monopitch outshut on the south side. The front wall at this time appears to have comprised ashlar stone blocks with a white timber fence on top.

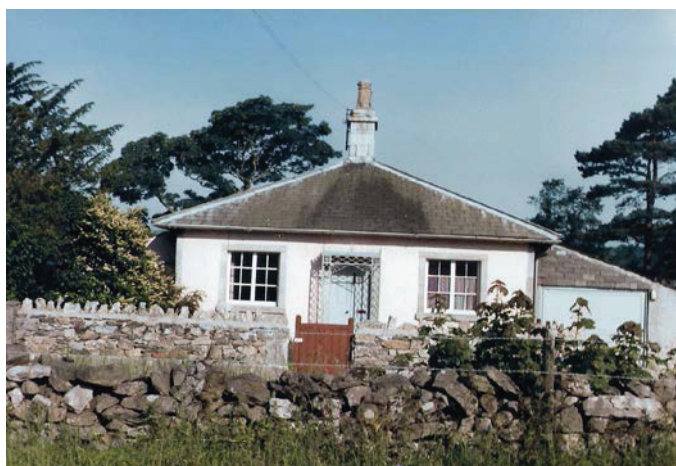
**Plate 10 (left): The east elevation of Greenfield Lodge prior to the development of c1984**

3.1.10 **Photographs, pre-1984:** two photographs exist of the house prior to it being enlarged in c1984. These show that while the main part of the building retained much of its earlier form as per the painting (Plate 9) the boundary wall had clearly been changed, with a stone wall built in place of the earlier picket fence, and a monopitch outshut had been added to the north end to provide a garage (Plate 10 and Plate 11).

5.2.3 **Phase 2 (pre-1984):** the photographs predating the extension of c1984 clearly show that the garage to the north (Room G1) was built first. It is not clear when but it must have been between the production of the Ordnance Survey map of 1933 and c1984. This also probably resulted in an initial remodelling of the eastern boundary wall, presumably to provide a new vehicular access to the north, although the front gate to the house seems to have remained in the same position, directly facing the front door.

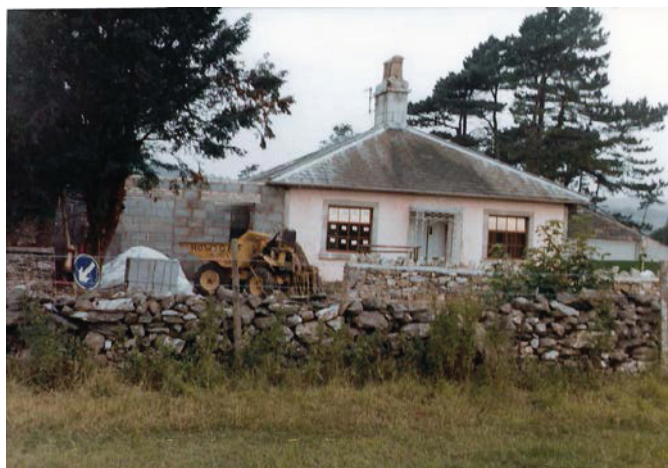
**Plate 12: The east elevation of Greenfield Lodge during the rebuilding of c1984**

3.1.11 **Photographs, c1984:** a collection of photographs dating from the work carried out to extend the original building in c1984. These demonstrate that the new build was constructed from concrete blocks but apparently retained much of the original roof structure (Plate 12 to Plate 14).

5.2.4 **Phase 3 (c1984):** the photographs from c1984 show that a large extension was added to the south of the building at this time, corresponding to Rooms G8-G11, with the conservatory (Room G7) also added – the door evidently inserted where there had previously been two windows (see Plate 11). The covered area making up Room G12 was probably also added at this time or perhaps slightly later, and effectively attached the building to the wall of the neighbouring building. The boundary wall to the east was also rebuilt to its current form at this time, moving the position of the gate to the east further south and presumably adding the gate to the north.

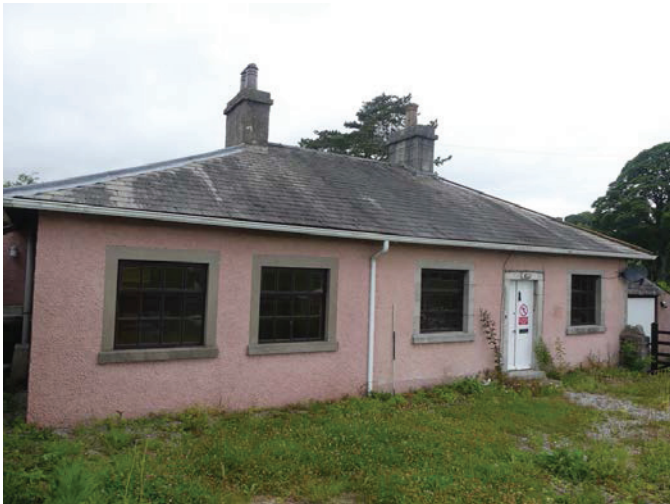
Plate 16 (left): General view of the east external elevation

4.2.1 **East external elevation:** this forms the front elevation onto Aynsome Road (Figure 1; Plate 16). It has a mono-pitch garage extension at the north end, with slate hung over the modern tilting garage roof (Plate 17). There is a slight return where it meets the main building with dressed ashlar quoins (Figure 2). The north end of the main elevation is symmetrical and has two square windows with dressed square, ashlar surrounds and projecting sills and modern 12-light hinged stained timber casements either side of the doorway (Plate 18). The doorway has similar ashlar surrounds and a lintel and step and split four-panel door the top two of which are raised and fielded. There are two more windows to the south, with plain square surrounds in concrete (Plate 19; Figure 2). The elevation steps back at the south end and returns with a shallow mono-pitch and timber outshut with plain door (Plate 20).

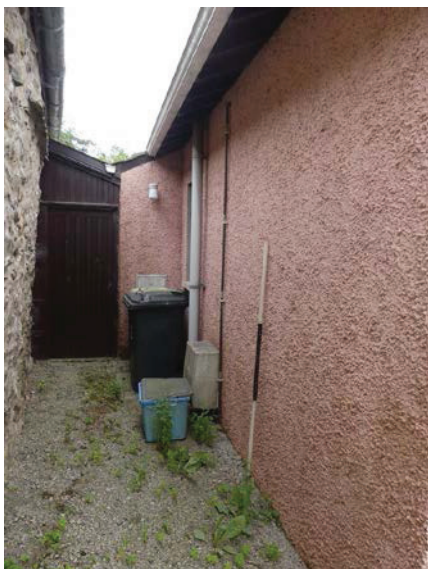
**Plate 20 (left): External elevation and mono-pitch timber outshut to the south**

**4.2.2 South external elevation:** the south external elevation is plain (Plate 20), rendered, and has a mono-pitch outshut to the west, obscured by an attached timber outshut (Figure 2). There is one window on the east side, with a six-light timber hinged casement and concrete sill (Plate 21).

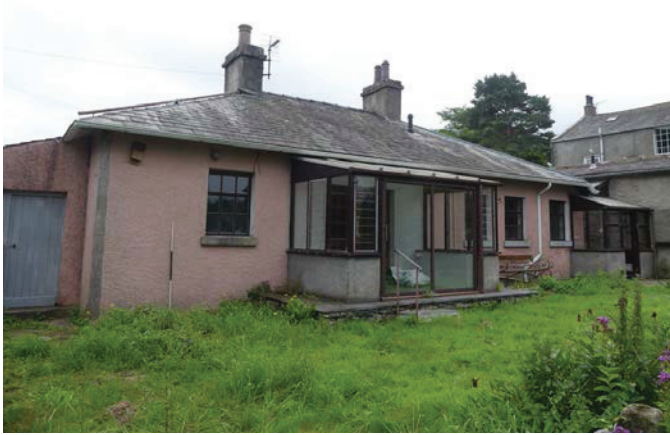
Plate 22 (left): General view of the west external elevation

**4.2.3 West external elevation:** the rear elevation (Figure 3; Plate 22). The south end is covered by a later mono-pitch porch/conservatory, with a plastic sheet roof, timber windows and glazed door on top of low rendered walls (Plate 23). There is a row of three windows to the north, with concrete sills and modern nine-light hinged timber casements (Plate 23). There is an obvious line in the render of the join with the original wall (Figure 3). The north end of the main building (towards the centre of the elevation) has a conservatory attached with a mono-pitch plastic roof and timber glazed structure on low rendered wall with a sliding French door sat on a raised platform of slate with slate flags (Plate 24). There is a single original window to the north with the same casement as those to the south and a dressed limestone sill (Plate 24). There are dressed ashlar quoins at the corner (Plate 25) and the return to the east is plain before continuing at the end of the garage with a plank door up one concrete step and a small single-light hinged timber window with slate sill (Plate 26).

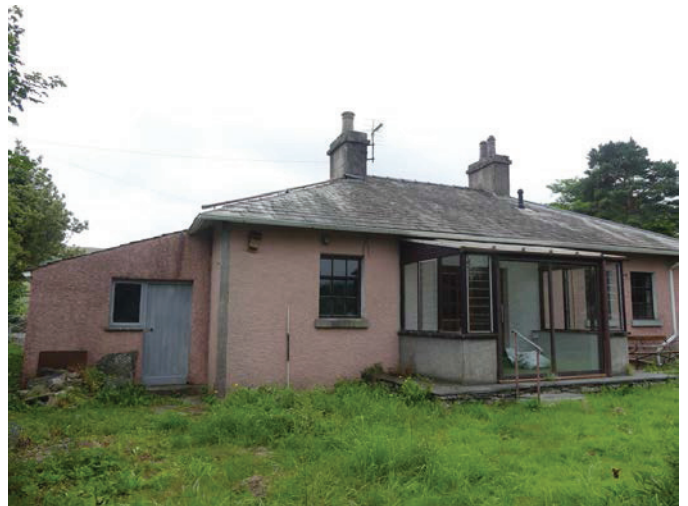
Plate 25 (right): General view of the north end of the west external elevation

4.2.4 **North external elevation:** the north external elevation is largely covered by a mono-pitch garage roof. It is plain rendered and extended on the west side by a conservatory/porch (Figure 3; Plate 25).

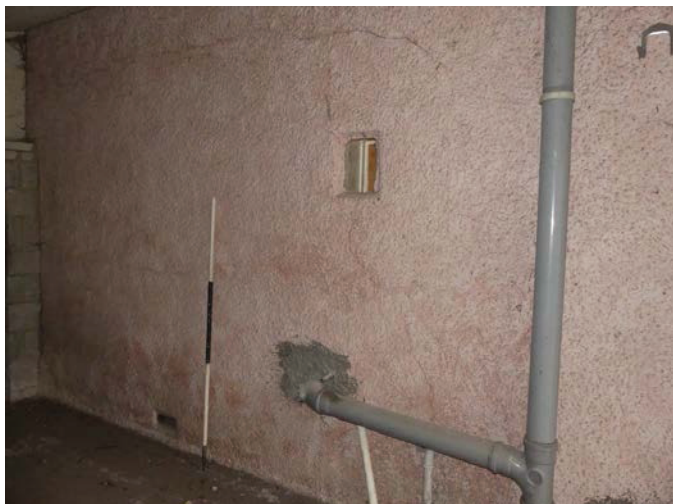
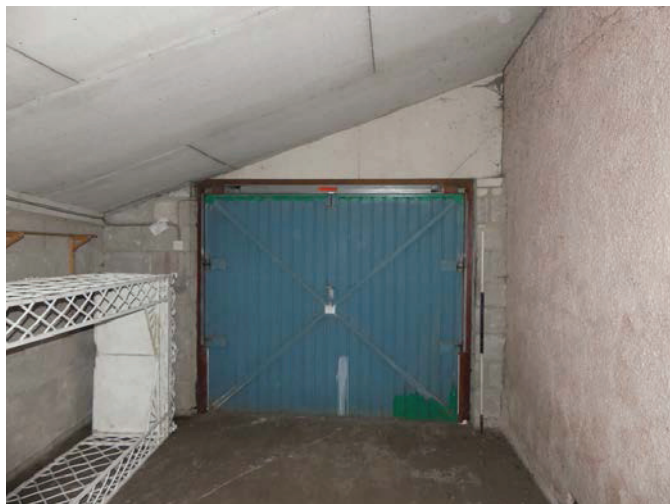
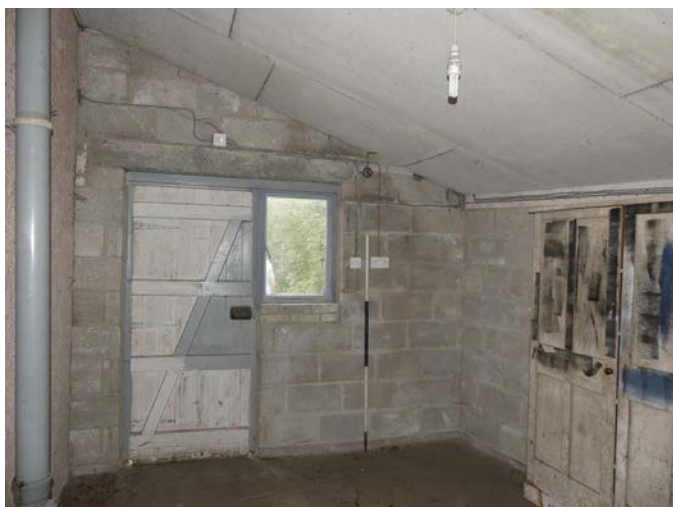
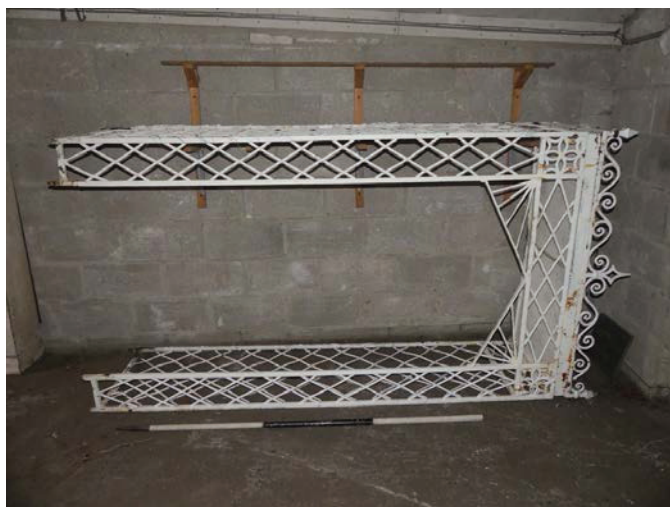
4.3.1 **Ground floor Room 1 (G1)**: this room has a concrete floor and mono-pitch sheet roof. The walls are concrete block except the **south**, which is roughcast rendered with a small window that is blocked internally (Plate 27). There is a metal garage door to the **east** (Plate 28) and there is a door and window to the **west** (Plate 29). There is a loose iron trellis on the floor (Plate 30). This was originally positioned over the front door in the east elevation but appears to be a relatively late construction possibly made up of two parts as the scrolled top does not match the style and manufacturing technique of the lower part and there is a modern thin sheet of metal forming the flat roof.

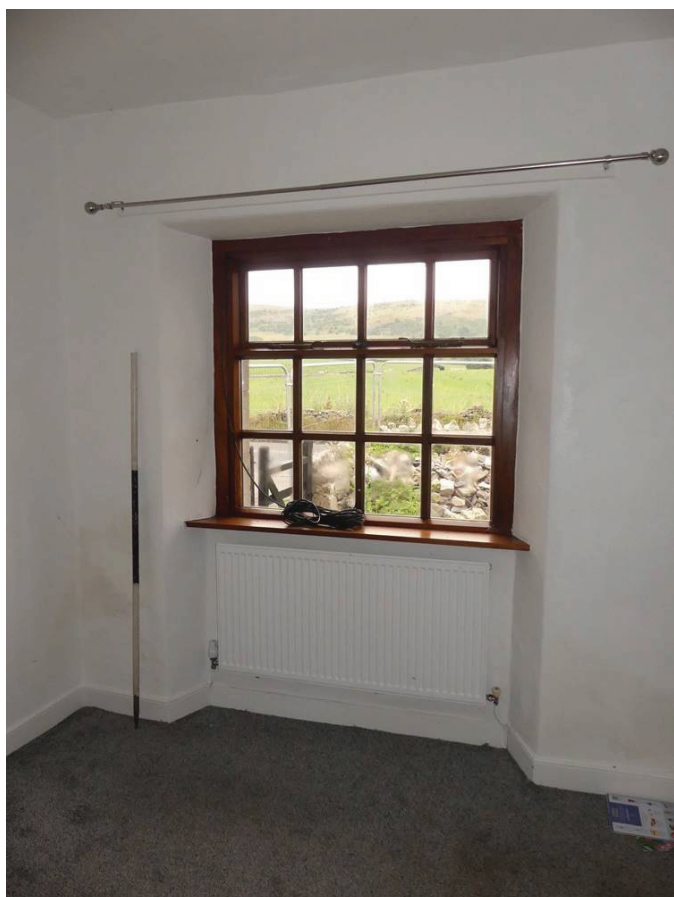
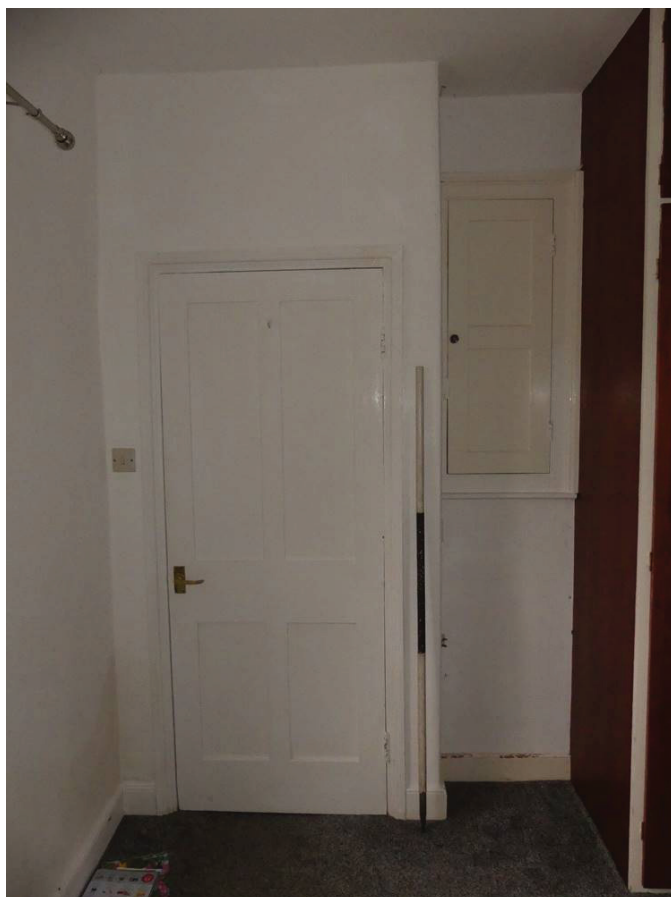
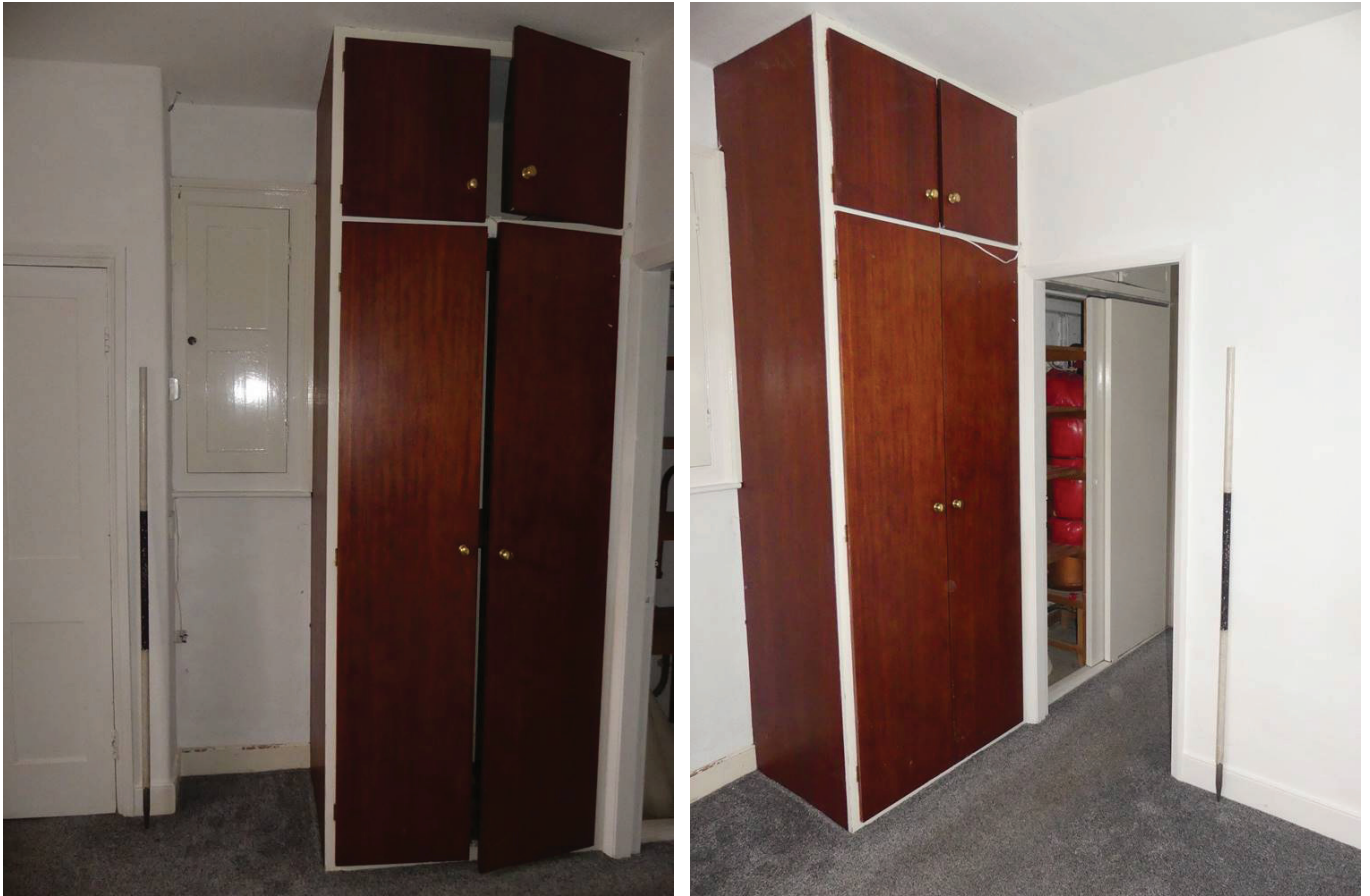
4.3.2 **Ground floor Room 2 (G2)**: this room has carpet on the floor and a flat plastered ceiling. The walls are finished with flock wallpaper and skirting board. The **north** elevation is plain. The **east** elevation has a window with splayed jambs to the floor and timber sill (Plate 31). The doorway on the east side to the **south** elevation, with the moulded surround, and the plain four-panel door are original (Plate 32). The cupboard to the west has a two-panel door and moulded surround and two shelves inside (Plate 32). There is a modern fitted cupboard to the west of that (Plate 33). The **west** elevation is a stud wall with a doorway on the south side with a plain surround (Plate 34).

5.2.2 **Phase 1 (mid to late 19<sup>th</sup> century):** the map evidence demonstrates that the building was originally constructed in the second half of the 19<sup>th</sup> century, with the census returns indicating that it was in existence by 1861. In its original form it was a small square structure, probably with only four rooms (Room G6 was probably sub-divided) but also an outshut on the south side, with a hipped main roof coming to a central chimney stack. The documentary sources show that it was occupied by either a groom or gardener and that it belonged to Ivy Cottage (now Ivy House). It was clearly never a lodge in the proper sense as it was not located at the end of a drive into the property, although it was referred to historically as Ivy Lodge and Ivy Cottage Lodge. Some original architectural elements still remain: the ashlar stone used externally in the quoins and original chimney, the panelled doors and moulded surrounds off the porch (Room G3), the cupboards in Rooms G2 and G6, and elements of the roof structure.

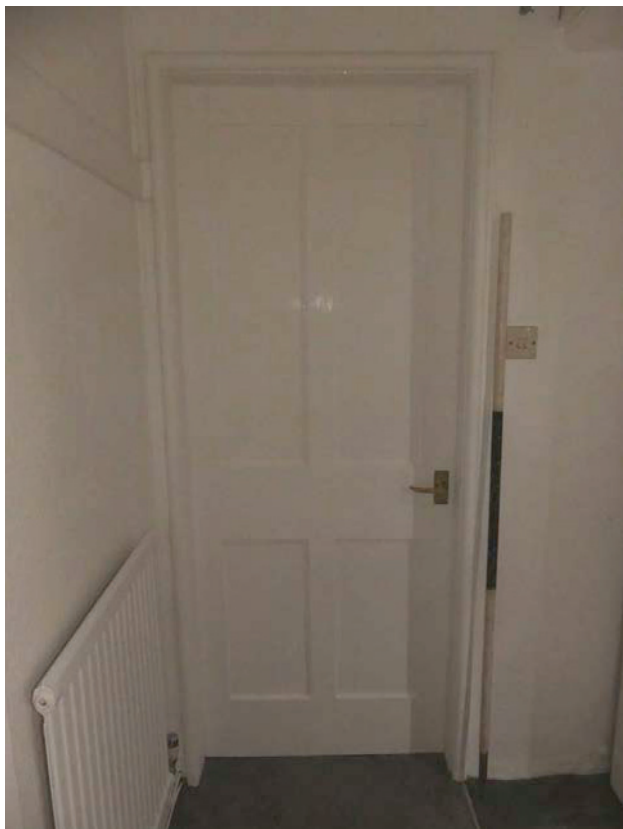
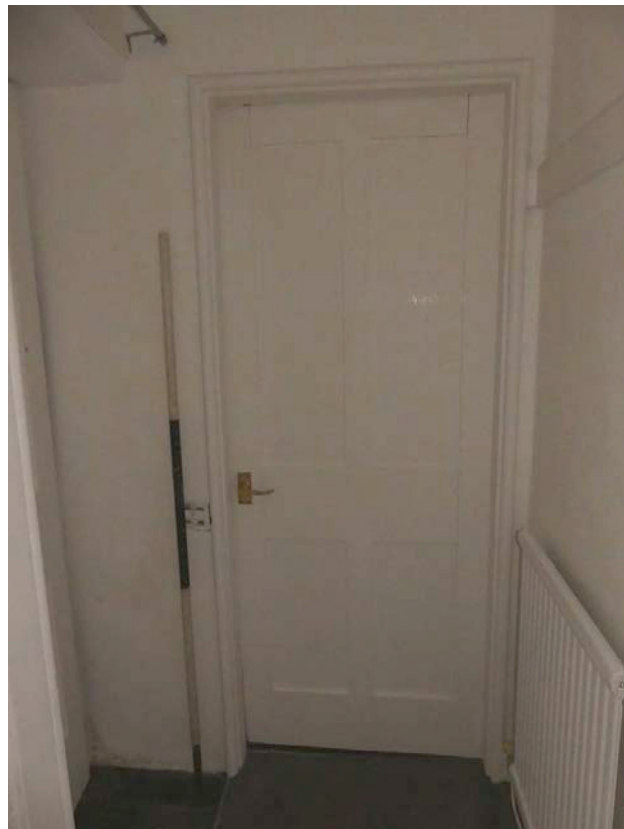
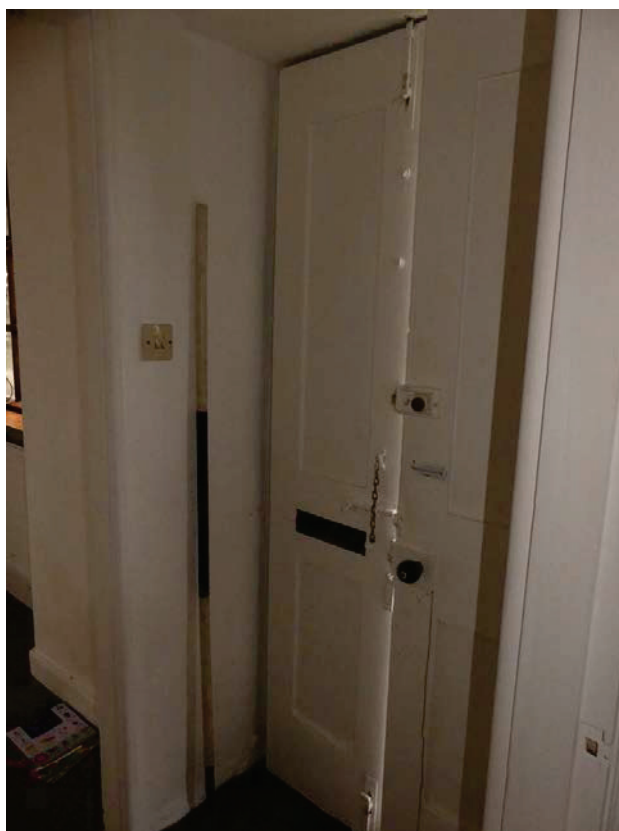
4.3.3 **Ground floor Room 3 (G3)**: this small porch has a carpet and vinyl floor and a flat plaster ceiling. The walls are finished with flock wallpaper. There are doorways to the **north** and **south**, with deep roll-moulded surround and four panel doors, are original (Plate 35 and Plate 36). The door in the **east** elevation is a split four-panel door, has fairly substantial bolts, and is perhaps designed to open back into the roll mouldings (Plate 37). The **west** elevation is plain apart from a chamfered batten with scars for coat hooks.

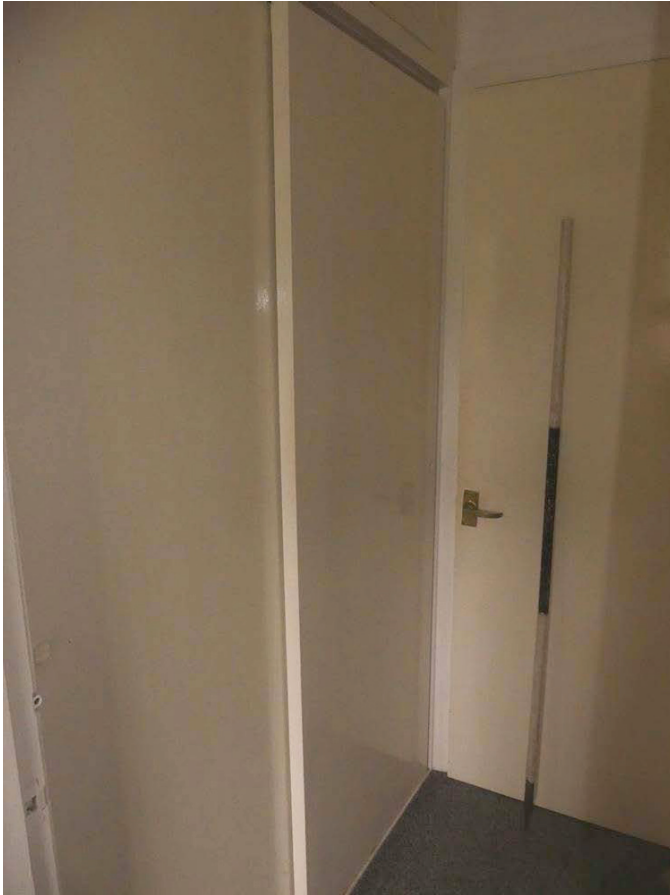
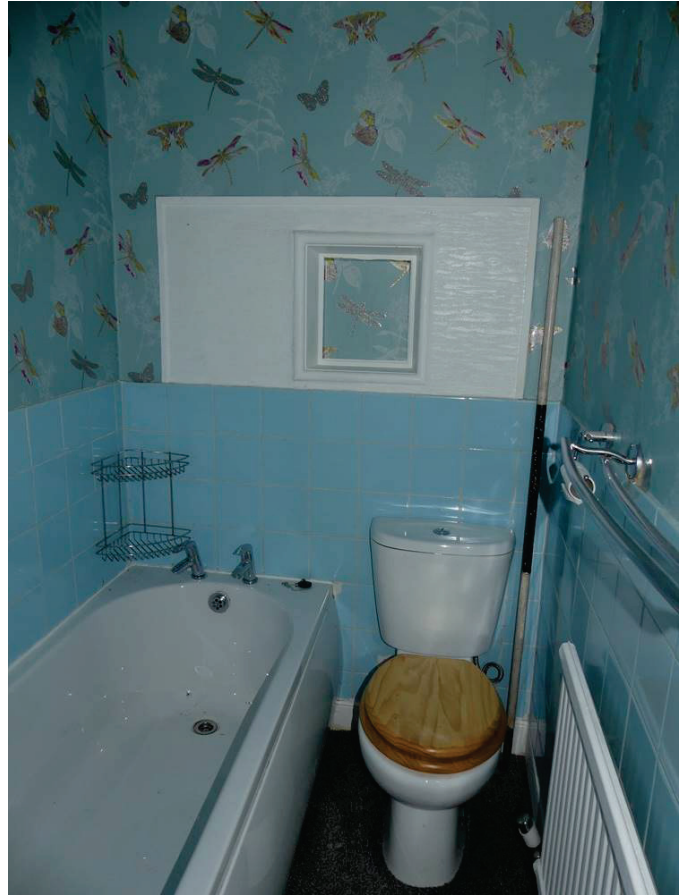
4.3.4 **Ground floor Room 4 (G4):** there is carpet on the floor and the ceiling is flat plaster. There are grill vents in the bathroom ceiling on the north side. The room is divided in two by a corridor along the **south** side with the airing cupboard to the south of that, housing the hot water tank with sliding lower doors (Plate 38), and a pair of doors over the bathroom to the **north**. The bathroom is accessed through a sliding door and has been modernised and tiled over the lower part. The **north** elevation has a small area in plain surround with a smaller central recess, possibly a window (Plate 39). The **east** and **west** elevations in the corridor have doorways with plain modern surrounds and a plain single panel door to the west.

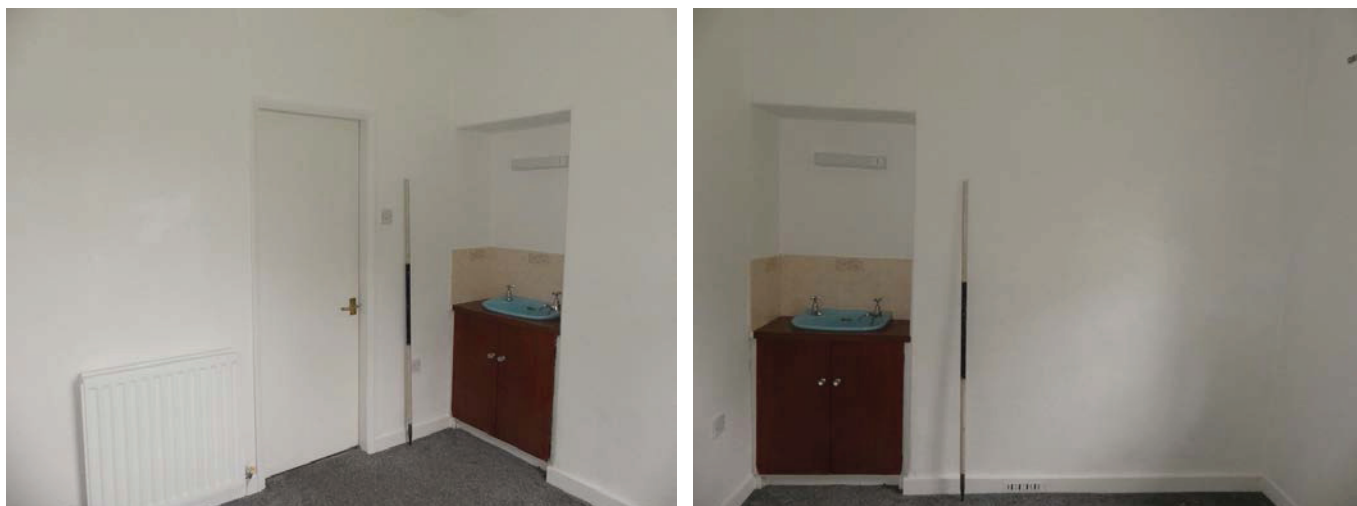
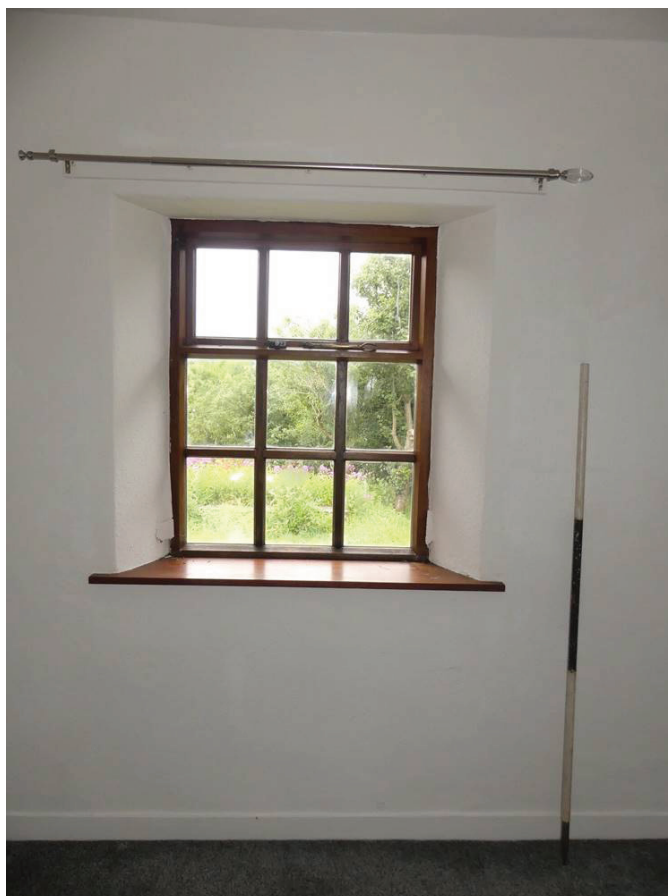
4.3.5 **Ground floor Room 5 (G5):** this room has a carpeted floor and flat plaster ceiling. The walls and ceiling are finished with flock wallpaper and there is plain square skirting board. The **north** elevation is plain. The **east** elevation is a stud wall with a doorway on the south side with a plain surround and door (Plate 40). The **south** elevation has an alcove on the east side of a former doorway, now with a sink and cupboard below (Plate 41). There is a vent in the skirting to the west, presumably for a former fireplace, and the wall is evidently infill on the west side. The **west** elevation has a single window with splayed jambs and a timber sill (Plate 42).

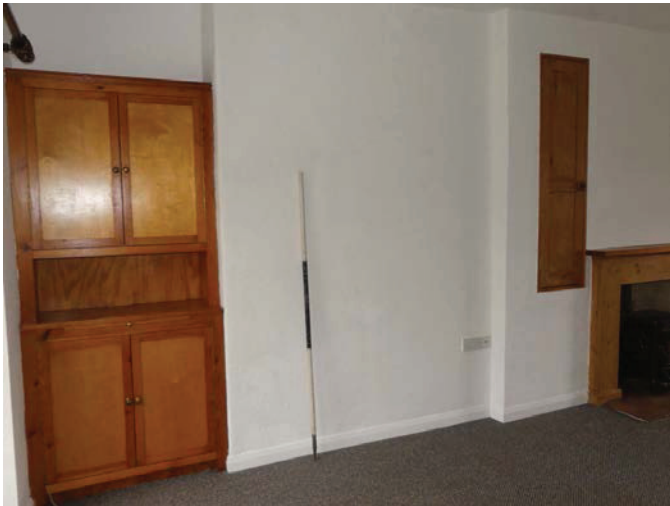
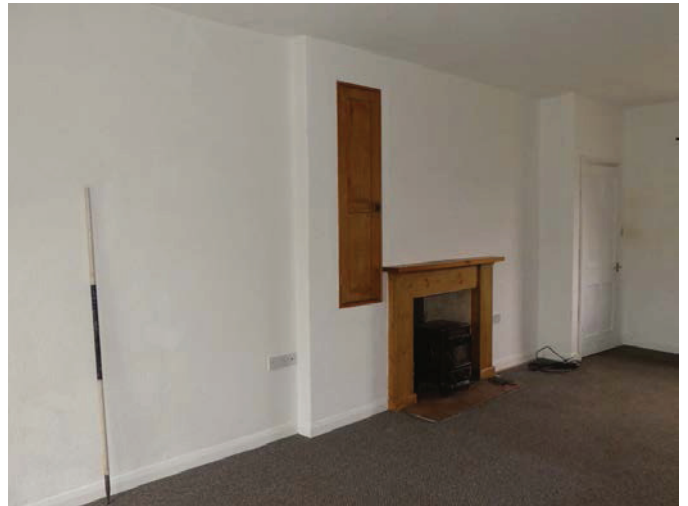
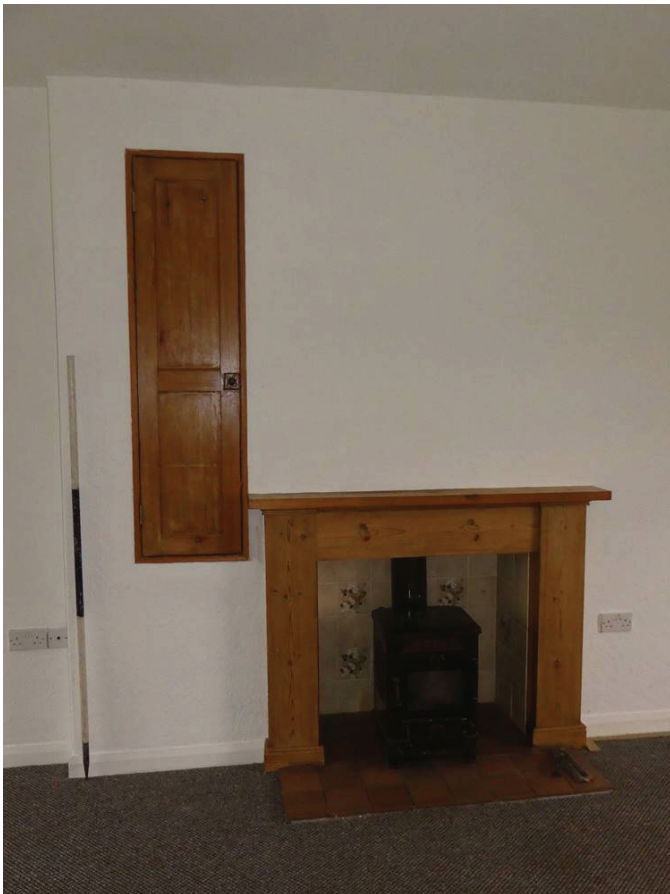
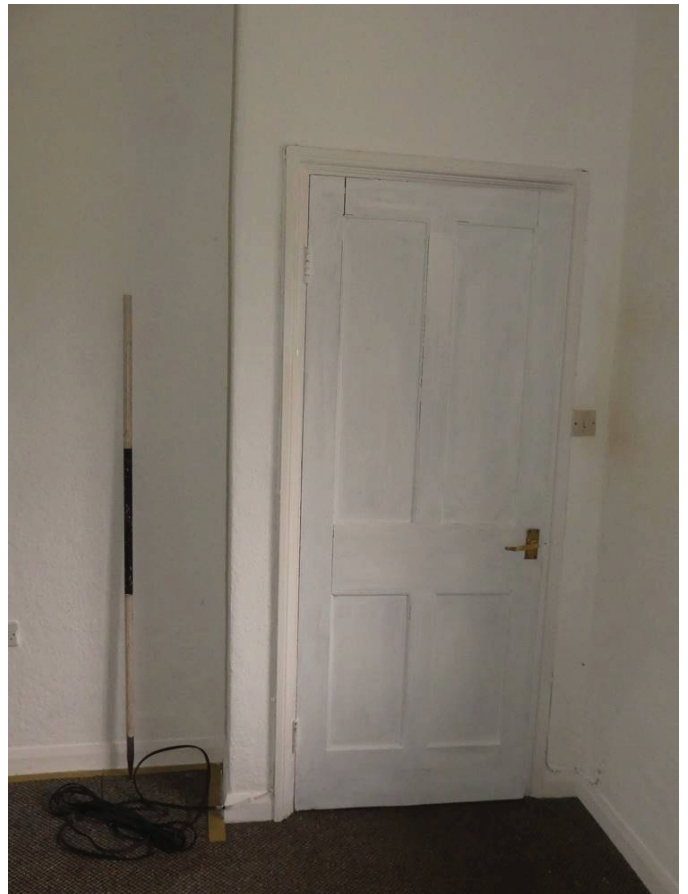
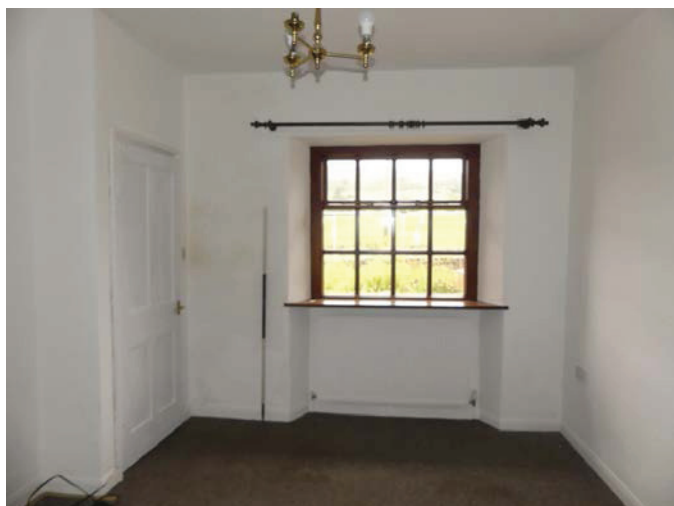
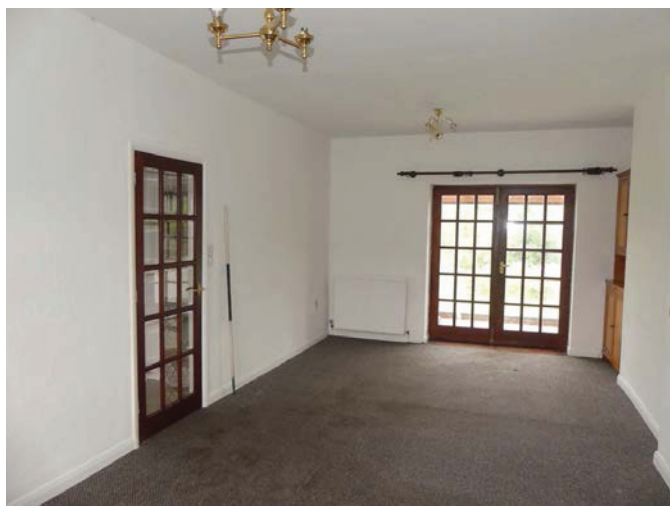
4.3.6 **Ground floor Room 6 (G6)**: this room has carpet on the floor and a flat plaster ceiling and this and the walls are finished with flock wallpaper and plain skirting. The **north** elevation has a recess to the ceiling on the west side with a modern fitted cupboard (Plate 43). It steps out to the east with a tall cupboard, with a two-panel door and four shelves, in a modern surround (Plate 44) to the east of which is a fireplace with modern timber surround and wood burning stove marked 'MORSØ' (Plate 45). There is a slight return again at the east end for a doorway with a moulded surround and fairly plain four-panel door with applied beading (Plate 46). The **east** elevation has a window with splayed jambs to the floor and a timber sill (Plate 47). The **south** elevation is plain apart from a single doorway with a modern,

fairly plain surround and glazed 15-light door (Plate 48). The **west** elevation has a double door with two modern 15-light doors (Plate 48).

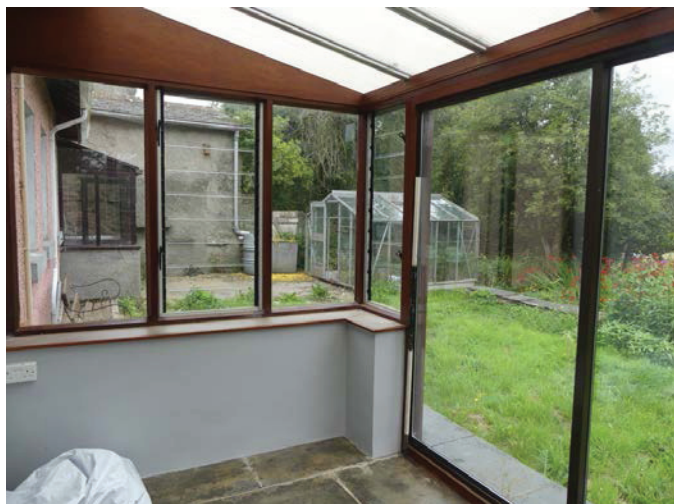
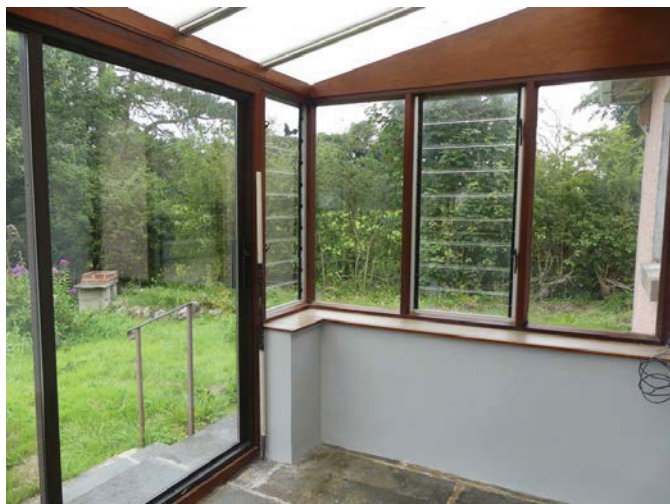
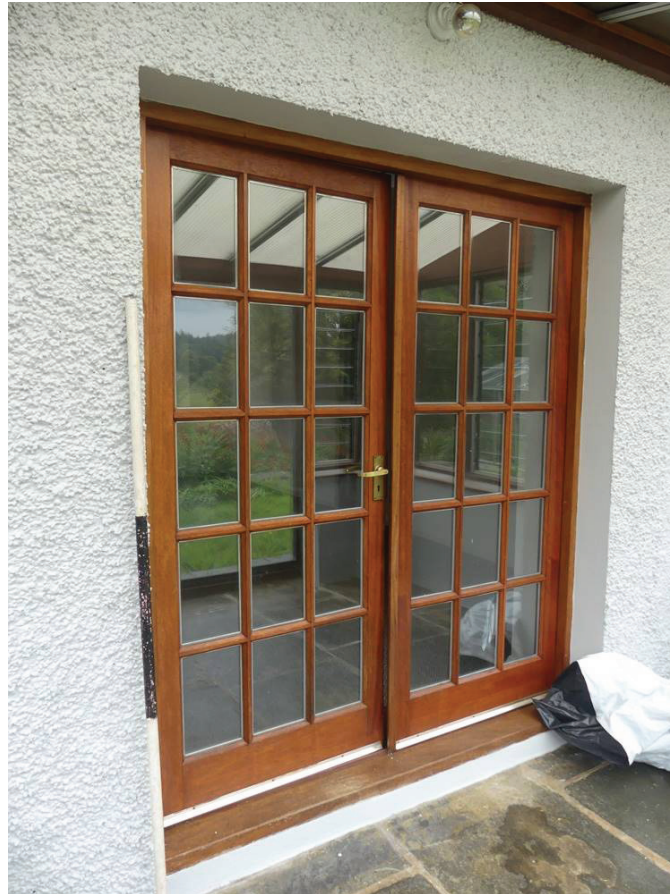
4.3.7 **Ground floor Room 7 (G7)**: this conservatory has a slate flag floor and mono-pitch plastic roof. The walls are glazed timber on low masonry to the **north** and **south** (Plate 49 and Plate 50), with hinged vents, with sliding French doors to the **west** and double, glazed door to the **east** (Plate 51).

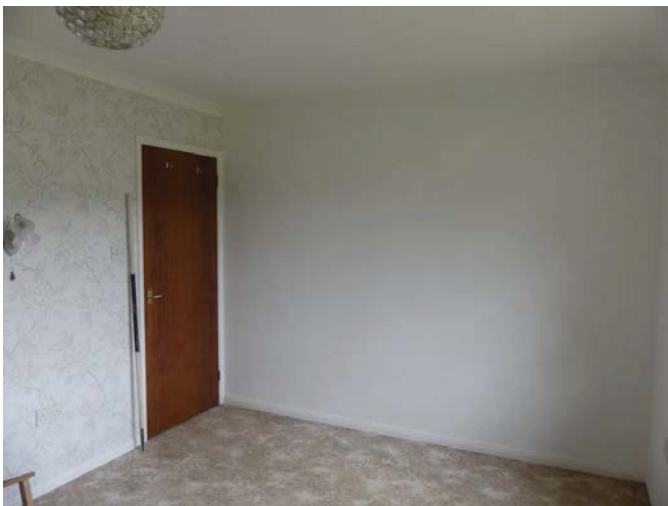
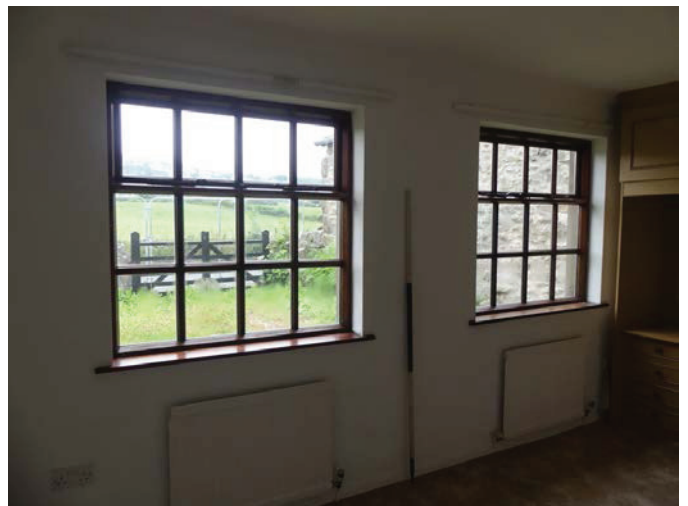
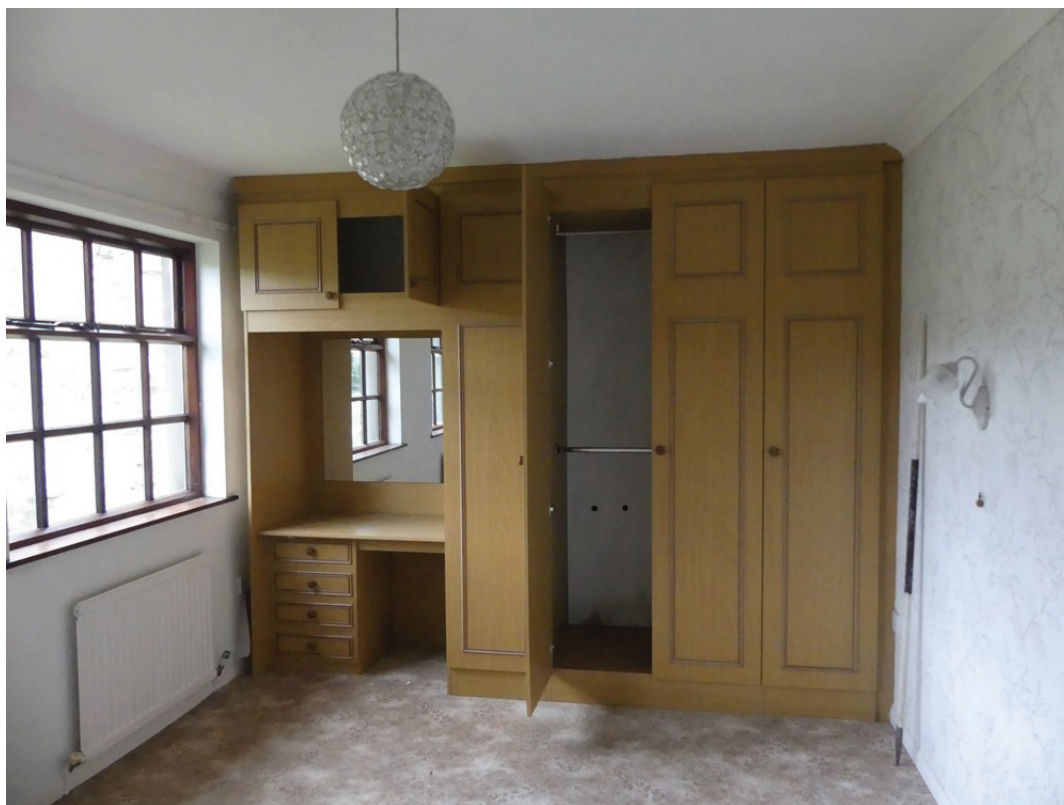
4.3.8 **Ground floor Room 8 (G8)**: there is carpet on the floor and a flat plaster ceiling, finished with flock wallpaper, and the walls are finished with paint or wallpaper, with modern curved coving and plain skirting. The **north** and **south** elevations are plain, with a fitted cupboard to the south (Plate 52 and Plate 54). There are two windows in the **east** elevation with square jambs and thin sills (Plate 53). The doorway on the north side of the **west** elevation has a plain surround and plain door (Plate 52).

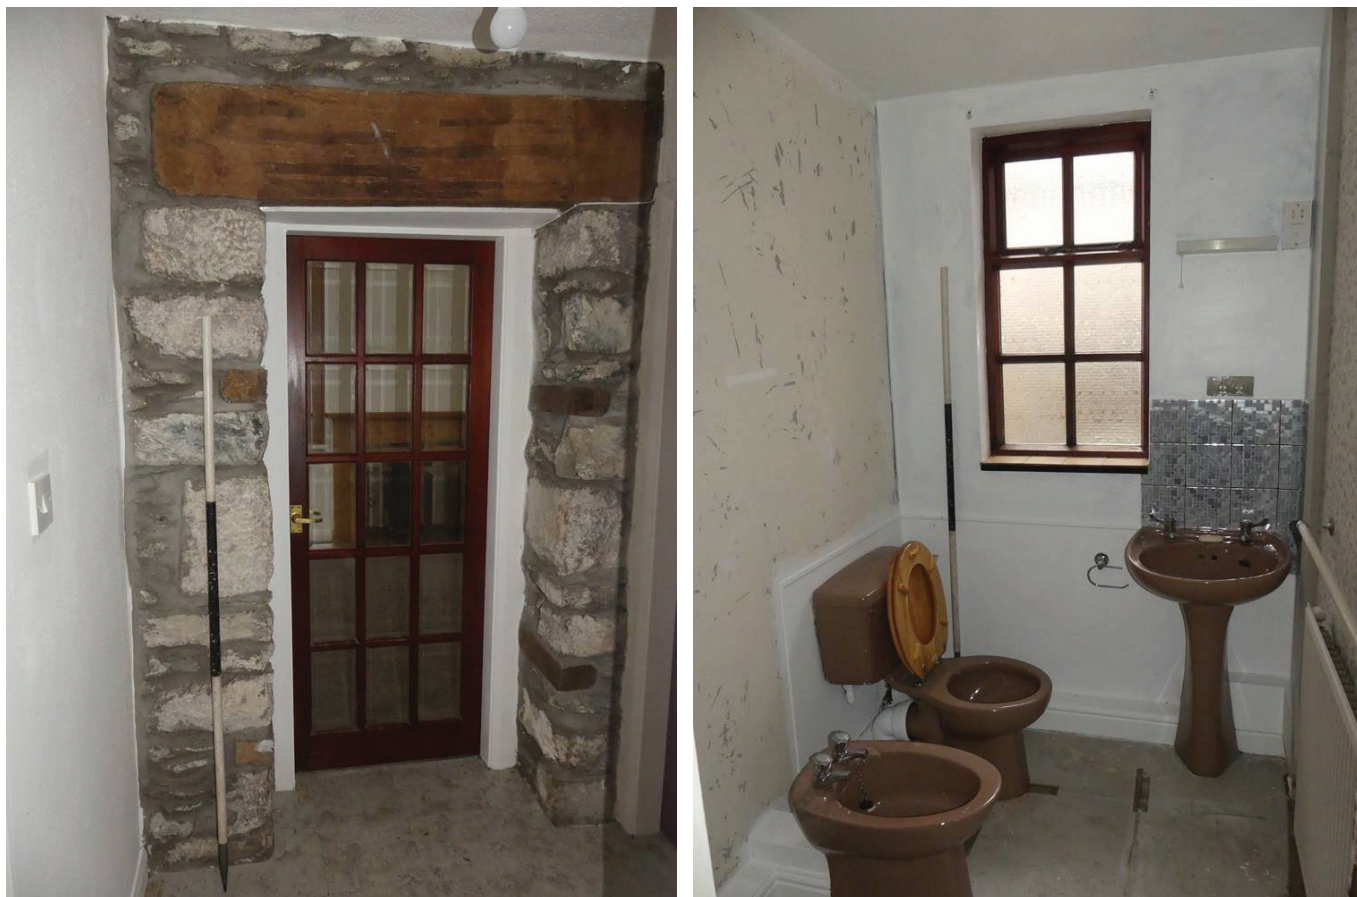
4.3.9 **Ground floor Room 9 (G9)**: this comprises a small corridor/lobby and bathroom. The flat plaster ceiling is finished with flock wallpaper and the walls are wallpapered and have plain skirting. There is concrete below the missing vinyl floor in the bathroom. The original stone of the **north** elevation is exposed around the doorway (Plate 55), which has a heavy, hand-finished timber lintel with marks for laths and timbers set in the jambs and rough quoins. The walls are otherwise plain. The doors to the **east** and **west** have modern plain surrounds, with a sliding door to the west, and there is a dividing door and stud wall for bathroom to the south with modern bathroom fittings – toilet, bidet, sink, and shower (Plate 56). There is a window in the **south** elevation with square jam and tiled sill (Plate 56).

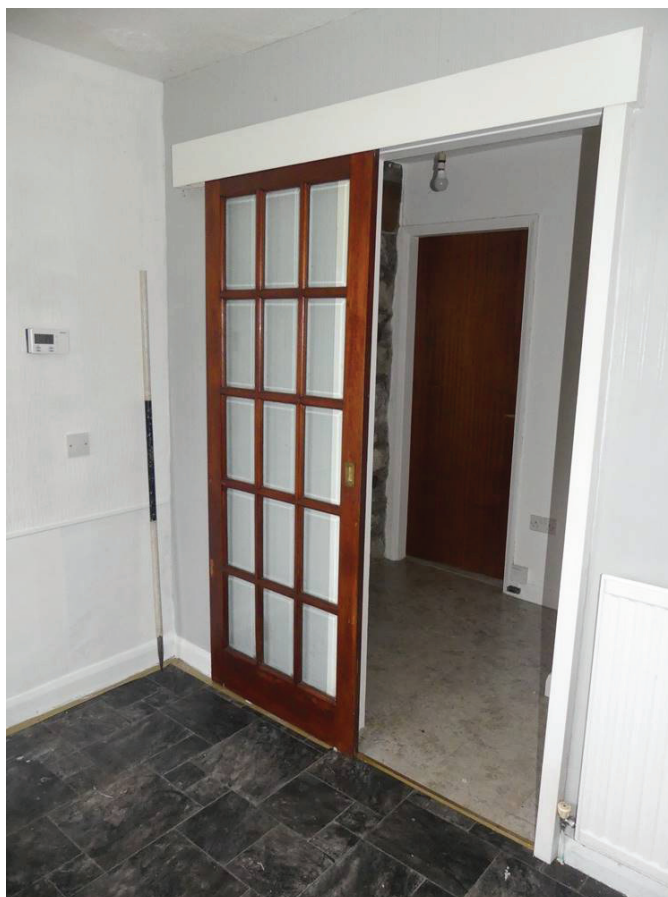
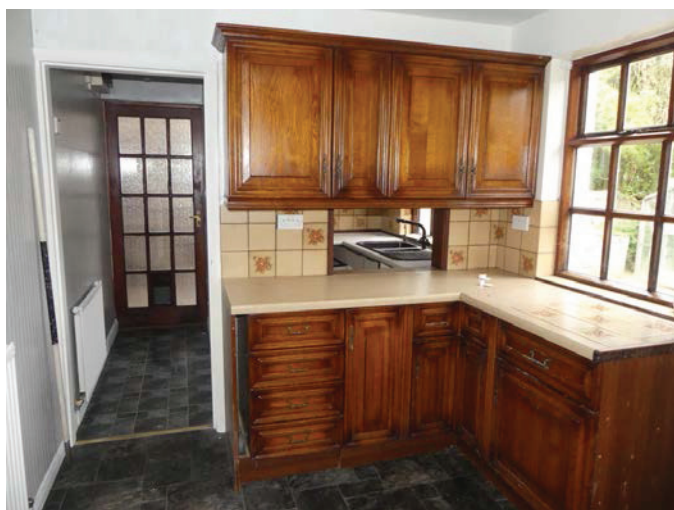
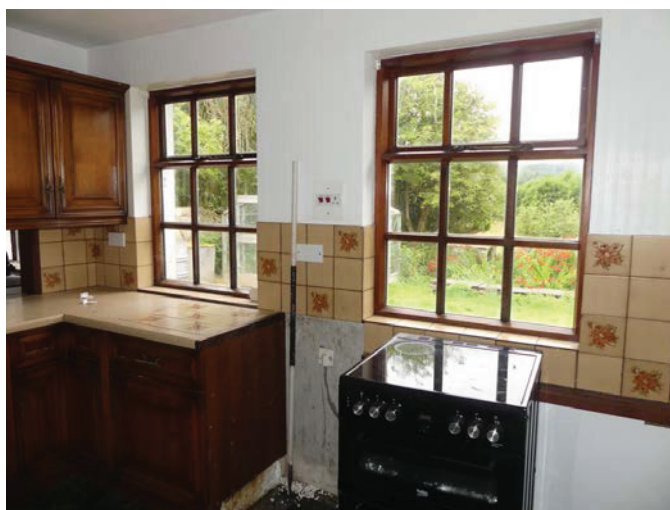
4.3.10 **Ground floor Room 10 (G10)**: this room has vinyl floor and flat plaster ceiling, finished with flock wallpaper and the walls are a mix of textured wallpaper, paint and tiles, with a plain skirting and kitchen units along the west and south sides. The **north** elevation is plain. The **east** elevation has a glazed 15-light sliding door on the north side (Plate 57). The **south** elevation has a doorway on the east side with a plain surround and no door and a serving hatch (Plate 58). The **west** elevation has two windows with square surrounds and tiled sills (Plate 59).
