# GREENFIELD LODGE, AYNSOME ROAD, CARTMEL, CUMBRIA

## Heritage Assessment

<b>Planning</b>	
Pre-planning?	No
Planning Application No.	SL/2021/0317
Plans (e.g. conversion, extension, demolition)	Demolition of existing dwelling and construction of replacement building
Condition number	n/a
Local Planning Authority	South Lakeland District Council
Conservation	Libby Mee, SLDC
Planning Archaeologist	Jeremy Parsons, Cumbria County Council

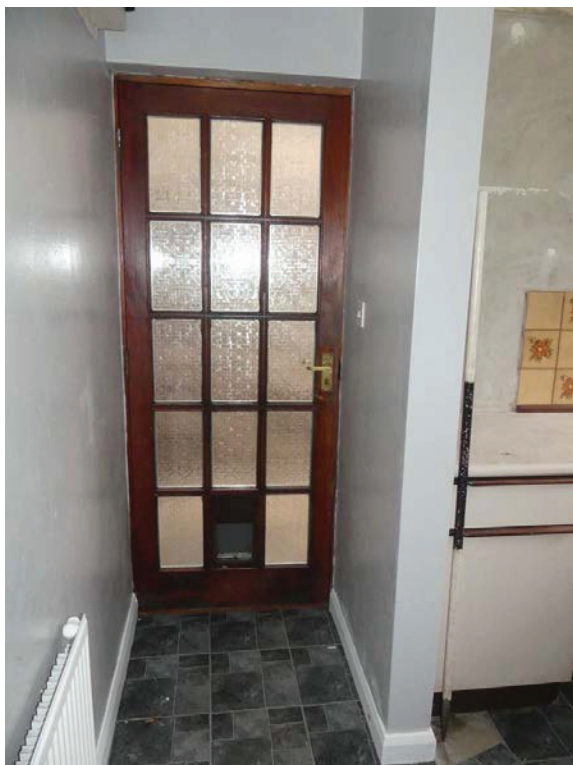
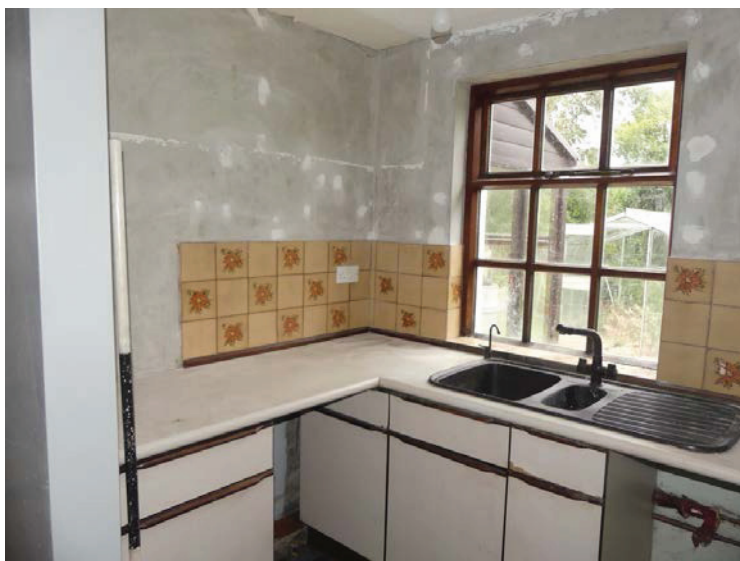
4.3.11 **Ground floor Room 11 (G11)**: this room has vinyl floor and flat plaster ceiling, finished with flock wallpaper. The walls are a mix of wallpaper, tiles and paint, with plain skirting and kitchen units to the south and west. There are doorways to the **north** and **south**, a 15-light door with cat flap to the south (Plate 60), and return wall to the west. The window to the **west** has square jambs and tiled sill (Plate 61) and there is a serving hatch to the north.

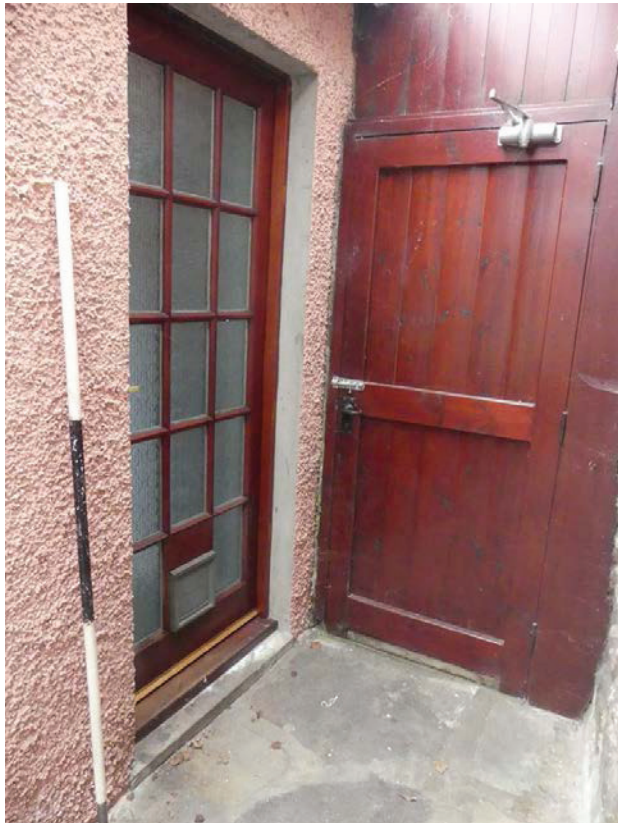
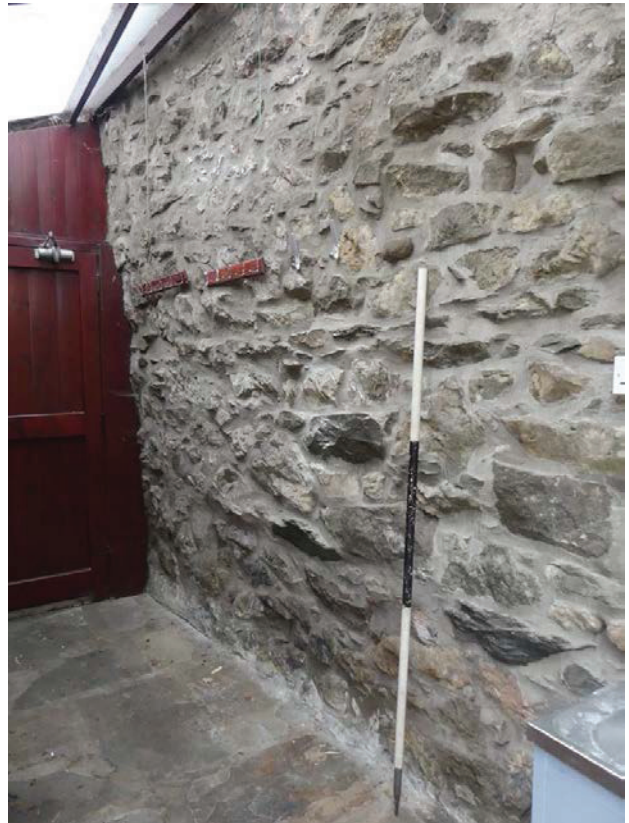
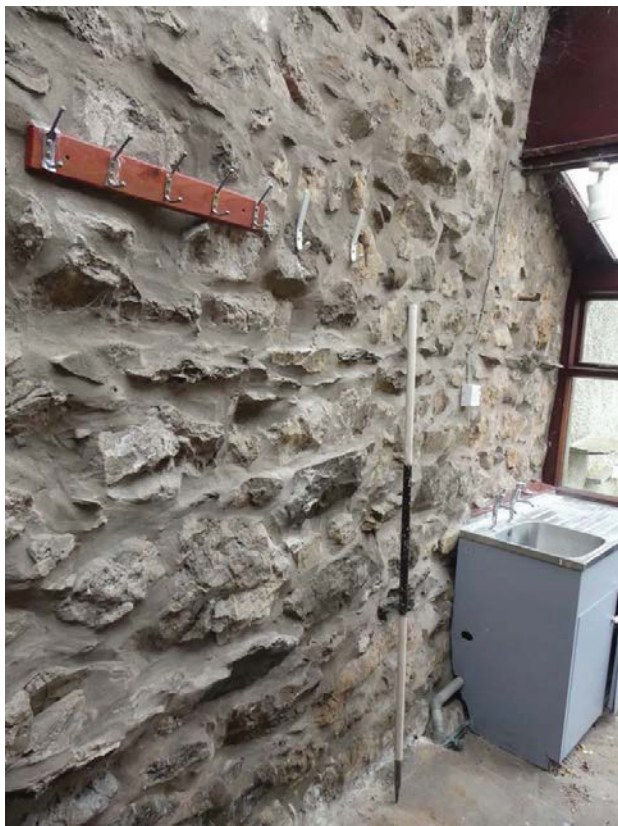
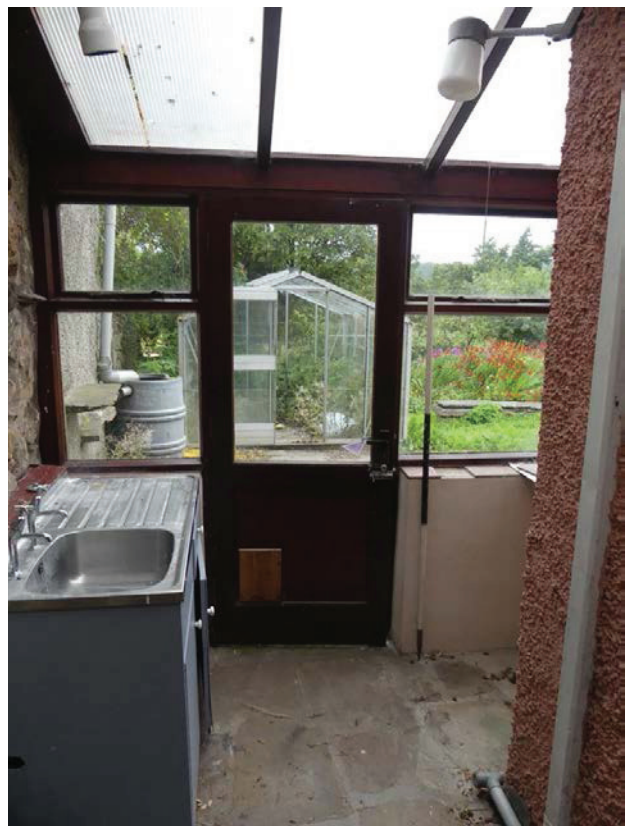
4.3.12 **Ground floor Room 12 (G12)**: this room forms an outshut against the adjoining building at the south end, with timber walls to the east and west, and it is open to the mono-pitch plaster roof. It has a (Yorkshire?) stone flag floor and steps down to the west. The **north** elevation is roughcast external render. There is a return at the west end for the main wall with a glazed door on the east side (Plate 62). The **east** elevation has a timber plank and batten door (Plate 62). The **south** elevation is formerly the external wall of the adjoining building, with rough courses of large stone, with concrete pointing (Plate 63), and an attached sink (Plate 64). The **west** elevation is a timber-glazed structure with a single-light door (Plate 65).

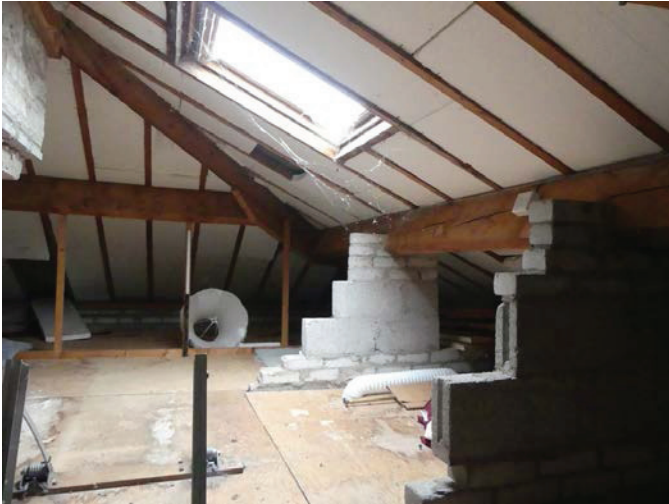
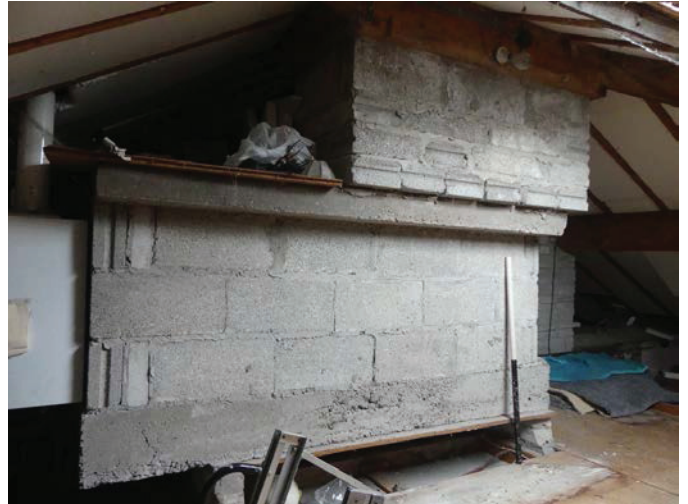
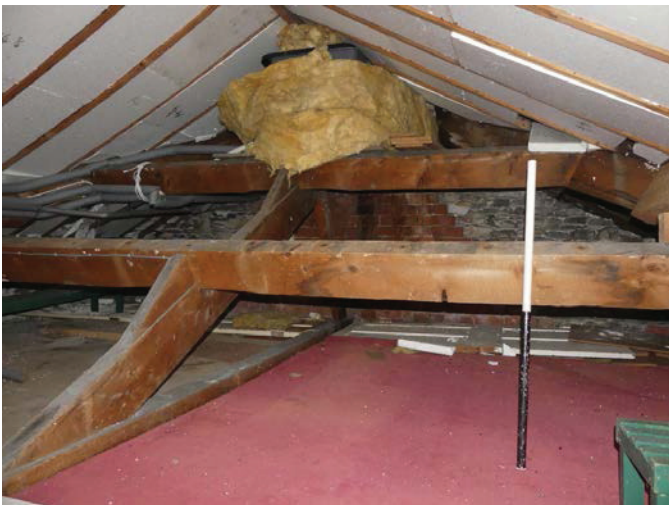
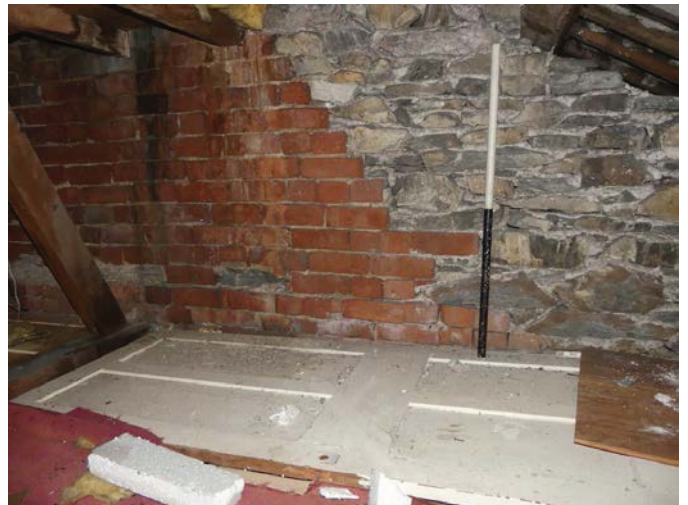
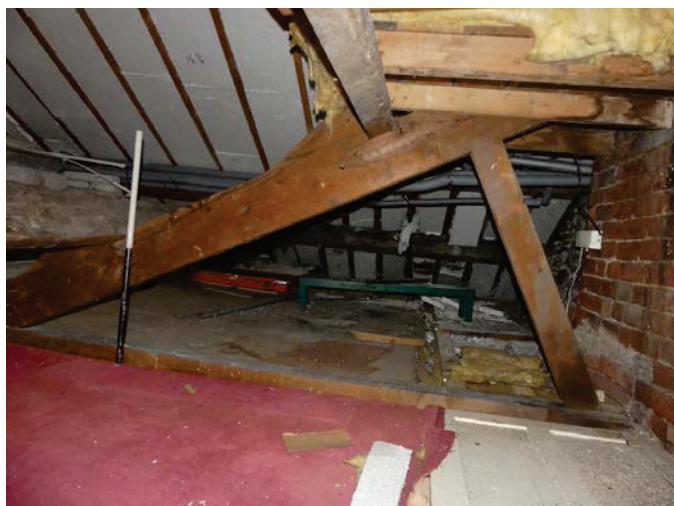
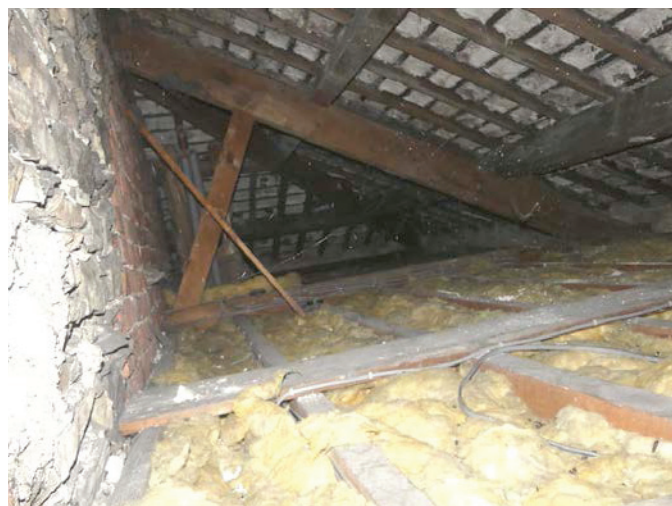
4.3.13 **Roof space:** the roof space is mostly above the modern extension. It has modern board floor and modern timber roof, with purlins to the south supported on concrete block walls (Plate 66), and there is a cantilevered stack on the north side also of concrete block construction (Plate 67). There is a skylight in the south pitch accessible over the original part to the north (Plate 66). The timbers are all sawn and adze-finished, probably Baltic red pine, with two purlins per pitch (Plate 68). The spine wall is a mix of rough slate and handmade brick (each 17cm x 10cm x 6cm) (Plate 69), the truss running north/south either side as two half-trusses each with an angled brace (Plate 70 and Plate 71). Original four-panel doors are used on the floor against the spine wall (Plate 69).

5.2.2 **Phase 1 (mid to late 19<sup>th</sup> century):** the map evidence demonstrates that the building was originally constructed in the second half of the 19<sup>th</sup> century, with the census returns indicating that it was in existence by 1861. In its original form it was a small square structure, probably with only four rooms (Room G6 was probably sub-divided) but also an outshut on the south side, with a hipped main roof coming to a central chimney stack. The documentary sources show that it was occupied by either a groom or gardener and that it belonged to Ivy Cottage (now Ivy House). It was clearly never a lodge in the proper sense as it was not located at the end of a drive into the property, although it was referred to historically as Ivy Lodge and Ivy Cottage Lodge. Some original architectural elements still remain: the ashlar stone used externally in the quoins and original chimney, the panelled doors and moulded surrounds off the porch (Room G3), the cupboards in Rooms G2 and G6, and elements of the roof structure.
