KINGS ARMS, CARTMEL, CUMBRIA

Archaeological Building Recording

Client: Tavern Propco Limited

August 2021

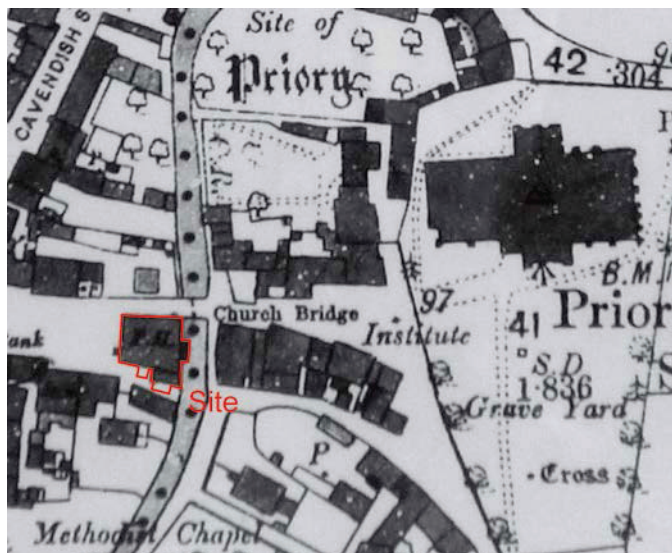
3.1.4 **Ordnance Survey, 1890:** this is probably the first map to accurately show the divisions within the different parts of the building, it is also the first to label it as a public house (Plate 3). The projecting section to the east, over the River Eea, has clearly been constructed by this date, there has clearly been some infilling of the south-east corner, there is a small projecting block to the west (most likely a mounting block or external staircase), and there is definitely an outshut to the south.

Plate 3 (left): Extract from the Ordnance Survey map of 1890

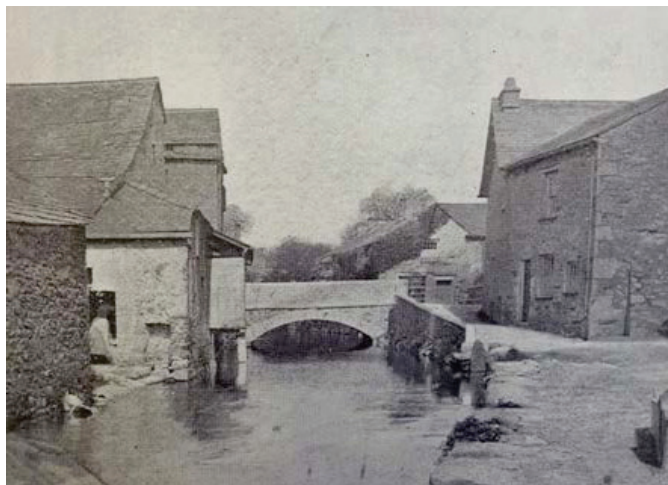
3.1.5 **Photograph, 1900:** a photograph, primarily showing the River Eea to the east of the Kings Arms and its bridge, provides a reasonable view of the rear (east) part of the property (Plate 4). It is evident that this part of the building has changed very little since this time, with the exception of the addition of a tall brick chimney to the south-east corner (see Section 3.1.11).

Plate 4 (right): View of the east end of the Kings Arms in 1900 (Richardson 1900)

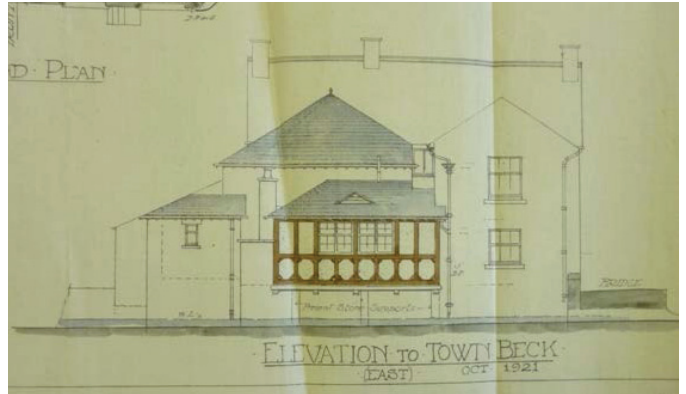
Plate 12 (left): Proposed second floor plan (CAC(B) BSRDNL/3/189 1921)

3.1.8 **Proposed plan, 1921:** these plans, this time by JW Grundy and Sons, relate to a series of proposals, similar to those of 1921, with alterations again seemingly largely restricted to the toilets and drainage, although it is apparent that the main part of the second floor had already taken on essentially its present arrangement by this time (Plate 10 to Plate 13). Of particular interest is an elaborate ‘timber-framed’ finish proposed for the section projecting over the River Eea, but it is apparent that many of these proposed alterations and the earlier ones were not carried out.

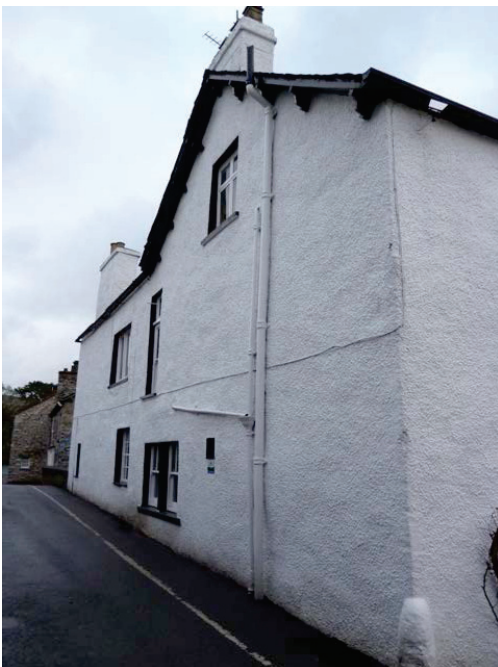
4.2.1 **North elevation:** the west end comprises the gable end of the main block of the building, which is largely plain and finished with render (Plate 25). The roof is supported by scrolled corbels and there is a modern vent and various iron pipes attached. On the east side of the ground floor there is a window filled with a pair of timber four-light sliding sash casements with a stone sill and timber mullion between. Above this is a tall narrow window with a four-light sash casement in the bottom half and a fixed two-light casement in the top. There is a further window with a four-light hinged casement at second floor level in the centre of the gable. The east end is the side wall of an evident extension, but only two storeys high. It has two ground floor windows, both with slate sills. The westernmost is large and has a 20-light fixed casement, while the east is quite small and has a two-light fixed casement. At first floor level there is a large window with a fixed three-light casement. There is a wide chimney projecting from the centre of the top of the elevation, which is finished with render and has two ceramic pots.

Plate 25 (left): North external elevation

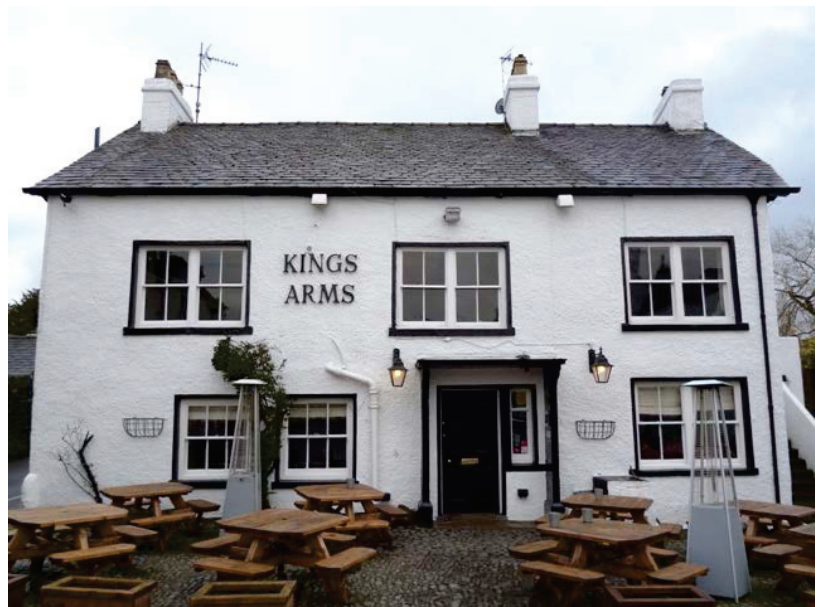
Plate 26 (right): West external elevation

4.2.2 West elevation: this is the front of the building, facing onto the square (Plate 26). It is two story and slightly asymmetrical, with three windows and a doorway on the ground floor and three windows on the first. The ground floor level windows consist of two close together to the north, with six-light sliding sash casements, stone sills, and narrow render surrounds. To the south of these is the front doorway, which has stone flanking pieces with corbels supporting a slab with a moulded edge forming a porch. Within this is the door itself, which has six panels, the top two of which are glazed, and to the south of it there is a small narrow window with a two-light casement. To the south of the doorway there is a mounting block against the wall, comprising a flight of three stone steps leading up to a low platform. South of this is a further window, comprising a pair of four-light sliding sash casements divided by a timber mullion with sill and surround as per the windows to the north. The first floor has three windows in a similar style and there is attached lettering spelling out 'KINGS ARMS'.

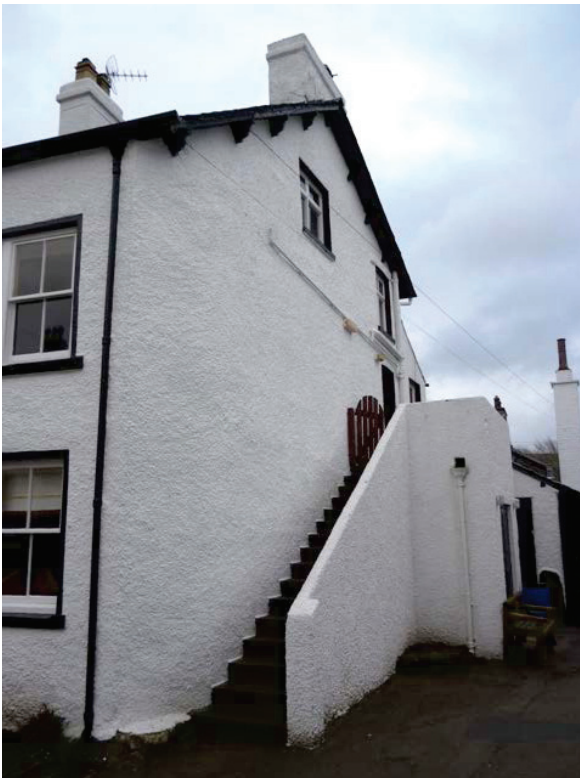
Plate 27 (left): West side of the south external elevation

4.2.3 South elevation: the east side of this runs up to the edge of the river and comprises a small mono-pitch outshut with a tall brick chimney on the corner. To the west of this is a larger mono-pitch outshut, the east (side) wall of which is also built of brick. This has a large slatted timber doorway and the west part of the wall is constructed from timber panelling supported between two stop-chamfered posts and with a row of edge-set slate slabs in front. This outshut returns to the north at the west end, where there is a further slatted door, which meets the main wall of the building beyond where it returns to the west again. This is finished with roughcast render and has a doorway with a plain door, and is two storey, with a pair of windows. The lower of these has a two-light UPVC casement, the upper a four-light timber sliding sash casement. There are a further two second floor windows to the west, both with four-light timber casements, the top two of which are hinged, and stone sills. Below these is an attached outshut, essentially comprising just a projecting staircase with a landing at the top surrounded by a low wall, and with another doorway leading to a space below (Plate 27). The gable end of the roof above is supported on scrolled corbels.

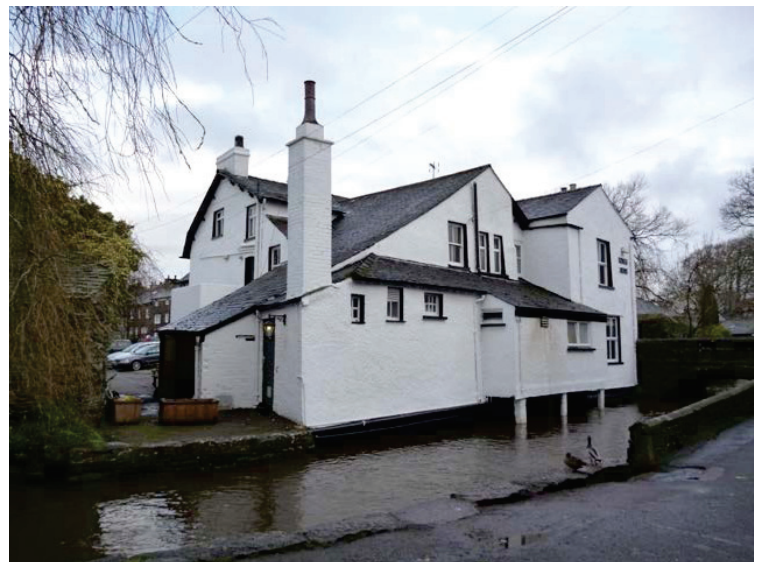
Plate 28 (right): South external elevation

4.2.4 East elevation: this comprises a complex arrangement of outshuts and extensions at various levels (Plate 28). The north side is formed by the gable end of the large extension, which seems to be butted by the bridge, which is dated 1829, and has a large window with an eight-light hinged casement

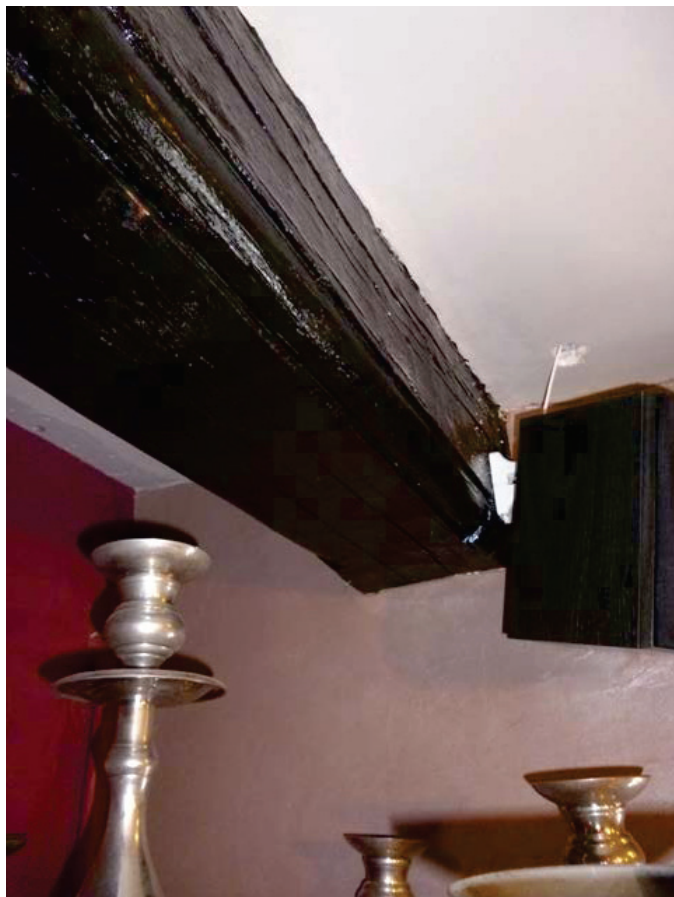
4.3.2 **Ground Floor Room 1:** this is extensively modernised throughout. It has a modern flag floor in the centre and timber laminate on the west side. There are numerous exposed beams, orientated east/west, in the ceiling, which is otherwise finished with plaster. All of the beams are hand-finished and have a glossy dark brown or black stain or varnish, and they are supported where they meet by three large square posts. Two of the beams on the west side are decorated with chamfering, one ovolo-moulded (Plate 29) the other an elongated stop-chamfer. The walls are finished throughout with plaster and paint. There is a modern brick fire surround on the north side, the bar is situated in the south-east corner, and there are openings to the east and south, and the main entrance via a short corridor or lobby is to the west. The west doorway has an inner doorway with an early(?) door with a large lower panel, and two glazed panels above. The main front door is also early and has six moulded panels, the top two of which are glazed. There is a small window to the south and an alcove in the wall to the south, formed against what is evidently a chimneybreast. The stairs run up opposite the main entrance to the west, and are finished with carpet and have a square newel post at the bottom. The wall along the north side is finished with moulded panels set below a beam with a beaded edge, and the stairs turn through a modern door at first floor level where there is a landing. There is an alcove in the wall to the east at this point, perhaps originally a window(?), with a boxed timber shelf below.

Plate 29 (left): Ovolo-moulded chamfer in Room G1

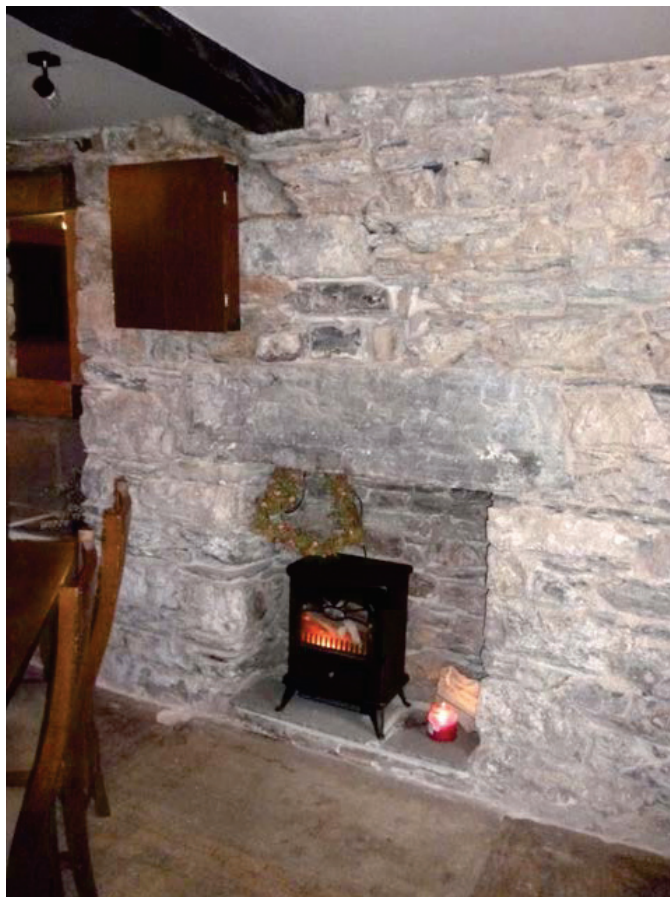
Plate 30 (right): Fireplace in Room G2

4.3.3 Ground Floor Room 2: this has the same modern flag flooring as Room G1 in the north-east corner, but the rest is early tiles, which incorporate a hearth slab on the south side. There are two beams orientated north/south, both of which are hand-finished, and the east of which has slots for a former stud wall. The north, east, and west elevations are all finished with plaster and paint while the south is exposed stone and is a mixture of limestone and slate. Within the south elevation there is a fireplace on the west side with a heavy slate lintel (Plate 30), above which two pieces of reused dressed stone are built into the wall, one with what appears to have a 'D' scratched into it. There is a further alcove to the east of this, which was evidently originally a doorway but is now blocked, and it has a rough timber lintel, and to the east of this is another fireplace, similar to that to the west and also with a stone lintel. There is a window in the west elevation with a moulded rail above it.

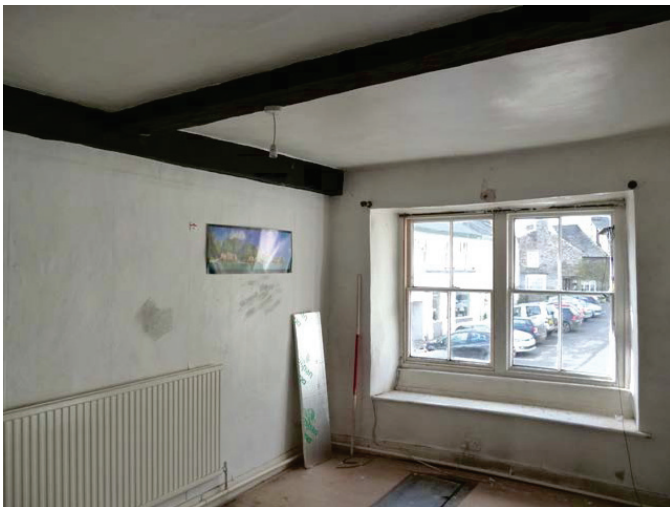
4.3.5 First Floor Room 1: the floor is finished with wide early floorboards, which are stained black, although these are mostly covered by plywood sheeting. The ceiling is finished with plaster and has a single beam orientated north/south, which rests on a beam orientated east/west, below which is a stud wall (Plate 31). The north/south beam is hand-finished while the east/west is skimmed with plaster. The walls are all finished with plaster and paint, with a plain skirting board throughout. The north and east elevations are essentially plain. The west has a large window with two four-light sash casements, slightly splayed jambs, and a timber window seat (Plate 32). The south elevation is a stud wall, perhaps early, with a doorway on the east side with a modern door.

Plate 31 (left): Window and beams in Room F1

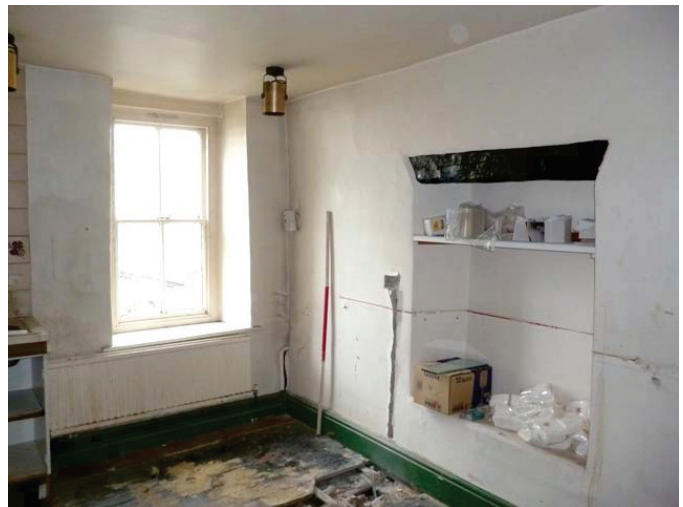
Plate 32 (right): Window and alcove in Room F2

4.3.6 First Floor Room 2: the floor, which is finished with tongue and groove floorboards stained black around the edges, is raised relative to the adjoining rooms to the south and west, and there is a step up into it from Room F3. It has a plaster ceiling with a single beam orientated east/west across the east side of the room and another orientated north/south above the east elevation. Both of these are hand-finished and the east/west beam has empty slots in the east face denoting the position of a former stud wall. The walls are largely finished with plaster and paint, with an ogee-moulded skirting board throughout, although there are tiles around the north-west corner where kitchen units are attached. The north elevation has a window on the east side, which forms the base of the tall window extending to the floor above, with splayed jambs and a timber sill and a four-light timber sash casement. The east elevation has a central alcove with modern shelves, presumably originally a window, with a rough timber lintel and

splayed jambs (Plate 32). The south elevation is a stud wall, with a doorway on the west side with a modern door, while the west elevation is also a stud partition.

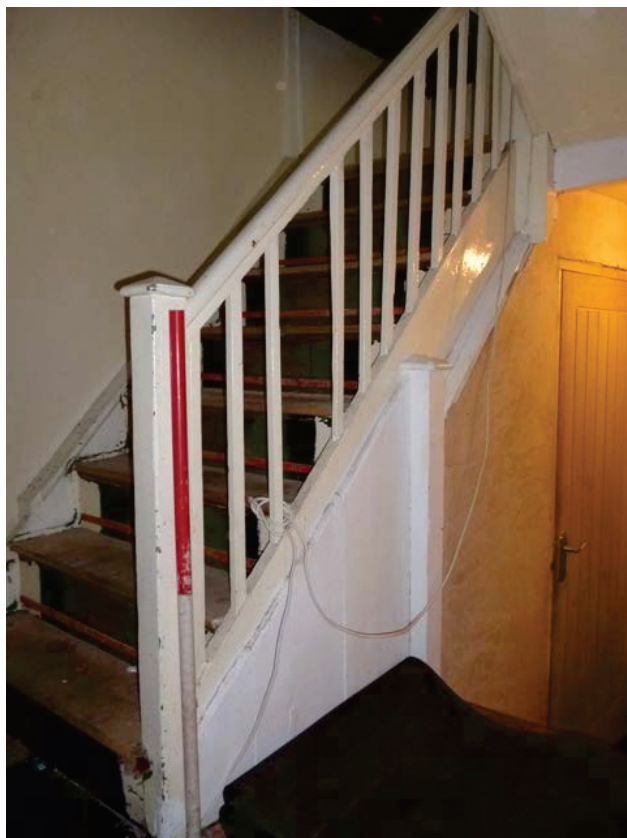
4.3.7 First Floor Room 3: this forms a hall and lobby to the main staircase. The floor is largely covered by modern chipboard sheeting, but early wide floorboards are visible beneath this in places, and there are steps up to Room F7 on the east side. The ceiling is finished with plaster with a single beam orientated east/west above the stairs. The staircase is probably original but has been extensively modernised, with new timber added on top of the originals. The staircase is quite plain, with square newel posts with pyramidal heads and square-section balusters (Plate 33), wide planking along the south face, and it turns to the west as it reaches the second floor (Plate 34). The east end of the northern truss is exposed on the north side of the landing; the tie beam has boxing over its south face and top, and the ends of two purlins corresponding to the extension to the east are visible. There is a modern skylight in the roof above the stairs. Room F3 is in general extensively modernised, with modern plain panel doors in all elevations, which are otherwise essentially plain. There is an alcove in the south elevation, next to the staircase, which was probably originally a window, the west jamb of which is splayed and within which are modern timber shelves. It is partially covered by the stairs on the east side, which would suggest that the stairs have evidently moved to some extent.

Plate 33 (left): Staircase in Room F3

Plate 34 (right): Side view of the staircase in Room F3

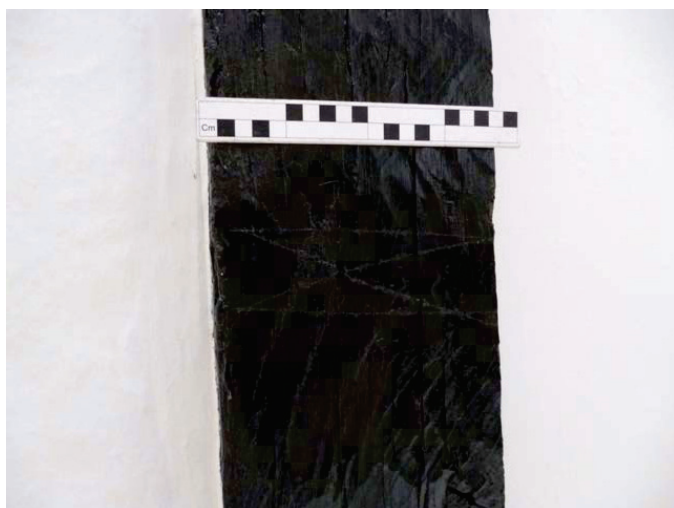
4.3.8 First Floor Room 4: this too has early wide floor boards, partially exposed beneath plywood sheeting. The ceiling is finished with plaster and has a single hand-finished beam orientated east/west, with levelling marks scored into the underside (Plate 35). The walls are also finished with plaster and flock wallpaper and there are modern stud partition walls in the north-west corner forming an *en suite* bathroom. The north elevation is entirely plain. The east elevation has a doorway with a modern panel door on the north side. The south elevation has a central chimneybreast, the fireplace of which is blocked (and the plain skirting board throughout the room goes across where it would have been), and there is a cupboard built into the recess on the east side (Plate 36). The cupboard is evidently early, perhaps original, with fielded panels, a moulded entablature above, and three original shelves in the top

Plate 35 (left): Levelling mark on the beam in Room F4

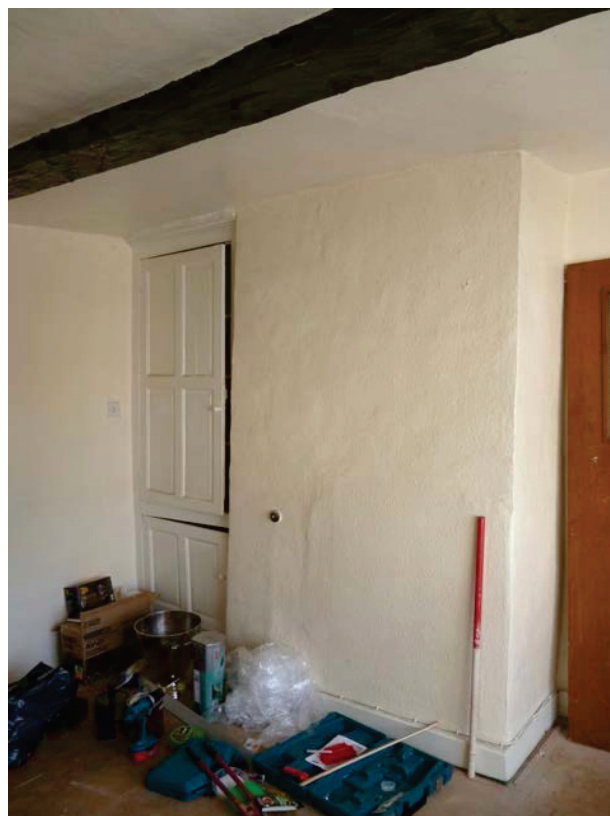
Plate 36 (right): Chimneybreast and cupboard, south elevation of Room F4

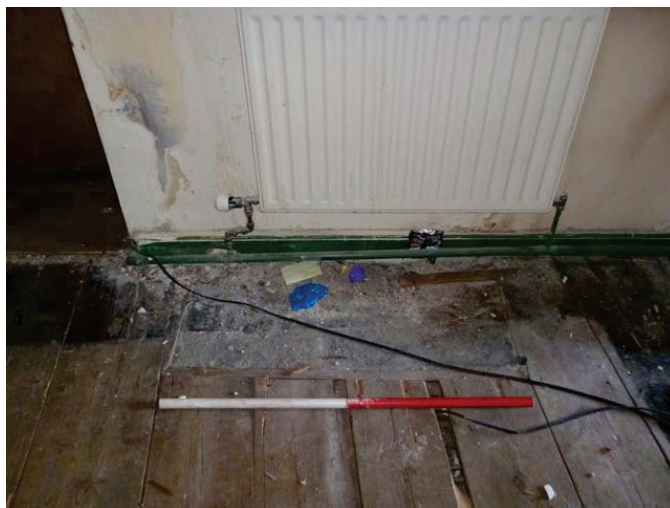
Plate 38 (right): Hearth slab in Room F6

4.3.10 **First Floor Room 6:** this is now essentially just a hall, connecting rooms to the east and north to a fire escape in the south elevation. It too has relatively wide early floorboards, which are stained black around the edges of the room. There is a hearth stone set into the floor against the west side of the south elevation representing the position of an evidently blocked fireplace (Plate 38). The walls are finished with plaster and paint throughout, with an ogee-moulded skirting board, and are mostly plain. The north elevation has a doorway, really just an opening, on the west side, which connects to Room F3. The east elevation has a doorway on the north side and the central section of the wall is slightly bowed and has an early pub sign attached, and there are boxed pipes from the floor above on the south side. The south elevation has a doorway on the east side with a door for a modern fire escape and the plaster has been partially removed because of the damp conditions revealing lathe and plaster dry-lining behind. The west elevation is a stud wall and has a doorway on the south side with a modern door.

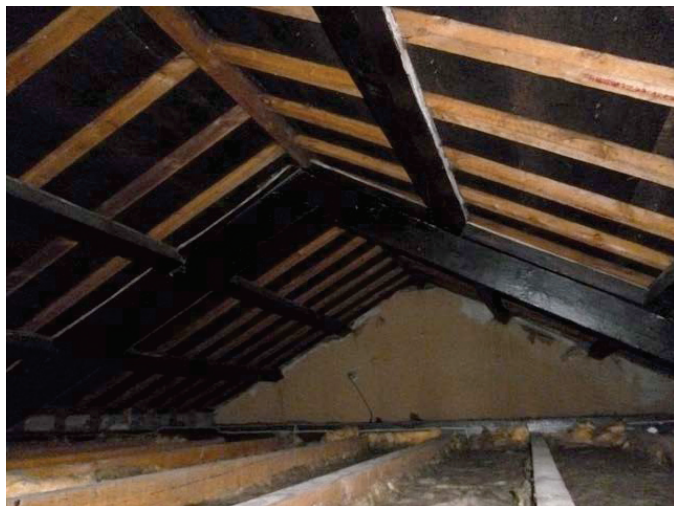
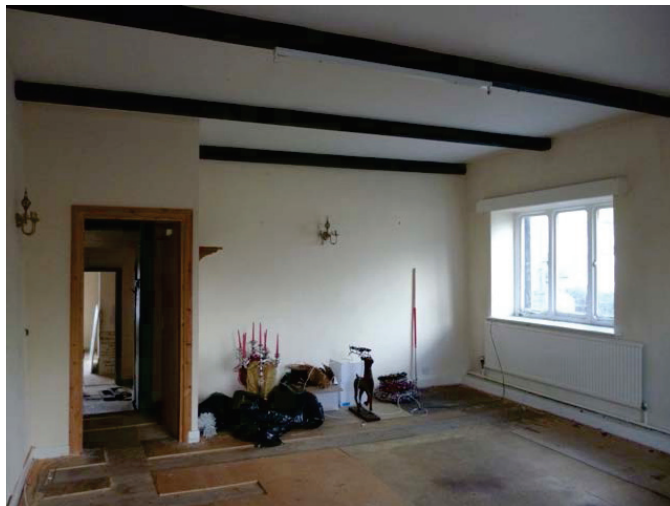
4.3.11 **First Floor Room 7:** this has relatively early but more regular floorboards, again exposed beneath sheets of plywood. The ceiling is finished with plaster, with five beams orientated north/south across it, including one against each of the end walls, all of which have a slight chamfer. Within the roof space there is a single tie-beam truss and two purlins per pitch, all of which are neatly hand-finished and stained dark brown (Plate 39). The principal rafters are lap-jointed together and the ridge purlin and rafters are relatively modern machine-cut timbers. The walls are relatively plain and finished with plaster and have a beaded skirting throughout. The north elevation has a large window on the west side with a three-light hinged casement (Plate 40). To the east there is a vent built into the wall where there is evidently a blocked fireplace, and there is some timber boxing along the base of the wall. The east elevation has a central window with a four-light sash casement and splayed jambs, which extend to the floor, beneath which is a modern timber bench, set in to the window reveal but projecting into the room on either side (Plate 41). The south elevation is plain, although the south-west corner has projecting stud walls coming from it, forming a porch, incorporating a doorway with a modern door. Within this is a doorway leading down two concrete steps to the east and an earlier doorway to the west, the surround of which remains and is clearly early and ovolo-moulded and beaded and leads to two timber steps (Plate 42).

Plate 39 (left): Truss within the roof space over Room F7

Plate 40 (right): General view of west end of Room F7

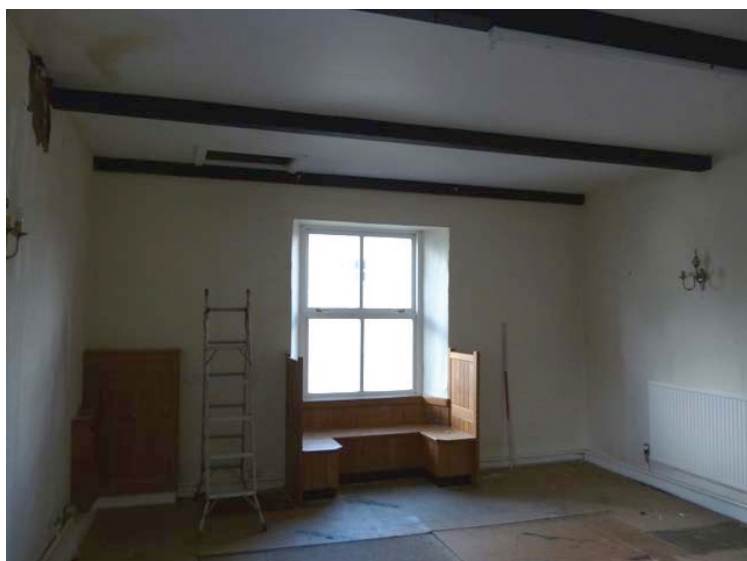
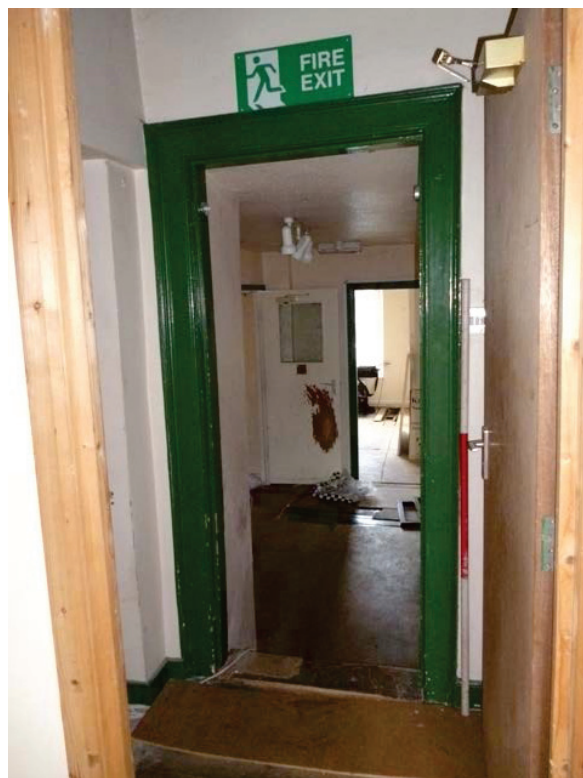
Plate 41 (left): General view of east end of Room F7

Plate 42 (right): Doorway with moulded surround at the south end of the west elevation, Room F7

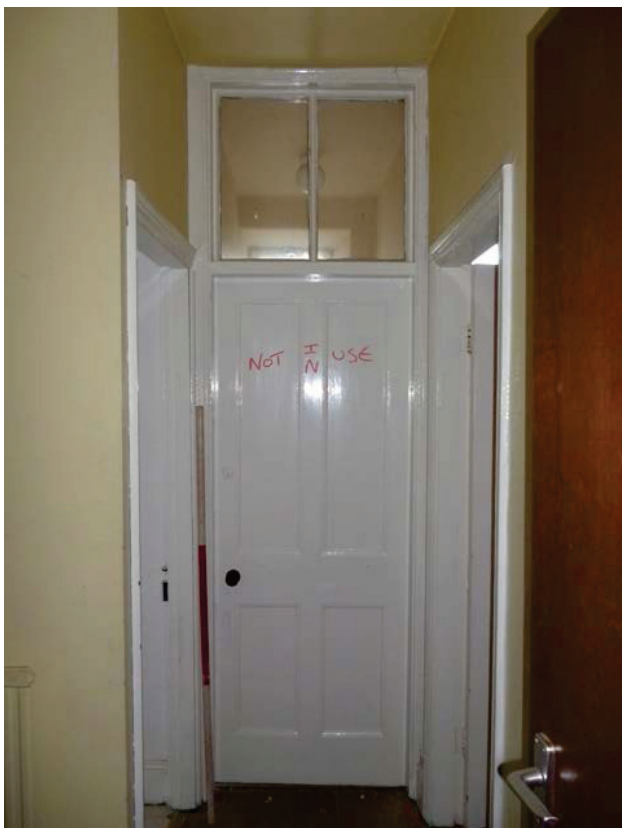
4.3.12 **First Floor Room 8**: this comprises a small group of interconnected rooms including what is essentially a hall with a large cupboard off one side and two toilets, separated by stud walls. The floor is finished with tongue and groove floorboards covered in places by vinyl, and the ceiling is finished with plaster and paint. The walls are finished with plaster and paint, with an ogee-moulded skirting board throughout. There are modern stud walls in the north-east corner forming a bathroom, and there are earlier stud walls forming the south and west elevations. The walls are generally plain, although there are doorways to the north, south and east with early four-panel doors; the one to the east has two lights over it (Plate 43). There is a shower against the north elevation, set against what may be an early door, and there is a toilet and sink against the east elevation in separate cubicles with a small two-light window in each.

Plate 43 (left): Door with light over, Room F8

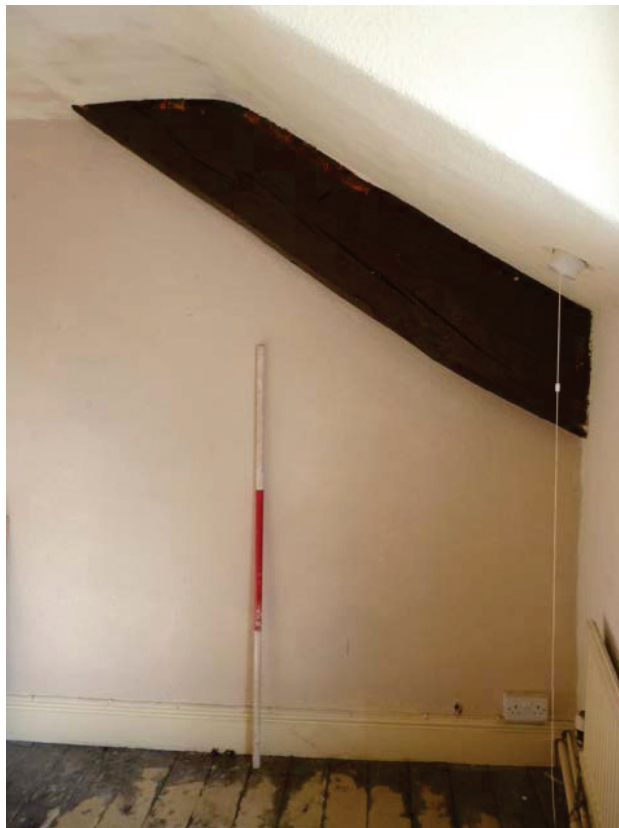
Plate 44 (right): Beam against east elevation, Room F9

4.3.13 **First Floor Room 9:** the floor is finished with carpet and the plaster ceiling slopes down to the south and is supported with a single east/west beam, which is hand-finished (Plate 44), and there is a step in the ceiling to the north of this. The walls are generally plain and finished with plaster and paint and an ogee-moulded skirting board throughout. The north has a doorway on the west side with an early four-panel door, while the east has a window on the north side with a four-light sash casement and timber sill, to the south of which the wall returns slightly. The south and west elevations are plain stud walls.

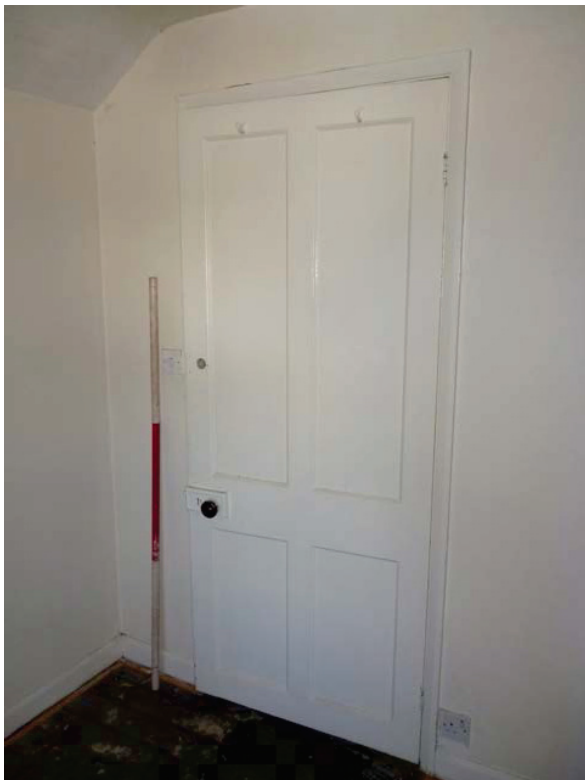
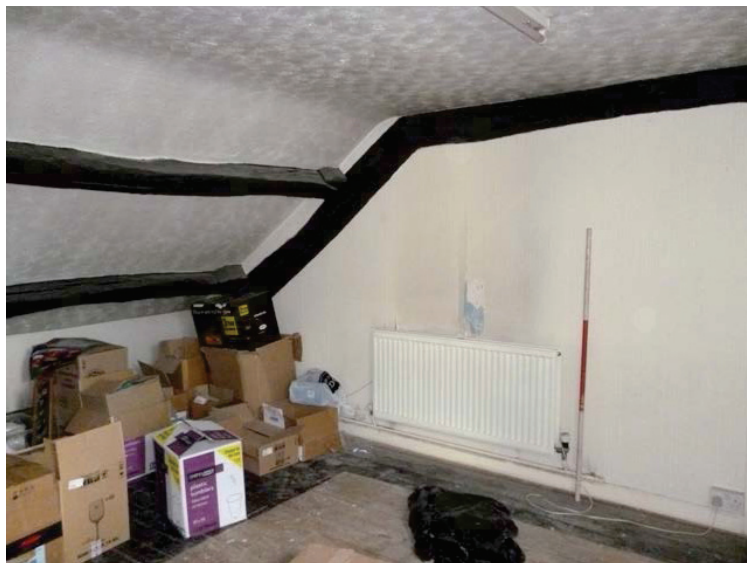
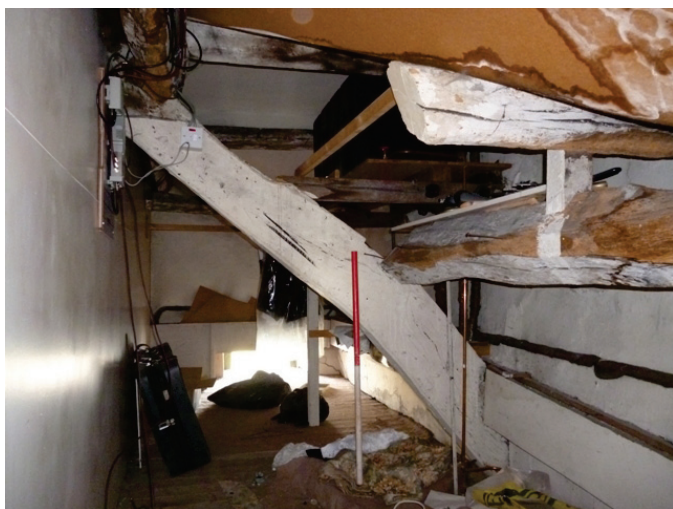
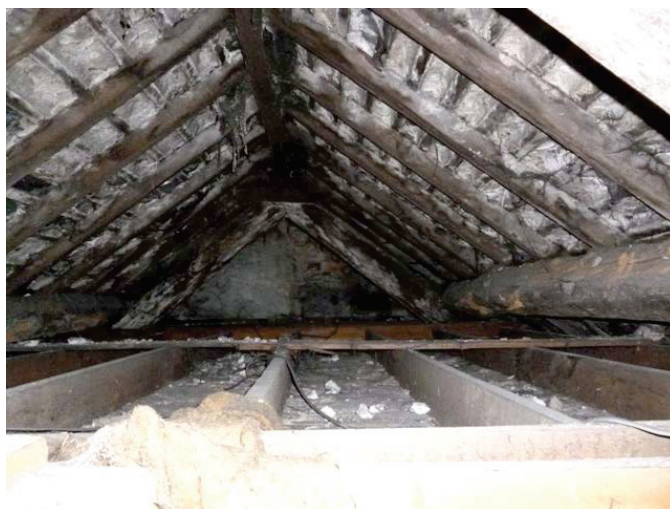
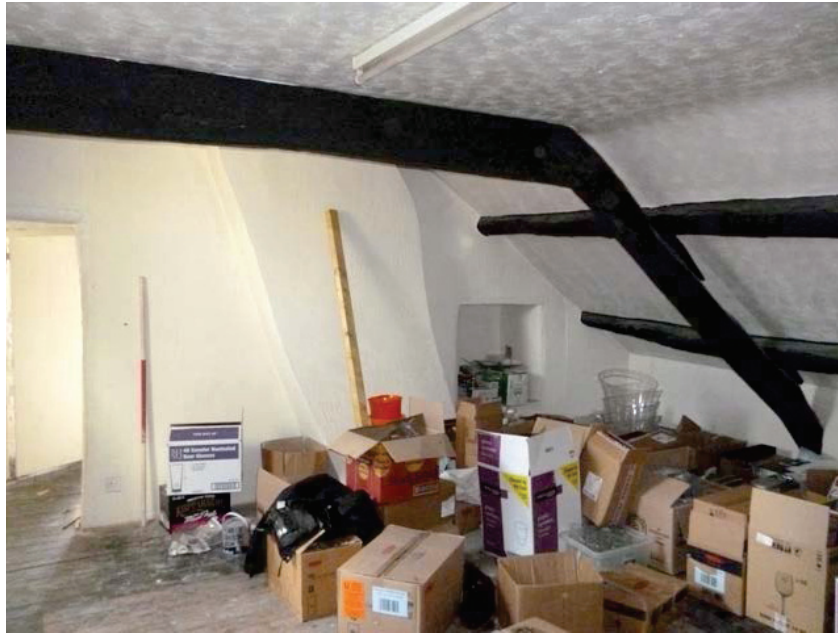
4.3.15 **Second Floor Room 1:** this is subdivided by stud walls forming three rooms. In general, the floors are finished with relatively late tongue and groove floorboards, which have been stained black, although only around the edges in the main subdivision. There is a doorway with a late 19th or early 20th century door in the north stud wall and a modern door to the east (Plate 45). There is a plaster ceiling, slightly sloping to the north, covering the upper part of the roof structure, but the lower parts of two trusses are visible. These are of tie-beam type (Plate 46), the principals curving slightly at either end (Plate 47) where they meet the tie beam (although this is below the level of the floorboards), with collars above to which the ceiling has been attached. A row of slots in the underside of the northernmost collar indicate the position of an earlier stud wall, essentially on the same line as the present one. There are

three purlins per pitch, which overlap at the trusses, and the top ends of the principals, which could only be viewed in the small roof space, were joined with a simple lap joint (Plate 48). A number of additional timbers have been added, in particular along the east side, evidently in connection with the addition of the extension on this side. The majority of the timbers are hand-finished, some evidently reused, and the joints held with pegs, although some later machine-cut timbers have been added, including the rafters and ridge purlins, which would suggest it has been relatively recently reroofed.

Plate 45 (left): Door in the dividing stud wall, Room S1

Plate 46 (right): Roof truss exposed on the north side, Room S1

Plate 47 (left): East end of north truss, Room S1

Plate 48 (right): Top of south truss, roof space over Room S1

Plate 49: South elevation and west end of south truss, Room S1

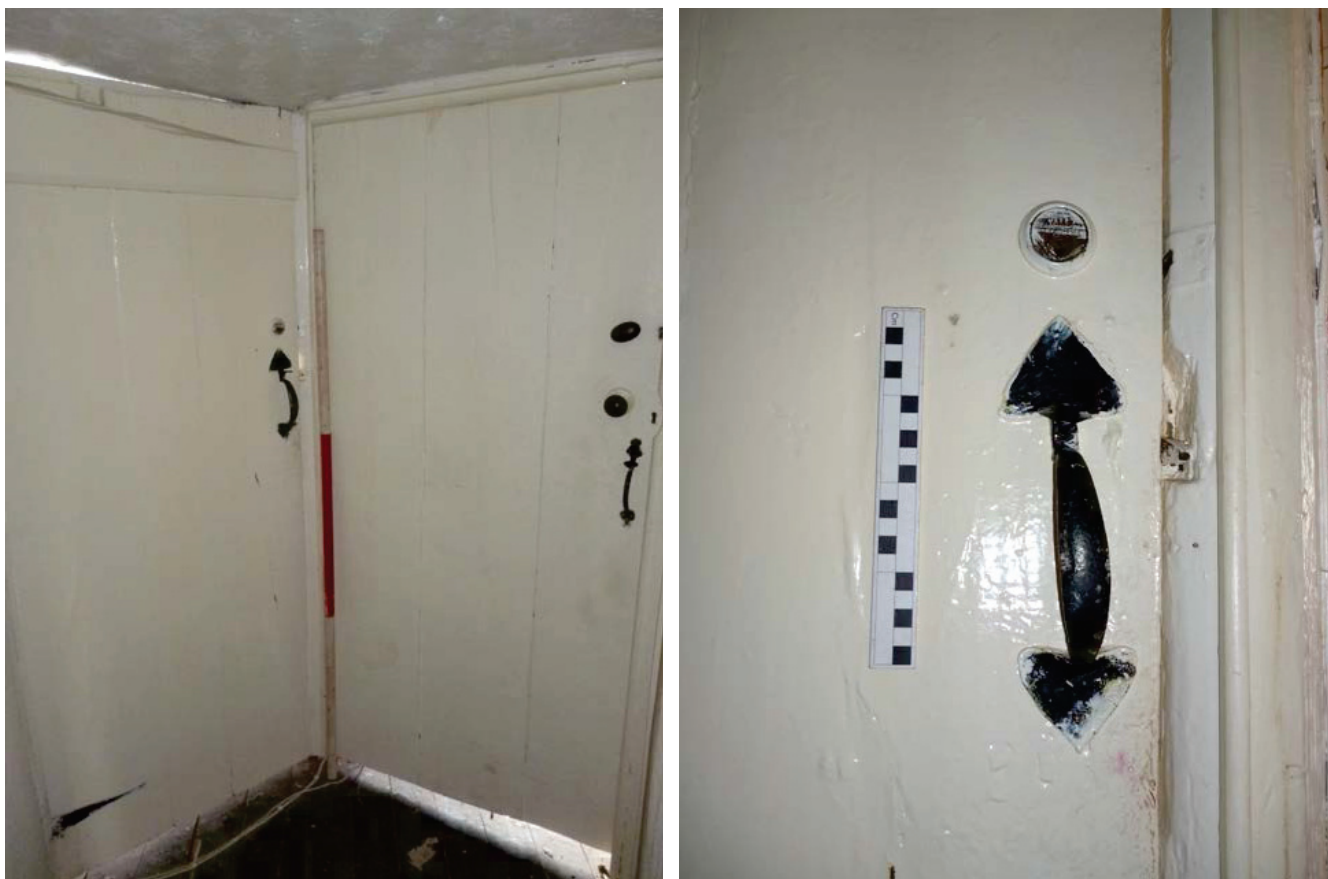
4.3.17 **Second Floor Room 2:** this evidently forms an extension to the main block to the north, and is subdivided by a stud wall into two smaller rooms with a connecting lobby. The floor is finished with relatively late tongue and groove boards, which are stained black round the edges. It has a flat plaster ceiling throughout, above which the roof structure (which could be viewed through a hatch on the east side) comprised only two purlins per pitch, all of which were hand-finished, although one appeared to have Baltic timber marks on it, and the ridge purlin and rafters were later and machine cut. The walls in general are finished with plaster and paint on the east side, but wallpapered on the west. The stud wall meets at a triangular lobby at the north end, with doors leading into the two rooms. Both of these doors are very early in style, built of wide planks with chamfered battens, and with strap hinges (some early) and with early latch plates (Plate 50 and Plate 51).

Plate 50 (left): Early doors on the north side of Room S2

Plate 51 (right): Early door latch on the north-east door, Room S2
