# HOLBECK PROPOSED DEVELOPMENT AREA, LEECE LANE, BARROW-IN-FURNESS, CUMBRIA

## Heritage Impact Assessment

Client: Holker Estates Co Ltd

August 2021

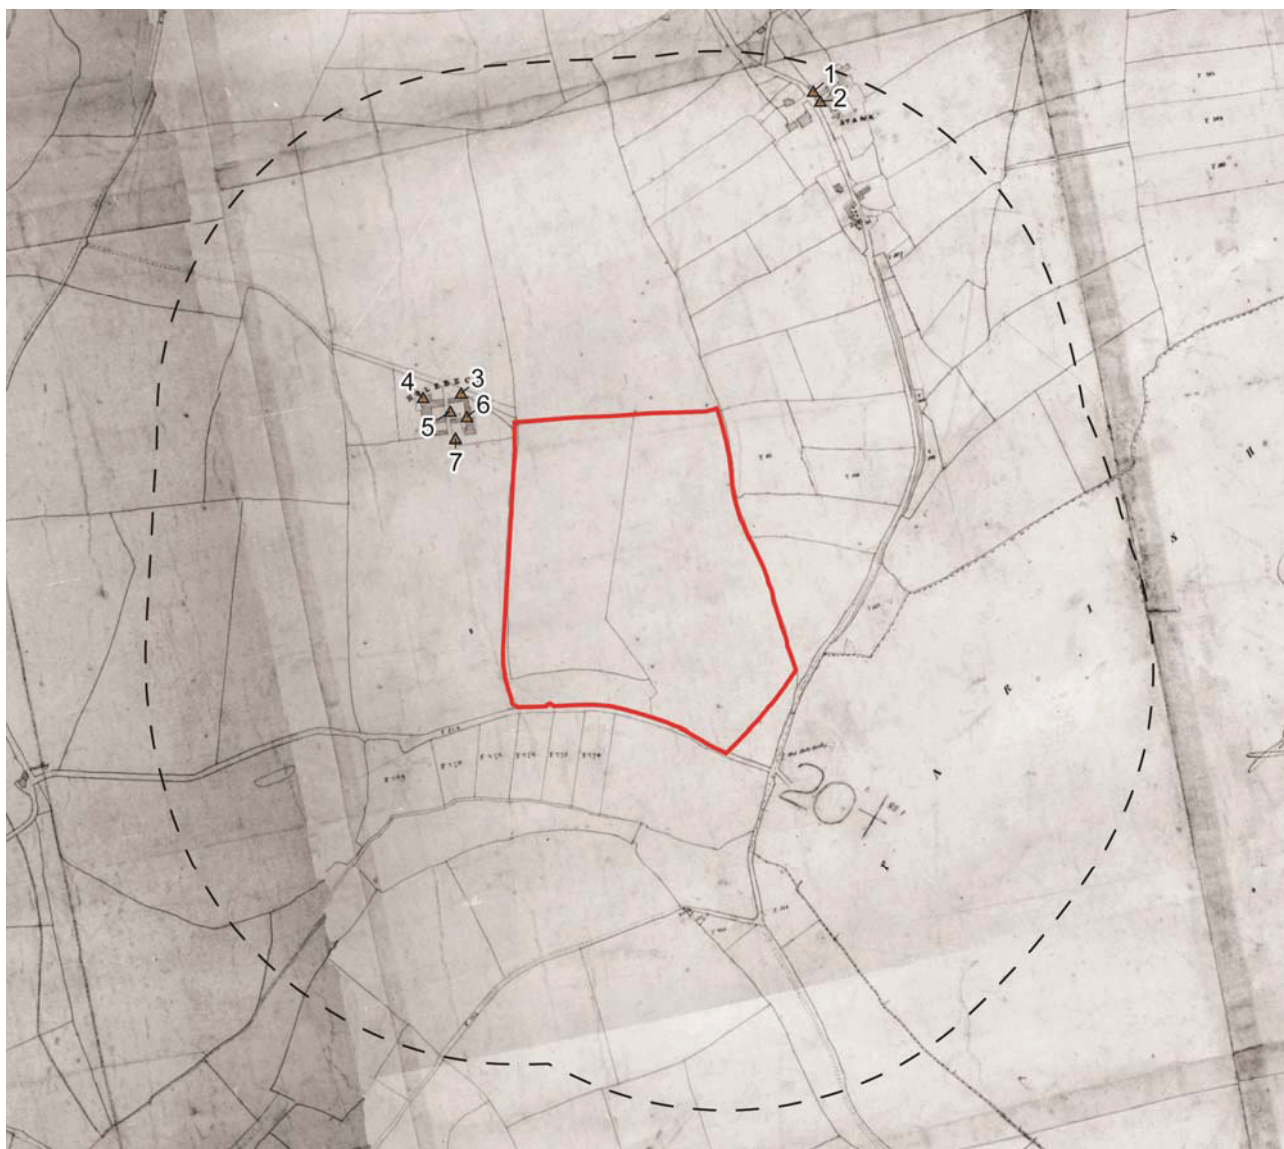
Plate 1: Extract from the tithe map of 1842

3.2.3 **Tithe map, 1842:** the tithe map (Plate 1), in this case for the Yarlside division of the parish of Dalton (NA IR 30/18/97 1842), apart from being the earliest detailed map produced at parish level, gives details of all the land owners, occupiers, field names, and uses. It clearly shows that the buildings at Holbeck Farm (**Sites 3-7**) and Stank Farm (**Sites 1-2**) existed at that point much as they do now and the landscape was essentially the same too, although with more boundaries dividing the fields to the north-west of the proposed development site.

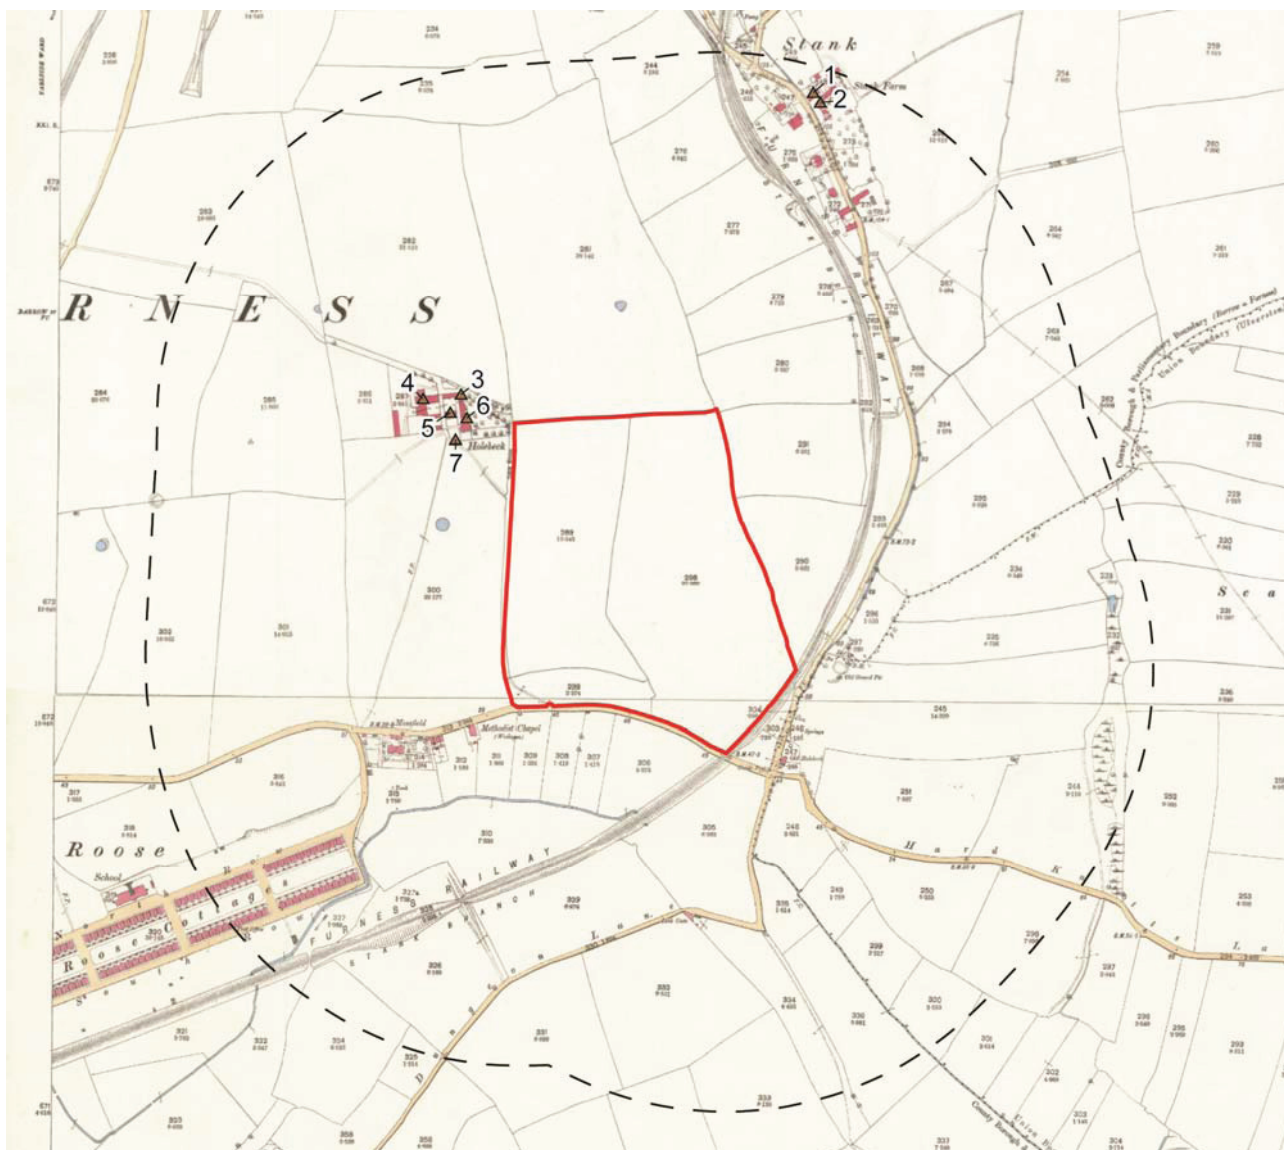
Plate 3: Extract from the Ordnance Survey map of 1891

3.2.5 **Ordnance Survey 1891:** the proposed development site is split over two map sheets (Ordnance Survey 1891; nd), and these show the same arrangement of buildings as the 1851 edition (Plate 3; cf. Plate 2) but in more detail. The major change to the wider landscape is the creation of the Stank branch mineral railway, which has been constructed by this date and passes by to the east and south sides of the site and along the south-west side of Stank.

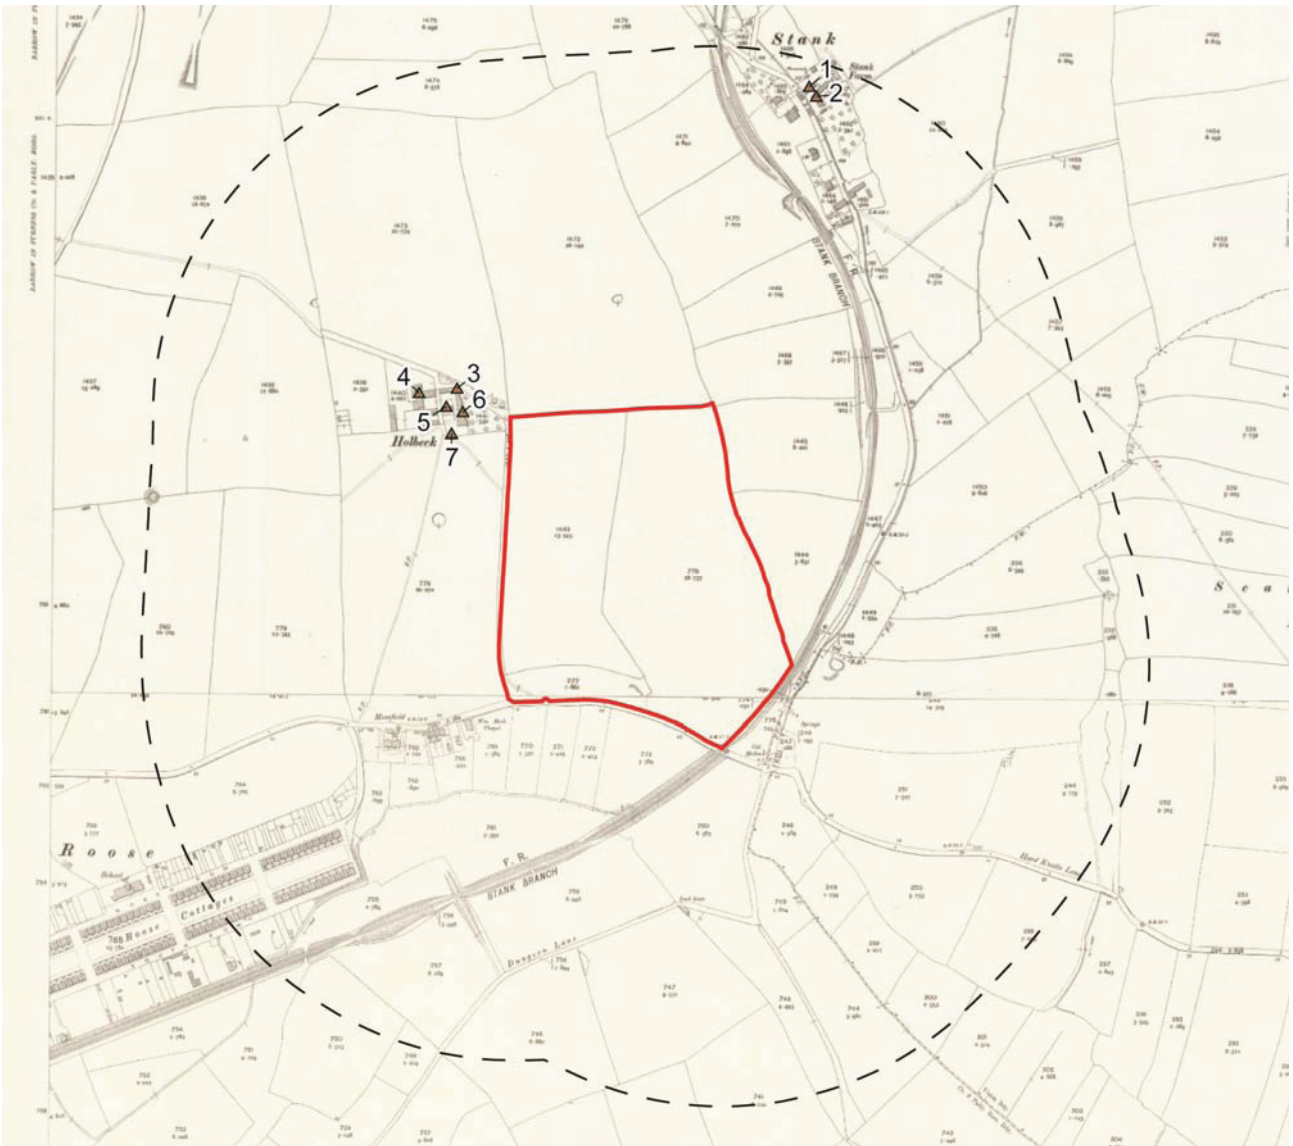
Plate 4: Extract from the Ordnance Survey map of 1913

3.2.6 **Ordnance Survey 1913:** this map is also split over two sheets (Ordnance Survey 1913a; 1913b), and essentially shows the same arrangement as the 1891 edition (Plate 4; cf. Plate 3).

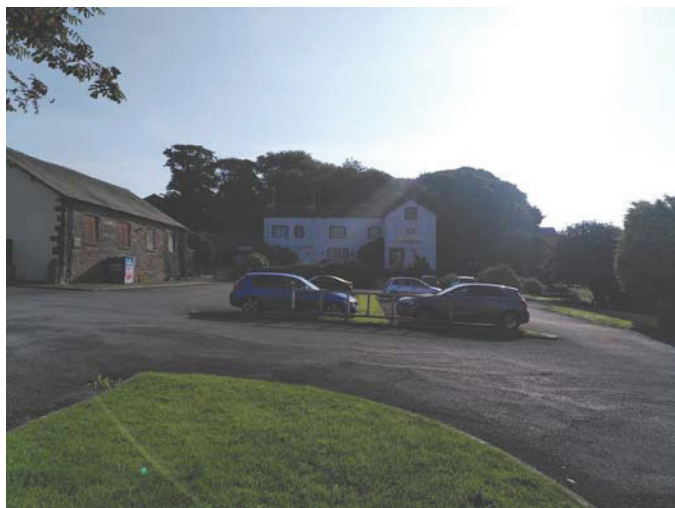
3.4.2 **Holbeck Farm:** the buildings making up what was Holbeck Farm still comprise an essentially square complex arranged around a former courtyard, although the south-west corner has lost some original buildings and now comprises a car park (Plate 5 and Plate 6). While the original farm house (**Site 6**, with its associated boundary wall; **Site 7**) now comprises the pub, it has retained much of its original form (Plate 5 and Plate 6). The former pigsty (**Site 3**) is now apparently disused (Plate 5). The other buildings (**Site 4** and **Site 5**) were originally barns and are now converted into dwellings, the former fairly recently – it was subject to archaeological recording in in 2015 (Greenlane Archaeology 2015c).

Plate 5 (left): General view of the former Holbeck Farm (Site 6) from the south-west

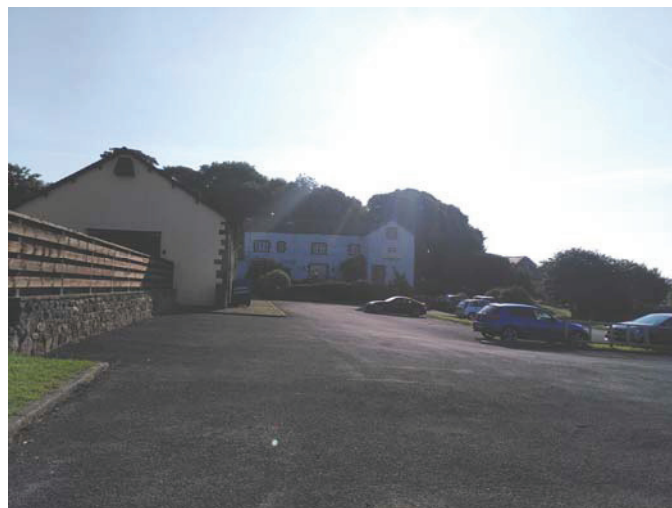
Plate 6 (right): General view of the former Holbeck Farm (Site 6) and pigsty (Site 5) from the west

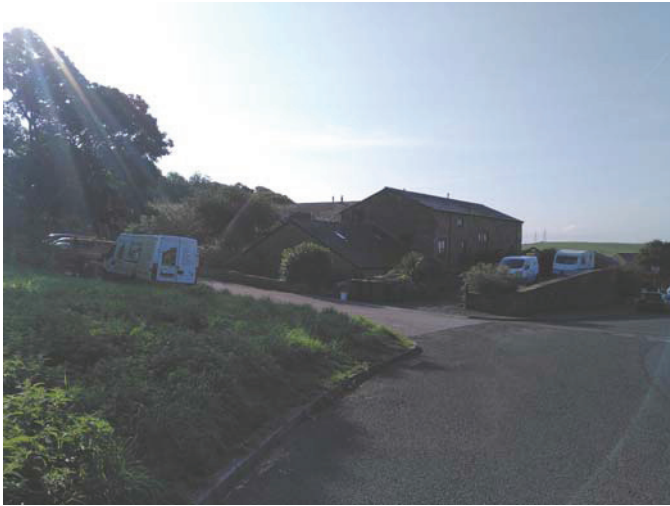
**Plate 7 (left): View of former farm building at Holbeck Farm (Site 5), from the north-west**

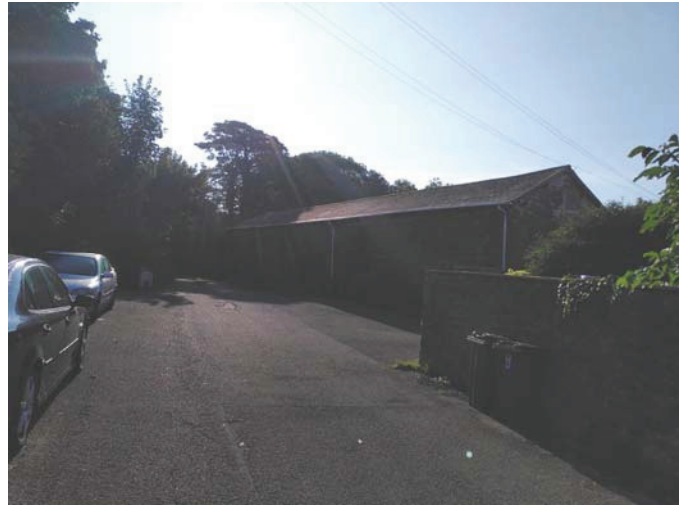
**Plate 8 (right): View of former farm building at Holbeck Farm (Site 3), from the north-west**

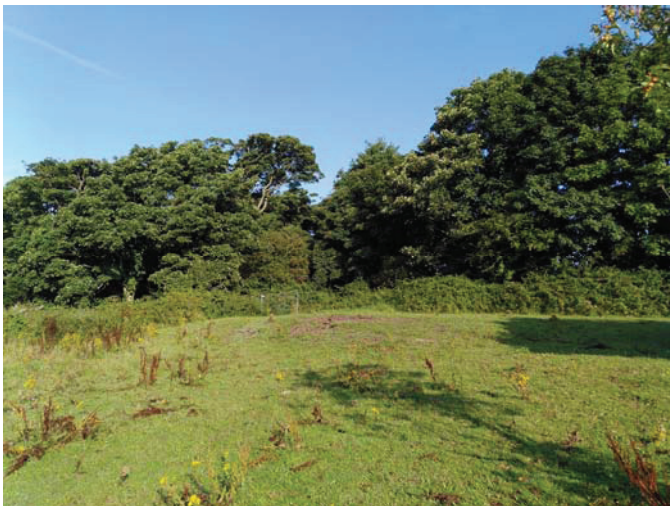
3.4.3 Views of the buildings at the former Holbeck Farm from the proposed development site to the south-east are almost entirely obscured by a wooded area immediately to the east of the former farmhouse (**Site 6**) (Plate 9 and Plate 10). The former farm is otherwise now surrounded on all but the east side by new housing.

**Plate 9 (left): View from the proposed development area towards Holbeck Farm, from the east**

4.4.1 Taking into account the impact on the setting of the designated heritage assets there is limited need for mitigation work. However, retaining the tall hedge along the northern boundary of the proposed development site would maintain the separation between it and **Sites 1-2**. In addition, the creation of additional screening in the form of tree planting in the north-west corner of the proposed development site would be of benefit in further protecting the setting of **Sites 3-7**.

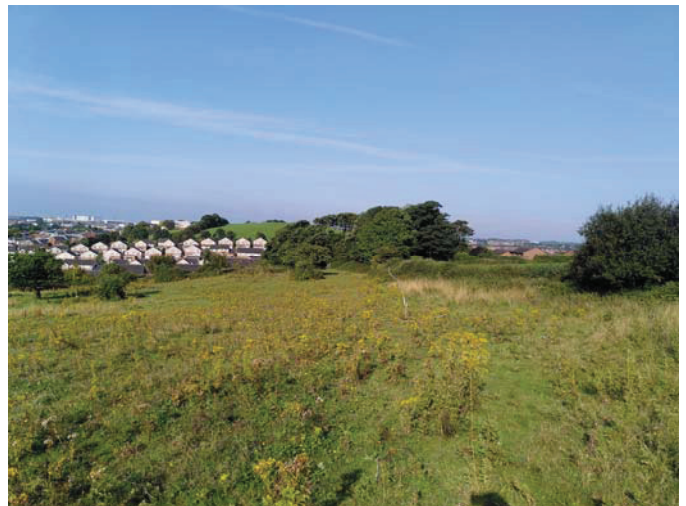
**Plate 10 (right): Distant view from the proposed development area towards Holbeck Farm, from the east**

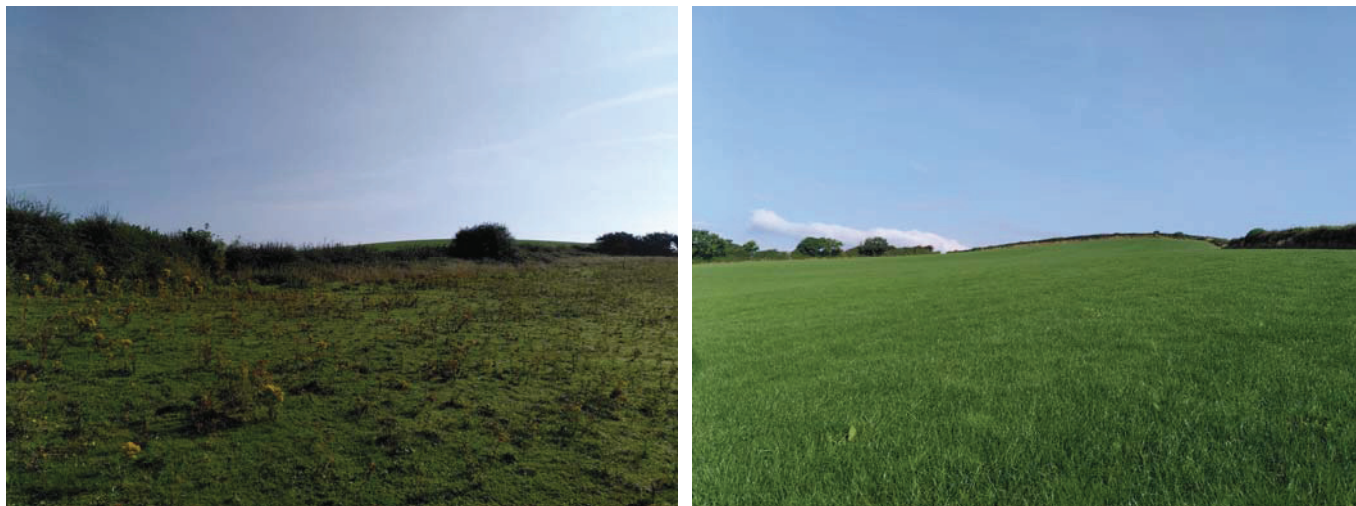
3.4.4 **Stank Farm**: the designated heritage assets at Stank Farm (**Site 1** and **Site 2**) are a considerable distance from the proposed development site – almost 500m from its north-east corner. They are not visible from the site as they are to the north of the top of the hill, which is in the field to the north of the proposed development area, and nor is it possible to view the site from them.

**Plate 11 (left): View towards Stank Farm from the north end of the western field of the proposed development area, from the south-west**

**Plate 12 (right): View towards Stank Farm from the centre of the eastern field of the proposed development area, from the south**

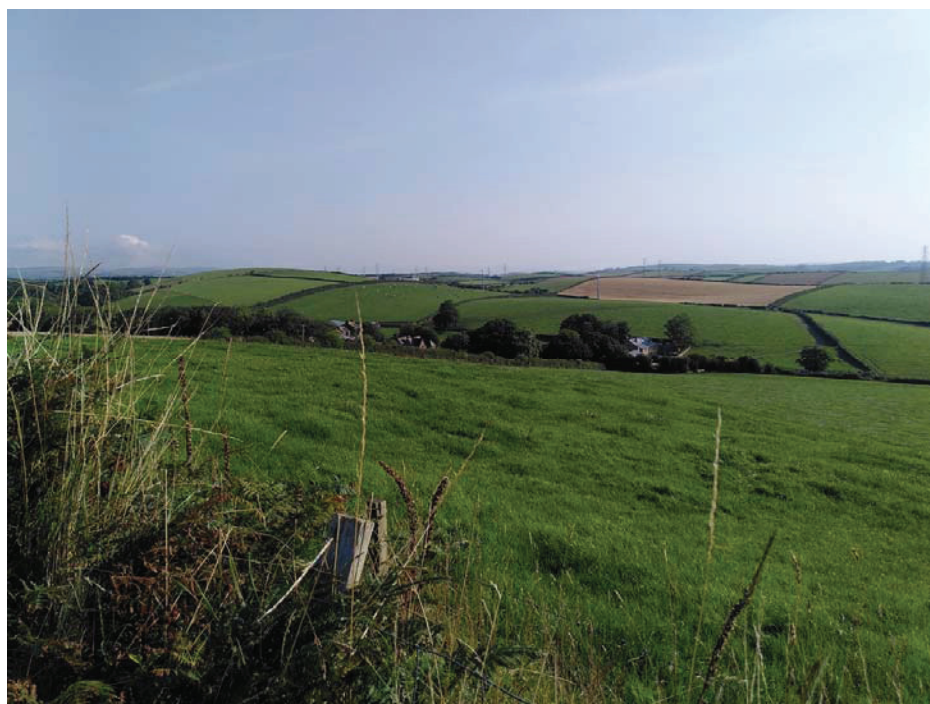
**Plate 13: The view from the field to the north of the proposed development area towards Stank, from the south-west**
