FORMER POLICE STATION, ULVERSTON, CUMBRIA

Archaeological Building Recording

Planning	
Pre-planning?	No
Planning Application No.	SL/2020/0885
Proposal	Partial demolition of elements of former police station and courthouse, remainder retained to form part of new dwellings
Condition number	None – at request of Conservation Officer
Level of recording	Historic England Level 2
Local Planning Authority	South Lakeland District Council
Conservation Officer	Libby Mee
Planning Archaeologist	Jeremy Parsons, Cumbria Historic Environment Service
Previous phase of work carried out?	Yes – heritage assessment

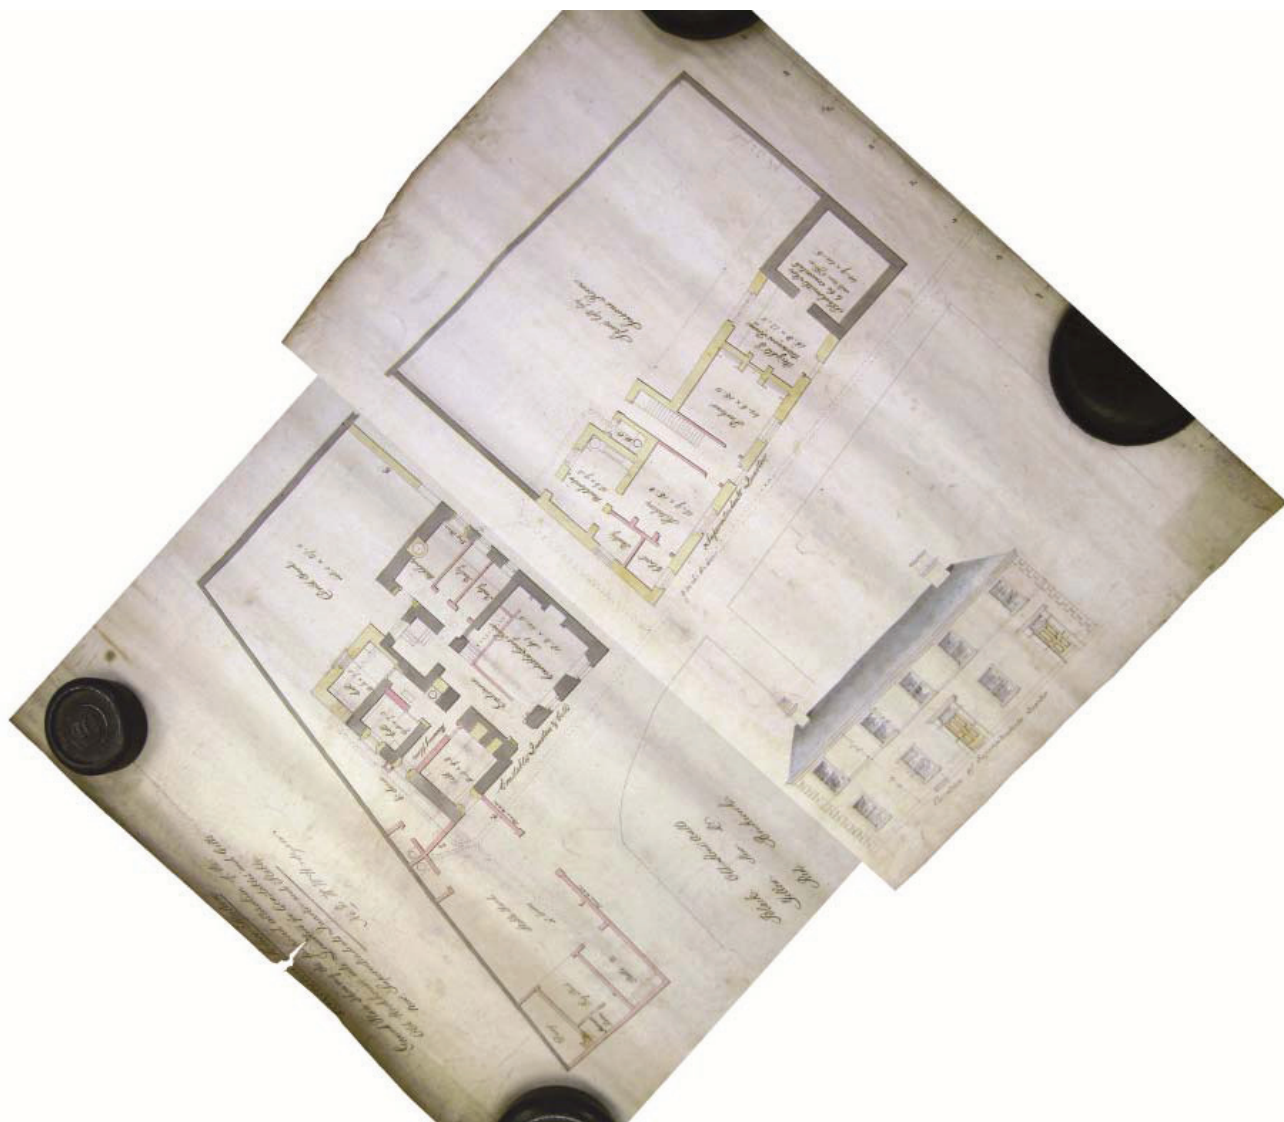
Plate 5: Undated ground floor plans of proposed alterations to 'Old Workhouse' (CAC(B) BDKF Plans/4 nd)

3.1.6 **Undated plans, late-19th century:** a series of plans and elevations of the site depict a range of alterations and additions that were proposed to the 'Old Workhouse', meaning the former Neville Hall, in order to provide a new Police Station. It is apparent that these initially intended to retain the former Neville Hall and convert it, but that a range of new buildings were also to be added to the north-east against an existing building, labelled 'Blacksmith's shop to be converted into an office', and others were to be constructed to provide stabling to the south (Plate 5 and Plate 6). The drawings also include an elevation of the new 'Superintendents Quarter' (Plate 7) as well as plans of the existing 'Old Workhouse' (the former Neville Hall), although these are mislabelled; the first is clearly the north-east elevation (Plate 8) while the latter is clearly the south-east (Plate 9) and the same as that shown in the earlier photograph (Plate 4).

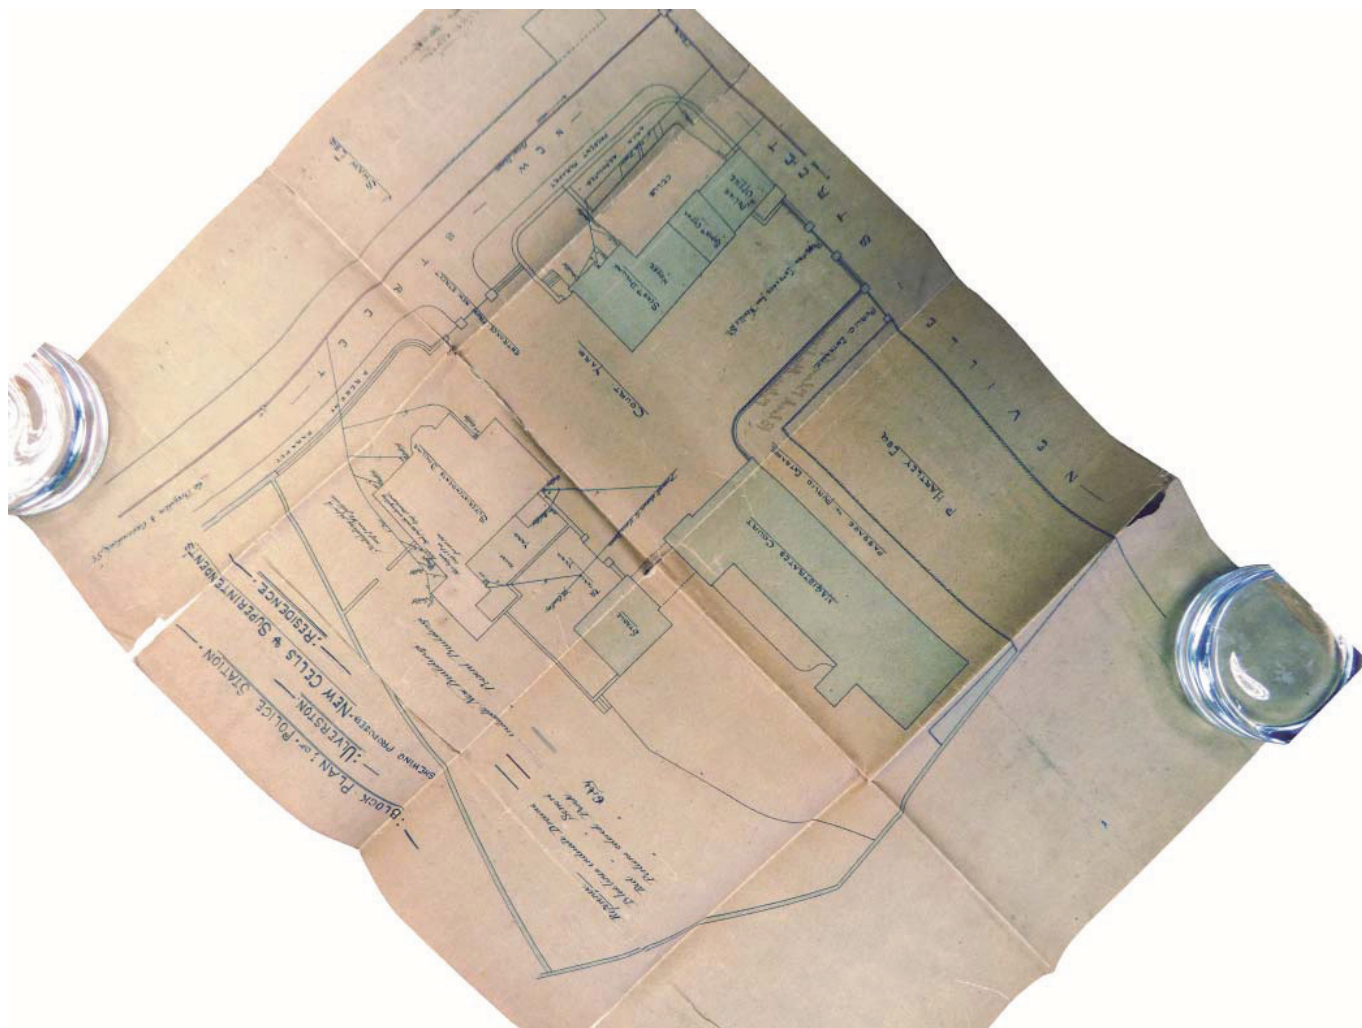
Plate 10 (right): Proposed new cells and superintendent's residence at police station (CAC(B) BSUDU/BIPLANS/1 20th century)

3.1.7 **Undated block plan:** this plan shows the positions of a proposed block of cells on the north side of the site and a 'Superintendent's Dwelling' to the west (Plate 10). The existing buildings are depicted in blue, some of which were clearly built as part of the previous proposal but which also include a 'Magistrates Court' that been built to the east in the meantime. This plan demonstrates not only that the site developed very gradually but the former Neville Hall/Old Workhouse was replaced by the construction of the new superintendent's house.

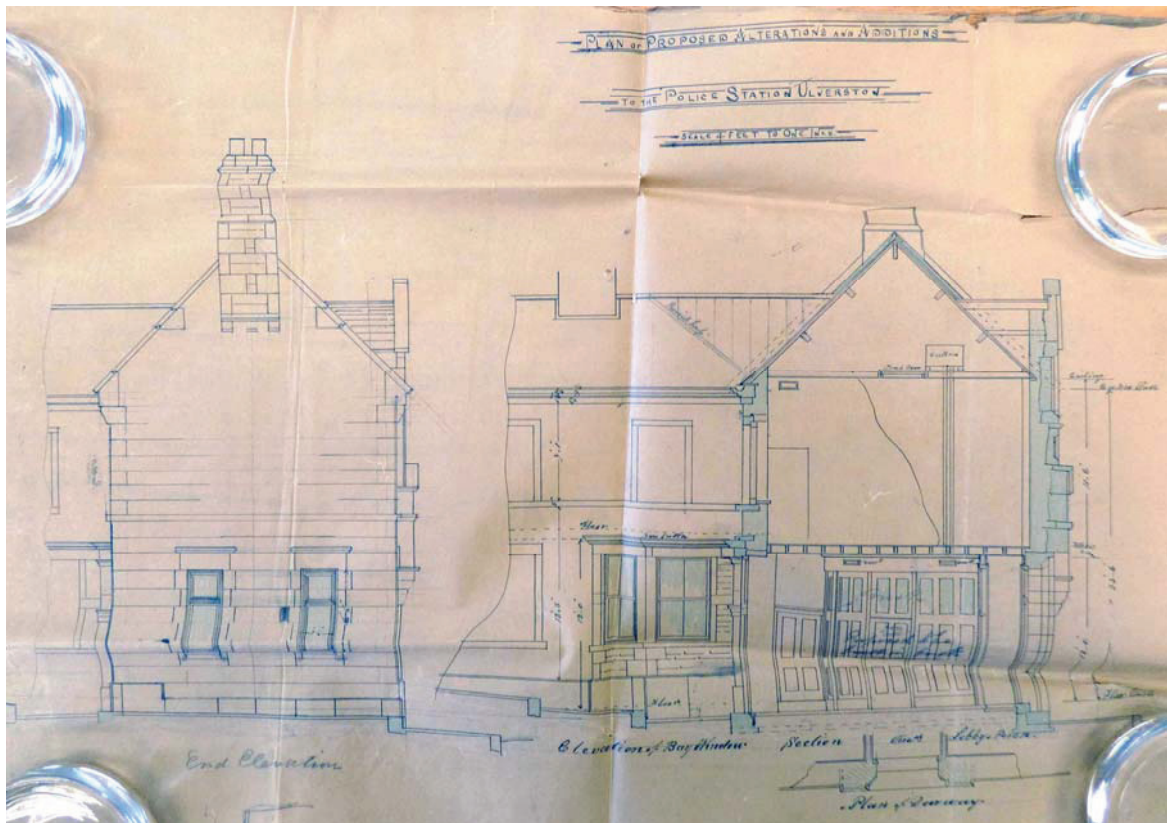
Plate 13: Elevation and section drawings for the new Police Station (CAC(B) Z/1086 1882-1888)

3.1.8 **Drawings, 1882-1888:** in order to facilitate the construction of the present police station buildings a new police station was constructed at the north end of the site, evidently in the position previously marked as a blacksmith's shop (parts of which were retained within the new building) and a range of drawings were produced for this (Plate 10 to Plate 15). The drawings were produced by the architect JW Grundy of Ulverston (CAC(B) Z/1086 1882-1888; the collection also includes contractors' specifications for the work), who was responsible for a number of significant public and private buildings in the town and the wider area.

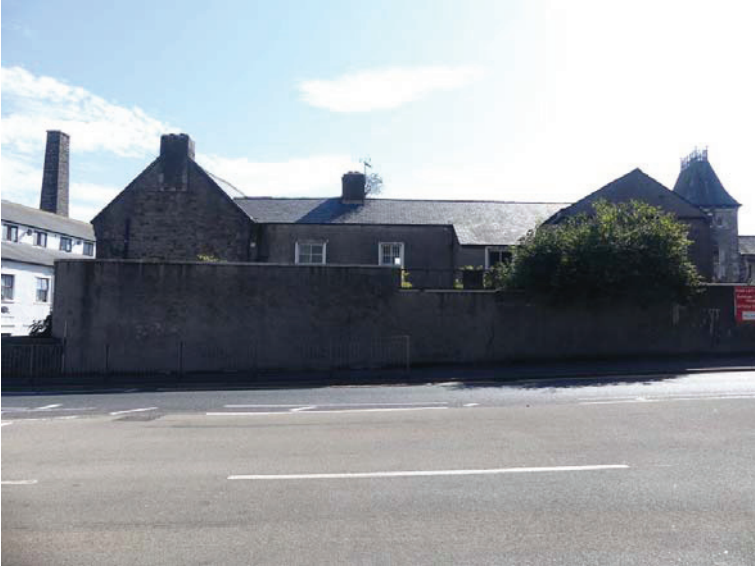
Plate 19 (left): The north-west external elevation of the police station, viewed from the north-west

4.2.1 **North-west external elevation – police station:** this is mostly obscured by the outer boundary, which is plain and finished with rough cast render although at the north-east end it comes to the gable of the police station proper (Plate 19), which is relatively plain, rock-faced stonework, with a projecting chimney at the top supported by corbels as per that to the south-east. Part of the lower section, adjoining the boundary wall, is a much rougher build; perhaps part of an earlier building (Plate 20). Behind the boundary wall the elevation proper has two windows on the north-east side of the first floor with painted thin render band surrounds, a stone lintel to the north-east and bars over the south-west. Both have eight-light sash casements. There is a slight return in the south-west with a similar window with a four-light sash casement and then another slight return to a gable, which is plain apart from a small window on the south-west side with thin painted band surrounds and an eight-light sash casement. The ground floor has return to the north-west at the north-east end, with a former doorway blocked with concrete blocks and another doorway with a modern door and with a single window and a further small window to the north-west with a two-light sash casement (Plate 21). The main elevation to the south-west has two doorways on the ground floor, both with plank and batten doors, the south-west with a modern timber and wire cage around it (Plate 22). To the south-west is a further tall window with a four light over one

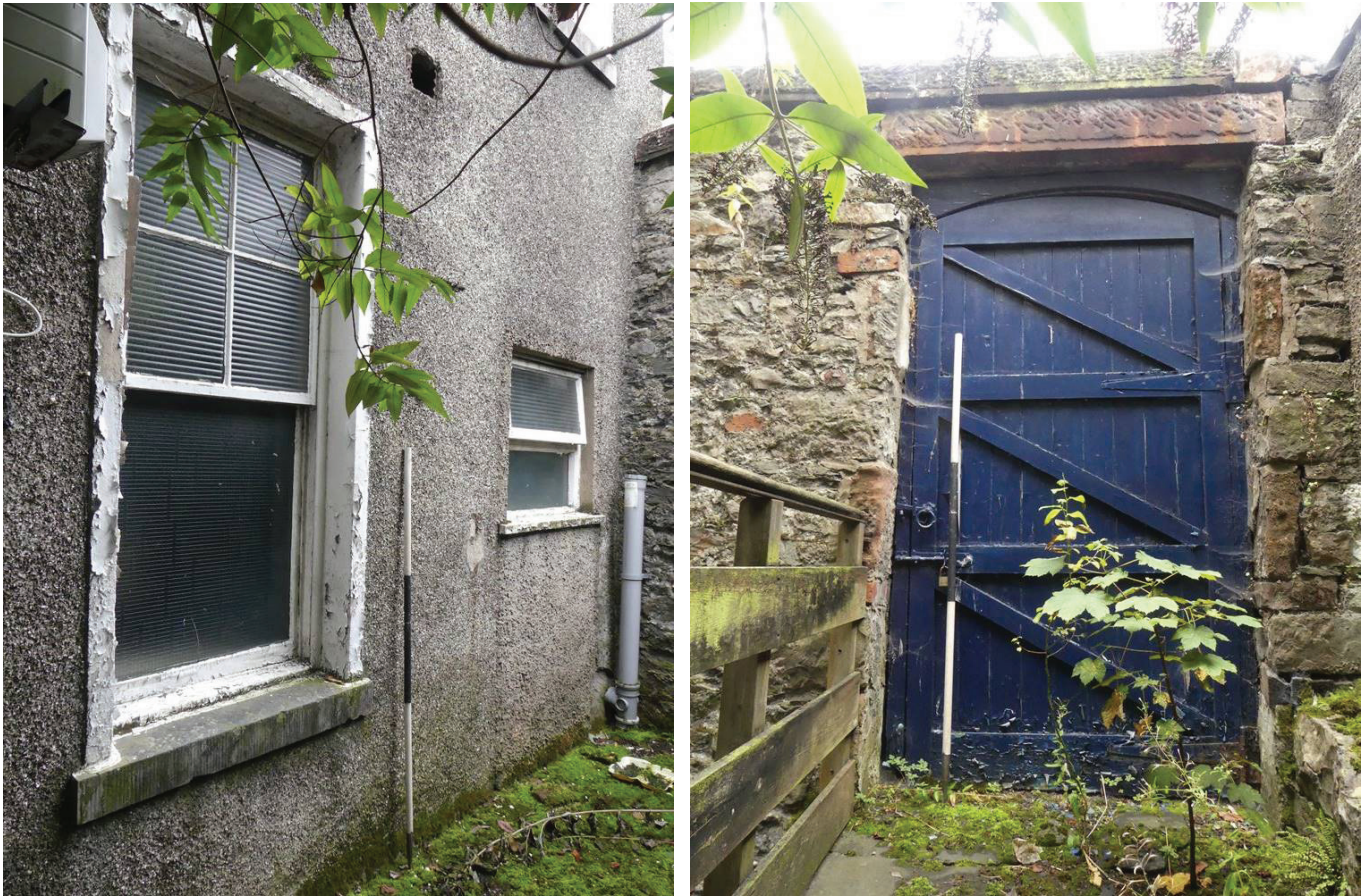
light sash casement with no horns and a painted render band around and stone sill (Plate 23). There is a further small window to the south-west with a two-light hinged casement and thin stone sill, which is positioned within a former doorway that has mostly been blocked up. The south-west end is continued by the boundary wall returning to the north-west, which has a doorway with a plank and batten door (Plate 24).

Plate 23 (left): Ground floor windows on the south-west side of the north-west external elevation of the police station, viewed from the north

Plate 24 (right): The doorway in the boundary wall to the south-west of the north-west external elevation, viewed from north-east

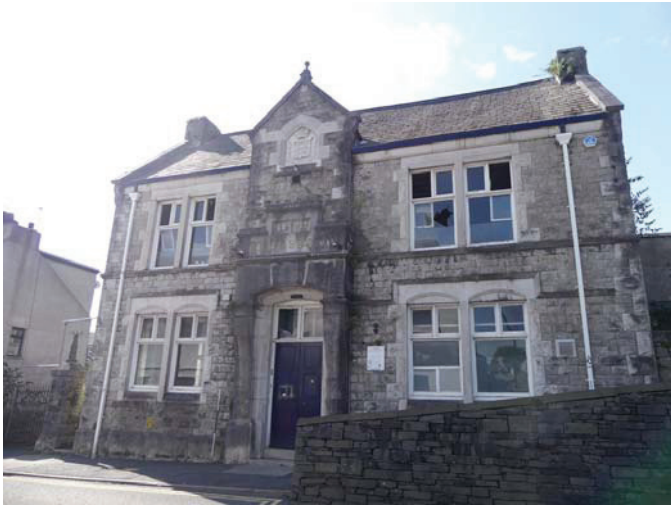
Plate 25 (left): The north-east external elevation of the police station, viewed from the north-east

4.2.2 North-east external elevation – police station: this is the front of the building and is entirely finished in rock-faced ashlar limestone blocks in random courses with dressed limestone detailing (Plate 25) and extended on the south-east end by the gateway (Plate 26). There are two pairs of windows on the ground floor both with modern timber three-light casements and rock-faced ashlar surrounds with blind arched lintels and hood moulds. Between these is a central doorway with a projecting surround, the jambs forming curving brackets to support the decorative dormer above (Plate 27). The doorway has a flat voussoir arch and a double six-panel door with two overlights. At the north-west side, below the window, there is a cast iron measures plaque attached to the wall inside a simple chamfered niche. It is marked 'STANDARD MEASURES AT 62 FARENHEIT VERIFIED BY THE STANDARDS DEPARTMENT BOARD OF TRADE 1878' with marks for 'ONE FOOT', 'TWO FEET' and 'IMPERIAL YARD', as well as a maker's mark 'DIGRAVE SHORT & Co LONDON 1879' (Plate 28). A chamfered string course denotes the first floor and forms the sill of another pair of doubled windows, again with modern three-light timber casements and rock-faced ashlar quoined jambs and square lintels. Between these is a decorative projecting dormer with a recessed niche with a pointed arch housing a coat of arms comprising three lions carved in relief and below it the words 'POLICE STATION' and the date 'AD 1888' are also carved. The top of the dormer comes to a gable with a ball finial on a small pedestal. There are the remains of a chimney at either end of the roof line above the coping.

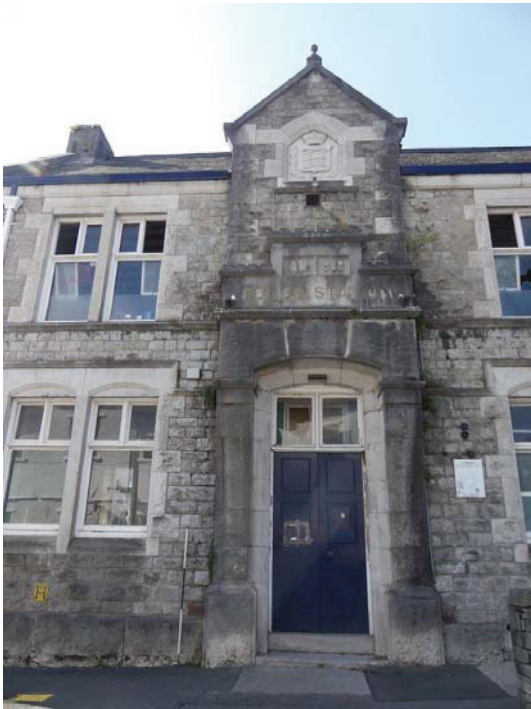
Plate 27 (left): The doorway and projecting decorative dormer above in the centre of the north-east external elevation of the police station, viewed from the north-east

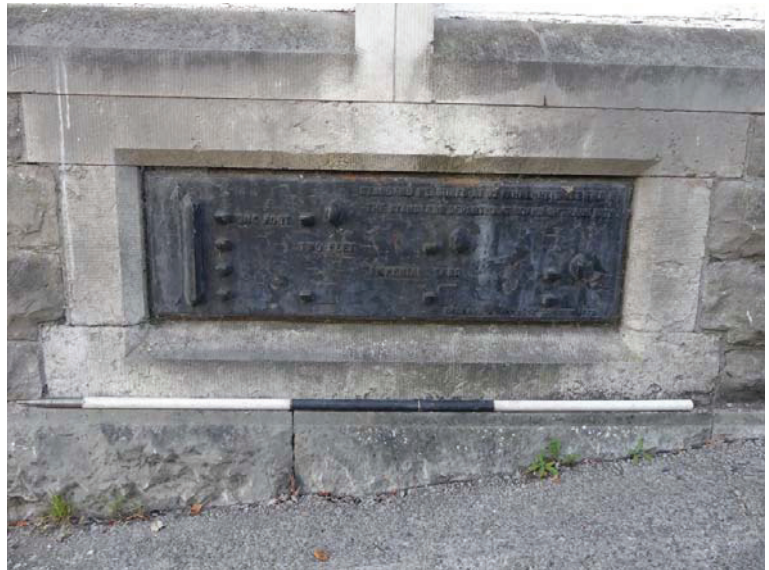
Plate 28 (right): The measures plaque on the north-west side of the north-east external elevation of the police station, viewed from the north-east

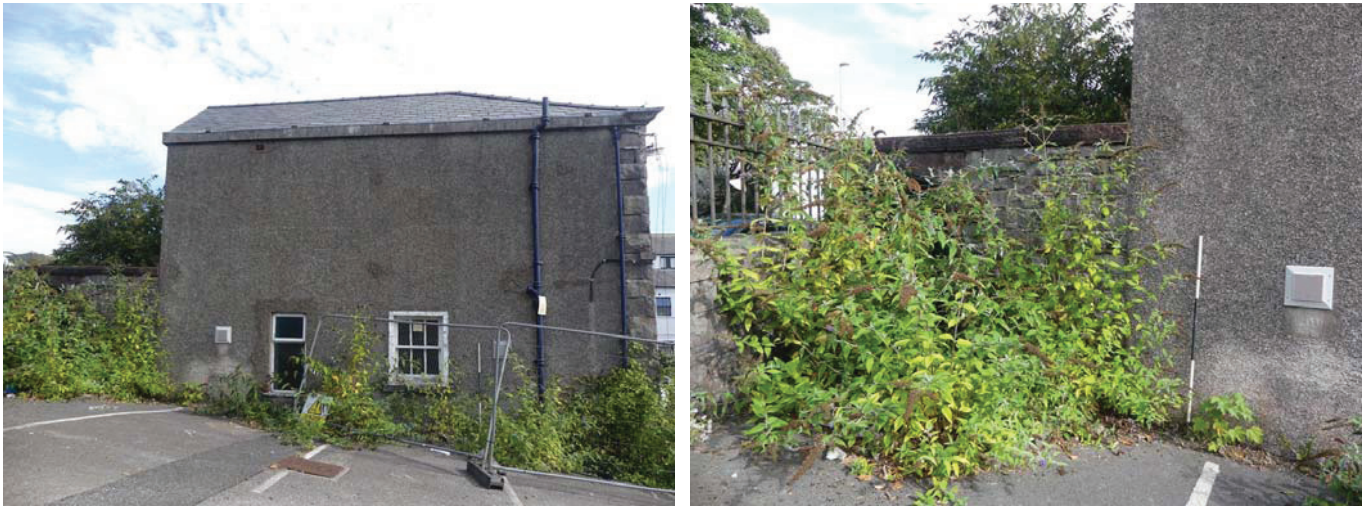
Plate 29 (left): The south-west external elevation of the police station, viewed from the south-west

4.2.3 **South-west external elevation – police station:** this is a plain end gable finished with roughcast render (Plate 29), extended on the north-west side by a boundary wall constructed from limestone blocks topped with rusticated sandstone blocks and with a doorway with a shallow arched top also in sandstone and a plank and batten door (Plate 30). There are two ground floor windows, the north-west perhaps inserted or modified as the render has evidently been changed around the jambs. It has a modern two-light casement and timber sill. The south-east has a thin render band around it and a six-light sash casement without horns and a dressed stone sill. There are otherwise several vents across the elevation and scars for others and the south-east end is finished with rock-faced ashlar quoins.

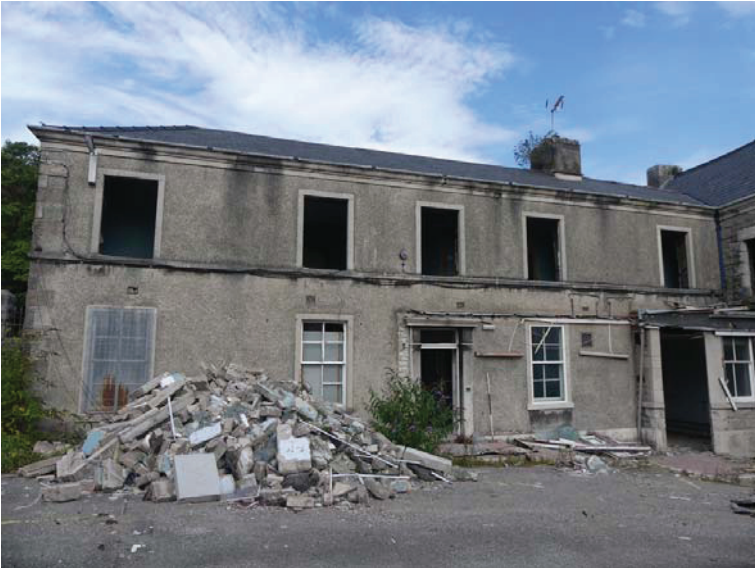
Plate 31 (left): The south-west and central section of the south-east external elevation of the police station, viewed from the south-east

4.2.4 South-east external elevation – police station: the main part of this is finished with roughcast but with dressed limestone detailing around the windows and doorways (Plate 31). The ground floor has three windows with eight-light sash casements and there is a doorway north-east of the centre with a dressed square surround and moulded details, moulded entablature, brass doorbell fitting and single-light over light (Plate 32). There is a canted porch at the north-east end finished with rock-faced limestone incorporating a doorway with a dressed stone surround and window with a similar surround and four-light sash casement (Plate 37). The scar of a later outshut is evident around this and extending across much of the elevation. The first floor has a row of five windows, none of which have surviving casements. The wall returns at the north-east end where it forms part of the front section and is also finished with rock-faced limestone with slate levelling (Plate 34). There is a doorway on the ground floor with a stone surround with moulded details as per that to the south-west including a tall entablature, which is partly covered by the scar of the later outshut. There is a small window to the south-east with a square surround and two-light hinged casement. The return to the south-east elevation proper is a relatively plain gable, with a first-floor window with rock-faced ashlar quoins, an angled entablature and two-light casement (Plate 35). The top of the chimney projects from the wall and is supported on three angled corbels. To the south-east are three original gate posts, all constructed from rock-faced ashlar blocks with pyramid tops and iron finials, perhaps the remains of gas lamps (Plate 36). The original iron gates are still hung between them.

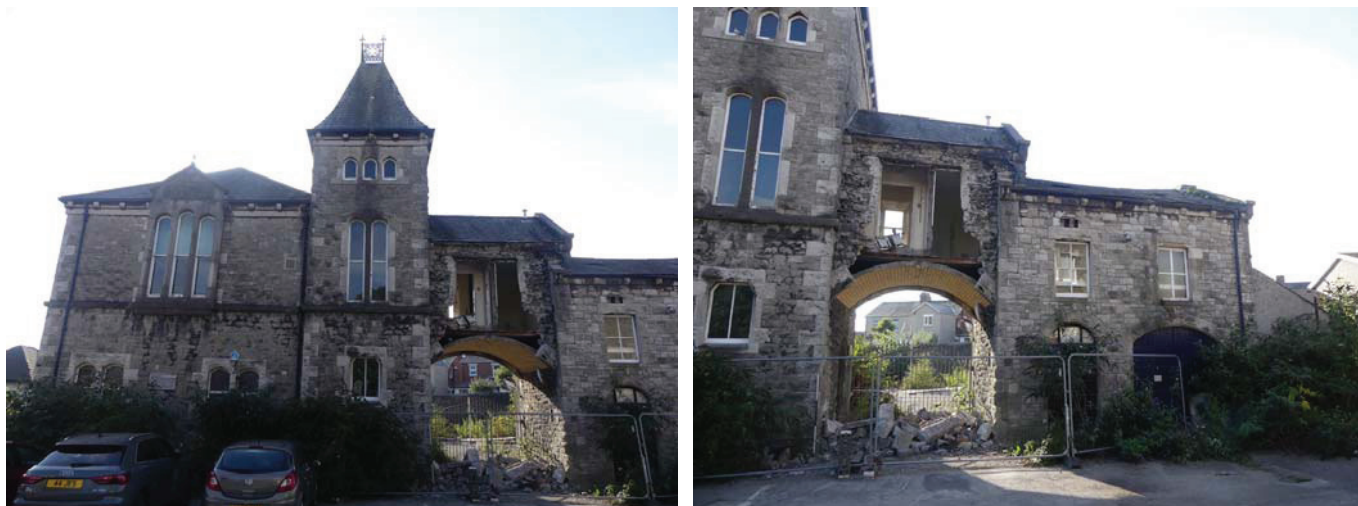
Plate 37 (left): The north-east side of the north-west external elevation of the courthouse, viewed from the north-west

4.2.5 **North-west external elevation – courthouse:** the north-east side has two ground floor windows each divided into two two-light casements with rounded arches (Plate 37). Above is a large three-part lancet-style window again with rounded arches divided by a chamfered mullion and housing two-light casements below a dormer gable. Its sill is supported on four angular corbels with a chamfered string course. There is a projecting plinth at the base of elevation. The wall projects slightly where it forms the tower and there is a single window with a canted arch and two-light casement on the ground floor, another tall lancet-style window above with two two-light casements and rounded arches, and above three small windows with single-light casements and pointed arches. The section above the gateway through the building has mostly collapsed revealing the rubble core but originally had at least one window. The arch itself was dressed limestone. The south-west end has two ground floor doorways, one with a pedestrian door with a rounded stone arch and three lights over and a beaded plank and batten door (Plate 38). The other is a wagon door with a stone arch and double plank and batten doors on long strap hinges. The elevation is continued at the south-west end by a monopitch outshut finished with roughcast render. There is a doorway in this elevation, the north-east jamb of which comprises projecting quoins continuing from those above while the lintel is concrete and it has a plank and batten door with a large metal vent inserted into it.

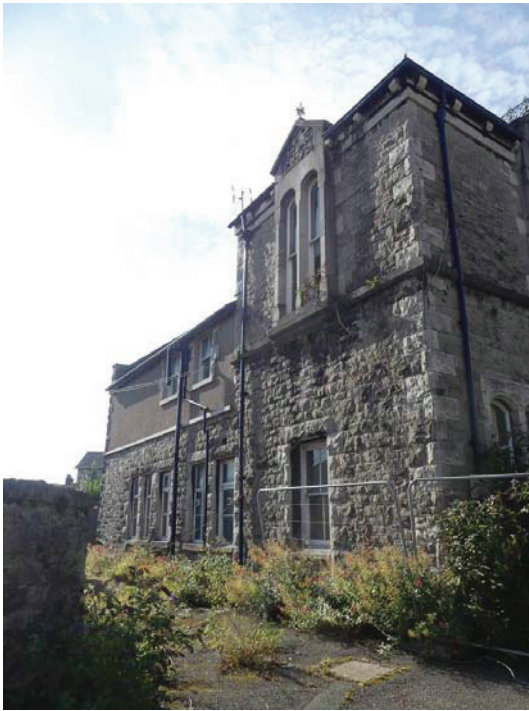
Plate 39 (left): General view of the north-east external elevation of the courthouse, from the north

4.2.6 **North-east external elevation – courthouse:** the majority of this is finished as per the north-west elevation (Plate 39), although the first-floor part of the south-east end is roughcast render above the plain string band. There is a row of six ground floor windows all with rock-faced ashlar limestone quoins and dressed sills and lintels; the south-eastern and the north-western have different, angled, sills and the jambs extend to the ground indicating that they were originally doorways (Plate 40). All have hinged three or six-light casements, except the north-west, which is a four-light sash. The first floor has two windows in the centre, again with dressed quoins and sills and four-light sash casements. At the north-west end the first floor has a pair of projecting lancet-style windows with chamfered mullions and jambs and rounded heads, the sill supported on five angled corbels. Above these windows is a dormer gable with stone coping and a metal finial (Plate 41).

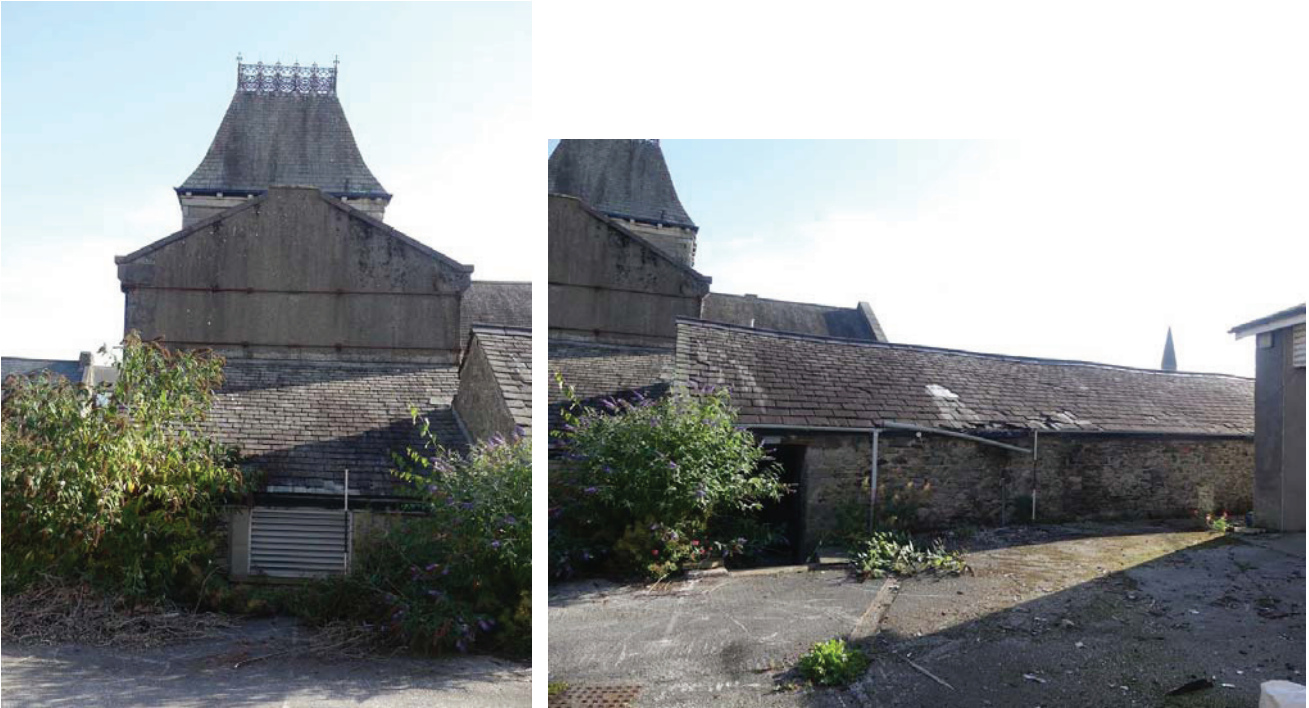
4.2.7 **South-west external elevation – courthouse:** this comprises a plain gable, the lower part of which is obscured by the monopitch extension (Plate 42). This has a small opening, probably originally a window, now mostly filled with a modern vent. The gable above is finished with roughcast render and has two iron tie rods running across it to plates at either end. There is the stub of a former chimney on top and kneelers either side. The tower projects above this. The elevation is extended to the south-east

by the long low wall of the open-fronted building, which is plain rough stone build, with a doorway on the north-west side with a rough stone lintel and plank and batten door (Plate 43).

Plate 42 (left): The south-west external elevation of the courthouse, viewed from the south-west

Plate 43 (right): The open-fronted building extending from the south-west end of the courthouse, viewed from the south-west

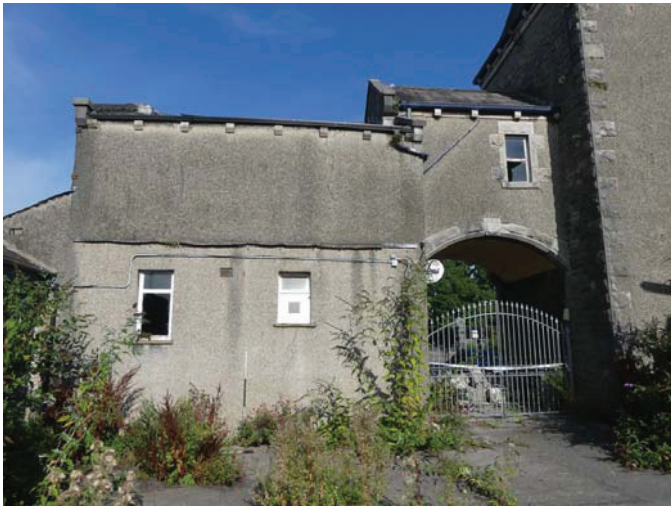
Plate 44 (left): The south-west side of the south-east external elevation of the courthouse, viewed from the south-east

4.2.8 South-east external elevation – courthouse: this is finished with roughcast but with dressed limestone used for details such as the quoins and door and window surrounds. The south-west end has two ground floor windows with thin stone sills and two-light hinged casements (Plate 44). A scar for a corrugated metal roof runs above these and there are angled corbels below the eaves. The wall returns to the north-east at the gate way, which has a modern metal gate below the chamfered limestone arch with keystone (Plate 45). There is a single window above with quoined jambs and a two-light casement and more angled corbels below the eaves. The wall returns again at the tower where there are more quoins, before a large return to the south-east (Plate 45). This has a pair of ground floor windows on the north-west side both with quoined jambs and dressed sills and lintels. The north-west has four-light sliding sash casement while the south-east has a modern three-light casement with bars over. There are two modern vents at ground floor level and two earlier iron vents in the plinth, which doesn't continue to the south-east end, perhaps indicating the location of a doorway (Plate 46). There is a string band at first floor level and four modern vents above. The return at the south-east end into the south-east elevation proper has a ground floor doorway with a quoined surround and a modern single panel door (Plate 47). There is a window above the string band, comprising two parts each with quoined surrounds and a four-light sash casement, although that to the south-west has been removed. The wall comes to a gable above with ashlar coping and kneelers.

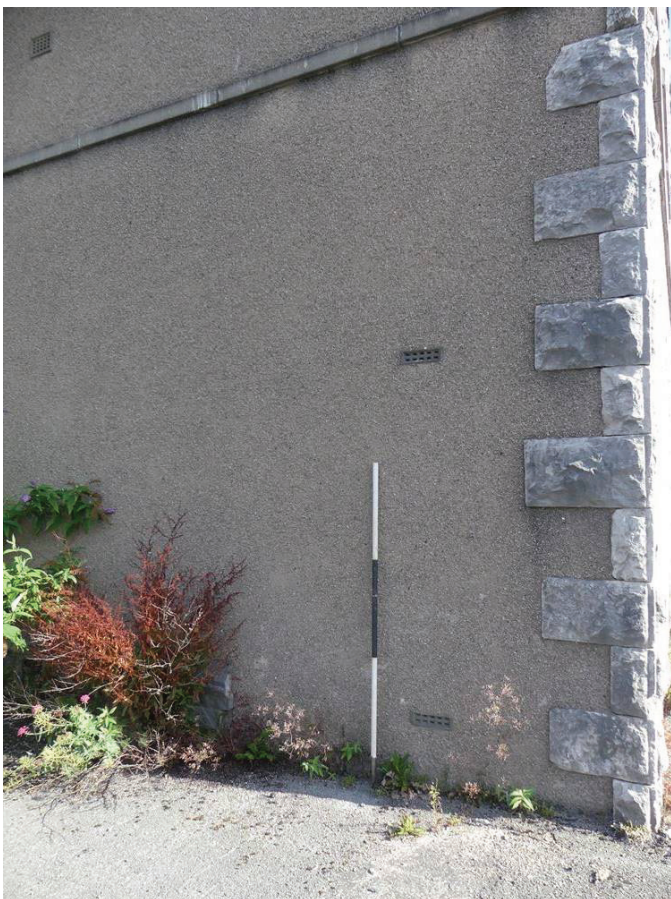
Plate 46 (left): The gap in the plinth in the return of the south-east external elevation of the courthouse, viewed from the south-west

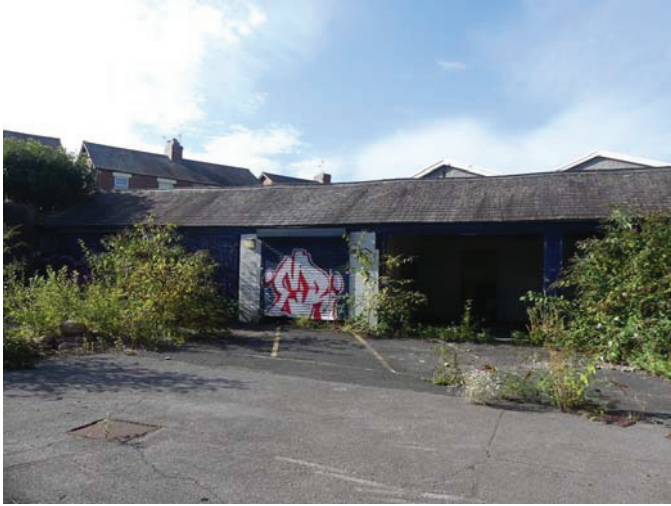
Plate 48 (left): The south-east end of the north-east elevation of the open-fronted building extending to the south-east of the courthouse, viewed from the north-east

4.2.9 *Open-fronted building to south-east of courthouse:* the external elevation to the south-west is described in *Section 4.2.7* above. The north-east side comprises a row of large openings (Plate 48 and Plate 49) divided by timber or concrete block walls, with the roof, which comprises simple tie beam

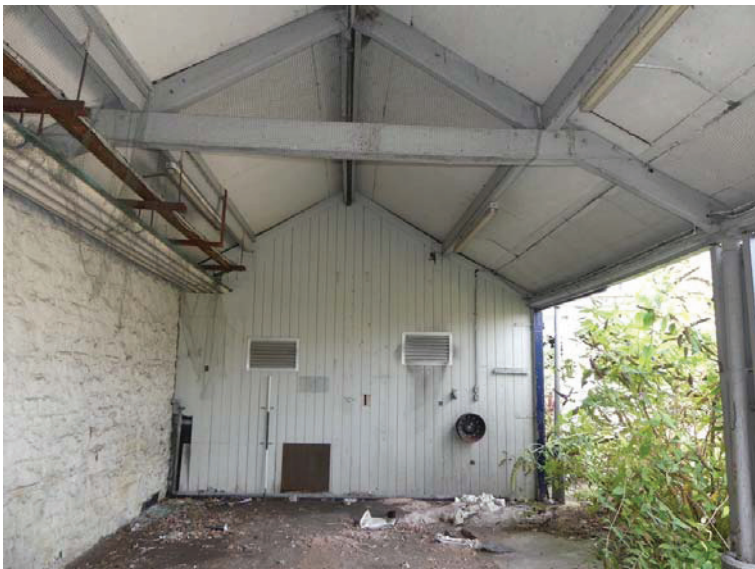
trusses and purlins all finished with stop-chamfer decoration (Plate 50), supported on iron columns (Plate 51) and incorporating timber plank infill with plank and batten doors at the north-west end (Plate 52) and modern metal tilting and roller garage doors. Internally all the rooms are relatively plain, the south-east incorporating the boundary wall to the south-west and south-east, while the north-west room houses modern heating plant and has a blocked window in the north-west elevation and the plank and batten door to the south-west has stop chamfered crossed battens (Plate 53).

Plate 50 (left): Example of a truss in the centre of the open-fronted building extending from the south-east side of the courthouse, viewed from the south-east

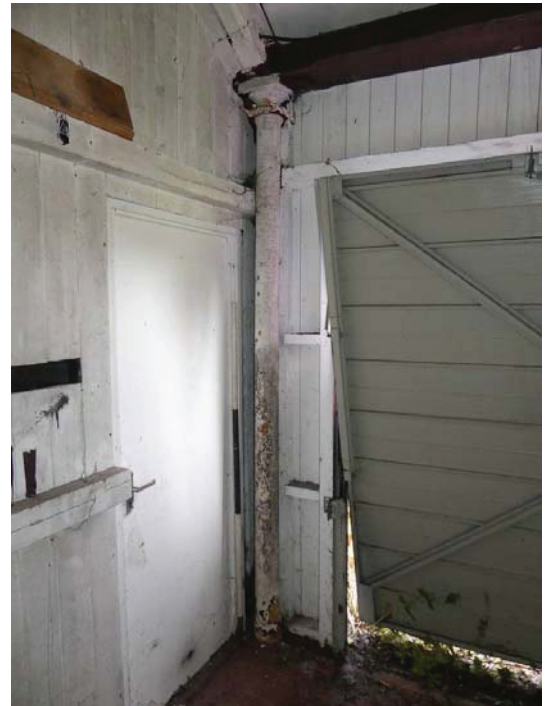
Plate 51 (right): Example of an iron column at the south-east end of the open-fronted building extending from the south-east side of the courthouse, viewed from the south

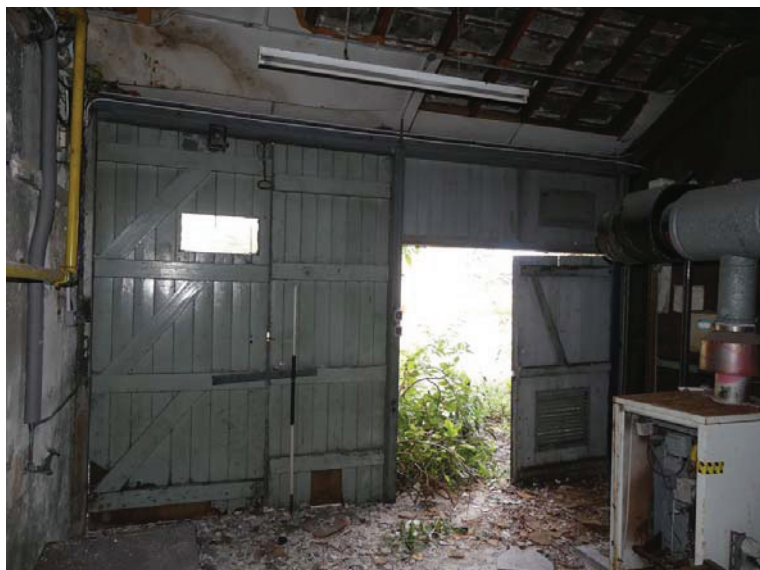
Plate 52 (left): Plank walling at the north-west end of the open-fronted building extending from the south-east side of the courthouse, viewed from the south-west

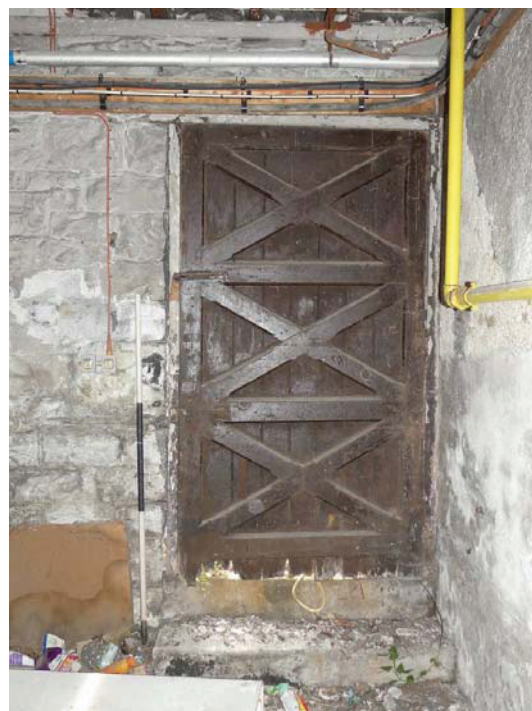
Plate 53 (right): Plank and batten door with crossed braces at the north-west end of the open-fronted building extending from the south-east side of the courthouse, viewed from the north-east

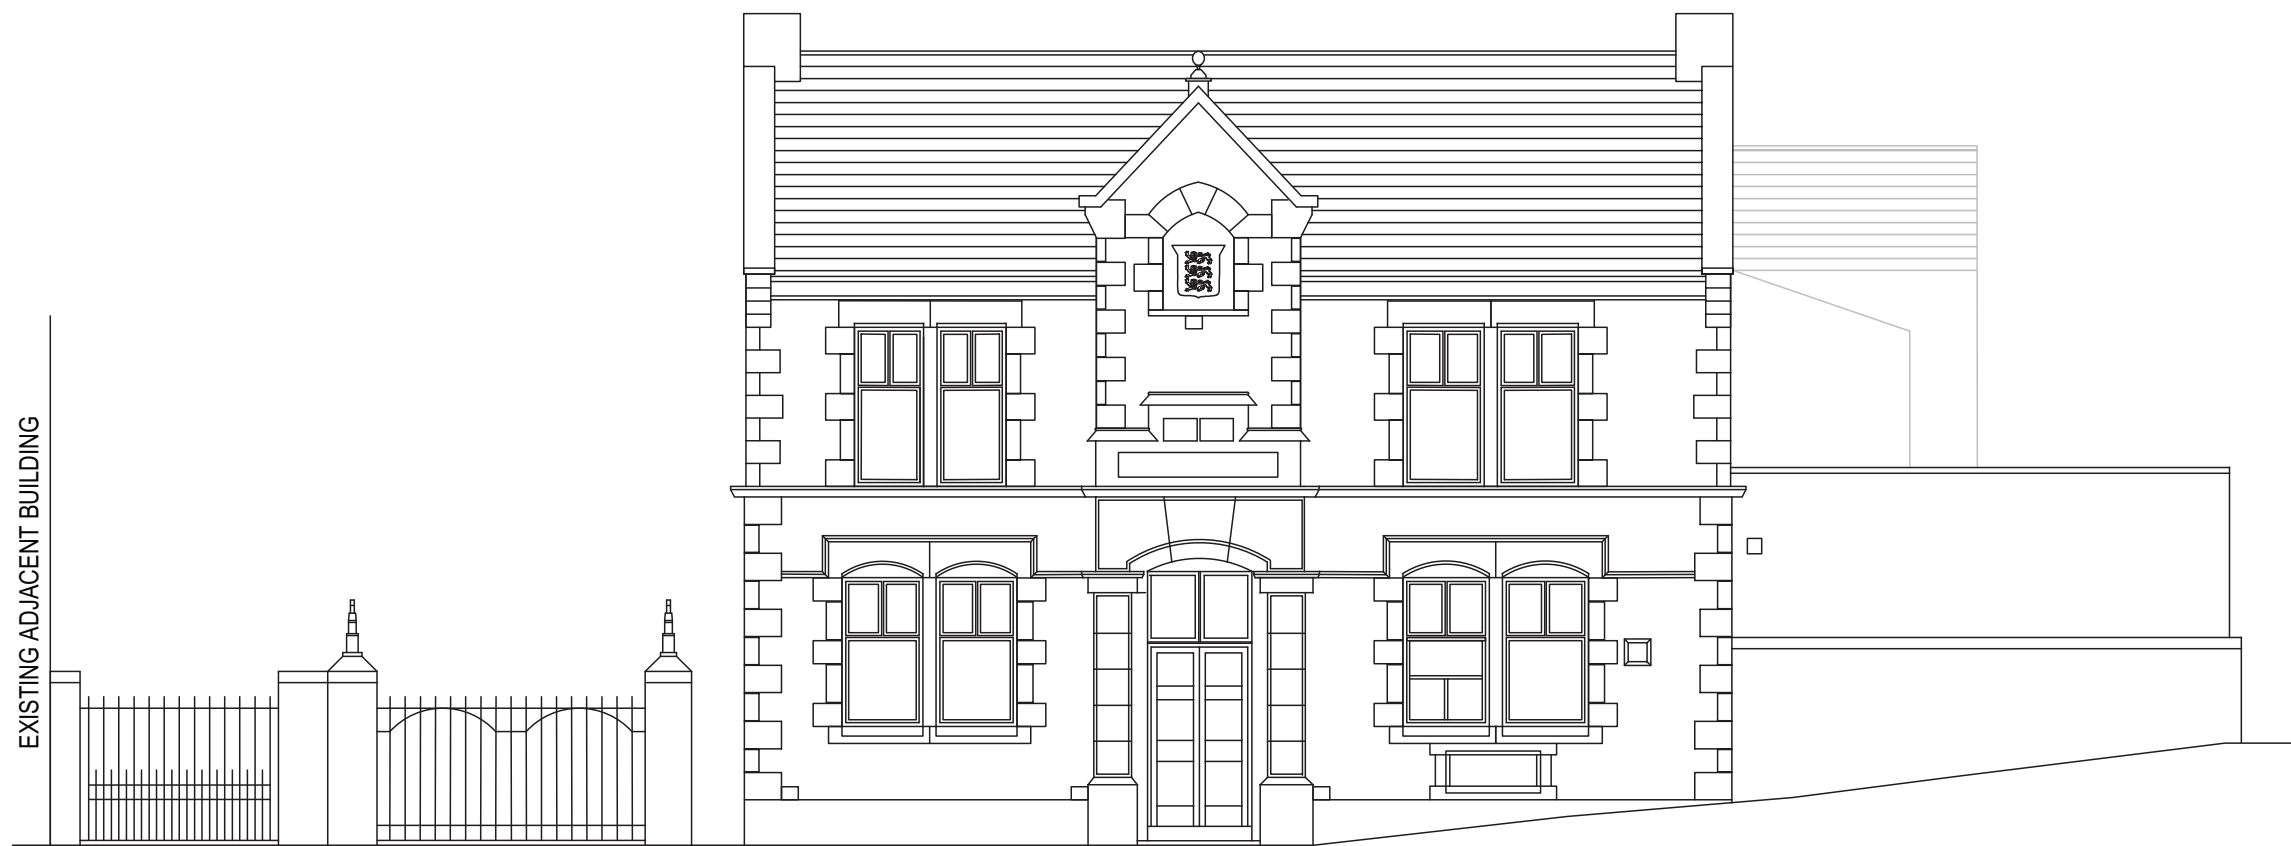
POLICE STATION - NORTH-EAST EXTERNAL ELEVATION

Key: — obscured / features to rear

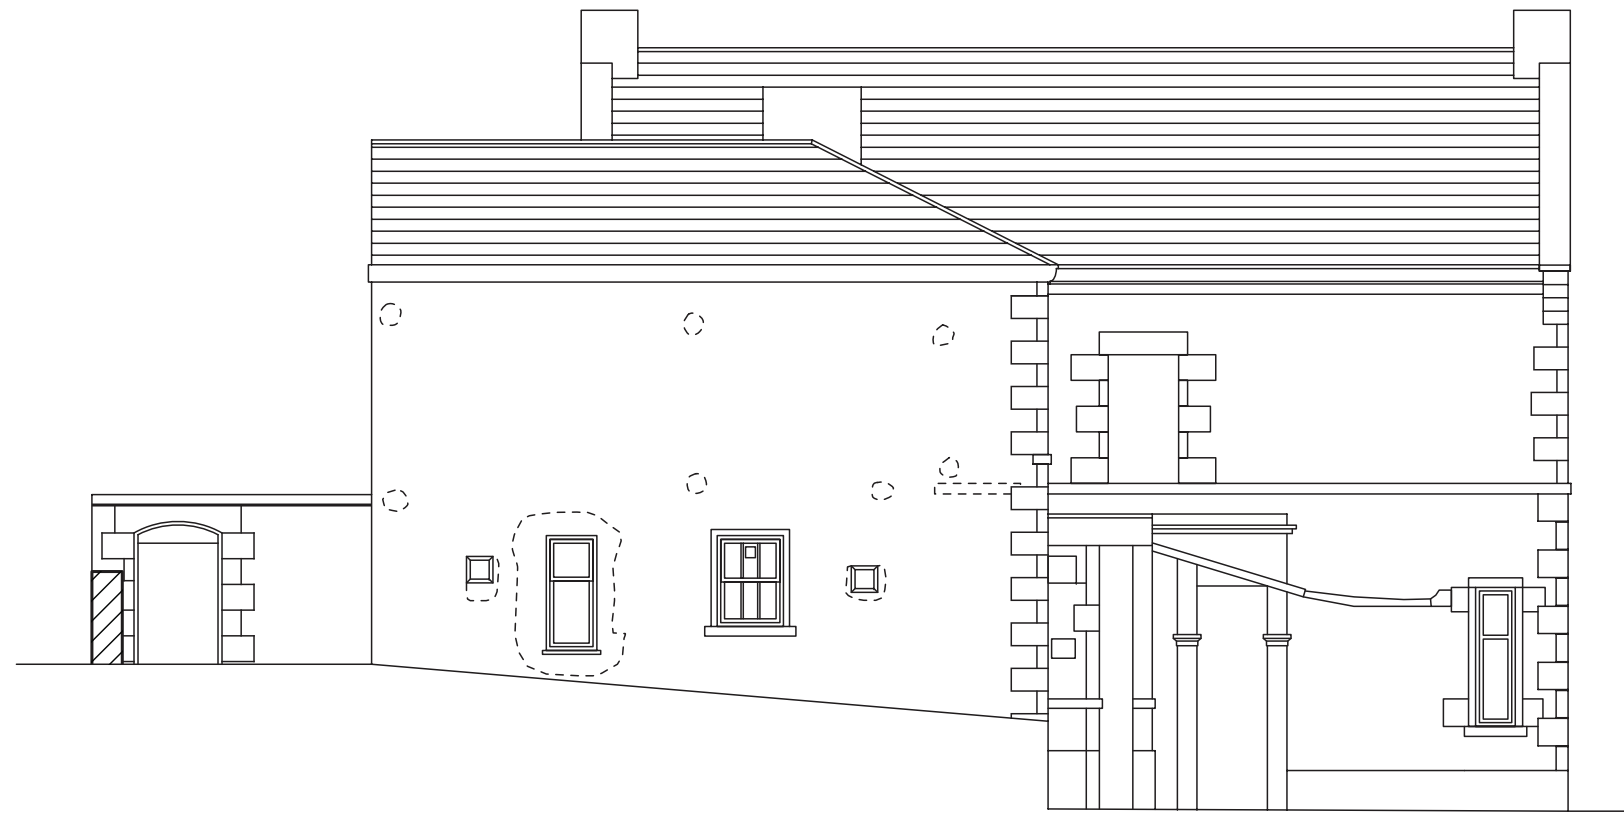
Figure 3: South-west external elevation of the Police Station

POLICE STATION - SOUTH-WEST EXTERNAL ELEVATION

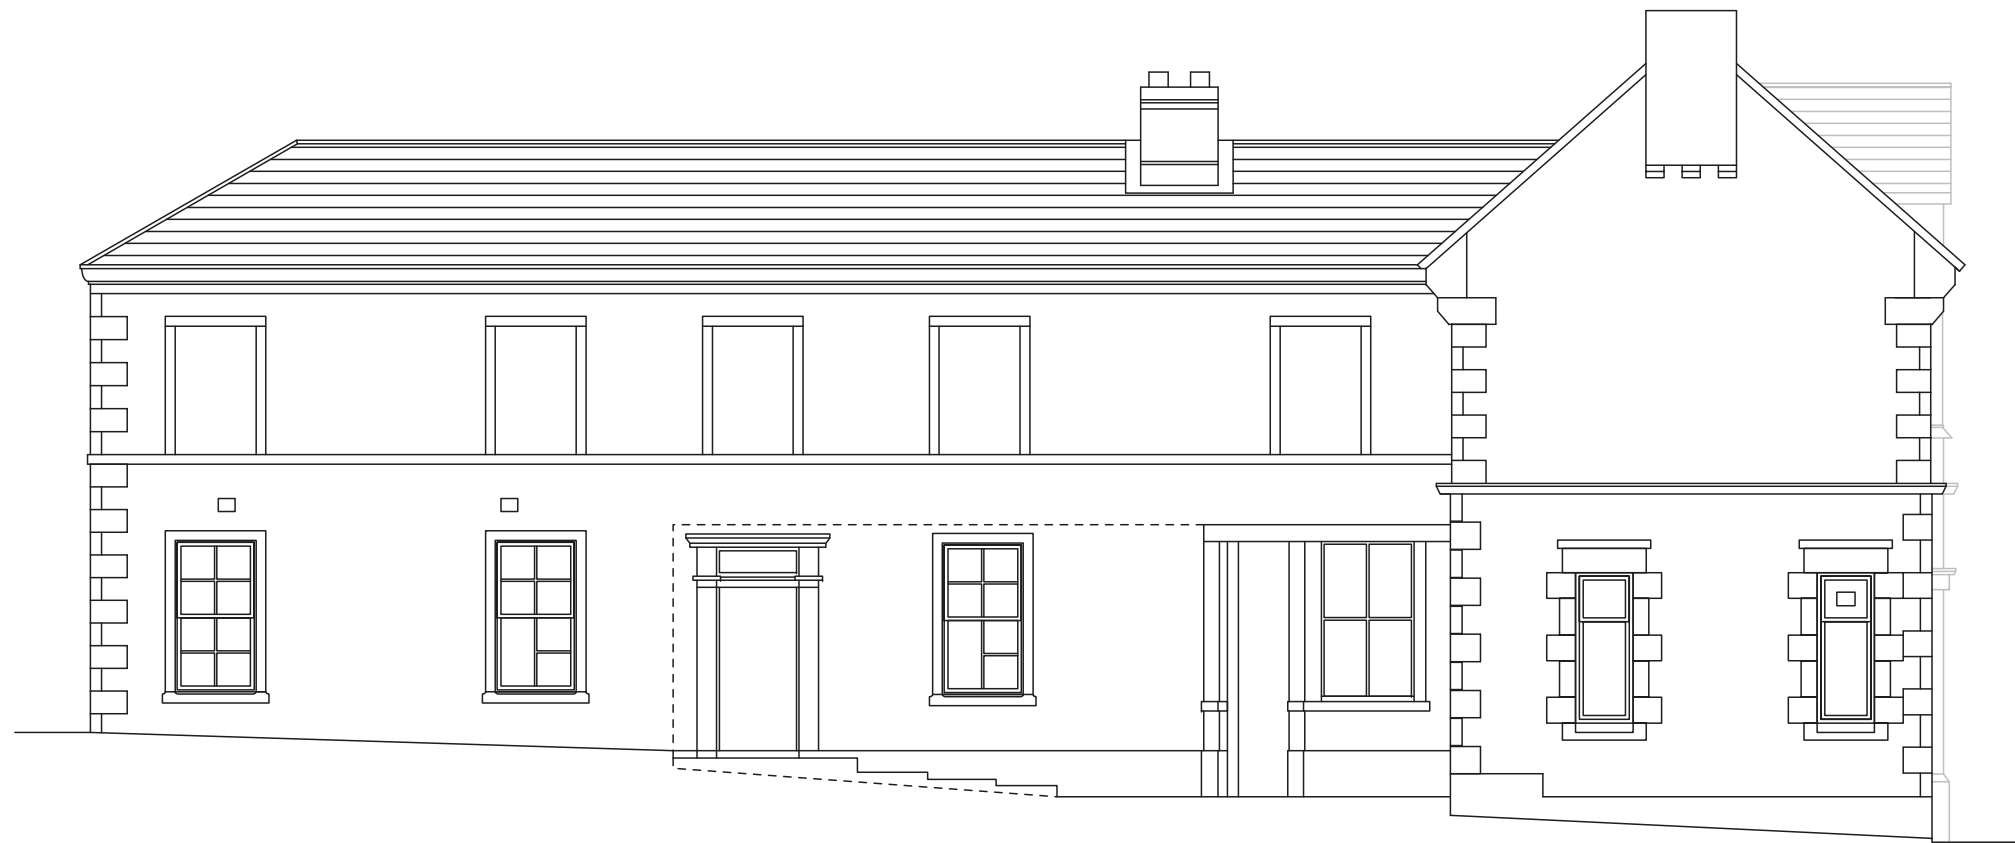
Figure 4: South-east external elevation of the Police Station

POLICE STATION - SOUTH-EAST EXTERNAL ELEVATION
