FORMER POLICE STATION, ULVERSTON, CUMBRIA

Archaeological Building Recording

Planning	
Pre-planning?	No
Planning Application No.	SL/2020/0885
Proposal	Partial demolition of elements of former police station and courthouse, remainder retained to form part of new dwellings
Condition number	None – at request of Conservation Officer
Level of recording	Historic England Level 2
Local Planning Authority	South Lakeland District Council
Conservation Officer	Libby Mee
Planning Archaeologist	Jeremy Parsons, Cumbria Historic Environment Service
Previous phase of work carried out?	Yes – heritage assessment

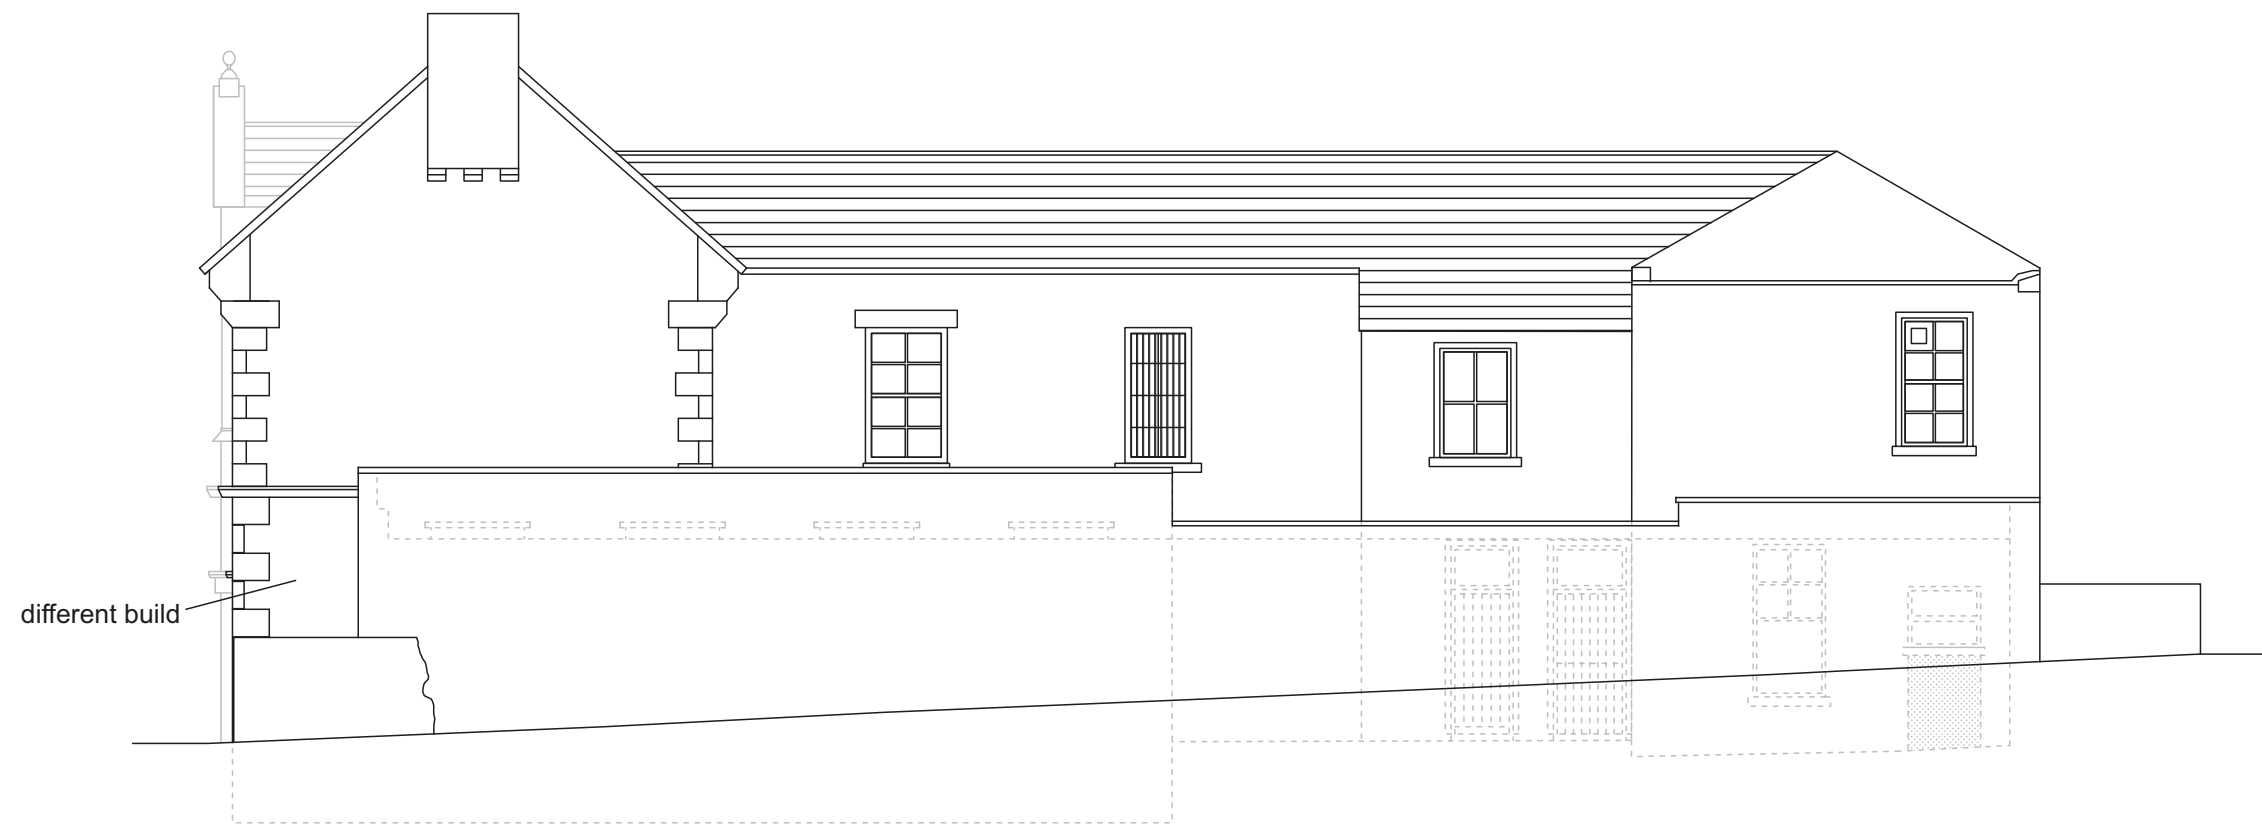
Figure 5: North-west external elevation of the Police Station

POLICE STATION - NORTH-WEST EXTERNAL ELEVATION

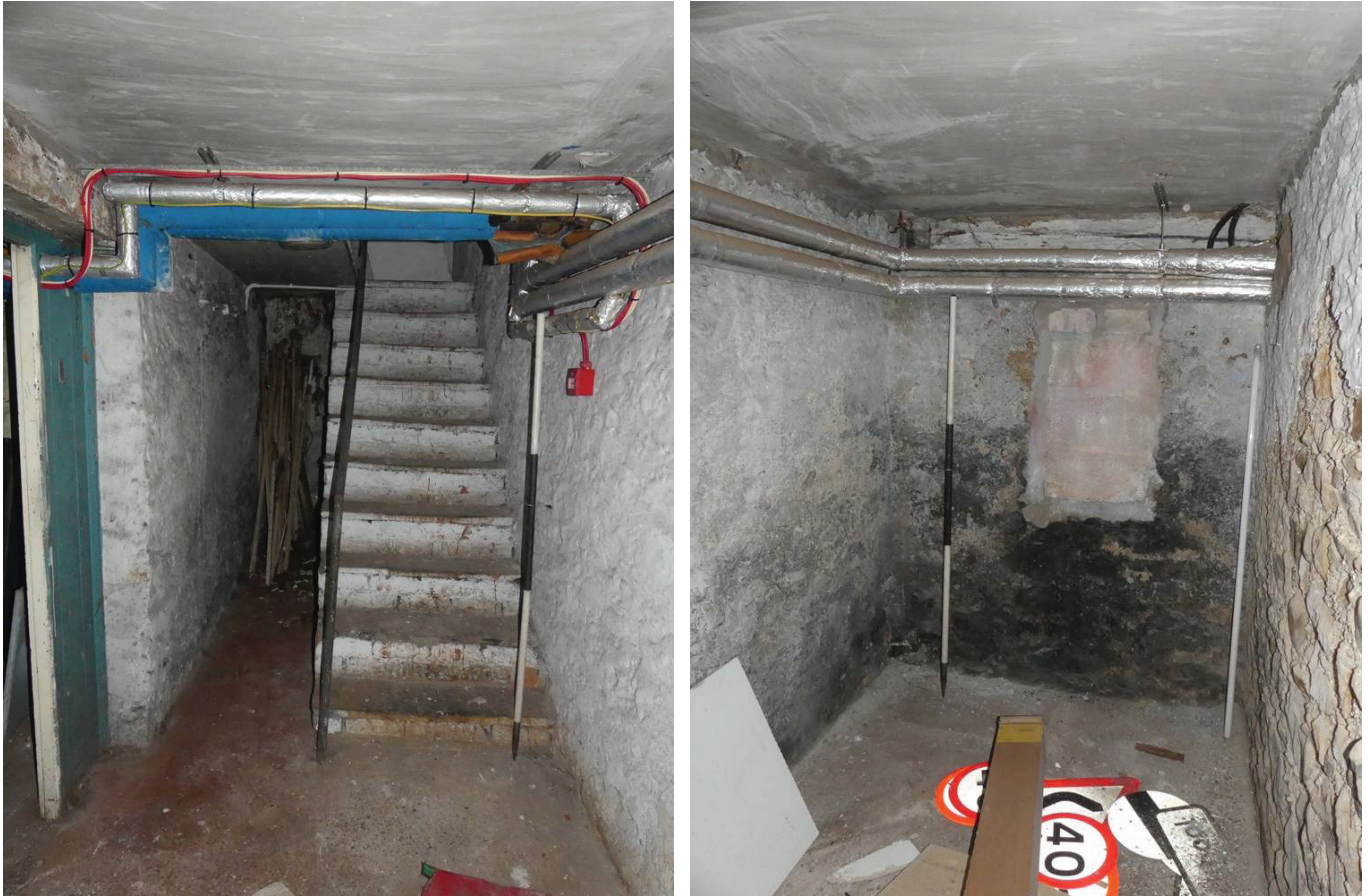
Plate 54 (left): The stairs on the north-west side of Room B1 of the police station, viewed from the south-east

4.3.1 **Basement Room 1 – police station:** this has a concrete floor and plasterboard ceiling with steps in the north corner constructed from stone flags on bricks with a plain iron handrail (Plate 54). The walls are painted masonry. There is a window in the south-east elevation that is blocked with concrete blocks (Plate 55) and a doorway in the south-west elevation with a timber lintel and beaded board wall filling the space to the north-west.

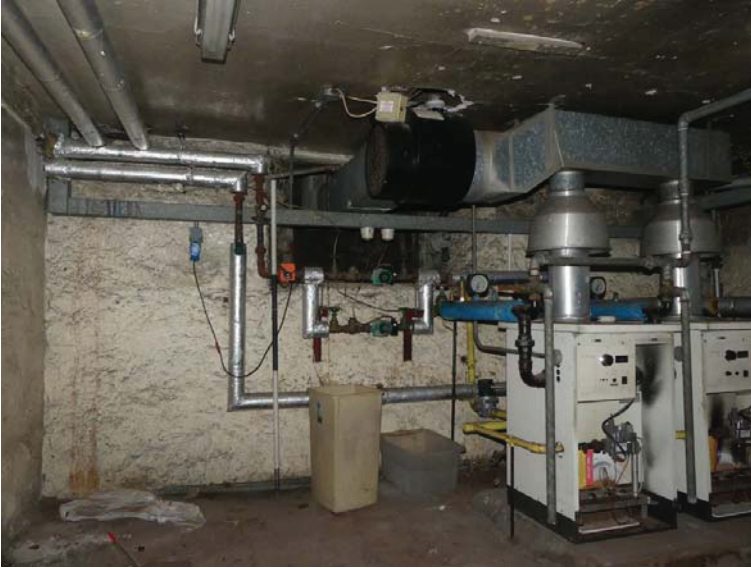
Plate 56 (left): The south-east elevation in Room B2 of the police station, viewed from the north-west

4.3.2 **Basement Room 2 – police station:** this has a concrete floor and lath and plaster ceiling; the walls are painted masonry and there are modern boilers etc filling much of the south-east half of the room. The north-west elevation is plain, the north-east has a doorway with tongue and groove timber panels filling the space to the north-west. The south-east elevation has a wide window with splayed jambs, mostly blocked in and housing vents from the boilers (Plate 56). The south-west elevation has a central chimney breast with alcoves to either side and a central metal vent with a cover marked 'DRAUGHT STABLIZER', 'IVO', and 'IVO ENGINEERING & CONSTRUCTION CO LTD LONDON W12' (Plate 57).

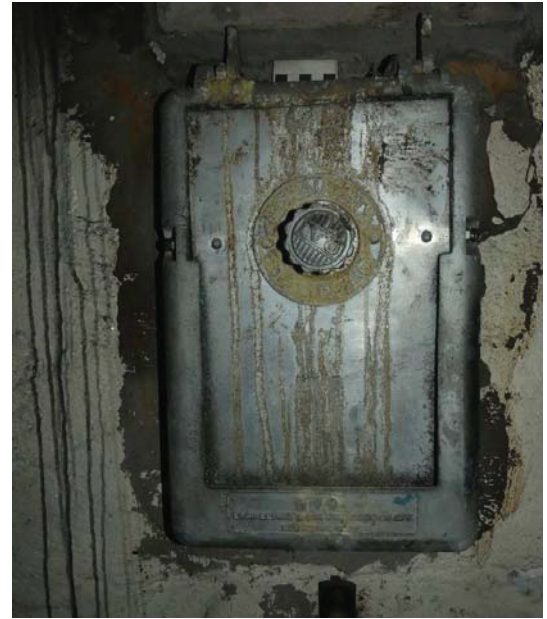
Plate 57 (right): The vent in the south-west elevation in Room B2 of the police station, viewed from the north-east

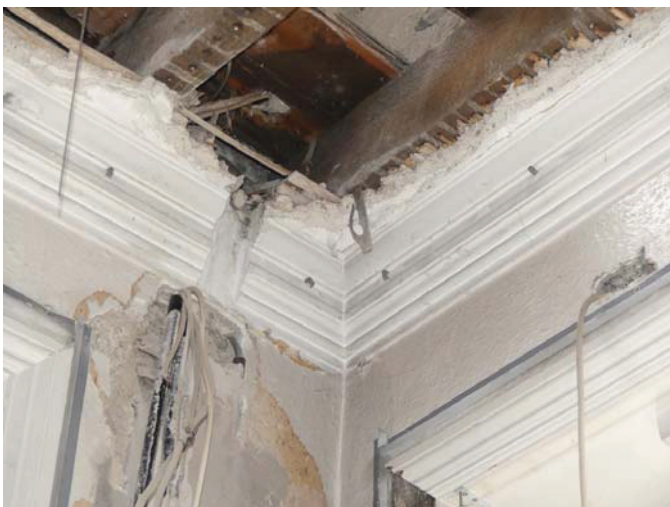
Plate 58 (left): The cornice in Room G1 of the police station, viewed from the west

4.3.3 Ground floor Room 1 – police station: the floor has been removed leaving a layer of rubble and the lath and plaster ceiling has been removed exposing the joists and few remaining floorboards of the room above, all of which are machine sawn. The lower parts of the walls have been stripped of their plaster exposing the stone rubble build, although it is brick on the north-west side. It is otherwise the original plaster, finished with flock wallpaper and there are the remains of a moulded cornice (Plate 58), except in the south corner where it has been removed due to some remodelling. There are two doorways in the north-west elevation, the south-west side of which is of concrete block construction (Plate 59). The north-east elevation has a wide window with square jambs extending to the floor, moulded panelling below, and a moulded surround (Plate 60). The south-east elevation has a pair of tall windows, in the same style, with moulded panelling below and the remains of a moulded surround, either side of a chimney breast, the fireplace of which is blocked with brick, and which has a brick arch (Plate 61). The south-west elevation has a narrow window on the south-east side with some tongue and groove planks in the jambs and square jambs extending to the floor. There is a doorway to the north-west extending to the ceiling with dressed stone jambs.

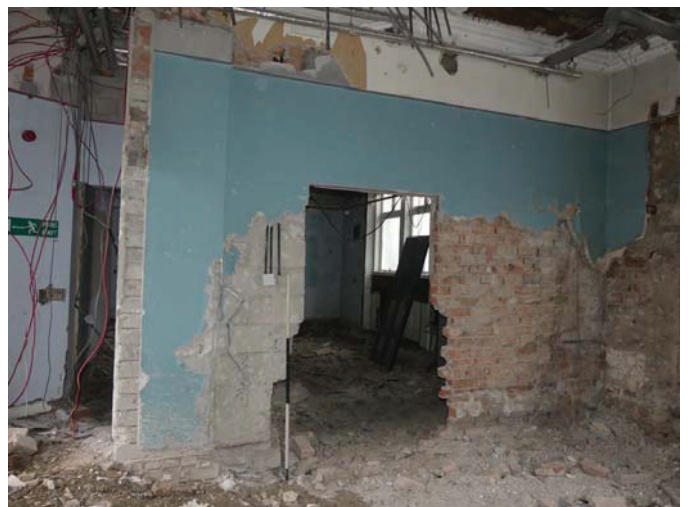
Plate 59 (right): The north-west elevation of Room G1 of the police station, viewed from the south-east

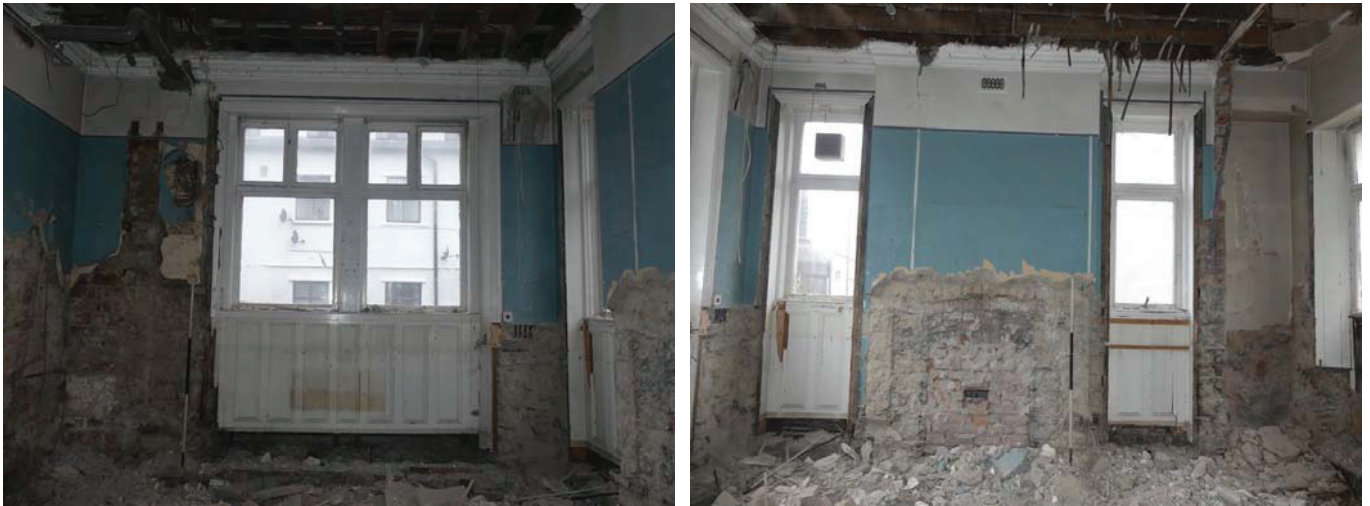
Plate 60 (left): The north-east elevation of Room G1 of the police station, viewed from the south-west

Plate 61 (right): The south-east elevation of the police station, viewed from the north-west

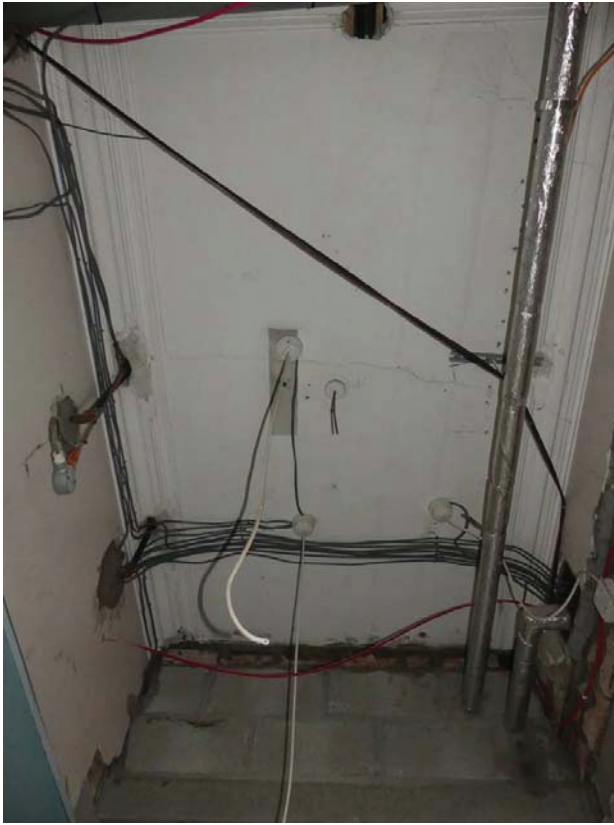
Plate 62 (left): The ceiling in Room G3 of the police station, viewed from the north-east

4.3.5 **Ground floor Room 3 – police station:** this comprises a short corridor connecting to the front door to the north-east. The floor has been removed to rubble and a suspended ceiling has been removed revealing the original plaster ceiling above which has a moulded cornice (Plate 58). The walls are brick but partly rebuilt in concrete block. There are wide openings to the north-west and south-east and an inner doorway at the north-east end with a moulded surround and two-light overlight. Inside the resulting porch is a moulded dado rail on the north-west and south-east elevations. The main external door to the north-east has a double door, with three plain panels in each and two lights over (Plate 59).

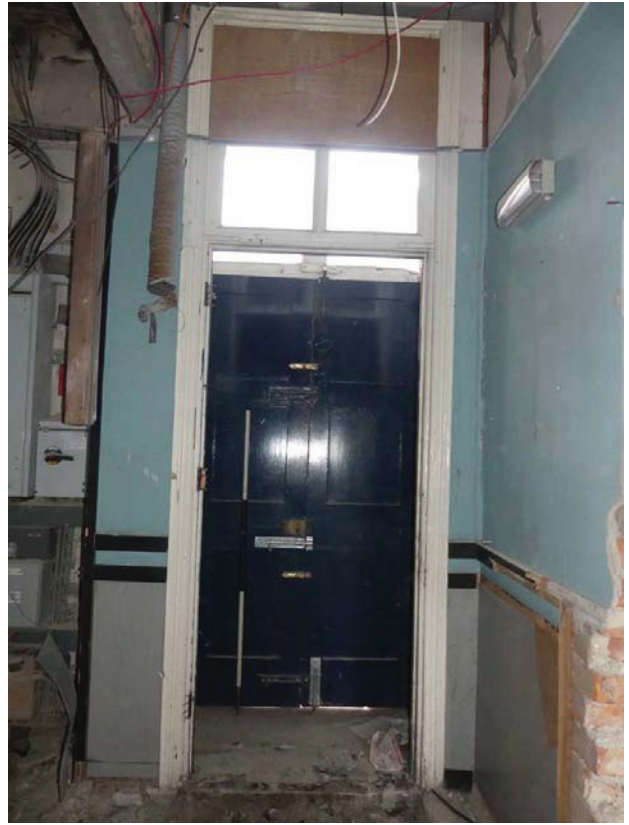
Plate 63 (right): The door at the north-east end of Room G3 of the police station, viewed from the south-west

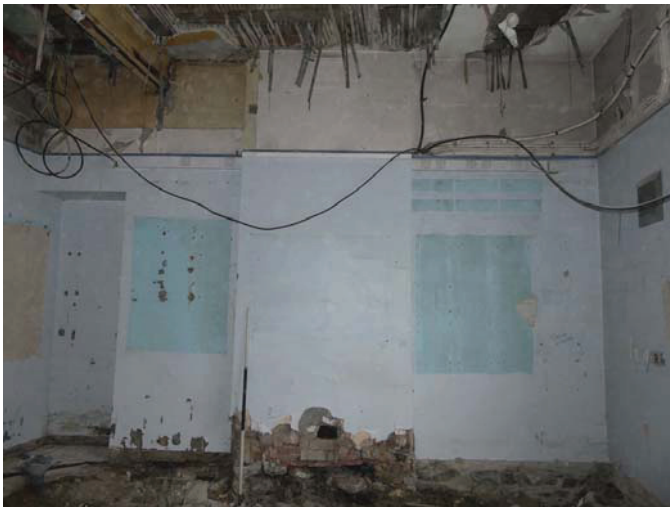
Plate 64 (left): The north-west elevation in Room G4 of the police station, viewed from the south-east

4.3.6 **Ground floor Room 4 – police station:** this has a rubble floor and the lath and plaster ceiling has been removed exposing the joists and some remaining floorboards of the room above, all of which are machine cut. There is a single beam on the south-west side of the room, orientated north-west/south-east and a shallow cornice remains throughout. The walls are finished with plaster and paint. The north-west elevation has an alcove on the south-west side and a projecting chimney breast in the centre, the fireplace blocked with brick. The north-east elevation has a wide double window with shallow jambs, a moulded surround and panelling below. The south-east and south-west elevations are fairly plain with a wide opening in the south-west and a step in the south-east where Room G3 extends.

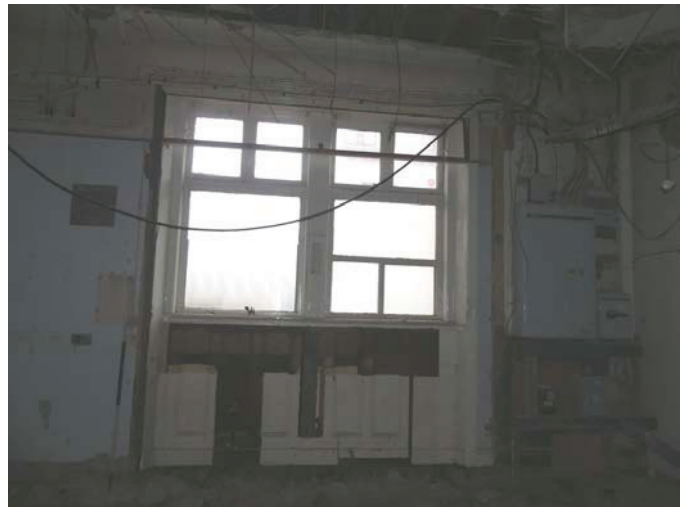
Plate 65 (right): The north-east elevation in Room G4 of the police station, viewed from the south-west

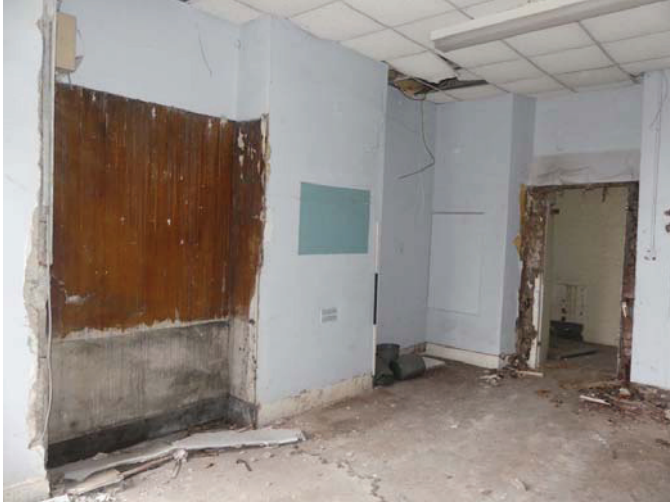
Plate 66 (left): General view of Room G5 of the police station, from the east

4.3.7 Ground floor Room 5 – police station: this has a vinyl floor and suspended polystyrene ceiling with a relatively modern plaster ceiling above. The walls are finished with modern plaster and paint. There is a doorway to the north-west in a tall recess, slightly splayed on the south-west side (Plate 66). The north-east elevation is plain. The south-east elevation is angled on the north-east side and has a window with a moulded surround (Plate 67), timber sill and four-light sash casement. There is a doorway to the south-west. The south-west elevation has two tall alcoves either side of a chimney breast with a vent in the flue (Plate 66).

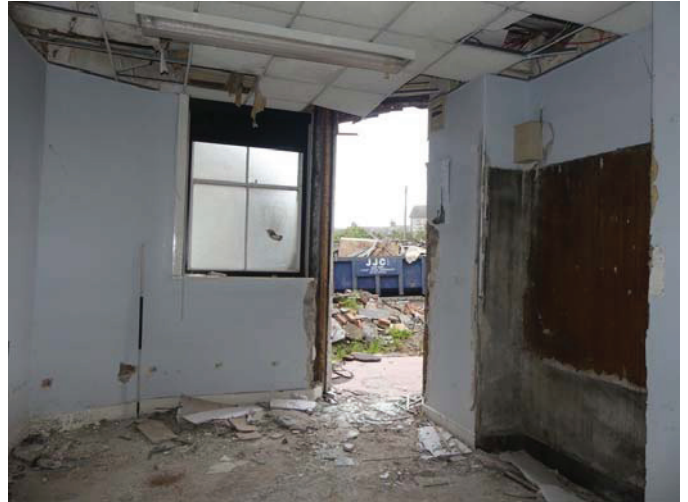
Plate 67 (right): General view of Room G5 of the police station, from the north-west

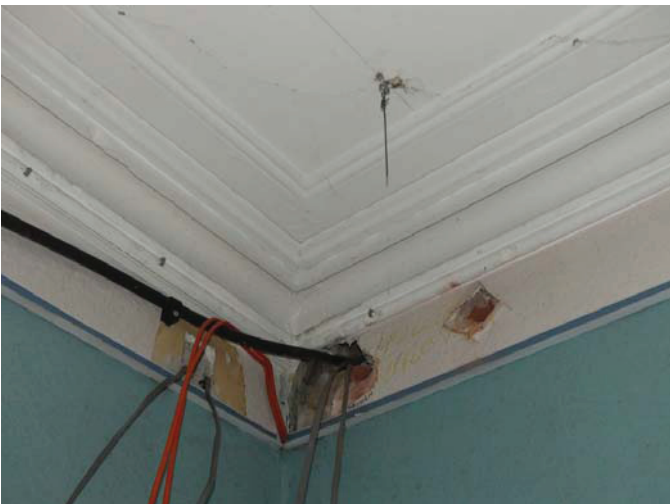
Plate 68 (left): The cornice in Room G6 of the police station, viewed from the east

4.3.8 Ground floor Room 6 – police station: this has a tongue and groove floor covered modern timber sheeting. It has an original plaster ceiling with a deep cavetto cornice (Plate 68). The walls are the original plaster finished with flock wallpaper; a tall skirting board has been removed. The north-west elevation is plain, the north-east elevation has a pair of alcoves either side of a chimney breast, which has a vent inserted into it (Plate 69). The south-east elevation has a single window with splayed jambs and panelling removed apart from over the lintel and a four-light sash casement (Plate 70). The south-west elevation has a doorway on the south-east side.

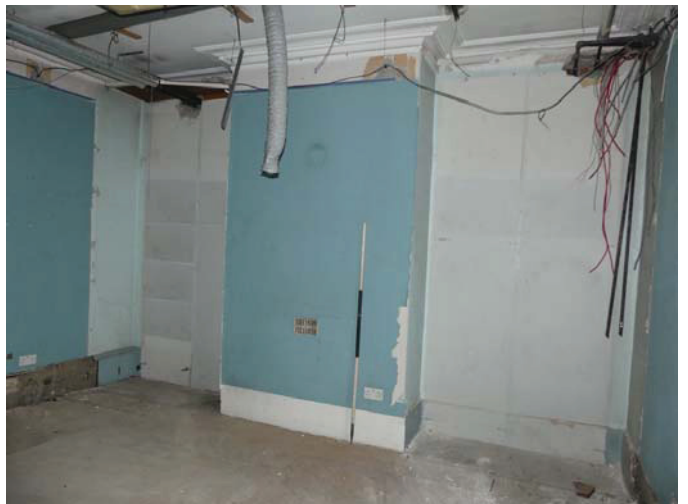
Plate 69 (right): General view of Room G6 of the police station, from the east

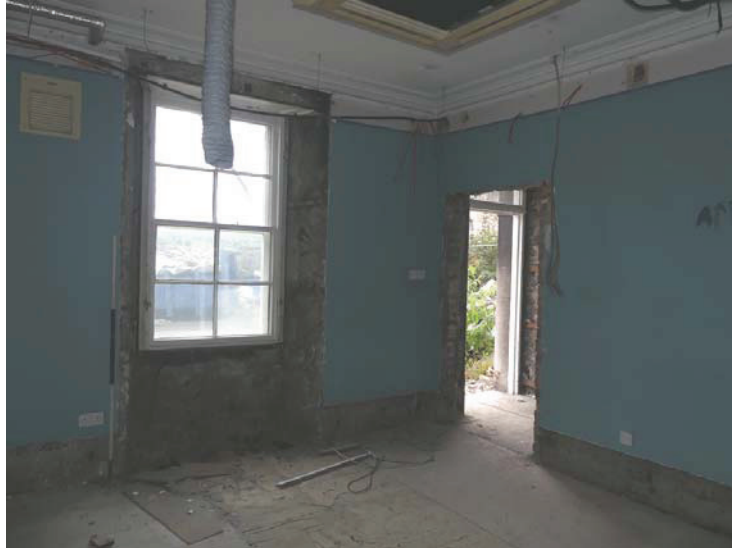
Plate 70: General view of Room G6 of the police station, from the north

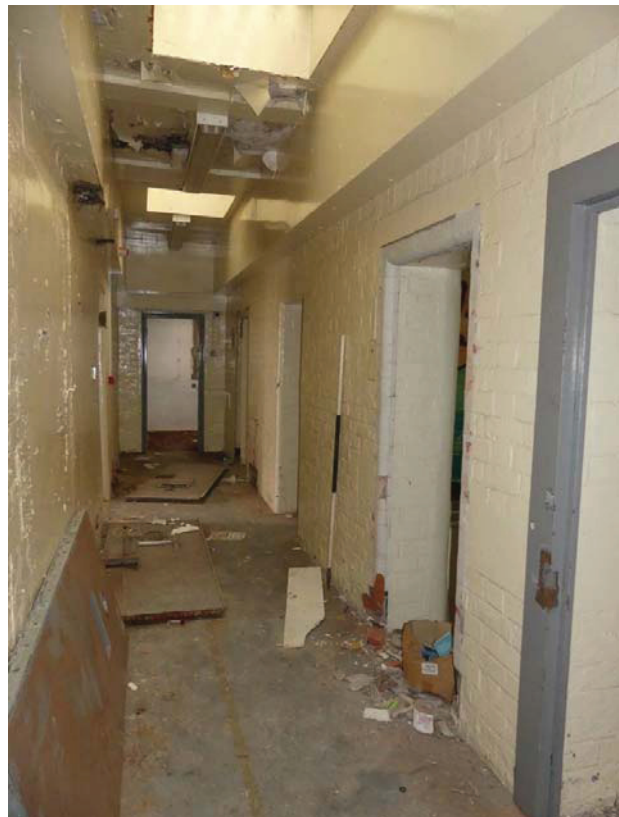
Plate 71 (left): Skylight in Room G7 of the police station, viewed from the south-west
Plate 72 (right): General view of Room G7 of the police station, viewed from the north-east

4.3.9 **Ground floor Room 7 – police station:** this comprises a corridor linking a row of cells along the north-west side to the main building to the south-east. It has a painted concrete floor and concrete roof with two skylights each with 45 block lights (the south-west is partly obscured by later boxing) (Plate 71). There is also boxing along the north-west side. The walls are finished with modern paint over plaster or directly onto the brick. There is a row of four doorways on the north-west side all with bullnosed brick surrounds and heavy metal cell doors with port hole windows and serving hatches, which are now lying on the floor (Plate 72). There is also a doorway in the south-east elevation, again with bullnosed jambs and there is a blocked doorway to the north-east of this with a stone lintel. There is a doorway in the south-west elevation with a modern timber surround.

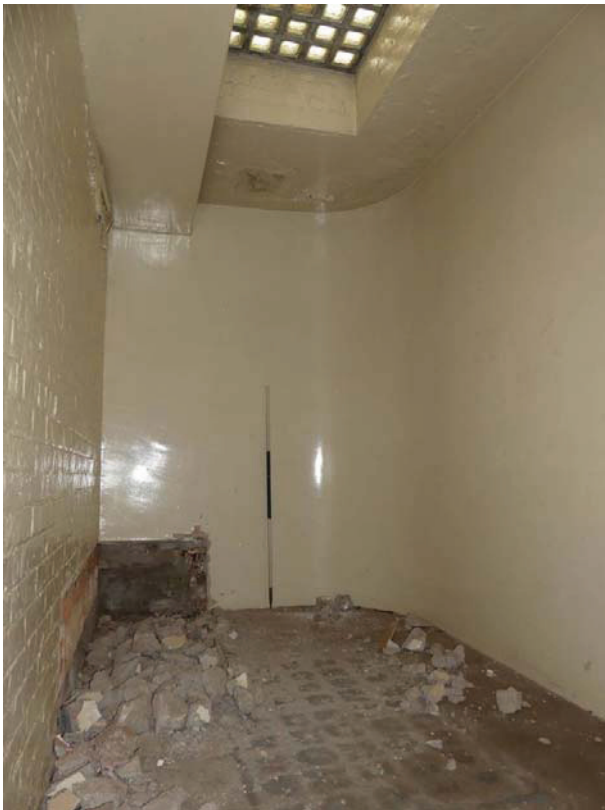
Plate 73 (left): General view of Room G8 in the police station, from the south

4.3.10 **Ground floor Room 8-11 – police station:** these comprise the four essentially identical former police cells arranged along the north-west side of Room G7. Each has a painted concrete or asphalt floor and a concrete roof with a single skylight comprising 45 block lights. The walls are painted brick and there is or was a bed on the south-west side constructed from concrete blocks with a timber top. The south-east elevation has a single doorway with bullnosed brick jambs. Room G8 has a curved north-west wall (Plate 73). Room G9 has substantial graffiti panels on all walls tagged 'MAK ONE', 'REFUSE & RESIST', 'HARM', 'GRUMPY', 'RIOT', 'LASM', 'WEB' and 'FAS' (Plate 74). Room G10 has the remains of a stud wall partitioning off part of the north-west end of the room and metal boxing along the north-east elevation (Plate 74). There is also some more graffiti in this room but no bed. Room G11 has a small square alcove with splayed jambs over the doorway to the south-west (Plate 76).

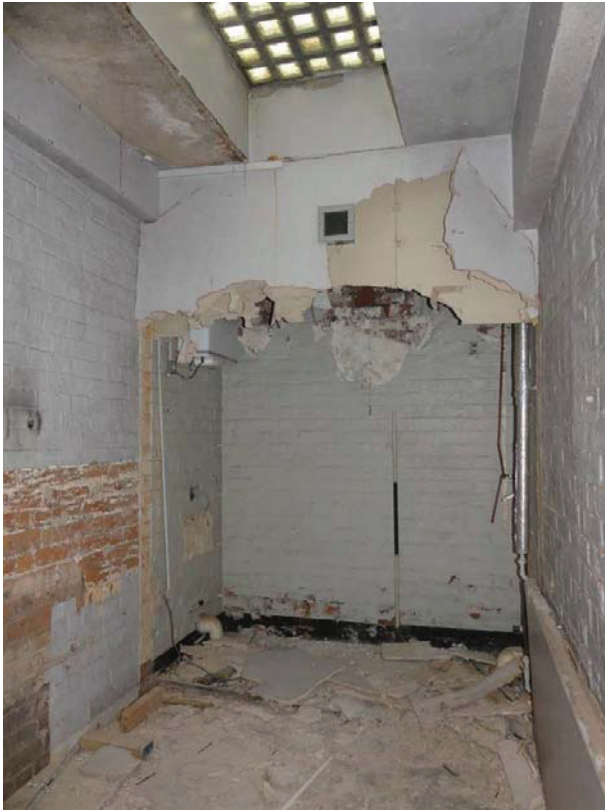
Plate 75 (left): The partition wall in Room G10 of the police station, viewed from the south-east

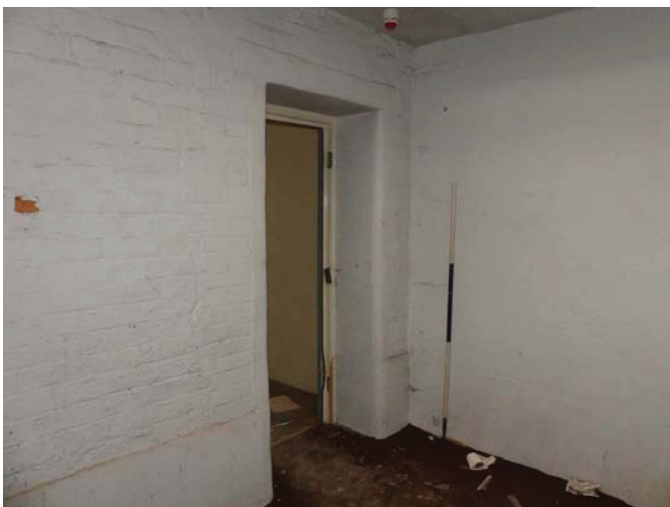
Plate 77 (left): General view of Room G12 of the police station, from the west

4.3.11 **Ground floor Room 12 – police station:** this has a carpeted floor over concrete and a concrete ceiling with a skylight of 25 block lights. The walls are painted plaster and brick and plain, except for a doorway to the north-east (Plate 77).

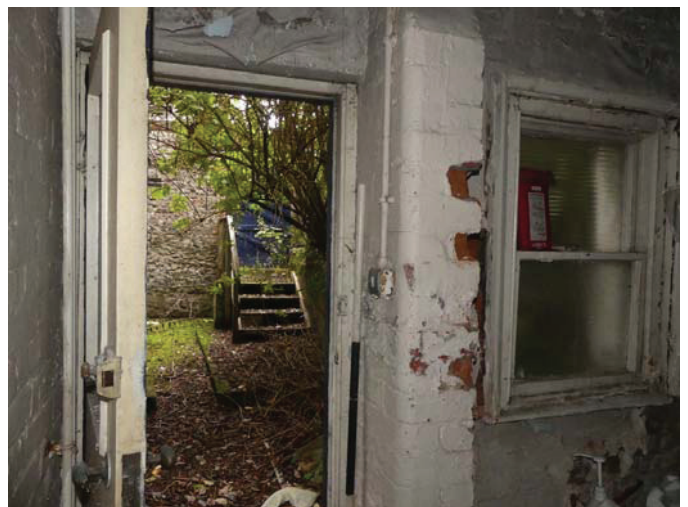
Plate 78 (right): The south-west elevation of Room G13 of the police station, viewed from the north-east

4.3.12 **Ground floor Room 13 – police station:** this has a painted concrete floor and modern plaster ceiling. It is sub-divided by a concrete block wall with a single doorway with a plain single panel door. The walls are painted brick and all plain, apart from the south-west, which has a doorway modern door with a single light and a window with a two-light sash casement in a plain surround (Plate 78). There is a Belfast-style sink and a toilet attached to the north-west elevation.

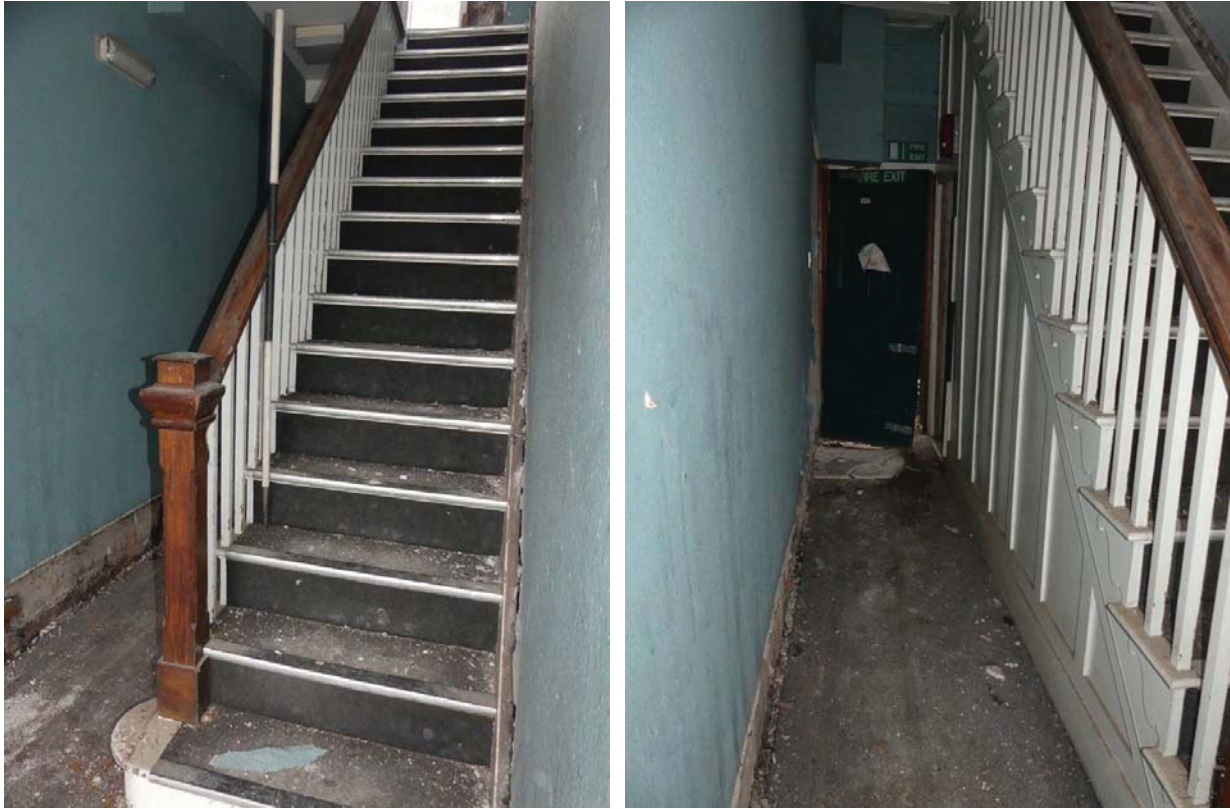
Plate 79 (left): The stairs in Room G14 of the police station, viewed from the south-east

Plate 80 (right): The panelling on the side of the stairs in Room G14 of the police station, viewed from the south

4.3.13 **Ground floor Room 14 – police station:** this comprises a hallway and the staircase connecting to the first floor. The floor is carpeted, the ceiling flat plaster and the walls finished with original plaster and flock wallpaper. The north-east and south-west walls are brick. The stairs are a simple slight with square section balusters and a wide moulded handrail with square stop-chamfered newel posts (Plate 79) and panelling over the south-west side (Plate 80). The north-east and south-west elevations both have doorways, the north-west elevation has an external doorway with a tongue and groove plank and batten door (Plate 81). There is another doorway to the south-east with the remains of a moulded surround, panelling and a single overhead (Plate 82).

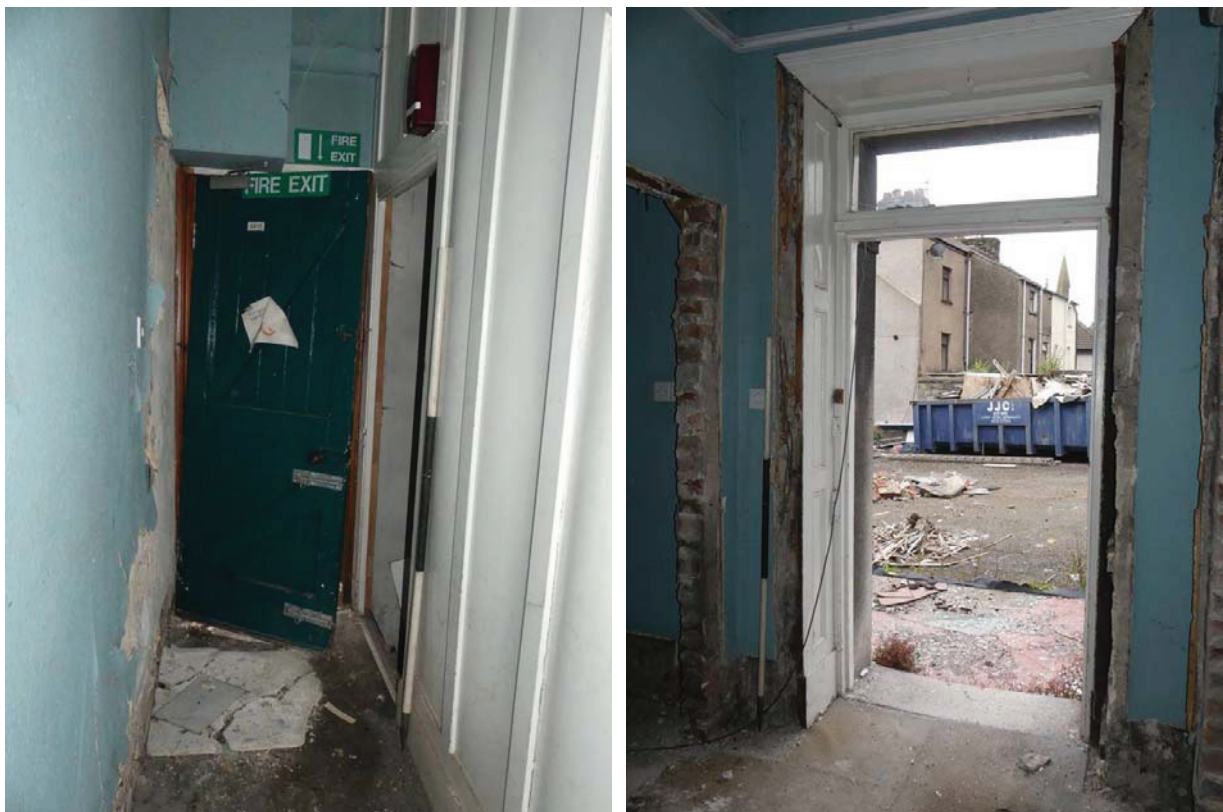
Plate 81 (left): Doorway to the north-west in Room G14 of the police station, viewed from the south-east

Plate 82 (right): Doorway to the south-east in Room G14 of the police station, viewed from the north-west

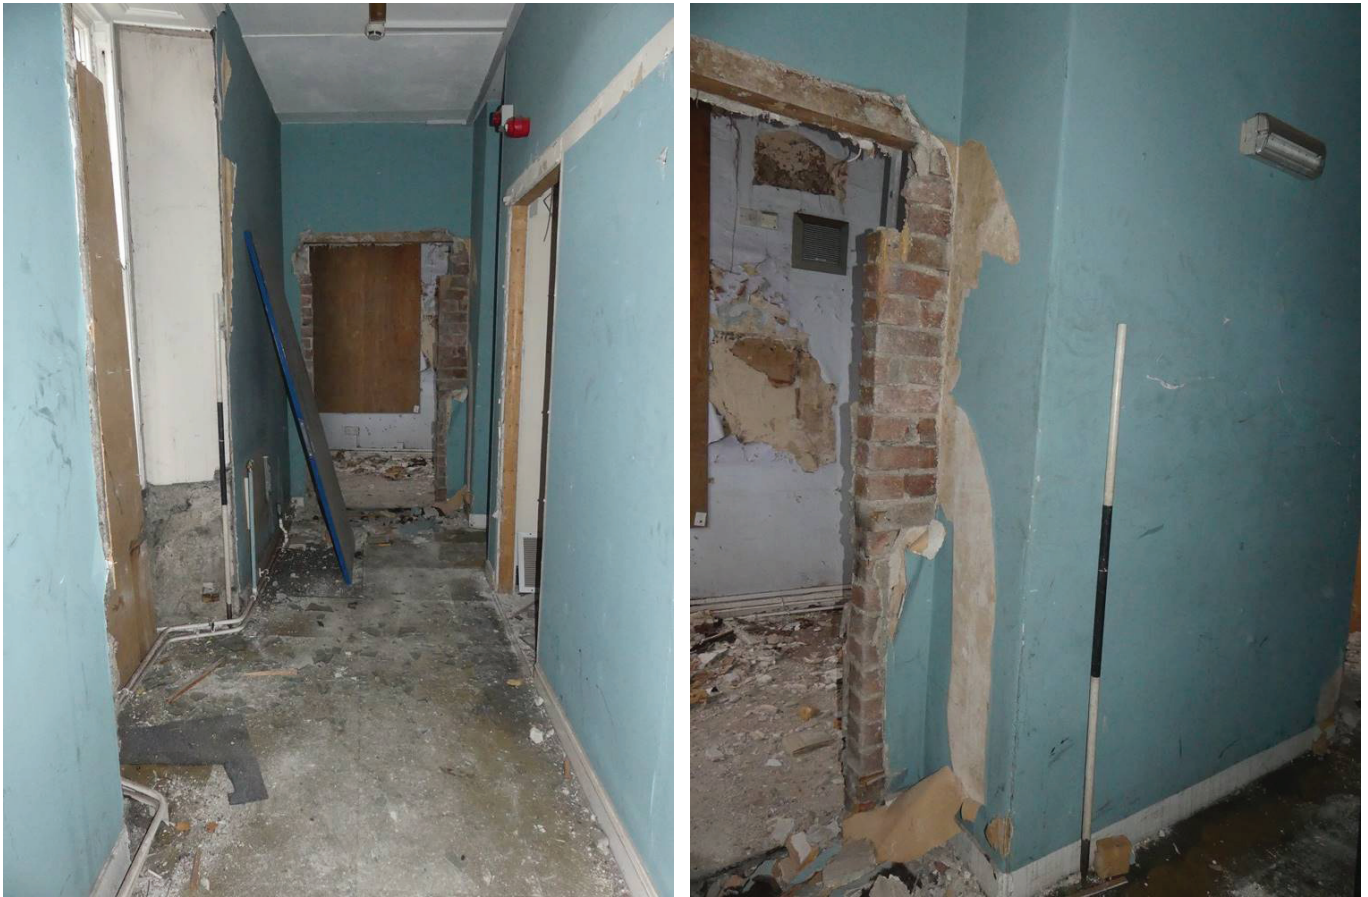
Plate 83 (left): General view of Room G15 of the police station, from the north-east

Plate 84 (right): The chimney breast on the south-west side of Room G15 of the police station, viewed from the east

4.3.14 **Ground floor Room 15 – police station:** this comprises an L-shaped corridor. The floor is finished with carpet, the ceiling is modern plaster, and the walls are finished with plaster and paint. There are doorways to the north-east, north-west and south-west and a chimney breast on the south-west side of the north-west return. There is a window to the south-east with splayed jambs extending to the floor, panelling in the top, the remains of a moulded surround and a four-light sash casement.

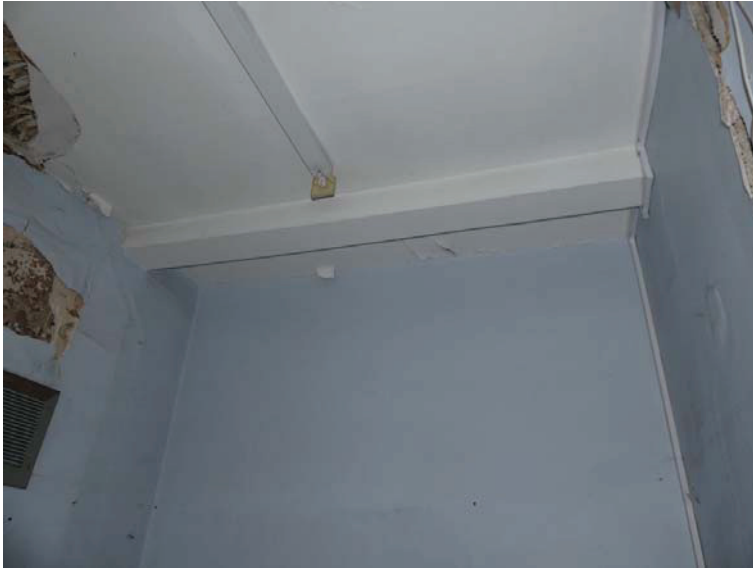
Plate 85 (left): The beam on the north-west side of Room G17 of the police station, viewed from the south-east

4.3.16 **Ground floor Room 17 – police station:** this has a vinyl floor and lath and plaster ceiling with a single plastered beam north-east/south-west on the north-west side (Plate 85). The walls are finished with plaster and all plain, although the north-east is brick and has a single doorway and the south-east has a window with splayed jambs, a timber moulding and an eight-light sash casement (Plate 86).

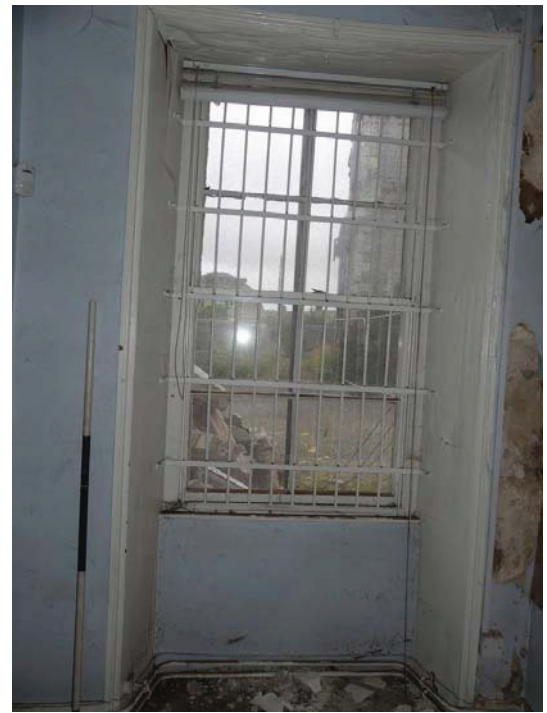
Plate 86 (right): The window in the south-east elevation of Room G17 of the police station, viewed from the north-west

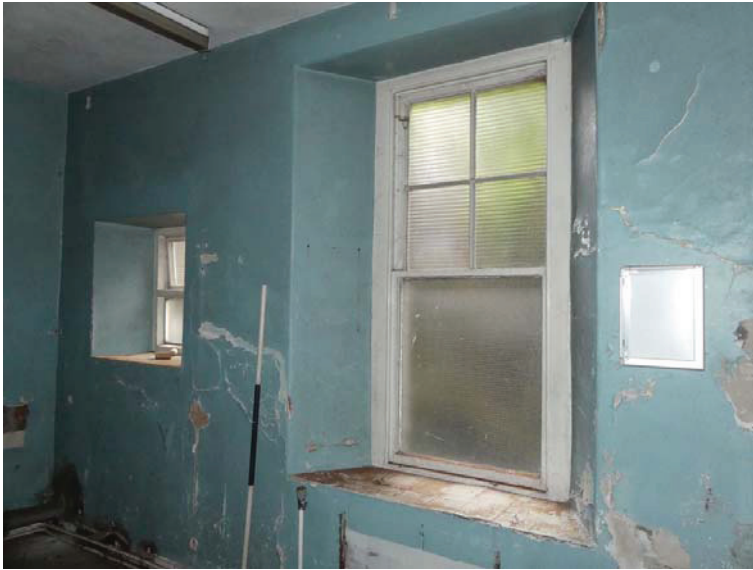
Plate 87 (left): Windows in the north-west elevation of Room G19 of the police station, viewed from the east

4.3.18 **Ground floor Room 19 – police station:** this also has a vinyl floor, flat plaster ceiling and plaster and paint finish to the walls. It is subdivided by a thin wall (Plate 88) and there is a plain skirting throughout. There are a pair of windows to the north-west, the south-west of which is small and has square jambs, the north-east is larger and has splayed jambs and a tiled sill (Plate 87). There is another window in the south-west elevation with square jambs (Plate 88) and a doorway to the south-east.

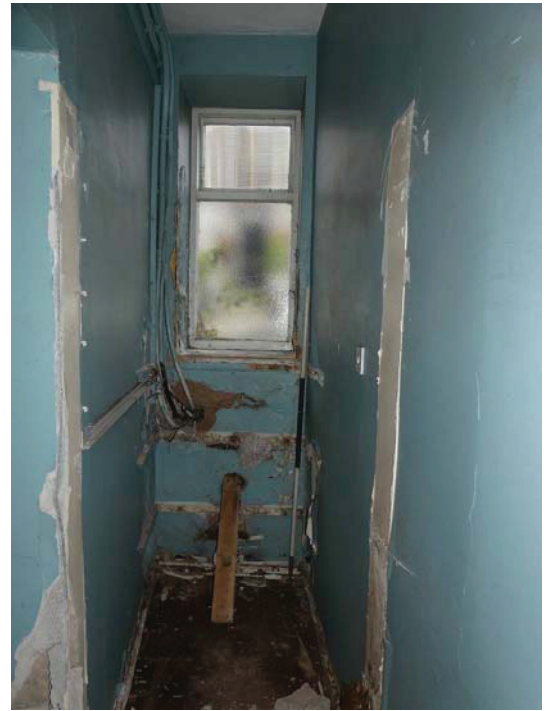
Plate 88 (right): The dividing wall and window to the south-west in Room G19 of the police station, viewed from the north-east

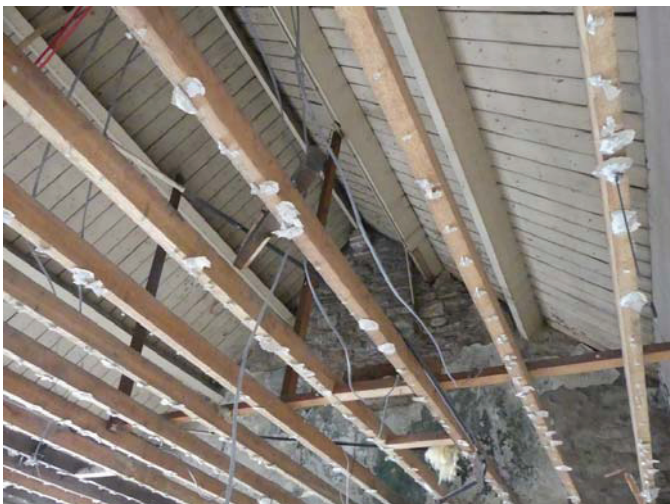
Plate 89 (left): The roof space in Room F1 of the police station, viewed from the north-west

4.3.19 **First floor Room 1 – police station:** this has a tongue and groove board floor, mostly removed, and a lath and plaster ceiling, also mostly removed, revealing the machine sawn joists above and roof space. This is boarded out with tongue and groove boards over the rafters and two plain purlins per pitch plus the ridge plank (Plate 89). The walls are all stripped of plaster and of stone rubble construction, except the north-west, which is brick. This has a doorway on the south-west side (Plate 90). The north-east elevation has a two-part window each part of three lights, with splayed jambs extending to the floor and a timber lintel (Plate 91). The south-east elevation has a narrow, blocked aperture, presumably a flue for a stove, blocked with brick (Plate 92). There is also brick and reused dressed stone in the wall above this. The south-west elevation is plain.

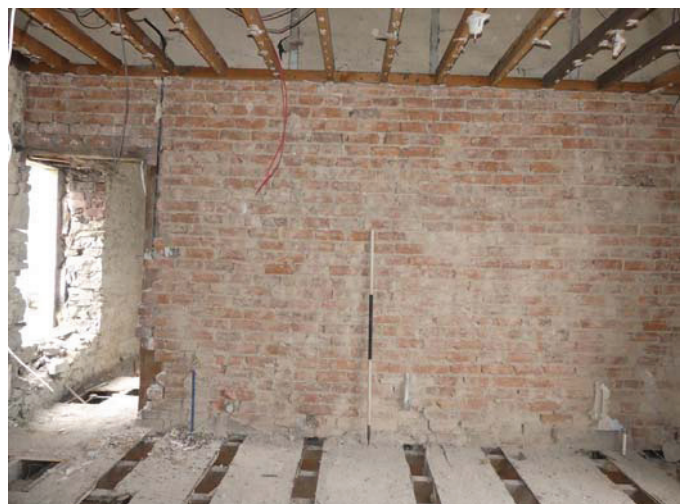
Plate 90 (right): The north-west elevation of Room F1 of the police station, viewed from the south-east

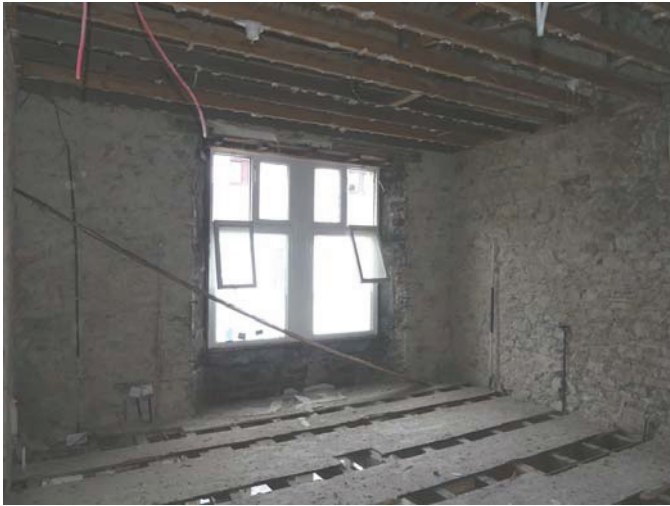
Plate 91 (left): The north-east elevation of Room F1 of the police station, viewed from the west

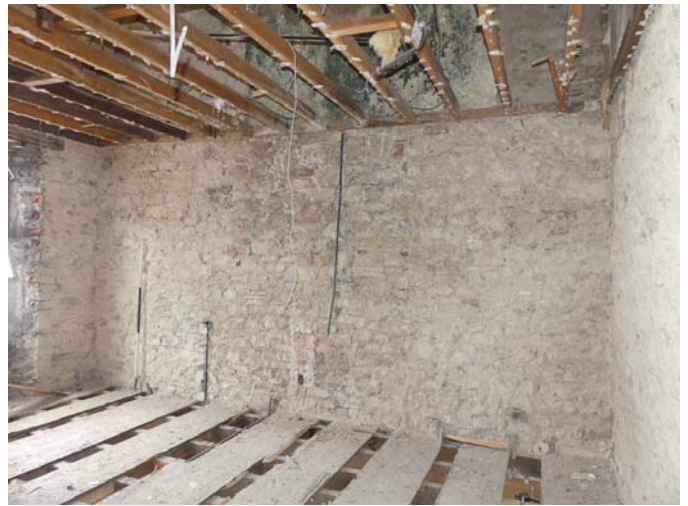
Plate 92 (right): The south-east elevation of Room F1 of the police station, viewed from the north-west

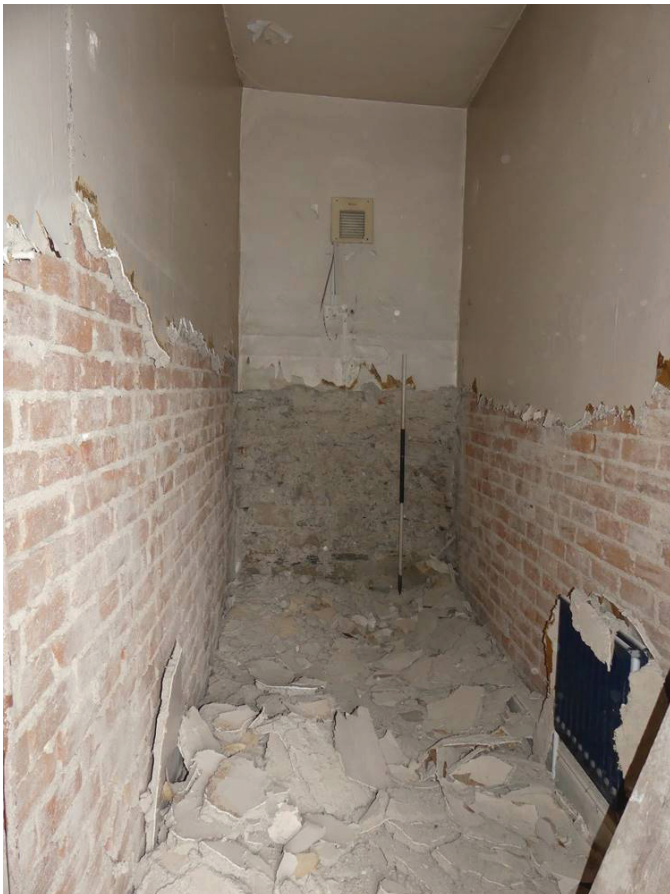
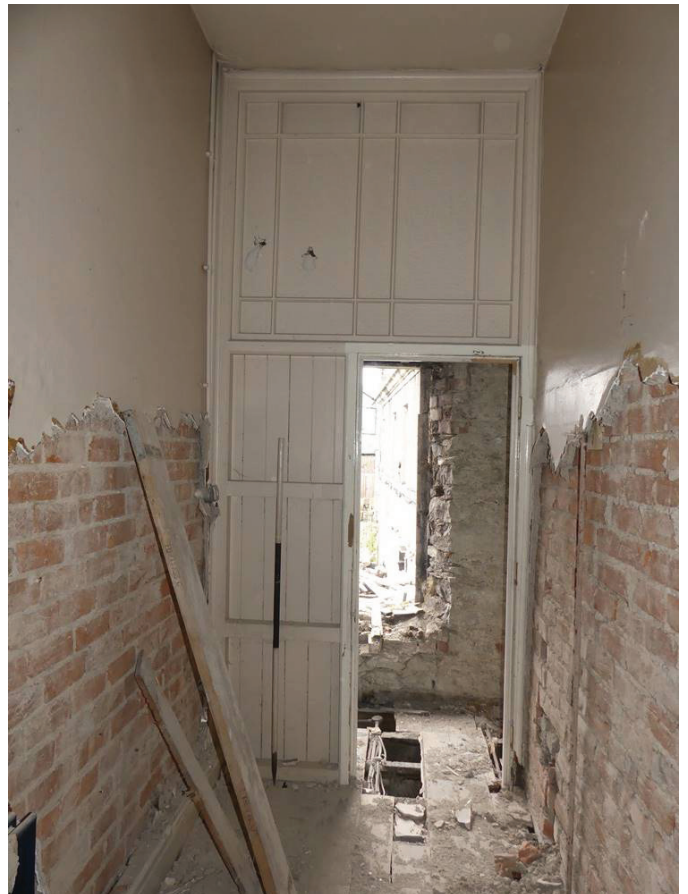
Plate 93 (left): General view of Room F2 of the police station, from the south-west

4.3.20 **First floor Room 2 – police station:** this has a board floor and a plain plaster ceiling and walls, all of which are essentially plain (Plate 93). The north-west and south-east are brick, laid in stretcher bond, and the south-west is an early timber stud partition finished with tongue and groove planks. There is a doorway to the south-west with a plain surround above which is a large, glazed section with etched glass that has been painted over (Plate 94).
