FORMER POLICE STATION, ULVERSTON, CUMBRIA

Archaeological Building Recording

Planning	
Pre-planning?	No
Planning Application No.	SL/2020/0885
Proposal	Partial demolition of elements of former police station and courthouse, remainder retained to form part of new dwellings
Condition number	None – at request of Conservation Officer
Level of recording	Historic England Level 2
Local Planning Authority	South Lakeland District Council
Conservation Officer	Libby Mee
Planning Archaeologist	Jeremy Parsons, Cumbria Historic Environment Service
Previous phase of work carried out?	Yes – heritage assessment

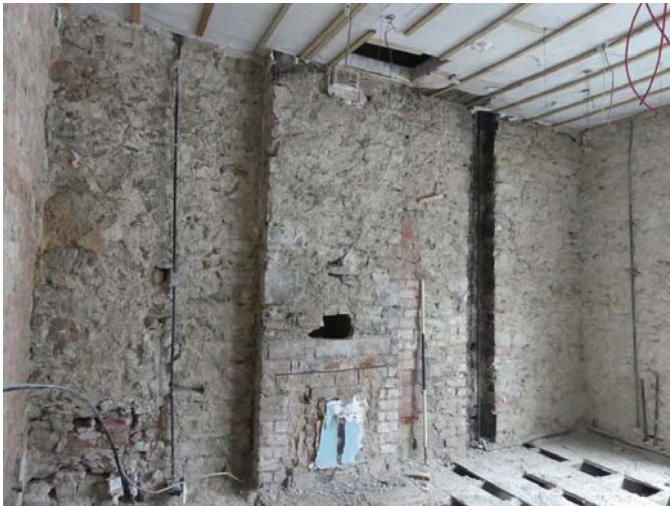
Plate 95 (left): The north-west elevation of Room F3 of the police station, viewed from the south

4.3.21 **First floor Room 3 – police station:** this has a board floor, which has been mostly removed, and the original plaster ceiling to which chicken wire and battens has been attached. The walls have been stripped of plaster and are of stone construction to the north-west and north-east and brick to the south-east and south-west, laid in stretcher bond. The north-west elevation has a chimney breast south-west of the centre, the fireplace blocked with brick (Plate 95). There is more brick incorporated into the wall to the north-east and a tall recess built into the wall housing pipes. The north-east elevation has a large window with a timber lintel and splayed jambs (Plate 96). The south-east and south-west walls are essentially plain with some stud walling in the south corner forming the corridor (Room F4).

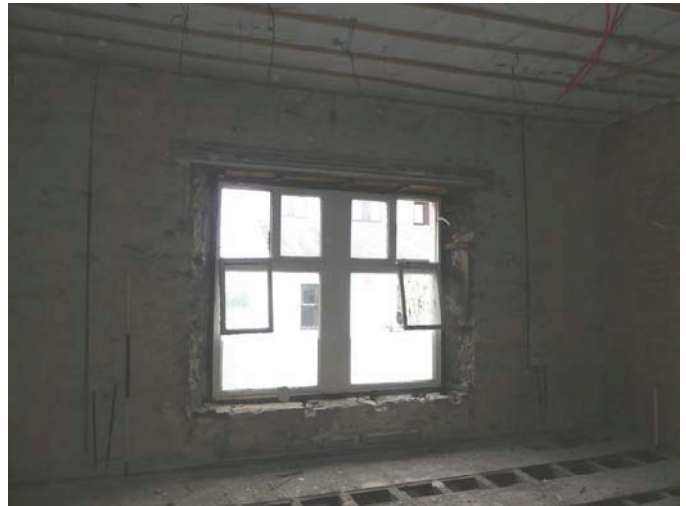
Plate 96 (right): The north-east elevation of Room F3 of the police station, viewed from the south-west

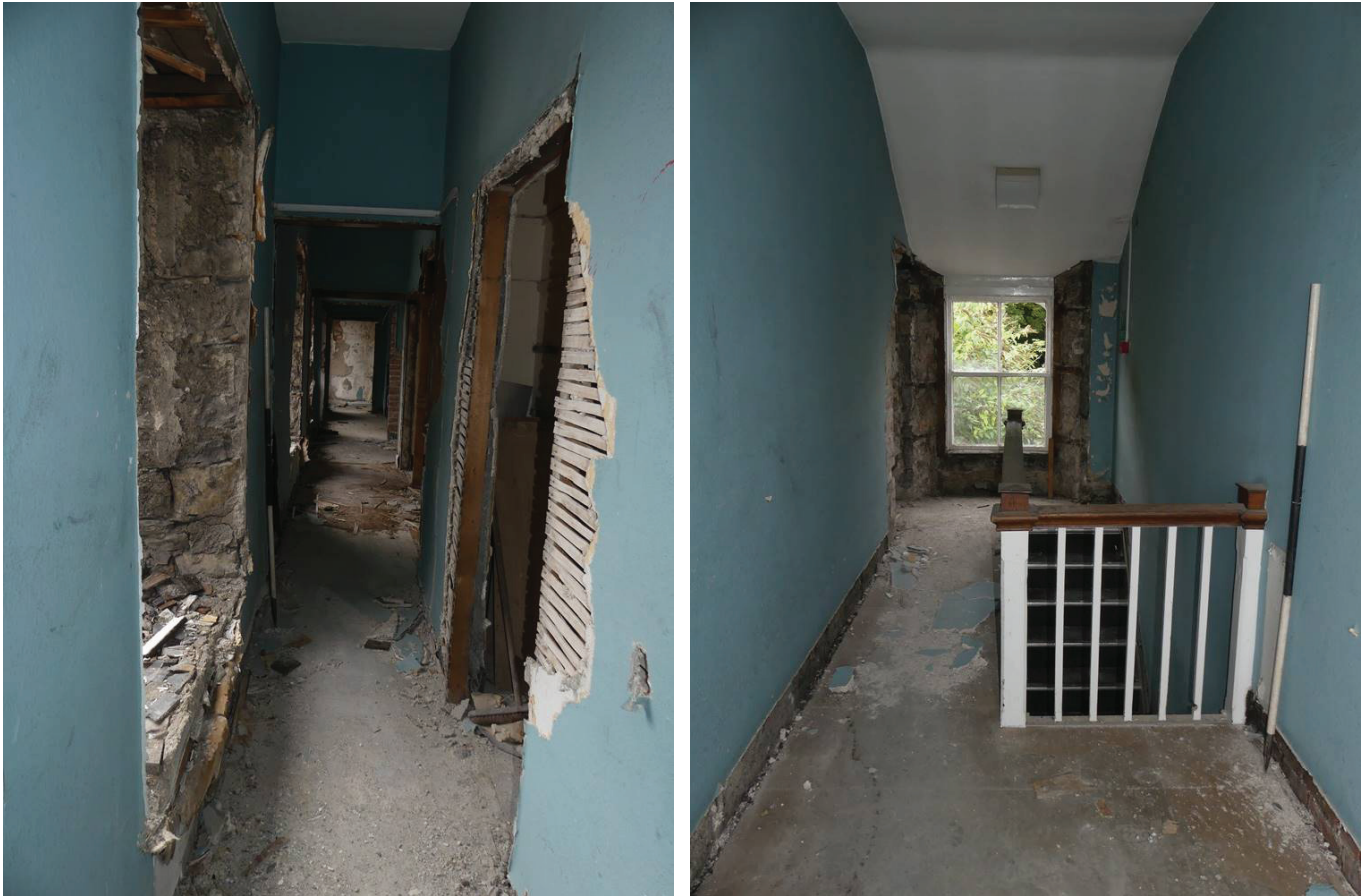
Plate 97 (left): General view of Room F5, from the north-east

Plate 98 (right): The stairs in Room F5, viewed from the south-east

4.3.23 **First floor Room 5 – police station:** this comprises a long corridor orientated north-east/south-west running along the south-east side of the south-west wing of the building (Plate 97). It turns to the north-west at its south-west end and meets the top of the stairs. The floor is finished with vinyl, and it has a flat plaster ceiling and the original plaster finishing the walls with flock wallpaper. The north-west side is a lath and plaster stud wall with two doorways. There are also doorways at the north-east and south-west ends. The south-east elevation has three windows each with splayed jambs and stone surrounds. The staircase is as per the ground floor, with three chamfered square-section newel posts with pyramid tops and a moulded handrail and thin square section balusters (Plate 98). There is a further window to the north-west of the stairs with splayed jambs extending to the floor and a four-light sash casement.

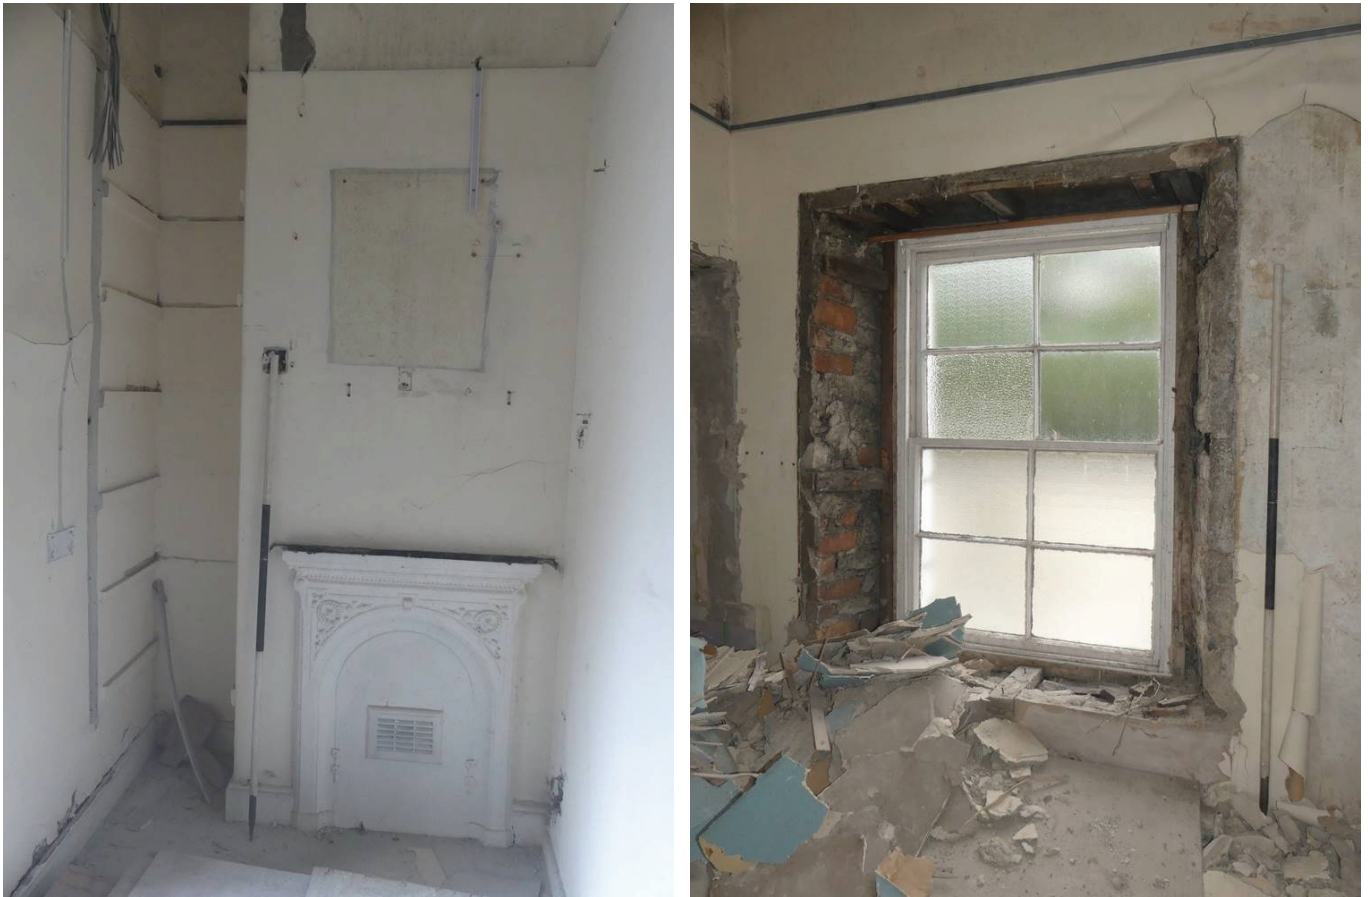
Plate 99 (left): The south-west elevation in Room F6 of the police station, viewed from the north-east

4.3.24 **First floor Room 6 – police station:** this has a vinyl or linoleum floor covering and lath and plaster ceiling with a boxed beam orientated north-west/south-east. The walls are plain plaster and mostly timber stud partitions, with doorways to the north-west and south-east. The south-west elevation has an alcove on the south-east side against a chimney breast which still retains an original iron fire surround, although it is missing its mantel piece (Plate 99).

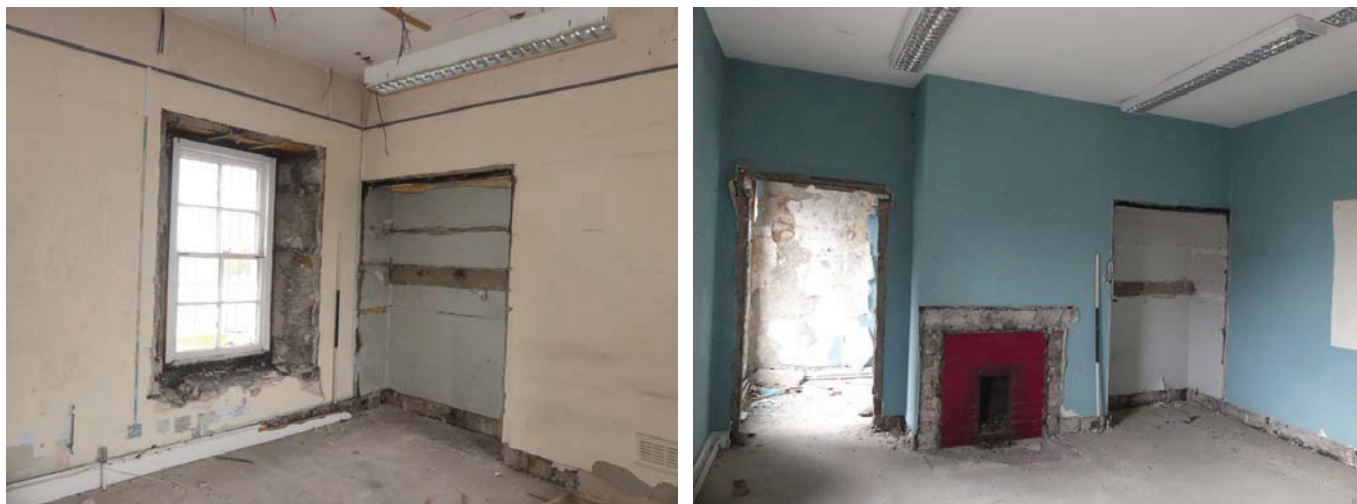
4.3.26 **First floor Room 8 – police station:** the floor is finished with vinyl or linoleum and it has a lath and plaster ceiling. The walls are original plaster with a tall skirting board. There is a window on the north-east side of the north-west elevation with splayed jambs and an eight-light casement (Plate 101). There is a large alcove on the north-west side of the north-east elevation against a fireplace, which is blocked and incorporates a single vent (Plate 101). The south-east elevation is a lath and plaster stud partition with a doorway on the south-west side.

Plate 101 (left): General view of Room F8 of the police station, from the south

Plate 102 (right): The south-west elevation of Room F9, viewed from the north-east

4.3.27 **First floor Room 9 – police station:** the floor is finished with vinyl or linoleum, and it has a flat plaster ceiling finished with flock wallpaper. The walls are original plaster, also finished with flock wallpaper. The north-west and north-east elevations are plain, the north-east is a stud wall with a doorway on the south-east side. The south-east elevation has a window with splayed jambs and a machine-sawn timber lintel. The south-west elevation has a doorway on the south-east side and a chimney breast in the centre with the fireplace partially blocked to form a smaller hearth with a plain iron insert (Plate 102). There is a large alcove to the north-west.

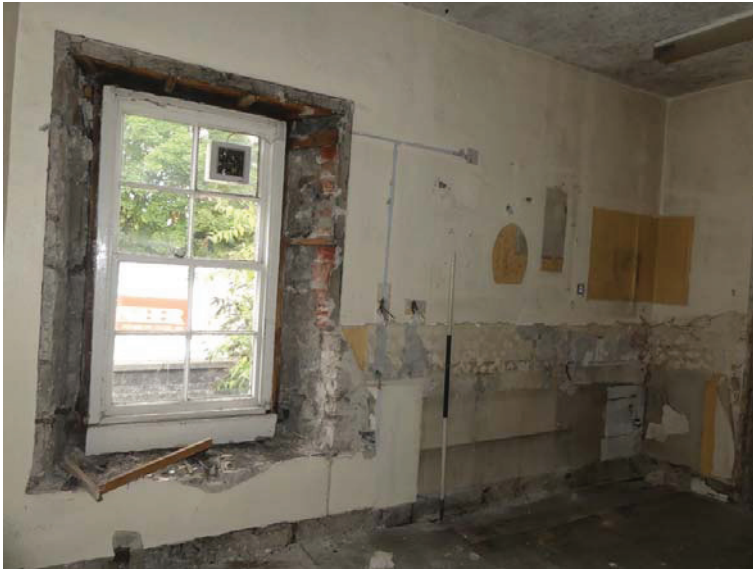
4.3.30 **First floor Room 12 – police station:** the floor is finished with vinyl sheets on ply and there is a plaster ceiling. The walls are the original plaster finished with flock wallpaper. The south-west and south-east elevations are plain, although there is a doorway to the south-east. The north-west elevation has a window on the south-west side with splayed jambs, a machine cut lintel and eight-light sash casement. There is a doorway to the north-east into a small lobby, which has a deep alcove on the south-east side with a raised floor inside.

Plate 103 (left): The north-west elevation in Room F12 of the police station, viewed from the south

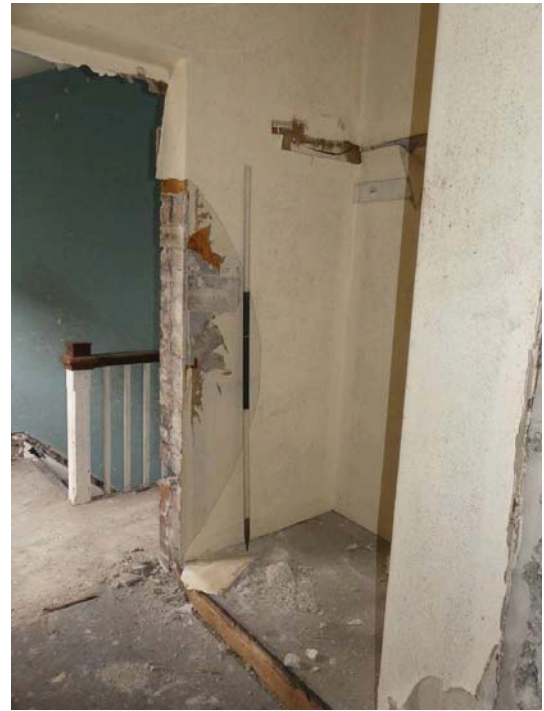
Plate 104 (right): The alcove in the north-east side of the south-east elevation in Room F12 of the police station, viewed from the west

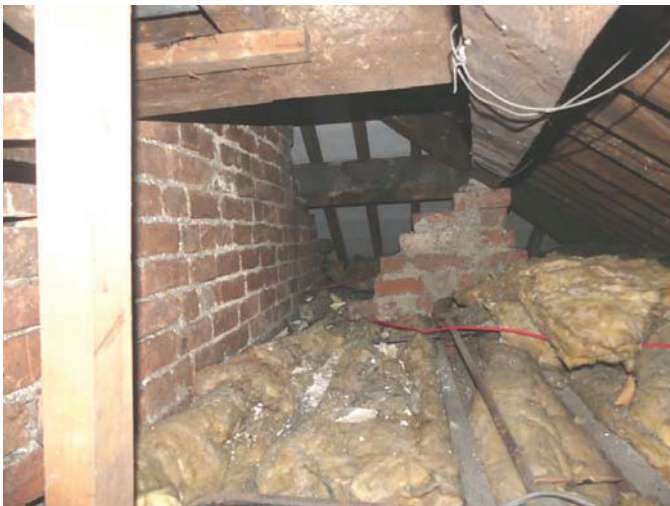
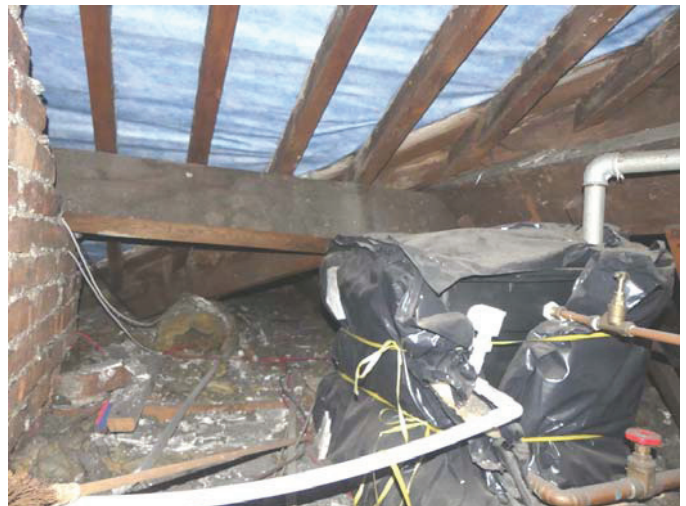
4.3.31 **Roof space – police station:** the hatch in Room F11 appeared to only provide access to the roof space over Rooms F9-F11. It had the trusses for the hipped end of the roof constructed from sawn, probably Baltic, pine, and a brick dividing wall on the south-west side, but was otherwise plain (Plate 105 and Plate 106).

Plate 105 (left): The south-west side of the roof space of the police station, viewed from the north-west

Plate 106 (right): The north-east side of the roof space of the police station, viewed from the south-west

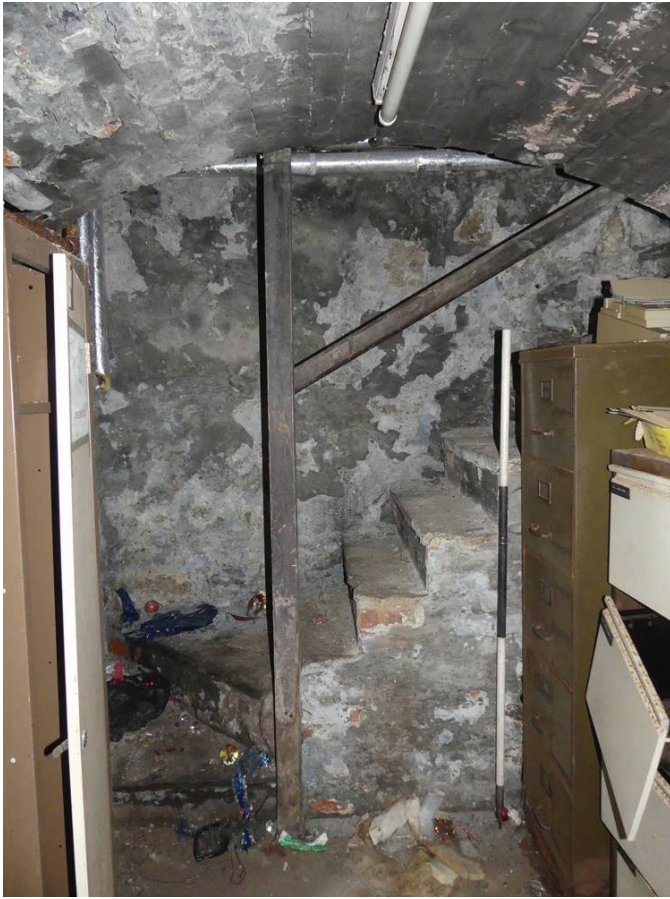
4.3.32 **Basement Room 1 – courthouse:** this has a concrete floor with steps against the north-west side constructed from bricks topped with slate flags. It has a brick vaulted ceiling finished with lime wash and with an opening on the north-east side for pipes with stone slabs over the space above, and the walls are stone finished with rough plaster and limewash. There is a small window in the south-east elevation with splayed jambs and a stone sill, which is mostly blocked to accommodate a later vent.

Plate 107 (left): The north-west end of Room B1 of the courthouse, viewed from the south-east

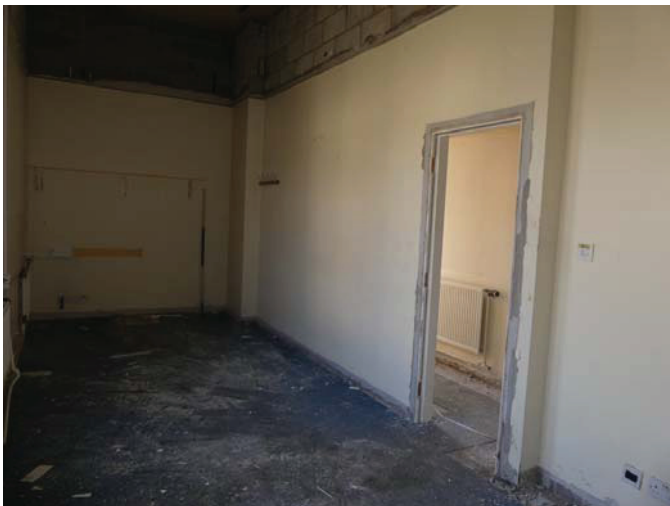
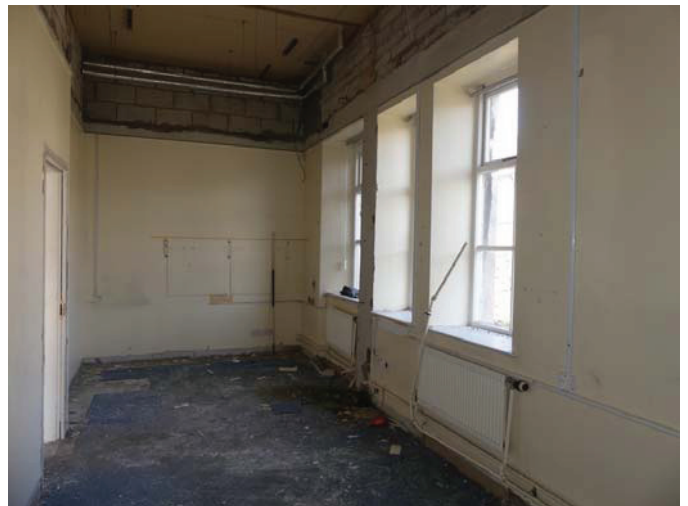
4.3.33 **Ground floor Room 1 – courthouse:** this has a carpet floor and modern plasterboard ceiling (although a suspended ceiling has been removed), with the walls finished with modern plaster and concrete blocks visible above the line of the suspended ceiling. Most of the walls are plain. There is a projecting buttress on the south-east side of the south-west elevation and a doorway (Plate 109), and there are three windows to the north-west, all with splayed jambs (Plate 110).

Plate 109 (left): General view of Room G1 in the courthouse, from the north

Plate 110 (right): General view of Room G1 in the courthouse, from the south

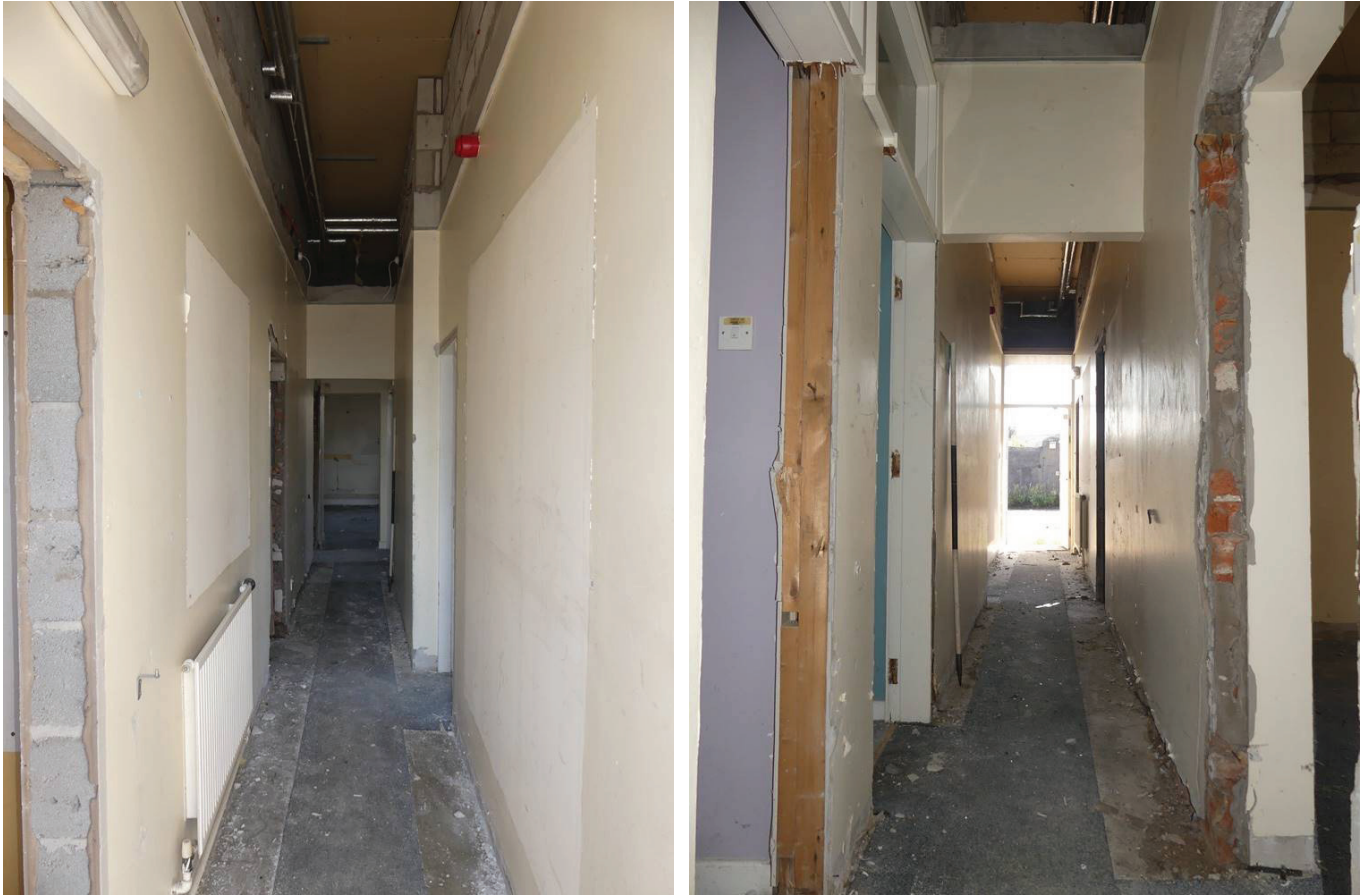
Plate 111 (left): General view of Room G2 in the courthouse, from the south-east

4.3.34 **Ground floor Room 2 – courthouse:** this comprises a corridor orientated north-west/south-east (Plate 111 and Plate 112). The floor is finished with carpet and the ceiling modern plaster board, with a suspended ceiling having been removed. All of the walls are modern plaster, apparently over brick with concrete blocks visible behind the former suspended ceiling. There is a doorway at either end and three to the south-west and four to the north-east, the two at the north-west end having a single light overlight.

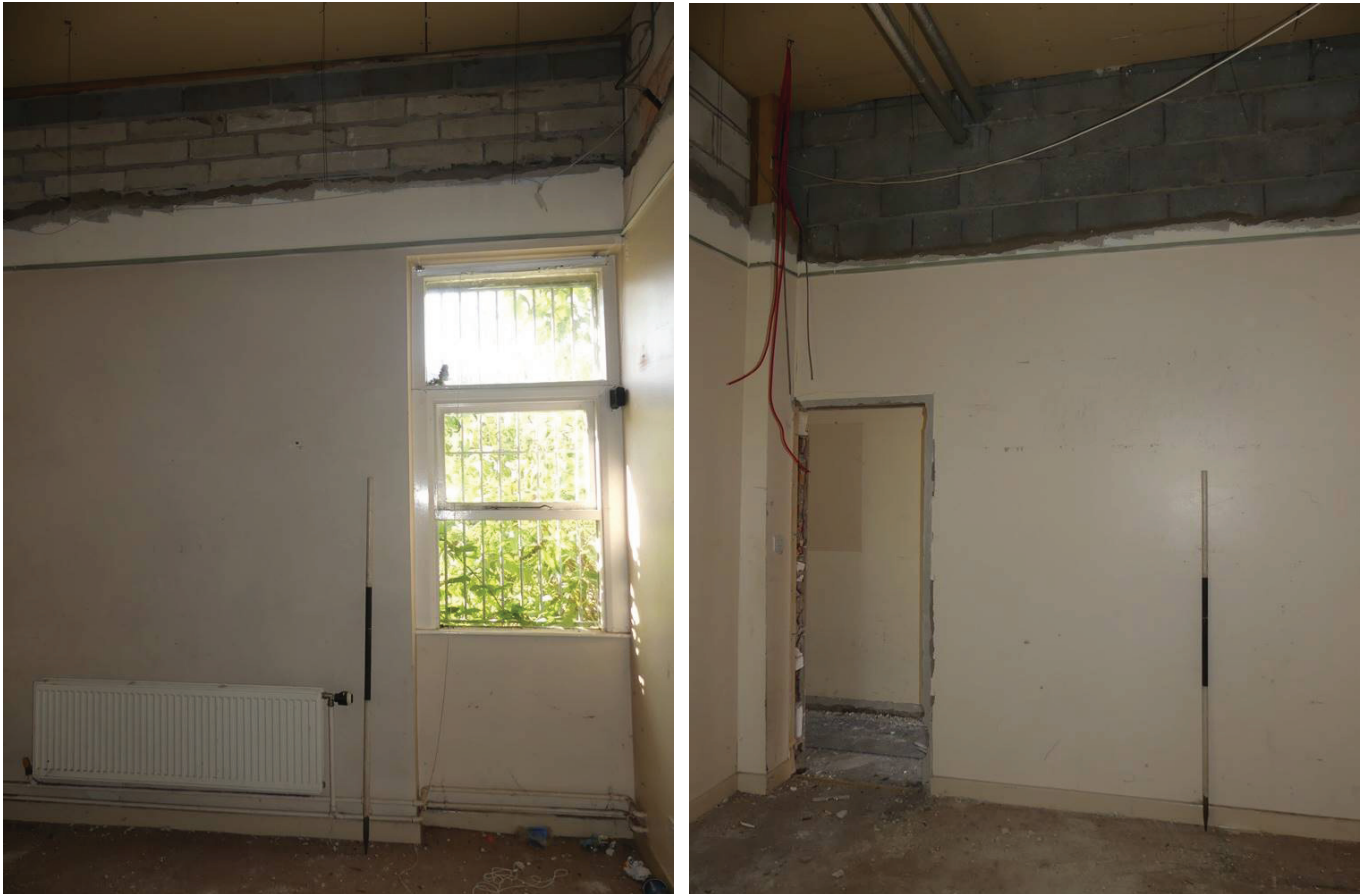
4.3.36 **Ground floor Room 4 – courthouse:** this has a carpeted floor and plasterboard ceiling, again with a removed suspended ceiling. The walls are modern plaster and paint with concrete block visible at the top. There is a window to the south-west with splayed jambs extending to the floor (Plate 113) and a doorway to the north-east with a projecting section to the north-west of this (Plate 114).

Plate 113 (left): The south-west elevation in Room G4 in the courthouse, viewed from the north-east

Plate 114 (right): The north-east elevation in Room G4 in the courthouse, viewed from the south-west

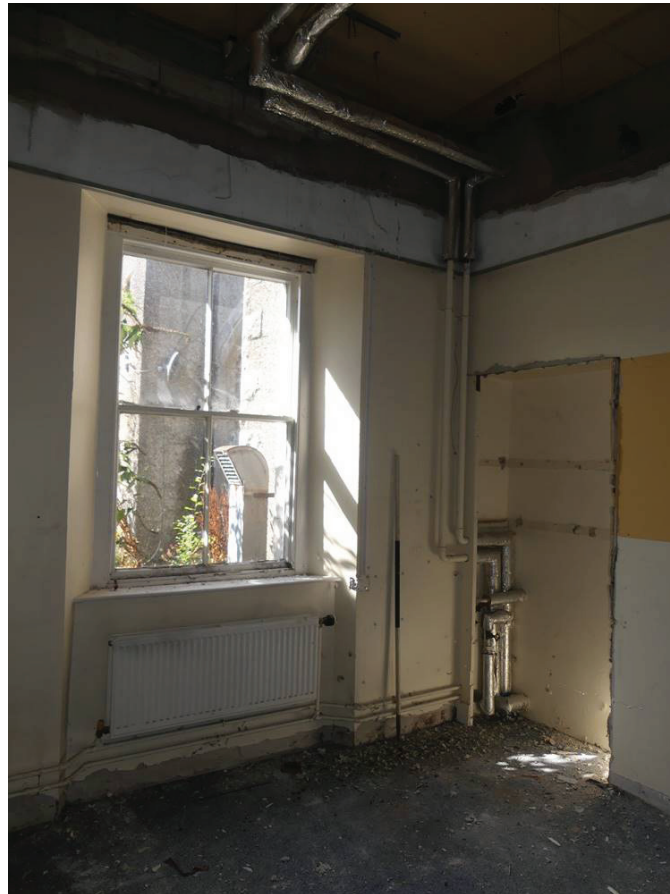
4.3.37 **Ground floor Room 5 – courthouse:** this has a carpeted floor and plasterboard ceiling above a suspended ceiling. The walls are modern plaster with concrete blocks visible at the top behind the former suspended ceiling to the north-east, south-west and south-east. There is concrete render over the north-west elevation at the same level. The north-east elevation has a doorway and projecting section to the north-west and a former doorway or cupboard on the south-west side that remains as a tall alcove (Plate 115). The south-west elevation has a window with splayed jambs extending to the floor with a timber sill.

Plate 115: General view of Room G5 in the courthouse showing the alcove and window, from the east

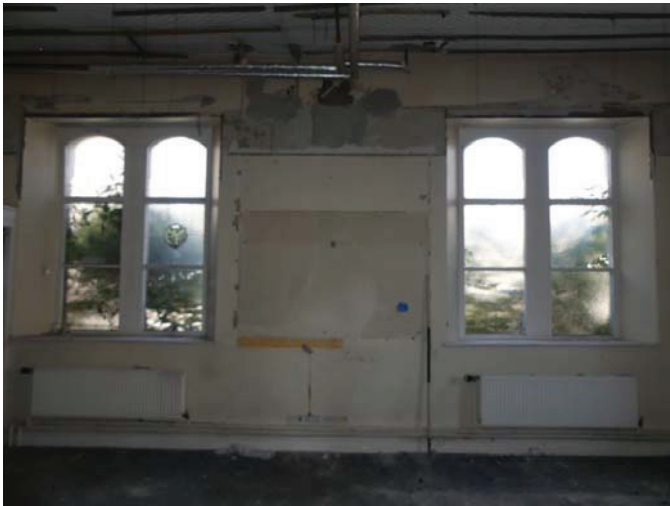
4.3.39 Ground floor Room 8 – courthouse: this has a carpeted floor and original plaster ceiling, which has had chicken wire and timber battens attached to it, and there is a line for a later suspended ceiling. The walls are plaster finished with paint, with the original plaster visible above the line of the suspended ceiling. There are stud walls on the south-west side forming a small space within the room and covering the stairs to the basement in the west corner. The north-west elevation has two windows, each with a pair of three-light casements below arched tops and with splayed jambs and timber sills (Plate 118). The north-east elevation has a single window with splayed jambs and timber sill (Plate 119). The south-east elevation has a doorway near the centre that is apparently inserted through a former chimneybreast as the wall steps out on the north-east side; the plaster above is graffitied 'Mark Postlethwaite 1992' in pencil. There is an alcove to the south-west, presumably representing the position of an earlier doorway (Plate 120). The south-west elevation is largely covered by stud walls, which have a plain doorway on the north-west side leading to the cellar and there is another plain doorway to the south-east (Plate 121).

Plate 118 (left): The north-west elevation of Room G8 of the courthouse, viewed from the south-east

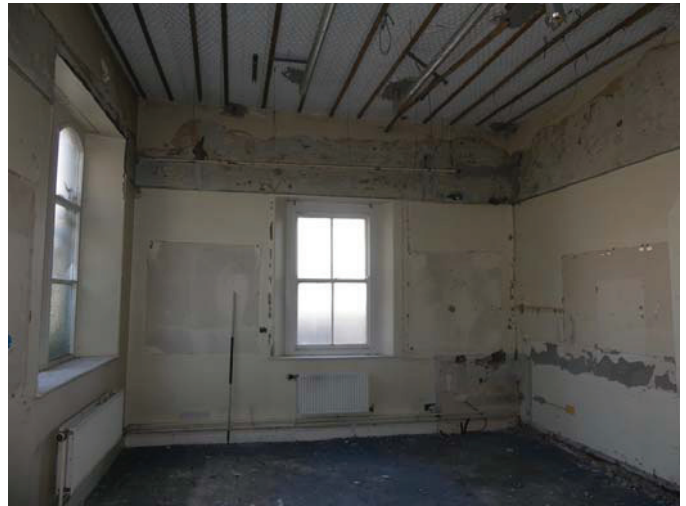
Plate 119 (right): The north-east elevation of Room G8 of the courthouse, viewed from the south-west

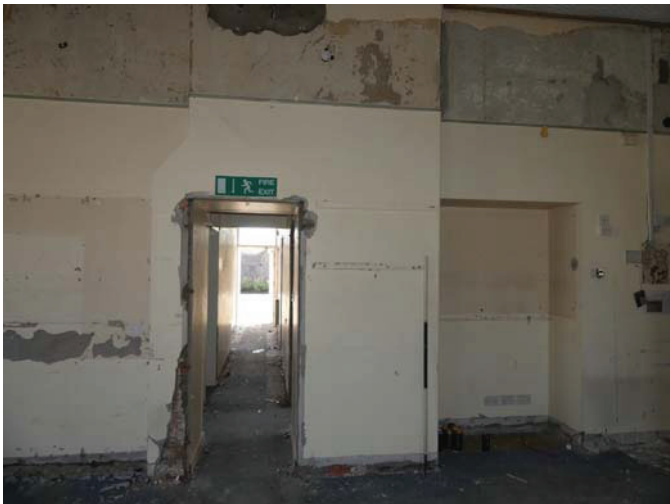
Plate 120 (left): The south-east elevation of Room G8, viewed from the north-west

some areas. More damaging was the demolition of the courthouse itself, which evidently projected to the south-west of what now remains, but other smaller changes also damaged original features, such as the creation of a doorway through what was evidently originally a fireplace in Room G8.

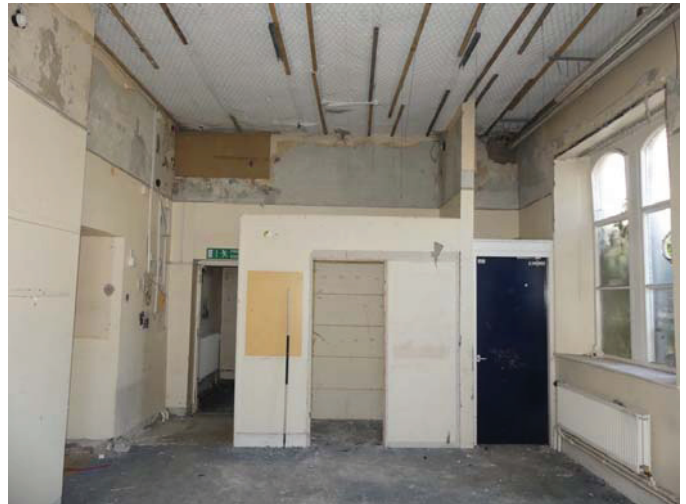
Plate 121 (right): The south-west elevation of Room G8, viewed from the north-east

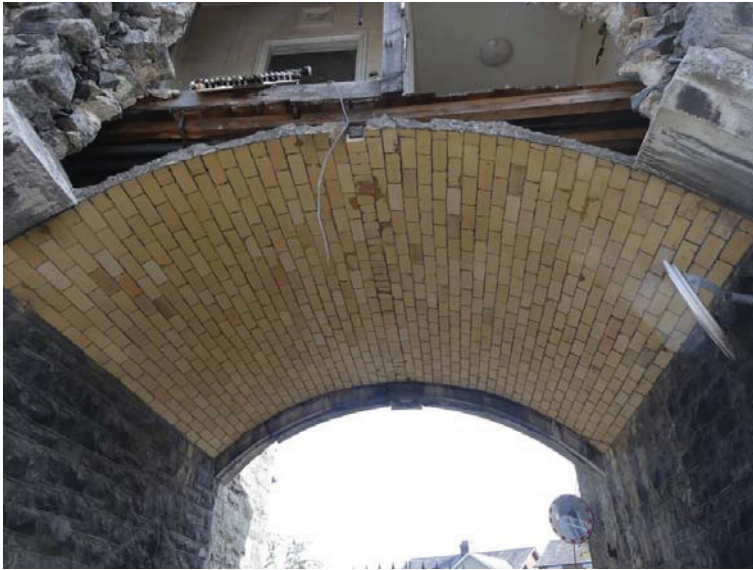
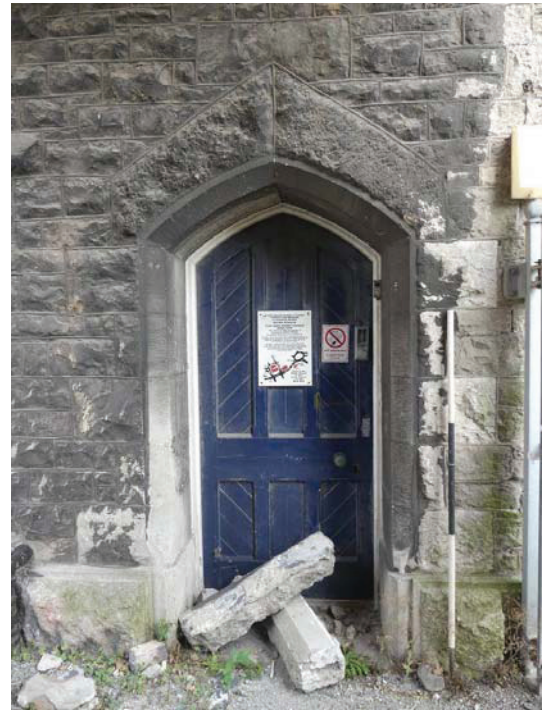
4.3.41 **Ground floor Room 10 – courthouse:** this comprises the open space below the arched entrance to the rear courtyard. It has a tarmac floor and the ceiling comprises a rounded arch constructed from machine made yellow brick (Plate 152). There are no walls to the north-west and south-east. The north-east elevation is rock-faced limestone with a doorway south-east of the centre with a pointed gothic arch constructed from two large pieces of limestone with a plank and batten door (Plate 153). There is a large vent to the north-west. The south-west elevation is plain and of the same construction.

Plate 124 (left): The arched ceiling of Room G10 of the courthouse, viewed from the north-west

Plate 125 (right): The doorway in the north-east elevation of Room G10 of the courthouse, viewed from the south-west

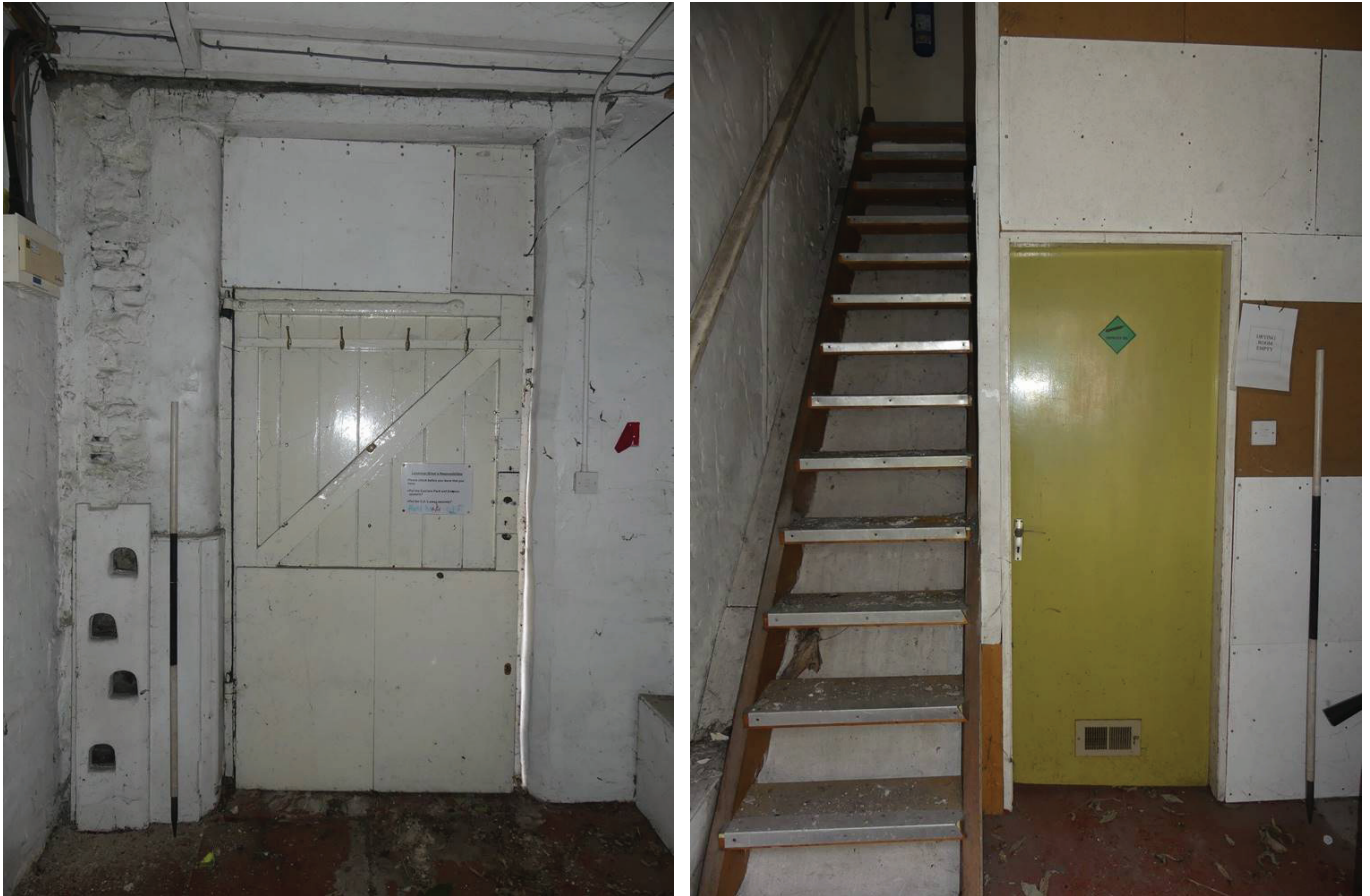
4.3.42 **Ground floor Room 11 – courthouse:** this comprises a small lobby with a painted concrete floor and the joists and floorboards of the room above forming the ceiling. The walls are finished with some rough plaster and paint over bricks. The north-west elevation has a wide doorway with a plank and batten door on long strap hinges (Plate 126). To the south-west is the remnants of a fixed timber wall ladder. The north-east elevation is plain, with some timber boxing along the base and modern timber steps leading up to the first floor on the south-east side (Plate 127). The south-east elevation is a stud wall with a doorway and a modern plain door. The south-west elevation is painted brick with a doorway with a timber lintel and modern sliding door.

Plate 126 (left): The north-west elevation of Room G11 of the courthouse, viewed from the south-east

Plate 127 (right): The south-east elevation of Room G11 of the courthouse, viewed from the north-west

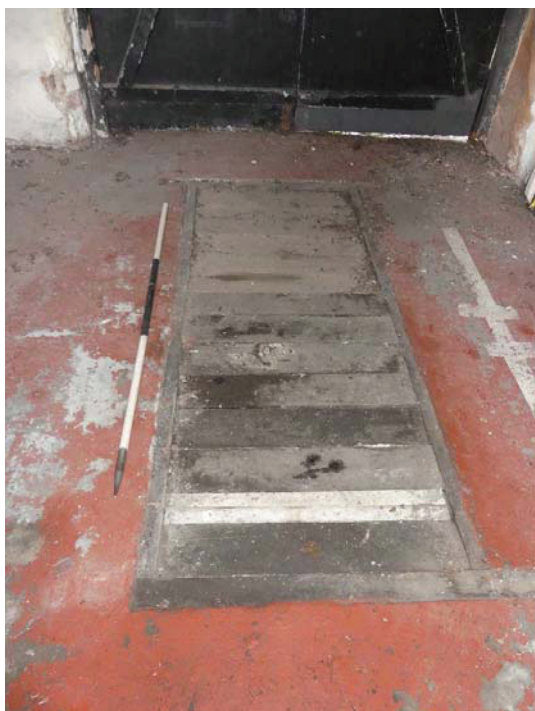
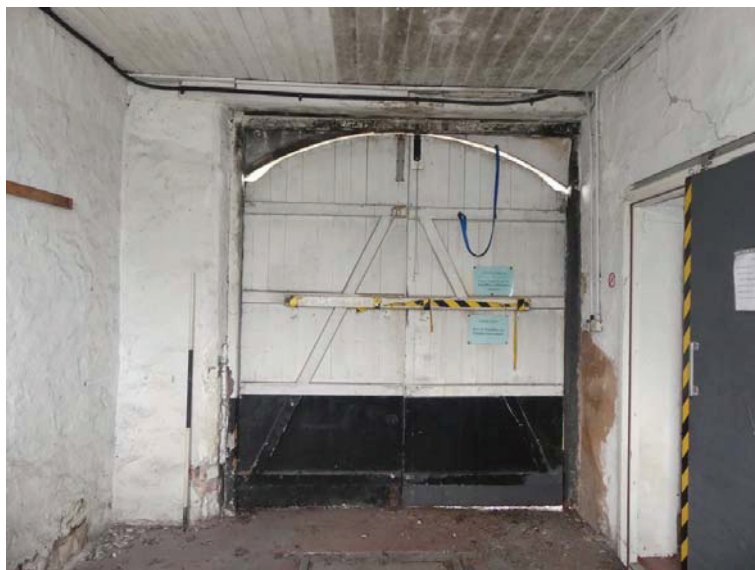
4.3.44 **Ground floor Room 13 – courthouse:** this also has a painted concrete floor, with an inspection hatch covered by timber boards on the north-west side (Plate 128). The walls are finished with limewash over stonework. The north-west elevation has a large wagon doorway with a plank and batten door (Plate 129). The north-east elevation has a doorway with a modern sliding doorway and the south-east side is finished with tongue and groove boards. The south-east elevation is also covered by tongue and groove planks with a heavy duty set of pegs on a chamfered timber batten on the north-east side and deep timber boxing along the base of the wall (Plate 130). There is a window with splayed jambs and a timber sill to the south-west. The south-west elevation is also covered by tongue and groove boards on the south-east side around a fireplace, which is blocked up but retains its original square stone surround and mantle with an iron hob grate insert with floral decoration (Plate 131).

Plate 128 (left): Inspection hatch in the floor of Room G13 of the courthouse, viewed from the south-east

Plate 129 (right): The north-west elevation in Room G13 of the courthouse, viewed from the south-east

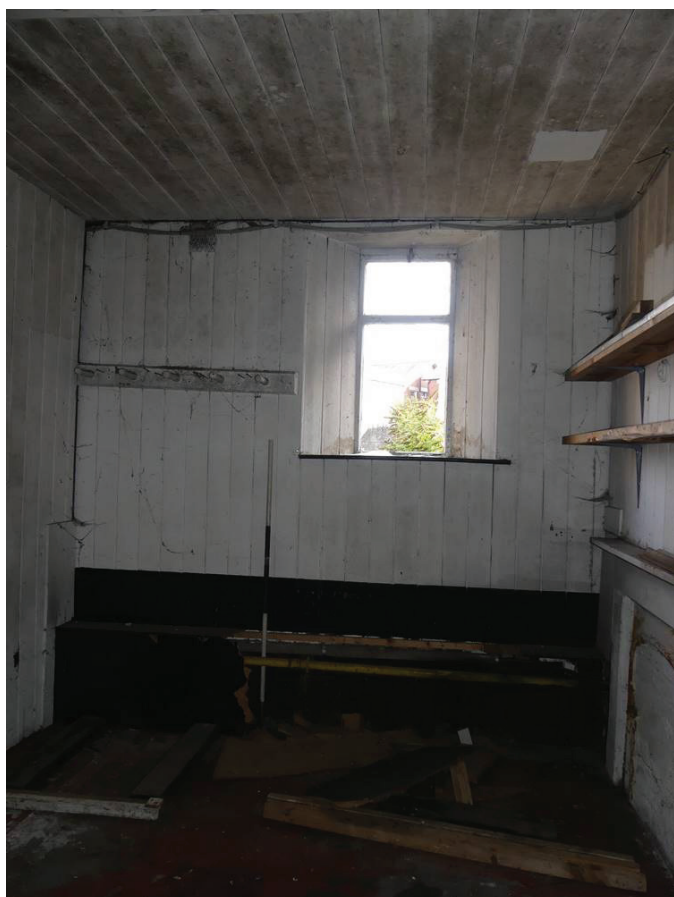
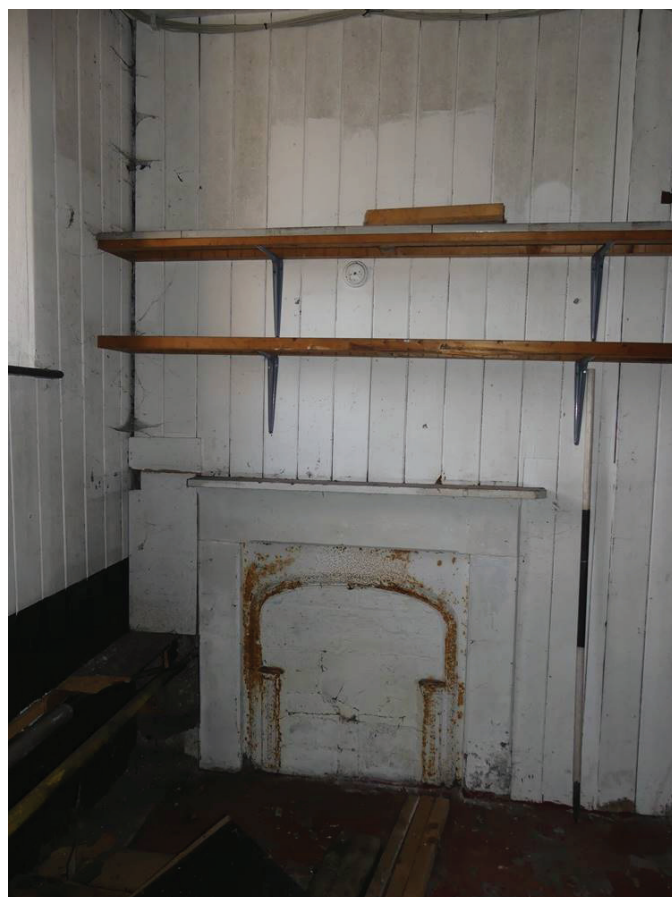
Plate 130 (left): The south-east elevation in Room G13 of the courthouse, viewed from the north-west

Plate 131 (right): The fireplace in the south-west in Room G13 of the courthouse, viewed from the north-east

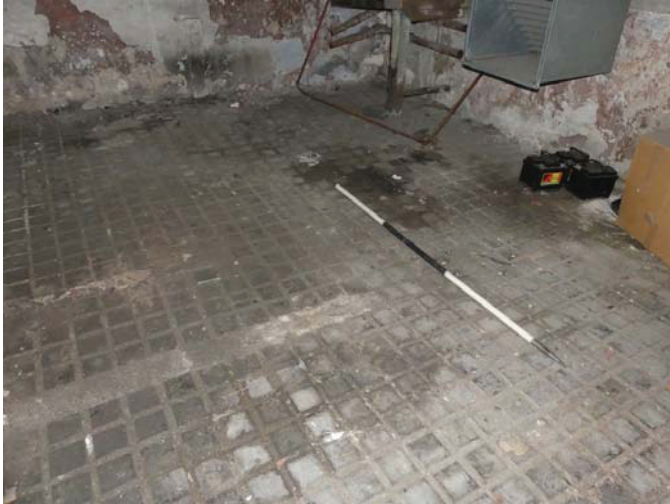
4.3.45 **Ground floor Room 14 – courthouse:** this comprises the interior of the monopitch outshut on the south-west end of the building. It has a gridded brick floor (Plate 132) and modern monopitch roof of rafters and felt with a single machine cut purlin running north-west/south-east. The walls are painted masonry. The north-west elevation has a large doorway with a plank and batten door on strap hinges (Plate 133). The north-east elevation is plain, with coat hooks on a timber batten attached. The south-east elevation has a small window high on the north-east side, which has been blocked from the other side leaving a small alcove (Plate 134). The south-west elevation is plain, with some rebuild in concrete block at the top and a modern extraction unit attached in the centre and a rough desk in the south corner (Plate 135).

Plate 132 (left): The gridded brick floor in Room G14 of the courthouse, viewed from the north

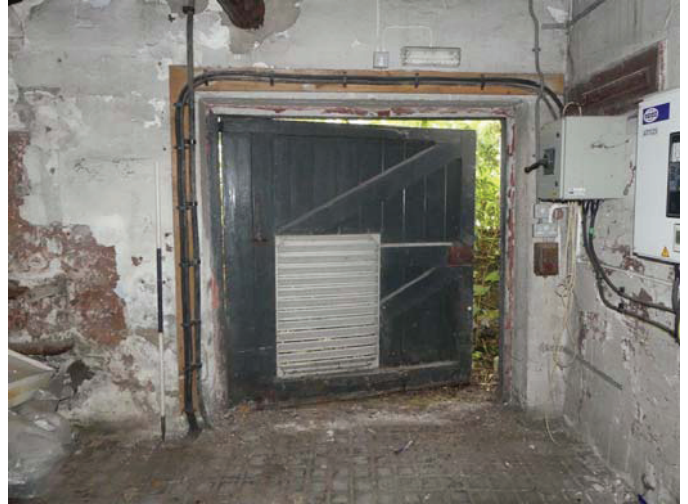
Plate 133 (right): The north-west elevation in Room G14 of the courthouse, viewed from the south-east

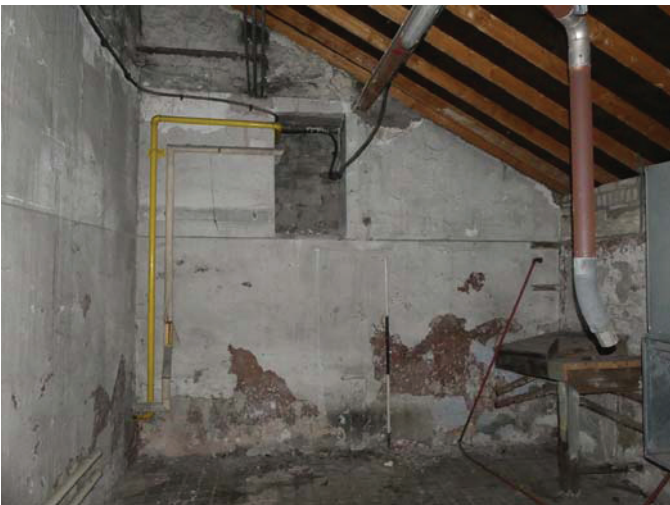
Plate 134 (left): The south-east elevation in Room G14 of the courthouse, viewed from the north-west

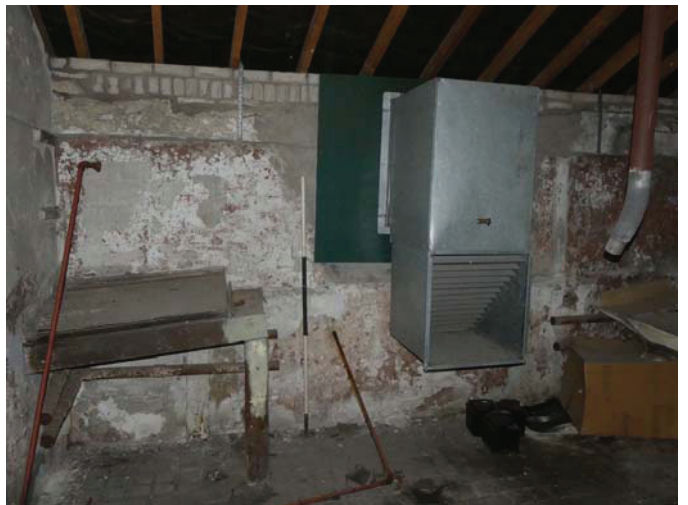
Plate 135 (right): The south-west elevation in Room G14 of the courthouse, viewed from the north-east

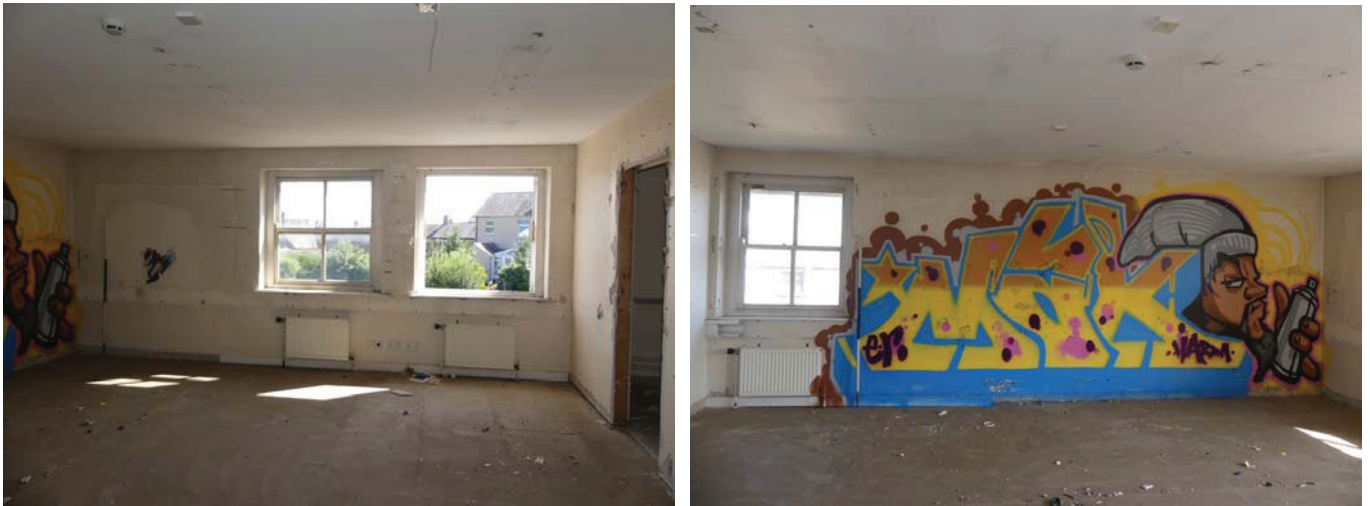
4.3.46 **First floor Room 1 – courthouse:** this originally had a carpet floor, now removed, and has a modern plasterboard ceiling. The walls are all finished with modern plaster and paint. There are two windows to the south-east, the north-eastern of which has a surviving four-light sash casement, and both have square jambs. The north-east elevation is covered in a large panel of graffiti tagged 'HARM' and has a window on the north-west side with a four-light sash casement and there are two doorways to the south-west in a timber stud wall and one to the north-west.

Plate 136 (left): The south-east elevation of Room F1 of the courthouse, viewed from the north-west

Plate 137 (right): The north-east elevation of Room F1 of the courthouse, viewed from the south-west

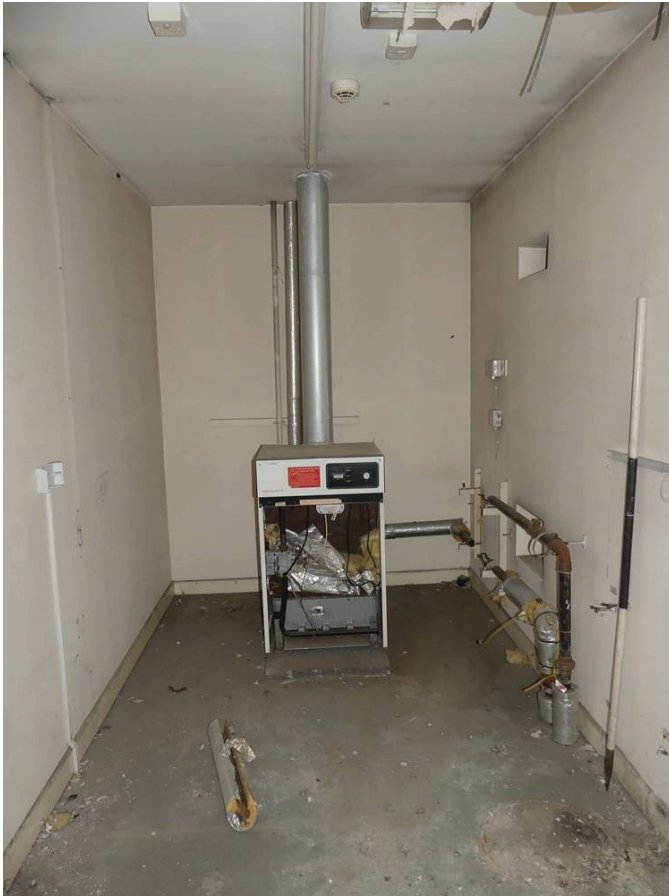
4.3.49 **First floor Room 4 – courthouse:** this has a vinyl floor and a plasterboard ceiling and modern plastered walls. There are two vents in the south-west wall, which has been lined with modern stud walls, and a doorway to the north-west and it houses a modern boiler (Plate 138).

Plate 138 (left): General view of Room F4 of the courthouse, from the north-east
