FORMER POLICE STATION, ULVERSTON, CUMBRIA

Archaeological Building Recording

Planning	
Pre-planning?	No
Planning Application No.	SL/2020/0885
Proposal	Partial demolition of elements of former police station and courthouse, remainder retained to form part of new dwellings
Condition number	None – at request of Conservation Officer
Level of recording	Historic England Level 2
Local Planning Authority	South Lakeland District Council
Conservation Officer	Libby Mee
Planning Archaeologist	Jeremy Parsons, Cumbria Historic Environment Service
Previous phase of work carried out?	Yes – heritage assessment

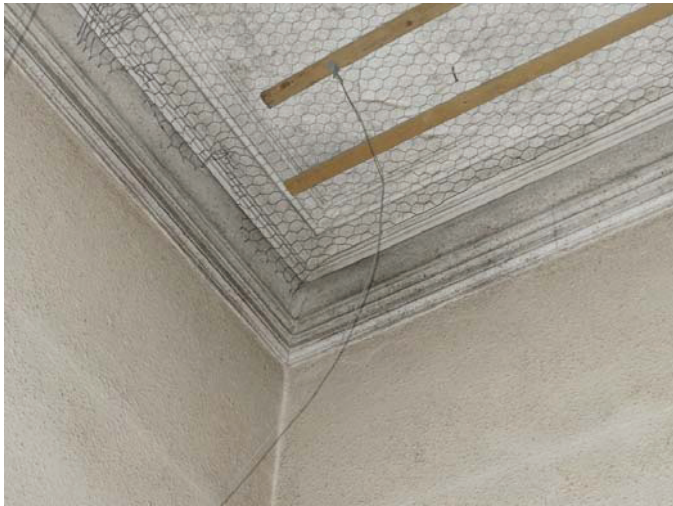
4.3.52 **First floor Room 7 – courthouse:** this has a carpeted floor and originally had a suspended ceiling, but this has been removed revealing the original plaster ceiling, which is covered with attached chicken wire and timber battens. It has a deep moulded cornice (Plate 140) and floral ceiling rose (Plate 141). There is a section of raised stud walling suspended from the ceiling on the west side. The walls are original plaster finished with flock wallpaper and paint and there is a tall, moulded skirting board. The north-west elevation has a wide window with splayed jambs extending to the floor in three sections with rounded arches and tongue and groove panelling below (Plate 142). The north-east elevation has another tall window with splayed jambs extending to the floor, again with a rounded arch although the top is hidden by the suspended stud wall (Plate 143). The south-east elevation has a doorway on the north-east side and a chimney breast to the south-west (Plate 144). The south-west elevation is a stud wall with a doorway on the south-east side and a wide opening to Room F8 on the north-west (Plate 145).

Plate 140 (left): The cornice in Room F7 of the courthouse, viewed from the west

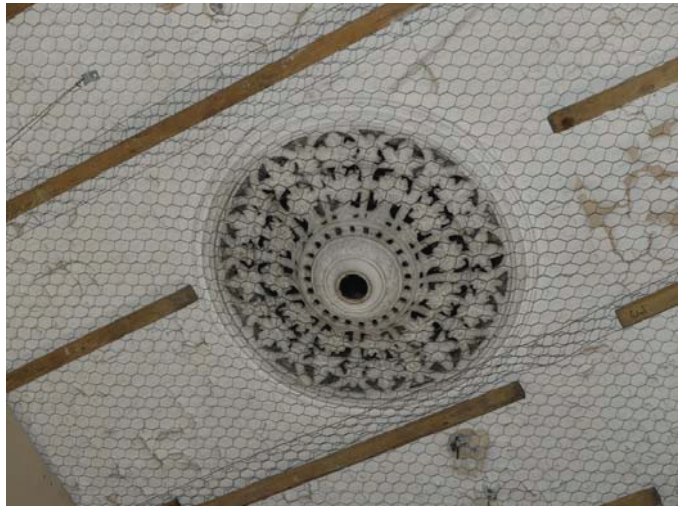
Plate 141 (right): The ceiling rose in Room F7 of the courthouse, viewed from the west

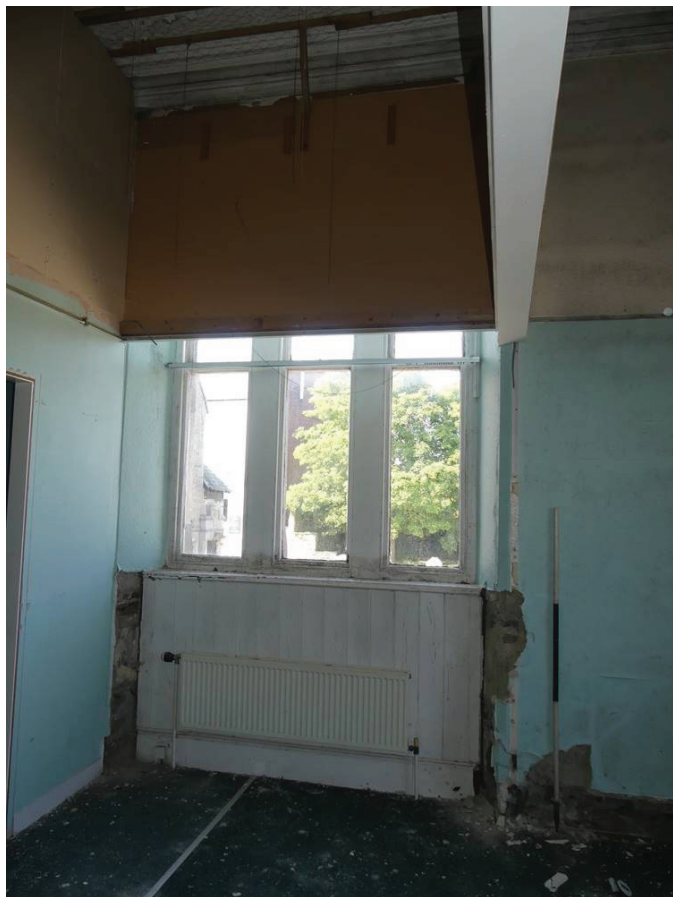
Plate 142 (left): The north-west elevation in Room F7 of the courthouse, viewed from the south-east

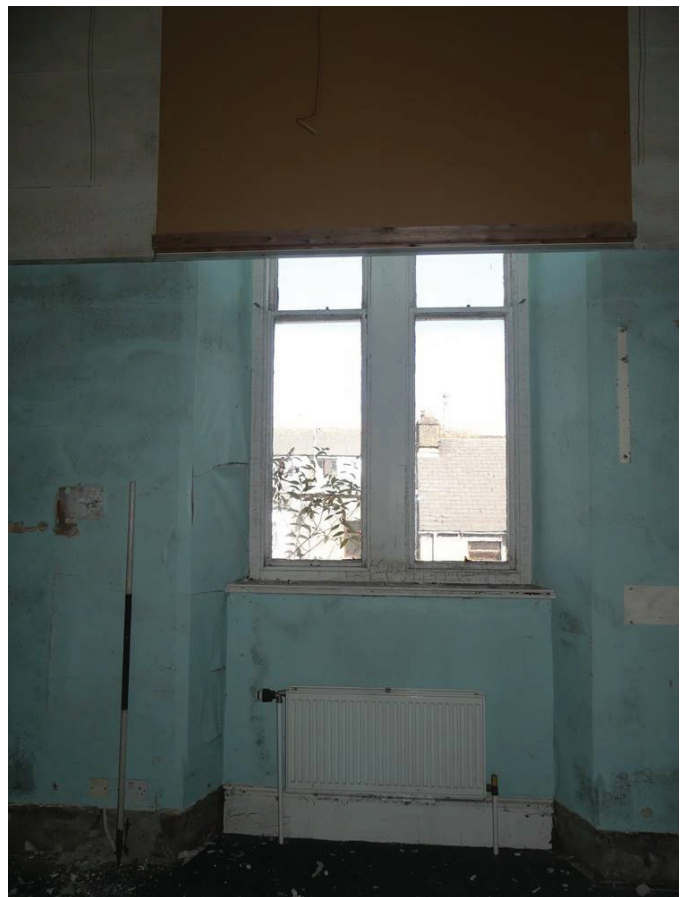
Plate 143 (right): The north-east elevation in Room F7 of the courthouse, viewed from the south-west

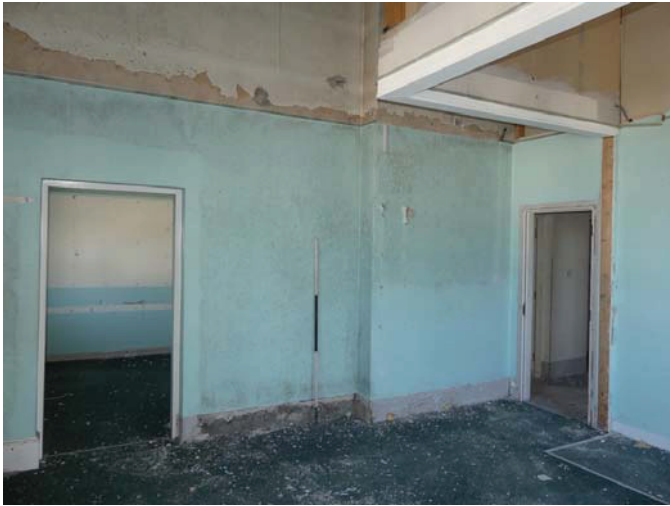
Plate 144 (left): The south-east elevation in Room F7 of the courthouse, viewed from the north

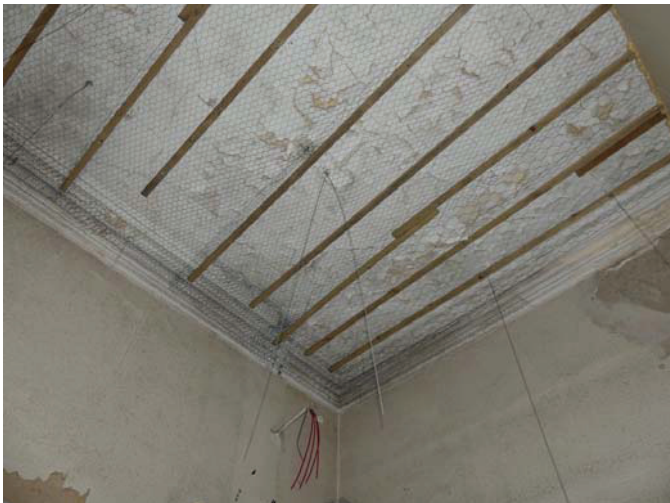
Plate 146 (left): The ceiling in Room F8 of the courthouse, viewed from the east

4.3.53 **First floor Room 8 – courthouse:** the floor is carpeted and there is the scar of a suspended ceiling above which is the original ceiling, which has a deep moulded cornice. The walls are finished with plaster and flock wallpaper and partly tiled on the south-west side. There is a doorway to the south-east, a large opening to the north-east, and an alcove in the south-west elevation that may have been a former doorway.

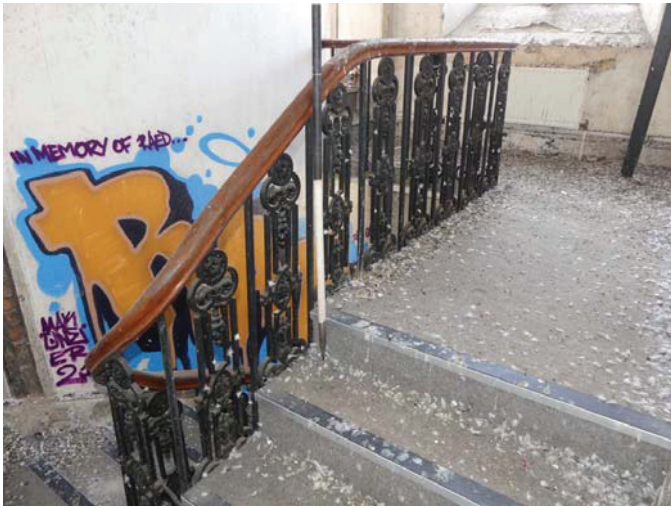
Plate 148 (left): Stairs in Room F8 of the courthouse, viewed from the east

4.3.54 **First floor Room 9 – courthouse:** this is the top of the staircase. The floor is carpet over the stone stairs, with the handrail and balustrades as per the floor below, with some sections of the iron balustrade missing at the top (Plate 148). The ceiling is tongue and groove boards comprising the floor of the space in the top of the tower, with a hatch on the north-east side (Plate 149). The walls are finished with original plaster and flock wallpaper. The north-west elevation has a tall window with splayed jambs and sill in two parts divided by a square stone mullion (Plate 150). Above this is a small window of three smaller lights also in splayed jambs. The north-east elevation has an iron ladder attached leading to the hatch in the ceiling. To the south-east is a doorway with two steps up. The south-east elevation is plain, the south-west has timber boxing on the south-east side for pipes with moulded battens either side (Plate 151). There is a large panel of graffiti to the north-west tagged 'IN MEMORY OF RAED...RIDE EASY' and 'MAK ONE ER 21'.

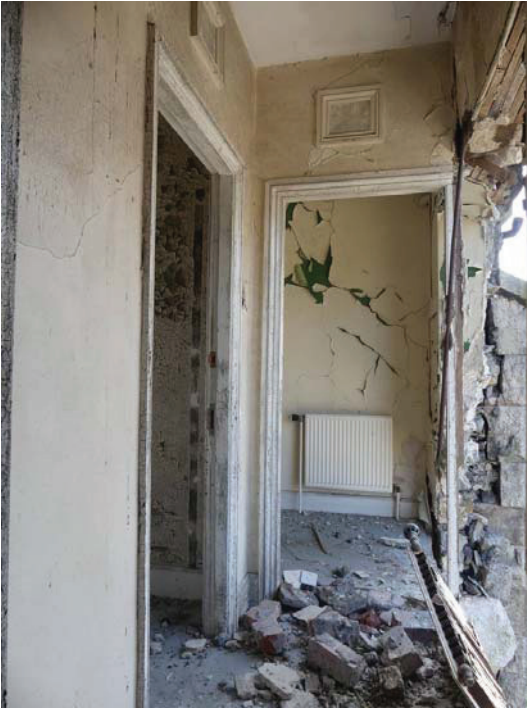
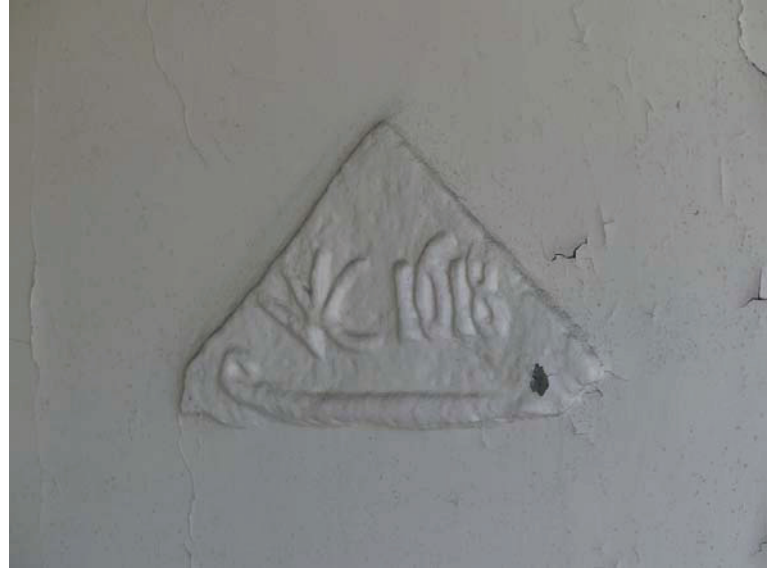
Plate 152 (left): General view of Room F10 in the courthouse, viewed from the north-east

4.3.55 **First floor Room 10 – courthouse:** this was not fully accessible due to the dangerous condition of the north-west elevation. The floor was finished with vinyl, and it had a plaster ceiling with a roof hatch on the north-east side; the roof above was just visible appeared to comprise only rafters. The room is subdivided into two roofs by a stud wall with mesh vents above the doorways, both of which have moulded surrounds (Plate 152). There is a window to the south-east with splayed jambs and a timber sill and a doorway to the north-east also with a moulded surround. The north-west elevation now has a large

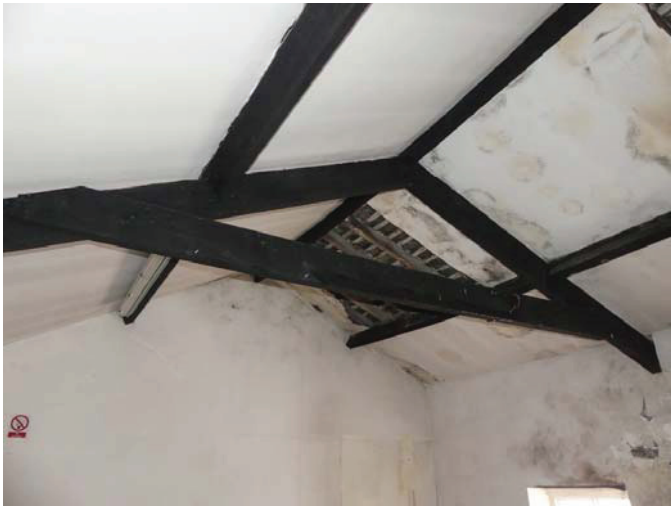
Plate 154 (left): The truss in Room F11 of the courthouse, viewed from the north-east

4.3.56 **First floor Room 11 – courthouse:** this has a chipboard floor with the remnants of carpet and is open to the roof, which is backed with plasterboard and has a single simple truss, with the principal rafters overlapping north-west on south-east with a slight notched joint. A raised tie-beam or collar is attached to the north-east face and there is a single purlin per pitch plus a ridge plank. The walls are modern plaster finished with paint, with some additional stud walling in the north corner and against the top of the stairs. There is also timber sheeting covering the lower part of most of the walls. The south-east and south-west walls are plain although there is modern timber boxing attached to the south-west end of the south-east elevation forming seats and at the north-east end there is a brass plaque attached to a timber blocked inscribed 'FURNESS MOUNTAIN RESCUE TEAM THIS BASE WAS OFFICIALLY OPENED BY CHIEF CONSTABLE A.E. ELLIOTT Esq. ON 23-11-91'. The north-west elevation has two windows both with square jambs, timber sills and four-light sash casements. The north-east elevation is mostly plain apart from the modern stairs and stud walling.

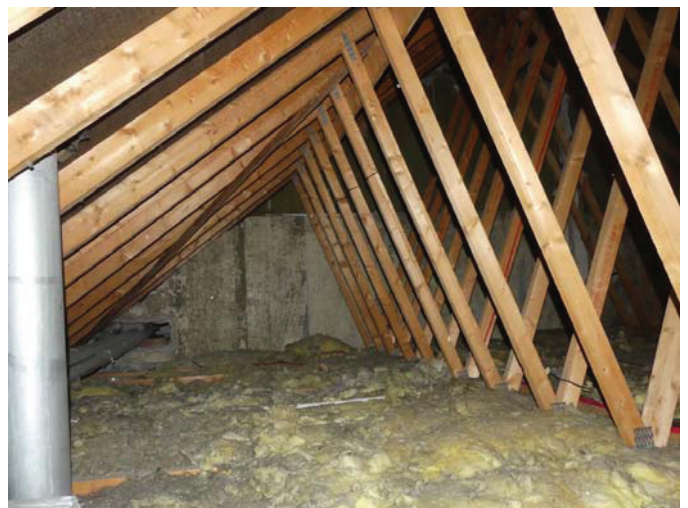
Plate 157 (right): General view of the roof space over Rooms F1-F6 of the courthouse, viewed from the south-east

4.3.57 **Roof space – police station:** the roof space over Room F9 was not safely accessible due to the dangerous access and pigeon infestation. Similarly, the roof space over Room F10 was not safely accessible due to the dangerous condition of the building at this point. The roof space over Rooms F1-F6 was entirely modern with modern timber joists forming the floor with insulation between and numerous modern rafters and angled struts supporting the roof (Plate 156 and Plate 157). The walls to the south-east are concrete block and the wall to the north-west is original and plastered (Plate 157).
