# WENNINGTON OLD FARM, TATHAM, LANCASTER, LANCASHIRE

## Heritage Impact Assessment

September 2021

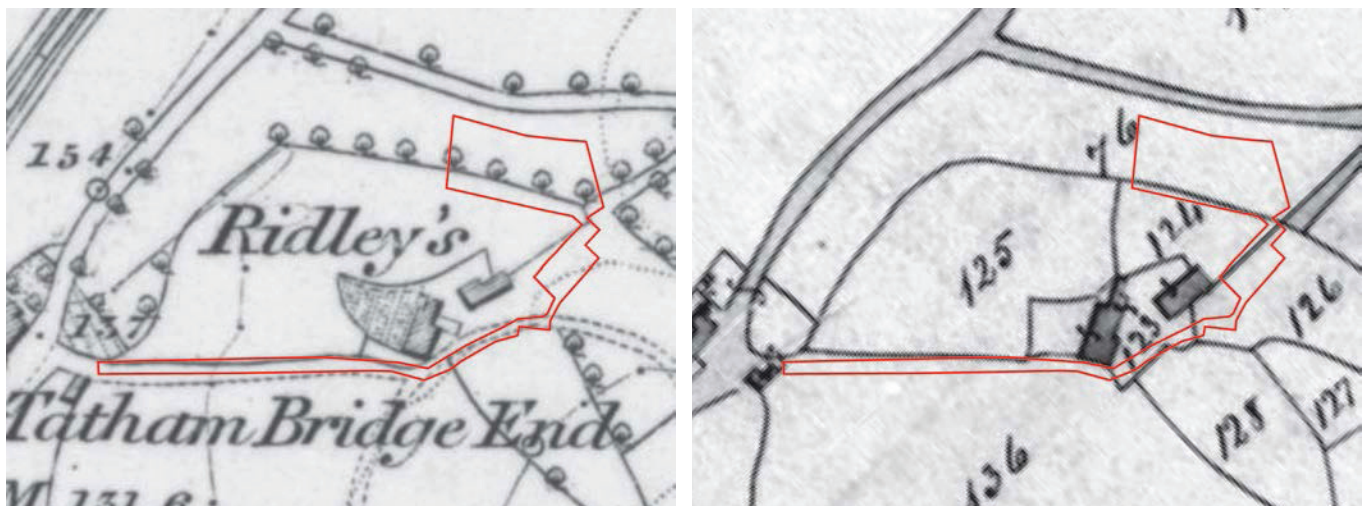
3.2.1 **Ordnance Survey, 1847:** the core elements of the cottage and farmhouse at Wennington Old Farm are clearly shown (Plate 1). The track forming the existing access to the farmhouse from the main road between Tatham and Wennington is also marked. The site of the proposed stables occupies an area of open field and the north end of the site (in the area of the proposed riding surface) cuts across a tree-lined 'boundary'.

3.2.2 **Tithe Map, 1848:** this map shows less detail than the earlier Ordnance Survey map. The tracks, for example, are not shown (TNA IR 29/18/300, 1848a) (Plate 2). A north/south boundary is shown to the north of the farmhouse, which was not shown previously.

Plate 1 (left): Extract from the Ordnance Survey map of 1847

Plate 2 (right): Extract from the tithe map of 1848

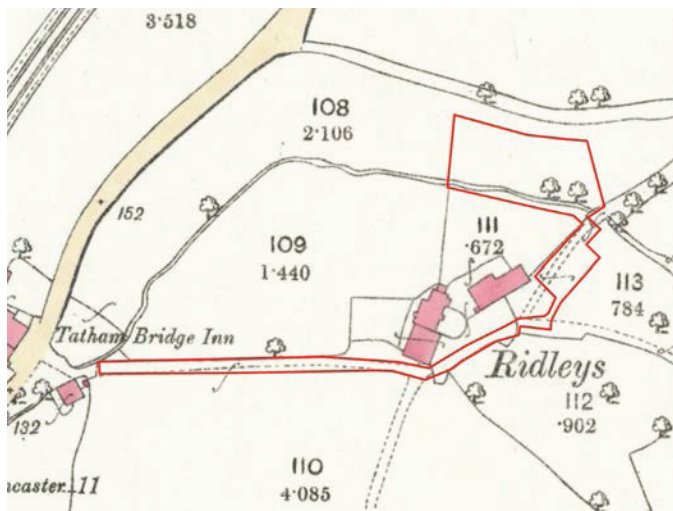
3.2.3 **Ordnance Survey, 1894:** this map is more detailed, but seems to show essentially the same arrangement of tracks and boundaries as the previous maps (Plate 3). A track is marked to the east of the cottage and the 'boundary' in the area to the north has two sides marked and continues as a stream further to the east.

Plate 3 (left): Extract from the Ordnance Survey map of 1894

4.2.3 The stone-lined culvert revealed during the site visit presumably corresponds with the watercourse most-clearly marked on the 1894 Ordnance Survey map (Plate 3). The riding surface is intended to be to the north of this and the open sections are to be retained as features (H Crabtree pers comm) so this will be retained.

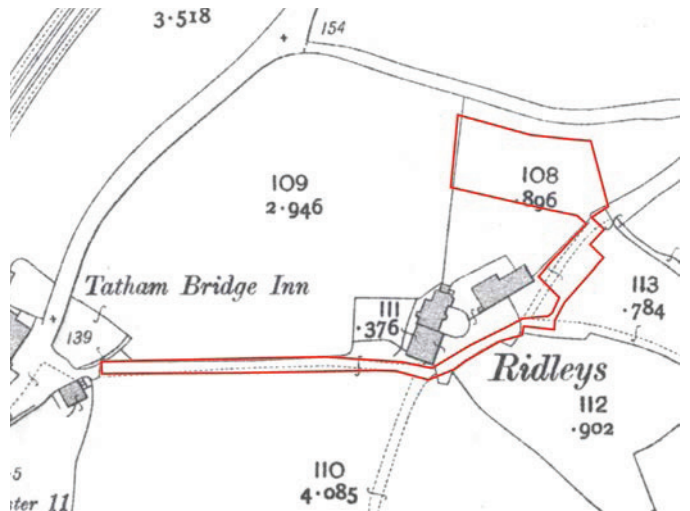
3.2.4 **Ordnance Survey, 1913:** the tracks round the farmhouse and cottage are still shown, but the boundary/stream to the north is no longer shown cutting across the area (Plate 4). The north/south boundary to the north of the farmhouse has been extended and now passes to the west side of the proposed all-weather riding surface.

Plate 4 (right): Extract from the Ordnance Survey map of 1913

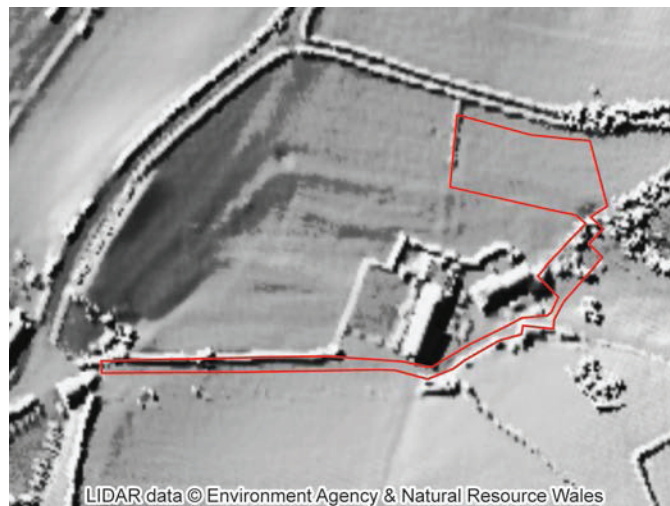
3.2.5 **Lidar**: lidar imagery for the site shows the route of the former stream marked on the earlier Ordnance Survey maps to the west of the proposed development area (Plate 5; cf. Plate 3). Its route is less discernible in the proposed development area, where it may have been infilled. The boundary wall to the west of the proposed all-weather riding surface is shown, the south end of which (where it continued to the north end of the farmhouse) is still traceable, but has largely been removed (Plate 5; cf. Plate 4).

Plate 5: Lidar data for the site

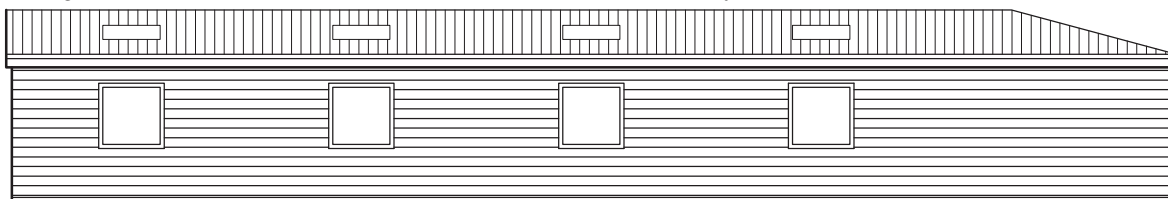
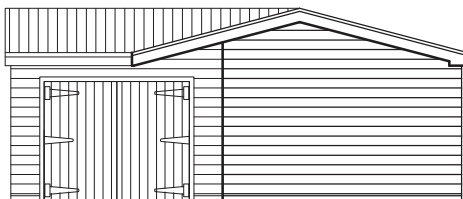
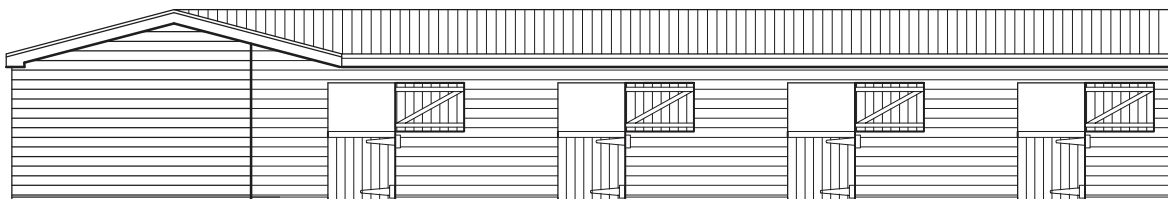
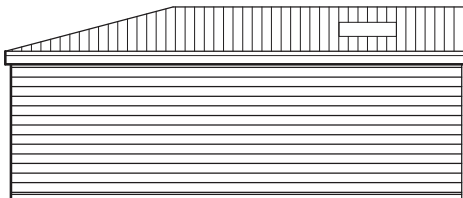
Figure 3: Proposed elevations of the stables

GRP Translucent  
Rooflights

Imitation Slate Roof  
Colour Grey

UPVC Gutters and Downpipes  
Colour Black

Horizontal Timber Cladding  
Natural Finish

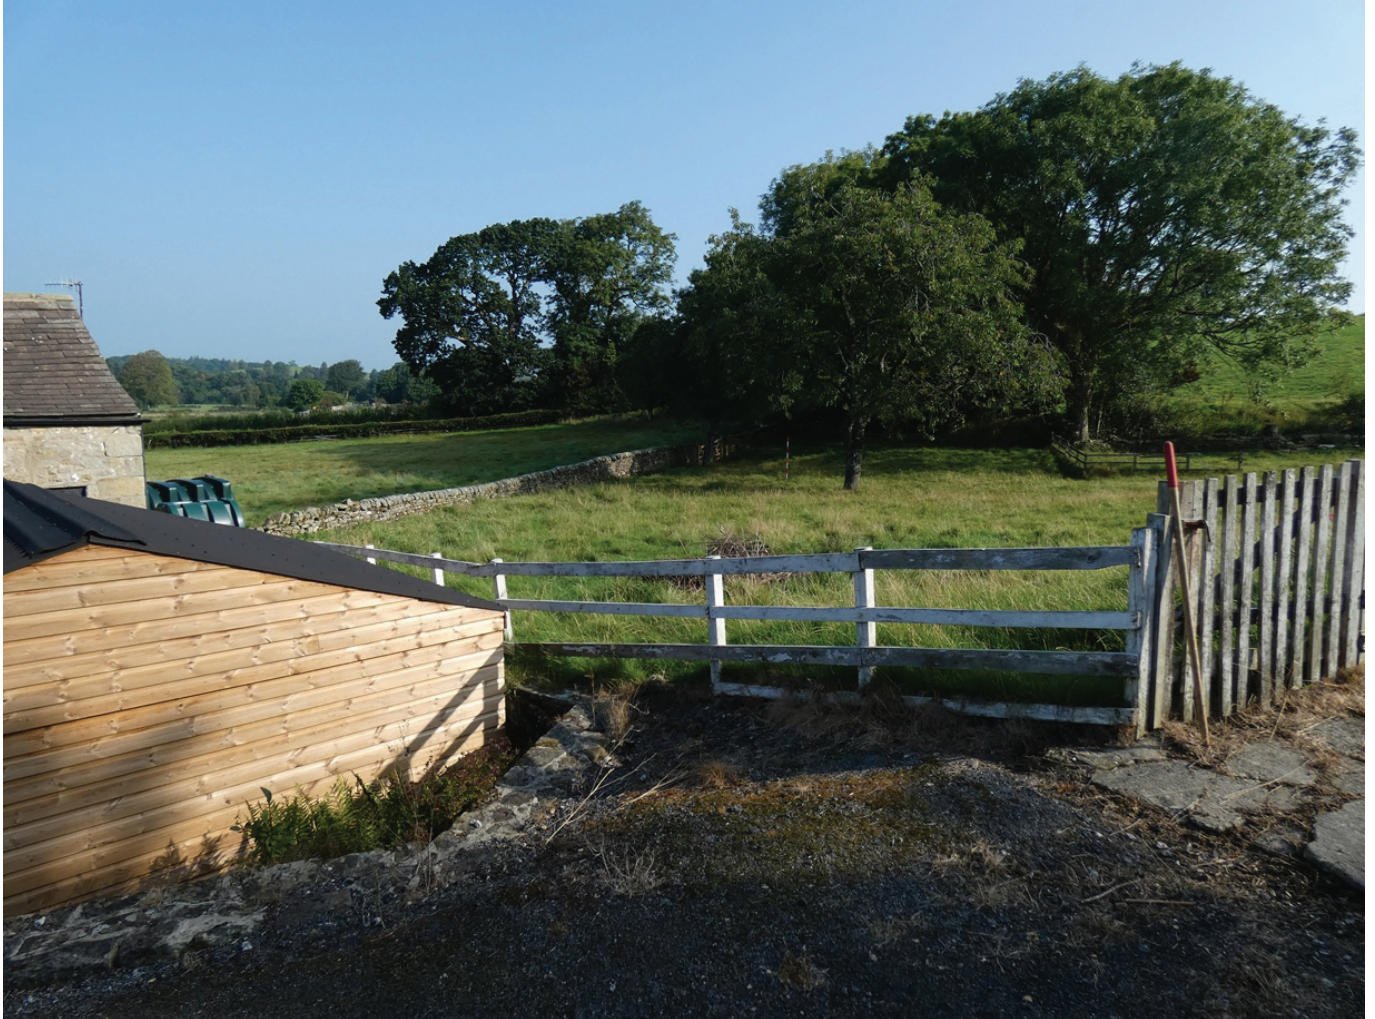
**3.4.3 Area of the yard and stables:** the single-storey stables are to be constructed behind Wennington Old Farm Cottage in a secluded area of fairly level ground at approximately 50m above sea level (see Figure 2; see Plate 10). The north-west edge of the area is defined by a drystone wall with a gated access at the north-east end (Plate 11 and Plate 12). There are two trees within the area of the stables and access through to the riding surface that will need to be removed (Figure 2; see Plate 13). The landscape rises steeply to the east and south of the proposed stables and yard, rising roughly 10m within 60m to 70m of the edge of the proposed stables (see Figure 1), and the site is therefore quickly overshadowed by the surrounding hills.

**Plate 10: General view of the proposed stable and yard area from the existing stables and greenhouse**

4.2.1 **Area of the yard and stables:** some groundworks will presumably be required to level the area for the construction of the yard and single-storey stables and work access is required from the area in front of the existing stables and greenhouse to the south. Two trees are required to be removed. The dry-stone wall to the north-west of the area is to be retained. There will be some visual impact on the setting of the farm, however, this is mitigated by the choice of location and the fact that the stables are to be offset to the rear of the cottage (see *Section 4.3* below).

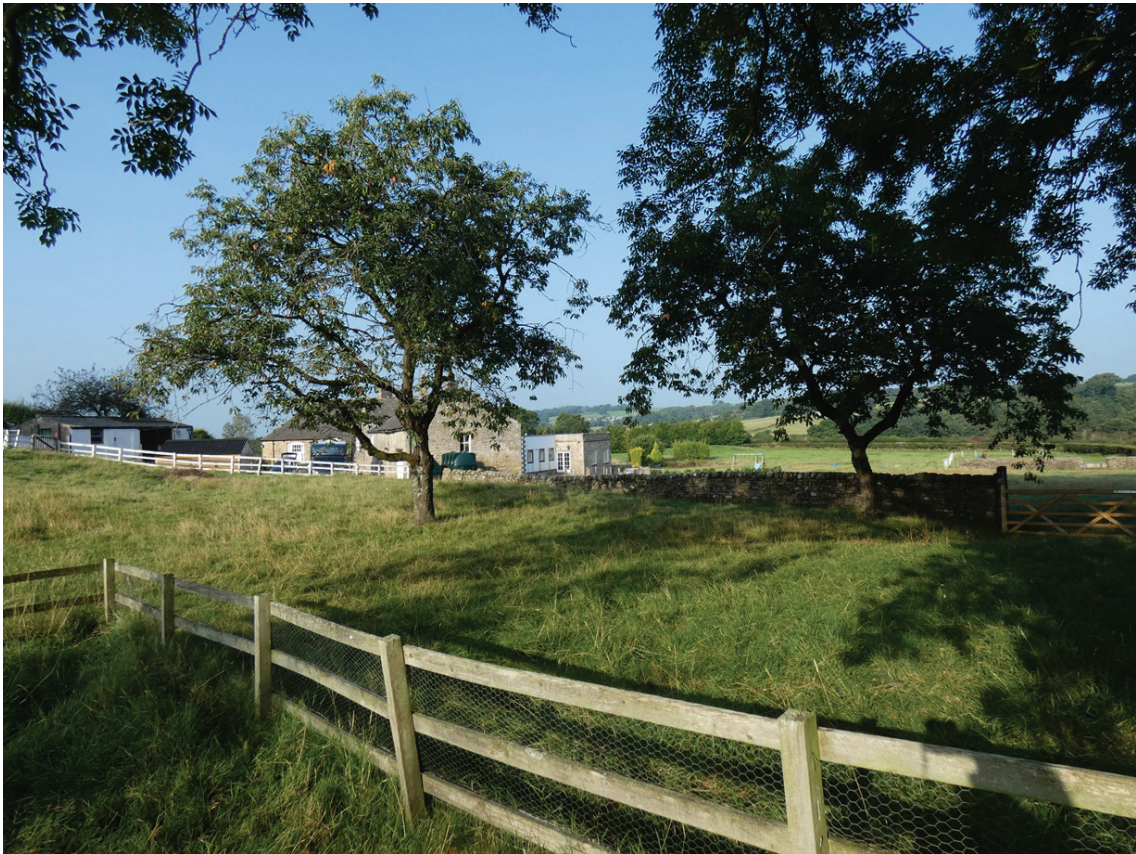
**Plate 13: Trees to be removed from the proposed area of the stables and yard**

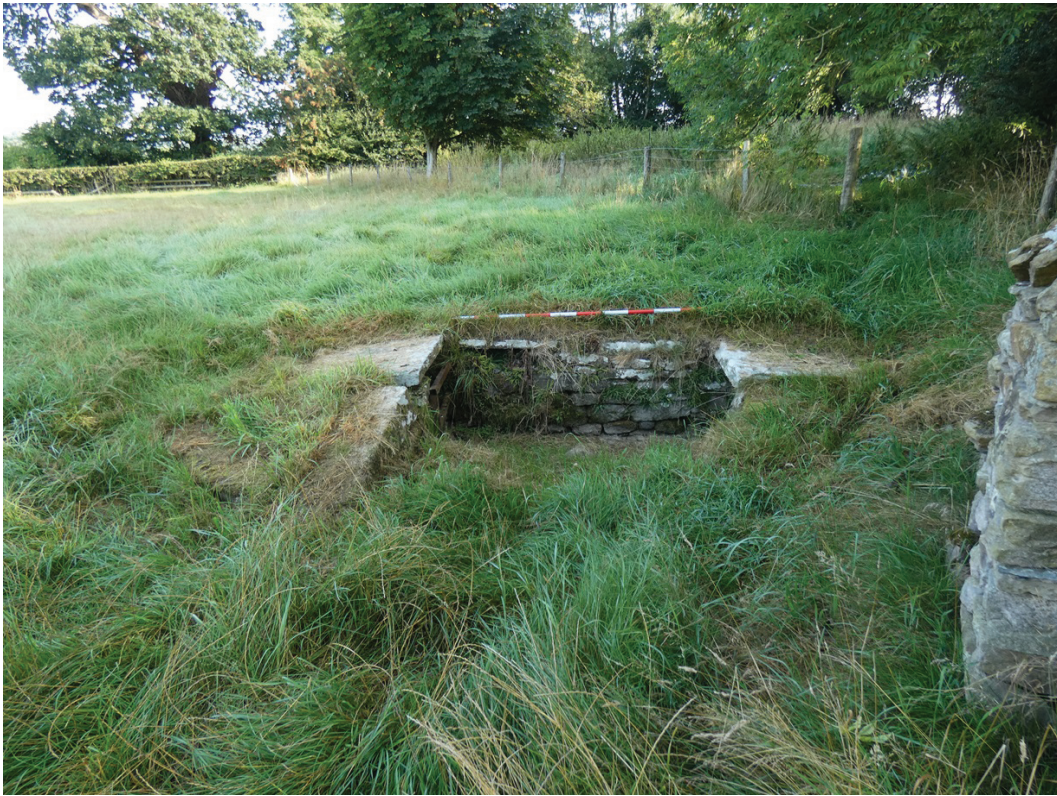
3.4.6 It was noted during the site visit that there are two sections of an open stone-lined water channel or 'culvert' in the field where the riding surface is to be located. The stone-lined channel to the east of the riding surface (Plate 23 to Plate 25) is potentially within the area of the work, but not within the footprint of the riding surface or stables proper. The section to the west (Plate 26 to Plate 28) is outside the area, but potentially helps identify the course of the channel. The existing sections of open culvert are known to the client and are to be retained (H Crabtree pers comm).

**Plate 23: Stone-lined channel to the east of the proposed riding surface, viewed from the south**

4.3.3 By positioning the riding surface as far to the north as is practicable (with regard to the location of a mature oak tree further to the north – H Crabtree pers comm), the existing sections of open culvert are to be retained and its route is to be avoided.

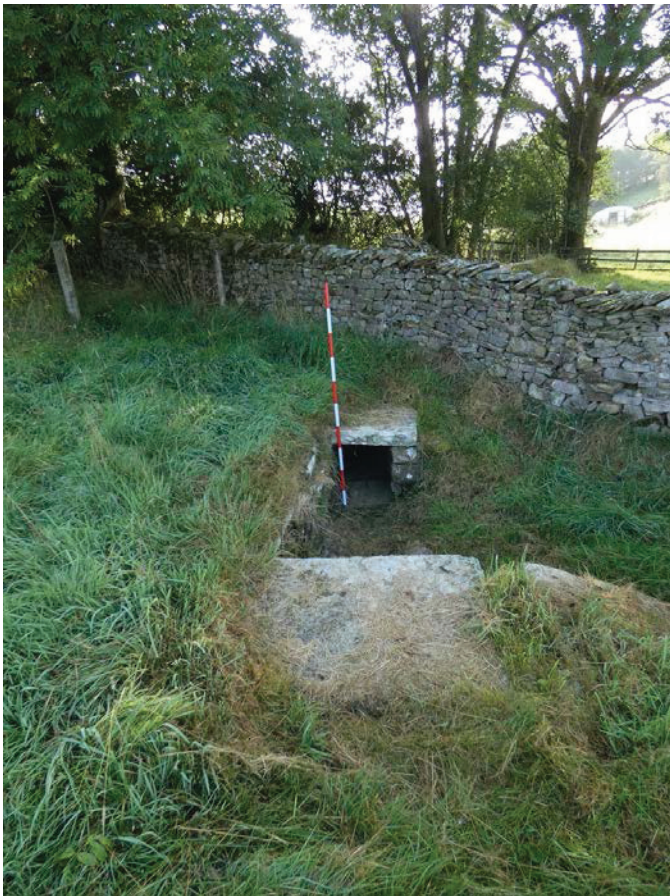
**Plate 24 (left): Stone-lined channel to the east of the proposed riding surface, viewed from the west**

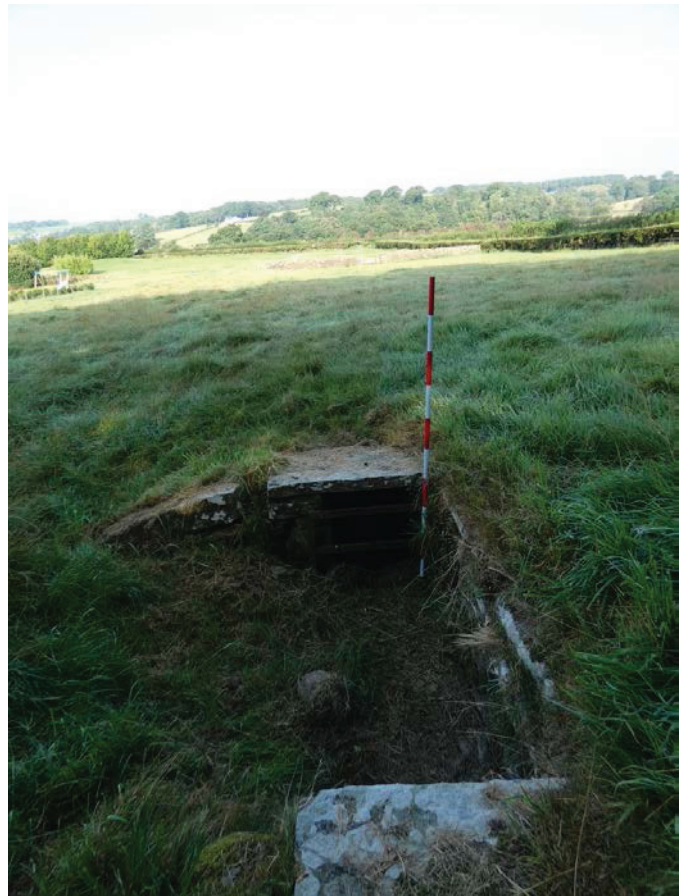
**Plate 25 (right): Stone-lined channel to the east of the proposed riding surface, viewed from the east**

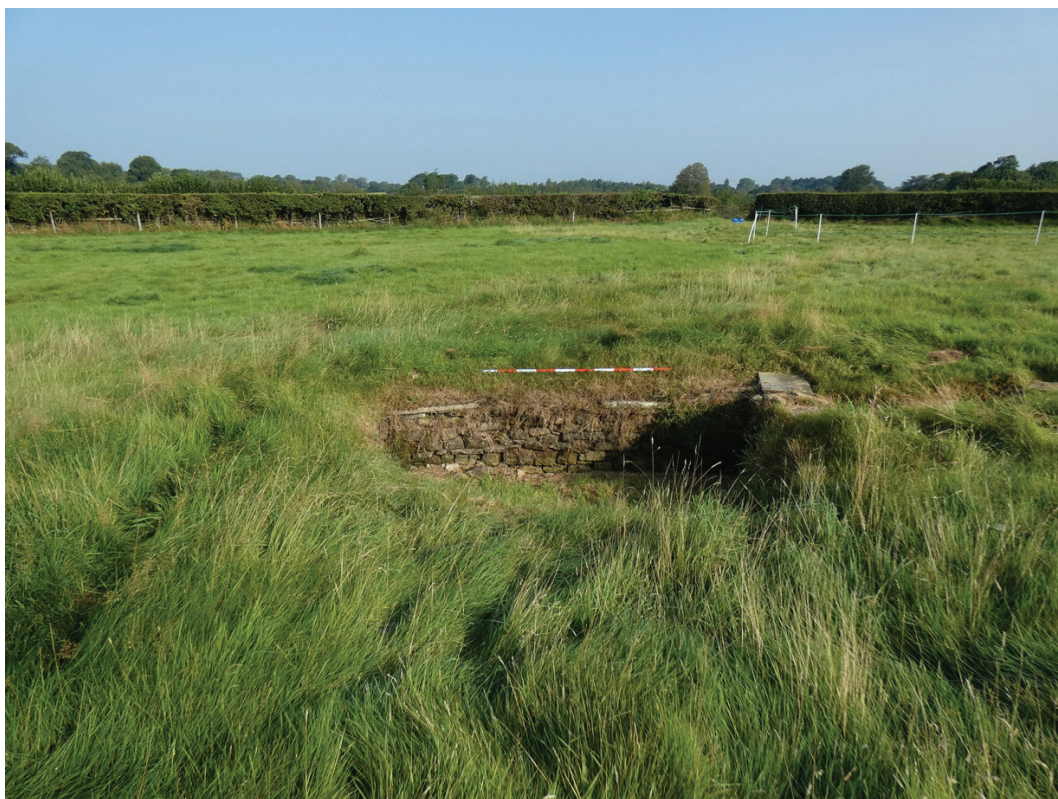
**Plate 26: Stone-lined channel to the west of the proposed riding surface, viewed from the south**

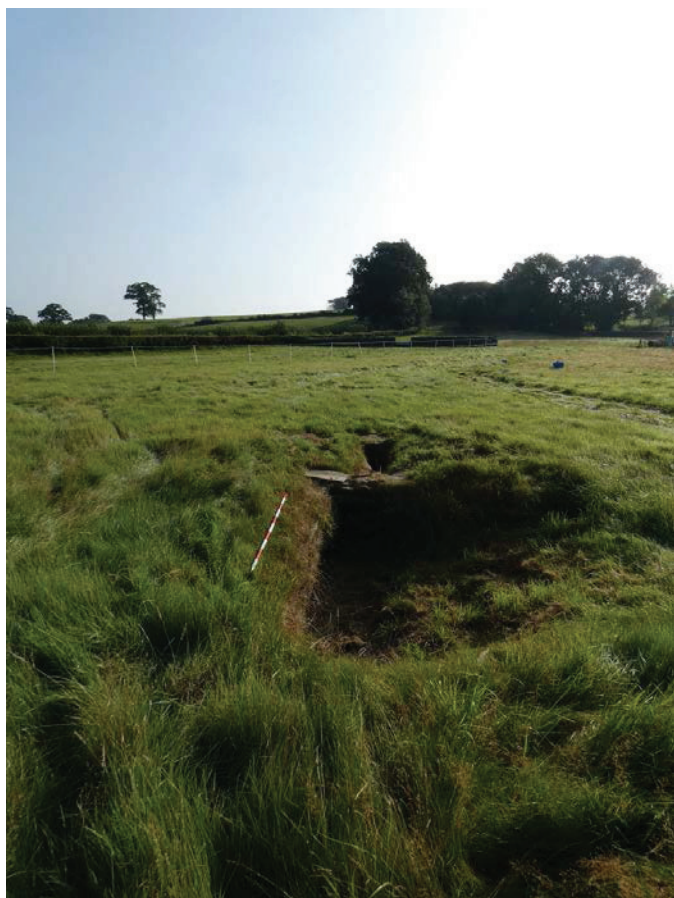
**Plate 27 (left): Stone-lined channel to the west of the proposed riding surface, viewed from the west**

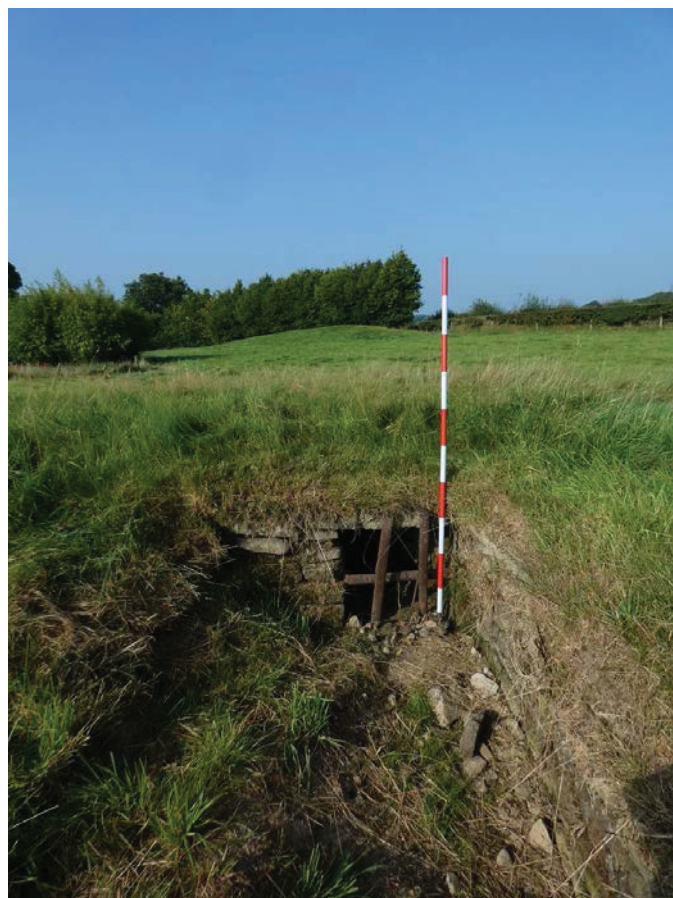
**Plate 28 (right): Stone-lined channel to the west of the proposed riding surface, viewed from the east**

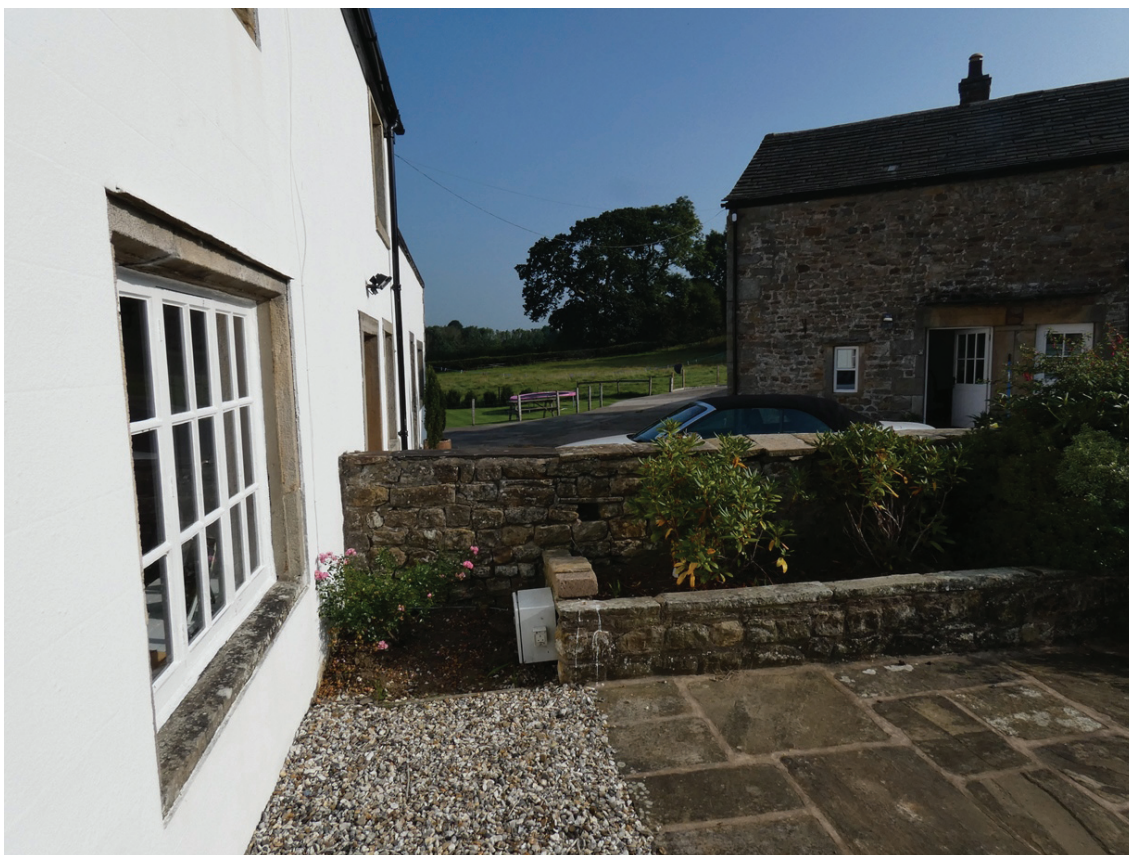
**Plate 30: View of the proposed riding surface along the east side of the farmhouse**

cottage through which the field can be viewed on approach to the cottage is also minimal (Plate 30). It should also be noted that the field is already in use as a paddock for horses.
