1 BREWERY MOUNT, ULVERSTON, CUMBRIA

Archaeological Building Recording

Planning	
Pre-planning?	No
Planning Application No.	SL/2021/0841
Plans (e.g. conversion, extension, demolition)	Demolition of existing 'barn' and creation of three new dwellings
Local Planning Authority	South Lakeland District Council
Planning Archaeologist	Jeremy Parsons, Cumbria County Council
Level of Building Recording required	Historic England Level 2

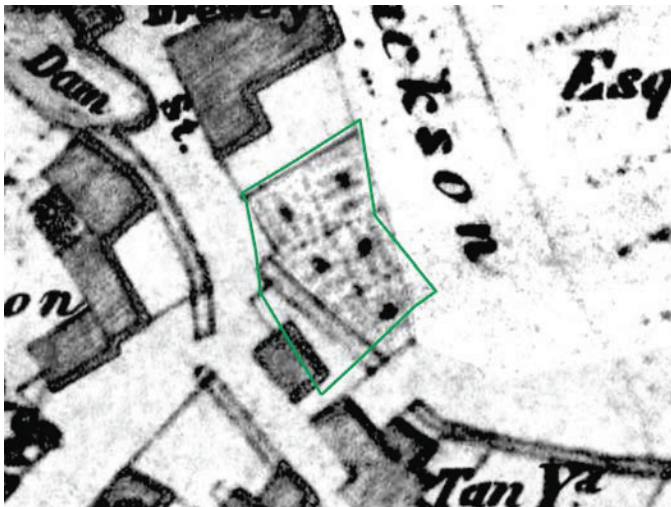
Plate 1 (left): Extract from Wood's map of 1832

3.1.1 **Wood's Plan, 1832:** the site is to the east side of Brewery Street and south of the 'Old Brewery' (Plate 1). Most of the site comprises gardens/allotments with an unidentified rectangular building to the south-west. There is a tannery nearby to the south and the land to the east of the area is owned by Mr. J. Jackson.

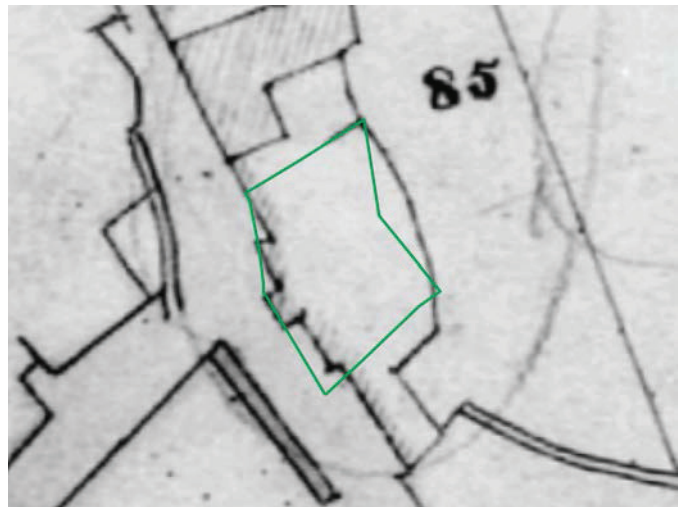
Plate 2 (right): Extract from the tithe map of Ulverston of 1849

3.1.2 **Tithe map, 1849:** the tithe map of Ulverston is not particularly informative about the site (NA IR 30/18/316 1850; Plate 2). It may show where the property boundary along Brewery Street steps out around the building shown on Wood's map of 1832, but this is very unclear (Plate 2; cf. Plate 1). The accompanying tithe apportionment lists the Plot 85, which may or may not include the area, as owned and occupied John Jackson and Company and it is described as 'Brewery Close' (NA IR 29/18/316 1849).

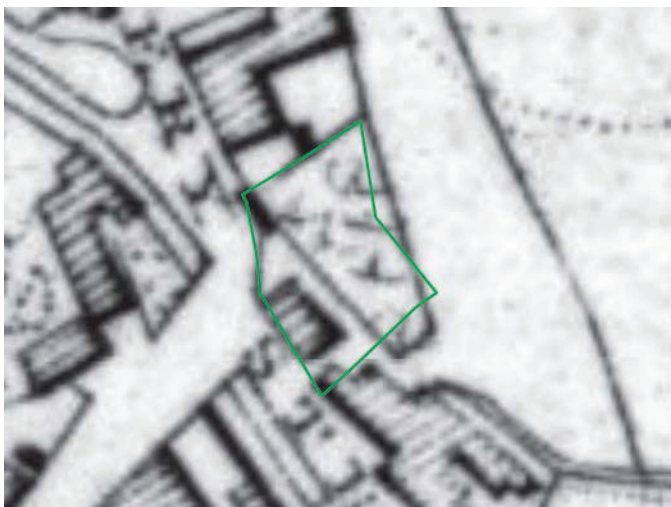
Plate 3 (left): Extract from the Ordnance Survey map of 1850

3.1.3 **Ordnance Survey, 1850:** the site is largely unchanged from Wood's map of 1832 (Plate 3; cf. Plate 1).

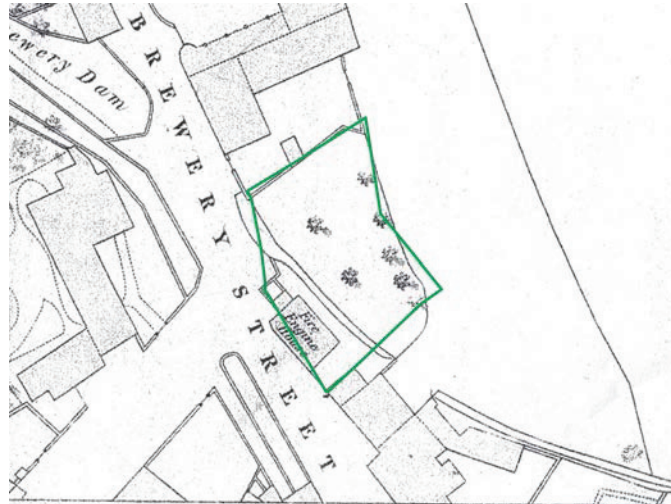
Plate 5: Extract from the Ordnance Survey map of 1852

3.1.5 **Ordnance Survey, 1852:** this is a more detailed Ordnance Survey map, which shows the internal divisions of buildings and other elements of the site (Plate 5). The building comprising the site, on the south-west side, is clearly labelled 'Fire Engine House' (Plate 5). A small building is located adjacent to the south side of the area.

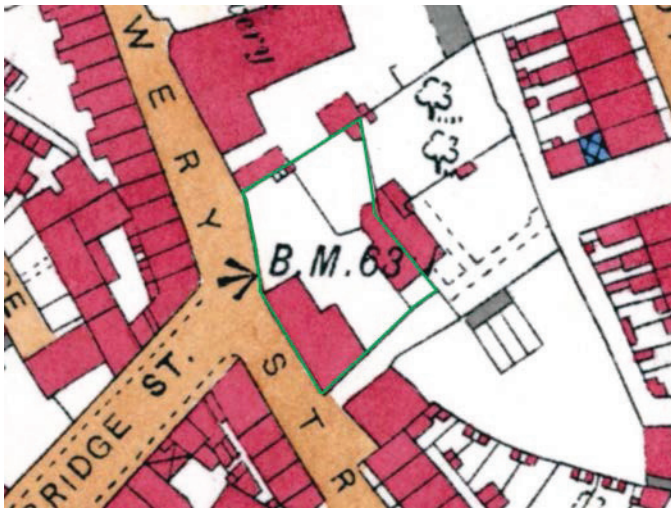
Plate 6 (left): Extract from the Ordnance Survey map of 1891

3.1.6 **Ordnance Survey, 1891:** substantial changes have been made to the site (Plate 6; cf. Plate 5). The east side of the site has been built upon and the south corner has been altered with additional / larger buildings. It is unclear if the building to the south incorporates elements of the fire engine house (Plate 6; cf. Plate 5). Two small outbuildings have also been built against the boundary of the Old Brewery site and rows of terraced houses have been built further to the south of the area along Brewery Street and along Burlington Street to the east of the area.

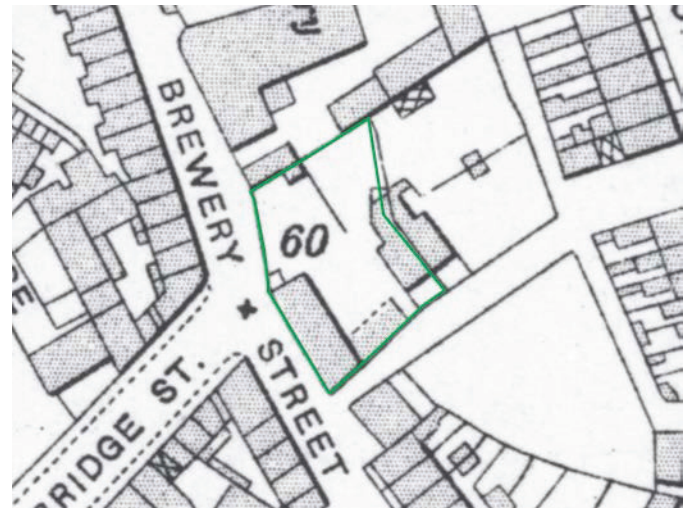
Plate 7 (right): Extract from the Ordnance Survey map of 1913

3.1.7 **Ordnance Survey, 1913:** further alterations have been made to the buildings on the site, most notably the addition of an open-fronted building along what is now Brewery Mount, which is the road linking Brewery Street and Burlington Street to the east (Plate 7; cf. Plate 6). One of the outbuildings to the north side of the area has been removed.

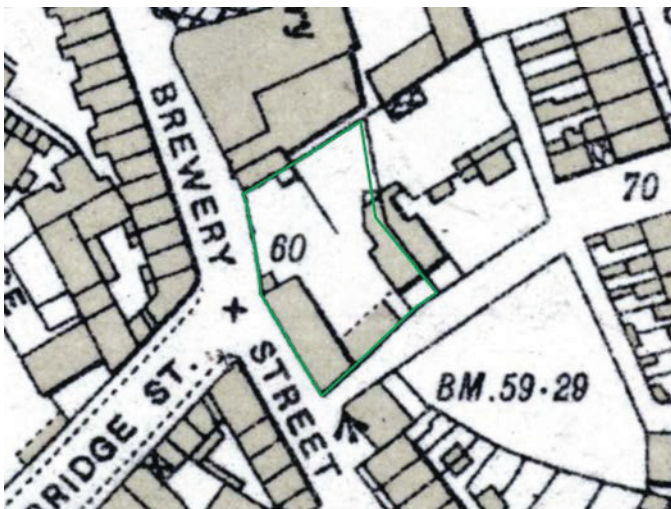
Plate 8 (left): Extract from the Ordnance Survey map of 1933

3.1.8 **Ordnance Survey, 1933:** some minor alterations appear to have been made to the buildings and outbuildings on the site (Plate 8; cf. Plate 7).

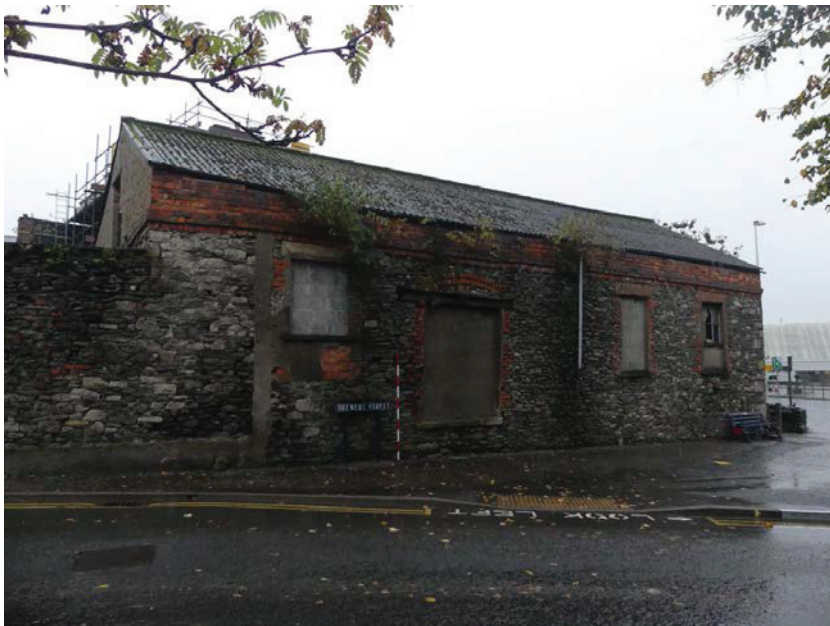
Plate 10: General view of the south-west external elevation, from the south-west

4.2.1 **South-west external elevation:** this is effectively the front of the building, facing onto Brewery Street (Plate 10). There are three similarly sized windows high off the ground, the north-west of which has a blocked or rebuilt section below in brick while the opening proper is blocked with concrete blocks and there is a yellow sandstone lintel above. There is an iron tie rod plate above the south-east side of this (Plate 11). The lower part of the south-east window is blocked with concrete blocks leaving an open window above with a fixed six-light casement and a red sandstone lintel above and to the north-west of this is another with a red sandstone lintel that is totally blocked with concrete blocks (Plate 12). North-west of the centre is a much larger window extending further toward the ground, which is entirely blocked, and the blocking finished with roughcast render that has a timber lintel with slate drip course and the remains of hung slate attached and a brick relieving arch above (Plate 11). All of the windows have brick in the jambs and the whole of the wall top is built in red brick, with a projecting band above an initial row of headers. The south-east end is finished with roughly dressed limestone quoins (Plate 11), while immediately north-west of the north-west window there is a band of render and north-west of this the upper part of the wall immediately below the brick has some small quoins but the wall otherwise appears to be continuous with the boundary wall, and continues to the north-west where it meets a large gateway with dressed sandstone quoins on the south-east side and the remains of some roughcast render (Plate 13).

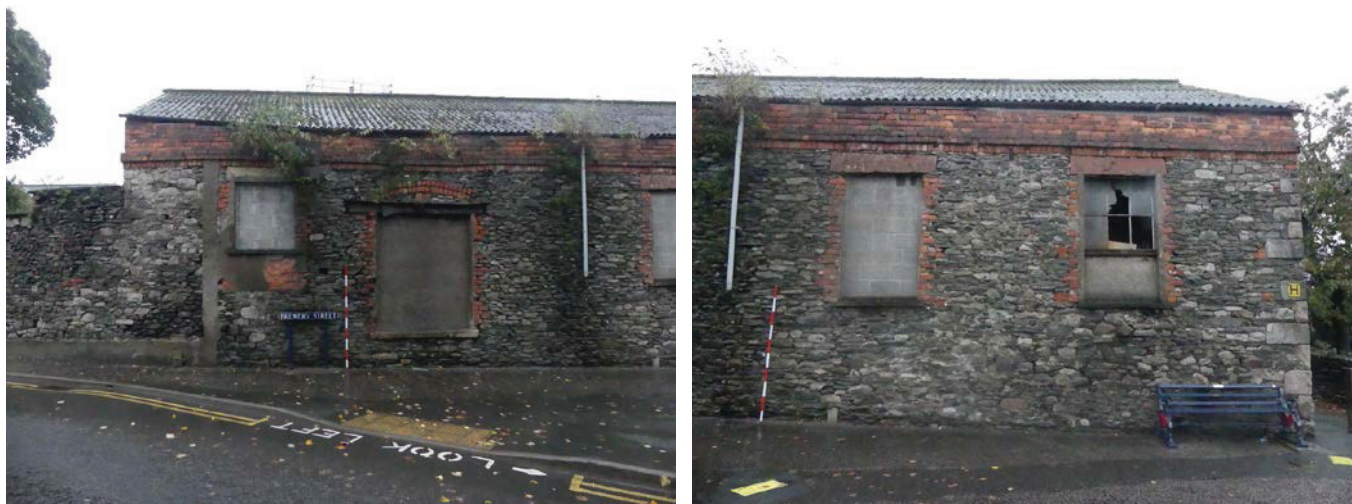
Plate 11 (left): The north-west end of the south-west external elevation, viewed from the south-west

Plate 12 (right): The south-east end of the south-west external elevation, viewed from the south-west

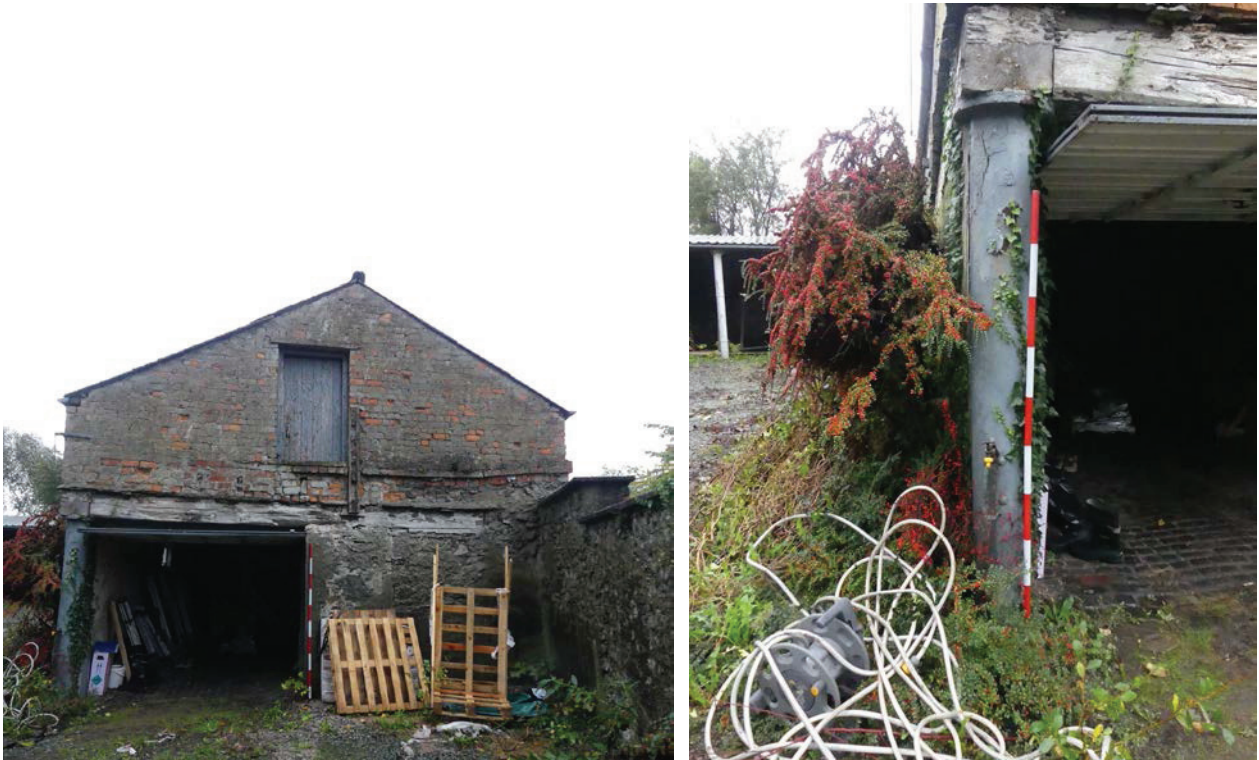
4.2.2 **North-west external elevation:** the south-west side comprises the gable end of the building and has a large doorway on the ground floor with a modern tilting metal garage door (Plate 14). The lintel for this comprises a massive timber beam, which extends over a window(?) on the south-west side blocked with stone and has a slate drip course over it. The north-east end joints into the beam in the north-east elevation and is supported by the same iron column (Plate 15). The upper section is brick laid in alternating headers and stretchers, with a projecting course on the south-west side. There is a first-floor loading doorway with a beaded plank and batten door and sandstone step and lintel. To the south-west of this a small iron I-beam is fixed to the wall, which is marked “[...]STEEL. 4”. The elevation is continued to the north-east, but set back, by the open-fronted outshut, which is supported by four iron columns with flanged round tops (Plate 16). The north-east end is machine-made red brick with a small tilting metal garage door.

Plate 14 (left): The south-west end of the north-west external elevation, viewed from the north-west

Plate 15 (right): Detail of the iron column on the north-east side of the north-west external elevation

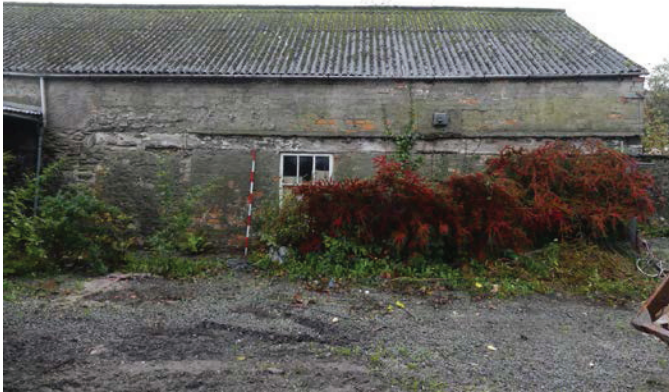
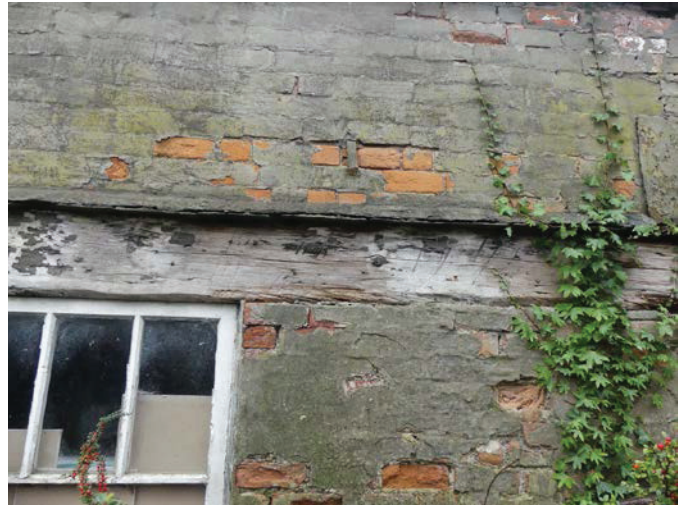
4.2.3 North-east external elevation: the main section of this is primarily constructed from brick, finished with limewash, but the lower part of this is apparently infilling a space below a massive timber beam (Plate 17). This has a slate drip course above, Baltic marks on this face (Plate 18) and is supported at the north end by a massive iron column with a round top plate. The infilled section has one extant window with a four-light casement (originally six-light?) and another window blocked with brick. The lower level at the south-east end is masonry where there is a doorway blocked with stone with a timber lintel (Plate 19) and a patch of modern render above. The upper level is of brick construction, laid

in stretcher bond, and also painted or finished with limewash and there is a large tie rod plate on the north-west side. This elevation continues below the roof of the open-fronted outshut (Figure 3) inside Room G3 (see *Section 4.3.3* below), although it is effectively continued by the side elevation of the outshut in the east corner, the upper part of which is plain machine-made brick laid in stretcher bond, while the lower part is hand-made brick (Plate 20).

Plate 17 (left): General view of the main part of the north-east external elevation, viewed from the east

Plate 18 (right): Detail of the beam in the north-east external elevation, viewed from the north-east

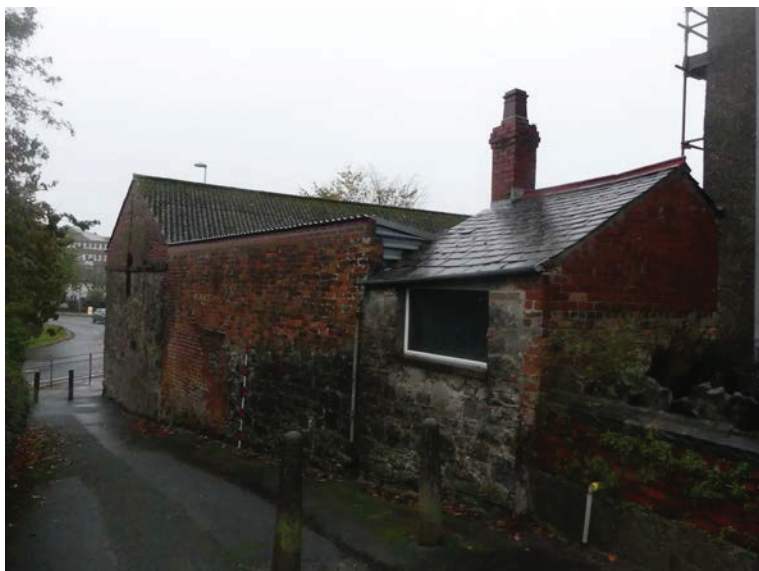
Plate 20 (left): General view of the south-east external elevation, viewed from the east

4.2.4 South-east external elevation: this comprises three different sections, facing onto Brewery Mount (Plate 20). The south-west side comprises the gable end of the building and is predominantly of rough rubble construction with the remains of an early gravelly roughcast render (Plate 21). There is a patch of brick on the south-west side, perhaps filling an opening or some form of repair, below which is the end of an iron I-beam. There is also a tie-rod plate to the north-east (Plate 22). The apex of the wall is built from red brick laid in stretcher bond, with a flat iron strap attached across it and two iron plates. The wall extends at ground floor level to the north-east, primarily in brick, laid as five rows of stretchers to one of alternating headers and stretchers, but this is apparently partly built on top of section of low stone wall, presumably a former boundary and immediately below the roof there are three courses of

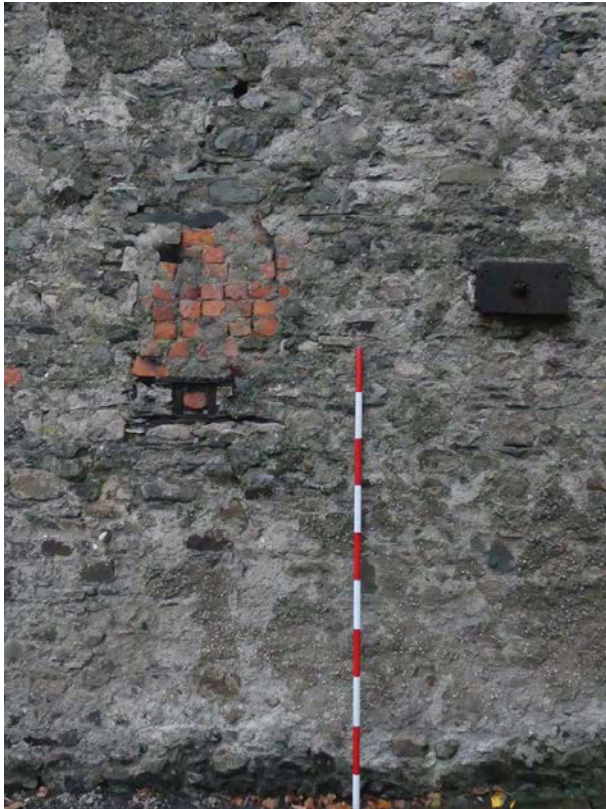
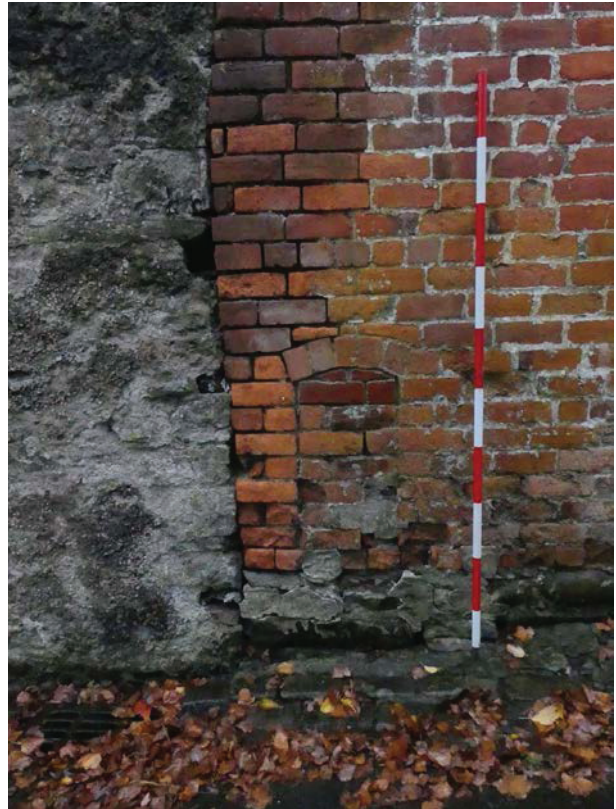
Plate 22 (left): Brick section, iron I-beam end and tie rod plate in the south-west end of the south-east external elevation, viewed from the south-east

Plate 23 (right): Blocked aperture in the south-east external elevation, viewed from the south-east

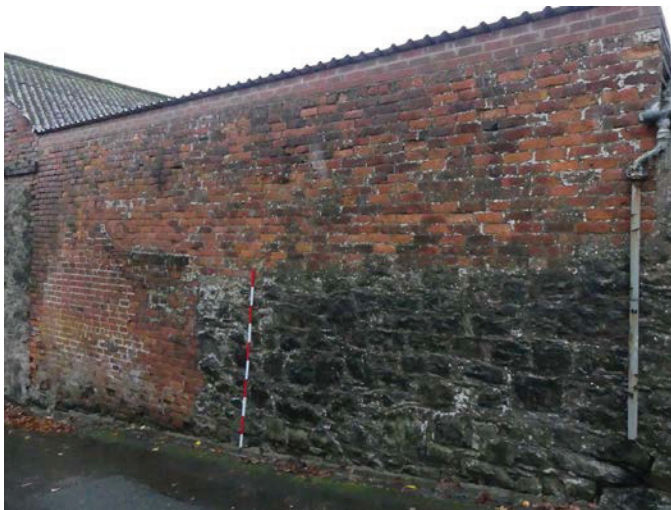
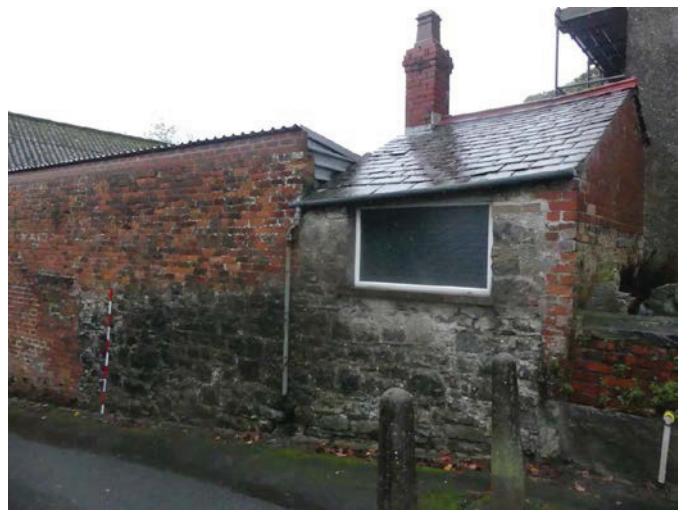
modern brick (Plate 24). On the south-west side, against the gable, there is a small opening with a brick arch, blocked with brick (Plate 24). At the north-west end it meets a small outshut constructed mainly from stone (apparently continuing from the boundary wall) but machine-made brick at the north-west end, which sits on one of the boundary stones of the adjoining front garden. It has a wide window with a single light casement and concrete sill. There is a brick chimney on the south-west side with a single ceramic pot (Plate 25).

Plate 24 (left): Central section of the south-east external elevation, viewed from the south-east

Plate 25 (right): North-east end of the south-east external elevation, viewed from the south-east

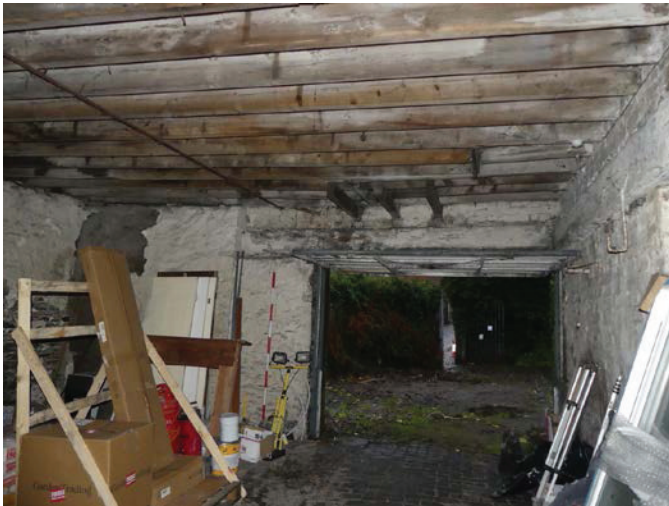
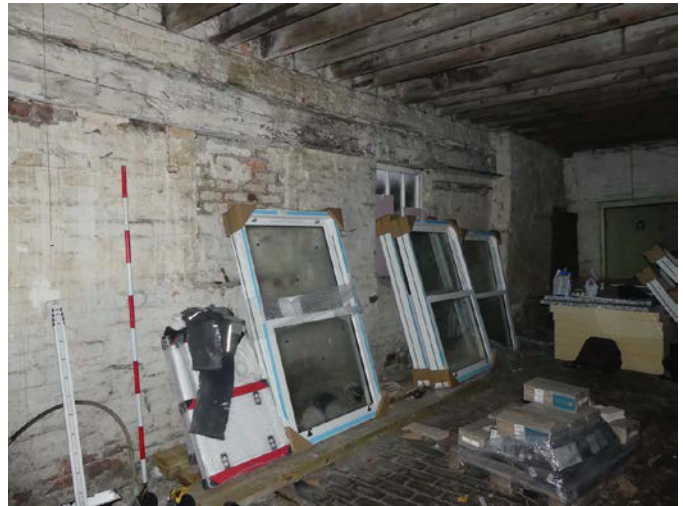
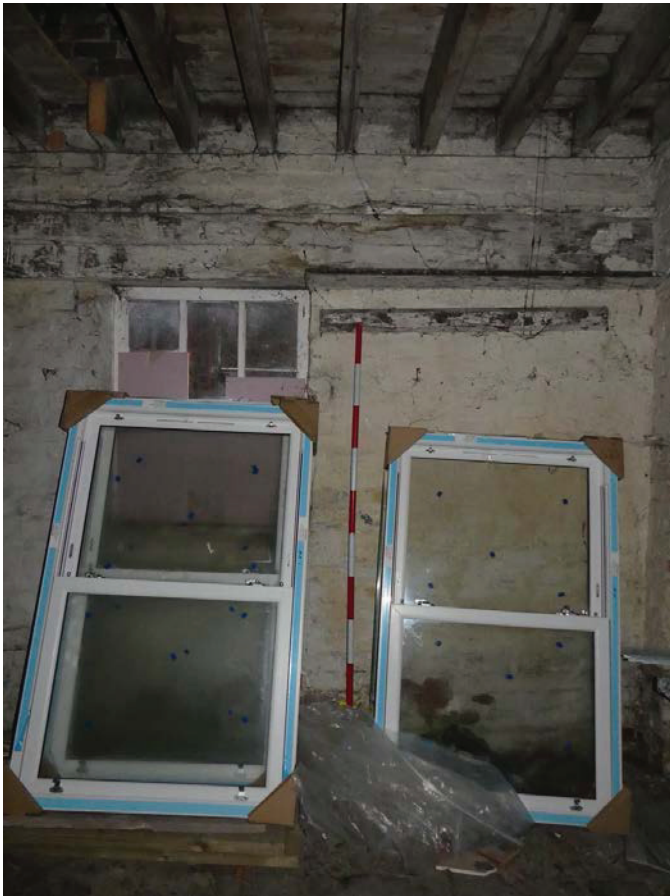
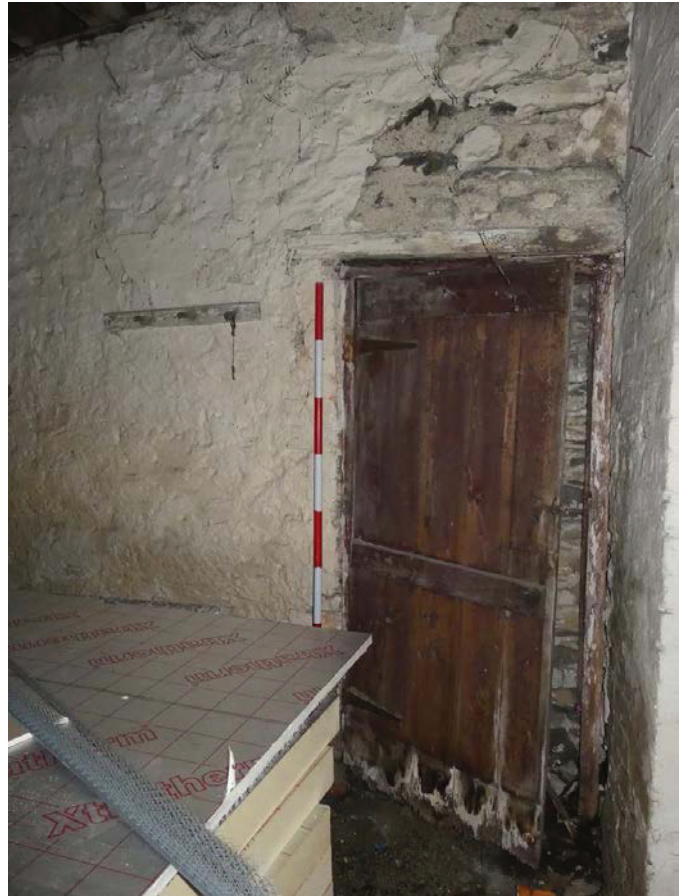
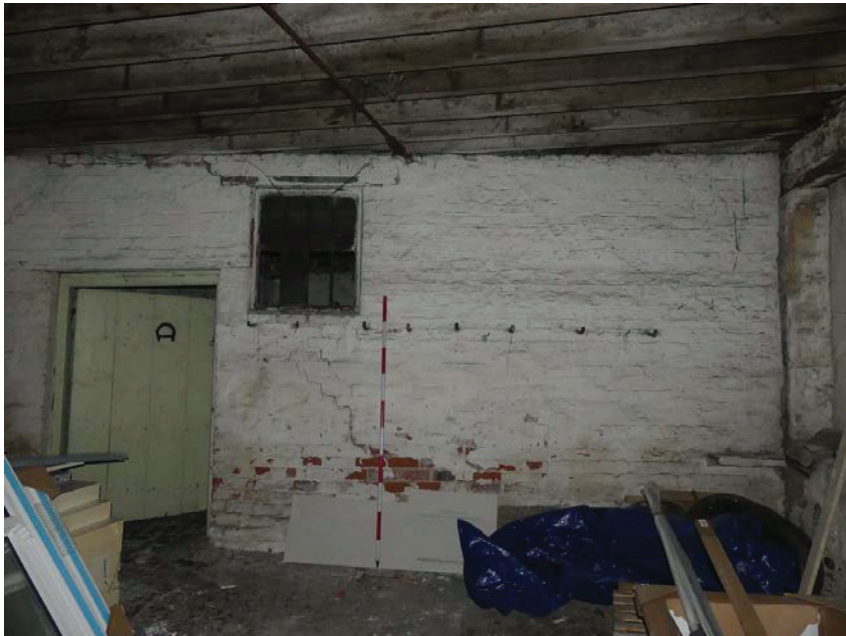
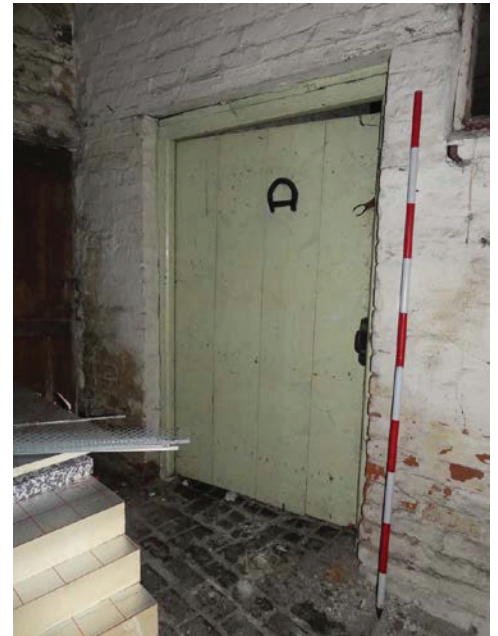
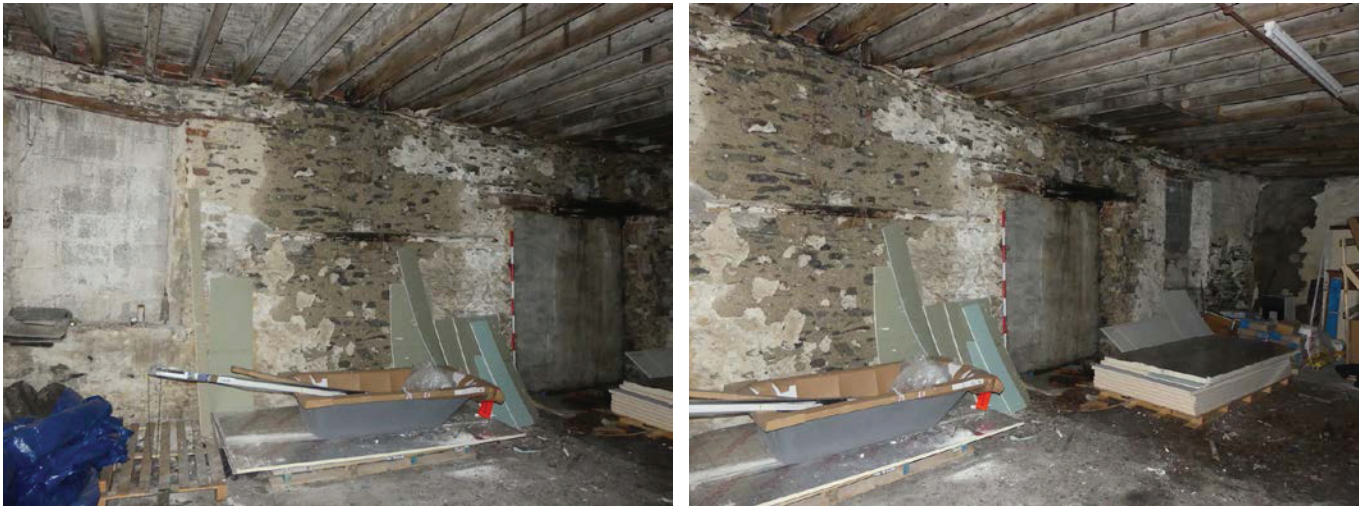
4.3.1 **Ground floor Room 1 (G1):** this room comprises the north-west end of the main building. The floor is a mix of brick, concrete and earth. The ceiling comprises the exposed, sawn joists and tongue and groove floorboards of the floor above. There is no access to the floor above from inside. There are tie rods north-west/south-east and north-east/south-west at the north-west side. The walls are roughly limewashed brick and stone. The **north-west elevation** has a garage door on the north-east side below a timber lintel (Plate 26). It steps at the end of this on the south-west side, with modern concrete on the south-west side. The **north-east elevation** has an alcove from a blocked window on the north-west side and an extant window to the south-east below a massive timber beam (Plate 27; Plate 28). The elevation then steps out at the south-east end and there is a doorway, with a plank and batten door still present (Plate 29); however, the door is blocked on the outside. The **south-east elevation** is formed by a brick division, with handmade brick in a stretcher bond butting the north-east and south-west walls (Plate 30). There is a wide doorway on the north-east side with a timber lintel and wide plank and batten door in a chamfered surround (Plate 31). The window to the south-west has eight fixed lights with a row of iron hooks. The **south-west elevation** has a former window at each end, surviving as an alcove with splayed jambs, blocked externally, with a timber lintel (Plate 32 and Plate 33). North-west of centre there is a wide opening, extending to the ground, with a rough timber lintel.

Plate 26 (left): North-west elevation of Room G1

Plate 27 (right): North-west end of the north-east elevation of Room G1

Plate 28 (left): Window and hooks on the north-east elevation of Room G1

Plate 29 (right): Doorway at the south-east end of the north-east elevation of Room G1

Plate 30 (left): South-east elevation of Room G1

Plate 31 (right): Doorway in the south-east elevation of Room G1

Plate 32 (left): South-east end of the south-west elevation of Room G1

Plate 33 (right): North-west end of the south-west elevation of Room G1

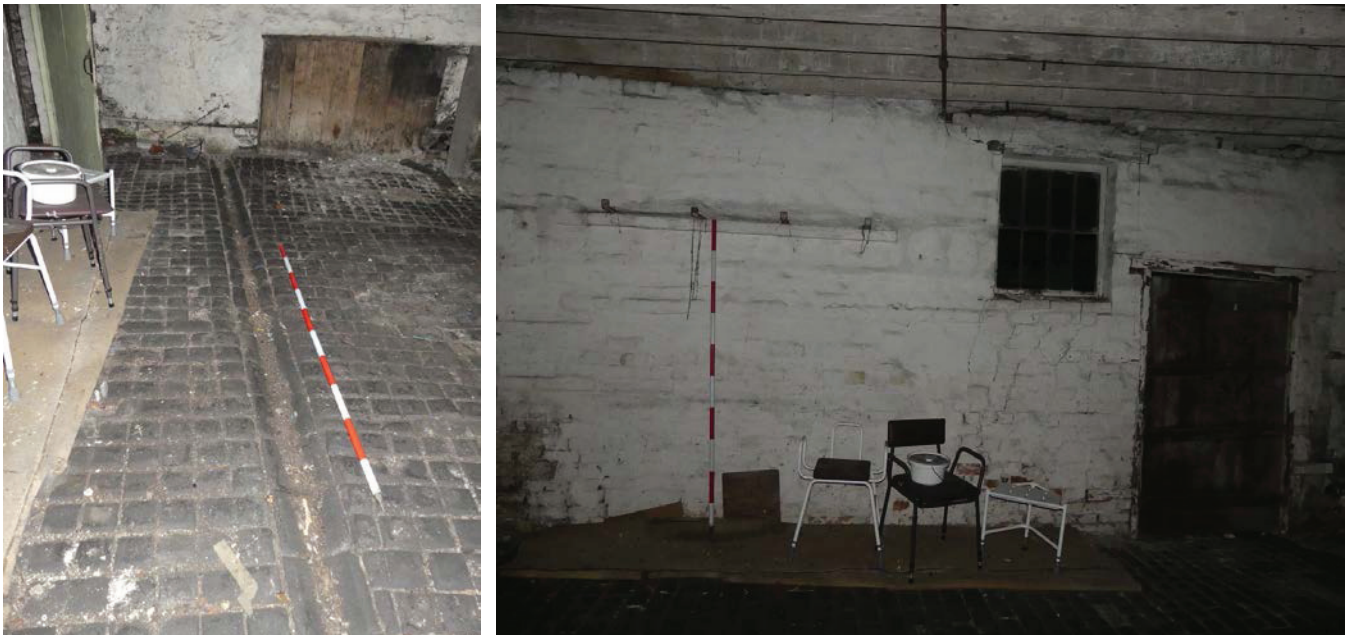
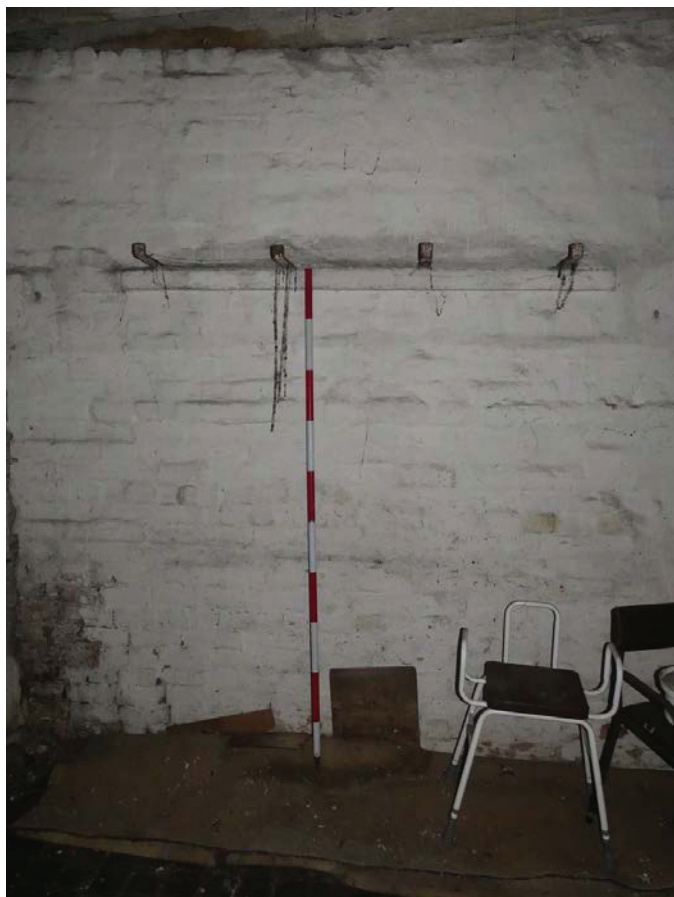
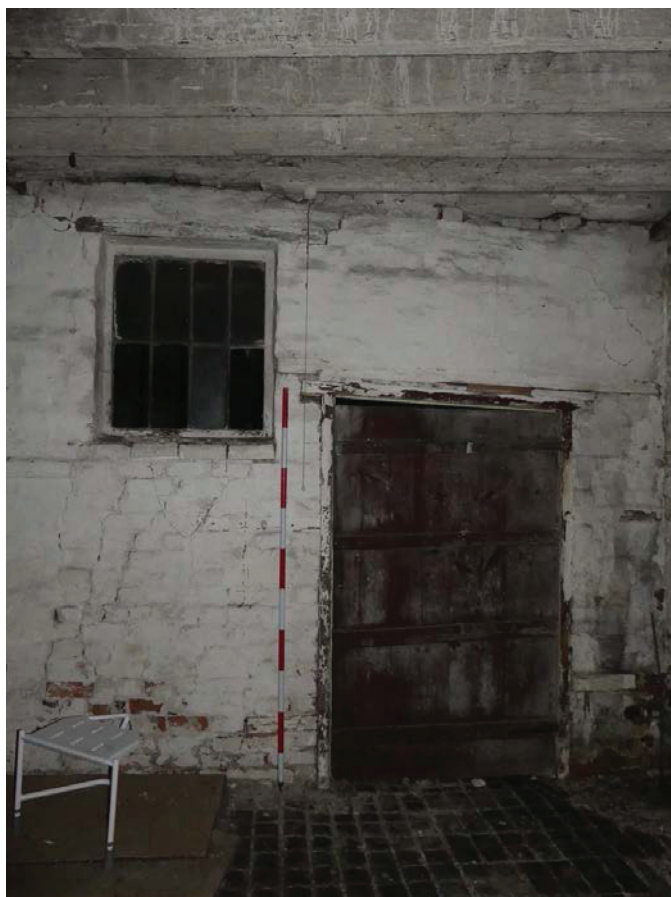
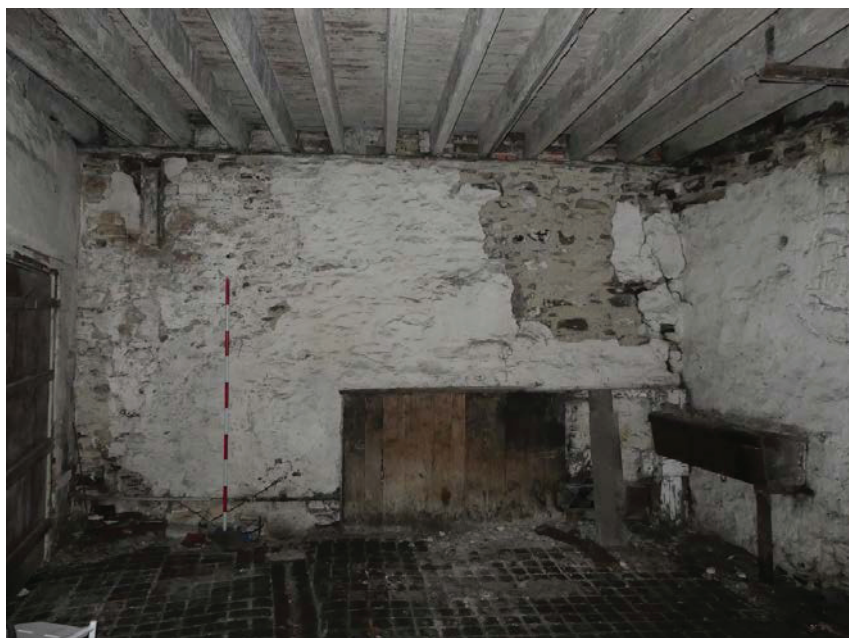
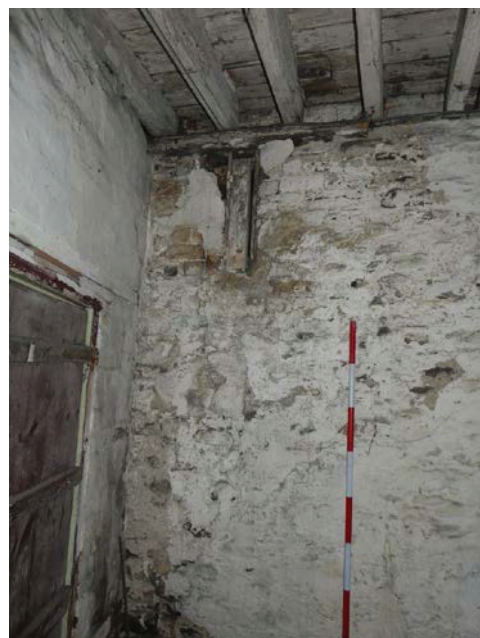
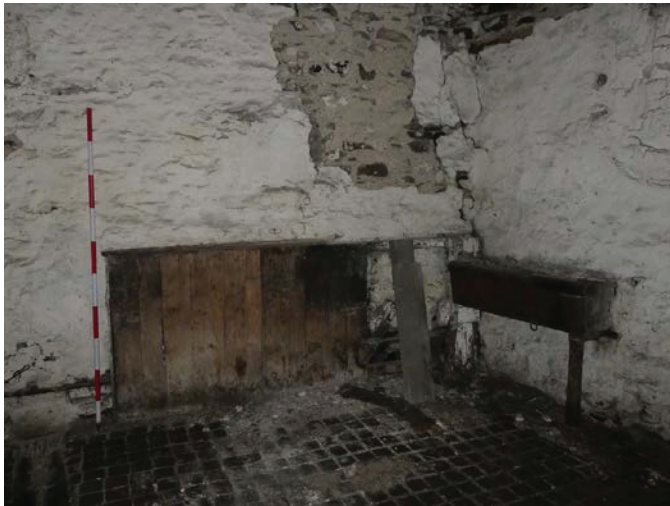
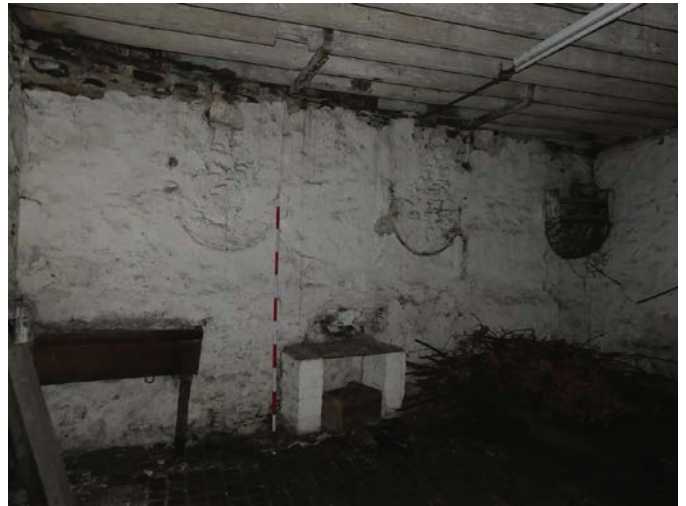
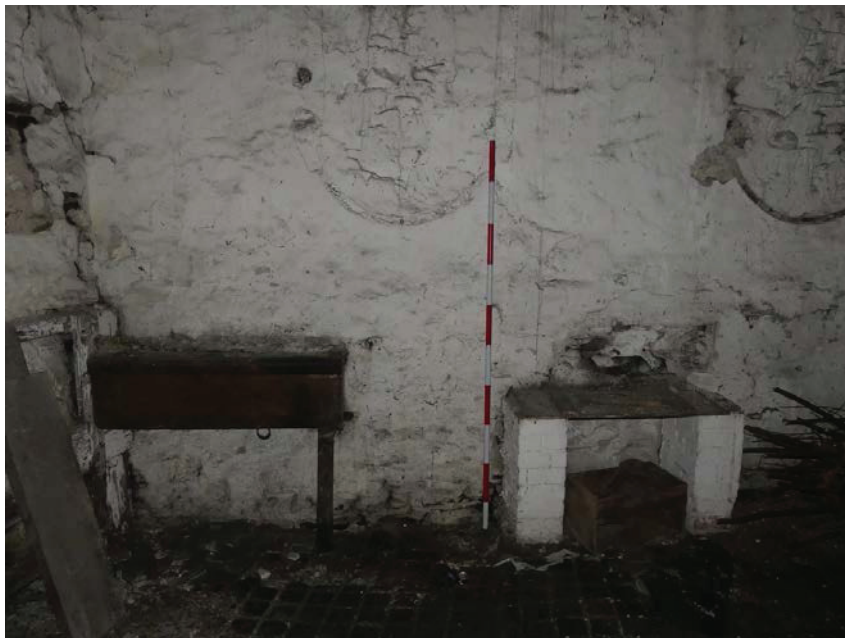
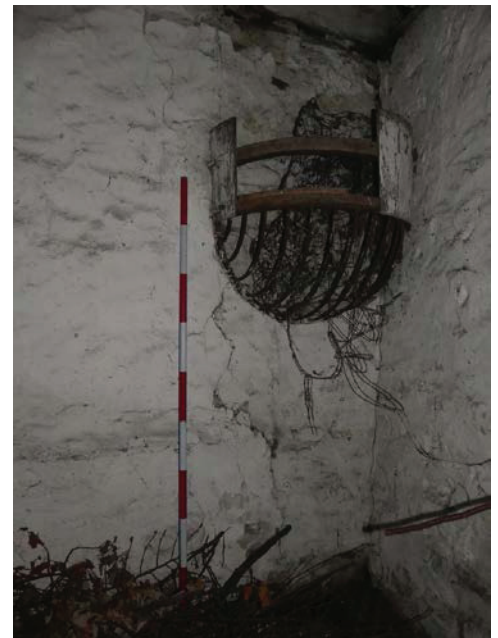
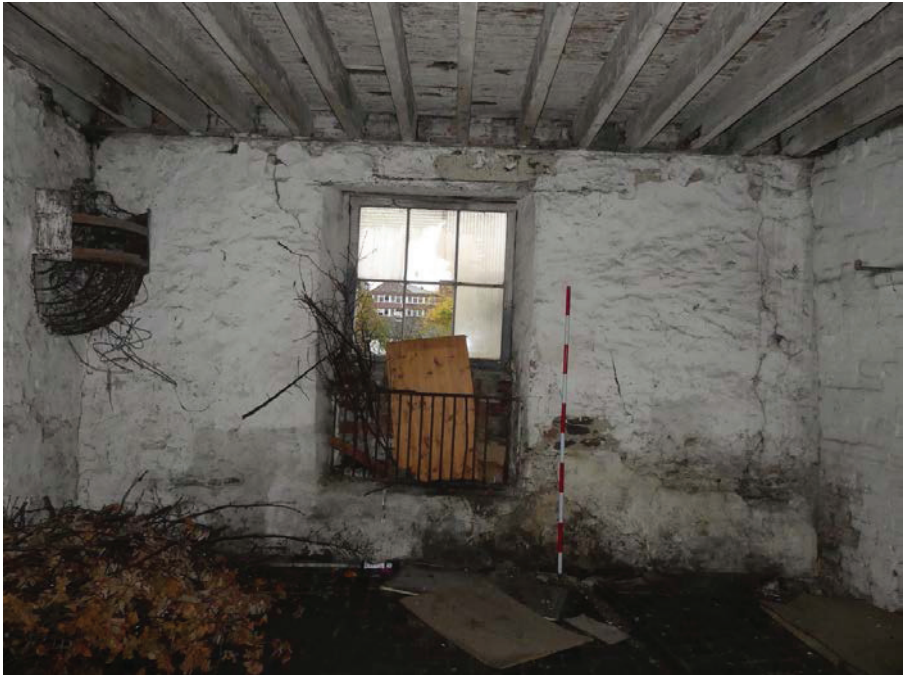
4.3.2 **Ground floor Room 2 (G2):** this is the south-east end of the main building. It has a gridded brick floor and a channel north-east/south-west on the north-west side (Plate 34) and scars of two stalls apparent from concrete in the floor and timbers in the ceiling. The ceiling comprises sawn joists and tongue and groove floorboards from the room above and the north-west/south-east tie rod from Room G1. The walls are mostly limewashed stone. The **north-west elevation** is limewashed brick with iron hooks on the south-west side and a window and door to the north-east (Plate 35, Plate 36, Plate 37) as described above (from Room G1). The **north-east elevation** has a small timber-lined aperture high on the north-west side with a plank door (Plate 38, Plate 39). The lower part of the south-east end of the elevation is covered by planks (Plate 40). The **south-east elevation** has a timber trough on the north-east side and a pair of brick bases with rough timber door on top to the south-west (Plate 41). There are two semi-circular scars for feed holders and one intact on the south-west side (Plate 42 and Plate 43) with a timber structure over scars of two stalls. The **south-west elevation** has a central window, with six lights in the top and sill below, with iron hanger set into the splayed jambs (Plate 44).

Plate 34 (left): Channel in the floor of Room G2

Plate 35 (right): North-west elevation of Room G2

Plate 36 (left): Hooks on the north-west elevation of Room G2

Plate 37 (right): Window and doorway in the north-west elevation of Room G2

Plate 38 (left): North-east elevation of Room G2

Plate 39 (right): Small aperture in the north-east elevation of Room G2

Plate 40 (left): Planks and trough in the east corner of Room G2

Plate 41 (right): South-east elevation of Room G2

Plate 42 (left): Detail of scar from feed holders and brick base against south-east elevation of Room G2

Plate 43 (right): Feed holder in the south corner of Room G2

Plate 44: South-west elevation of Room G2

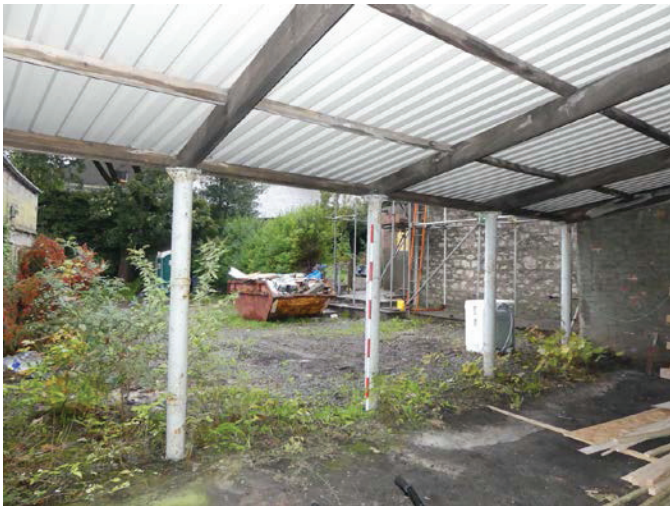
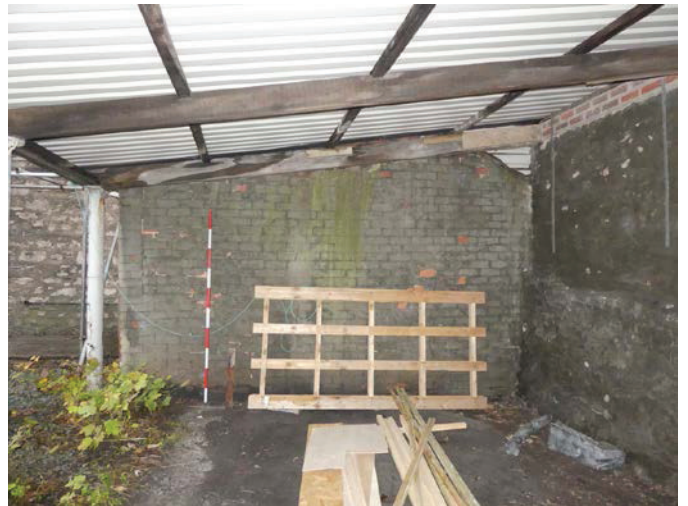
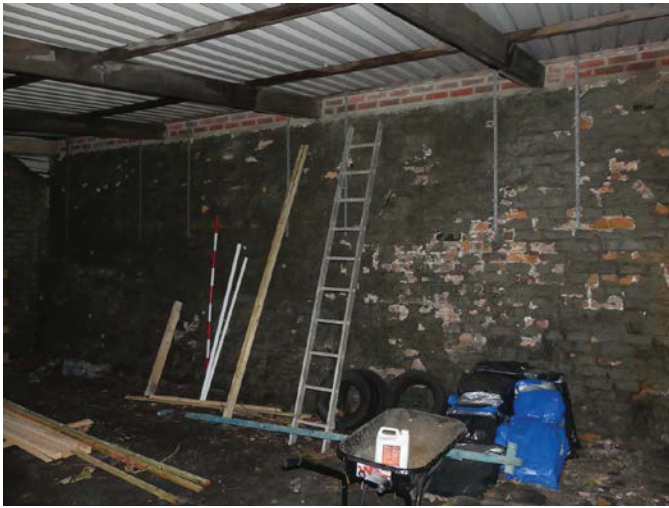
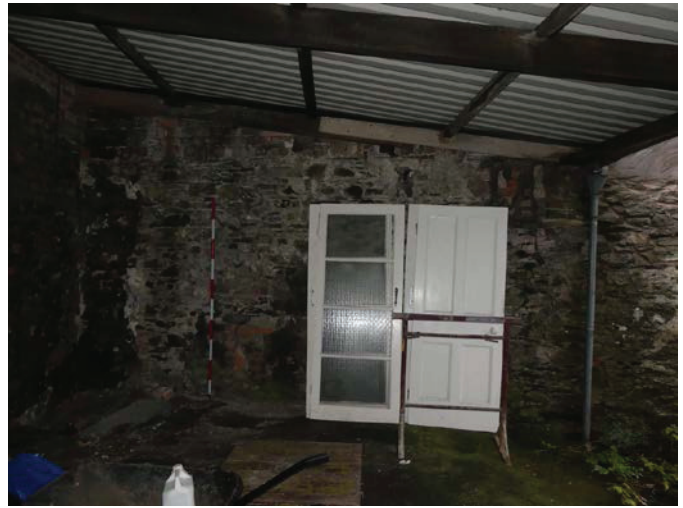
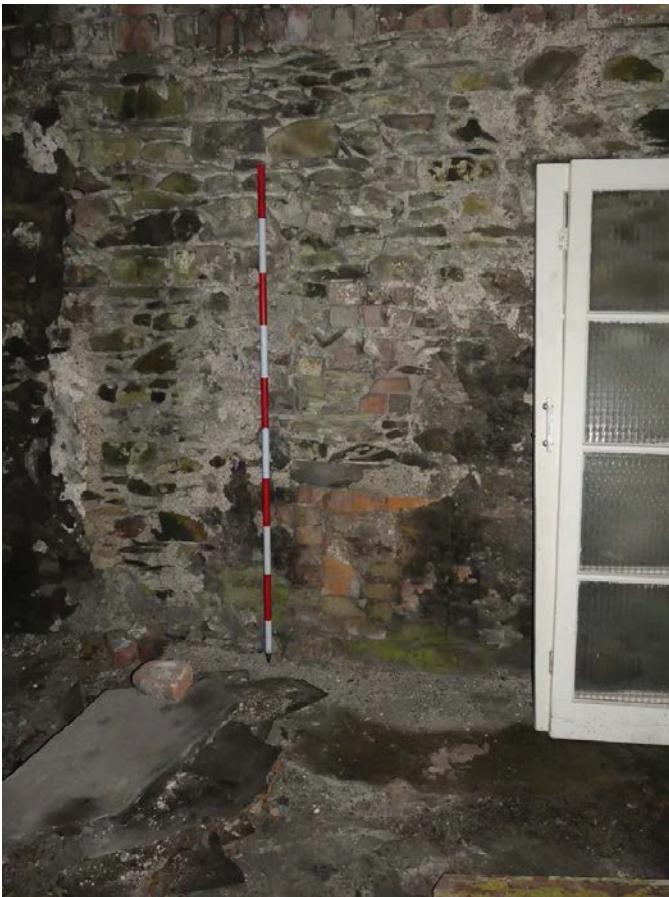
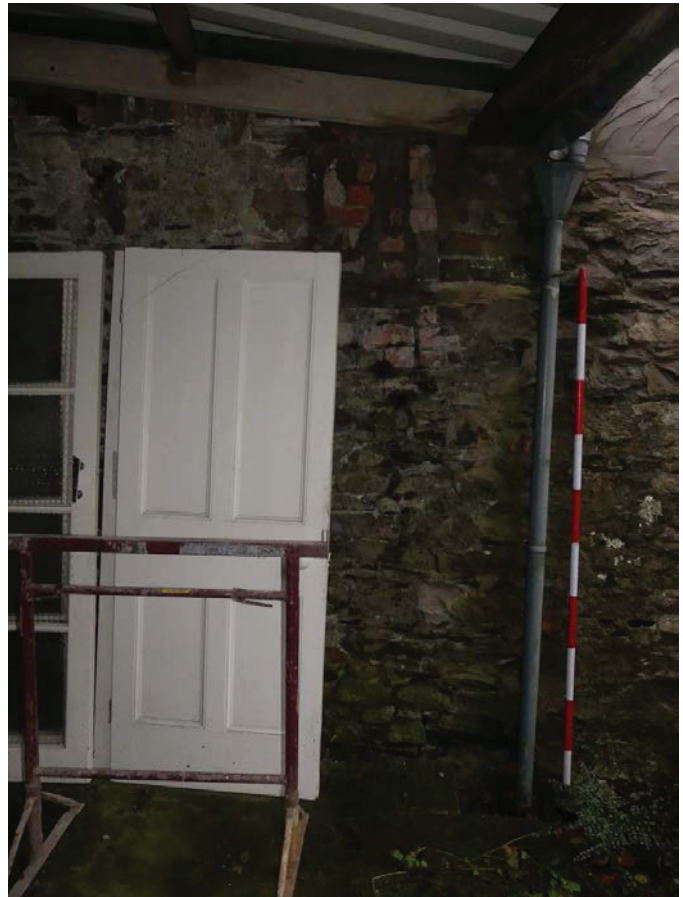
4.3.3 **Ground floor Room 3 (G3):** this room comprises an open-fronted section to the north-east side of the main building. There is no wall to the north-west, it simply comprises four columns supporting the wall plate (Plate 45). The roof is modern corrugated metal. The **north east elevation** is painted, late brick (Plate 46). The **south-east elevation** is mostly painted handmade brick and projects out on the lower part of the north-east end (visible to the right in Plate 46; Figure 3). This is the original boundary wall and there is modern brick at the top of the elevation below the roof (Plate 47). The **south-west elevation** has stone and some brick patching and rebuild (Plate 48), and two small infilled apertures (Figure 3), one low on the south-east side (Plate 49) and one higher up on the north-west side (Plate 50).

Plate 45 (left): North-west elevation of Room G3

Plate 46 (right): North-east elevation of Room G3

Plate 47 (left): General view of the south-east elevation of Room G3

Plate 48 (right): South-west elevation of Room G3

Plate 49 (left): Detail of lower blocked feature in the south-west elevation of Room G3

Plate 50 (right): Detail of upper blocked feature in the south-west elevation of Room G3
