1 BREWERY MOUNT, ULVERSTON, CUMBRIA

Archaeological Building Recording

Planning	
Pre-planning?	No
Planning Application No.	SL/2021/0841
Plans (e.g. conversion, extension, demolition)	Demolition of existing 'barn' and creation of three new dwellings
Local Planning Authority	South Lakeland District Council
Planning Archaeologist	Jeremy Parsons, Cumbria County Council
Level of Building Recording required	Historic England Level 2

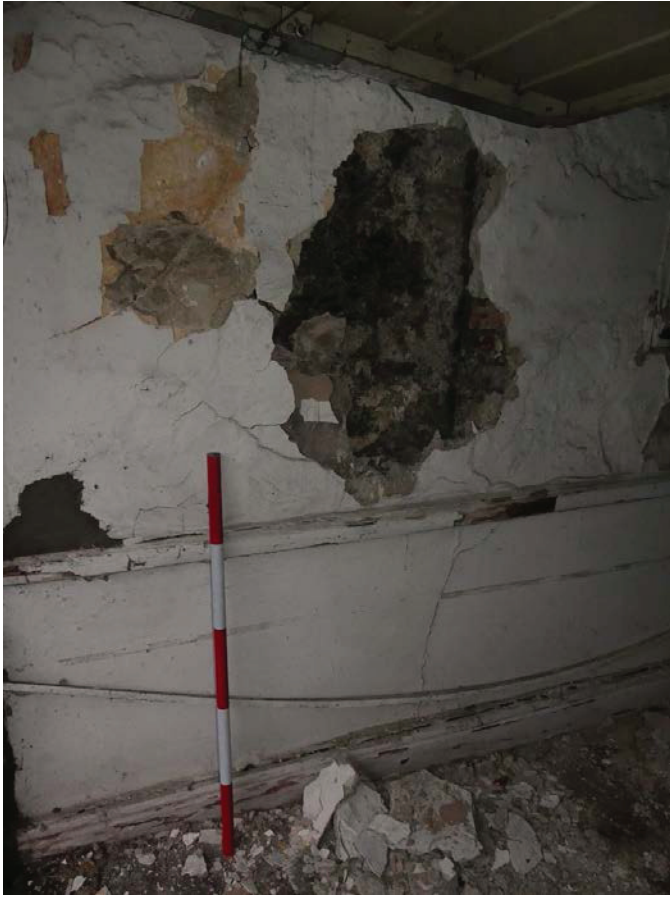
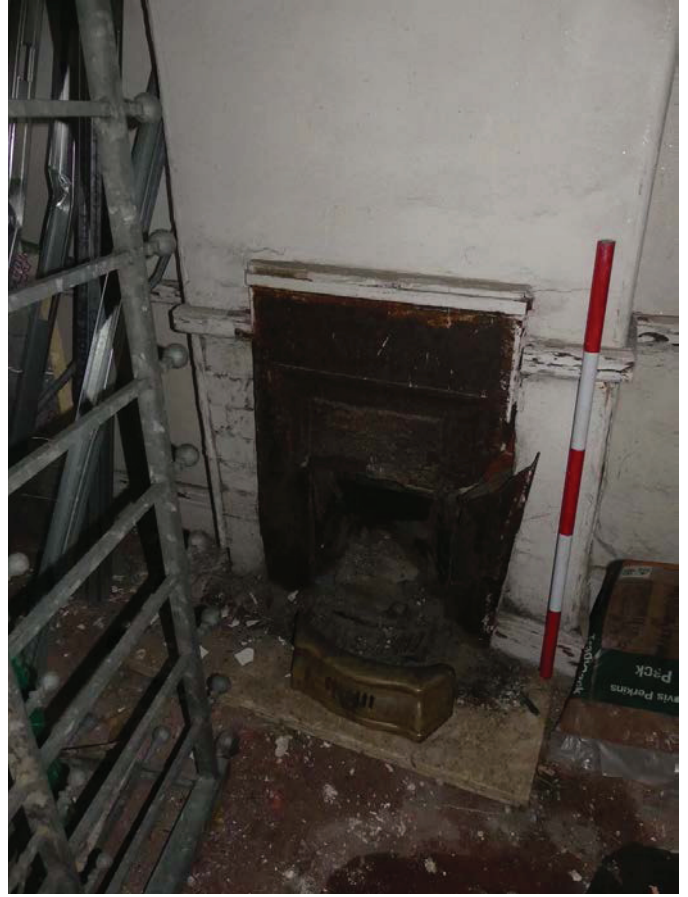
4.3.4 **Ground floor Room 4 (G4)**: this room comprises an outshut north-east of the open-fronted section (Room G3). It has a concrete floor, the walls are plastered and painted and it has a dado rail, with a garage door to the north-west. Some of the plaster has been removed on the **north-east elevation**, showing butt joint of stone and brick in the wall (Plate 51). There is a long and narrow window in the **south-east elevation** with a timber sill. The **south-west elevation** has battens with hooks to the north-west and south-east, either side of a central projecting chimneybreast with small fireplace. This has a fairly plain, iron surround (Plate 52), with shelf on brackets to the north-west.

Plate 51 (left): North-east elevation of Room G4

Plate 52 (right): South-west elevation of Room G4

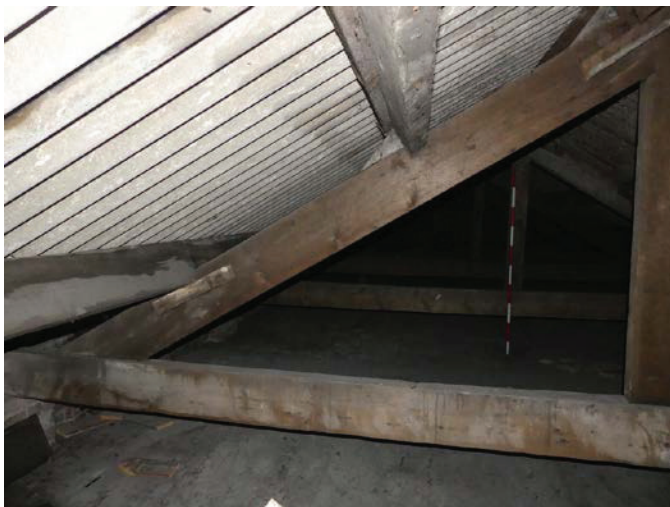
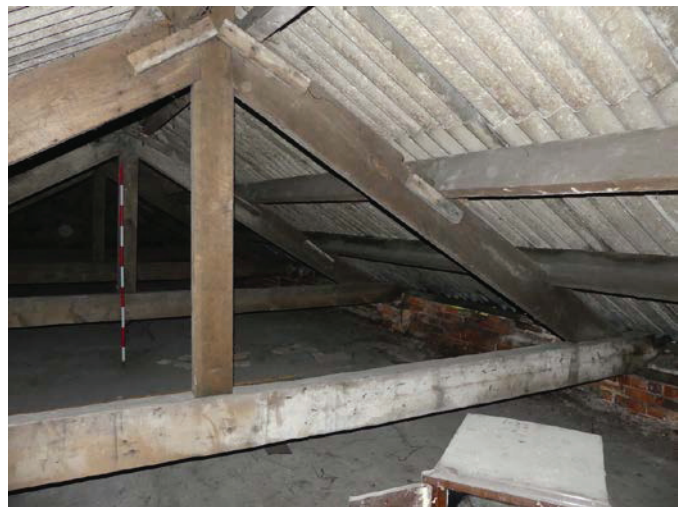
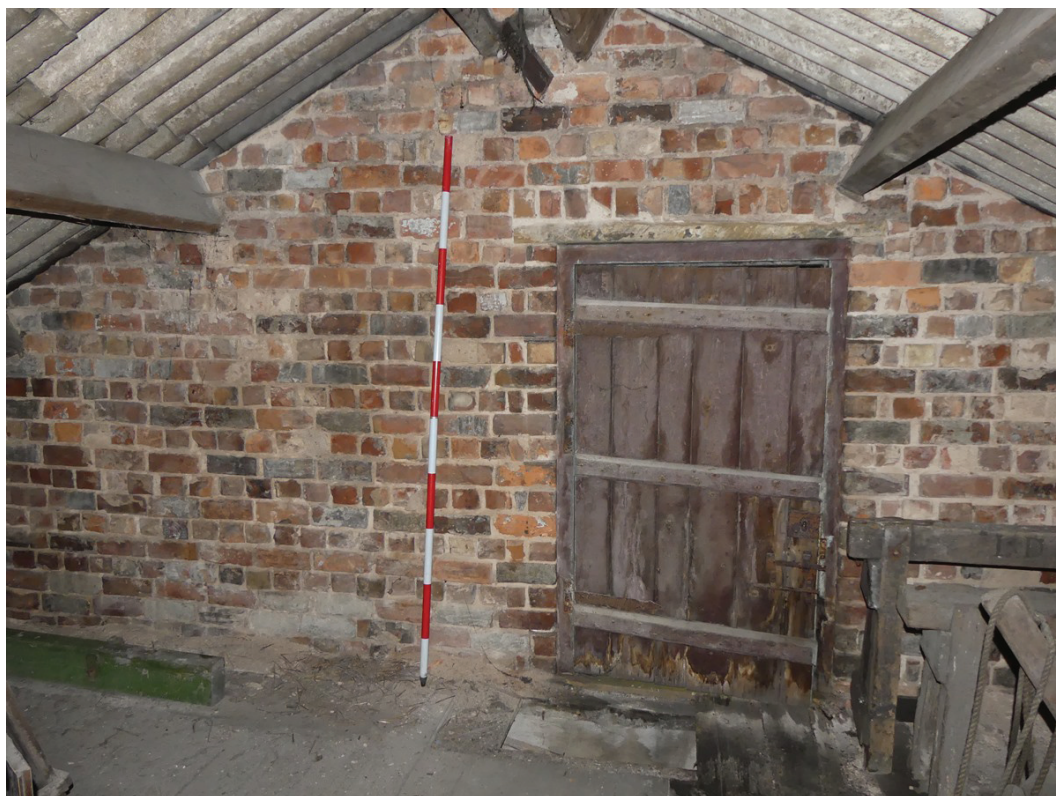
4.3.5 **First floor Room 1 (F1)**: this room has tongue and groove floorboards and a corrugated concrete roof supported by four trusses, each with a king post notched to meet principals and bolted to the tie beam (Plate 53 and Plate 54; Figure 7). All the timber is sawn, with very limited carpenter's marks. There are brick walls to the north-west and south-east, alternating header/stretcher to the north-west and a mix of Flemish and stretcher to the south-east. The tie beams sit on projecting buttresses at either end in the south-west and north-east brick walls. Access is from a loading door in the **north-west elevation**, with a stone lintel and plank and batten door (Plate 55).

Plate 53 (left): North-east side of a truss in Room F1

Plate 54 (right): South-west side of a truss in Room F1

Plate 55 (left): North-west elevation of Room F1
