# DERBY HOME, PATHFINDERS DRIVE, LANCASTER, LANCASHIRE

## Archaeological Building Recording

Client: Oakmere Homes

May 2022

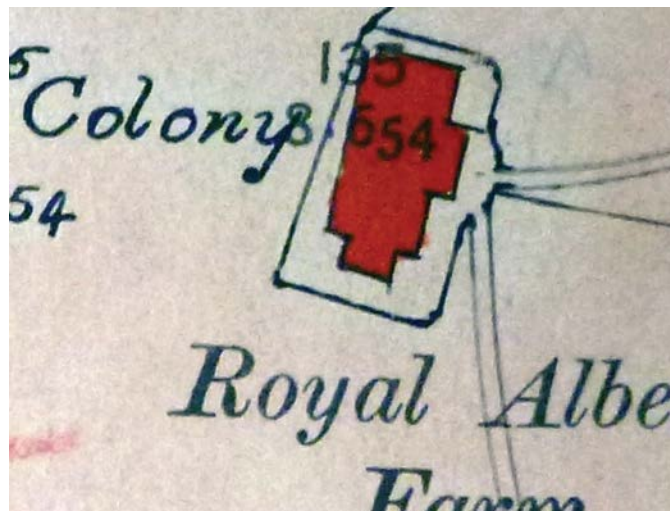
Plate 1: Extract from an estate plan of 1913

3.1.3 **Estate plan, c1913:** this is an estate plan of the whole of the Royal Albert Hospital marked on a copy of the 1913 Ordnance Survey map, which has been amended to include Derby Home (LRO HRRA/50/43 1913; Plate 1). It is clearly labelled 'Farm Colony' on this map but is shown slightly further to the north and slightly rotated to the north-east relative to its final position (Plate 1; cf. Plate 5).

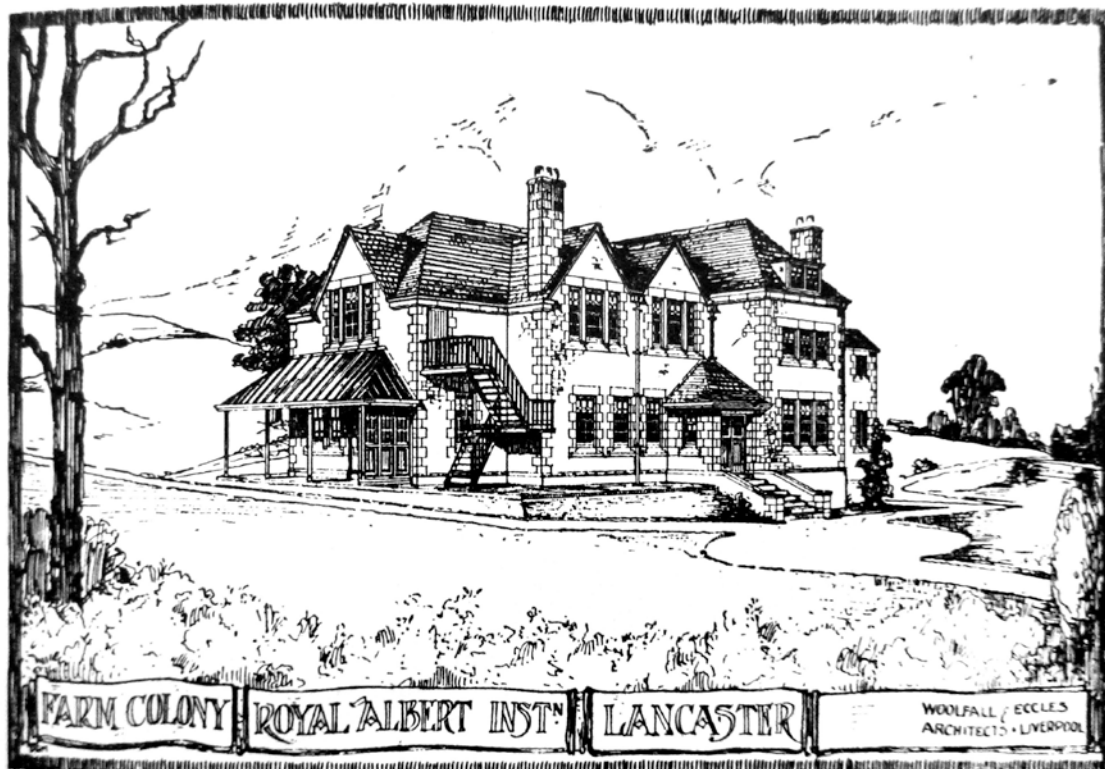
**Plate 2: Illustration from the "Ninth Quinquennial Festival: Opening of the Farm Colony"**

3.1.4 **"Ninth Quinquennial Festival: Opening of the Farm Colony", 1913:** this illustration shows an artists' impression almost of how the Farm Colony would look (LRO HRRA/30/35 1913; Plate 2). It is not exactly how the building would ultimately appear (compare with Plate 3); for example, the external staircase on the south side of the east elevation was moved to the north and an extra window added to the south of it and the second-floor section towards the centre is clearly only an attic space illuminated by a pair of dormer windows.

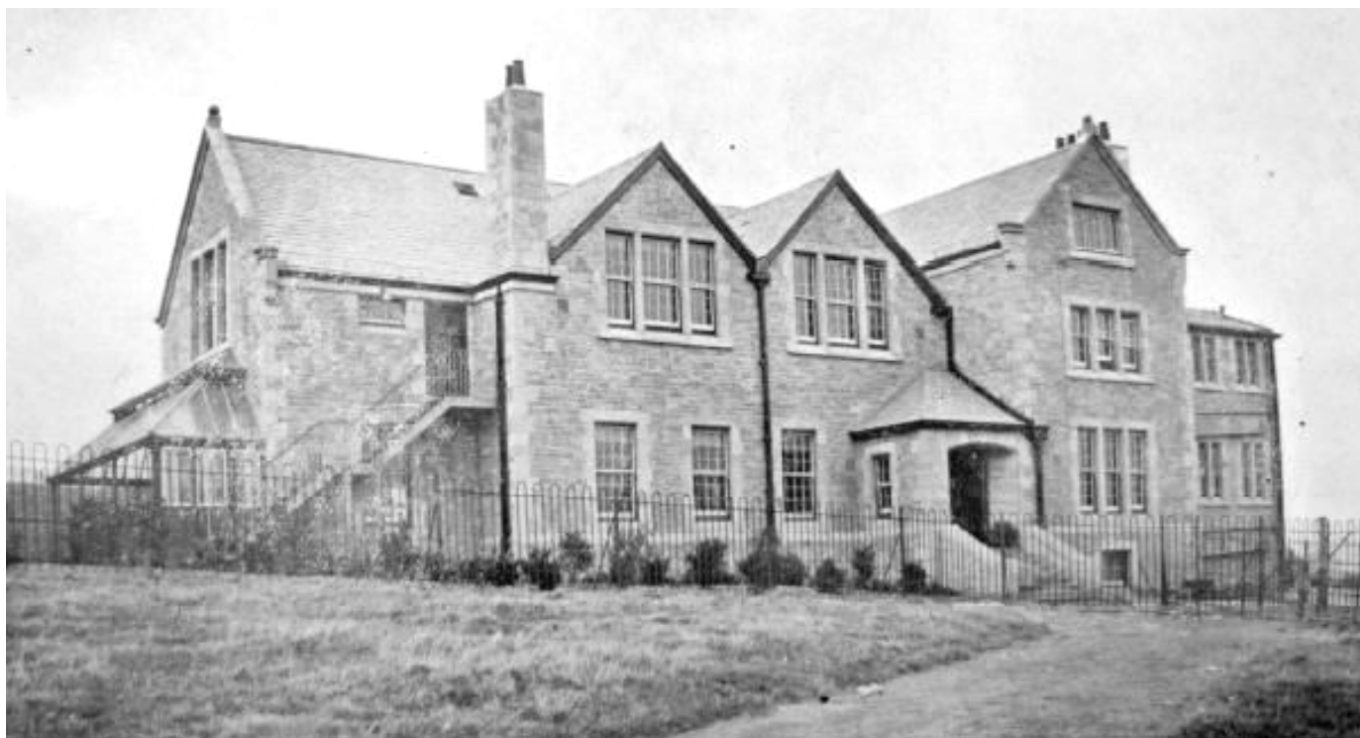
**Plate 3: Photograph, c1914 (from O'Flaherty 2019, 10, figure 11)**

3.1.5 **Photograph, c1914:** a photograph of Derby Home c1914, included in an earlier heritage assessment and reproduced in O'Flaherty (2019, 10, figure 11), is reproduced here (Plate 3). Unfortunately, the original source is not certain but is given as "*Royal Albert Institution Annual Reports 1914*". This shows the building as it was originally constructed, with the open fronted veranda at the south end the most noticeable difference to the current arrangement, although the window casements are also clearly different, apparently being 24 lights.

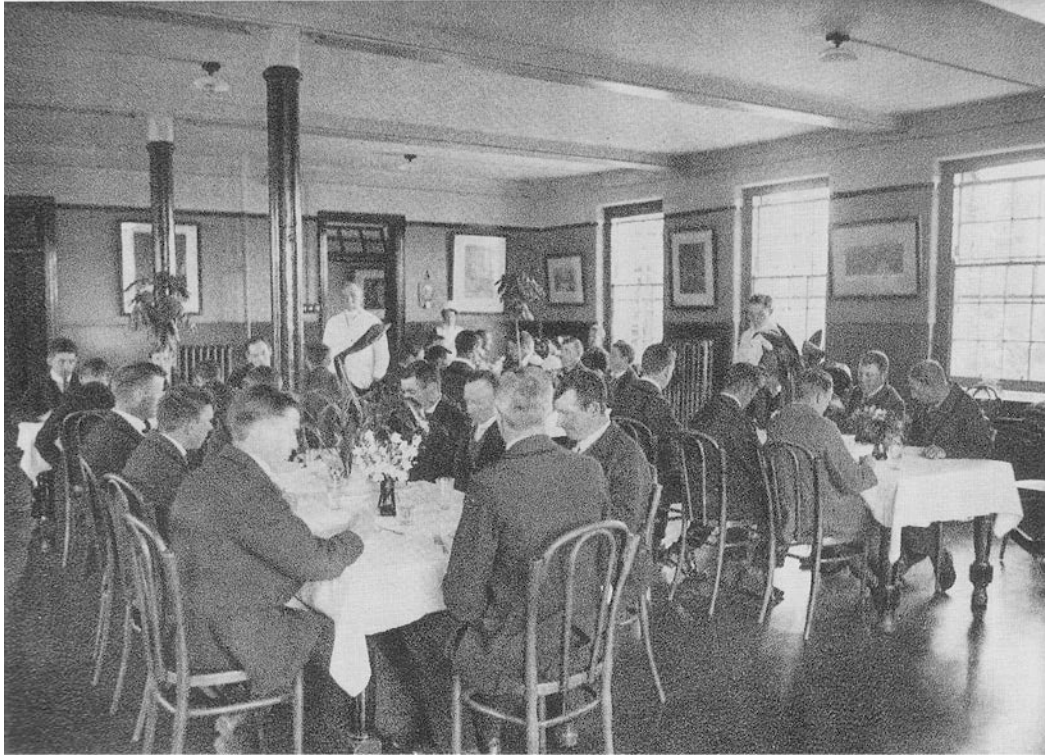
Plate 4: Photograph of the 'Farm Colony dining room in 1923' (after Ashton 1992, 6)

3.1.6 **Photograph, 1923:** a single photograph of the interior of the 'Farm Colony dining room' dated to 1923 is reproduced in Ashton (1992, 6; Plate 4). This appears to correspond to the area making up rooms G3/G4, viewed from the south-west, and shows the same windows in the east elevation as those in the photograph of 1914 (Plate 3) and the doorways, with tilting over lights and columns apparently clad with timber.

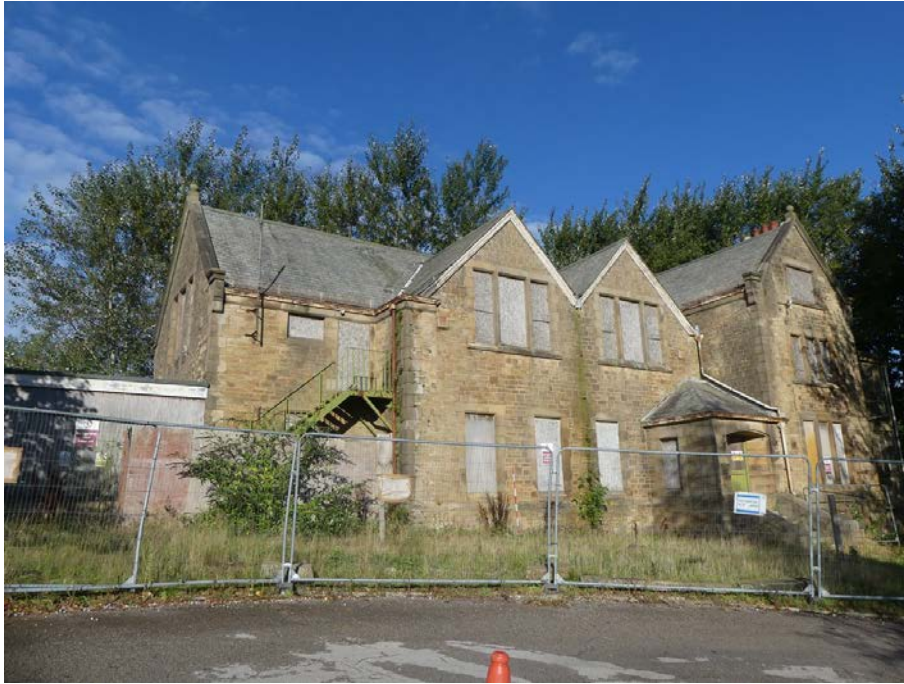
Plate 9: The front (east) external elevation, viewed from the south-east

4.1.1 **Arrangement:** the building comprises a single block orientated north/south, with the front on the east side facing onto Pathfinders Drive and the rear facing a field to the west. It is mostly two storeys, with a small basement below the north of the centre section and a small second floor above this. The south end is extended by a modern single-storey flat-roofed addition.

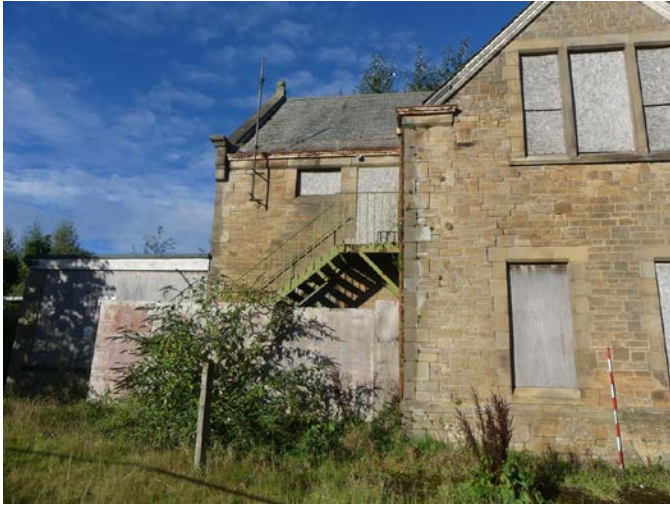
**Plate 10 (left): The south end of the east external elevation, viewed from the east**

4.2.1 **East external elevation:** the south end is extended with the later flat-roofed single-storey extension with a large window (Plate 10). Beyond this the building proper has a narrow window and a doorway at first floor level both with chamfered ashlar surrounds, the door accessed by a flight of iron steps attached to the wall on brackets (Plate 10). There is also a single ground floor window in the same style. Beyond this the wall returns to the east where there are two gables each with a three-part window divided by square stone mullions on the first floor and three separate windows on the ground floor, all of which have chamfered ashlar surrounds (Plate 11). North of this is a return at ground floor level forming a porch with a hipped roof and a small window in the south side. This is accessed by a flight of stone steps to the east with flanking stone walls; there is a small alcove on the north side created below a concrete slab roof. The doorway has double plank and batten doors, with a single light in each, set in deep splayed jambs and with a flat voussoir arch and with a slight rebate around (Plate 12). The northern jamb has 'THE DERBY HOME' carved into it in relief with a single rose motif either side (Plate 13). There is a further return to the north beyond this forming another gable with curved kneelers and

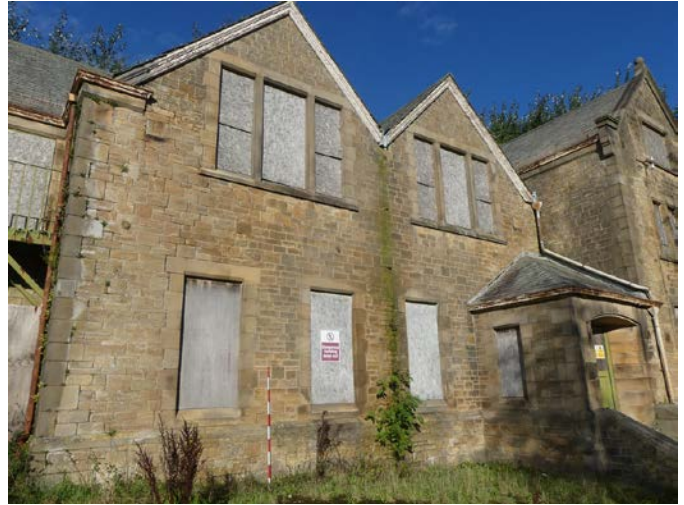
**Plate 11 (right): The centre of the east external elevation, viewed from the south-east**

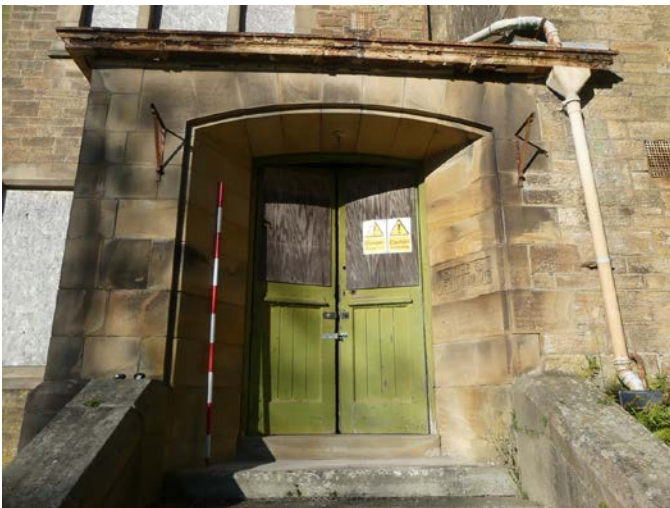
**Plate 12 (left): The doorway in the east external elevation, viewed from the east**

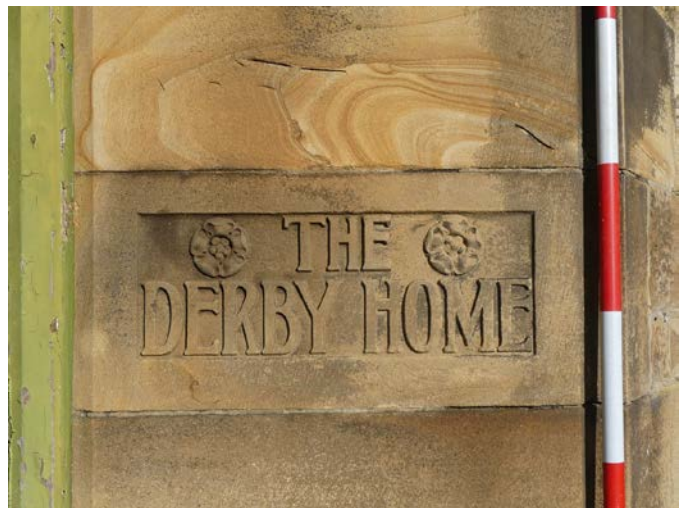
**Plate 13 (right): The carved name plaque in the north jamb of the doorway in the east elevation, viewed from the south**

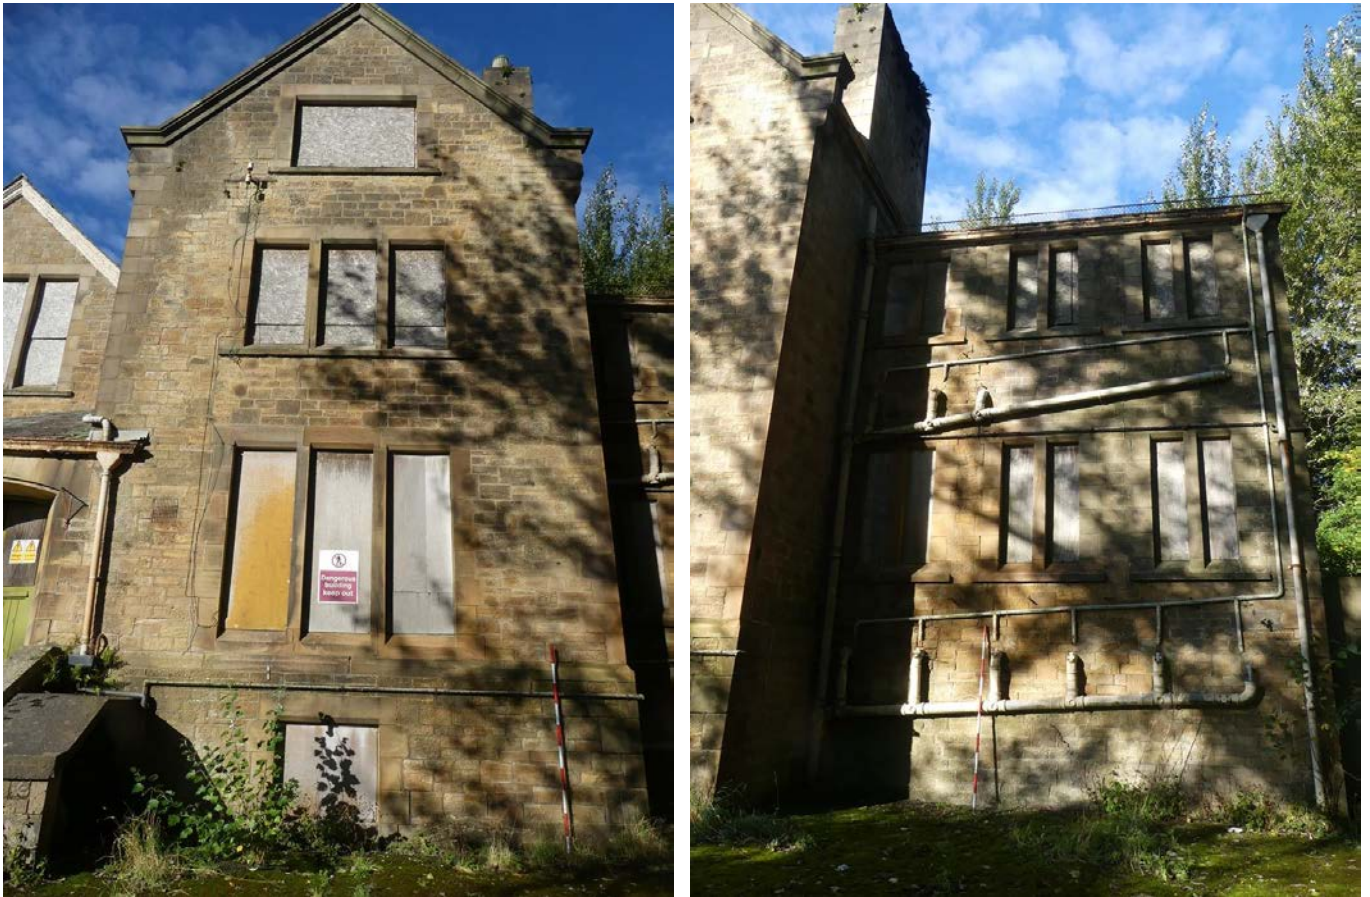
**Plate 14 (left): North of the centre of the east external elevation, viewed from the east**

**Plate 15 (right): The north end of the east external elevation, viewed from the east**

coping and a ball finial on top. This has a window at second floor level, a three-part window divided by square stone mullions at first floor and ground floor (taller on the ground floor), and a single window for the basement (Plate 14). To the north of this section, after a return to the west, there are three paired mullion windows per floor and water pipes projecting below both levels (Plate 15).

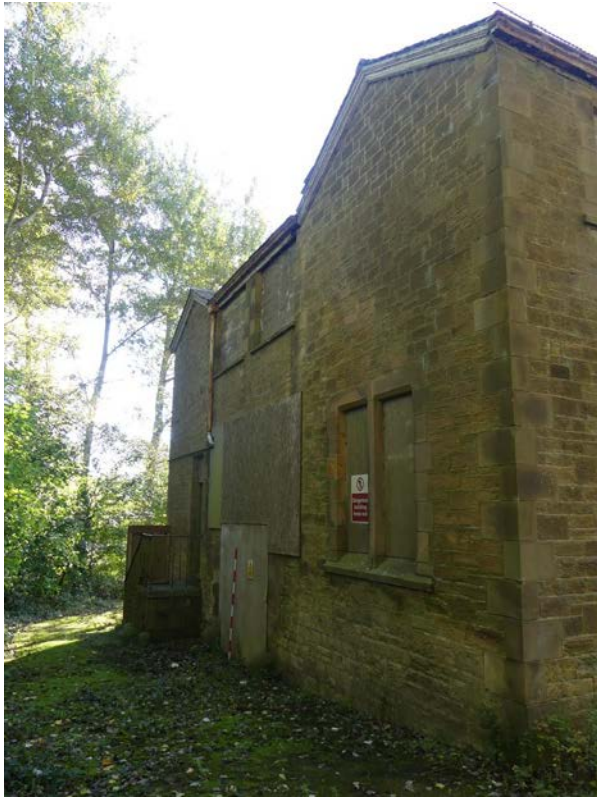
**Plate 16 (left): The north external elevation, viewed from the north-west**

4.2.2 **North external elevation:** the east side comprises a relatively plain gable with a moulded barge board (Plate 16). There is a doorway within this section with ashlar quoined jambs, a plank and batten door, and an overlight, accessed by a short flight of steps with plain iron railings on top with a scrolled end (Plate 17). To the west is a wide doorway with ashlar quoins and block stones at the base; the quoins continue to the upper part of this, although some are missing, and it appears to have originally been an open space that was filled in (Plate 18). There are two windows at first floor level with wide quoined jambs and a timber lintel (essentially part of the wall plate) and a projecting sill. Above this are two windows at second floor level, set back from the main elevation, and the chimneys. The west side comprises a further gable with a pair of windows on the ground floor with a square stone mullion between (Plate 19).

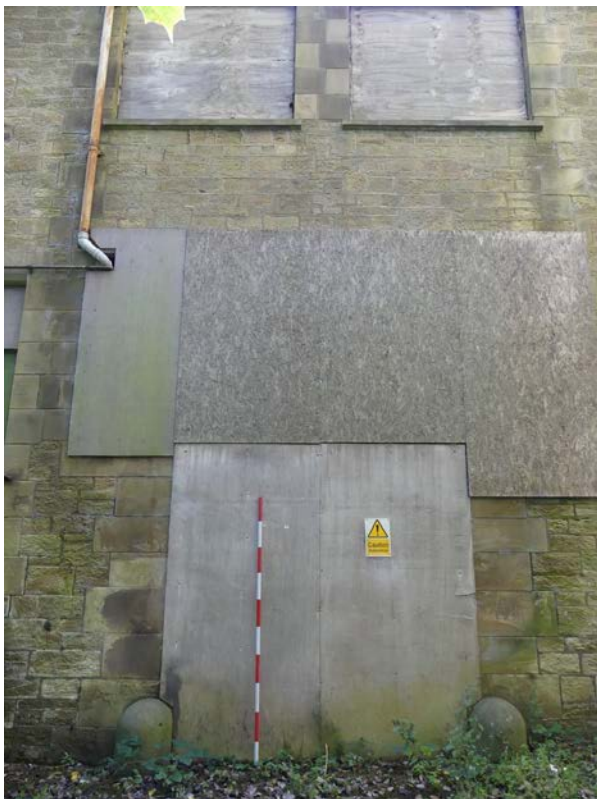
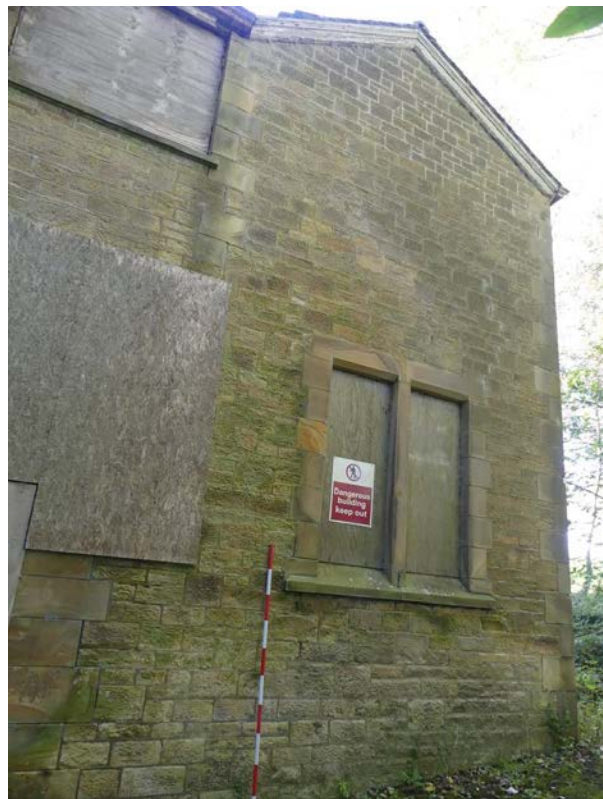
**Plate 18 (left): Central opening in the north external elevation, viewed from the north**

**Plate 19 (right): West side of the north external elevation, viewed from the north-east**

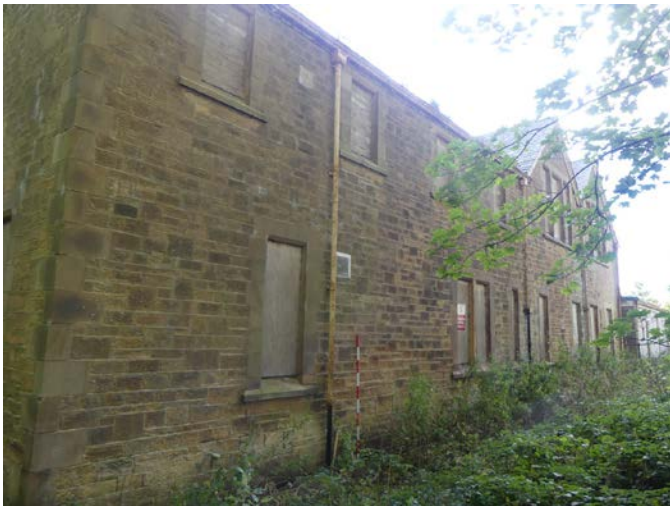
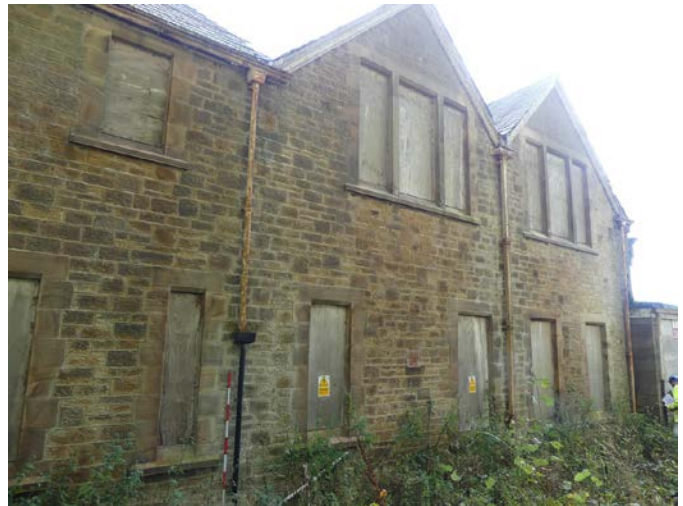
Plate 20 (left): The north end of the west external elevation, viewed from the north-west

Plate 21 (right): The south end of the west external elevation, viewed from the north-west

4.2.3 **West external elevation:** this had a row of seven windows on the ground floor mostly in the same style, but one double with a dividing square stone mullion to the north and one unusually narrow to the south of this (Plate 20). All have quoined ashlar jambs, sloping sills and a chamfered lintel. There are also four first floor windows at the north end, all of the same form. The south end has two gables both with a three-part window on the first floor divided by square stone mullions (Plate 21), and it is extended by the single-storey flat-roofed addition at the south end, which has three large windows (Plate 22). This wraps around the main building, which is visible above and has a single window at first floor level (Plate 23).

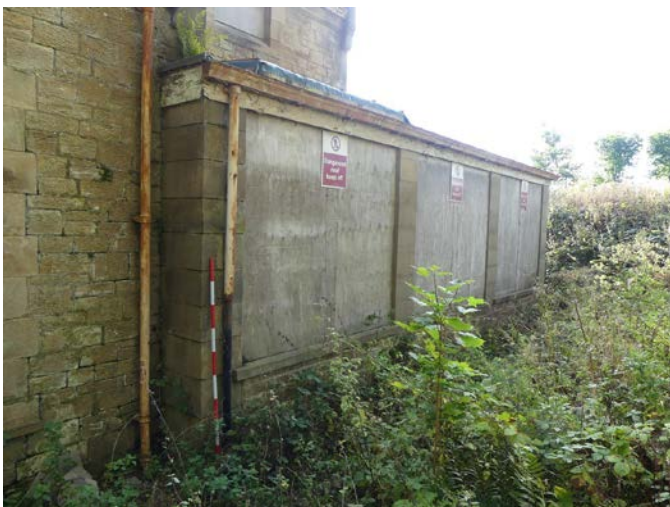
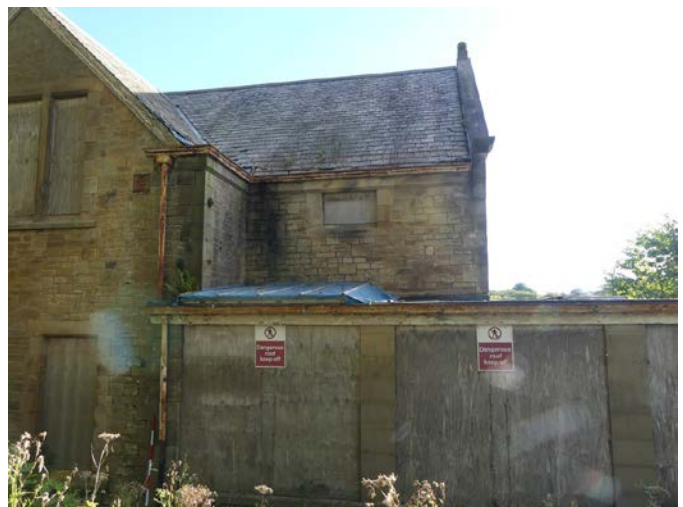
Plate 22 (left): The later extension at the south end of the west external elevation, viewed from the north-west

Plate 23 (right): The later extension wrapping round the original building at the south end of the west external elevation

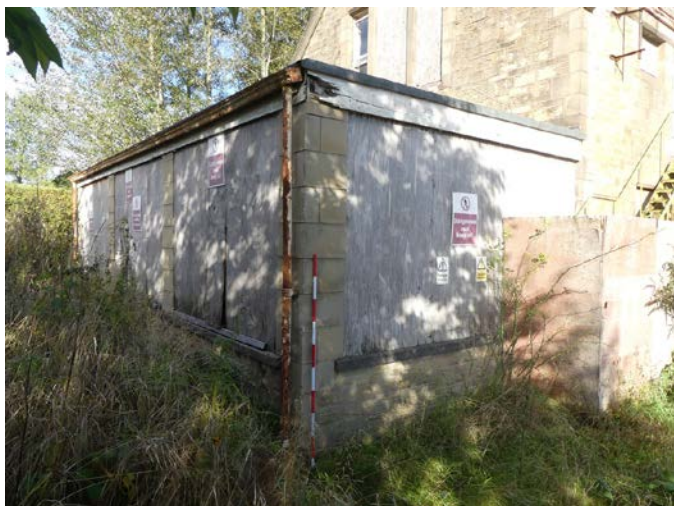
**Plate 24 (left):** The later extension on the south external elevation, viewed from the south-east

4.2.4 **South external elevation:** the ground floor of this is obscured by the later flat-roofed extension, which has three wide windows and a central doorway (Plate 24). Above this the main elevation forms a gable with kneelers, cavetto coping, and a ball finial. There is a large three-part window in the centre at first floor level divided by square stone mullions (Plate 25). The subsequent demolition of the later extension allowed the original arrangement to be observed more clearly (Plate 26), and exposed the scar of the roof of the earlier veranda on the east side.

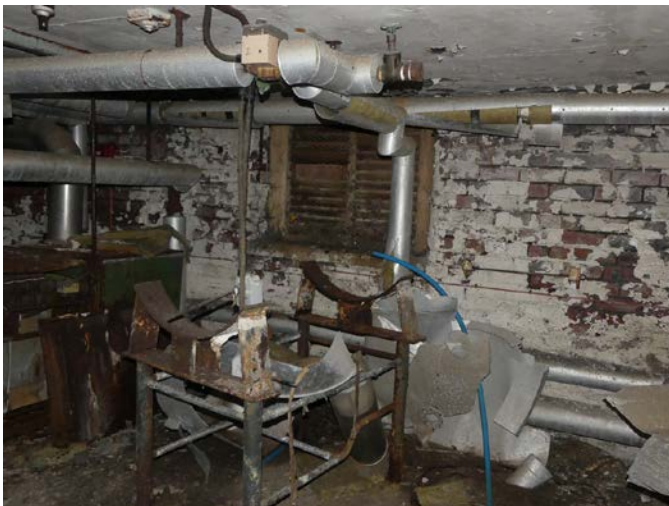
Plate 27 (left): The east side of basement Room 1 prior to soft stripping, viewed from the south-west

4.3.1 **Basement Room 1:** this has a concrete floor and initially had a range of boilers and associated pipework taking up much of the space (Plate 27 and Plate 28). The ceiling is plaster and paint over concrete supported by iron beams. The walls are machine made brick laid in English garden wall bond (at a ratio of three rows of stretchers to one row of headers) finished with the remains of limewash. The room is relatively plain, with a window on the east side filled with timber slats (Plate 27 and Plate 29), and a doorway to the west with bullnosed brick jambs. The north side has an alcove across most of it formed by an iron square-section beam, within which is a concrete-lined flue extending the full height of the building, and patch of concrete rebuild in the wall proper (Plate 30).

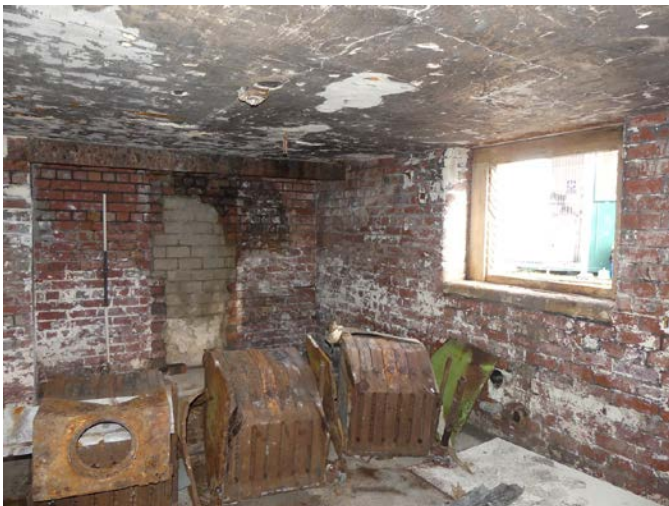
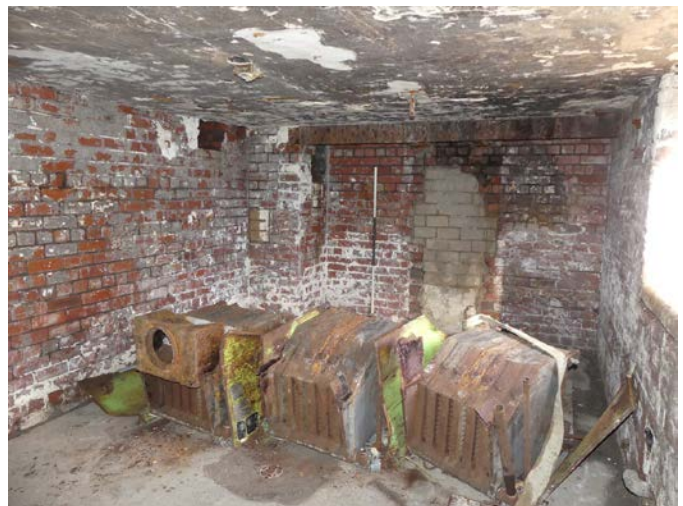
Plate 29 (left): The east side of basement Room 1 after soft stripping, viewed from the south-west

Plate 30 (right): The north side of basement Room 1 after soft stripping, viewed from the south

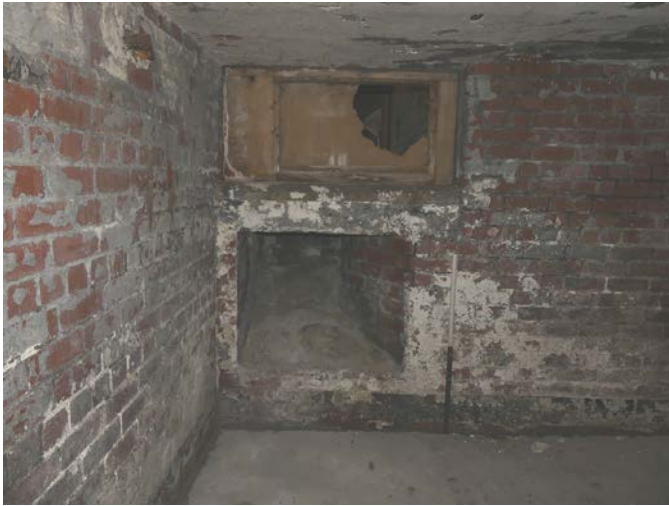
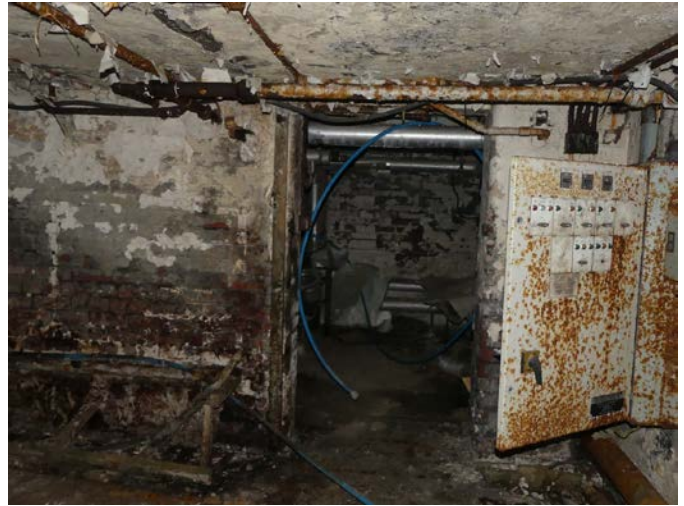
Plate 31 (left): Window and chute in the north elevation of basemen Room 2, viewed from the south

Plate 32 (right): Doorway between basement Rooms 1 and 2, viewed from the west

4.3.2 **Basement Room 2:** this also has concrete floor and a plaster ceiling over concrete and the walls are also brick finished with the remains of limewash. There is a window in the north elevation, looking into Room G11, with a sandstone sill and timber infill. Below this is a low chute with a sloping sandstone sill and a circular iron hatch in the top inside (Plate 31). To the east is a doorway with bullnosed jambs (Plate 32), and to the west a doorway with a timber surround, which leads to a staircase. This has sandstone steps and a handrail on the east side and at the top is a landing with a window to the north with a two-light sliding sash (Plate 33).

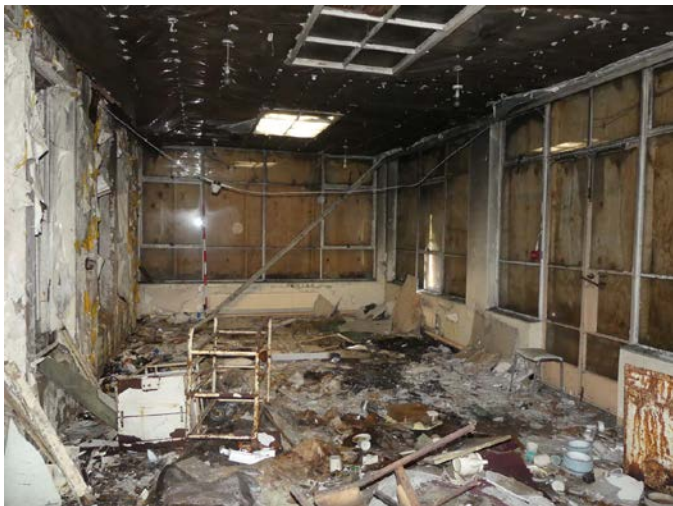
**Plate 34 (left): The east side of Room G1, viewed from the west**

4.3.3 **Ground floor Room 1:** the floor was obscured at the time of survey but evidently concrete. The ceiling is mostly missing but modern plastic sheeting. The walls are largely made up of large windows with metal casements with hinged sections, which make up all of the east and south elevation, the latter of which also has a central double doorway (Plate 34 and Plate 35). The west elevation extends further to the north around the original building and has three further large windows (Plate 36). The north elevation is finished with plaster and has four window with two-light sash casements and a central doorway.

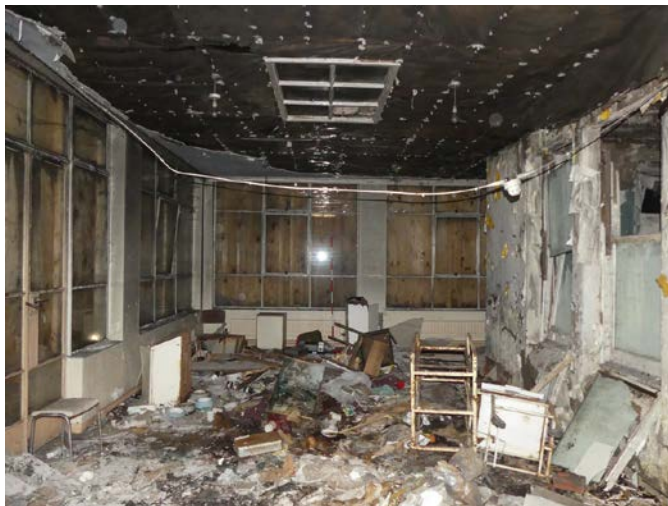
**Plate 35 (right): The west side of Room G1, viewed from the east**

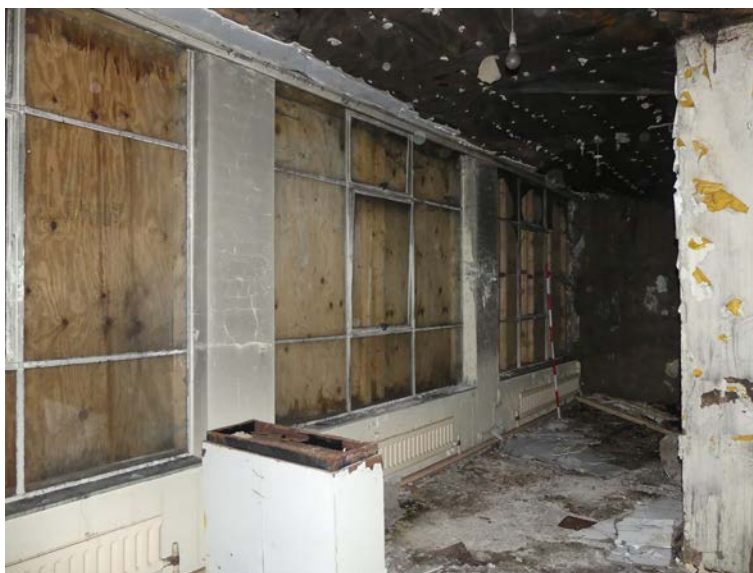
**Plate 36: Extension of the west elevation around the original building**

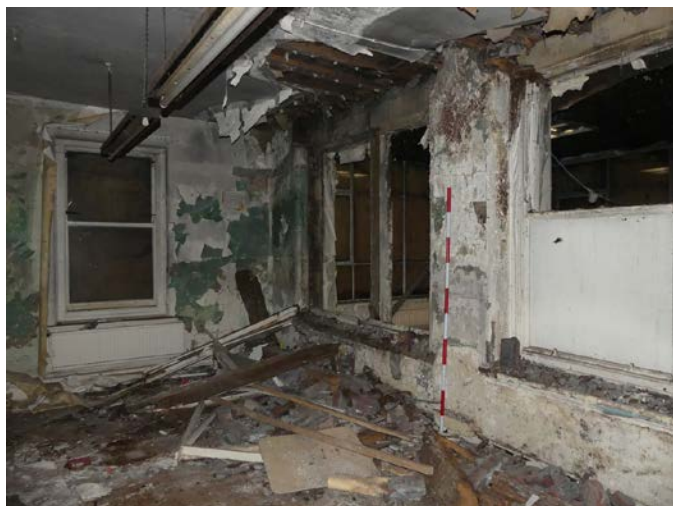
**Plate 37 (left): South and east side of Room G2, viewed from the west**

4.3.4 **Ground floor Room 2:** this has vinyl floor tiles, a lath and plaster ceiling, and the walls are finished with plaster and paint over brick. There are a two large windows each divided into two sections by square stone mullions to the south (Plate 37), a doorway to the west with three-light overlight (Plate 38), and a further window to the east (Plate 37), with a two-light sliding sash casement and there is an iron vent to the south of each of these. The north elevation is a glazed timber stud partition with two doors with two lights and overlights (Plate 39). After soft stripping it was revealed that this wall was formed below an iron I-beam marked 'DORMAN LONG & C<sup>O</sup> L<sup>D</sup>'.

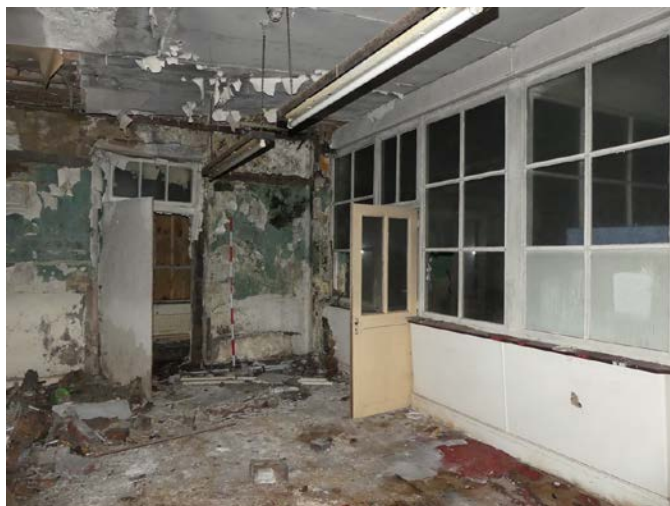
**Plate 38 (right): North and west side of Room G2, viewed from the south-east**

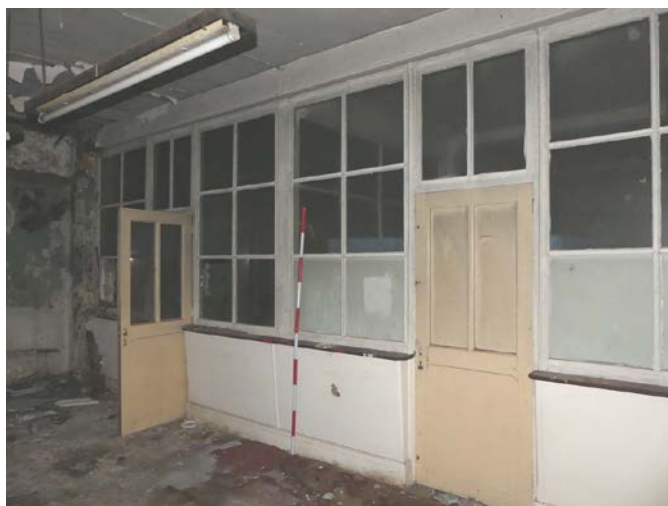
**Plate 39: North elevation of Room G2, viewed from the south-east**

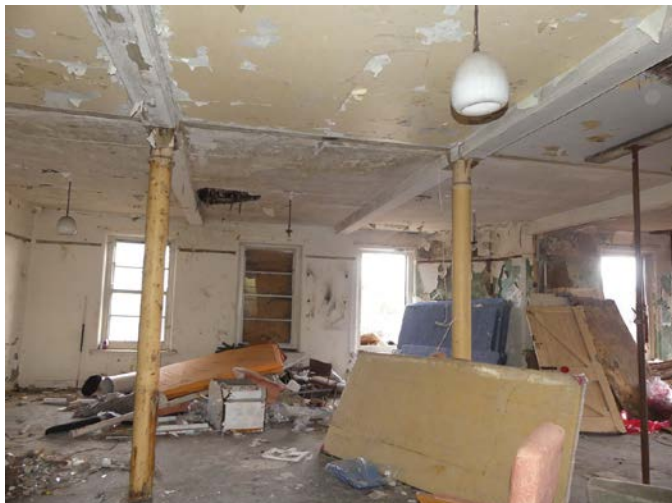
**Plate 40 (left): Beams and columns between Rooms G3 and G4 exposed following the soft strip, viewed from the west**

**4.3.5 Ground floor Room 3 and 4:** these originally formed two rooms but were within a single large space that was clearly sub-divided by a later central timber partition wall. The floor is finished with vinyl tiles and the ceiling lathe and plaster supported by a pair of beams in turn each supported by an iron column with a flanged top (Plate 40 and Plate 41). The beams were originally finished with plaster and beaded but the soft stripping revealed iron I-beams below marked 'LEEDS STEEL WORKS ENGLAND'. There are three windows in each of the east and west walls with two-light sliding sash casements with brick relieving arches over and the remnants of a moulded picture rail between (Plate 42 and Plate 44). The south-west and south-east corners of the room are angled for former fireplaces, which are blocked with concrete. There is a main doorway in the north elevation of each room and a further lower door and a small window to the west in Room G4. There is also an iron vent on the north side of the west elevation of Room G4 (Plate 46). The central dividing wall was constructed from a glazed timber partition, which its subsequent removal demonstrated was sat on top of the vinyl tiles (Plate 47 and Plate 48). The southern wall of each room was also the same type of stud partition but with a central doorway in each part (Plate 43 and Plate 45).

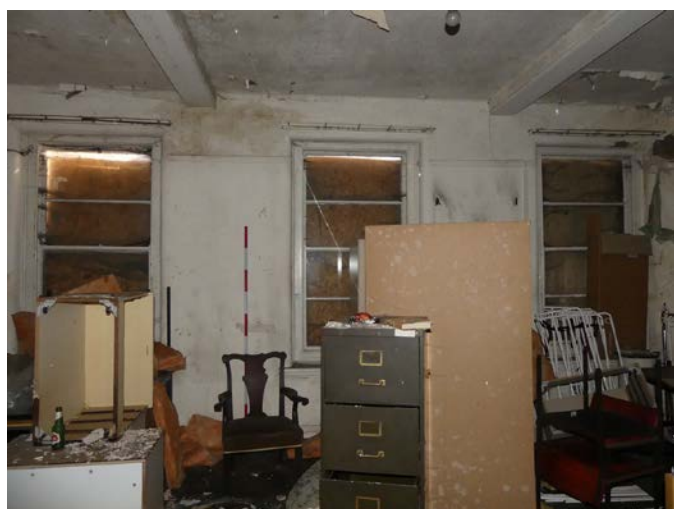
**Plate 42 (left): The east elevation of Room G3, viewed from the west**

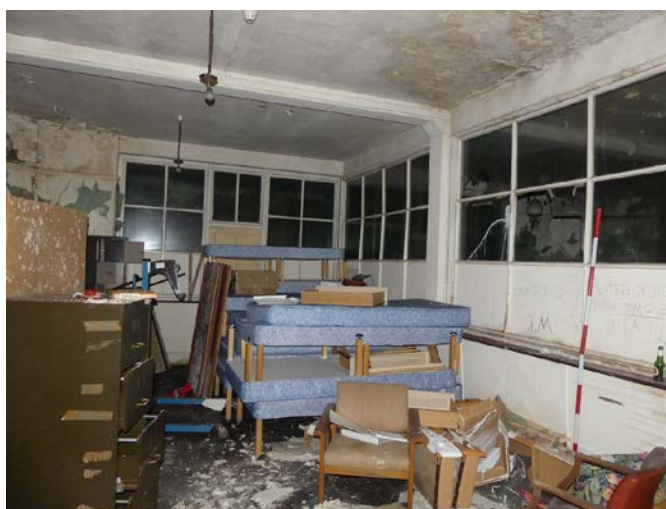
**Plate 43 (right): The south and west elevations of Room G3, viewed from the north**

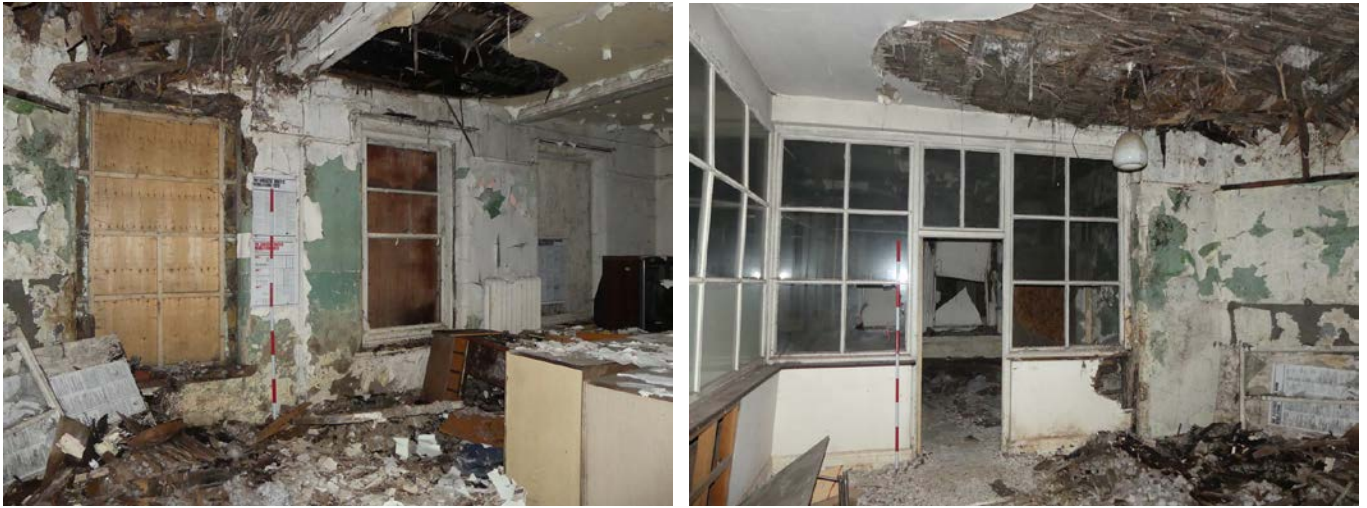
**Plate 44 (left): The west elevation of Room G4, viewed from the south-east**

**Plate 45 (right): The south elevation of Room G4, viewed from the north**

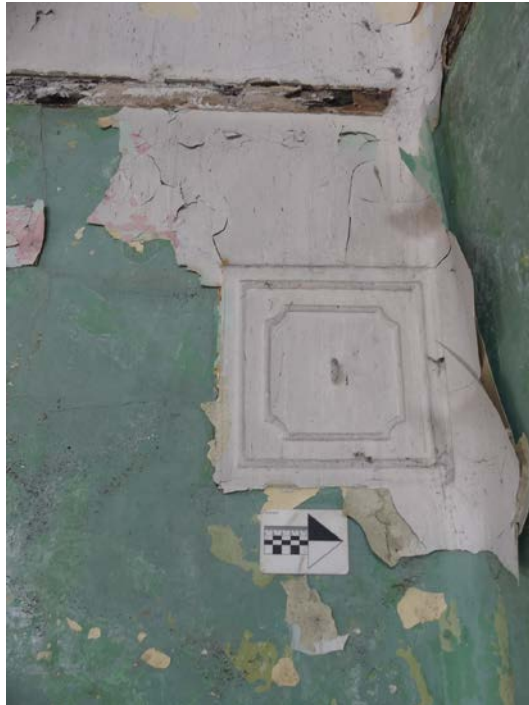
**Plate 46: Vent in the west elevation of Room G4, viewed from the east**

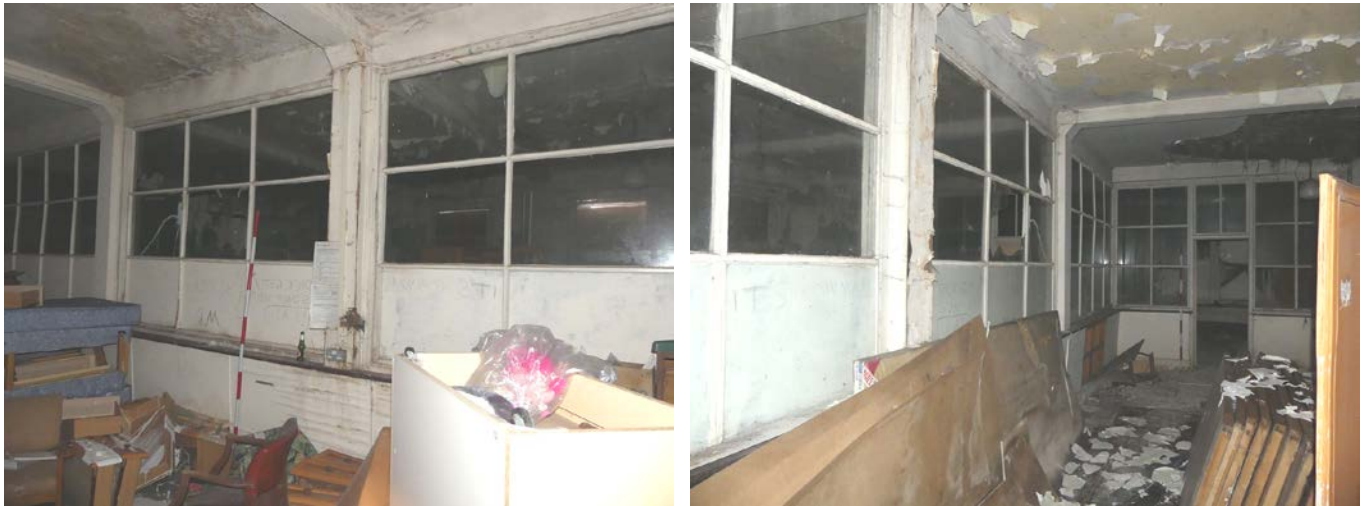
**Plate 47 (left):** The dividing stud partition wall between Rooms G3 and G4, viewed from the north-east in Room G3

**Plate 48 (right):** The dividing stud partition wall between Rooms G3 and G4, viewed from the north-west in Room G4

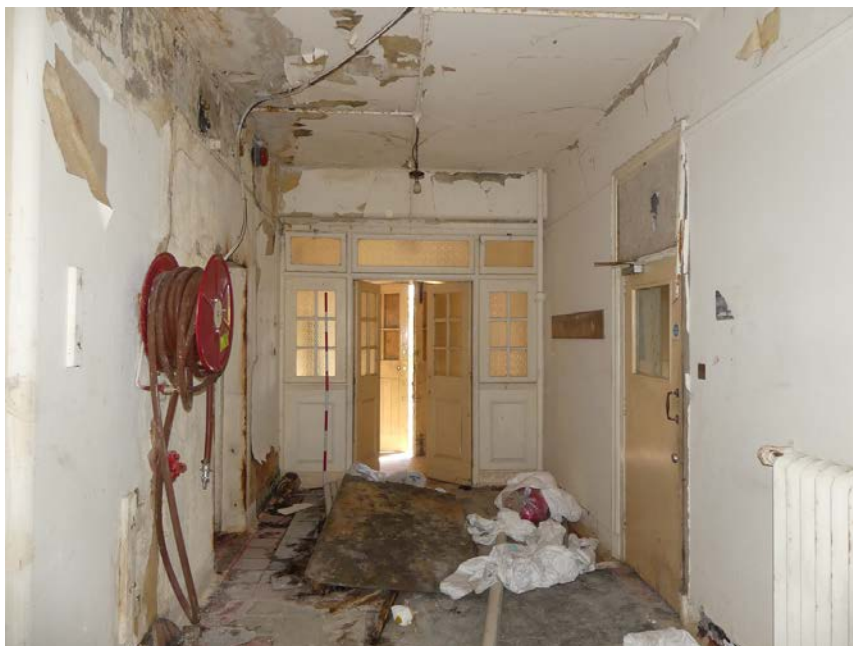
**Plate 49:** General view of the east end of Room G5, from the west

**4.3.6 Ground floor Room 5:** this comprises an L-shaped corridor linking the front door to the east with the stairs to the upper floors and rooms to the north and south (Plate 49). The floor is finished with asphalt or vinyl and the ceiling plaster over concrete. It is divided at the east end to form a porch by a double door with glazed and panelled flanking sections, the top lights tilting, while the doors each have a single panel and six lights (Plate 50). To the east the front door is also a double door but of plank and batten form with four lights above, a flat arched top, and moulded surround (Plate 51). Within the porch there is a small window to the south with a two-light sliding sash casement. Elsewhere there are two doorways to the north, the west of which was evidently originally wider and has been narrowed with concrete blocks, the original relieving arch above visible once some of the brickwork was exposed (Plate 52). To the west of this was the staircase, which had timber stairs and a fairly plain timber handrail attached to the east and west walls. The soft strip revealed that the return to the north has an iron fitting in the floor, apparently relating to another dividing door (Plate 53), and the opening into this part of the corridor and the stairs is supported by iron I-beams.

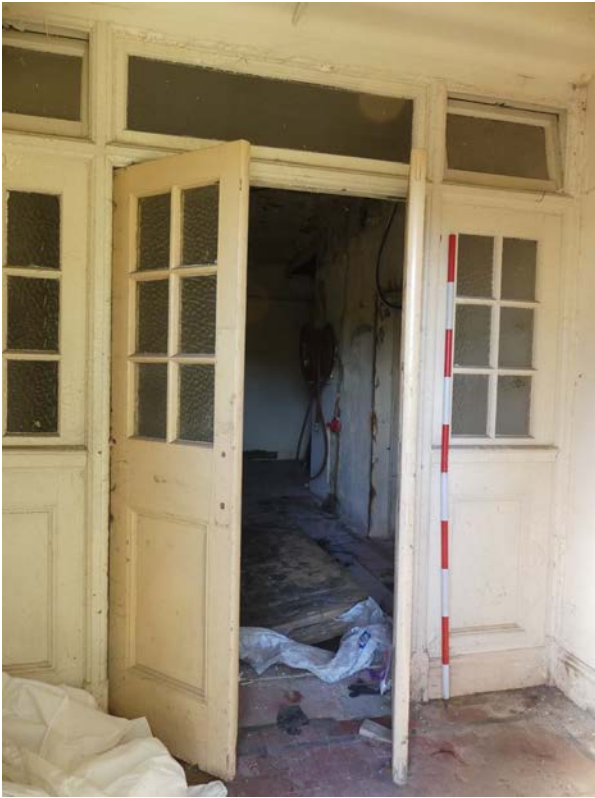
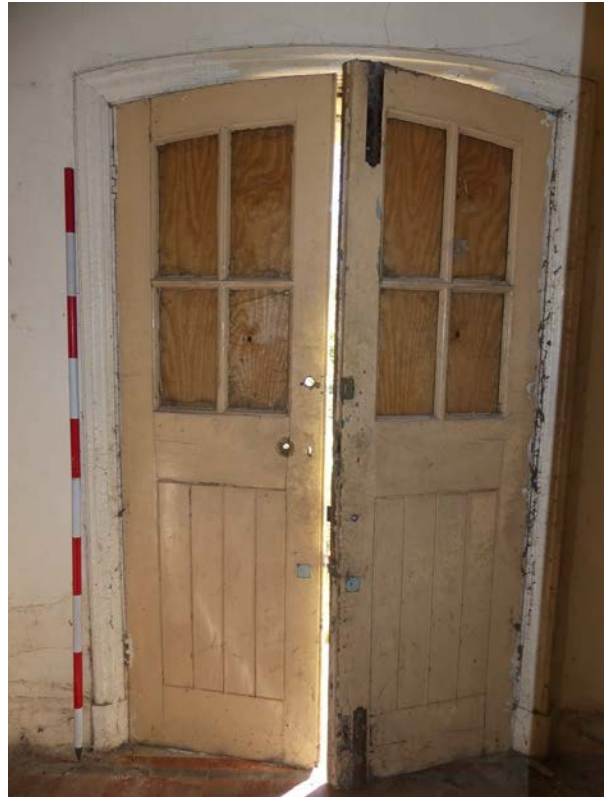
**Plate 50 (left):** Partition wall forming the porch at the east end of Room G5, viewed from the south-east

**Plate 51 (right):** Doorway at the east end of Room G5, viewed from the west

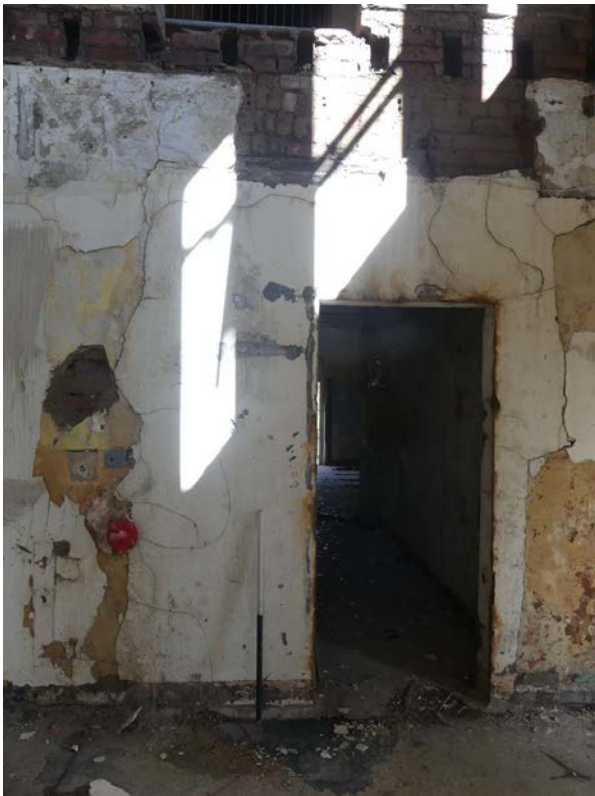
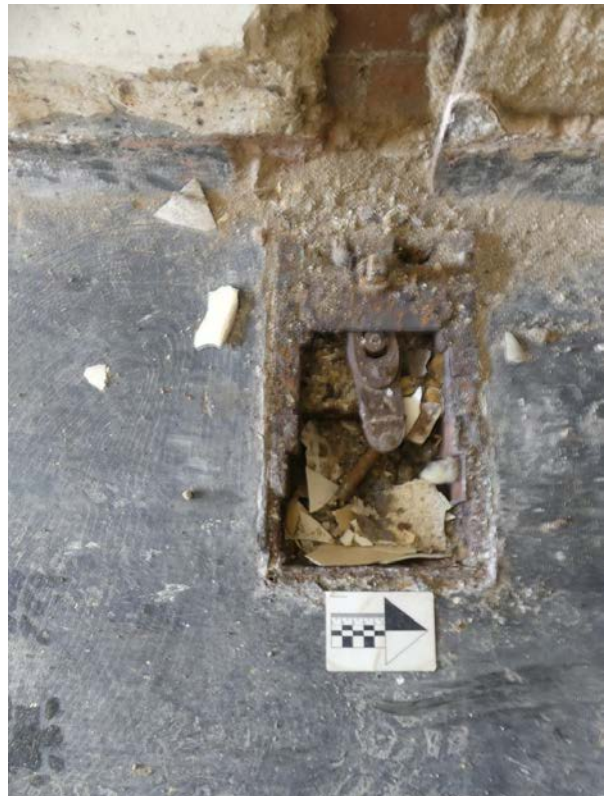
**Plate 52 (left):** Modified doorway on the north side of Room G5, viewed from the south

**Plate 53 (right):** Door fitting in the floor of Room G5, viewed from the east
