# DERBY HOME, PATHFINDERS DRIVE, LANCASTER, LANCASHIRE

## Archaeological Building Recording

Client: Oakmere Homes

May 2022

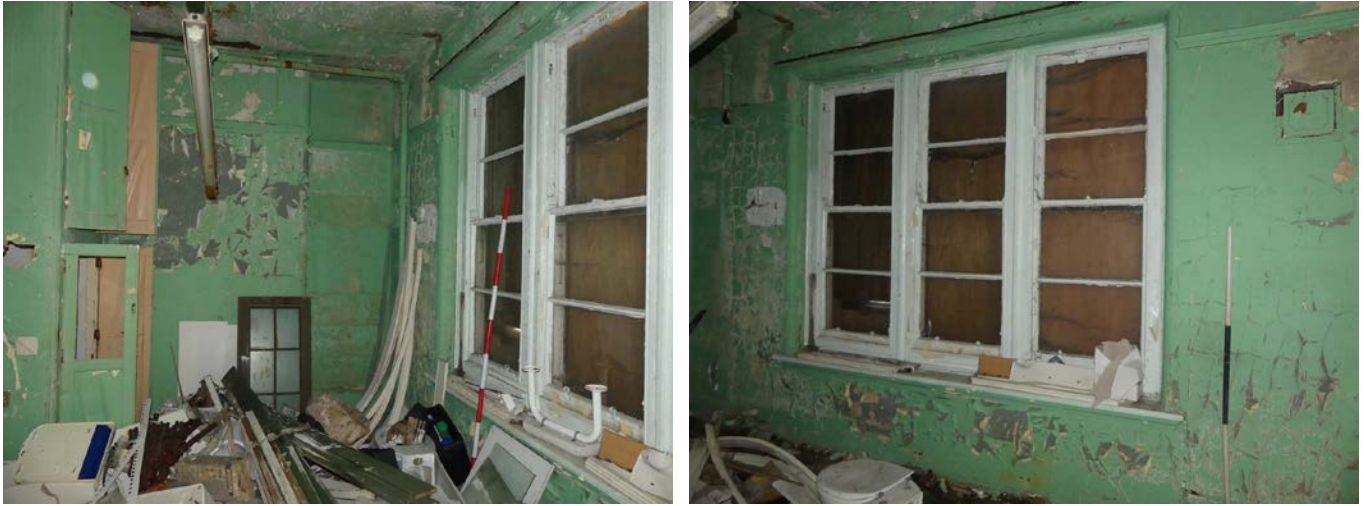
Plate 54 (left): The north end of Room G6, viewed from the south

Plate 55 (right): The window on the east side of Room G6, viewed from the south-east

4.3.7 **Ground floor Room 6:** this has a vinyl floor and plaster ceiling over concrete and the walls are finished with plaster and paint. The north elevation has a chimney breast, the hearth blocked and left with a vent, to the east of which is an alcove (Plate 54). The remains of a timber cupboard are attached in the north-west corner and further shelf scars to the west (Plate 54). The east elevation has a large window with three four-light sliding sash casements (Plate 55) and there is a doorway to the south (Plate 56).

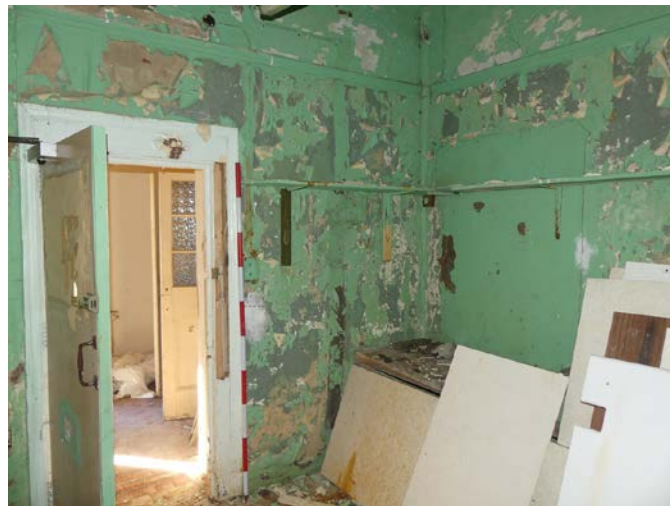
Plate 56: The south end of Room G6, viewed from the north-east

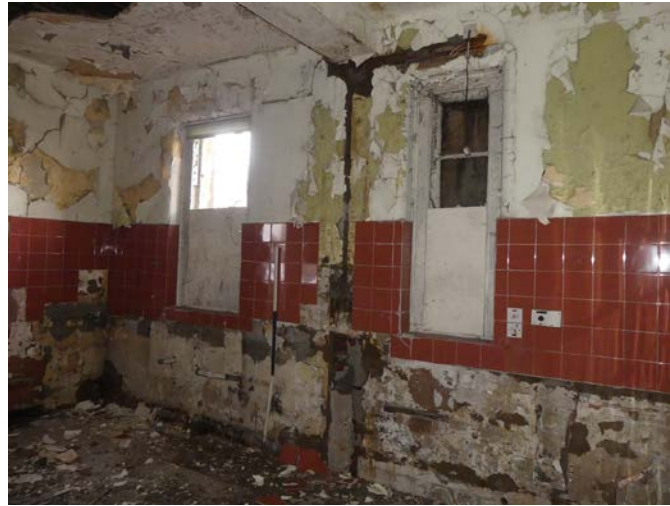
**Plate 57: General view of the west side of Room G7, from the north-east**

4.3.8 **Ground floor Room 7:** this has a vinyl floor over earlier ceramic tiles, a plaster ceiling over concrete, and the walls are also partially tiled. The north wall is a timber stud, which its removal showed had been sat on top of the tiles. There are two small windows with sliding sash casements to the west and a doorway and window to the south.

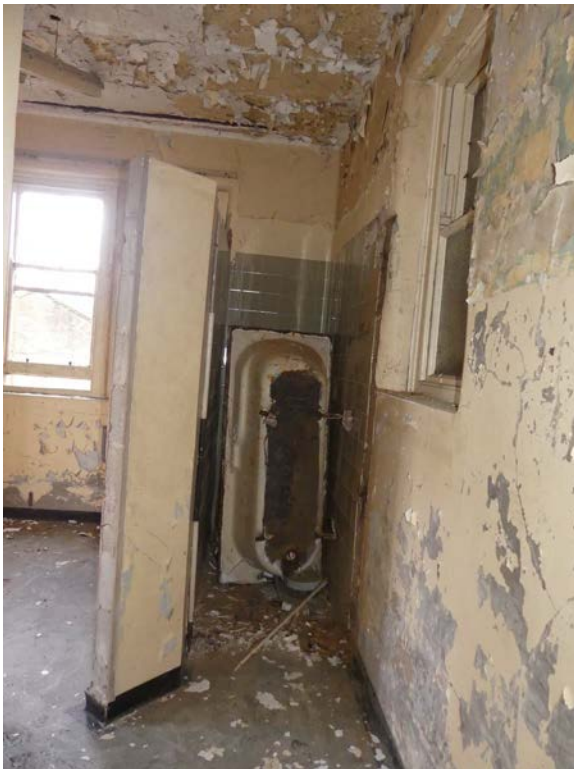
**Plate 58 (left): North end of Room G8, viewed from the south**

4.3.9 **Ground floor Room 8:** this has the same floor as Room G7, and a range of internal divisions, again sat on top of the tiles. There are a pair of windows to the north with sliding sash casements (Plate 58), and one to each of the west and east elevations (Plate 59).

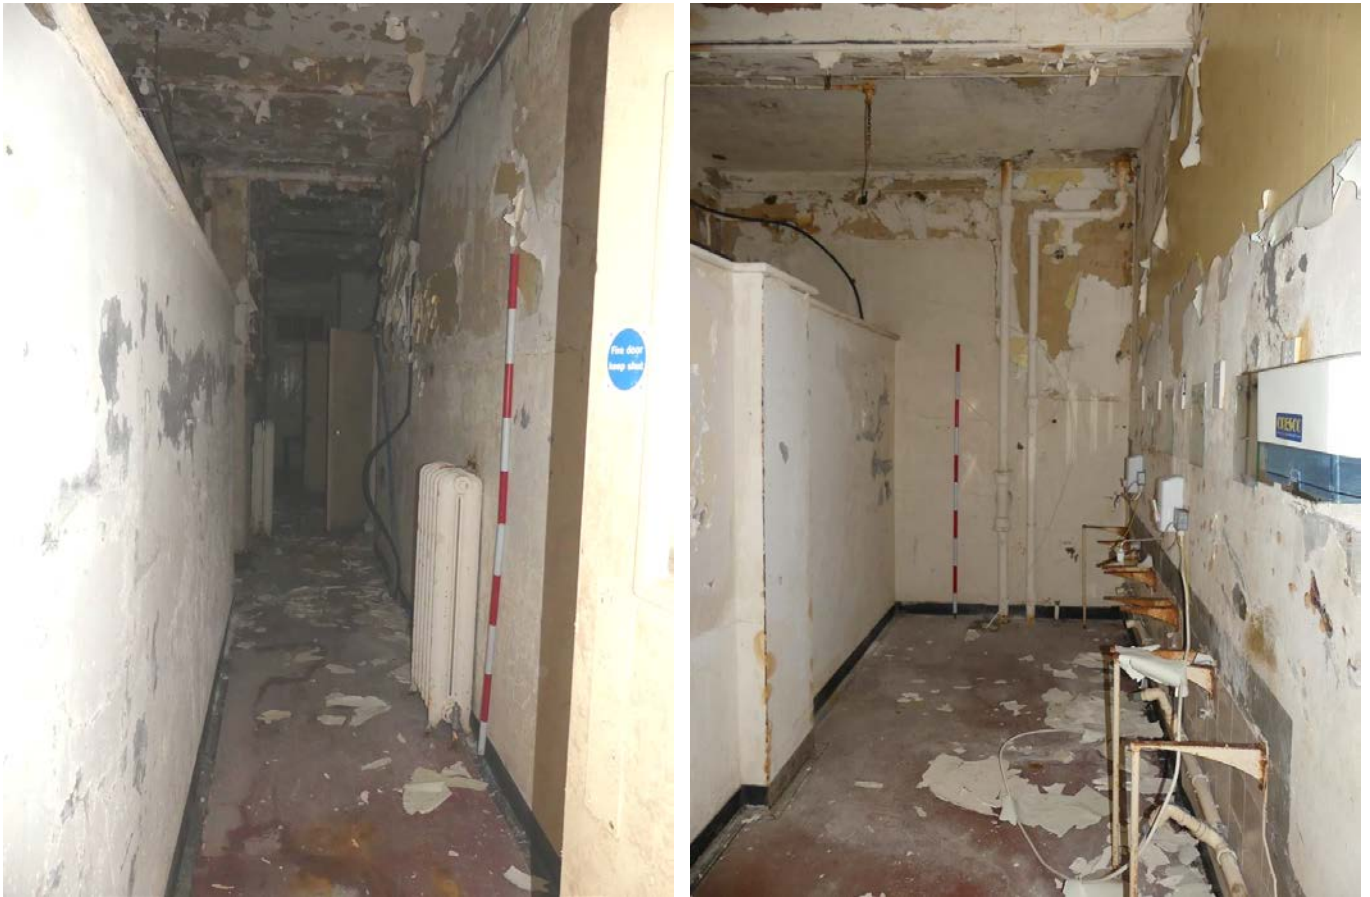
4.3.10 **Ground floor Room 9:** this has two layers of vinyl flooring and the ceiling is finished with plaster with a beaded beam running east/west. The walls are painted plaster and partly tiled, with a dividing stud wall, sat on top of the earlier floor covering, forming a corridor connecting to Room G10 along the east side (). There are the remains of a row of sinks along the west elevation and a window with a two-light sliding sash casement to the north-west.

**Plate 60 (left):** The corridor along the east side of Room G9, viewed from the south

**Plate 61 (right):** The west side of Room G9, showing the remains of the sinks, viewed from the north

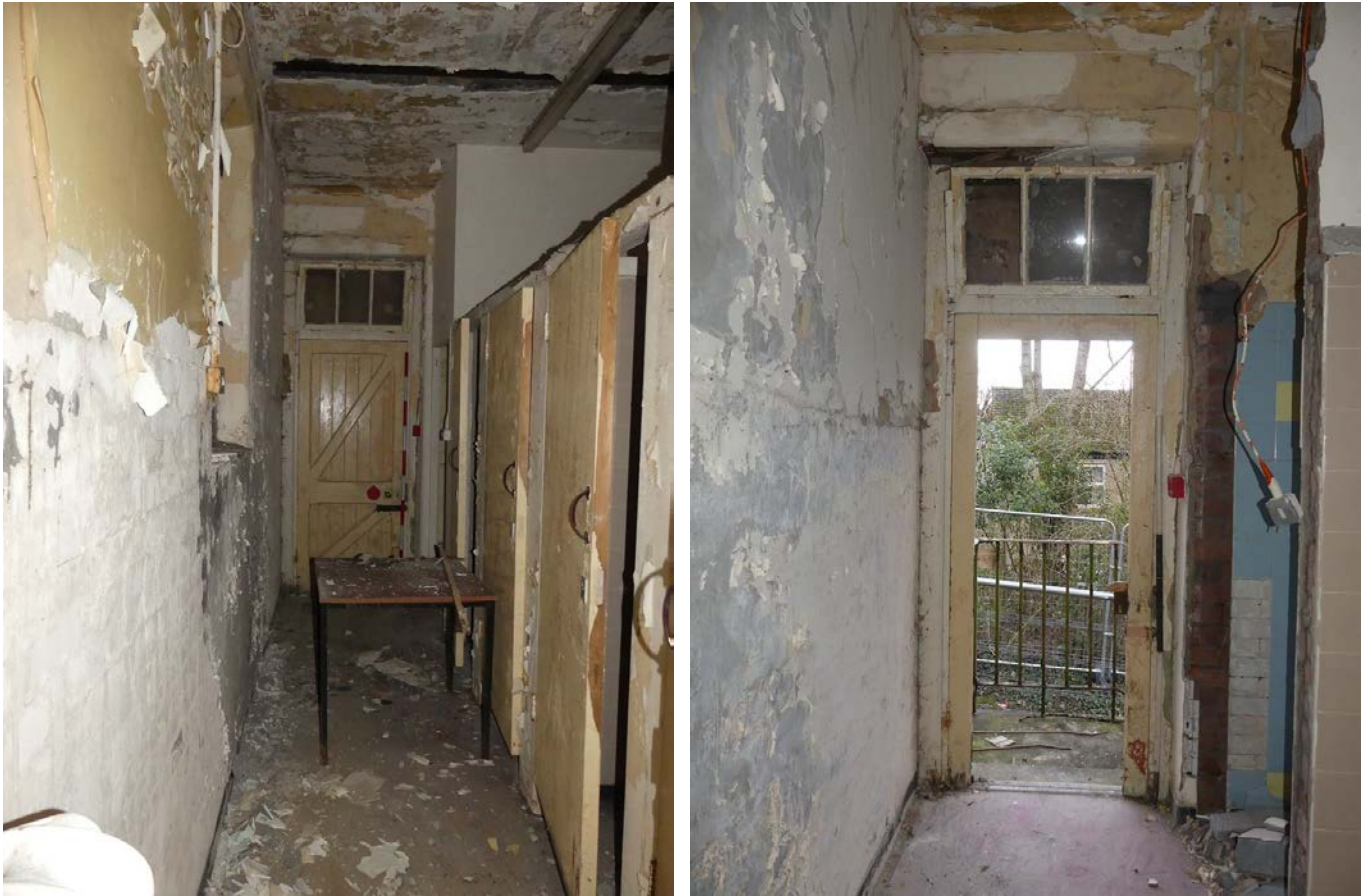
4.3.11 **Ground floor Room 10:** this has a vinyl floor, plaster ceiling covering concrete, and stalls along the east side formed by brick walls. The walls are otherwise finished with plaster apart from the north and east, which have two layers of tiles, the original red and white rectangular ones underneath later square ones. There are three paired narrow windows with sliding sash casements to the east, a window with a two-light sash casement to the west, and a doorway to the north with a plank and batten door and a three light hinged overlight.

**Plate 62 (left): General view of Room G10, from the south**

**Plate 63 (right): The doorway at the north end of Room G10, viewed from the south**

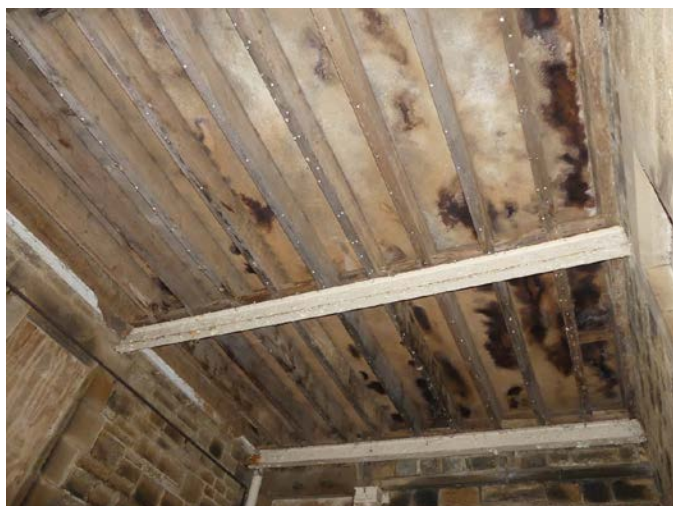
4.3.12 **Ground floor Room 11:** this was evidently an essentially external space accessed via a large doorway on the north side. It has a stone sett floor, sloping up slightly to the south. The ceiling is supported by three iron I-beam lintels running east/west, which support machine cut timber joists with chipboard sheets on top (Plate 64). The walls are exposed stone in random ashlar courses, with windows to the east and west with sloping sills, quoined jambs and chamfered lintels (Plate 66 and Plate 67). The north end has a large doorway filling most of it at the top, but narrowed by pillars on either side lower down finished with pyramid copings (Plate 65). The south elevation has a low window on the east side leading into basement Room 2, with a chamfered lintel and quoined jambs (Plate 68). Above are two further irregular windows in the same style as those to the east and west. To the west is a stone staircase with an iron hand rail with a scrolled end leading to a doorway (Plate 69). This has quoined jambs and a chamfered lintel.

**Plate 64 (left): The ceiling in Room G11, viewed from the north**

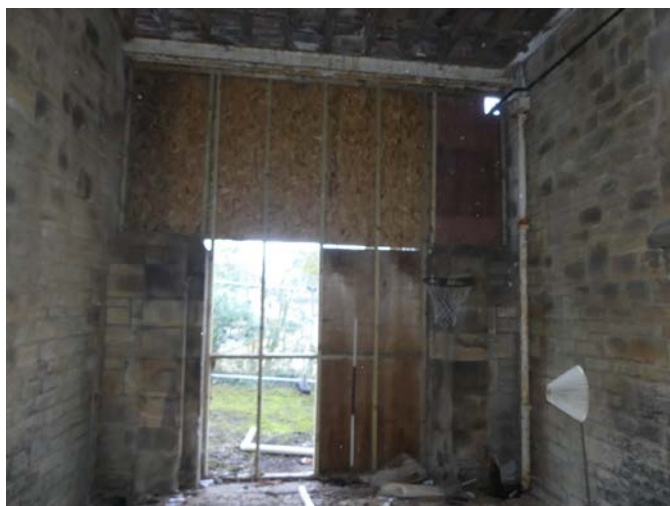
**Plate 65 (right): The north end of Room G11, viewed from the south**

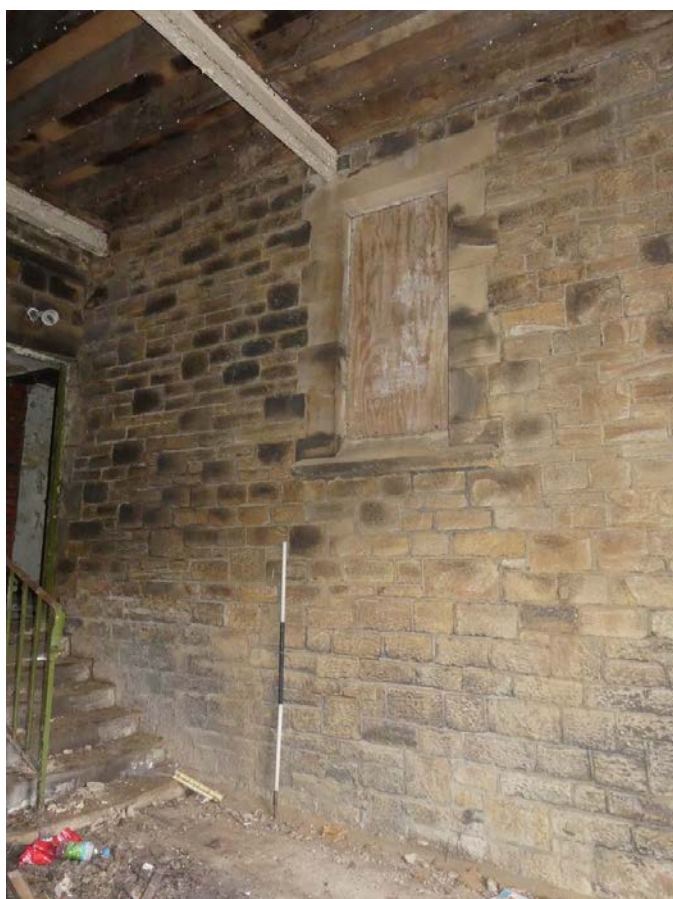
**Plate 66 (left): The west elevation in Room G11, viewed from the north-east**

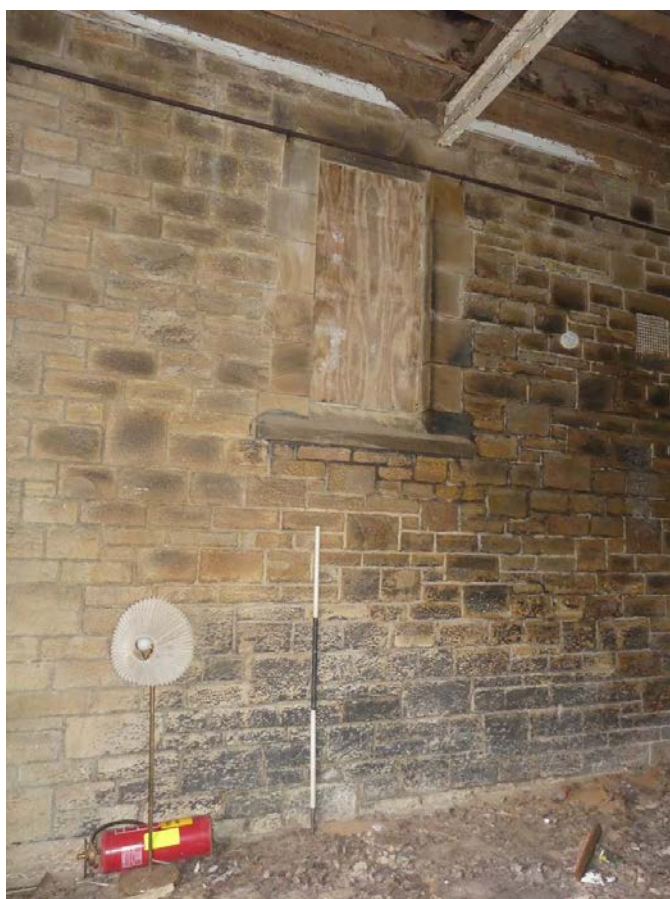
**Plate 67 (right): The east elevation in Room G1, viewed from the north-west**

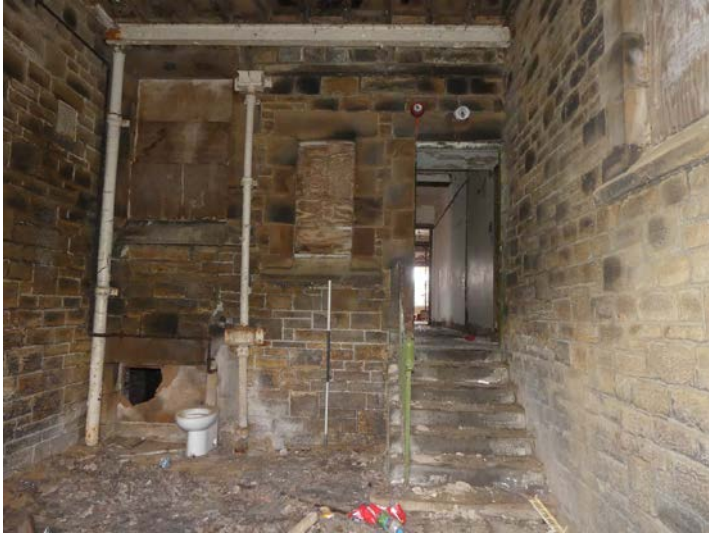
**Plate 68 (left): The south side of Room G11, viewed from the north**

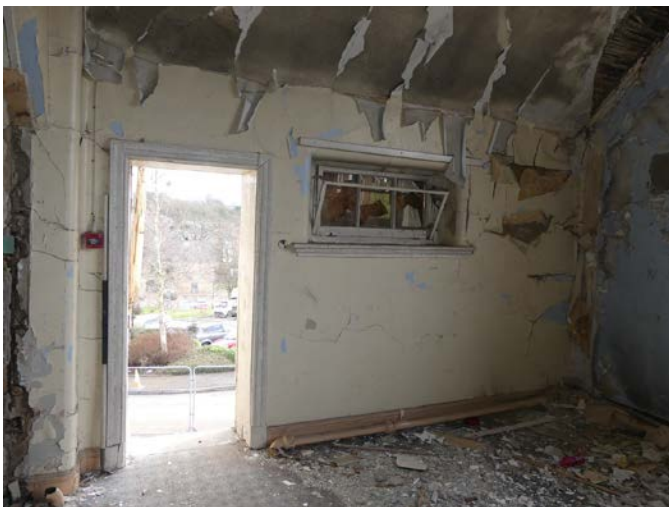
4.3.13 **First floor Room 1:** this is located at the south end of the building and has a carpet floor over floorboards. The ceiling is lathe and plaster, sloping with the angle of the roof on the east and west sides, and with a chamfered beam along the north side. The walls are finished with plaster and paint. The north elevation is entirely open into the rooms beyond, the east elevation has a doorway on the north side with a moulded surround (accessing the external metal stairs) and a small window to the south with a tilting three-light casement (Plate 70). The south elevation has a large three-part window, each part comprising a two-light sash casement (Plate 71). There are possible blocked vents either side of this. The west elevation has another small window with a three-light tilting casement (Plate 71).

**Plate 70 (left): The east elevation of Room F1, viewed from the north-west**

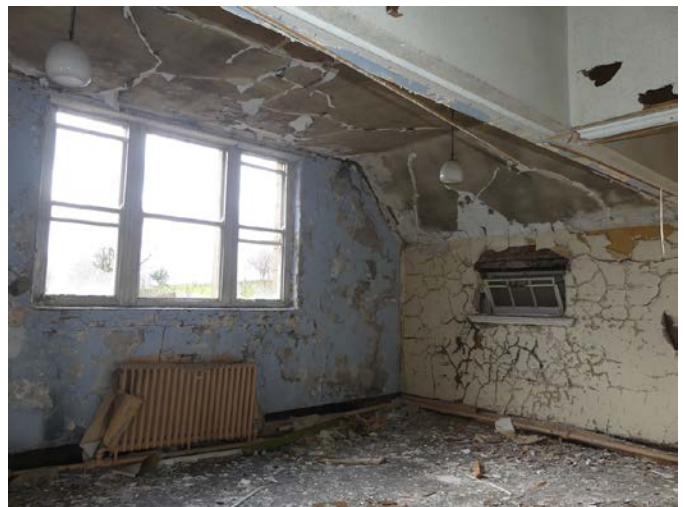
**Plate 71 (right): The south and west elevations of Room F1, viewed from the north-east**

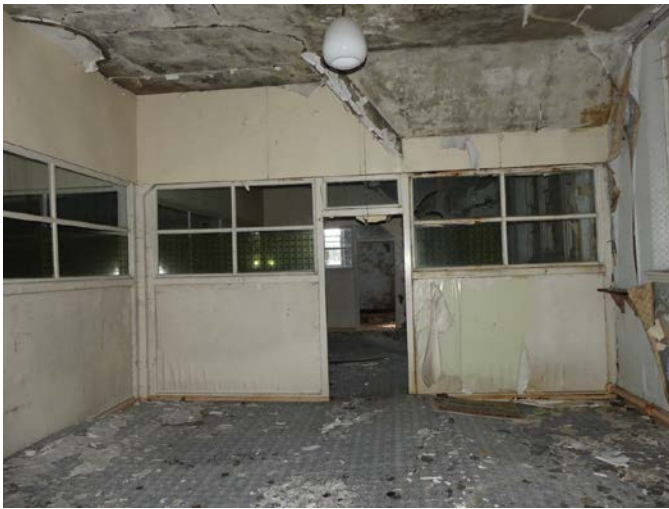
4.3.14 **First floor Rooms 2-5:** the floor was again carpet over floorboards, ceiling lathe and plaster (with two large circular openings, presumably former roof lights, exposed following soft stripping), and the walls finished with plaster and paint. The rooms were formed within a single large space that had been split in four by timber stud partitions set around a column on the north side. Only Rooms F4 and F5 were accessible during the initial phase of recording. The dividing stud walls were glazed with large, long windows and dividing doors in the south/north sides (Plate 72 to Plate 74). The east and west elevations had a large window per room, each made up of three four-light sash casements (Plate 75 to Plate 77), and there were iron vents in the north end of each side. The north elevations of Rooms G5 and G4 each had a single doorway (Plate 78). The column around which the dividing walls are located is plain but has a flanged top (Plate 79). The north-east corner of Room G4 had an angled glazed section, apparently a window into Room F10 (Plate 80), and the south-west and south-east corners of Rooms G3 and G2 respectively had square flues exposed following soft stripping, continuing from the angled fireplaces in the rooms below (Plate 81).

Plate 72 (left): Dividing wall between Rooms G3 and G5, viewed from the north

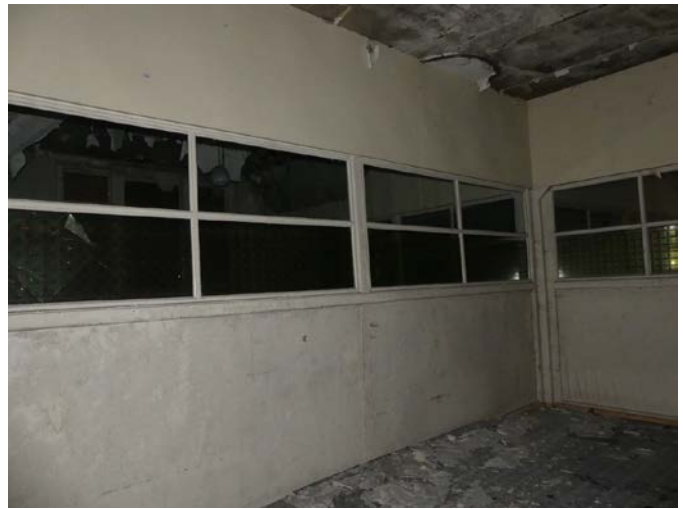
Plate 73 (right): Dividing wall between Rooms G4 and G5, viewed from the north-west

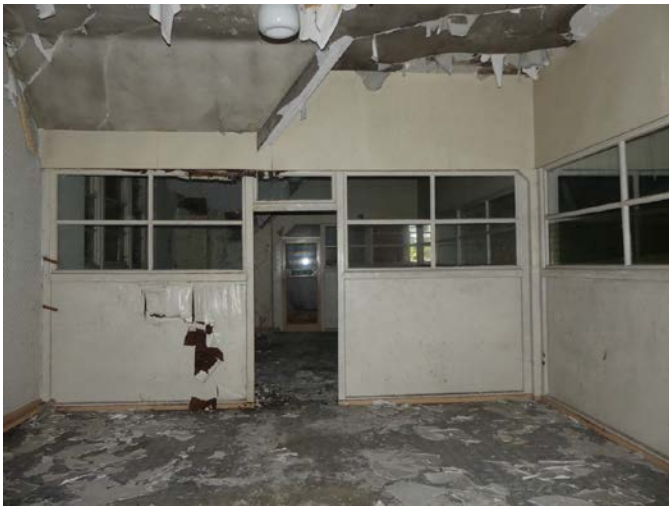
Plate 74 (left): Dividing wall between Rooms G2 and G4, viewed from the north

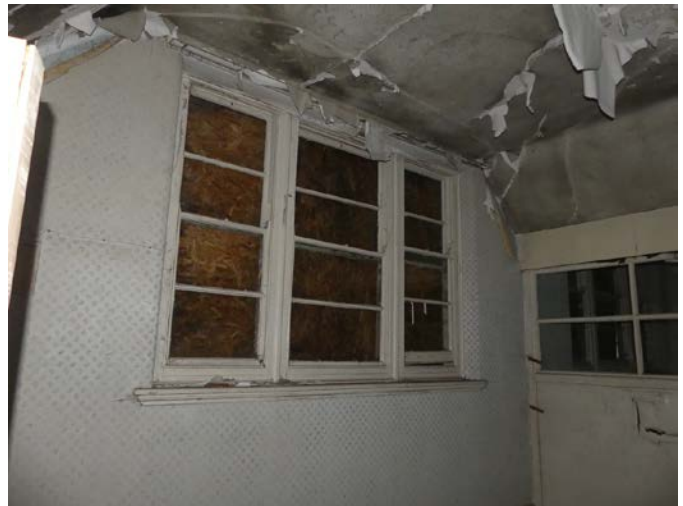
Plate 75 (right): Window in the east elevation of Room G4, viewed from the north-west

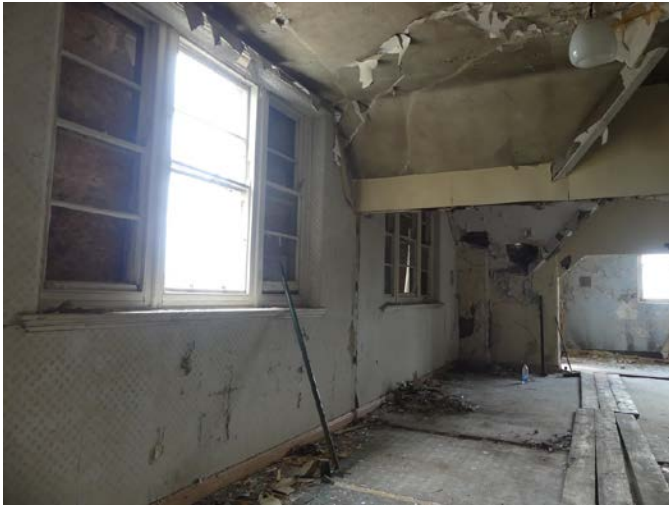
**Plate 76 (left):** Windows in the west elevations of Rooms G2 and G4, following the removal of the dividing wall

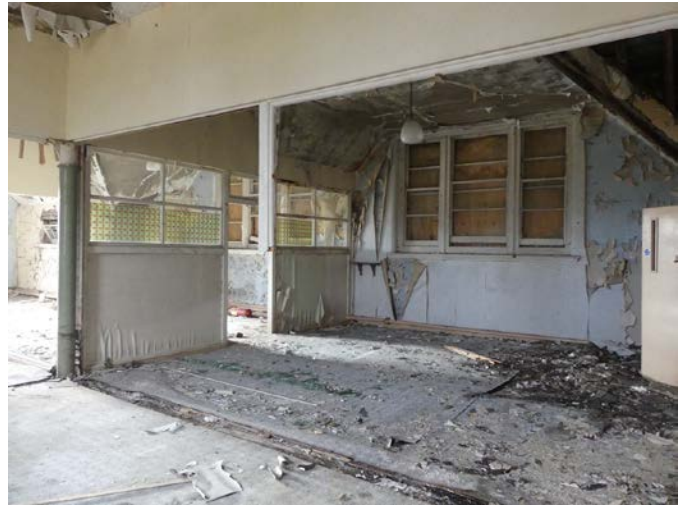
**Plate 77 (right):** Windows in the east elevation of Rooms G2 and G4, showing the remains of the dividing walls

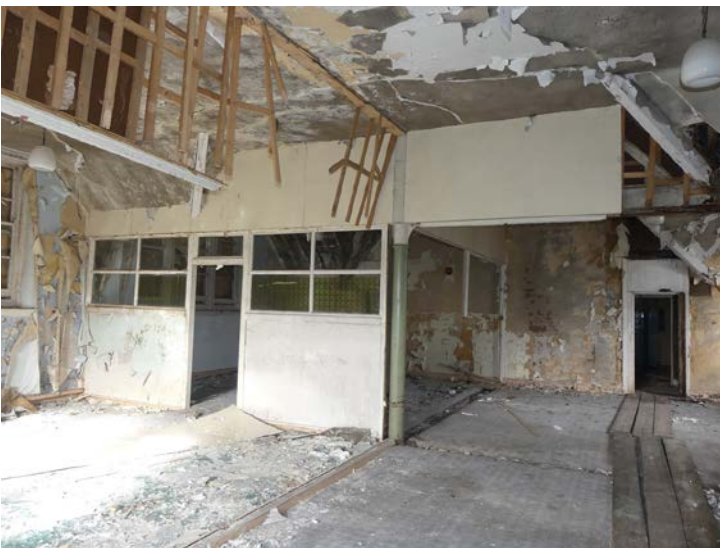
**Plate 78 (left):** The north end of Rooms G4 and G5 following the removal of some of the dividing walls, viewed from the south-east

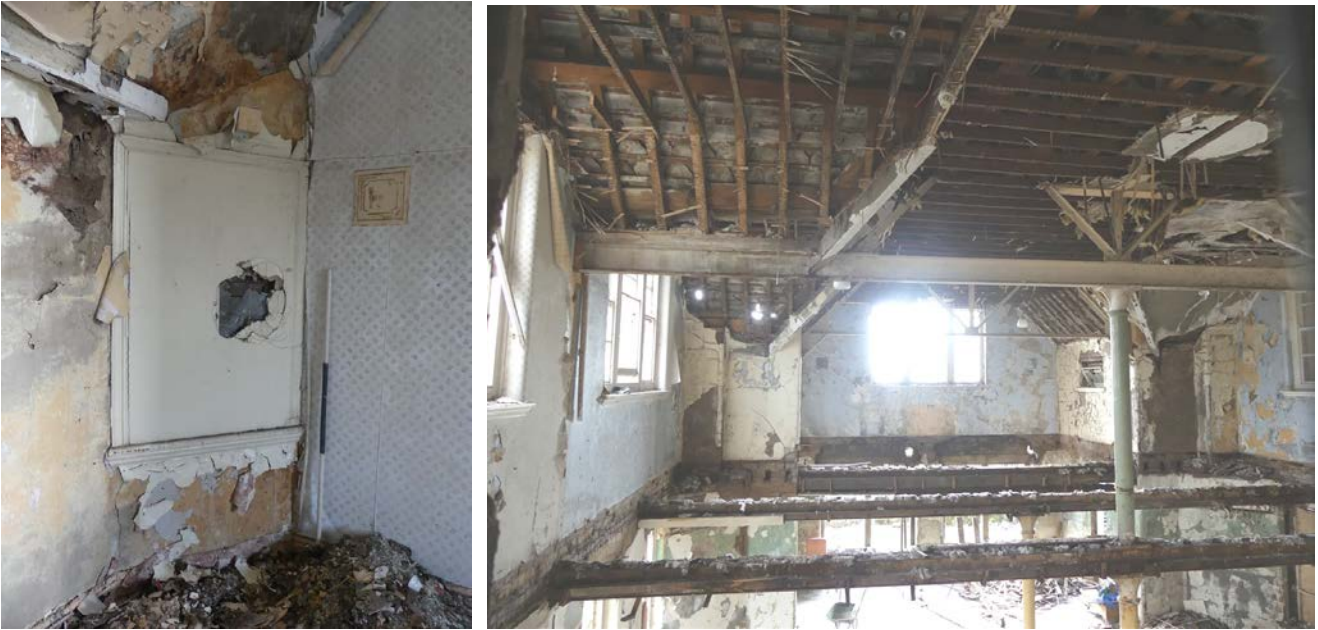
**Plate 80 (left):** Window in the north-east corner of Room G4, viewed from the south-west

**Plate 81 (right):** View across the site of Rooms F2-F5 following soft stripping, from the north

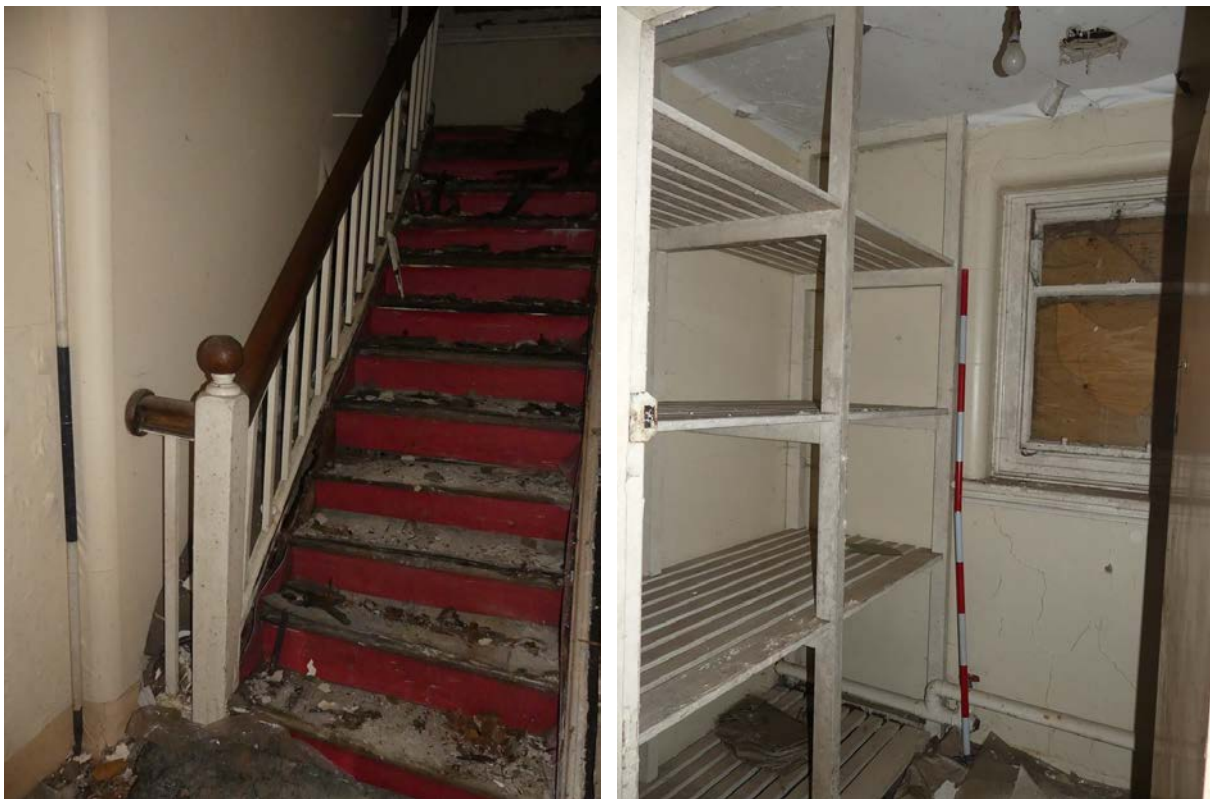
4.3.15 **First floor Room 6:** this comprises a corridor along the first floor connecting the stairs with rooms to the north and south. It has an asphalt floor covering over concrete, lathe and plaster ceiling on machine cut joists, and there are doorways on all sides and the stairs on the north side. Those to the second floor are timber and missing from the next landing. There is a handrail on the west side with square balusters and a square newel post at the south end with a chamfered top and ball finial.

**Plate 82 (left):** Stairs to the second floor on the north side of Room G6, viewed from the south

**Plate 83 (right):** General view of Room G7, from the north-east

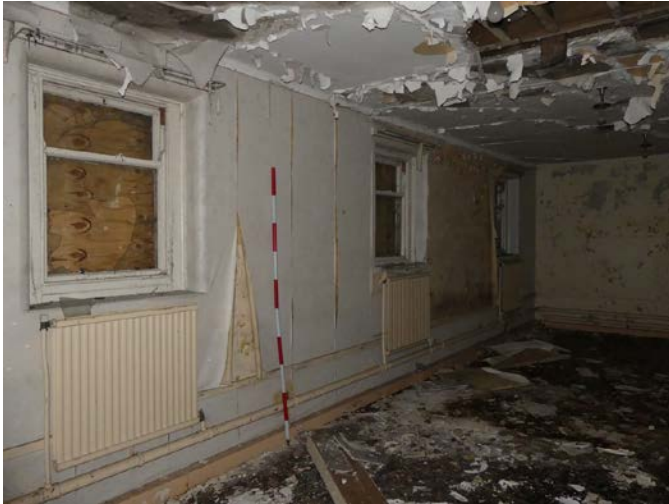
4.3.17 **First floor Room 8:** this has a vinyl floor over concrete, lathe and plaster ceiling on machine sawn joists, and the walls are finished with plaster and paint. There are three windows on the west side, each with two-light sliding sash casements and a wide opening to the east. Later clearance revealed this to probably be inserted and the lintel to comprise an iron I-beam marked 'SHELTON ENGLAND'.

Plate 84 (left): The west side of Room G8, viewed from the south-east

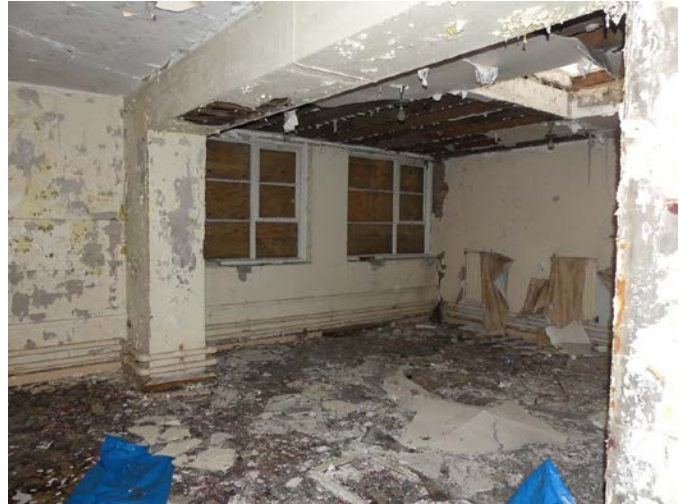
Plate 85 (right): The east side of Room G8, viewed from the south-west

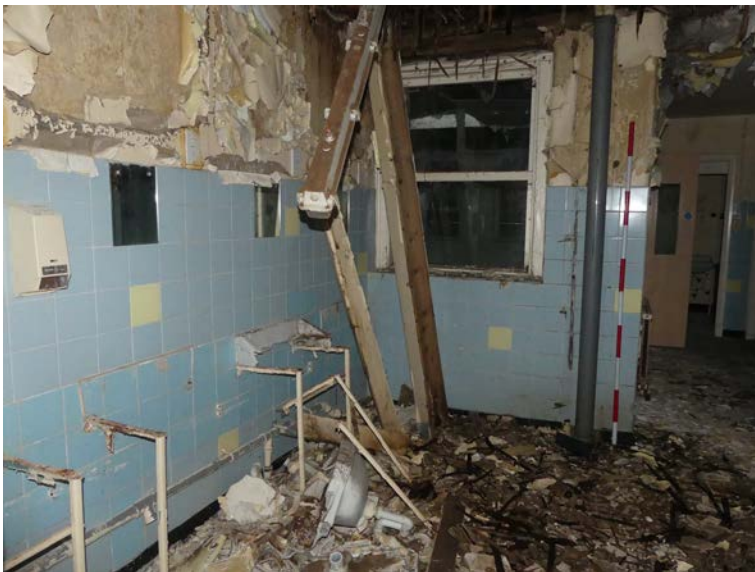
4.3.18 **First floor Room 9:** this has a vinyl floor covering and lathe and plaster ceiling and the walls are finished with plaster and paint and modern tiles. It is largely featureless, although there are a row of sink brackets along the west side and a window in the north-west with a two-light sliding sash casement (Plate 90). The north-east side turns into a corridor essentially forming part of Room F11 (Plate 91).

Plate 86 (left): The north-west side of Room G9, viewed from the south-east

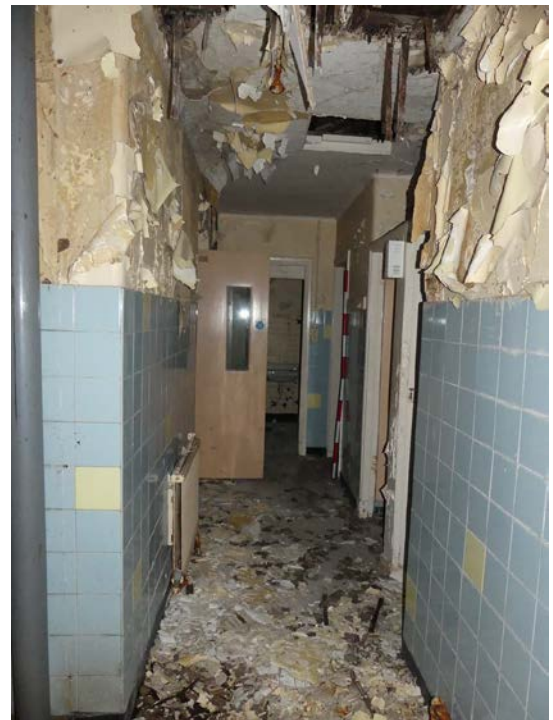
Plate 87 (right): The north-east side of Room G9, viewed from the south-west

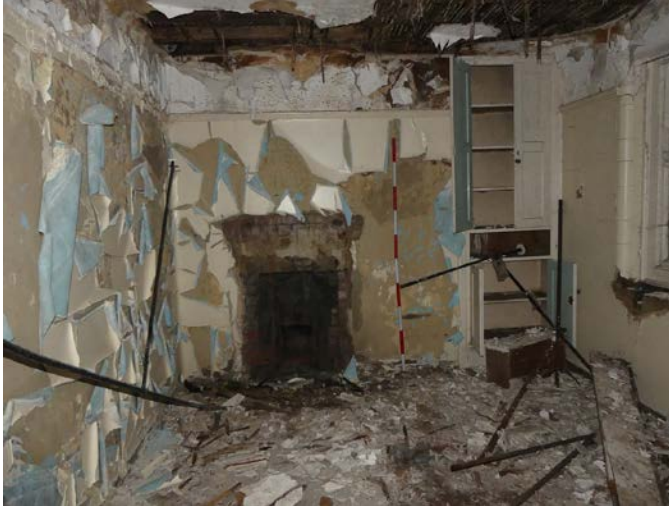
4.3.19 **First floor Room 10:** this has a vinyl floor covering and lathe and plaster ceiling on machine cut joists. The walls are finished with plaster and paint with a scar for a picture rail. There is a small fireplace on the north side, the surround for which is missing revealing the sandstone lintel, but there is a tiled hearth (Plate 88 and Plate 89). To the east of this is an alcove containing cupboards with a pair of panelled doors on the top and bottom divided by a central drawer (Plate 88). The east elevation has a large window comprising three parts each with a two-light sash casement (Plate 90). There is an angled section in the south-west corner filled with a window but boarded over (Plate 91).

Plate 88 (left): The north end of Room F10, viewed from the south

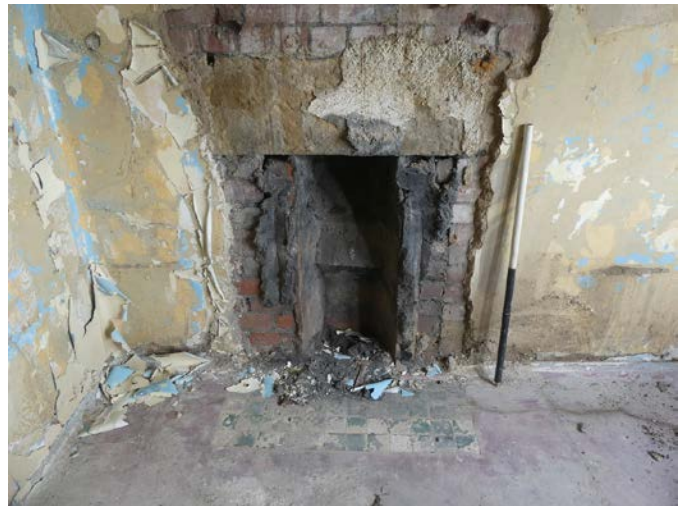
Plate 89 (right): Detail of the fireplace in Room F10 after clearance, viewed from the south

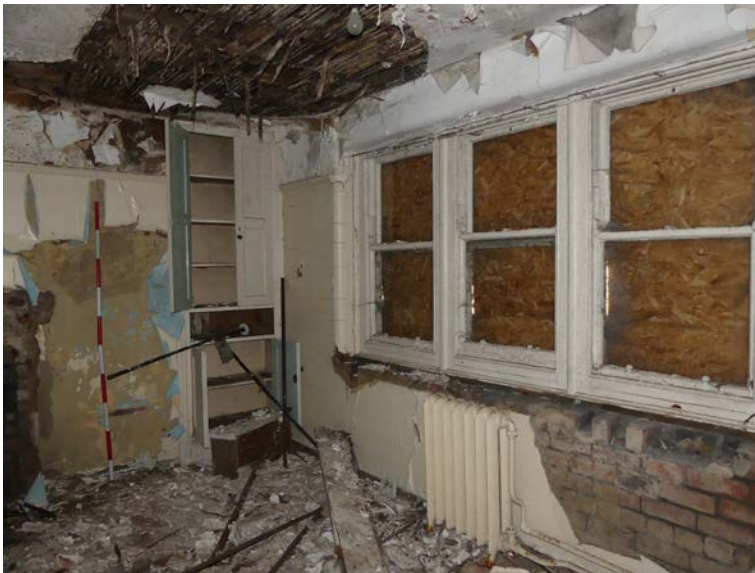
Plate 90 (left): Window in the east elevation of Room F10, viewed from the south-west

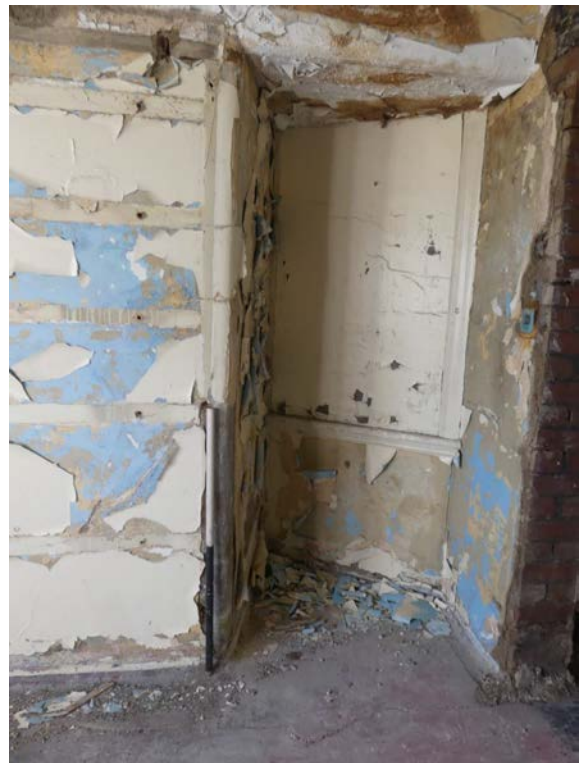
Plate 91 (right): Window in the south-west corner of Room F10, viewed from the north-east

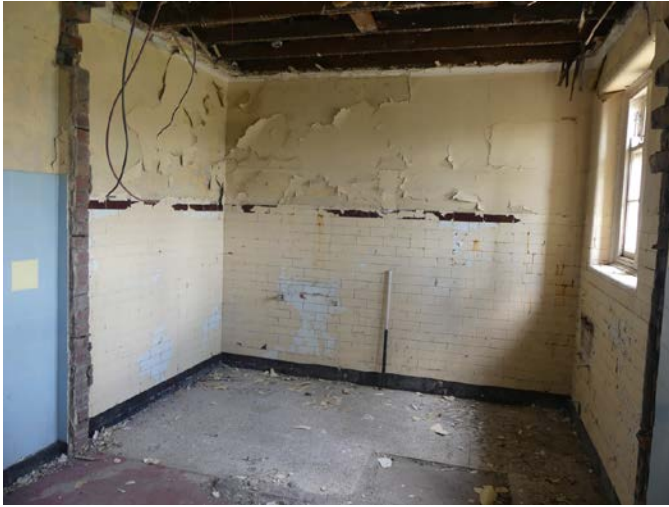
4.3.20 **First floor Room 11:** this has a vinyl floor covering over concrete with the scars for stalls along the east side. The walls are finished with plaster and paint although the north and south and part of the east are partially finished with early red and white long narrow tiles (Plate 92). There is a brick dividing

**Plate 92 (left): original tiles exposed after soft stripping at the north end of Room F11, viewed from the south**

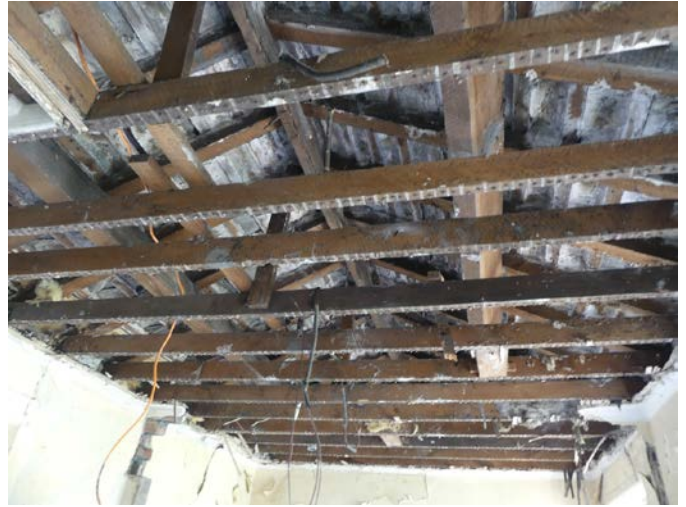
wall at the north end and a row of three small, paired windows on the east side. The ceiling is lathe and plaster below sawn joists, exposed following soft stripping (Plate 93). There are doorways to the west and south.

**Plate 93 (right): The roof structure of Room F11, viewed from the south**

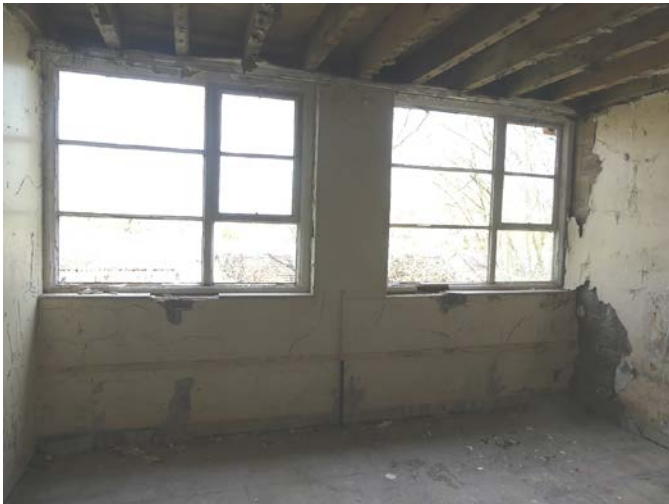
4.3.21 **First floor Room 12:** this has a vinyl floor covering over chipboard sheeting, a flat plaster ceiling with a large skylight in the centre, supported by machine cut joists and an iron I-beam running east/west, and the walls mainly finished with plaster and paint although this has fallen away in several areas revealing the stone below. The north elevation has two large windows with metal casements with hinged openings (Plate 94). There is a wide opening to Room G8 in the west elevation and a doorway in the east elevation with a chamfered lintel and where the stone is exposed behind the plaster it is in irregular course of ashlar blocks (Plate 95). The south elevation has three windows, one tall and with a sloping sill and two-light casement, the other two are low and narrow and within what was originally a single larger opening. Again, where the plaster has come away ashlar stonework is revealed (Plate 96).

**Plate 94 (left): Windows in the north elevation of Room F12, viewed from the south**

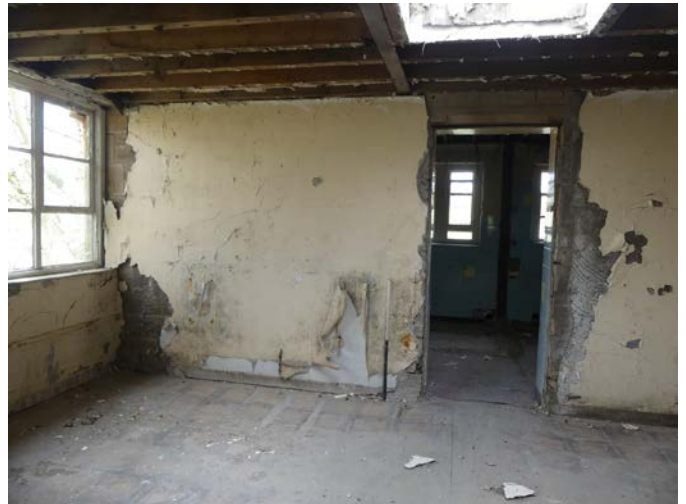
**Plate 95 (right): The east elevation of Room F12, viewed from the west**

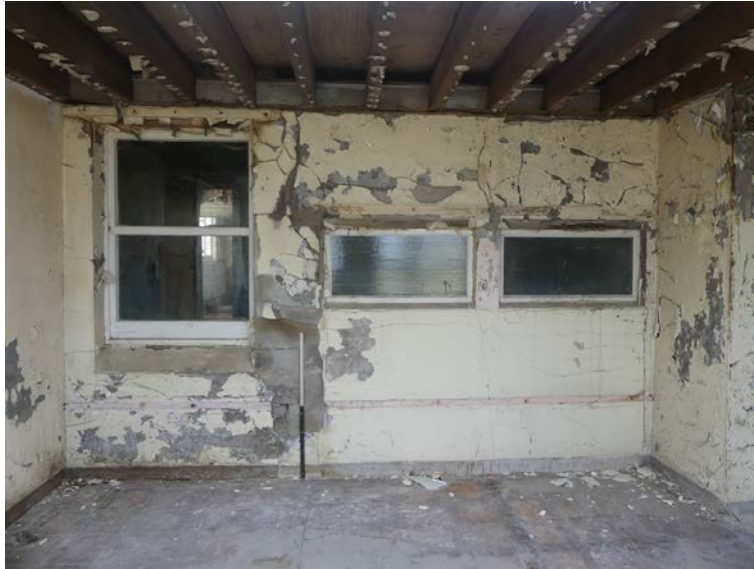
**Plate 96: The south elevation of Room F12, viewed from the north**
