FLAT 1, CAVENDISH HOUSE, CAVENDISH STREET, ULVERSTON, CUMBRIA

Heritage Assessment

December 2021

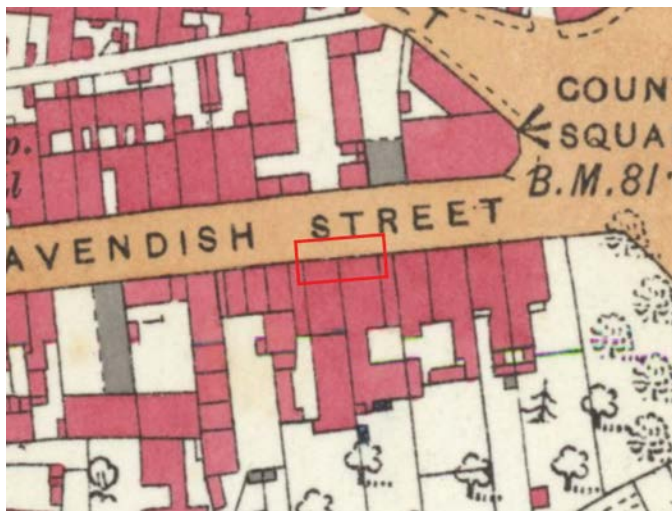
Plate 3 (left): Extract from the Ordnance Survey map of 1891

3.2.3 **Ordnance Survey, 1891:** this is slightly less detailed but seems to show essentially the same layout to the south side of Cavendish Street as the previous map (Plate 3). County Square is now in existence.

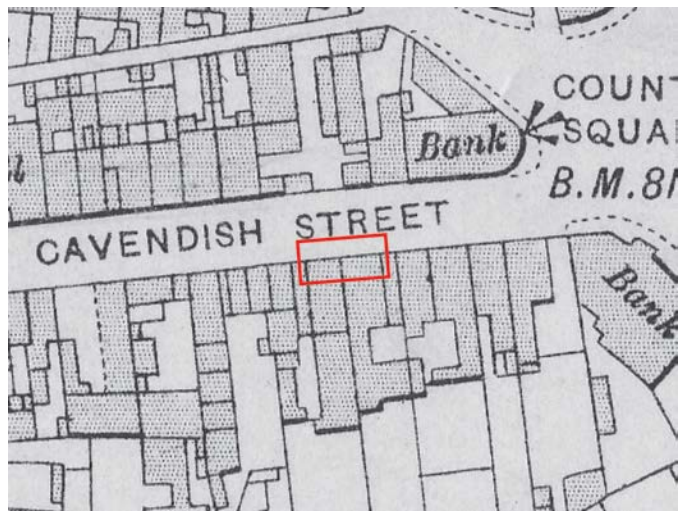
Plate 4 (right): Extract from the Ordnance Survey map of 1913

3.2.4 **Ordnance Survey, 1913:** the building is shown in essentially the same form as on the previous map (Plate 4). The bank has been built to the east end of the street on the south side.

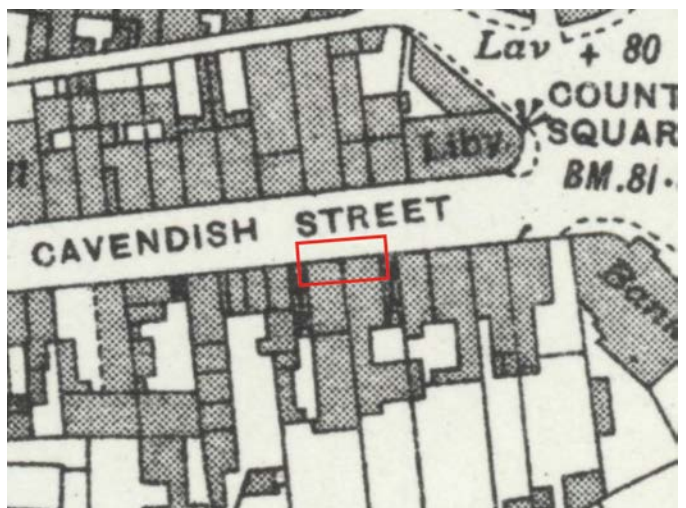
Plate 6 (right): Extract from the Ordnance Survey map of 1941

3.2.6 **Ordnance Survey, 1941:** the site appears unchanged (Plate 6).

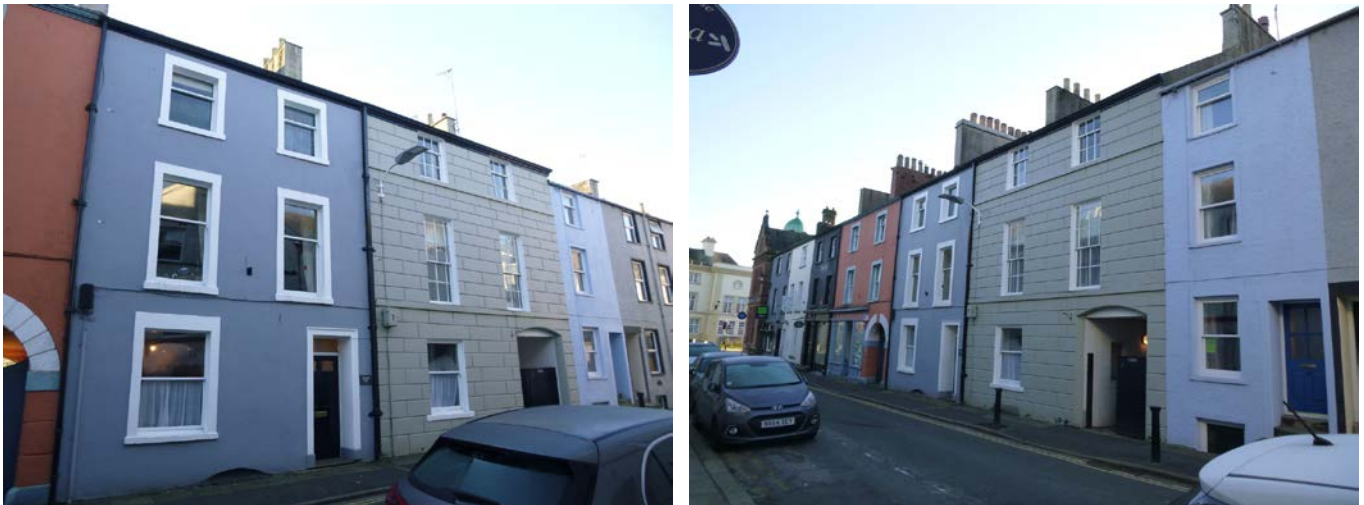
3.4.2 **North external elevation:** the bulk of the property evidently originally formed part of a single three storey house, with a window and doorway on the ground floor (corresponding with Flat 1) with a pair of windows on each of the floors above. The westernmost room of Flat 1 evident originally formed part of the adjoining property. The first and second floor windows have square dressed stone surrounds, arranged symmetrically, while the ground floor window is slightly wider but in broadly the same style. The doorway has a moulded surround. The adjoining property to the west has scored stucco in false blockwork and the ground floor window is relatively short compared to those above, which are symmetrical and have four over four lights with side light sash casements on the first floor and three over six casements on the second floor. The adjoining property to the east has a large shop window with dressed timber surround on the east side and arched opening to the west. Above there are a pair of windows on each floor, the first floor with two-light sash casements and the second with three over six sash casements.

Plate 7 (left): The north elevation, viewed from the north-east

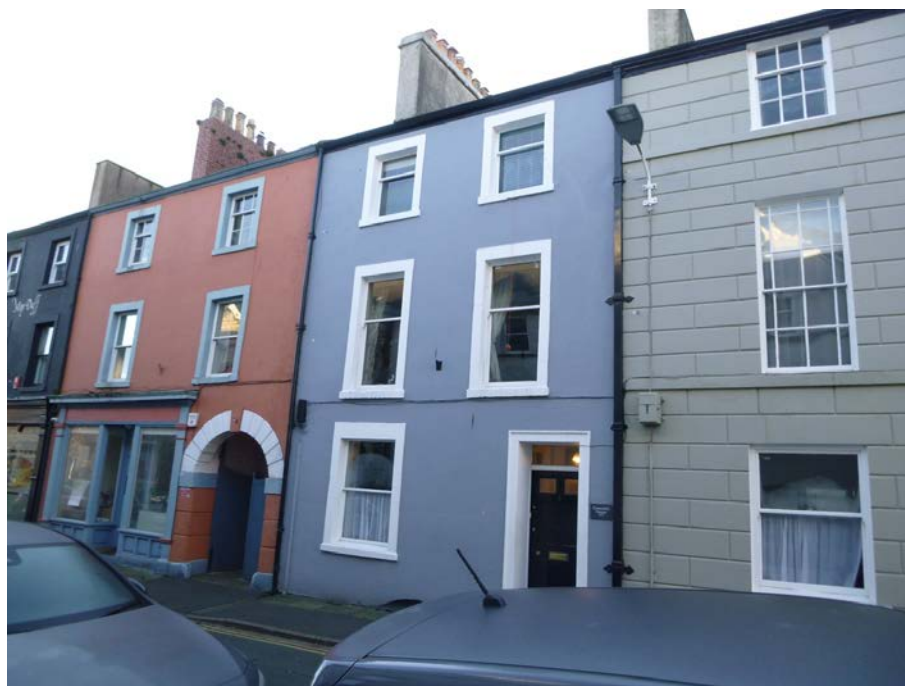
Plate 9: General view of the building and adjoining property to the east, from the north

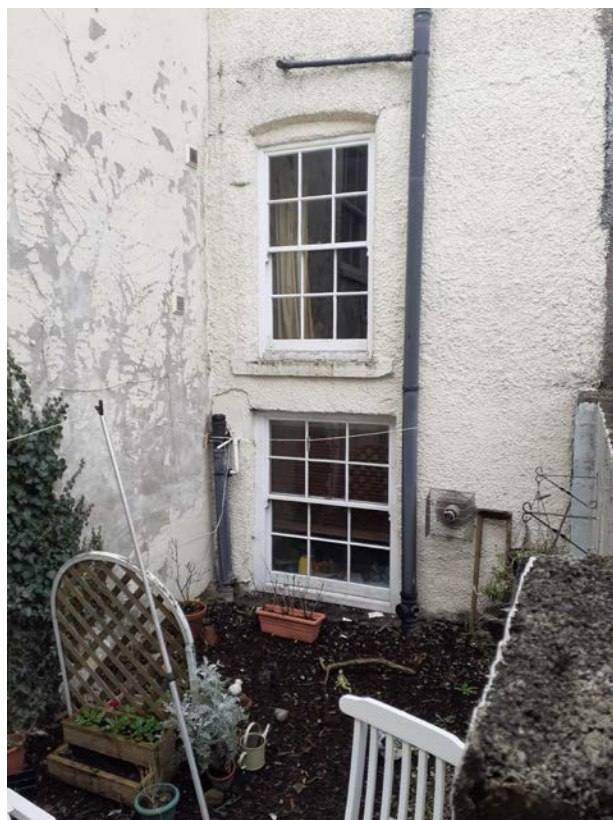
Plate 10: The south external elevation, viewed from the south-east

3.4.3 **South external elevation:** this was not accessed at the time of the site visit but a photograph was provided by the client, which shows that the basement level window is wider than the ground floor one, which also has a shallow arched lintel. Both have 12-light sash casements with horns in the same general style.

4.3.2 The windows casement to the rear (south) are evidently both modern, albeit relatively good copies of types appropriate for the property. The modern sash pulley and crisp paint and joints are obvious evidence and these are perhaps only 30 years old, although they may also have been installed as recently as when the building was converted into flats a little over 20 years ago. The use of this form of window, copying original sash casements, might be evidence that they were installed after the building was listed in 1996 (*Appendix 1*).

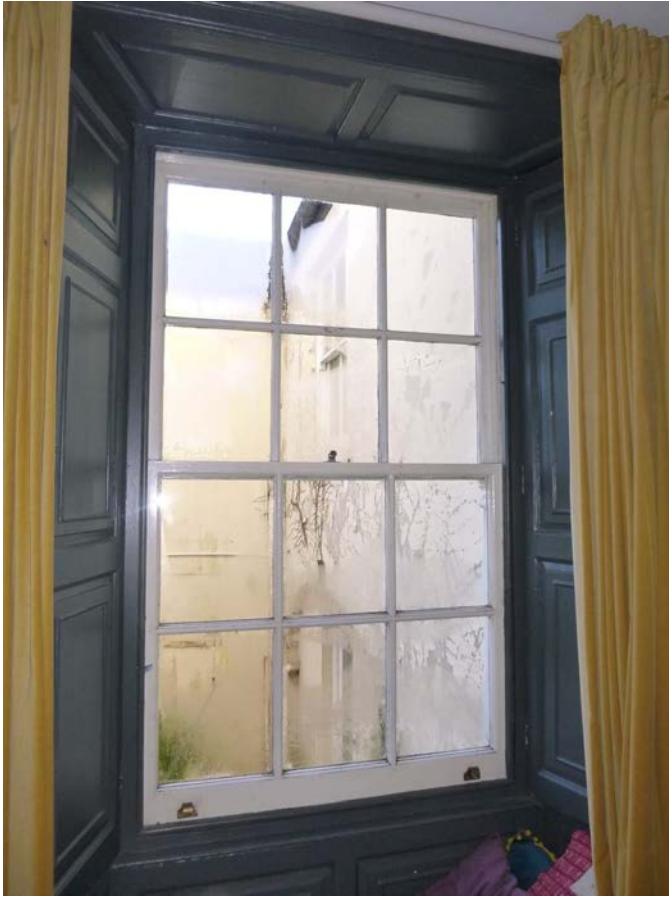
Plate 11 (left): Interior view of the ground floor south window

3.4.5 **Ground floor, south window:** this has a 12-light sliding sash casement, of six over six with horns (Plate 11). There are modern screw-threaded closures and pulls and the cord pulley is clearly quite modern and fixed with modern screws (Plate 12). The original shutters remain, which have raised and fielded panels, which are also present across the lintel and underneath the window. It is not heavily painted and the edges of the timber are very crisp.

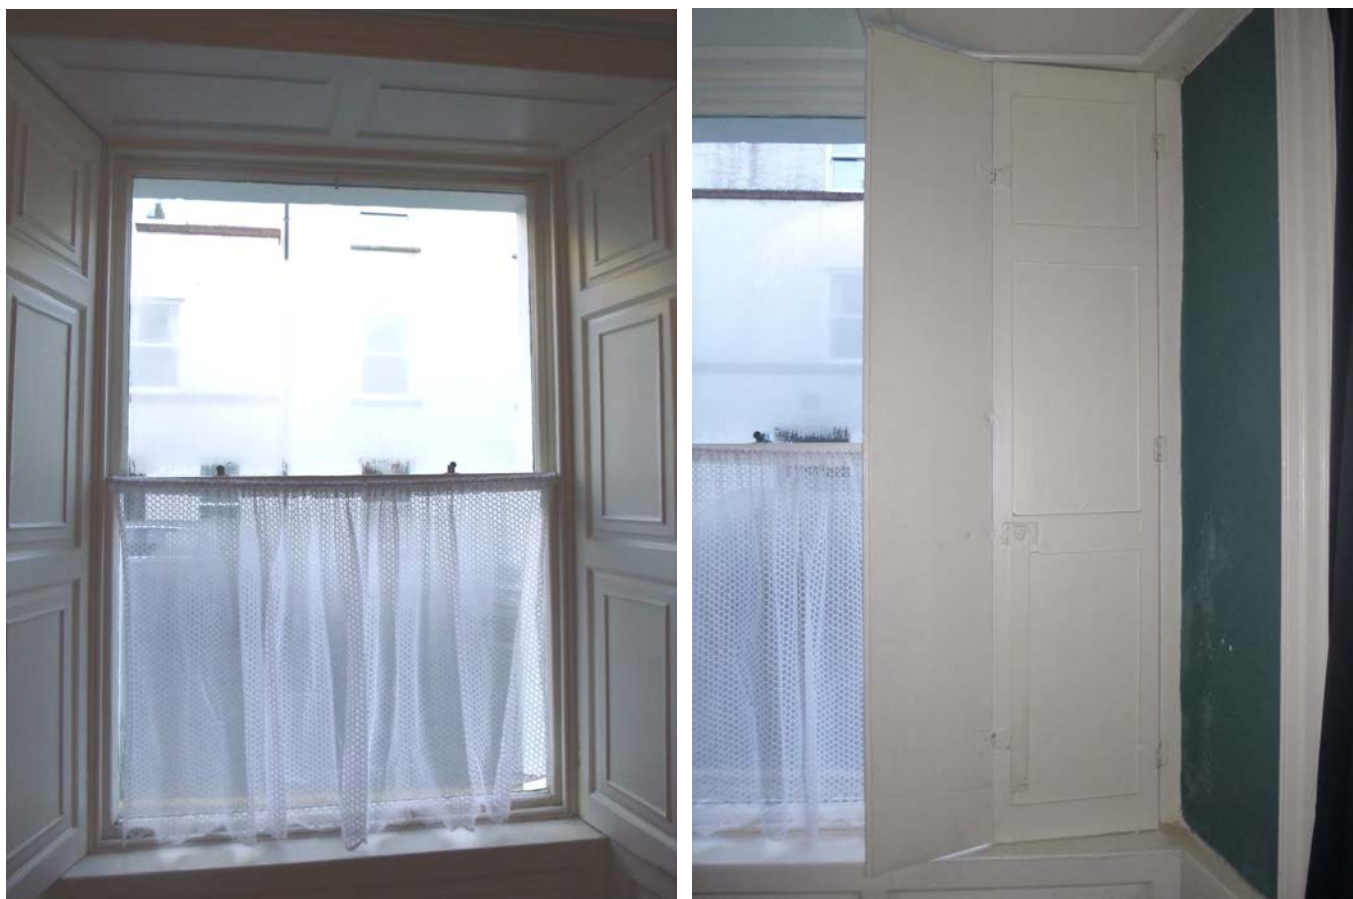
3.4.6 **Ground floor, north window, east side:** this has a two-light sliding sash casement, of one over one and no horns. Internally, it has screw-threaded closures and a loop pulls and beaded edges (Plate 13). There are moulded panelled shutters still *in situ* with butterfly hinges (Plate 14). It is all relatively heavily over-painted.

Plate 13 (left): Interior view of the ground floor north window, east side

Plate 14 (right): The right-hand shutter opened showing the hinges

4.3.1 The removal and replacement of the window casements within the property would potentially represent a substantial loss of original fabric. However, it is apparent from the site visit that none are original. The earliest is the ground floor, which does not have horns, suggesting it pre-dates the general use of these in c1840 (Wedd 1999, 2), although it has two large single lights, indicating a date post-1830 when sheet glass became more widespread (*ibid*). Given that all the evidence suggests that Cavendish Street was constructed by the early 1820s, it is possible that this window is original, however other properties on the same street have six over six casements without horns, which would be more typical of the period (The Georgian Group 2004). Perhaps the most original set of windows on the street is No .12, to the west of the site (Plate 16). The window to the west of this in the north elevation is undoubtedly later still as it has horns and is again two large single lights, suggesting a date of later than c1840. Given that there are shop windows in the properties to the east of the site and the relative width of these windows, compared to those on the upper floors, it is conceivable that both of these windows were originally shop windows, modified within a few decades of the building being constructed to their present form.

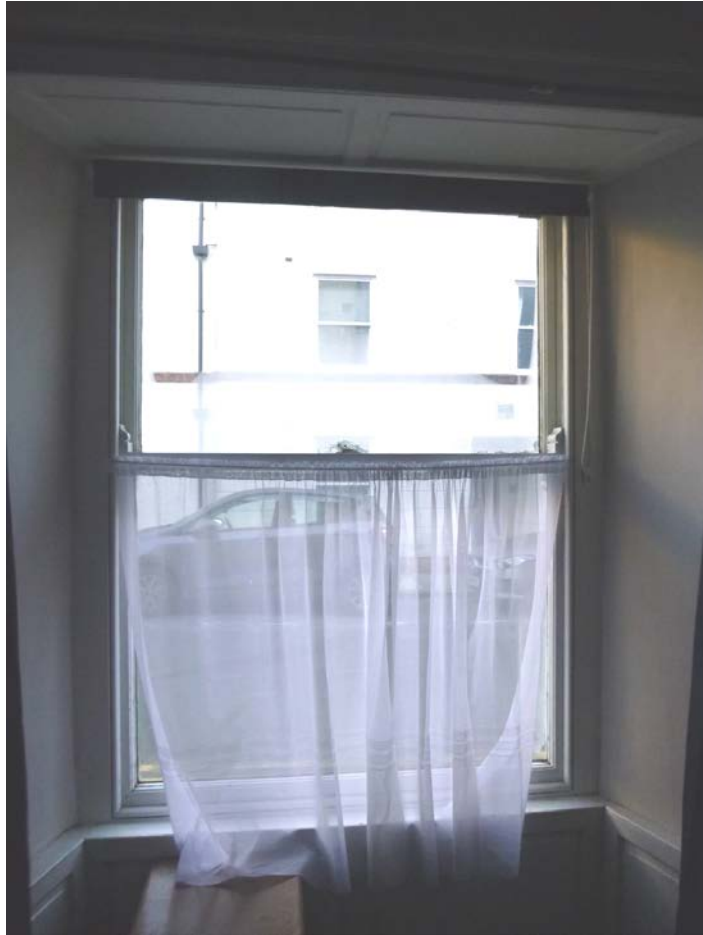
Plate 15: Interior view of the ground floor north window, west side

3.4.7 **Ground floor, north window, west side:** this has a two-light sliding sash casement, of one over one with horns. It has turning closures and beaded edges. The panels and shutters are gone, apart from a section below the lintel and underneath the window (Plate 15). It is less heavily over painted and the cord pulley is partly painted.
