COACH HOUSE TO REAR OF MANSERGH HOUSE, BORWICK LANE, BORWICK, CARNFORTH, LANCASHIRE

Archaeological Building Recording

June 2022

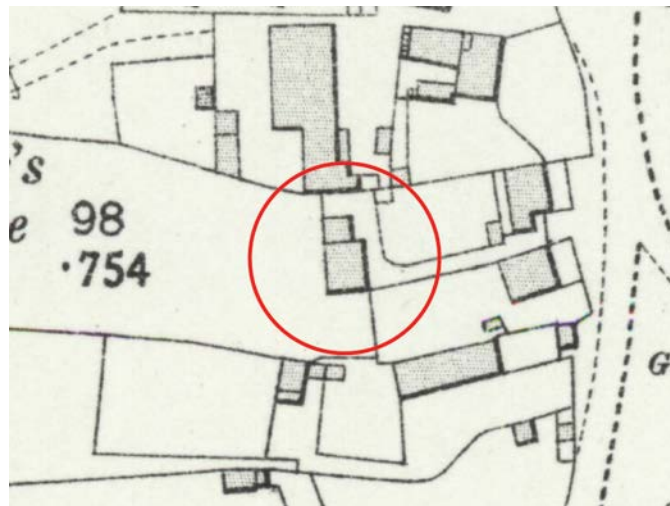
Plate 5: Extract from the Ordnance Survey map of 1913

3.1.4 **Ordnance Survey, 1913:** the building is shown in the same form as on the previous map, but this time a division is marked between the main part and the smaller northern section (Plate 5). This clearly shows that the current arrangement was in place by at least the early 20th century.

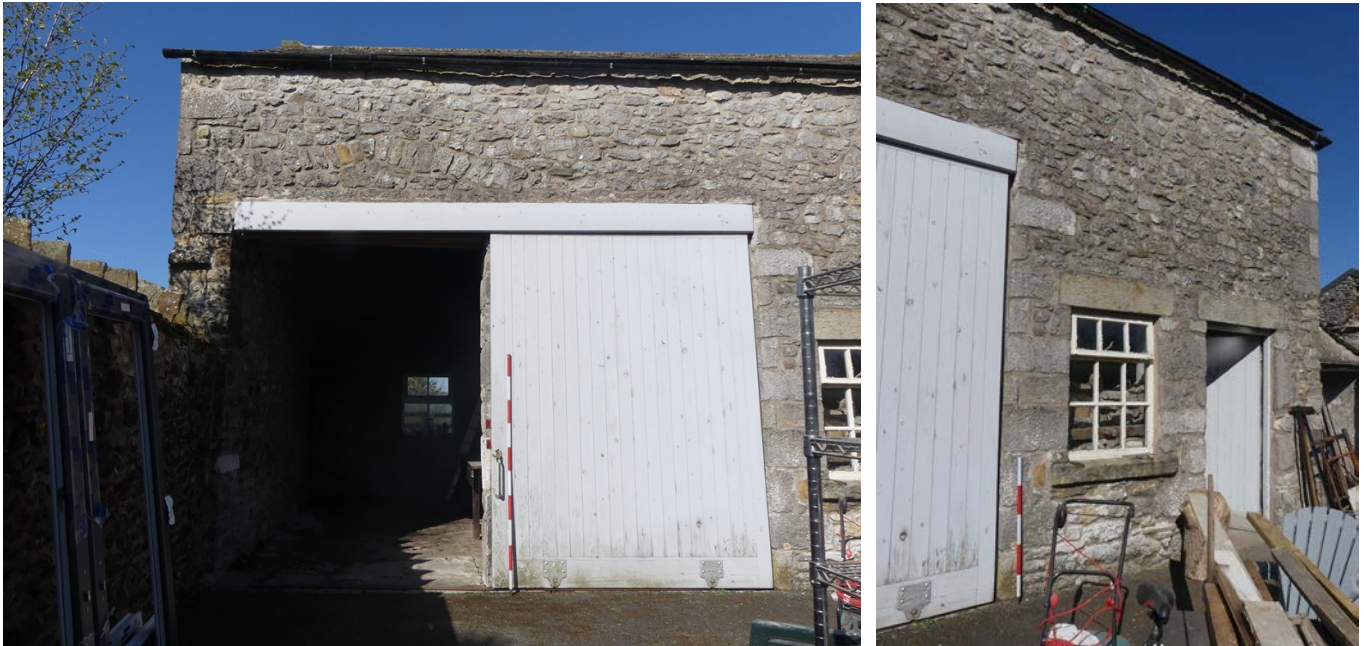
4.2.1 **East external elevation:** this is the front elevation of the barn, facing towards the house (Figure 2). It has a wagon door at the south end with a stone relieving arch over and a modern sliding plank and batten door in a recess, stepping out at the north end (Plate 6). The doorway has quoins in the jamb to the north side. The window to the north is a nine-light casement, the top three of which are hinged, and has a dressed gritstone sill and lintel (Plate 7). The doorway to the north has a dressed gritstone lintel and beaded plank and batten door and stop-chamfered surround (Plate 7). There is a return to the west at the north end of the main building. The corner has dressed quoins above c2m. The return to the north is a rougher build and butts the main building. There is a low wide door on the north side of this mono-pitch outshut, with a sandstone flag drip course over and plank and batten door on pivots (Plate 8).

Plate 6 (left): Doorway at the south end of the east external elevation

Plate 7 (right): Window and door in the east external elevation

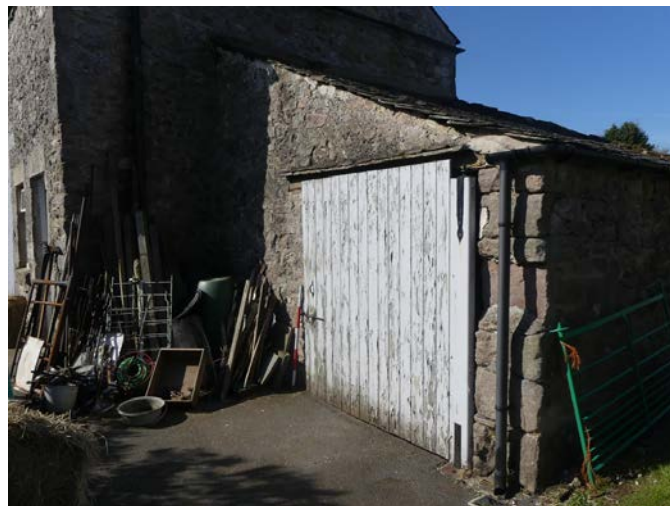
Plate 8: East external elevation of the outshut

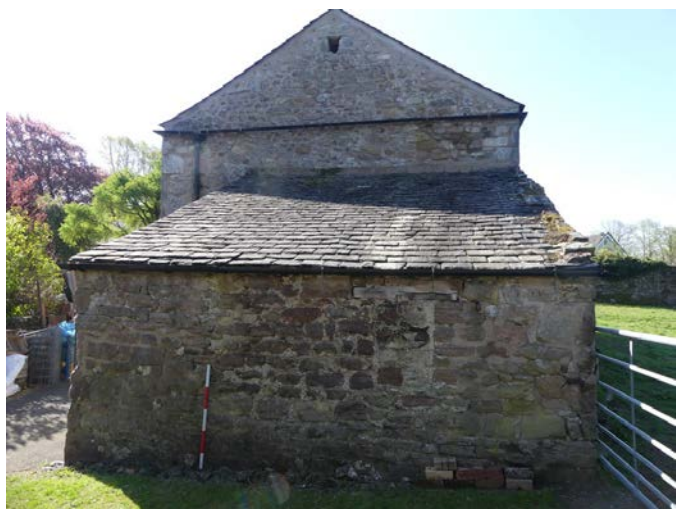
4.2.2 **North external elevation:** the lower part of the north elevation is covered by a mono-pitch outshut with slate roof (Plate 9; Figure 2), with some rough stone coping on the west side. The outshut has a small window on the west side, which is blocked with masonry and has a rough reused timber lintel with a notch (Plate 10). There are rough quoins at both ends. The gable end of the main elevation is visible behind, with the line of an earlier, lower and steeper pitch visible. The elevation has been raised, with dressed quoins visible above earlier pitch line, and there is an owl hole near the top in the raised section.

Plate 9 (left): General view of the north external elevation

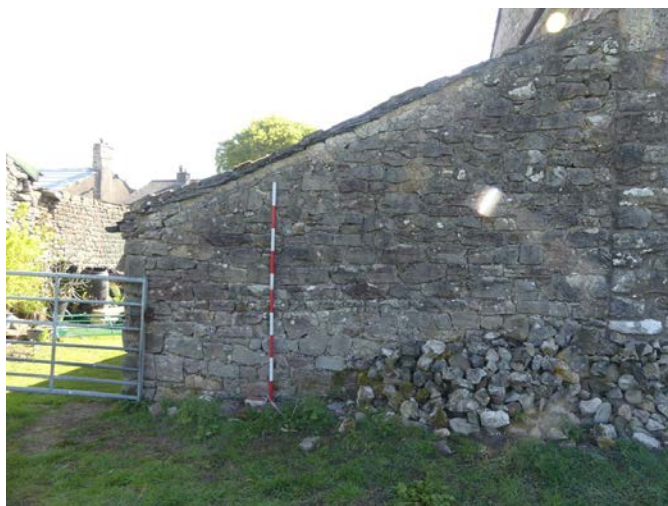
4.2.3 **West external elevation:** the north end has been extended to the north by a mono-pitch outshut in a fairly rough build (Plate 11; Figure 3). The main part has quoins at the top of both ends but not the lower part. There is a small window to the north of centre with a dressed gritstone lintel and sill and two-light hinged casement (Plate 12 and Plate 13). The second window to the south is a similar style (Plate 14 and Plate 15). There is some recent repointing along the eaves.

Plate 11: Mono-pitch outshut to the north end

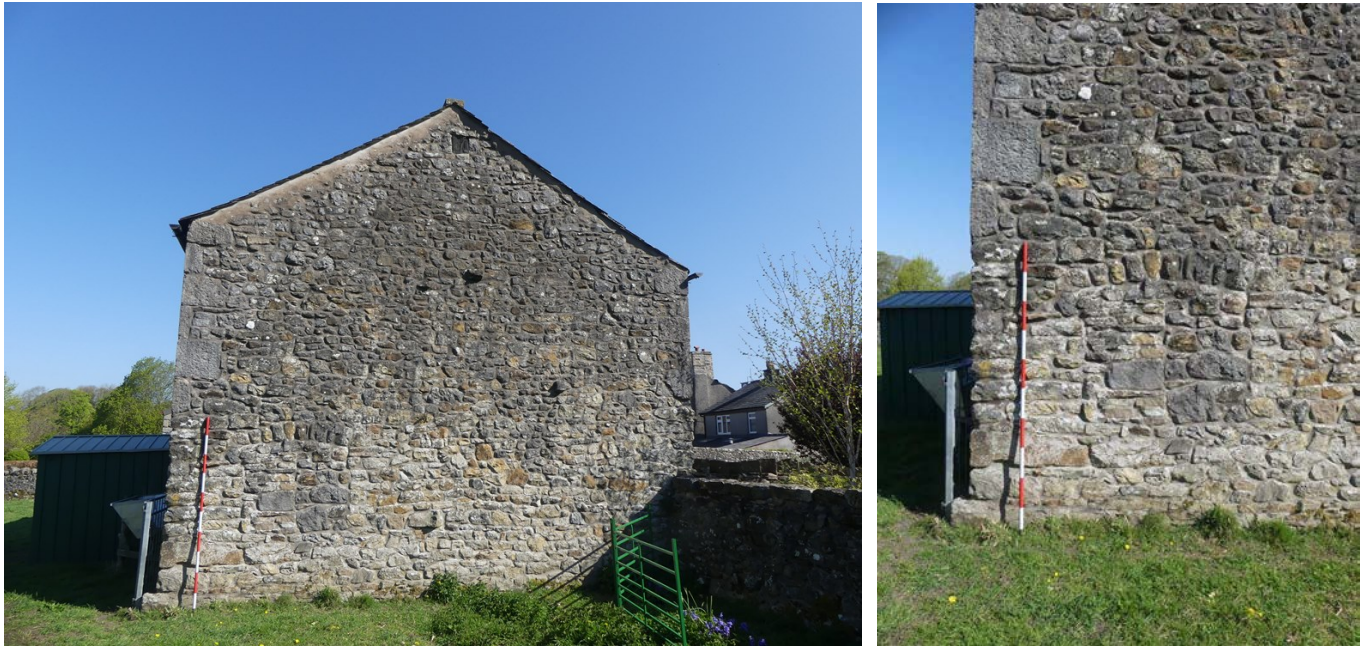
4.2.4 **South external elevation:** this is the gable end of the building (Plate 16; Figure 3). The original roof line, which was steeper, has been raised with quoins in the raised section. A former window, with a stone arch lintel and blocked with stone, is visible low on the west side (Plate 17). There is modern repointing at the eaves.

Plate 16 (left): General view of the south external elevation

Plate 17 (right): Window to the west side of the south external elevation

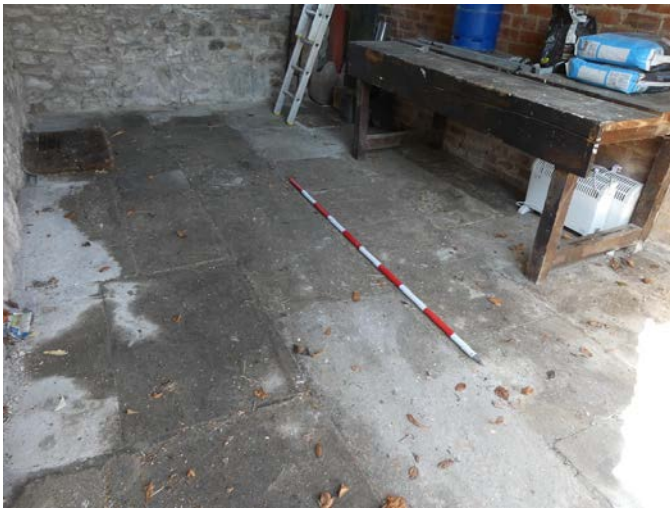
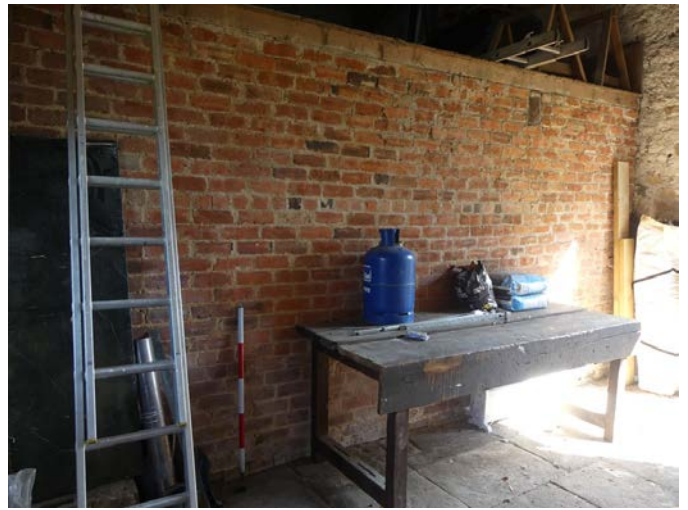
4.3.1 **Ground Floor Room 1 (G1):** this room, at the south end of the building (Figure 4), has a very neat stone flag floor, which is original (Plate 18). It is open to the roof (described in Section 4.3.5). The walls are exposed stone with lime mortar to the east, north and most of the west. The south has modern repointing. The **north elevation** is handmade brick in English garden wall bond pattern, in a ratio of nine rows of stretches to one row of headers (Plate 19), each brick being 0.22m by 0.10m by 0.07m. The **east elevation** is plain apart from a doorway on the south side with a small alcove to its north side (Plate 20 to Plate 22). The door has a reused cruck timber lintel (Plate 21). The **south elevation** is plain, mostly repointed, with an arched window on the west side. The window has been fully blocked on the west side and partially blocked, leaving an alcove, on the east side (Plate 23). The **west elevation** has a low window on the south side, with an arched opening and narrow sill (Plate 24), but is otherwise plain to the north.

Plate 18 (left): Stone flag floor in Room G1

Plate 19 (right): North elevation of Room G1

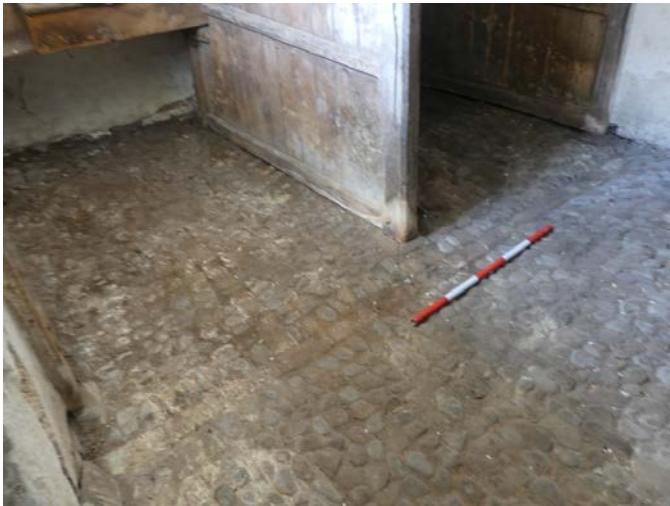
4.3.2 **Ground Floor Room 2 (G2):** this room has a cobbled floor running down to a brick drainage channel, aligned east/west (Plate 25). There is central stall partition on the south side and partitions

Plate 25 (left): Cobbled floor and brick channel in Room G2

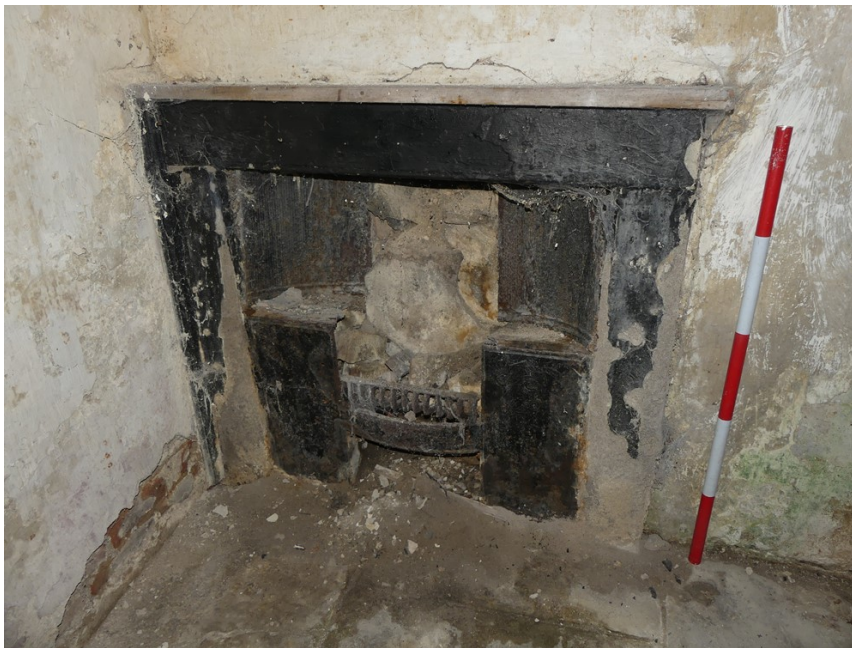
4.3.3 **Ground Floor Room 3 (G3):** this room has the original, very neat stone flag floor (Plate 36). The walls are plaster and limewash and the ceiling is lath and plaster. The **north elevation** has a step in it like Room G2 (Plate 37). The **east elevation** has a beaded plank and batten door on the north side on strap hinges (Plate 38) and a shelf and batten with coat hooks to the south (Plate 39 and Plate 40). The **south elevation** is plain with brick beneath the plaster. The **west elevation** has a fireplace to the south side, with a square stone surround, beaded edge, iron back, hob grate with geometric design, and timber mantel (Plate 41). The window to the north has a timber sill and arched lintel (Plate 42).

Plate 41 (left): Fireplace in Room G3

5.2.2 **Phase 1 (17th -18th century?):** it is apparent that the building as it now stands has been raised in height from an earlier structure. Although the exact form of this is uncertain it had essentially the same footprint as Rooms G1-3 and F1. It seems likely that the, now blocked, window in the south elevation of Room G1 belongs to this building as well as the doorway in the north elevation of Room G2 and perhaps the fireplace in the west elevation of Room G3. The form of this would suggest an 18th century date but it is otherwise not obvious what function this building had. It was perhaps domestic, given the numerous windows and the fireplace (although this was undoubtedly used in the later coach house too); the evidently steep pitch of the roof perhaps also indicates that it was originally thatched or had a cruck frame. There must have been a chimney on the west side from at this this phase to serve the fireplace in Room G3, which has since been removed.

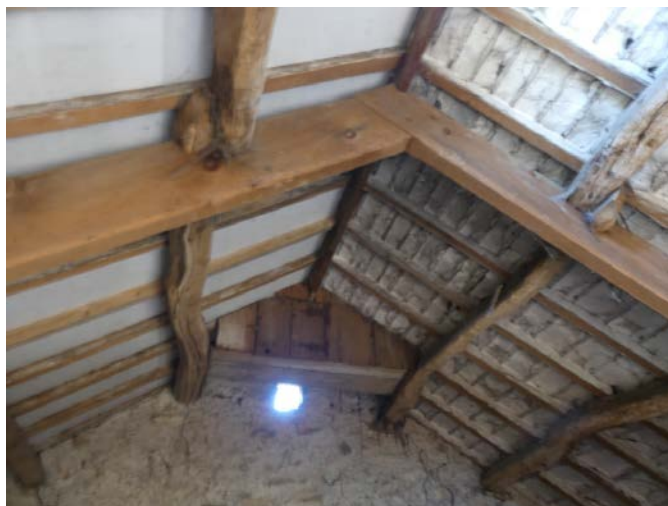
4.3.5 **First Floor Room 1 (F1):** the walls are exposed stone with lime mortar. The south end of the space is open above Room G1 (Figure 5). There are two simple east/west tie-beam trusses of neatly hand-finished red pine, overlapping east-on-west at the ridge and bolted between the tie beam and the principals (Plate 50 and Plate 51; see Figure 6). There are two purlins per pitch, which are a mix of neatly finished and rough hand finished and reused timbers, and ridge plank. Above that is modern felt and battens, with a single skylight on the west side and original parging and earlier battens on the east. At the north end there is a boxed section attached to the eaves constructed from planks and with a small hinged doorway on the south side, possibly a dovecote (Plate 52). The floorboards are fairly narrow with

Plate 52: Probable dovecote to the north end of Room F1

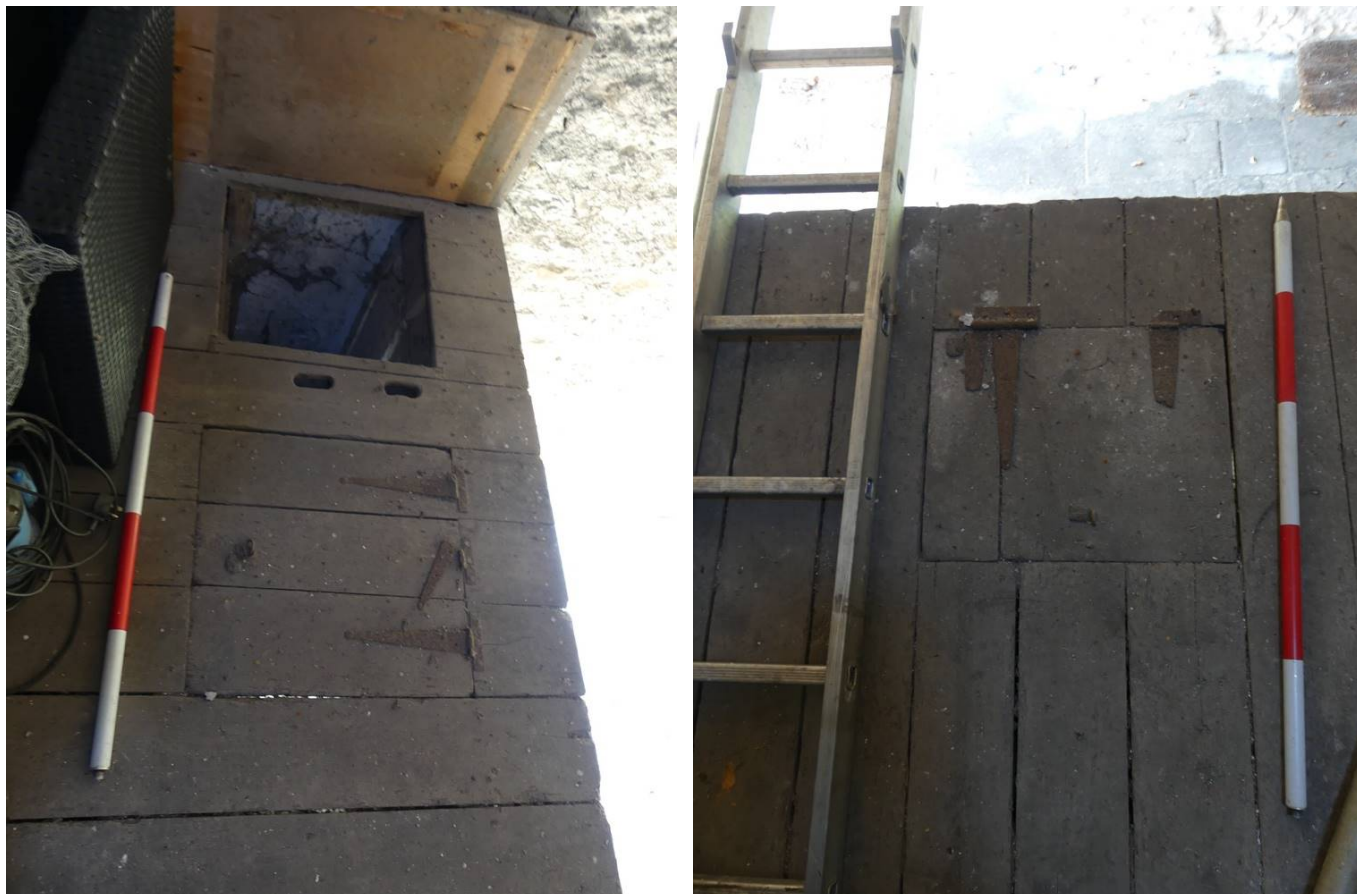
three hatches on the south side, one of which is missing its cover, assuming it ever had one, and has two hand holes(?) to the west, while the other two have hinged plank covers (Plate 53 and Plate 54).

Plate 53 (left): Two hatches to the east side of the floor in Room G1

Plate 54 (right): Hatch to the centre of the floor in Room G4
