# EAST LODGE, ALDCLIFFE, LANCASTER, LANCASHIRE

Heritage Assessment

May 2022

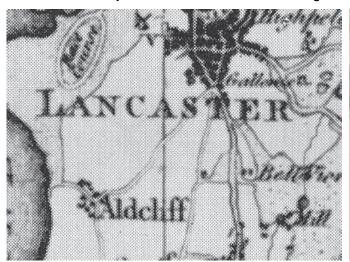
Plate 1 (left): Extract from Yates' map of 1786
Plate 2 (right): Extract from Hennet's map of 1830

- 3.2.1 *Introduction*: early maps of the area tend to be relatively lacking in detail, such as Yates' (1786) and Hennet's (1830) maps of Lancashire, so the earliest useful maps therefore only date from the 19<sup>th</sup> century. There is no tithe map for the area.
- 3.2.2 **Yates' map of Lancashire, 1786**: this early plan of the area shows the location of Aldclife relative to Lancaster without labelling the hall (Plate 1). The canal has not been built yet.
- 3.2.3 *Hennet's map of Lancashire, 1830*: this map shows Aldcliffe Hall, with a track to a junction with the main road adjacent to the canal, but the lodge has yet to be built (Plate 2).

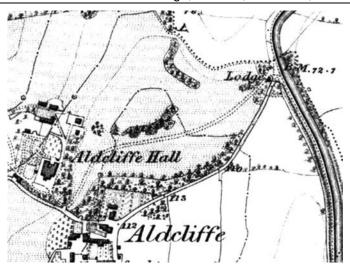
Plate 3: Extract from the Ordnance Survey map of 1848

3.2.4 *Ordnance Survey, 1848*: the first edition 1:10,560 Ordnance Survey map, surveyed in 1844-5, shows a similar field arrangement to Hennet's map (Plate 3; cf. Plate 2). The lodge is now clearly marked at the junction of Aldcliffe Hall Drive and Aldcliffe Road; however, very little detail is discernible.

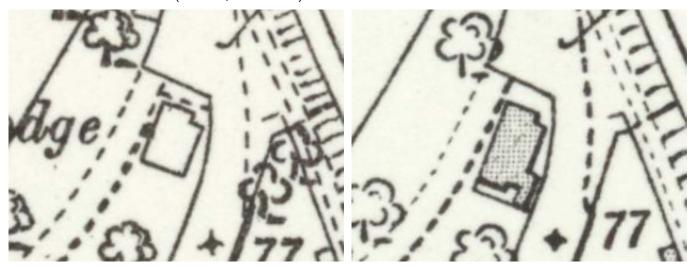
Plate 4 (left): Extract from the Ordnance Survey map of 1893
Plate 5 (right): Extract from the Ordnance Survey map of 1913

- 3.2.5 *Ordnance Survey, 1893*: the 1893 edition of the Ordnance Survey map, at a scale of 1:2,500, was surveyed in 1891-3. The lodge at this point comprised a rectangular block stepped in slightly at the north-east corner (Plate 4) and possibly has a porch off the west side.
- 3.2.6 *Ordnance Survey, 1913*: this edition, revised in 1910, shows the building has been extended to the south and south-east (Plate 5; cf. Plate 4).

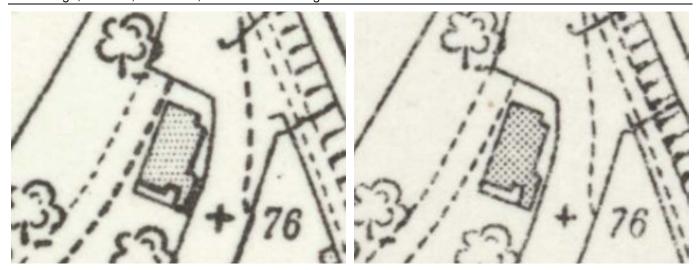
Plate 6 (left): Extract from the Ordnance Survey map of 1933 Plate 7 (right): Extract from the Ordnance Survey map of 1939

- 3.2.7 *Ordnance Survey, 1933*: the 1933 edition of the Ordnance Survey map was revised in 1931; however, the site appears unchanged (Plate 6; cf. Plate 5).
- 3.2.8 *Ordnance Survey, 1939*: the 1939 edition of the Ordnance Survey map contains revisions from 1938. No changes to the lodge are indicated (Plate 7; cf. Plate 6).

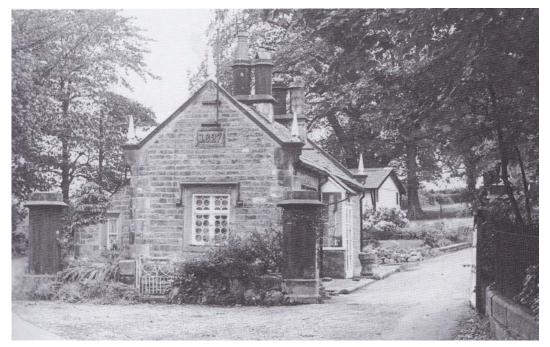
Plate 8: Photograph of the site (from Martin 2004, 219)

3.2.9 **Photograph, pre-2004**: a photograph of the building, viewed from the north, is reproduced in Martin (2004, 219; Plate 8). It is not clear when it was taken but it obviously must have been before 2004. While this shows the site much as it now is and confirms that the porch on the west side was present at this time, it is of interest as it shows another, apparently detached building, perhaps a garage, was located to the south at this time. This is not shown on any of the maps up to 1939 but is also no longer present on site.

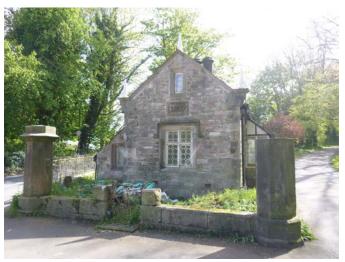
adjoining road (Plate 14 and Plate 15). It is largely constructed from local yellow gritstone, externally finished in courses of roughly dressed ashlar with finer detailing around the doors and windows and in the two pairs of octagonal-section chimneys and copings (Plate 10 and Plate 11). The windows have Tudor style drip moulds and the earlier ones have cast iron casements made up of octagonal sections surrounding rhomboids with etched decoration (Plate 13). The later ones are poor copies in the same style. The north elevation also has a small high-level window and a datestone carved '1827' in relief (Plate 10). The south end has clearly been extended, in stonework but without the substantial dressed plinth and cut into the ground to the south (Plate 13), and there is also a later porch on this side around the original doorway with modern 'Gothic' style timber decorations (Plate 12). The south-east corner has also been extended (Plate 14), with a flat dormer in a similar style to the porch (Plate 15).

Plate 10 (left): The north external elevation, viewed from the north

Plate 11 (right): The west external elevation, viewed from the south-west

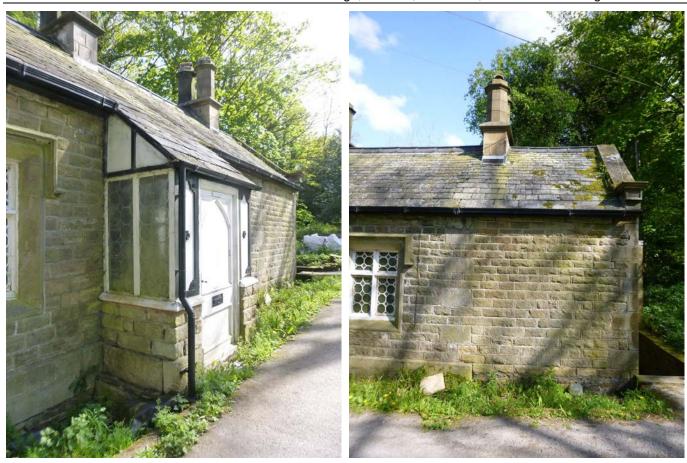
Plate 12 (left): The porch on the west external elevation, viewed from the north-west Plate 13 (right): The later extension visible in the south end of the west elevation, viewed from the west

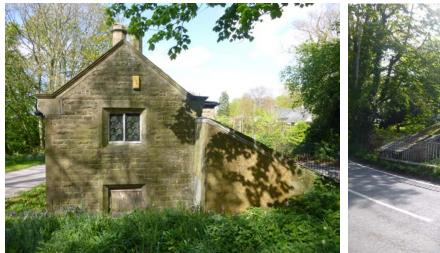
3.4.1 A brief site visit was made, although access to the interior was limited due to the condition of the building, with the floor of the south-west room actively collapsing, and the cluttered interior. The building is orientated broadly north/south, with the east side alongside Aldcliffe Road. It comprises a relatively small and irregular but essentially L-shaped block, projecting from the south-east end towards to the

Plate 14 (left): The south elevation, viewed from the south Plate 15 (right): The east elevation, viewed from the north-east

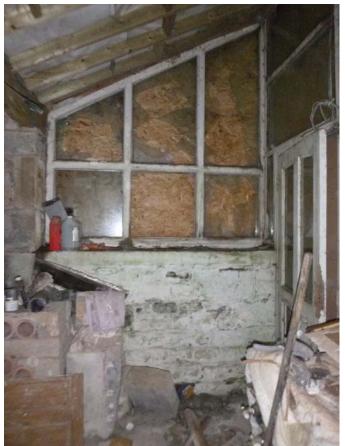
3.4.2 Internally the building consists of one main room at the south end, with a smaller one to the east, another large room to the south-west, and an irregular collection of smaller rooms accessed via a staircase that drops down from north to south on the south-east side (Plate 16 and Plate 17). Very few features of architectural interest have survived internally; the walls in the main rooms have been largely stripped of plaster back to the stone and have windows to the north and west (Plate 18, Plate 20 and Plate 22), but there is a small fireplace with a stone with a very crude armorial carved in it above, and a small window with an arched top in a brick section to the west (Plate 19), as well as a larger fireplace in

Plate 16 (left): The south-eastern room, viewed from the north

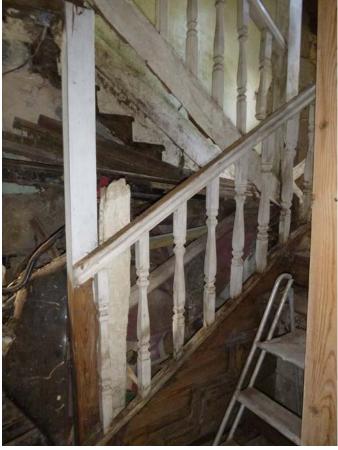
Plate 17 (right): The staircase linking the south and north ends of the building, viewed from the east

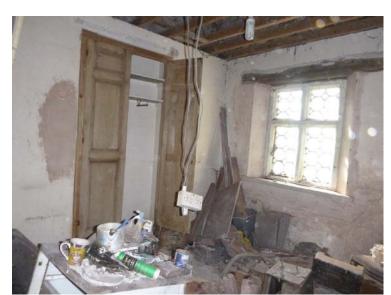
the main north room, with a curved timber lintel with bead-moulded ends (Plate 21), probably a modern addition. The large room to the south-west has a stud wall against the south elevation incorporating a large cupboard with double three-panelled doors (Plate 18). There are suspended timber ceilings in the main rooms, forming a low attic above, the staircase between the north and south ends has square section moulded balustrades (Plate 17), probably also relatively late additions, and the door inside the porch on the west side has five studded panels and a Gothic style handle (Plate 23).

Plate 18 (left): The south-western room, viewed from the north-east

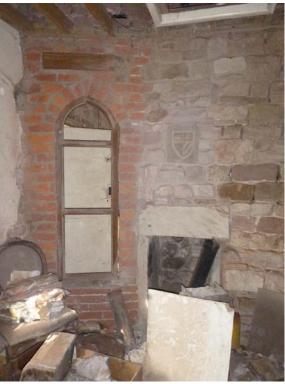
Plate 19 (right): The arched window and fireplace in the south-western room, viewed from the south-east

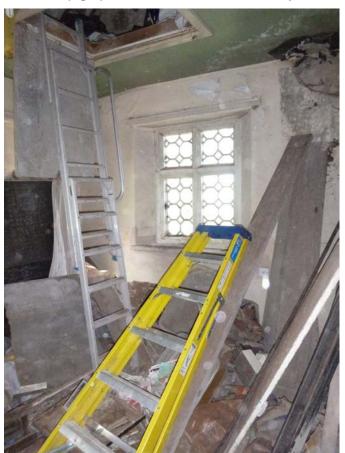
Plate 20 (left): The north side of the north-west room, viewed from the south-east

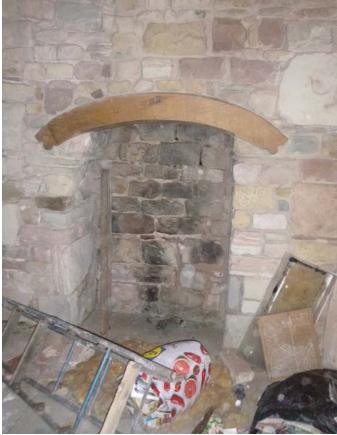
Plate 21 (right): The fireplace on the south side of the north-west room, viewed from the north

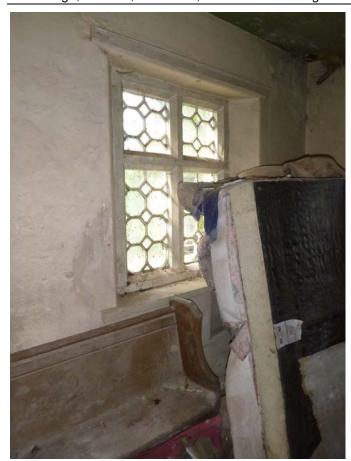
Plate 22 (left): The west side of the north-west room, viewed from the south-east

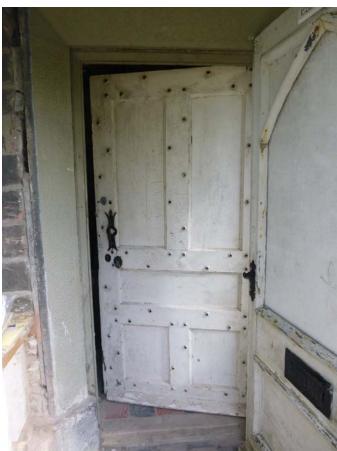
Plate 23 (right): The internal doorway inside the porch on the west side of the building, viewed from the

west
