LAND NORTH OF OLD HALL FARM, OVER KELLET, LANCASHIRE

Archaeological Watching Brief and Evaluation

Client: Oakmere Homes

October 2022

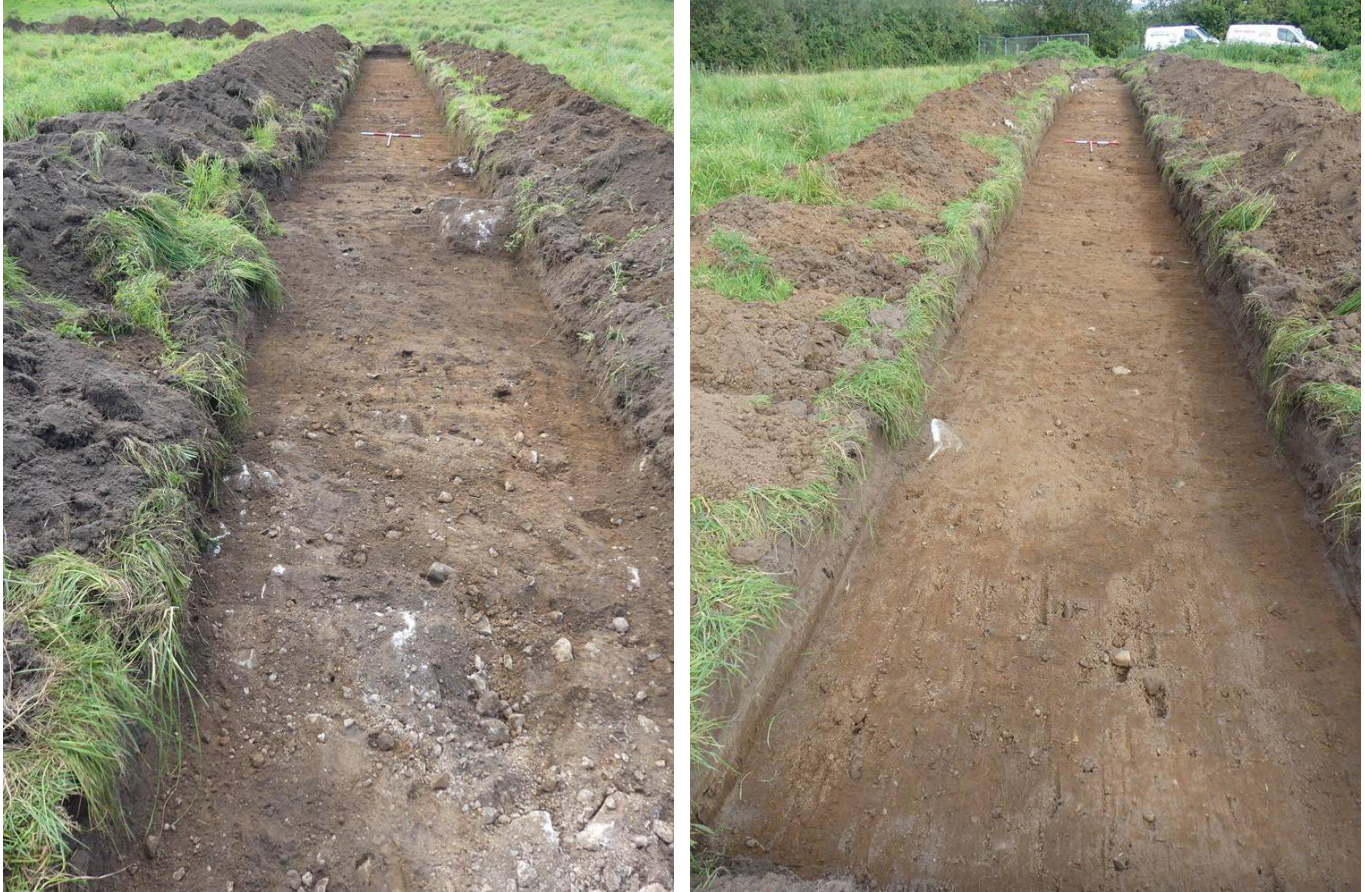
4.3.1 Trench 1 was c30m long and aligned approximately north-east/south-west (Plate 26 and Plate 27; see Figure 3). The c0.4m thick topsoil (**100**) was a mid-greyish brown silt, below which was the brownish-orange sandy/silty clay natural (**101**). Two large boulders, possibly large fragments of bedrock, were noted at the north-east end of the trench and areas of pebbles and gravel were also noted.

Plate 26 (left): Trench 1 viewed from the north-east

Plate 27 (right): Trench 1 viewed from the south-west

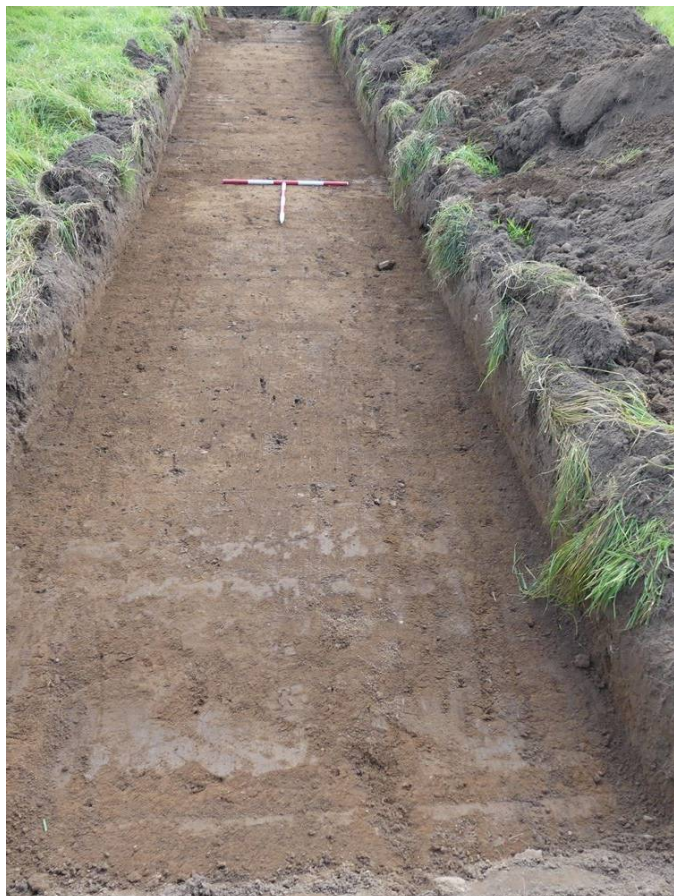
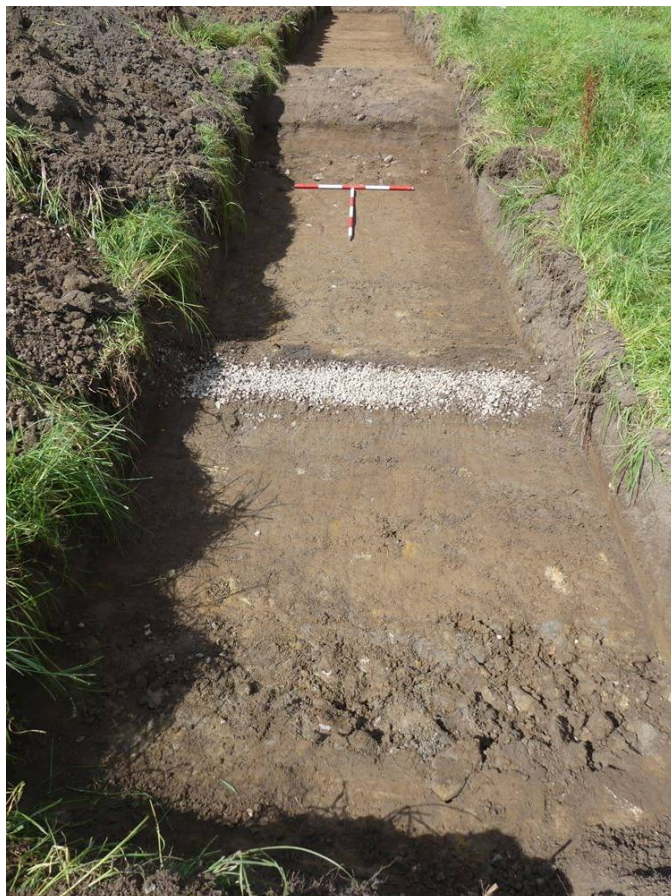
4.4.1 Trench 2 was c21m long and aligned approximately north-west/south-east (Plate 28 and Plate 29; see Figure 3). The topsoil (**200**) was a soft, greyish-brown silt. Below that was a thin, silty-clay subsoil (**201**). There was a stone and earth bank towards the centre of the trench (Plate 30 and Plate 31), which corresponded to the earthwork noted in the area, believed to be a former field boundary. The upper part of the bank comprised loose rounded pebbles within the subsoil. This stony area was 1.9m to 2m wide and spread perhaps another 0.95m to the south-east, and was 0.3m to 0.4m thick. Below this stony deposit, friable sandy-silt (**206**) was banked against another stony deposit (**207**), which extended 1.6m into the trench from the south-west side. This spread of stone to the south-east side of the bank was possibly spread from material further up in the bank (in **201**) or possibly a revetment or old plot boundary. The friable silt which formed the bank appeared to continue beyond the north-west limits of the trench. There was a gravel-filled north-east/south-west drain to the south-east of that, housing a black plastic pipe (fill **202** and cut **203**; Plate 32 and Plate 33). It appeared to be a re-cut of an earlier ceramic field drain, the cut for which had been filled with clay (fill **209** and cut **210**; Figure 8). There was a further stone-filled drain to the south-east end of the trench (fill **204** and cut **205**). The natural (**208**) varied between a light grey and, lower down, a yellow clay.

Plate 28 (left): Trench 2 viewed from the north-west

Plate 29 (right): Trench 2 viewed from the south-east

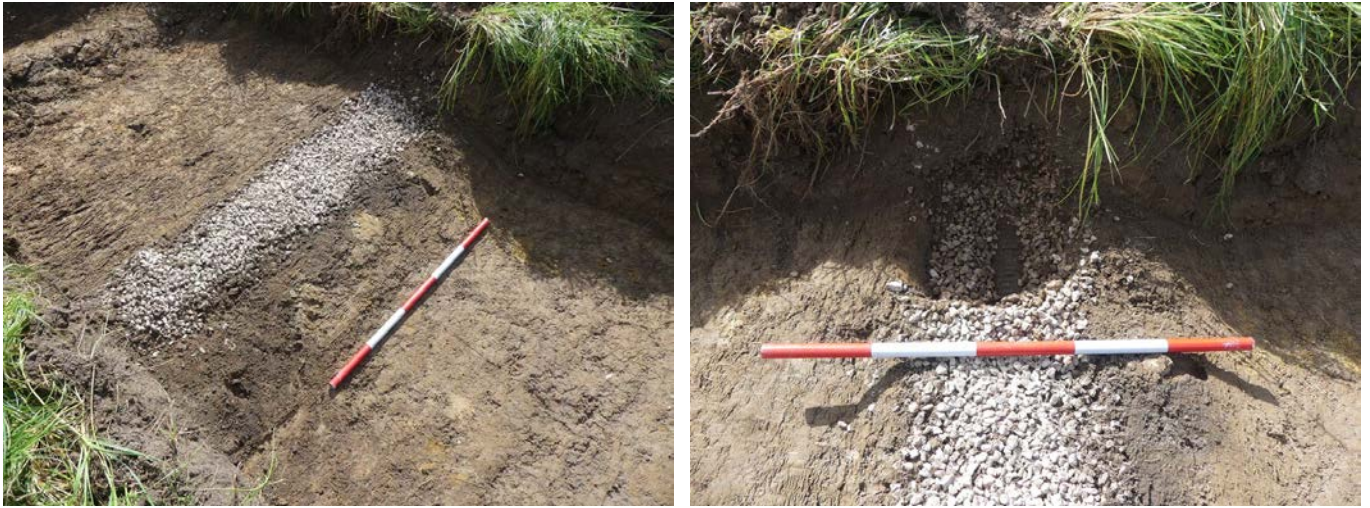
Plate 32 (left): Drain cut 203 viewed from the north

Plate 33 (right): Plastic pipe in 202 viewed from the north-east

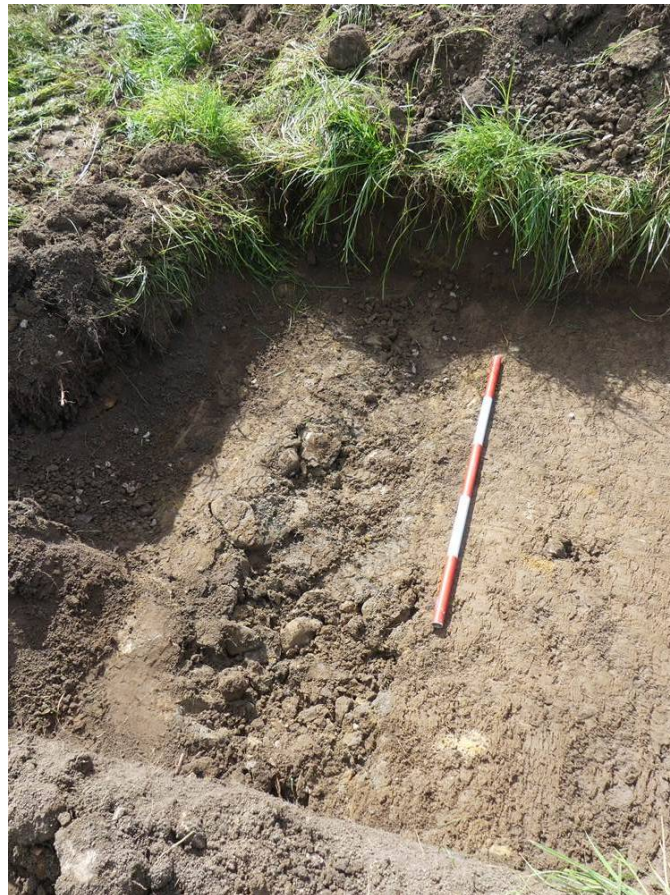
Plate 34: Drain 205 viewed from the north-east

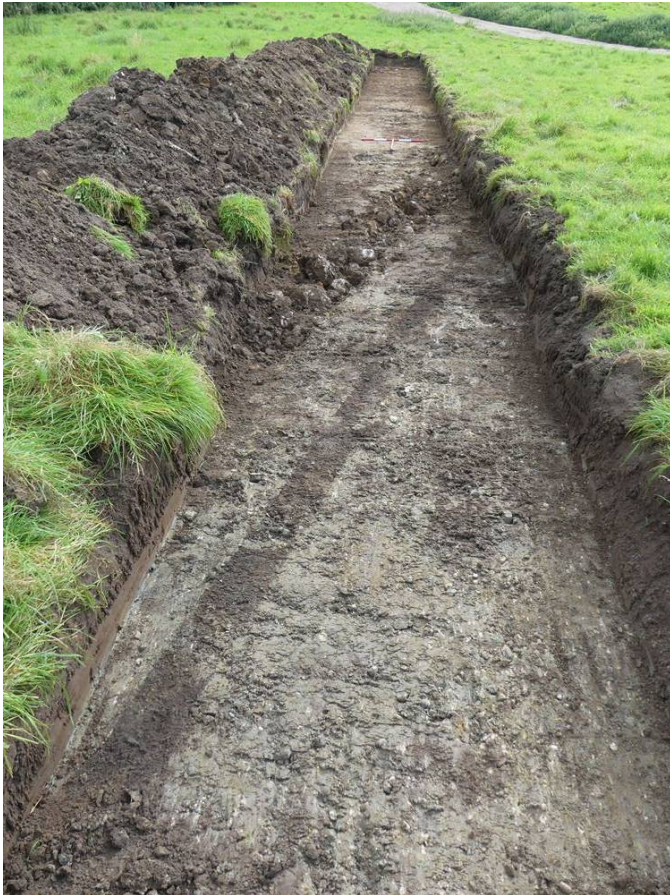
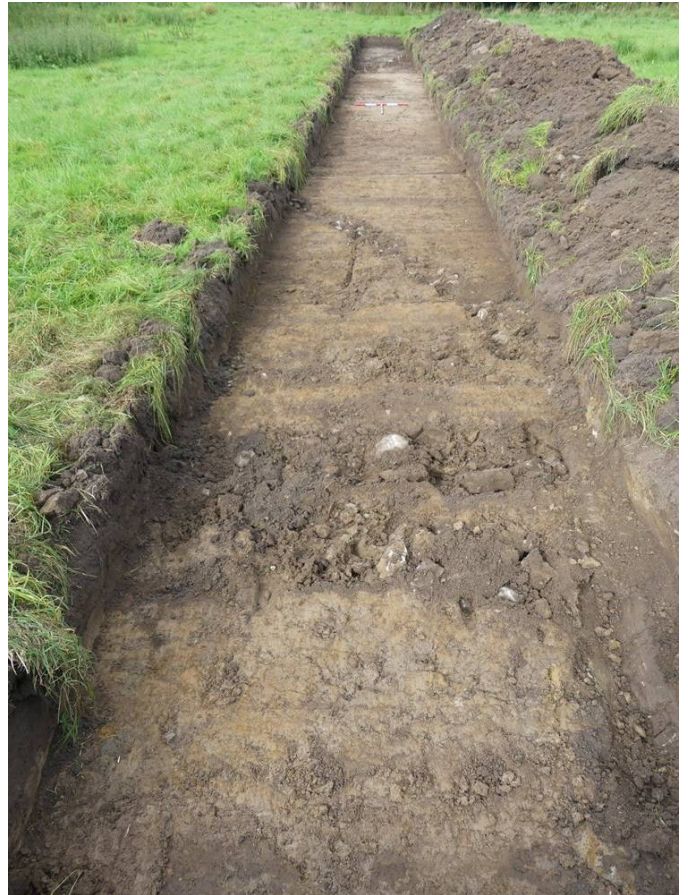
4.5.1 Trench 3 was c30m long and aligned almost north/south (Plate 35 and Plate 36; see Figure 3). The topsoil (**300**) was a greyish-brown silt, up to 0.4m thick. There was no discernible subsoil. Three drains cut the trench, two aligned north-east/south/west (**302** and **304**; Plate 37) and one aligned closer to north/south (**306**; Plate 38). Drain **302** was 0.2m wide, had near vertical sides, and was filled by a soft dark grey silt (**301**). Drain **304** and **306** were 0.4-0.5m wide, with vertical sides, and filled with loose cobbles and clay (**303** and **305**). The natural (**307**) was a firm silty-clay.

Plate 35 (left): Trench 3 viewed from the north-east

Plate 36 (right): Trench 3 viewed from the south-west

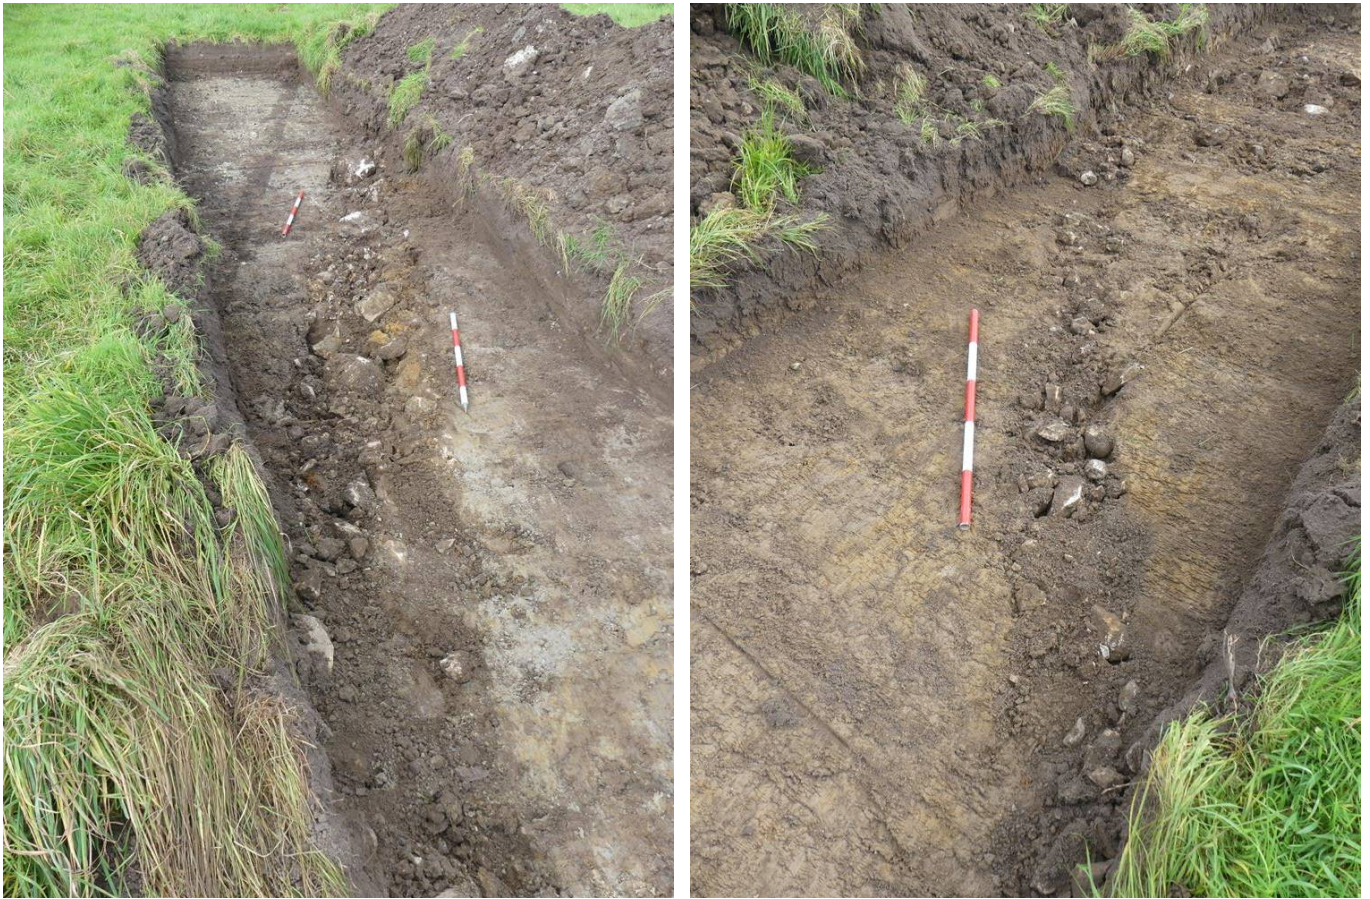
Plate 37 (left): Drains 302 and 304 viewed from the south-west

Plate 38 (right): Drain 306 viewed from the north

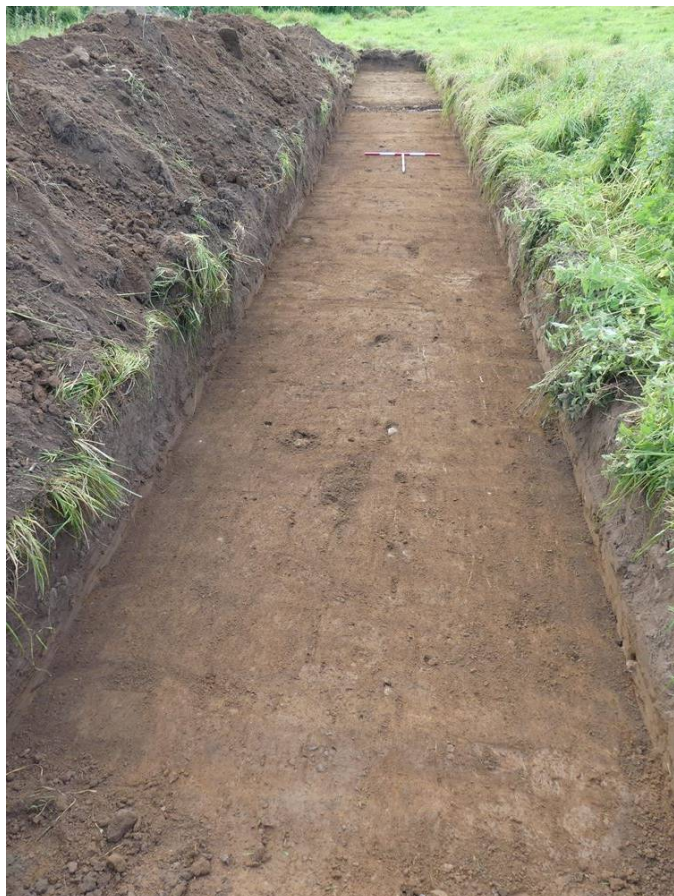
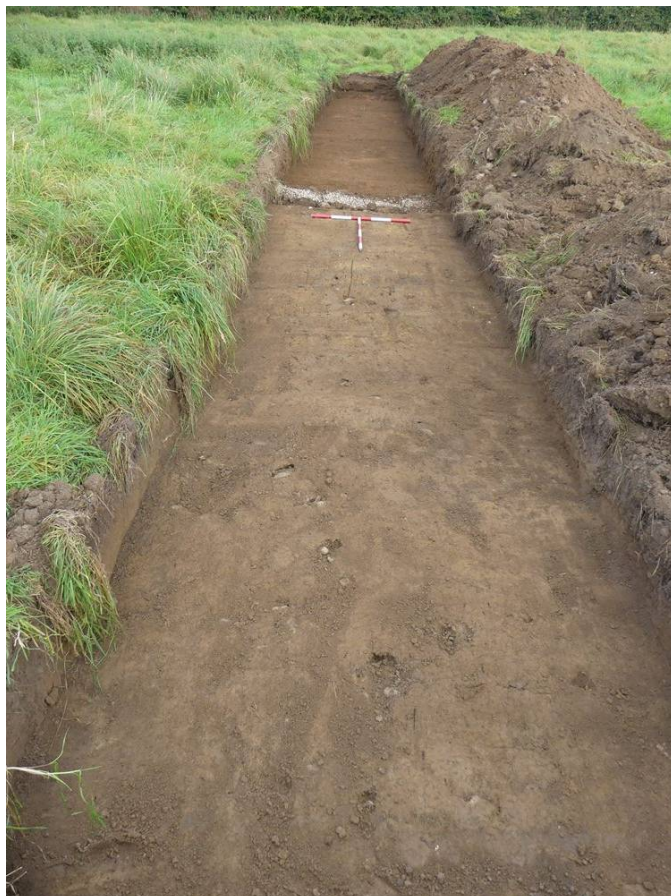
4.6.1 Trench 4 was c21m long and aligned north-west/south-east (Plate 39 and Plate 40; see Figure 3). The topsoil (**400**) was 0.2m to 0.35m thick greyish brown silt above a mid orangey brown subsoil (**401**). Two drains cut the trench (Plate 41), one, filled with loose angular gravel and black plastic pipe (fill **402** and cut **403**), cutting an earlier one filled with loose rounded cobbles in a dark greyish-brown silt (fill **404** and cut **405**). Both drains were at least 0.3m to 0.4m wide. The natural was a pale orangey-brown silty clay (**406**).

Plate 39 (left): Trench 4 viewed from the north-west

Plate 40 (right) Trench 4 viewed from the south-east

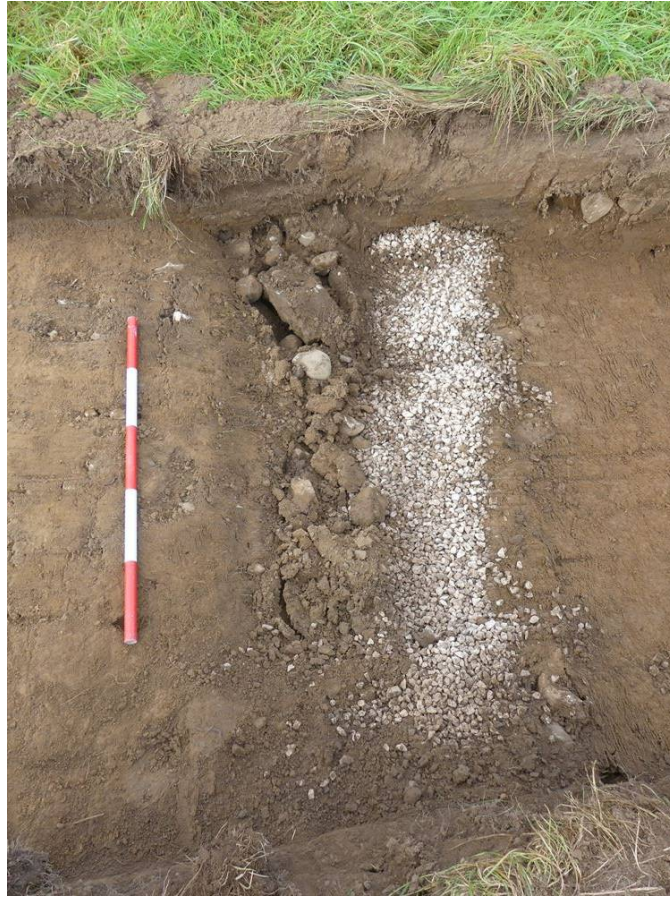
Plate 41: Drains 405 and 403 viewed from the north-east

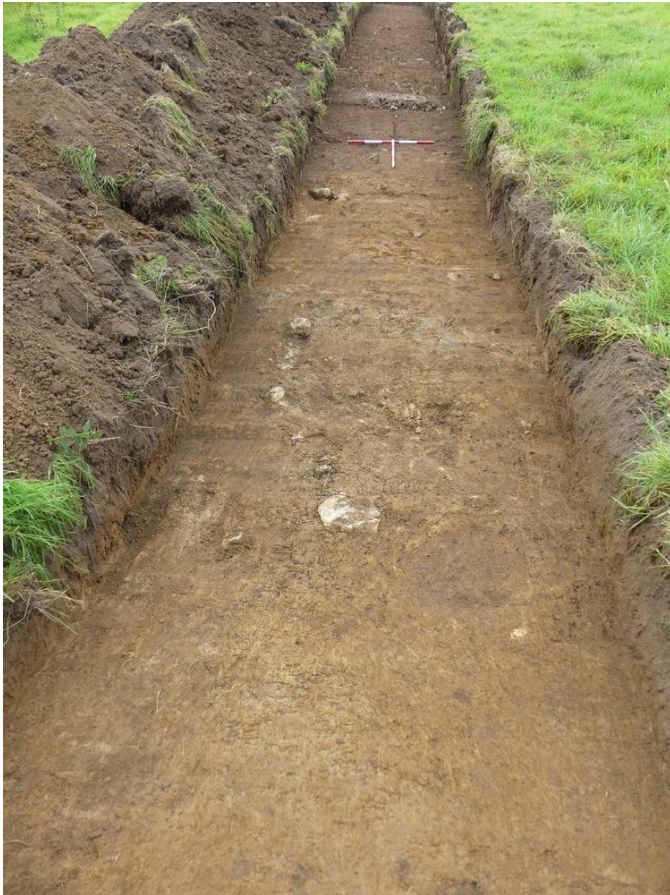
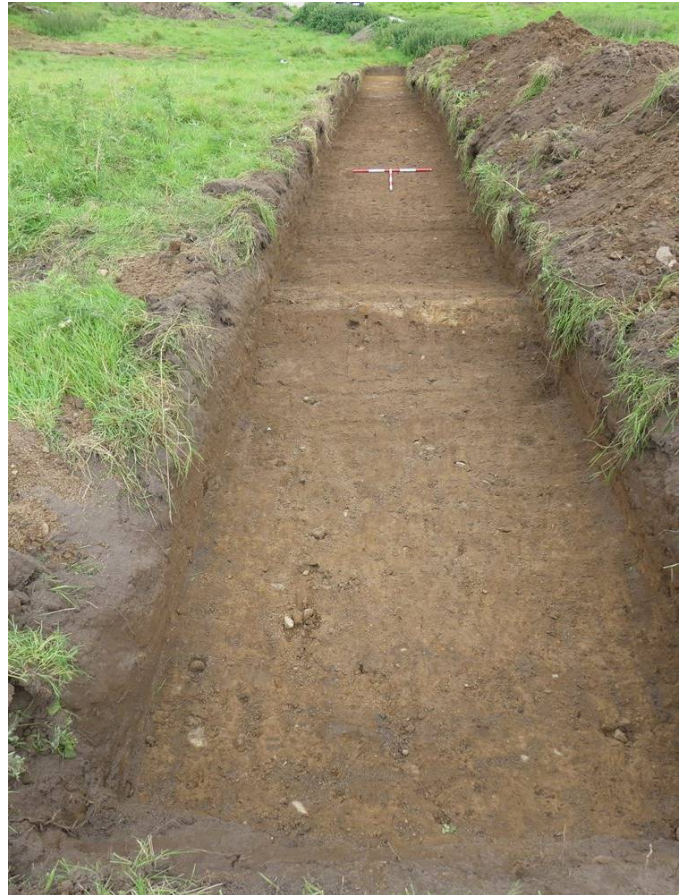
4.7.1 Trench 5 was c31m long and aligned approximately north-east/south-west (Plate 42 and Plate 43; see Figure 3). The topsoil (**500**) was a greyish-brown silt, 0.3m to 0.4m thick above a 0.1m to 0.2m thick sandy-silt subsoil (**501**). Three drains cut across the trench, two of which were back-filled with clay (cut and fill **504** and **505** (Plate 44) and cut and fill **506** and **507**) and one that contained a stonier fill (cut and fill **502** and **503**; Plate 45). A possible pit (**509**), 0.45m in diameter, was investigated at the north-east end of the trench (Plate 46 and Plate 47); however, it was extremely shallow and most likely of natural origins, containing no finds. The firm clay natural (**508**) varied from pale yellowish orange to dark brown.

Plate 42 (left): Trench 5 viewed from the north-east
Plate 43 (right): Trench 5 viewed from the south-west

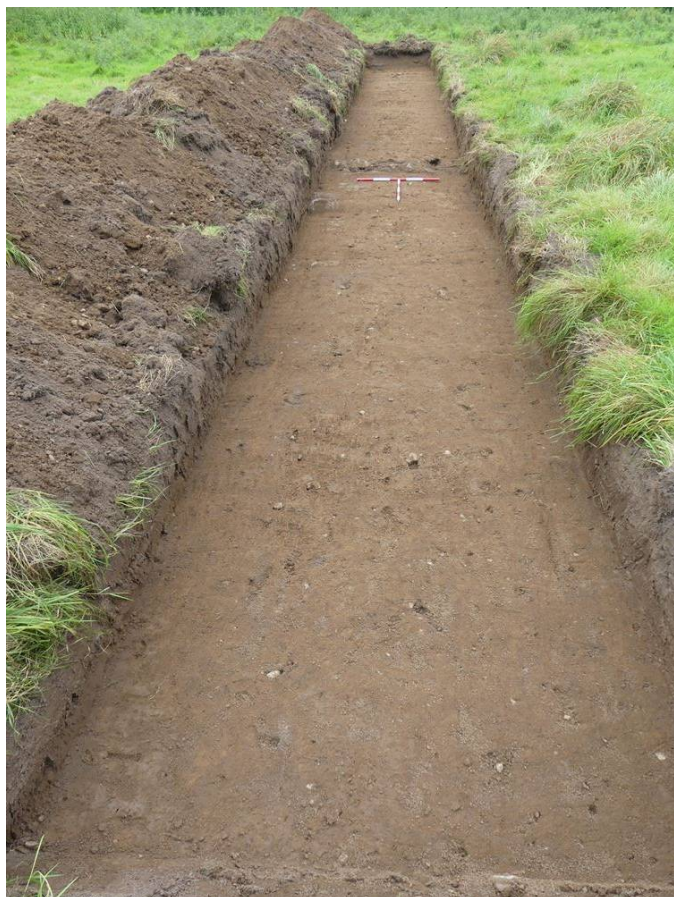
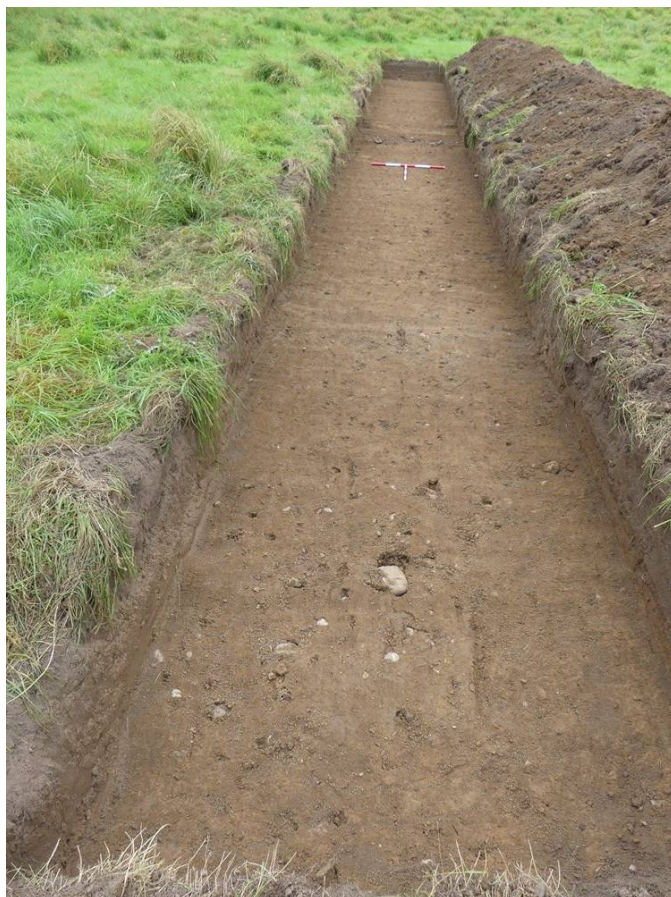
4.8.1 Trench 6 was 20.7m long and aligned approximately north/south (Plate 48 and Plate 49; see Figure 3). The silt topsoil (**600**) was 0.3m thick and below that was a lighter coloured subsoil (**601**), up to 0.2m thick. Two approximately north-west/south-east drains cut across the trench: the one to the north (**603**) was 0.5m wide and filled with loose, sub-angular cobbles (**602**) (Plate 50); the one to the south

Plate 48 (left): Trench 6 viewed from the north

Plate 49 (right): Trench 6 viewed from the south

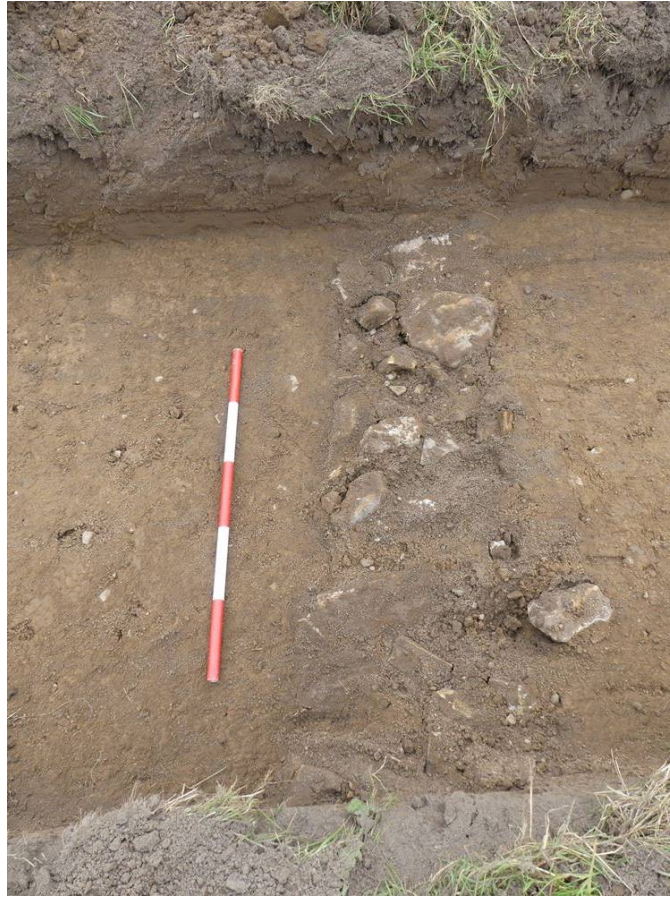
Plate 50: Drain 603 viewed from the east

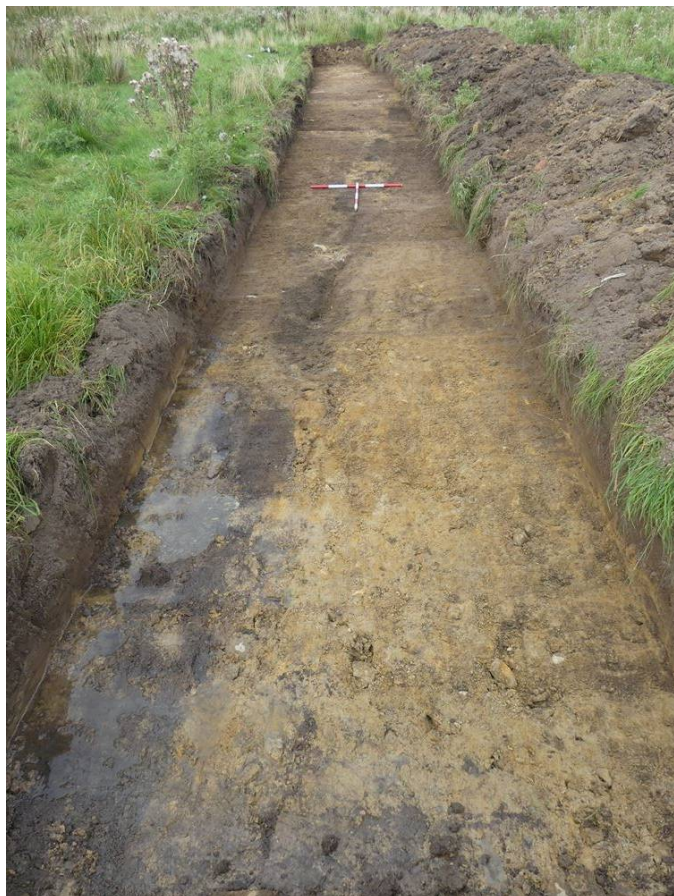
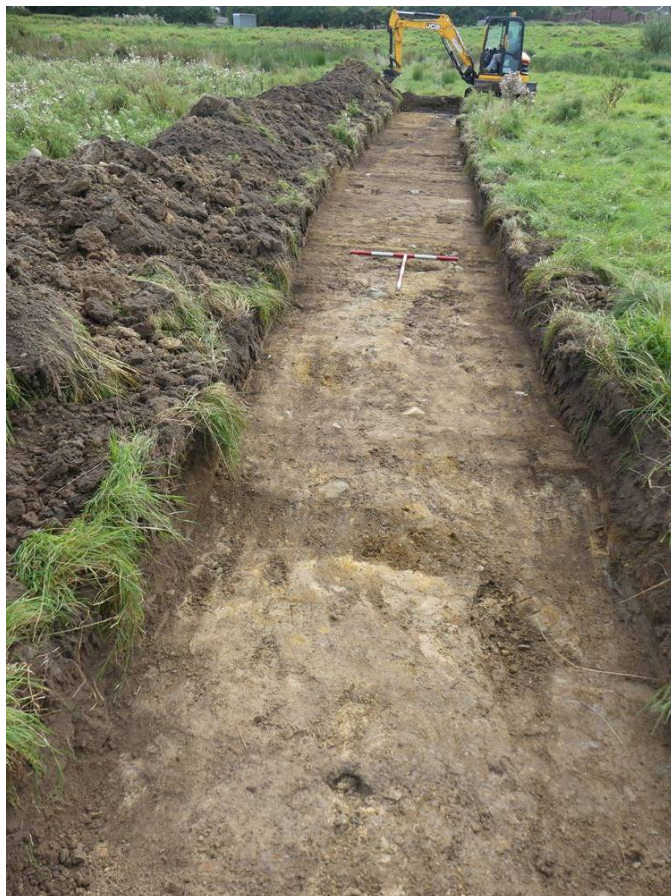
4.9.1 Trench 7 was c25m long and aligned approximately north-east/south-west (Plate 51 and Plate 52; see Figure 3). The 0.2m to 0.3m thick topsoil was a greyish-brown silt. The subsoil below that was an orangey-brown, slightly sandier silt, 0.1m thick. Four clay-filled drains, each c0.4m wide, cut across the trench north-west/south-east (cuts **703** (Plate 53), **705** (Plate 54), **707**, and **709** and fills **702**, **704**, **706**, and **708** respectively) and a fifth (cut **711** and fill **710**; Plate 55) cut across at least two of these perpendicularly.

Plate 51 (left): Trench 7 viewed from the south-west

Plate 52 (right): Trench 7 viewed from the north-east

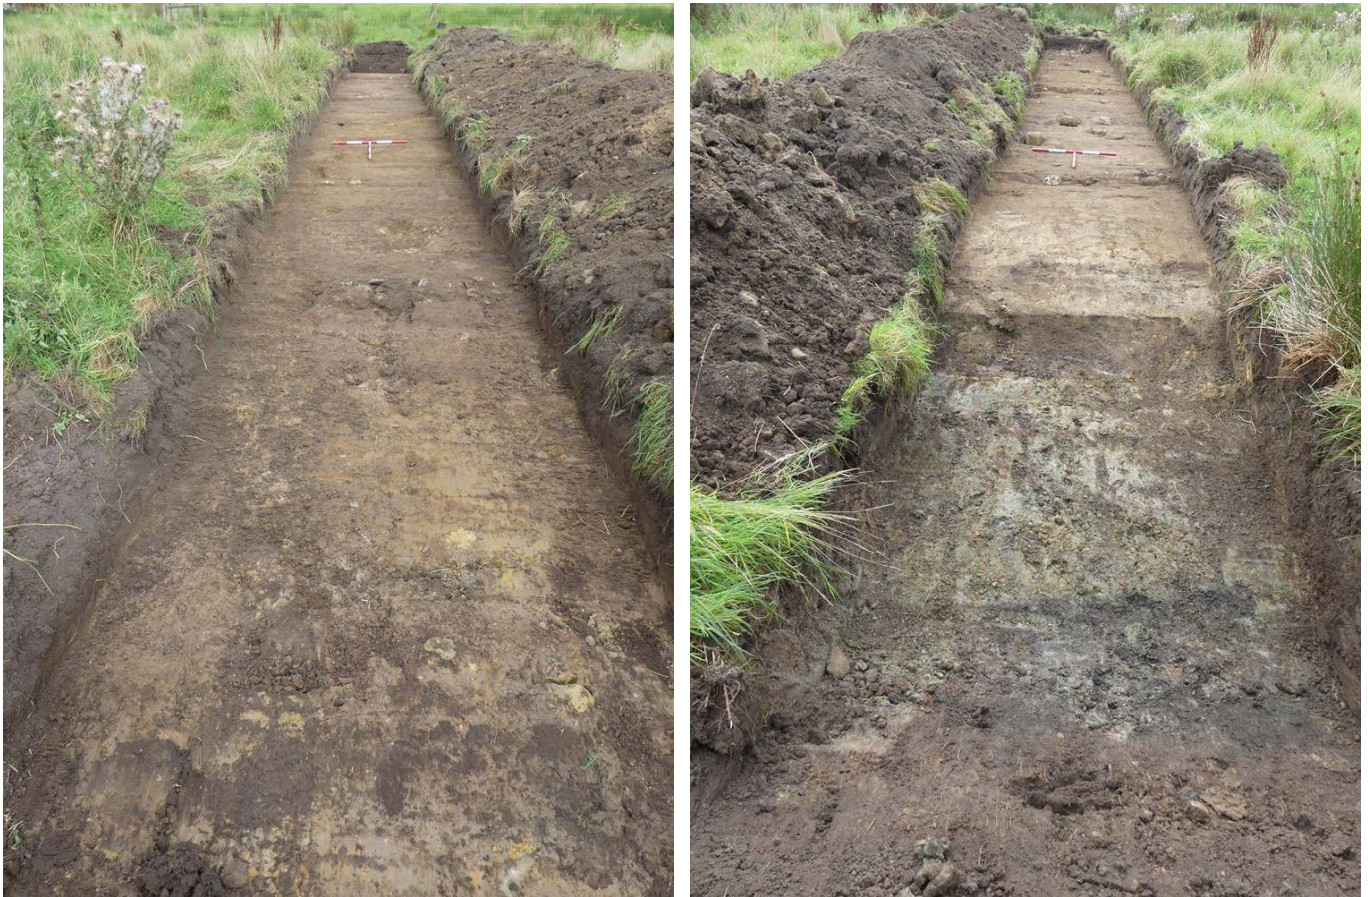
4.10.1 Trench 8 was 25m long and aligned approximately north-east/south-west (Plate 56 and Plate 57; see Figure 3). The silt topsoil (**800**) was 0.2m to 0.3m thick above an orangey-brown, 0.1m thick subsoil (**801**). A wide, shallow, U-shaped ditch (**803**) cut across the north-east end of the trench on a north-west/south-east alignment (Plate 58 and Plate 59). It was filled with a sandy clay (**802**) which contained fragments of ceramic drain. Three loose pebble- and silt-filled drains cut the trench north-west/south-east (cuts **805**, **807** and **809** and fills **804**, **806** and **808** respectively; see Plate 60 and Plate 61) and a fourth clay-filled drain cut perpendicularly across one of these at the south-west end (cut **811**; fill **810**; see Plate 62 and Plate 63). The firm clay natural (**812**) had occasional boulders.

Plate 56 (left): Trench 8 viewed from the south-west

Plate 57 (right): Trench 8 viewed from the north-east

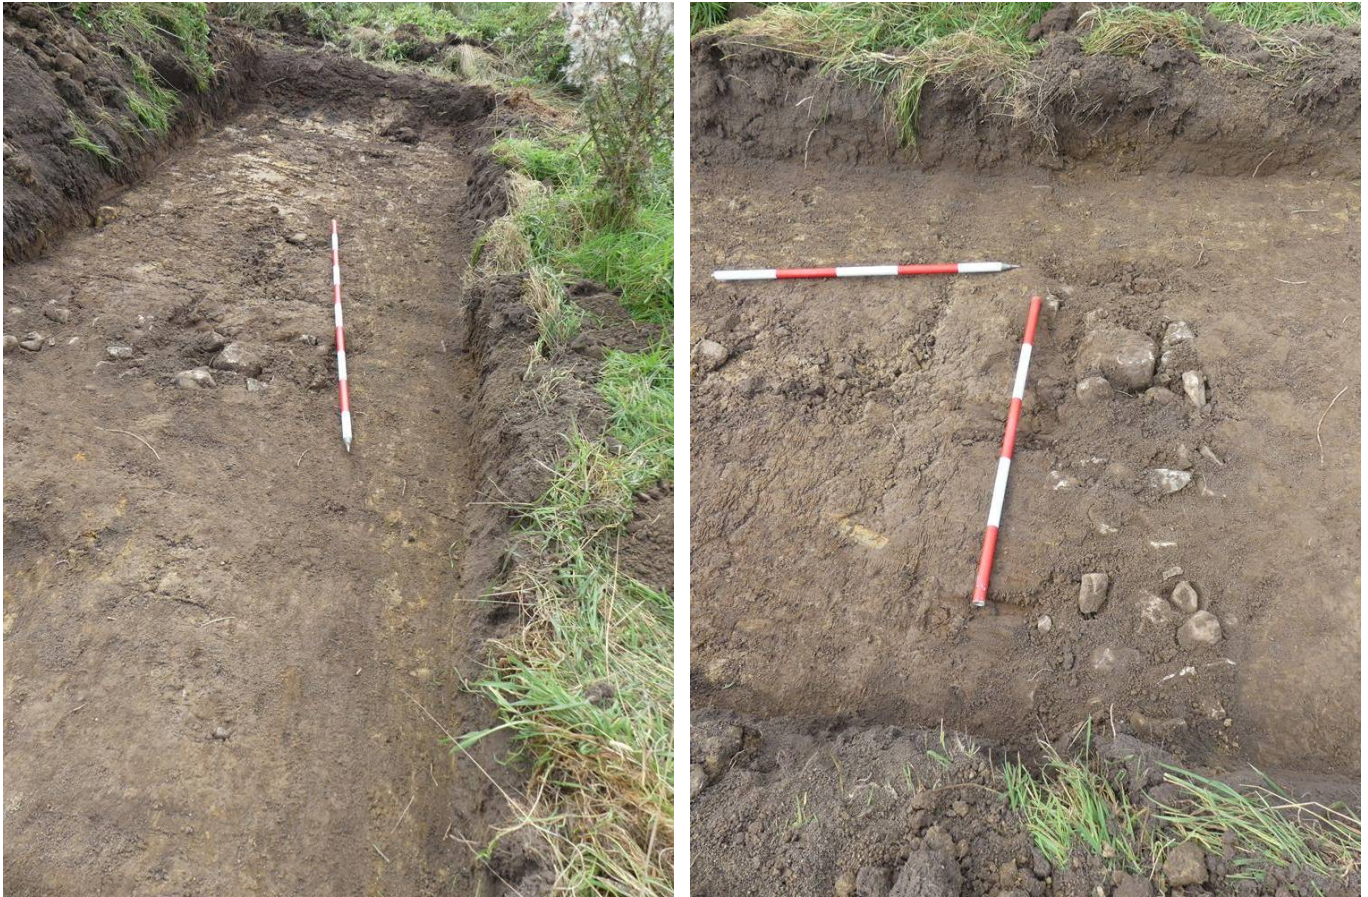
Plate 62 (left): Drain 811 viewed from the north-east

Plate 63 (right): Drains 809 and 811 viewed from the south-east

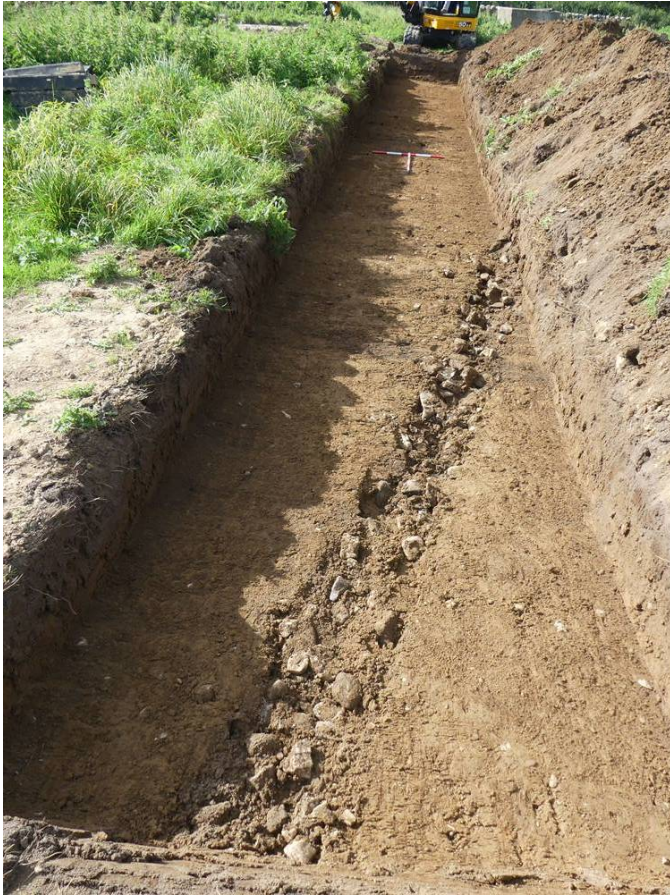
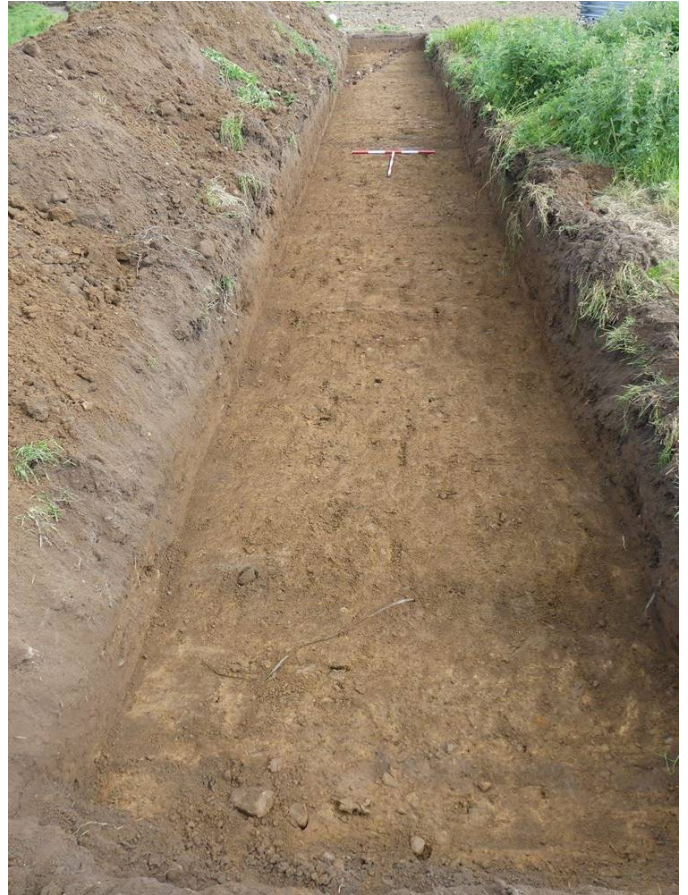
4.12.1 Trench 10 was c20m long and aligned approximately north-west/south-east (Plate 70 and Plate 71; see Figure 4). The silt topsoil (**1000**) was 0.1m thick. The orangey sandy-silt subsoil (**1001**) below that was 0.3m thick. There was a loose stone-filled drain, aligned north-west/south-east, at the south-east end (cut **1003** and fill **1002**; Plate 72). This was cut by a north-east/south-west aligned drain with a

Plate 70 (left): Trench 10 viewed from the south-east

Plate 71 (right): Trench 10 viewed from the north-west

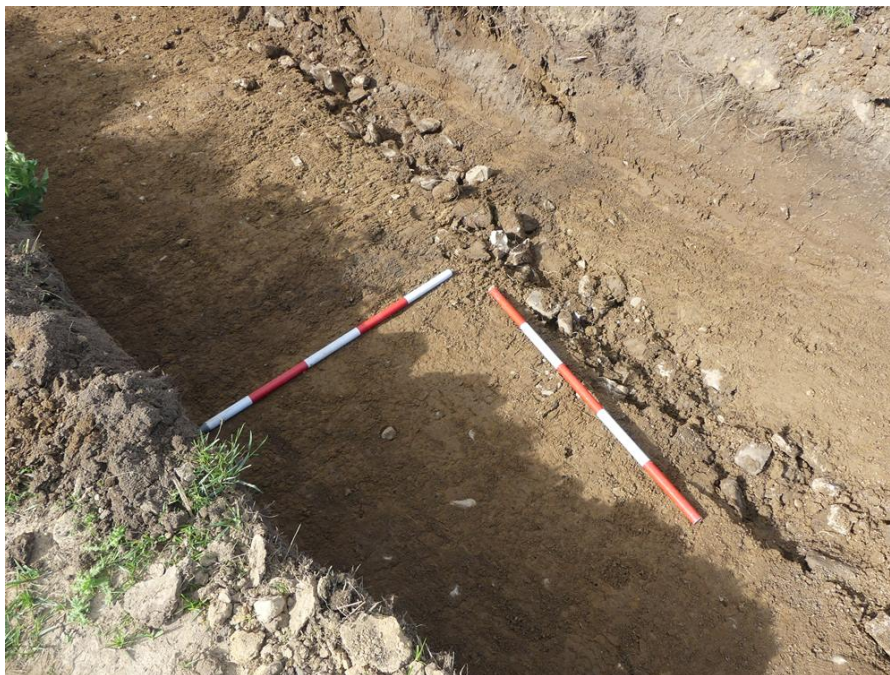
ceramic pipe at the base (cut **1005** and fill **1004**). There were two more ceramic drains to the north-west (cuts **1007** and **1009** and fills **1006** and **1008** respectively; Plate 73 and Plate 74). The natural (**1010**) was a pale clay.

Plate 72: Drain 1003 cut by drain 1005, viewed from the south

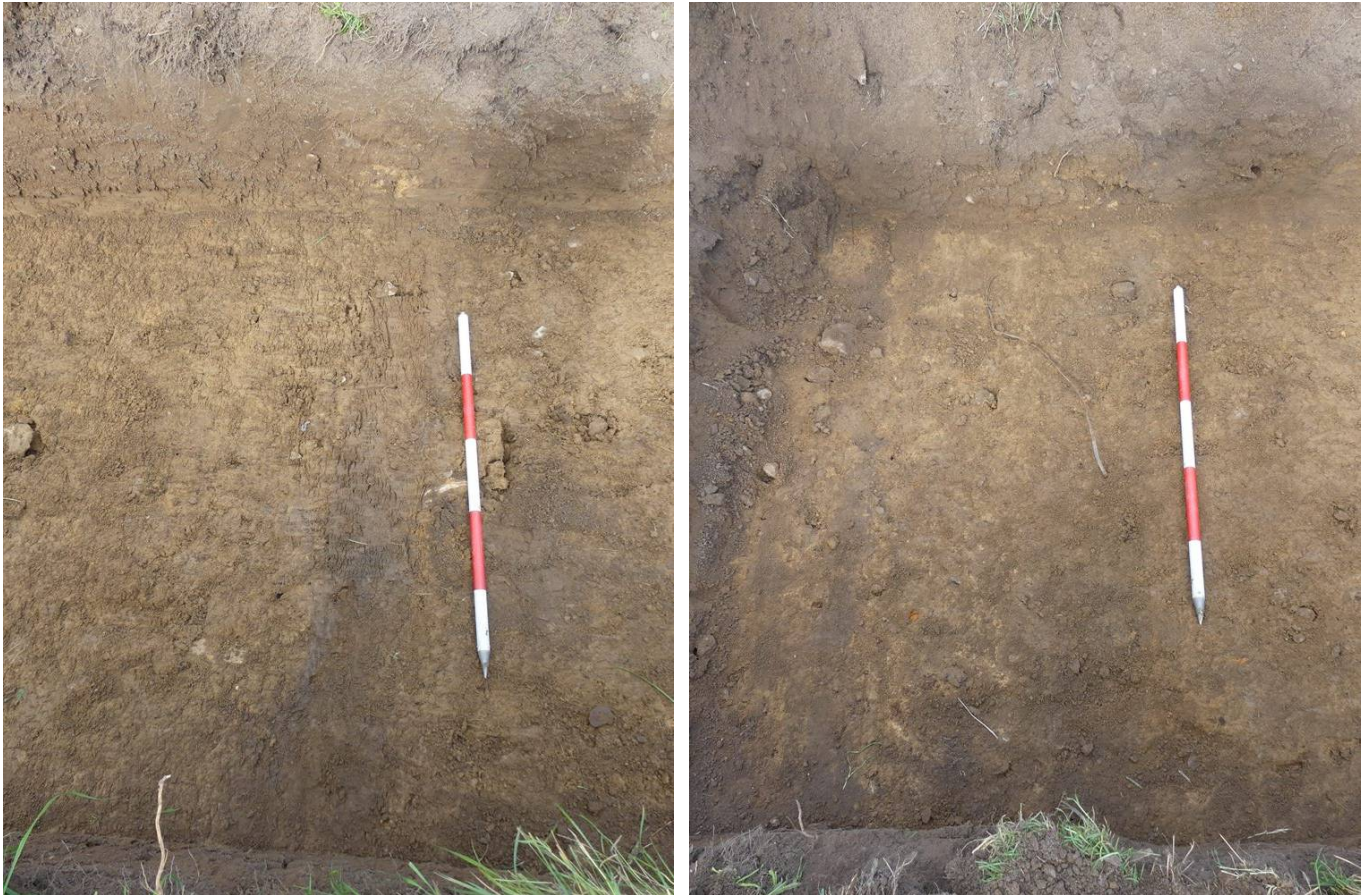
Plate 73 (left): Drain 1007 viewed from the south-west

Plate 74 (right): Drain 1009 viewed from the south-west

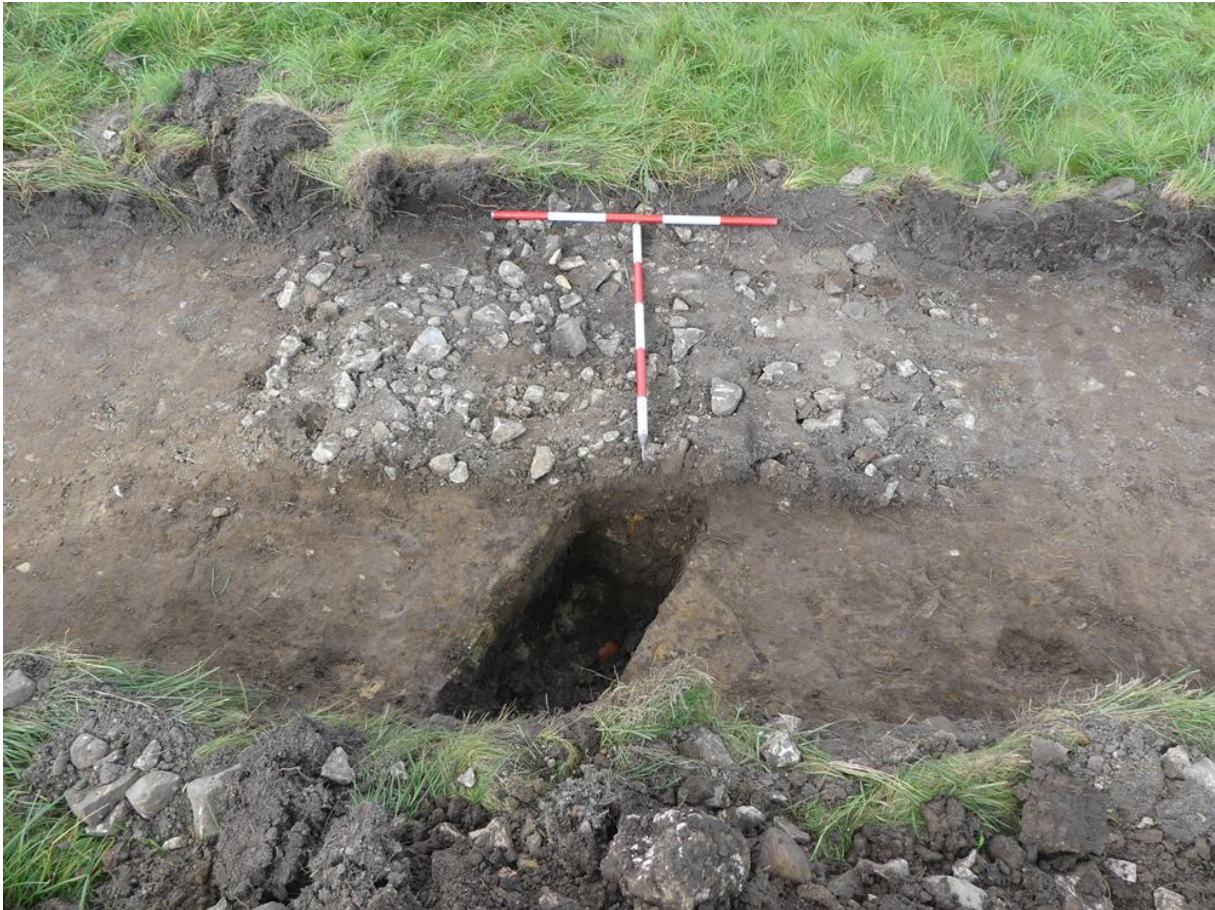
Plate 81: Ceramic drain visible in the base of cut 1123 below track 1103

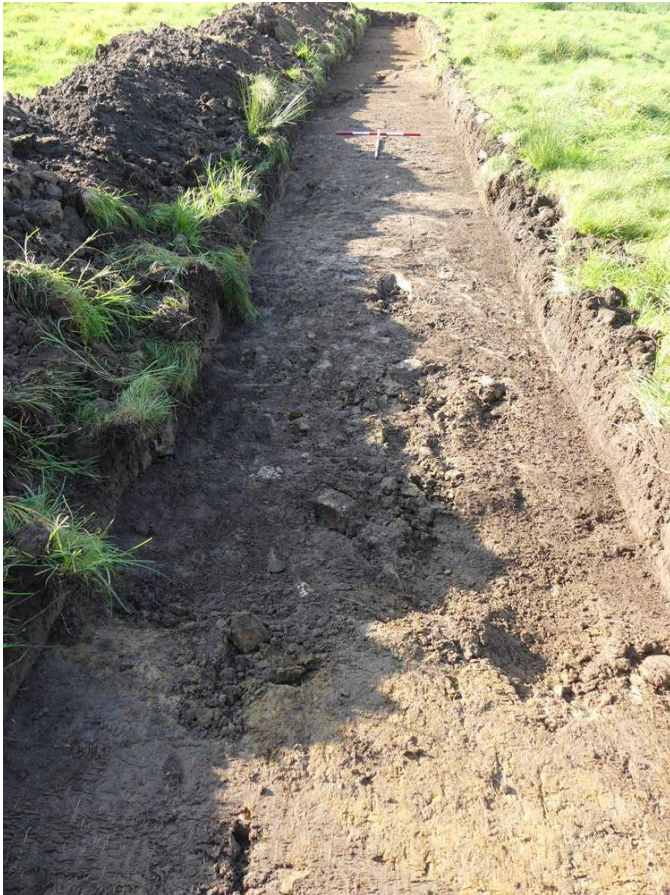
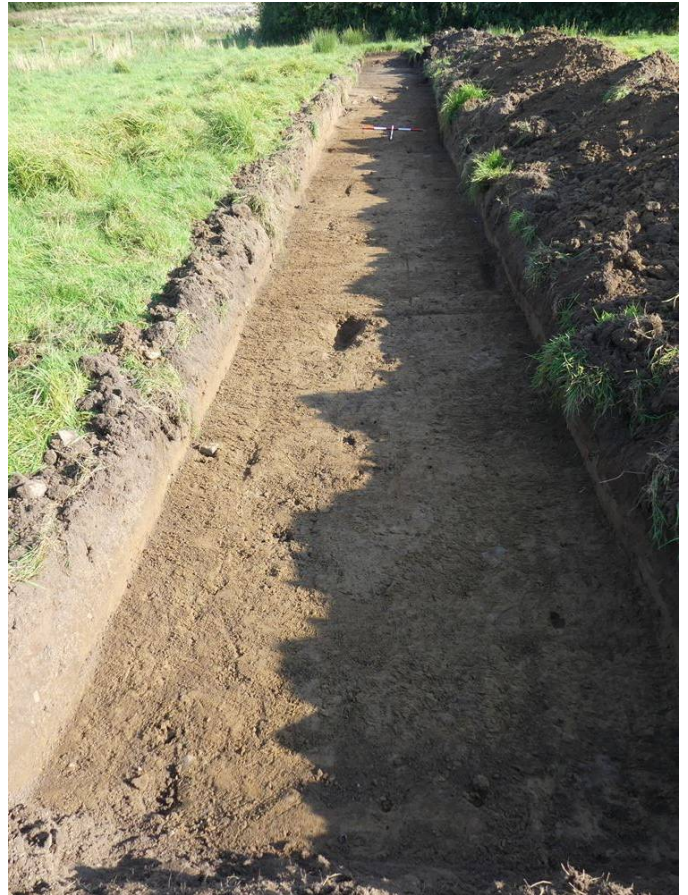
4.14.1 Trench 12 was 29.7m long and aligned approximately north/south (Plate 88 and Plate 89; see Figure 4). The silt topsoil (**1200**) was 0.1m to 0.2m thick above a mid orangey-brown sandy-silt subsoil (**1201**), 0.2m thick. A stone-filled drain cut across the centre of the trench on a north-east/south-west alignment (cut **1205** and fill **1204**; Plate 90). A similar stone-filled drain cut across the north end of the trench perpendicular to this (cut **1203** and fill **1202**). A further narrow curvilinear cut, probably another drain, cut across the south end (cut **1207** and fill **1206**; Plate 91). The natural was a brownish-grey/grey clay to the north end of trench (**1209**) and an orangey-brown, slightly sandy clay to south (**1208**).

Plate 88 (left): Trench 12 viewed from the north

Plate 89 (right): Trench 12 viewed from the south
