LAND NORTH OF OLD HALL FARM, OVER KELLET, LANCASHIRE

Archaeological Watching Brief and Evaluation

Client: Oakmere Homes

October 2022

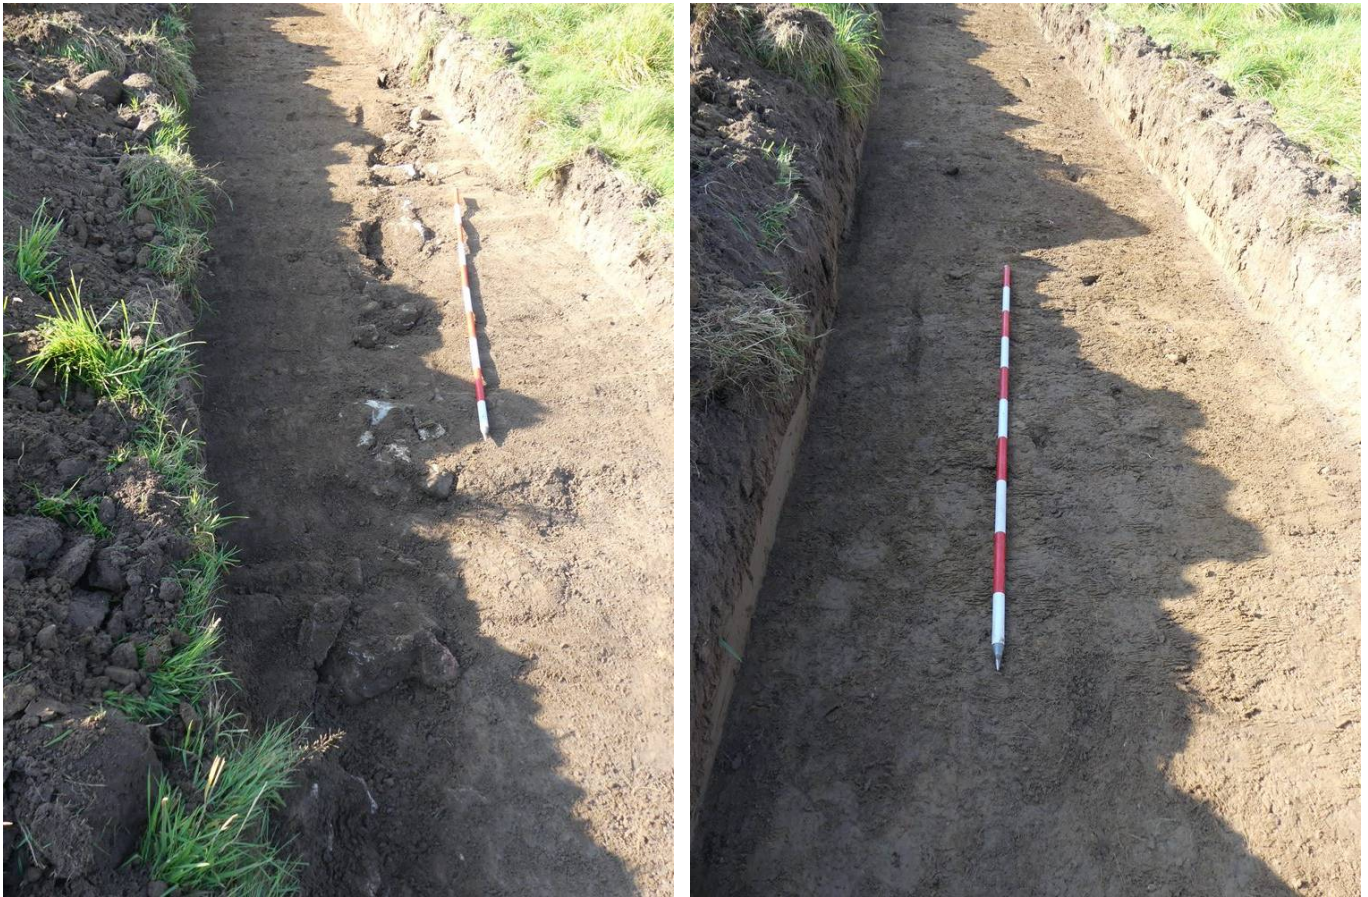
Plate 90 (left): Drain 1205 viewed from the north-east

Plate 91 (right): Drain 1207 viewed from the north-east

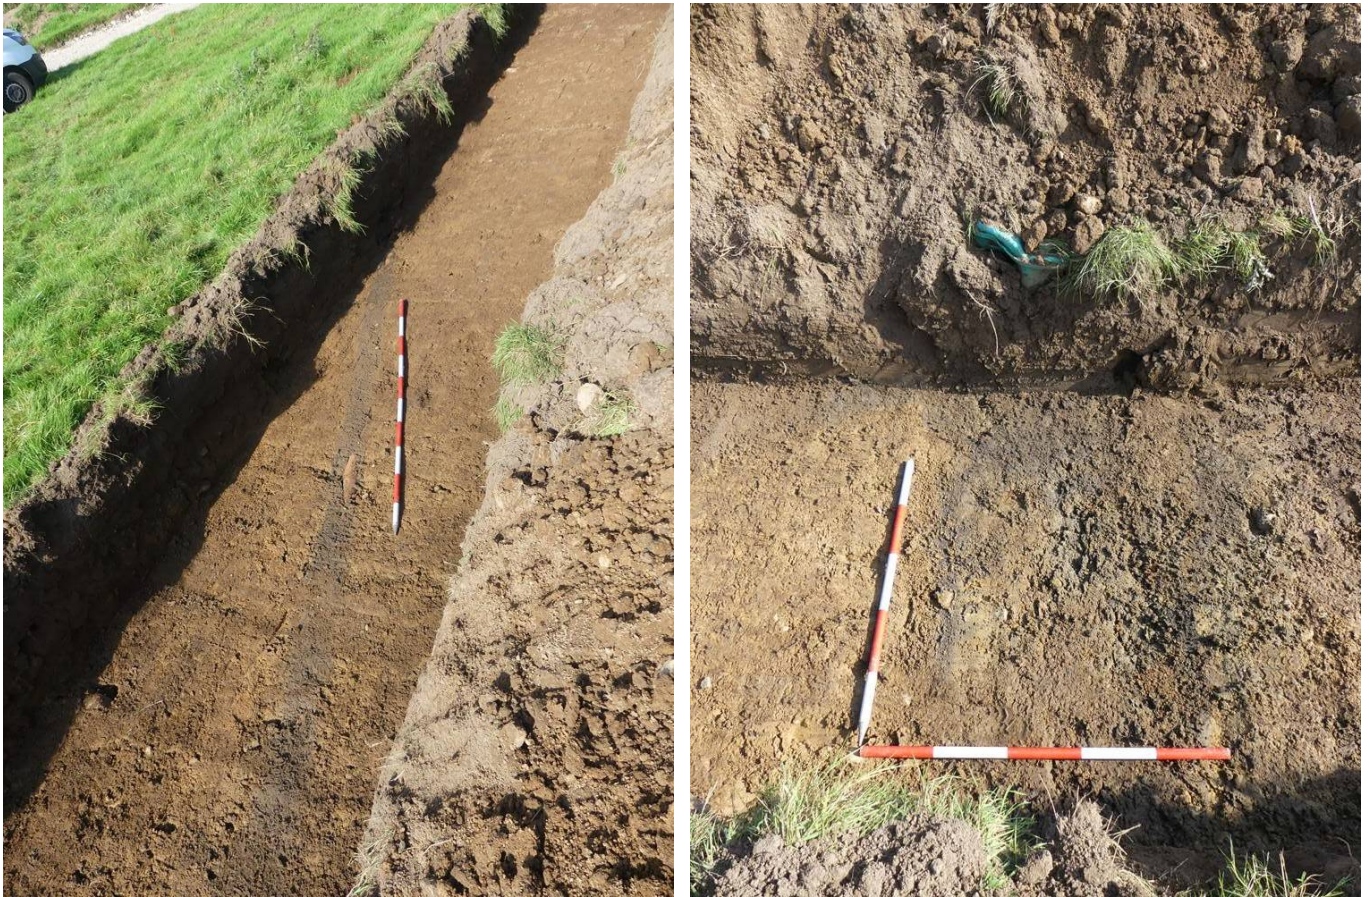
Plate 94 (left): Drain 1303 viewed from the east

Plate 95 (right): Ditch 1305 viewed from the south-west

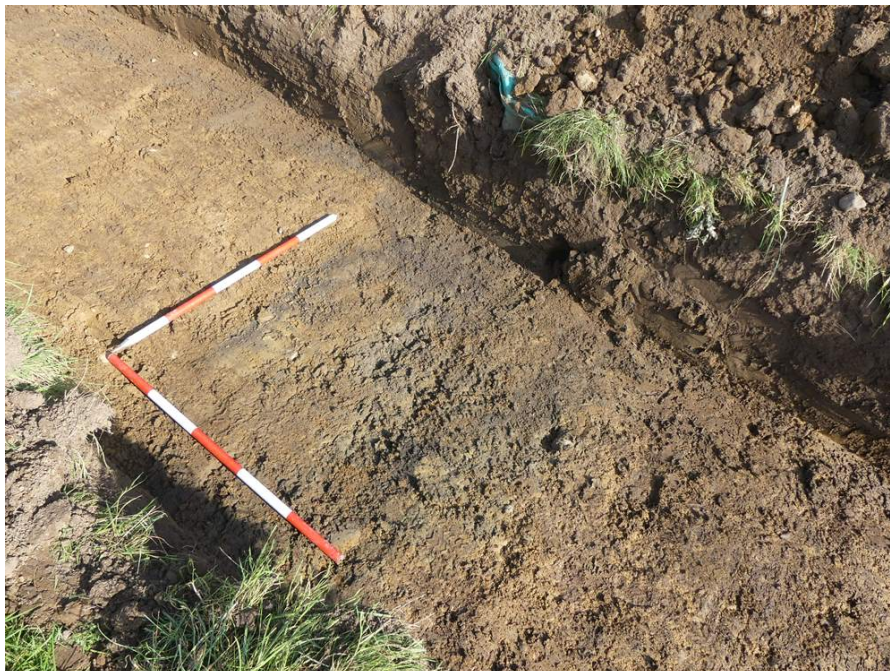
Plate 96: Ditch 1305 viewed from the south

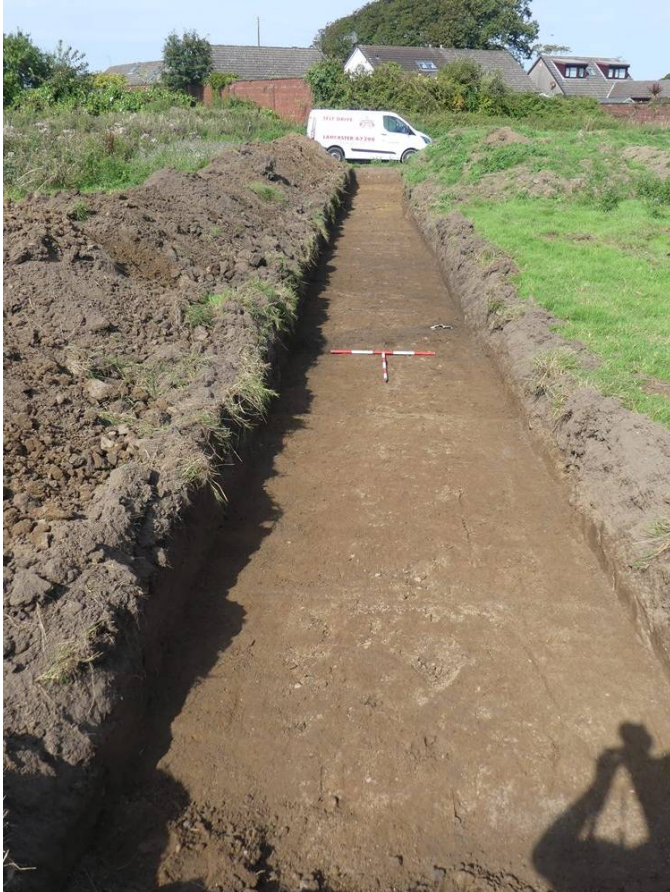
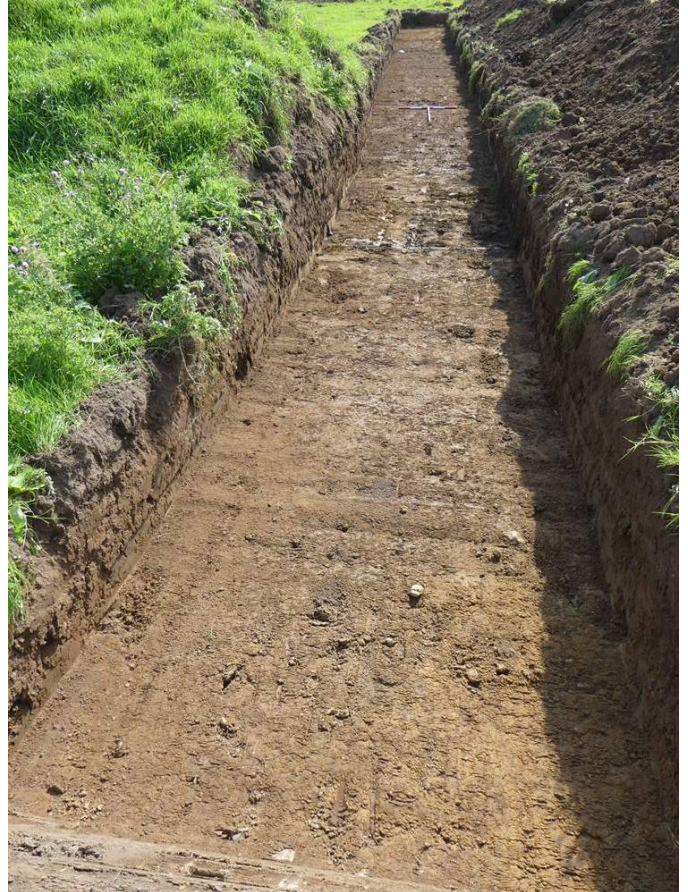
4.16.1 Trench 14 was 29.7m long and aligned approximately north-west/south-east (Plate 97 and Plate 98; see Figure 4). The silt topsoil (**1400**) was up to 0.2m thick above a 0.3m thick sandy-silt subsoil (**1401**). The trench was crossed by three silt- and clay-filled drain cuts with ceramic drain pipes in the base (cuts **1403**, **1405** and **1407** and fills **1402**, **1404** and **1406** respectively; see Plate 99 and Plate 100), one of which also contained plastic pipe (cut **1403** and fill **1402**). Another silt- and clay-filled drain cut the trench north/south at the south-east end (cut **1409** and fill **1408**; Plate 101). The fill of this one contained a plastic sack. The natural (**1410**) was an orange sandy-clay.

Plate 97 (left): Trench 14 viewed from the south-east

Plate 98 (right): Trench 14 viewed from the north-west

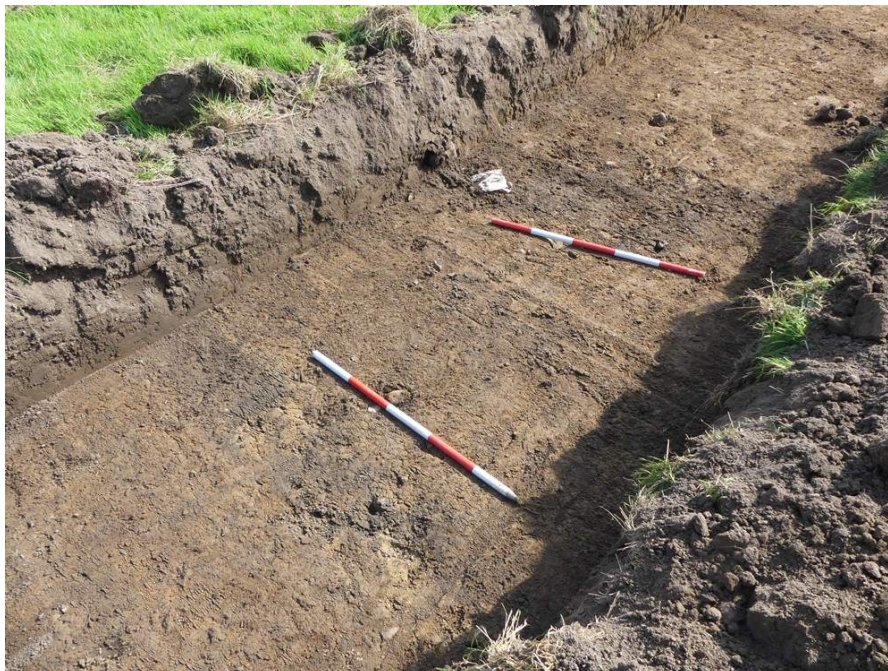
Plate 101: Drains 1407 and 1409 viewed from the west

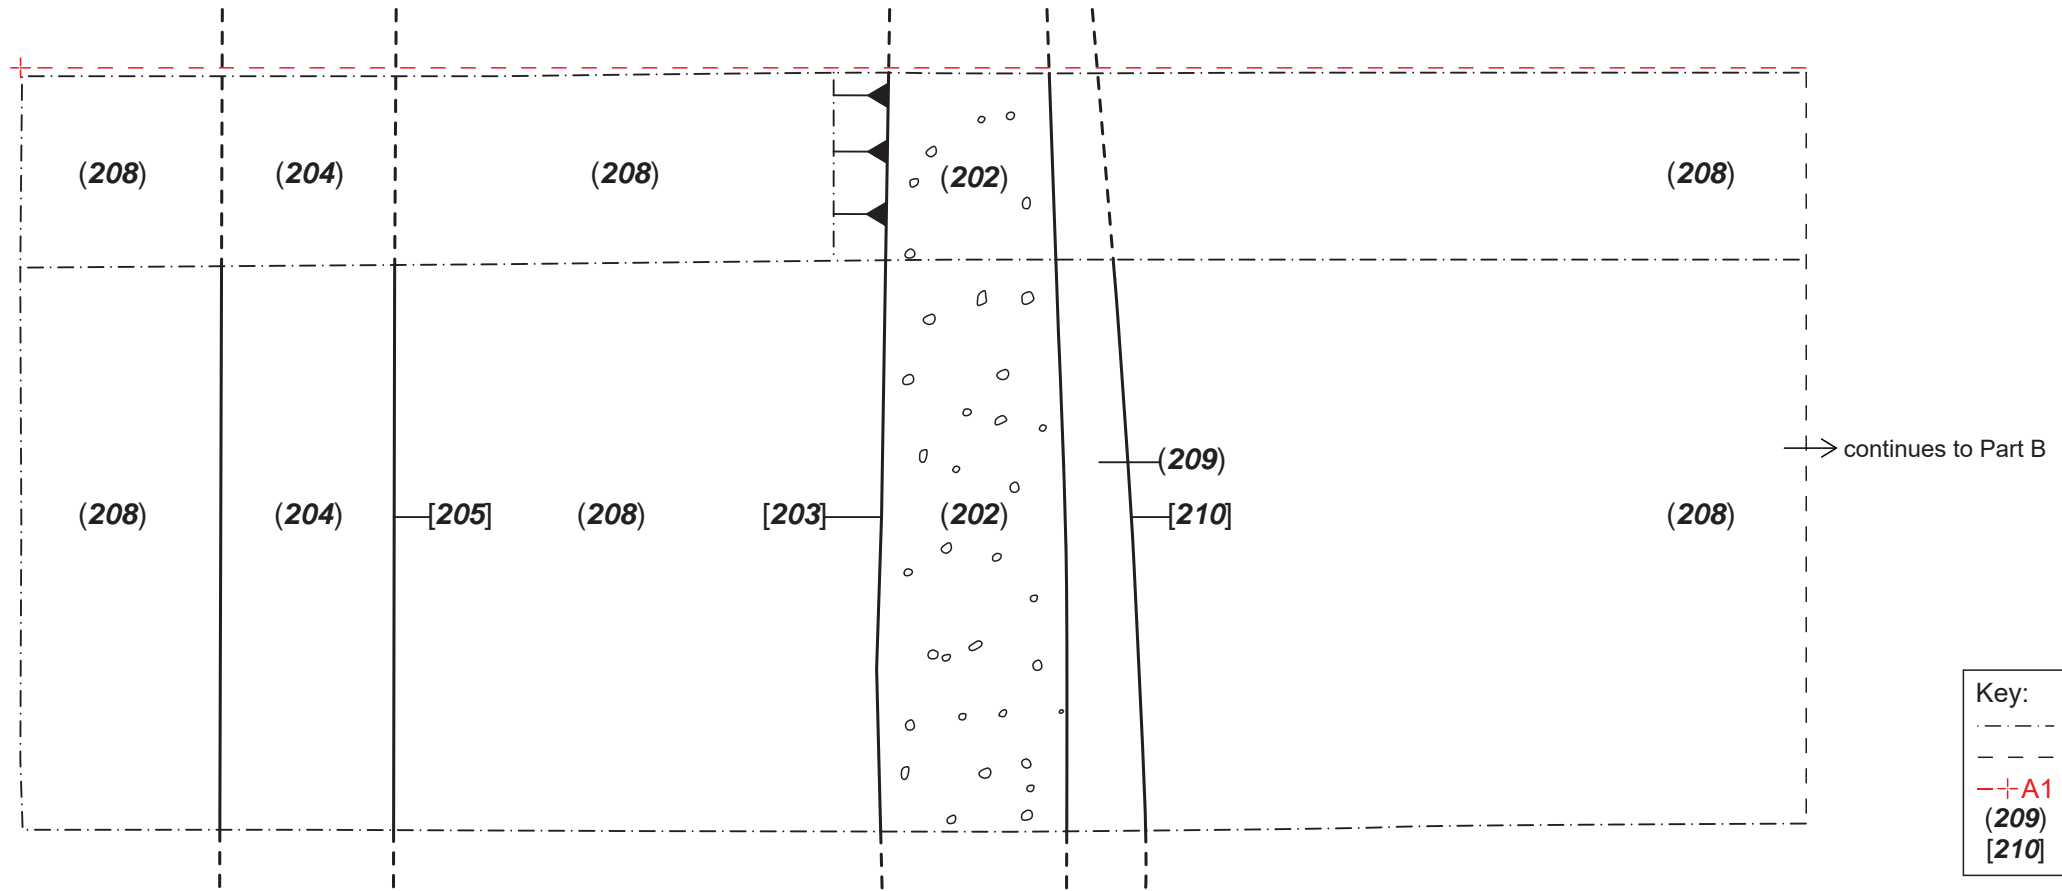
Figure 7: Plan of the south-east end of Trench 2

PLAN - SOUTH-EAST END OF TRENCH 2 (PART A)

PLAN - SOUTH-EAST END OF TRENCH 2 (PART B)
