HODDLESDEN MILL, HODDLESDEN, DARWEN, LANCASHIRE

Archaeological Building Recording, Evaluation and Strip, Map and Record

Client: Kingswood Homes

September 2022

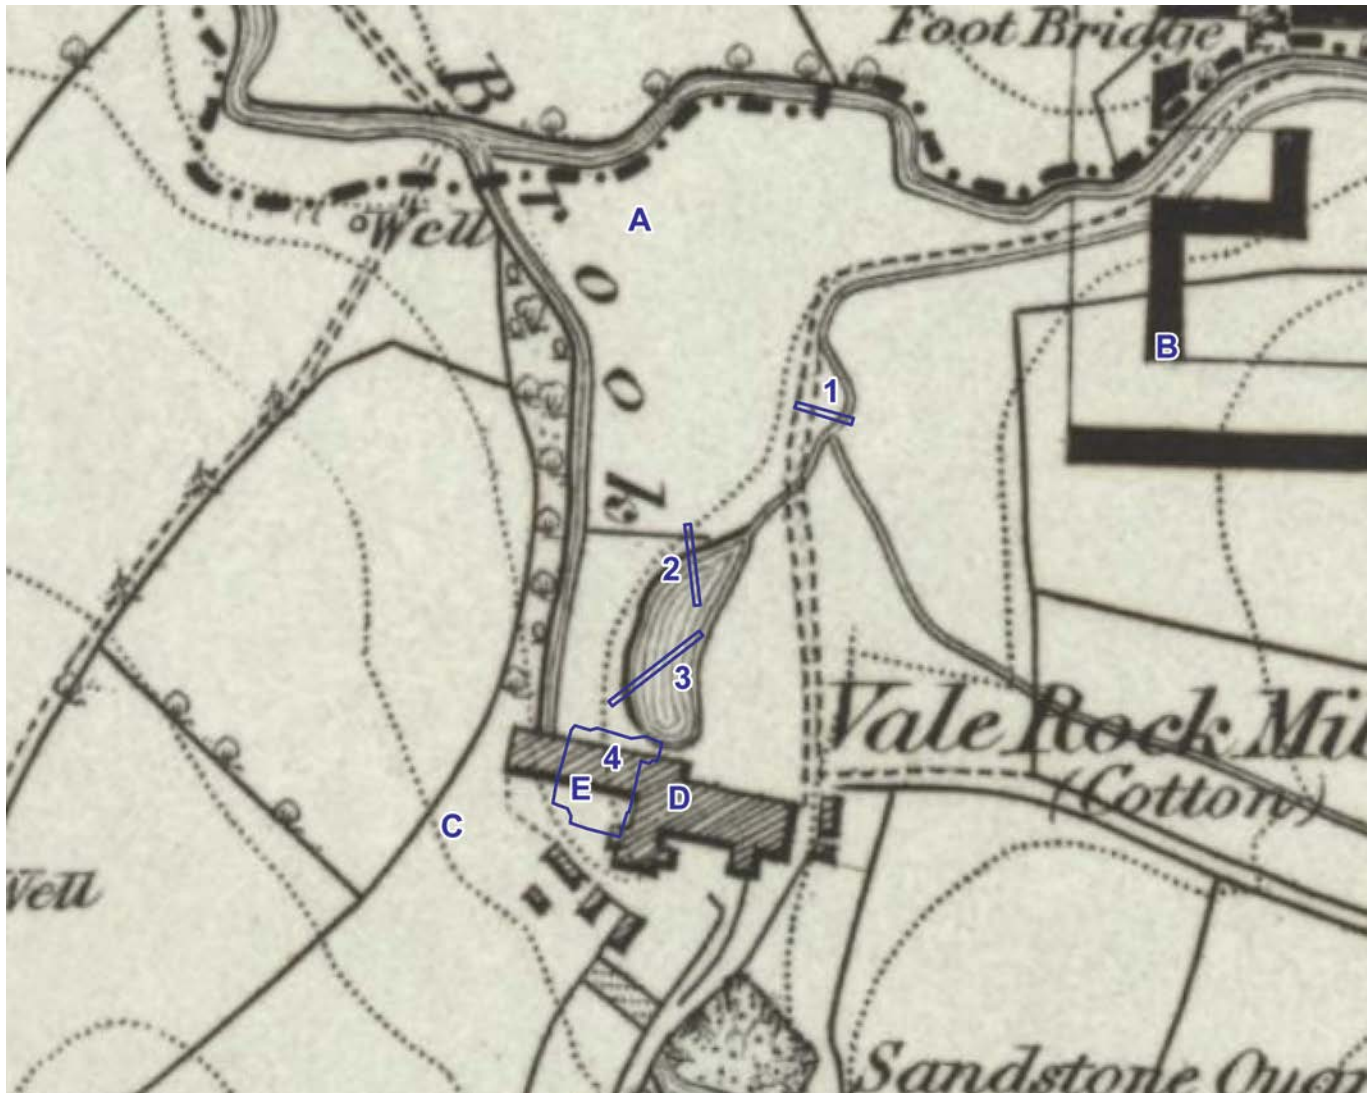
Plate 3: Extract from the Ordnance Survey map of 1849

3.2.4 **Ordnance Survey, 1849:** the 1849 edition of the Ordnance Survey shows the confluence of Hoddlesden Brook (north/south) and Pickup Bank Brook (east/west) to the north of the area, with smaller channels running to a pond north of Vale Rock Mill cotton mill (Plate 3).

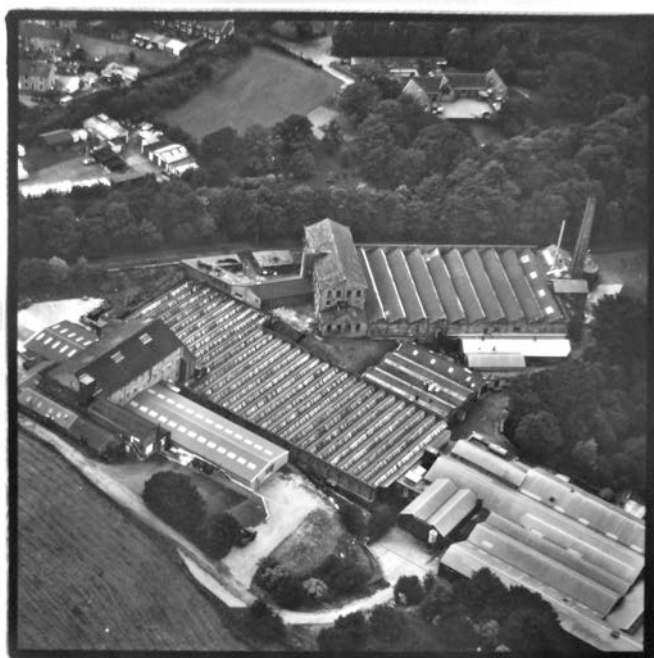
Plate 8: Aerial view of the site from the north-east (LRO LCC 4254/14 1988)

3.2.9 **Aerial Photographs, 1988:** a series of eight aerial views of the site were captured as part of the Lancashire Mills Survey in 1988 (LRO LCC 4254/13-20 1988). These show the site essentially entirely intact as it was by the mid-20th century, although with some obvious modern additions to the east side of the Vale Rock weaving shed.

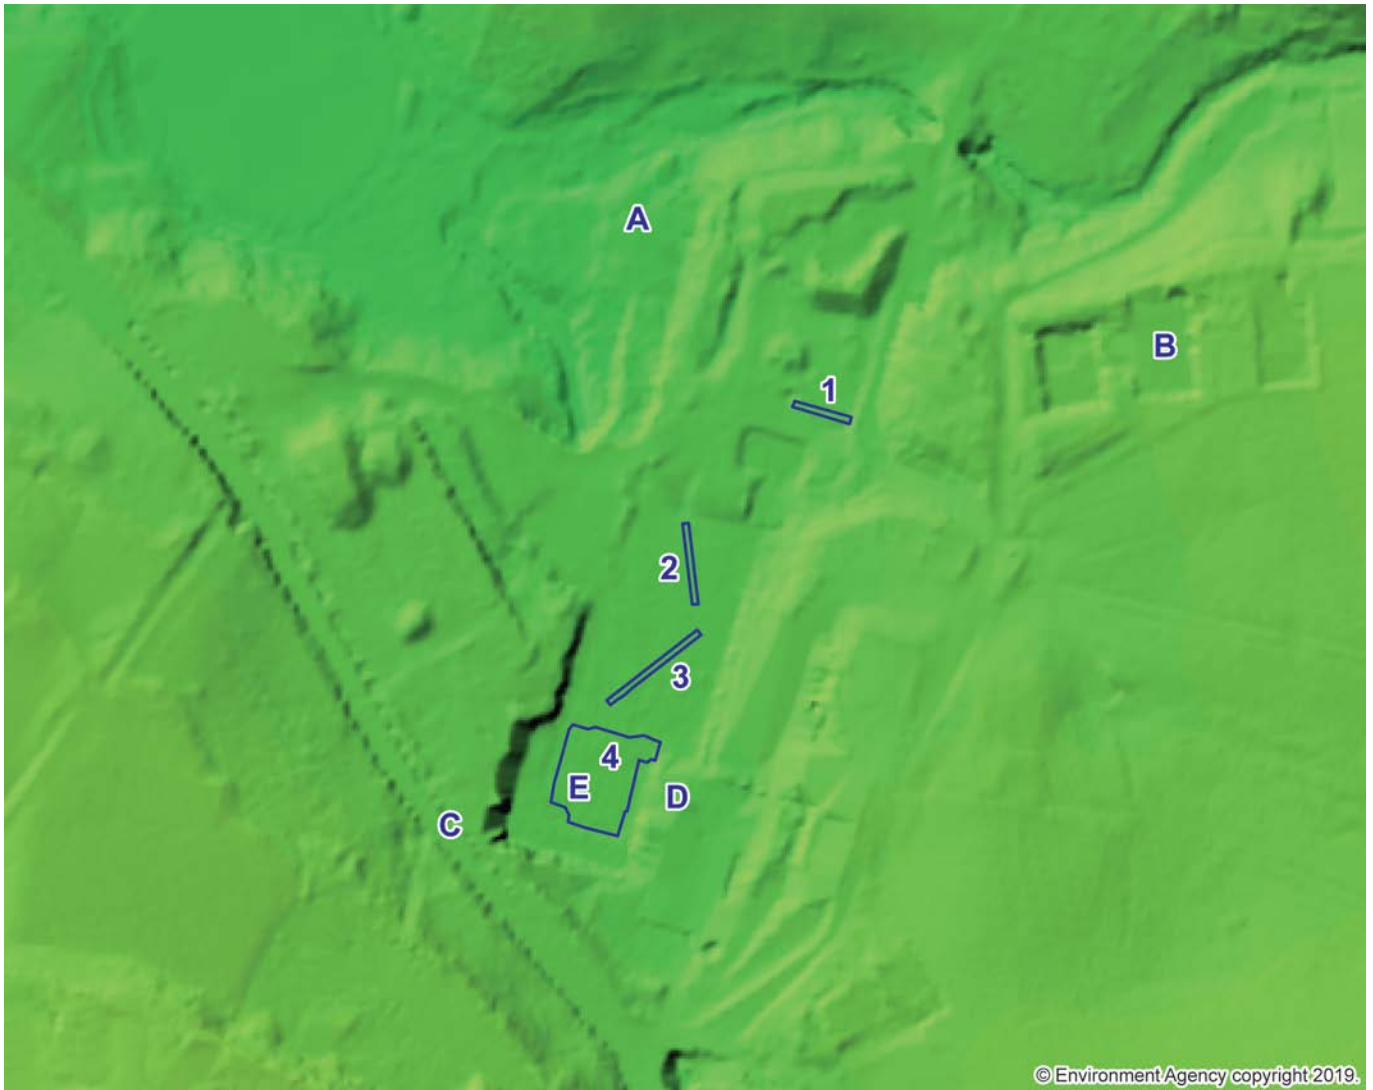
Plate 12: Lidar imagery of the site

3.3.1 **Lidar:** various elements of the former mill buildings can be seen on lidar imagery of the site freely available online. This shows the extent of the standing remains on the site, in particular the footprint of the main buildings, the reservoirs and other structures.

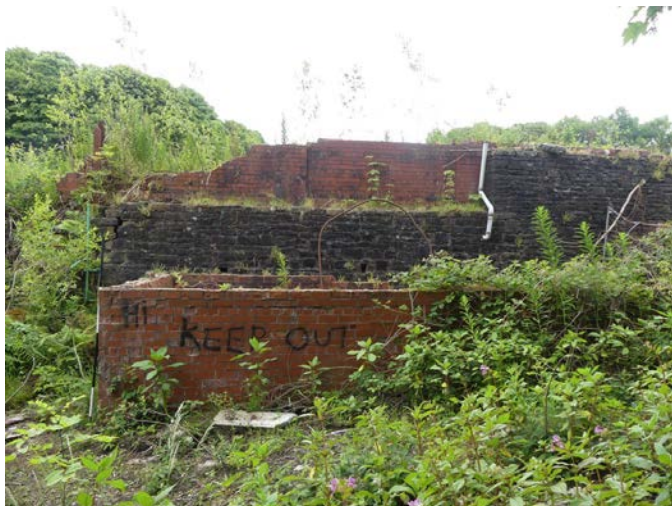
Plate 13 (left): Boundary wall in Area A

4.2.1 There is a tall, approximately north/south, **boundary wall** to the east. The south end is constructed from well-built stone walling, partially topped with red machine-made brick (Plate 13). At the north end the stone section is in much rougher large slabs of stone. In front (west) of the boundary wall, at its south end, is a rectangular **brick tank** constructed from machine-made brick (Plate 14), built against the wall but not butting it. Inside are the remains of three rectangular brick bases with curved tops, which evidently supported a cylindrical tank of some form.

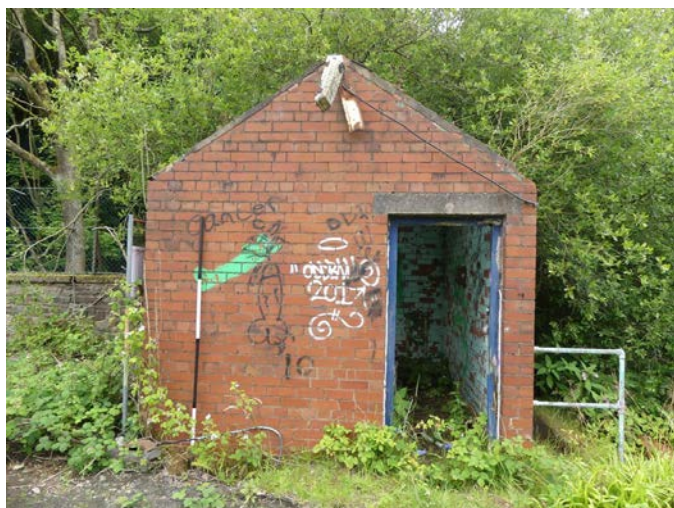
Plate 15 (left): East elevation of the small brick structure in Area A

4.2.2 To the north of the brick tank there is a **small brick structure** against the boundary wall. The brick is laid in English Garden Bond in a ratio of three rows of stretchers to one row of headers. It has a pitched roof, with some slate remaining, a door to the east (Plate 15) and a 10-light metal casement window, with two hinged lights in the top, to the south (Plate 16). The doorway and window both have concrete lintels and the doorway has remains of a plain surround. Inside, it is fairly plain, with electrical boxes on the east wall and pipes in the floor (Plate 17 and Plate 18) and valve or pump and a deep pit in the north-west corner.

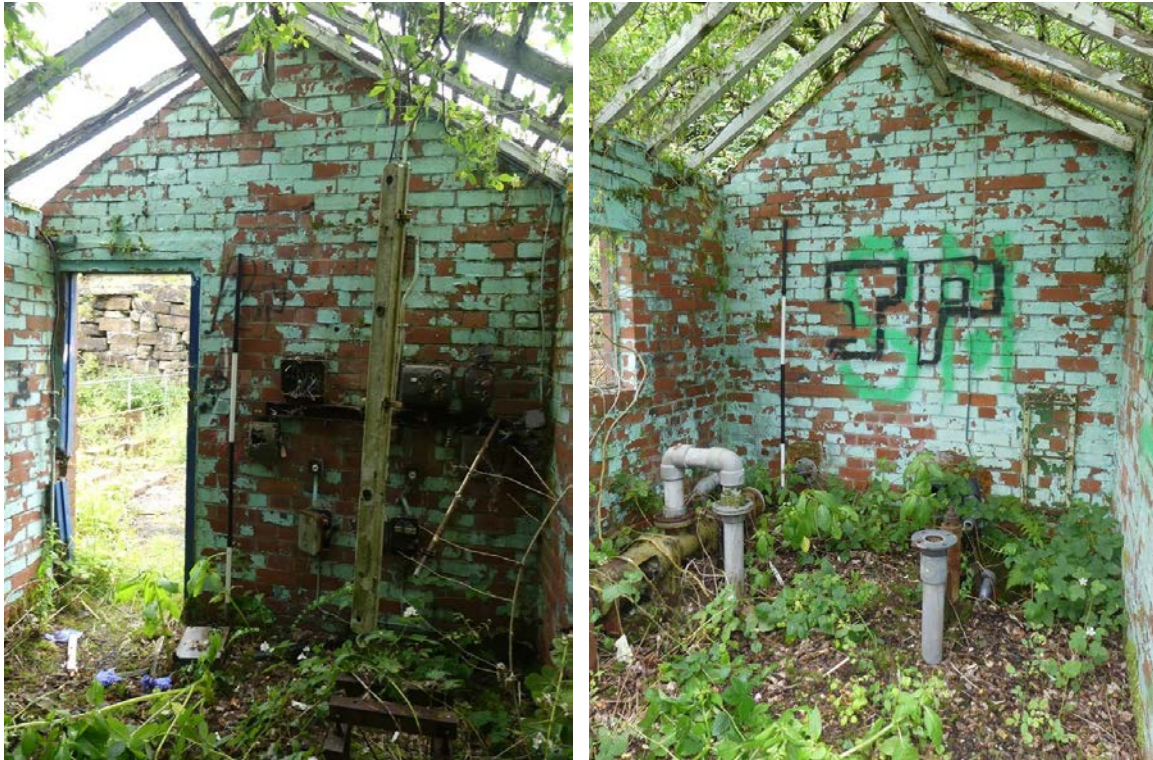
Plate 17 (left): Electrical boxes inside the small brick structure in Area A

Plate 18 (right): Pipe work inside the small brick structure in Area A

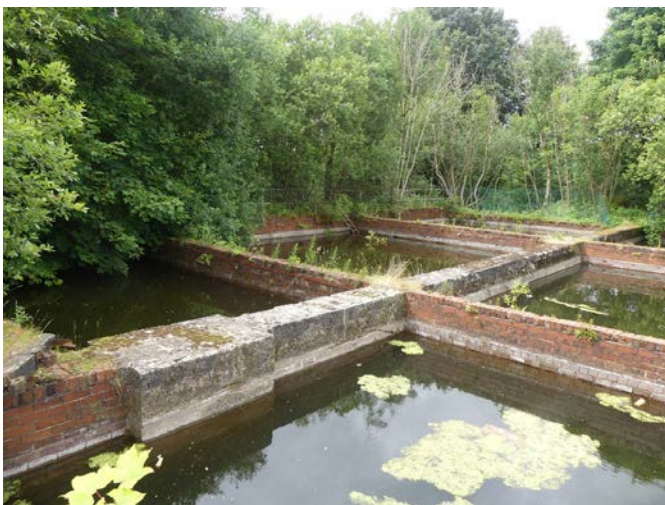
Plate 19 (left): General view of the filter beds from the south-east

4.2.3 The **filter beds** are to the north of the small brick structure in Area A. They comprise two sets of three rectangular tanks separated by east/west brick walls coming off a north/south concrete spine wall that splays slightly at the north end and has the remains of a sluice gate just before this (Plate 19 to Plate 24). The south-eastern tank has an additional rectangular block of concrete set within it and a sluice gate leading into a channel alongside the east wall. There is a handrail on the south side and stepped section with pipe brackets and additional walls forming small channels with sluice gate on the north side (Plate 25 to Plate 26). There is also a driveshaft attached to the wall to the east just to the south of these. To the north are similar walls creating additional channels and four or more large concrete columns with iron brackets on top for supporting concrete pipes (Plate 27).

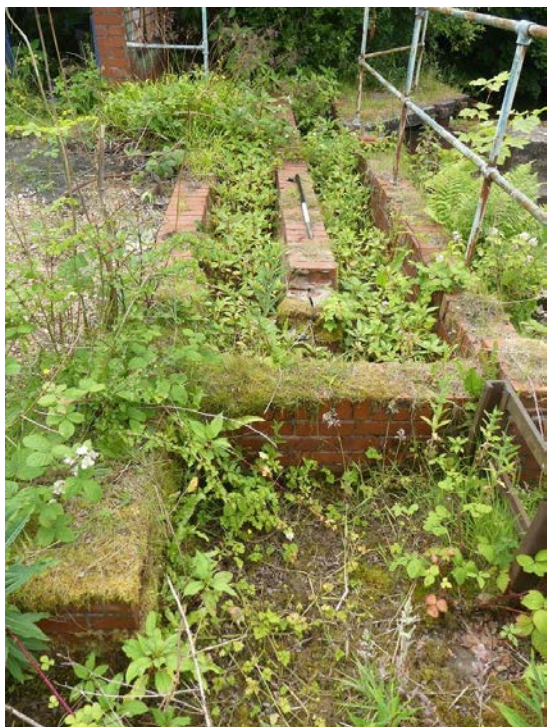
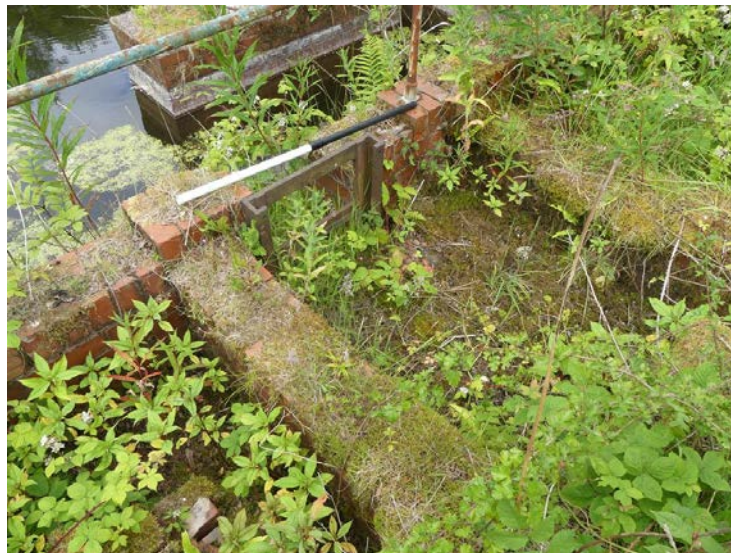
Plate 25 (left): Walls forming channels to the south of the filter bed, from the east

Plate 26: Sluice on the north side of the channels to the south of the filter beds, from the south

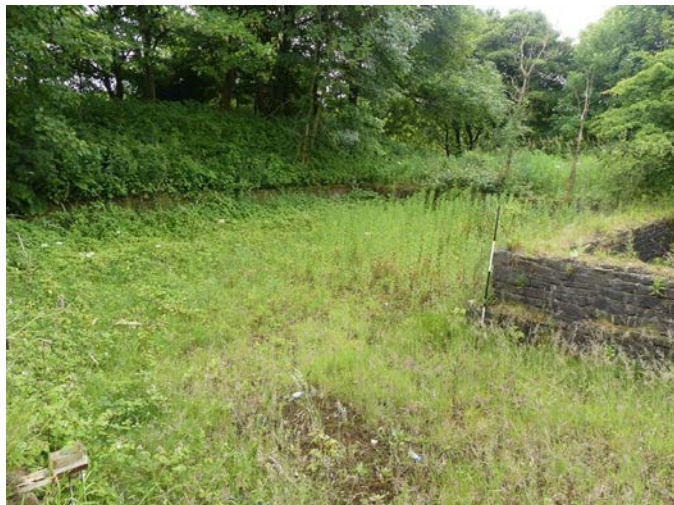
Plate 28 (left): The west tank in Area B viewed from the north-east

4.3.2 The **west tank** comprises three irregular, stone-built tanks with plinths (Plate 28 to Plate 32; Figure 5). The largest tank, to the south, is L-shaped and the other two are rectangular. There is a sluice

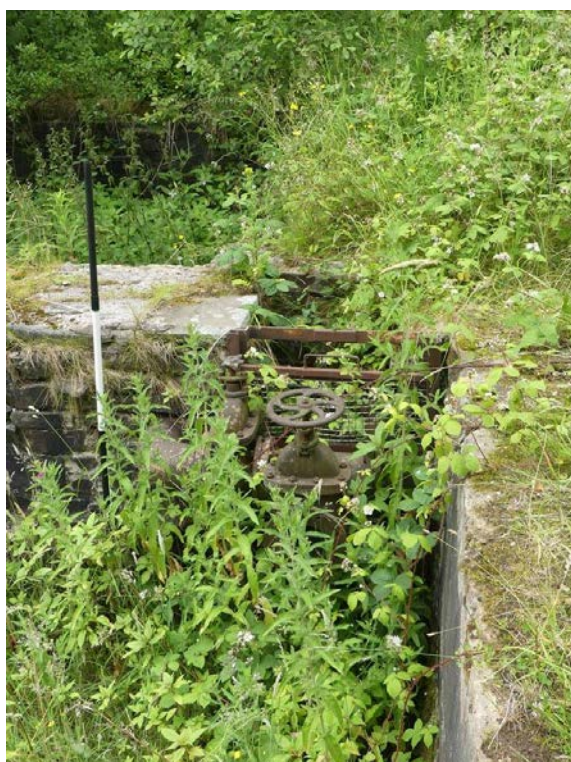
Plate 33 (left): Sluice in the west tank in Area B

Plate 34 (right): Handhold ladder in the west tank in Area B

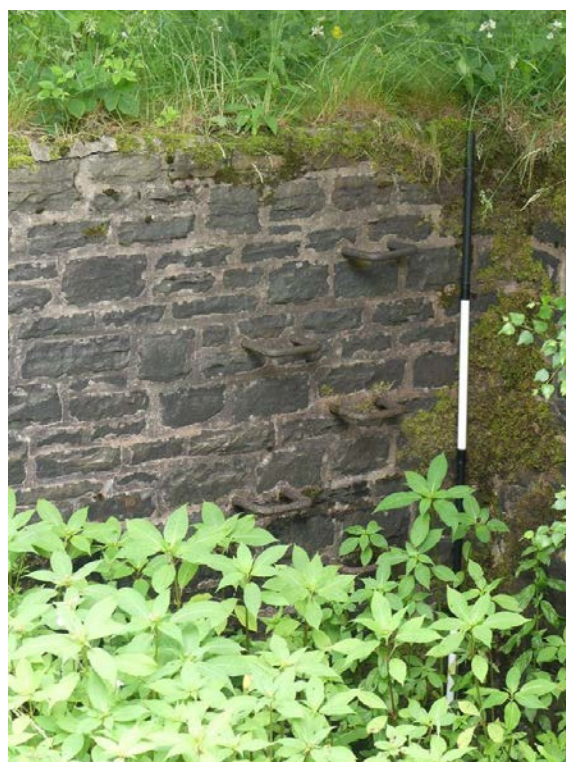
gate with a wheel at the east side (Plate 33) and an iron handhold ladder in the north-west corner (Plate 34). There is a channel from the west side with concrete sides and a valve in the base and pipe across (Plate 35 and Plate 36).

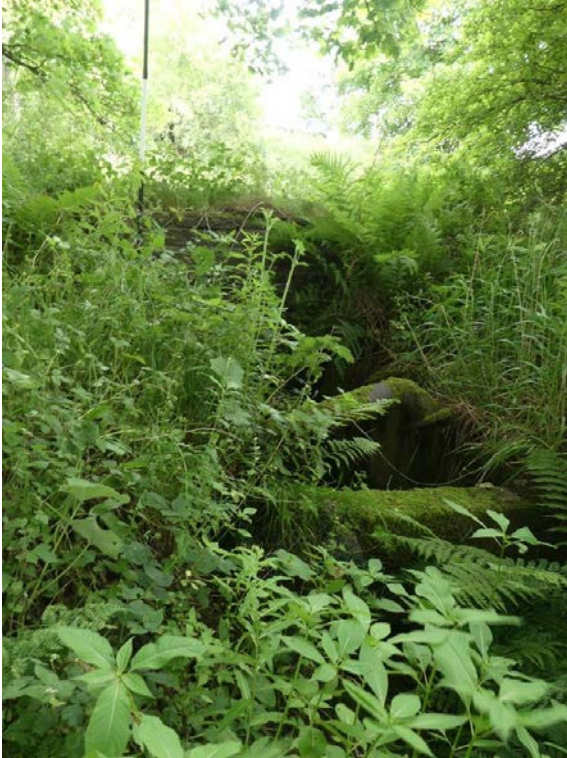
Plate 35 (left): Channel from the west side of the west tank, Area B

Plate 36 (right): Pipes in the channel from the west side of the west tank, Area B

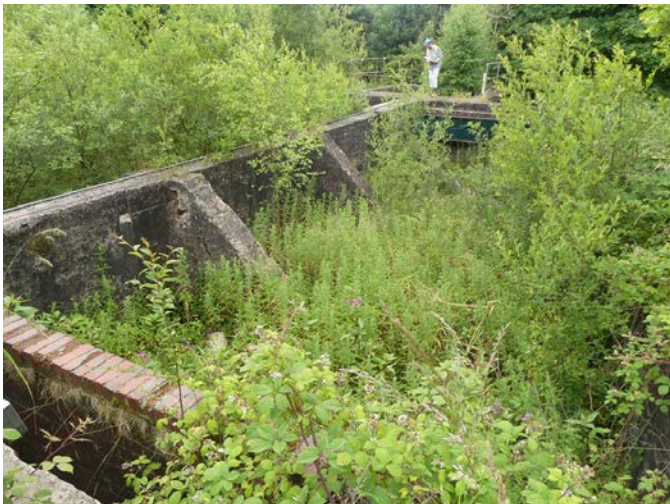
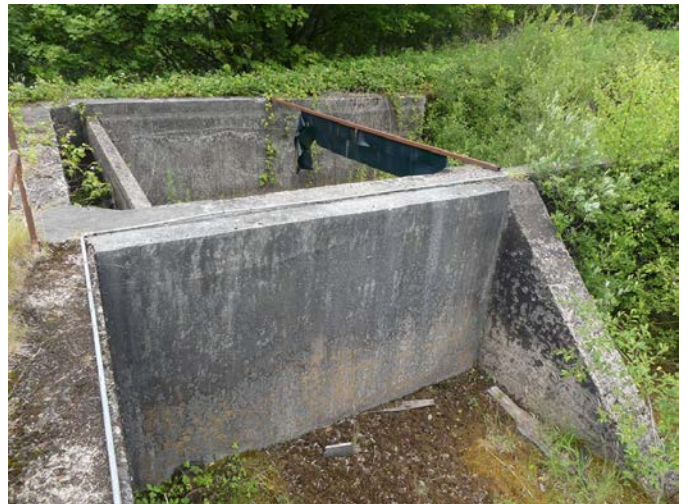
4.3.3 The **central tank** is of concrete construction, with a large tank to the south side, with an east/west iron pipe to the east side, and smaller tank to the north (Figure 5; Plate 37 and Plate 38). There is a row of three buttresses on both sides of the wall dividing the two tanks. The smaller tank has a machine-made red brick dividing wall on the east side (Plate 39), a single brick-length thick, and there is a further division at the west end in concrete (Plate 40).

Plate 37 (left): The large tank to the south, part of the central tank, Area B

Plate 38 (right): The smaller tank to the north, part of the central tank, Area B

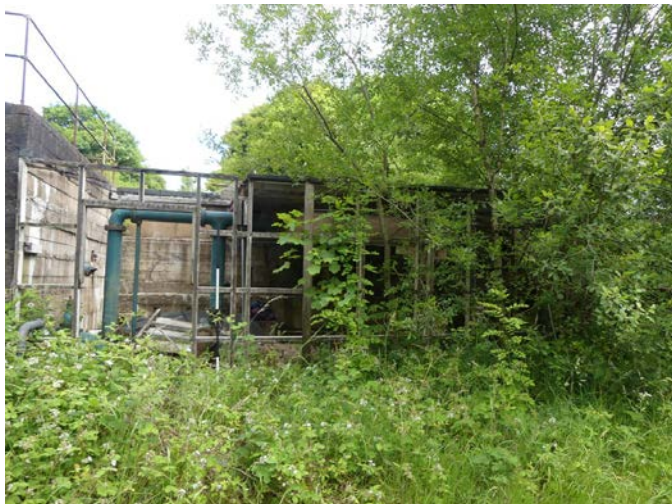
Plate 41 (left): Timber structure to the west of the central tank, Area B

4.3.4 The building is extended by a mostly flat-roofed **timber structure**, centrally located on the west side (Plate 41). Although all of the cladding has been removed, it evidently housed a range of pipes, valves and other plant (Plate 42 to Plate 48). One of the valves is marked "B/G//8" on the west side and a pump(?) has a maker's plate, which is illegible. This structure is roughly rectangular with a stepped out section to the south-east corner and stairs down from the south (Plate 49 and Plate 50). Internally there is brick walling in the south-east corner and forming plinths and a concrete machine base. The stairs to the south are flanked by walls of machine-made brick.

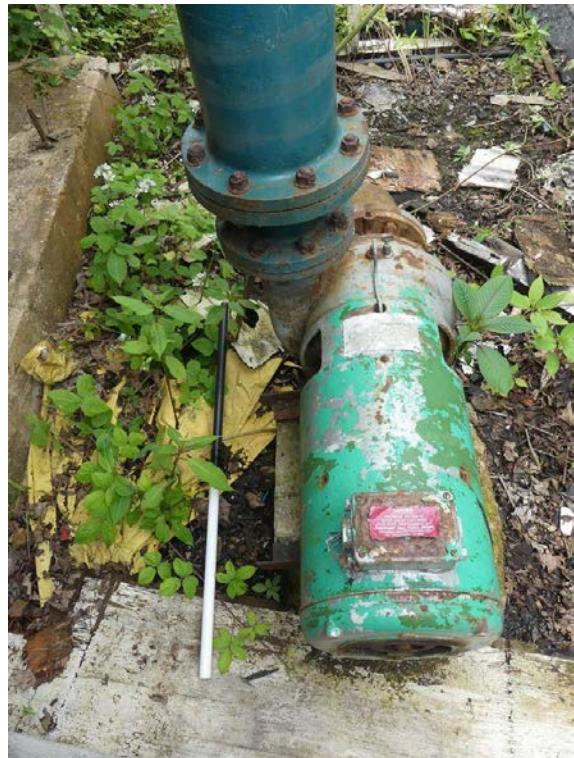
Plate 46 (right): pump inside the timber structure, Area B

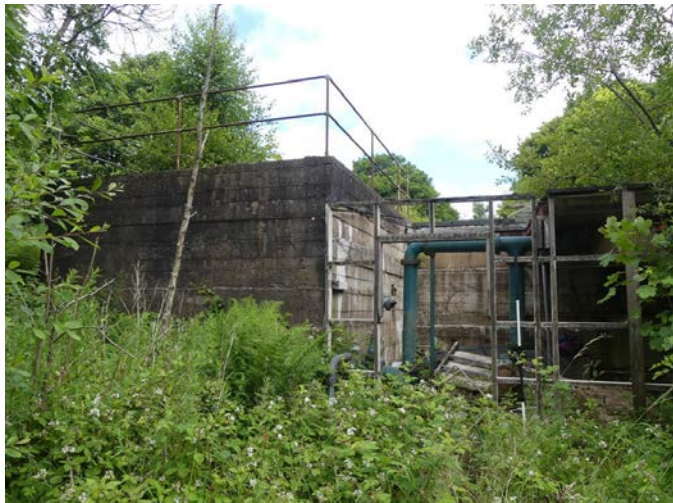
Plate 51 (left): Concrete tank and timber structure to the west of the central tank, Area B

4.3.5 There is a further extension to the north, comprising a tall concrete tank, topped with an iron handrail (Plate 51), with additional east/west divisions inside and pipes and bearings to the base (Plate 52 and Plate 53).

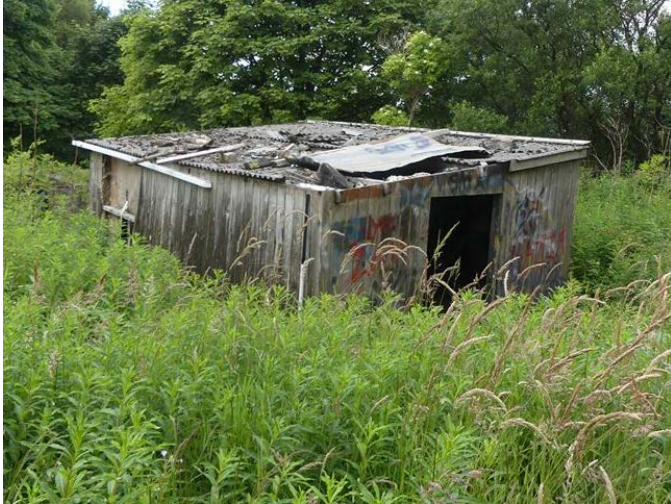
Plate 54 (left): Timber shed, Area B, viewed from the south-east

4.3.6 There is a **timber shed** between the east and central tank. The shed is constructed from tongue and groove planks on a timber frame and plywood inside (Plate 54 to Plate 56). It has a corrugated concrete roof and concrete floor and fixed structure comprising four steel L-beams on the south side (Plate 57). There is a plan window to the west.

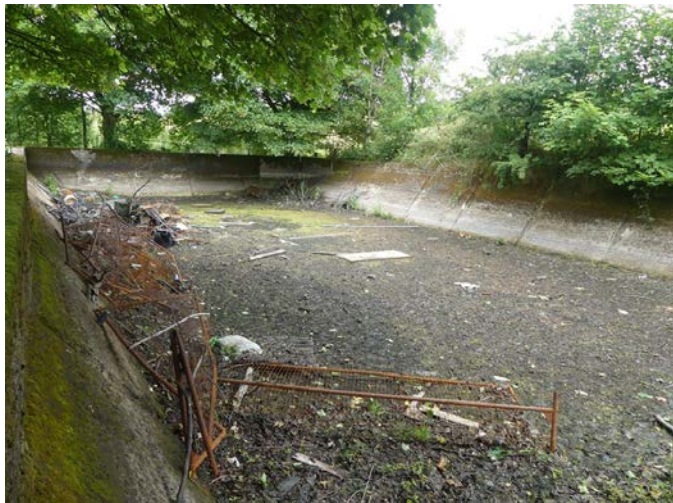
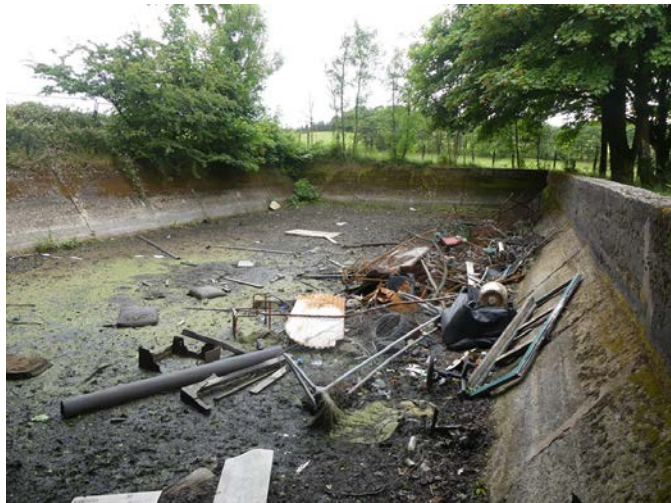
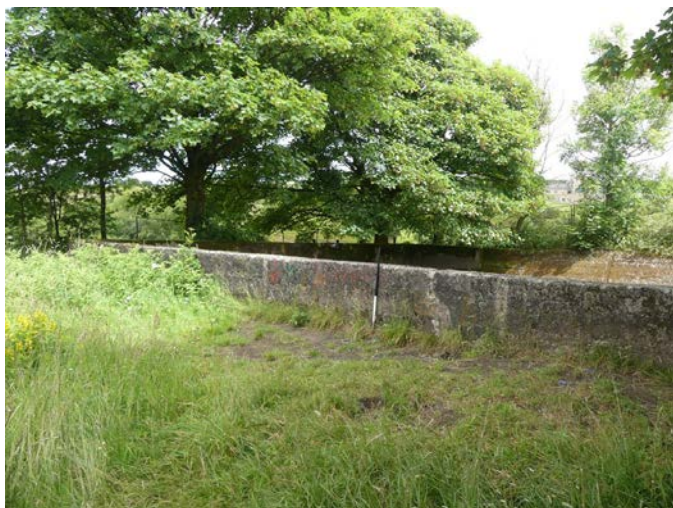
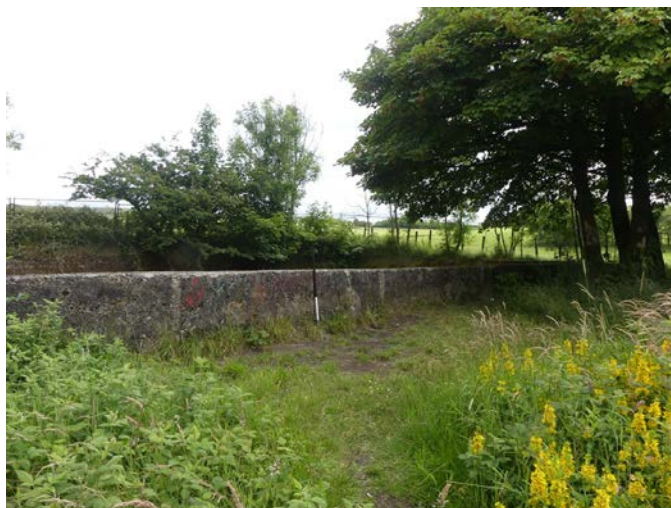
4.3.7 The **east tank** is a simple rectangle of concrete construction with steep battered sides with channels and an iron pipe in the north-east corner (Figure 6; Plate 58 to Plate 61). There is a projecting section on the north side, forming a small pit with a plastic pipe projecting high-up from the main wall (Plate 62). This small pit is also of concrete construction with two iron pipes in the base.

Plate 58 (left): General view of the east tank, Area B, viewed from the south-west

Plate 59 (right): General view of the east tank, Area B, viewed from the north-west

Plate 60 (left): North end of the west wall of the east tank, Area B

Plate 61 (right): South end of the west wall of the east tank, Area B

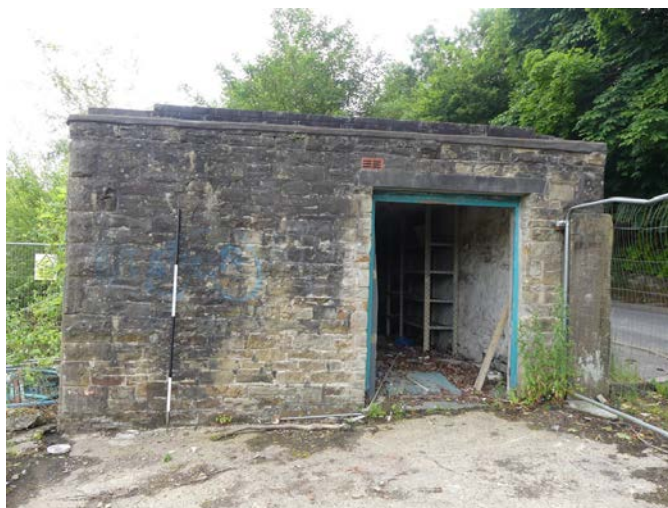
Plate 63: North-west external elevation of the substation, Area C

4.4.2 The **north-west** external elevation has quoins at the corners and a large stone gatepost against the south-west end (Plate 63). It is fairly plain except for a very wide doorway inserted on the south-west side, with a concrete lintel, the remains of a plain surround and obvious areas of rebuild around it.

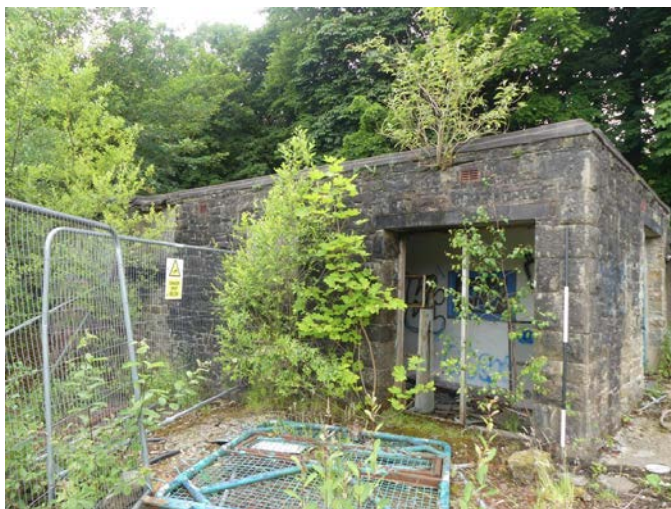
Plate 64 (left): North-east external elevation of the substation, Area C

4.4.3 The **north-east** external elevation has a doorway on the north-west side (Plate 64), with quoins in the jambs, and a concrete lintel with rebuild around this and the south-east jamb, suggesting it was inserted. There are two windows to the south-east: the north-west one has a concrete lintel and rebuild around and below it, suggesting it was originally a doorway; the south-east window is higher and has a concrete sill and no lintel, just rough stones at the top of the wall, where it was perhaps reduced in height (Plate 65).

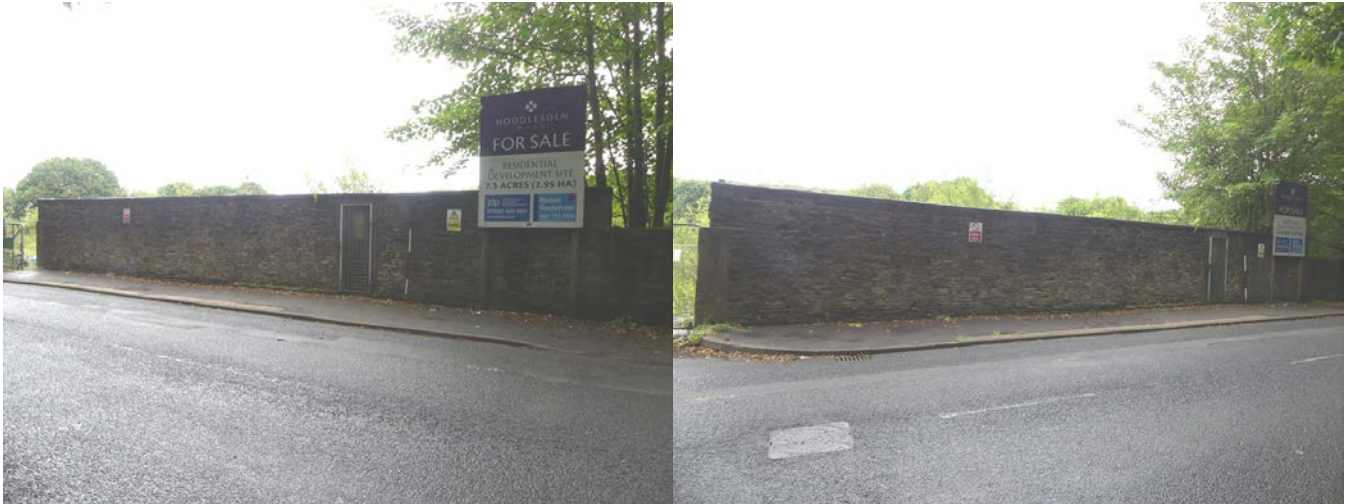
Plate 66 (left): North-west end of the south-west external elevation of the substation, Area C
Plate 67 (right): South-east end of the south-west external elevation of the substation, Area C

4.4.7 The **south-west** external elevation is mostly fairly plain with randomly coursed stone (Plate 66 and Plate 67). There is a doorway at the south-east end with a security grill over (Plate 68). There are quoins at the south-east end that extend 0.5m into the boundary wall (Plate 69).

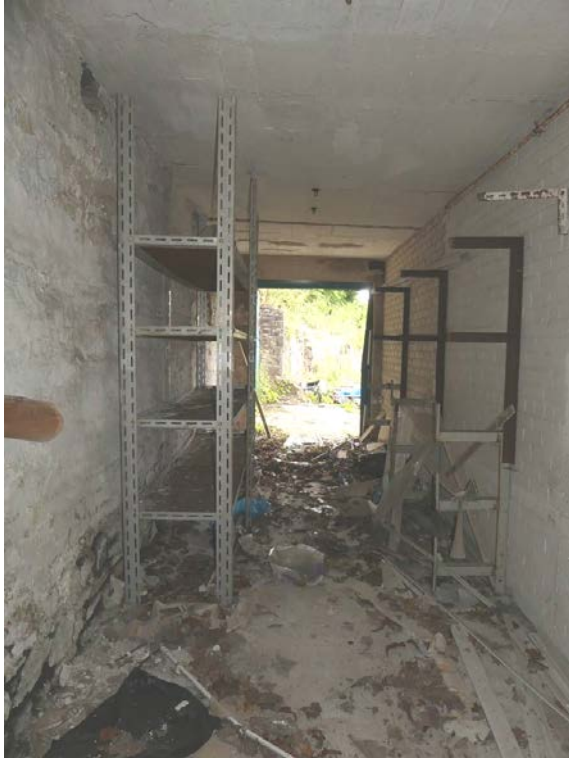
Plate 70 (left): The west room of the substation, Area C

4.4.8 Internally, the **west room** has a concrete floor and concrete ceiling on I-beams. The walls are mostly limewashed/painted white (Plate 70). The **north-west** elevation has a wide doorway for a double door with plain surrounds and concrete over the jambs (Plate 71). The **north-east** elevation is concrete block laid English Garden Bond in a ratio of five rows of stretchers to one row of headers, with a join or opening in the centre (Plate 72 and Plate 73). The **south-east** elevation has a double doorway, with only one modern glazed door remaining, and a concrete lintel (Plate 74). The lower part of the **south-west** elevation is stone and the upper part is brick. It is mostly plain, with modern shelves against it, and three high vent holes (Plate 75).

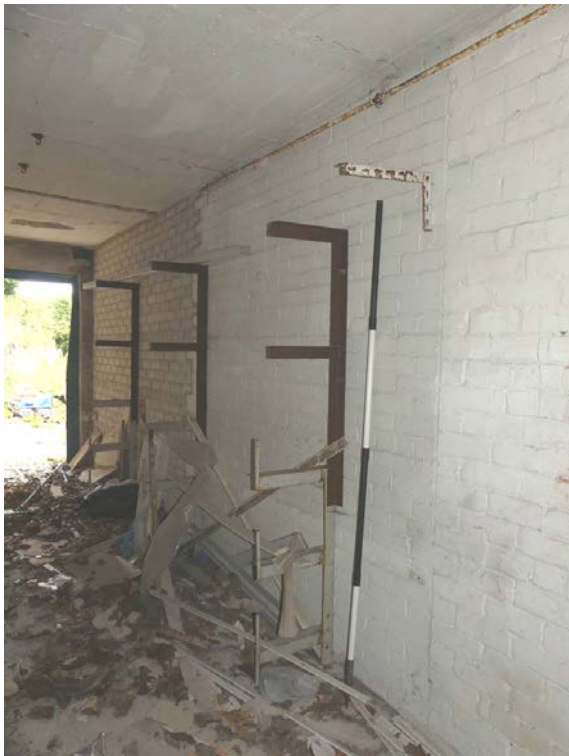
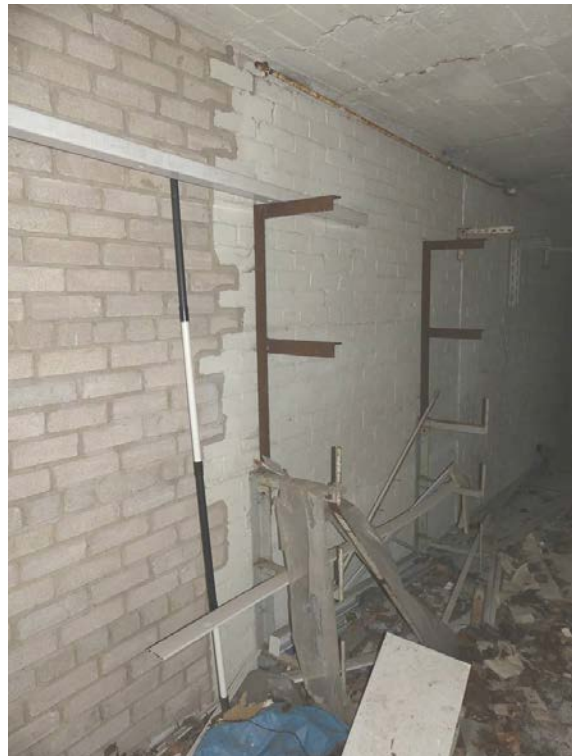
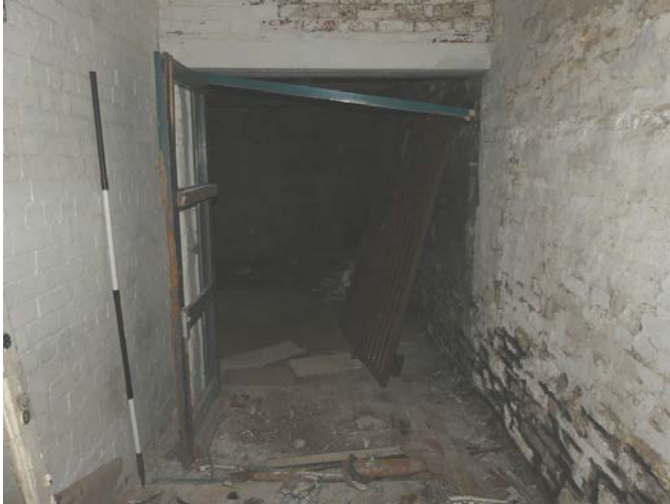
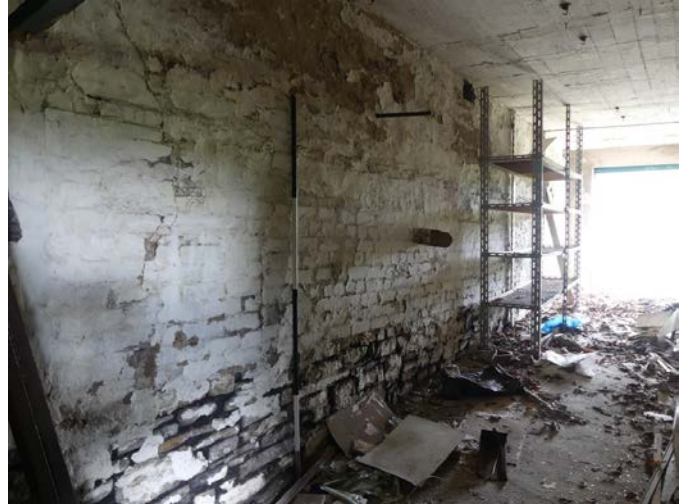
Plate 72 (left): North-east elevation of the west room of the substation, Area C, viewed from the south

Plate 73 (right): North-east elevation of the west room of the substation, Area C, viewed from the north

Plate 74 (left): South-east end of the west room of the substation, Area C

Plate 75 (right): South-west elevation of the west room of the substation, Area C

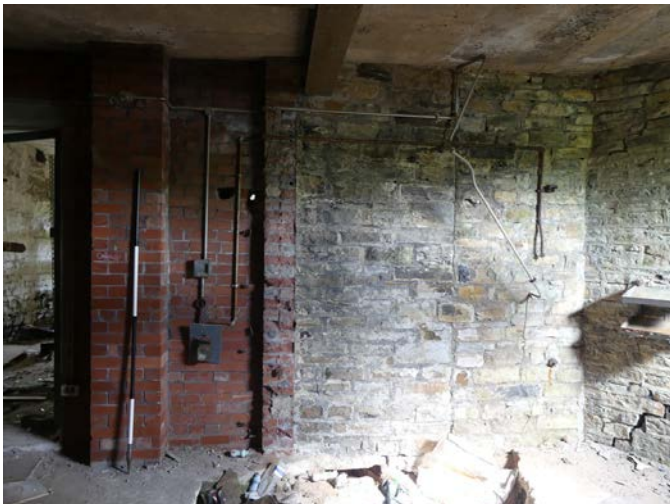
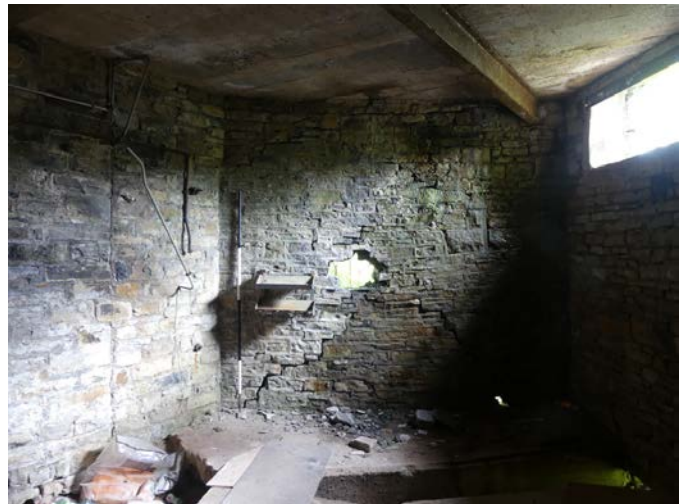
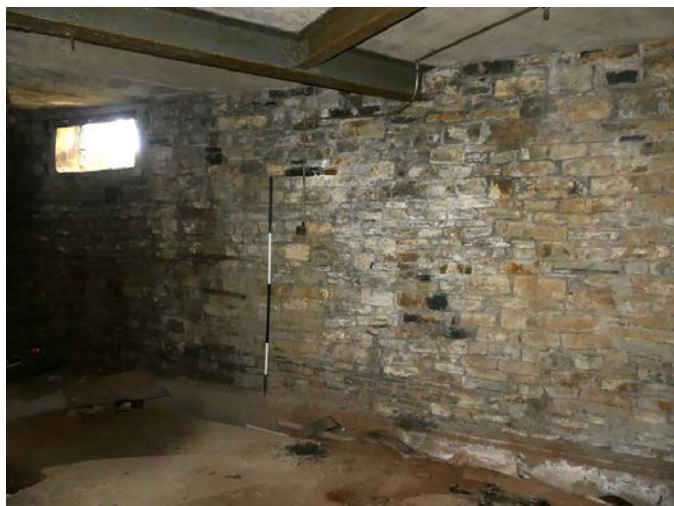
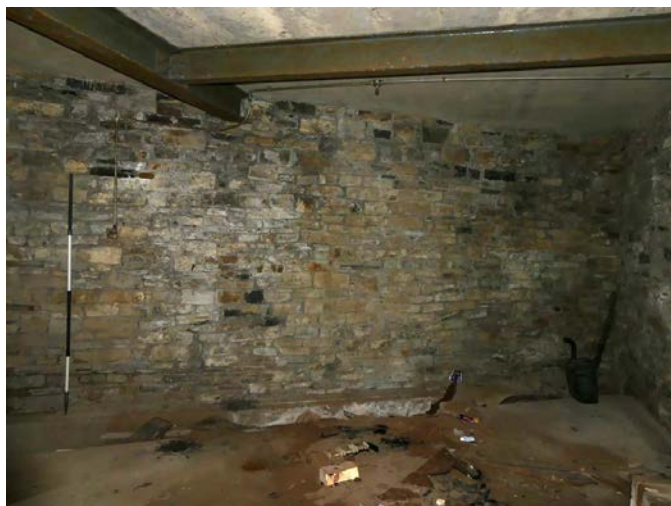
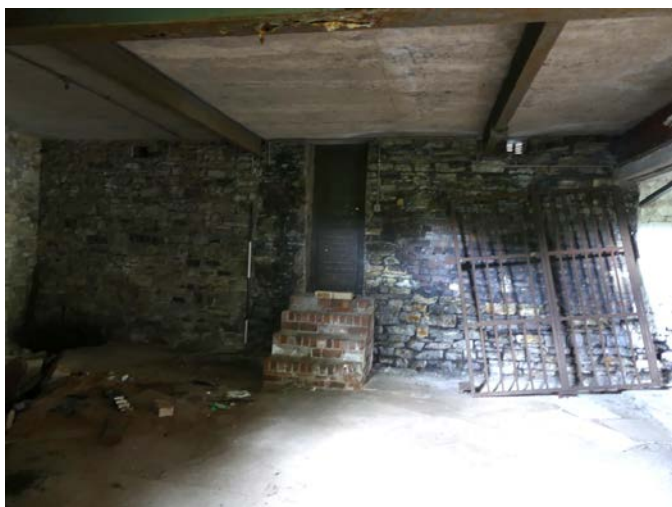
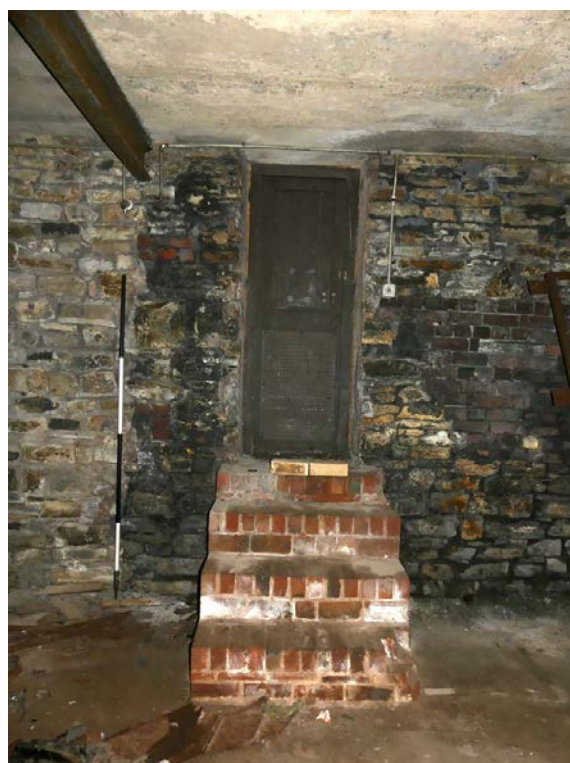
4.4.9 The **south room** has a concrete floor with a channel along the south, east and part of the north sides of the room (Figure 7). The ceiling is concrete on iron I-beams. The walls are mostly exposed stone and parts are machine-made red brick. The **north-west** elevation has a wide doorway on the south-west side with a concrete lintel. There is a pillar in brick to the north-east and a slight recess and return for a broken stub wall in brick beyond which is a blocked doorway or opening filled with stone (Plate 76). The **north** elevation comprises an angled return, which is very cracked and damaged, with some odd reused dressed quoins (Plate 77). The **south-east** elevation has a very high window at the north-east end, concreted round the surround and with iron pieces over the lintel (Plate 78). The elevation is otherwise plain with a small high vent near the centre and slightly rounded in the south corner (Plate 79). The **south-west** elevation has two high level vents and a central plank and batten door up a flight of brick steps (Plate 80 and Plate 81). The lower section is gridded, extending to the ceiling, mostly stone but part of the north-west end is brick.

Plate 76 (left): North-west elevation of the south room of the substation, Area C

Plate 77 (right): North elevation of the south room of the substation, Area C

Plate 78 (left): North-east end of the south-east elevation of the south room of the substation, Area C

Plate 79 (right): South-west end of the south-east elevation of the south room of the substation, Area C

Plate 80 (left): South-west elevation of the south room of the substation, Area C

Plate 81 (right): Door in the south-west elevation of the south room of the substation, Area C

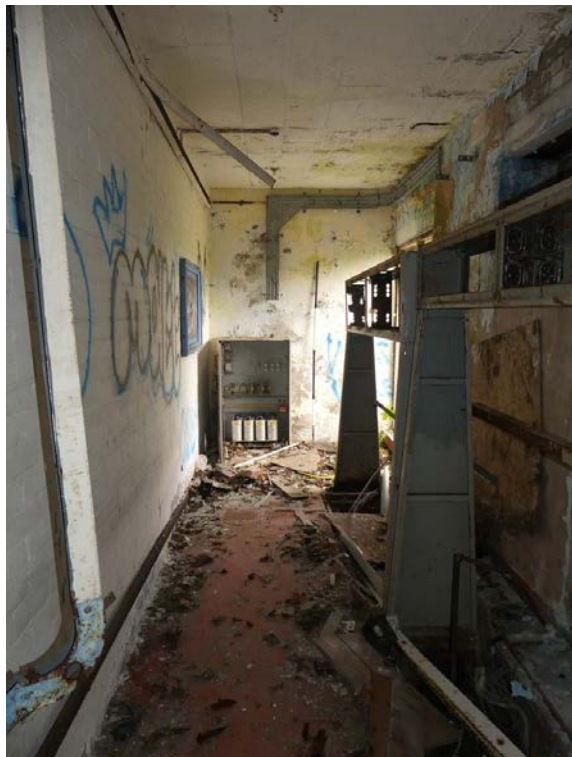
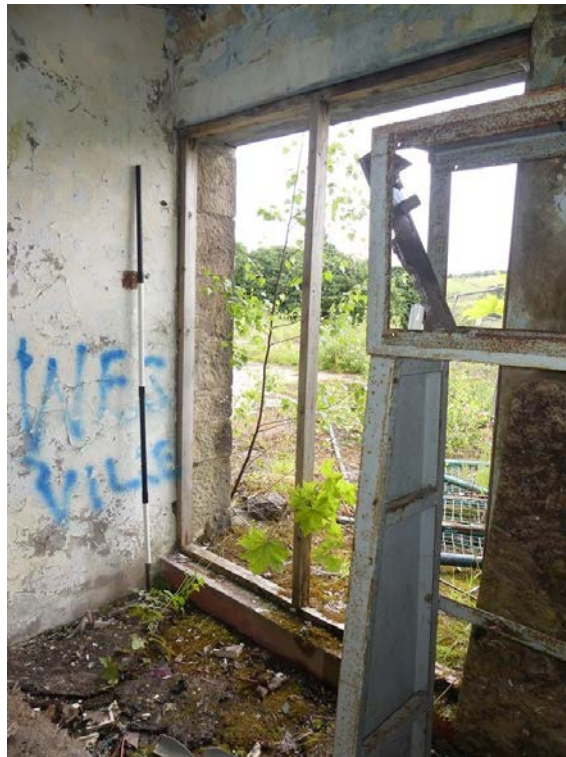
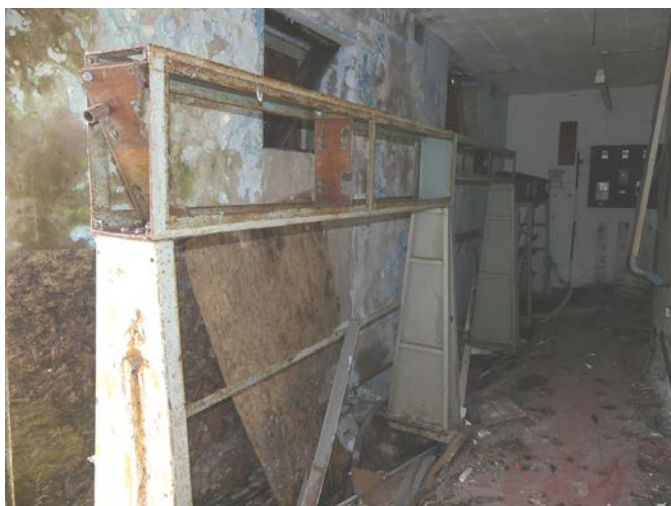
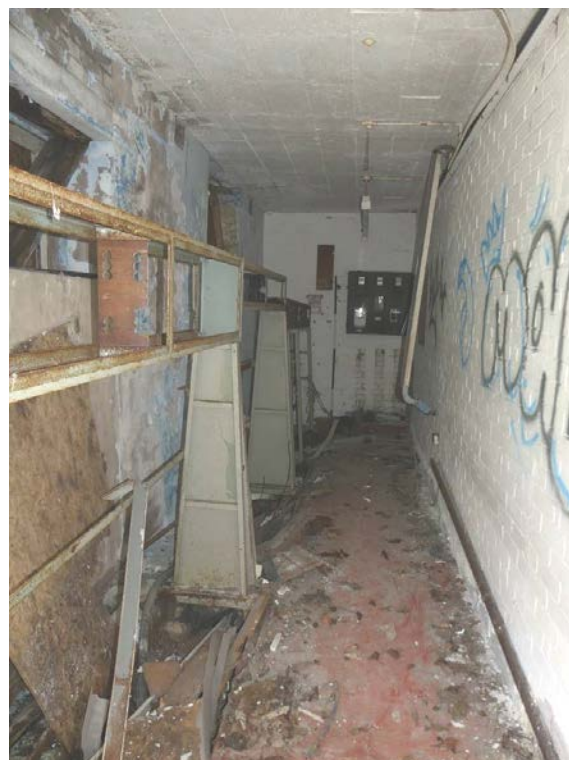
4.4.10 The **north room** has a tiled floor comprising red quarry tiles and a concrete ceiling. The walls are mostly painted brick. The **north-west** elevation is plain with an electrical cabinet attached (Plate 82). The **north-east** elevation has a doorway on the north-west side with a concrete lintel (Plate 83). The doorway now houses the remains of a timber frame, apparently for a window. The wall is finished with gypsum plaster. There are two windows to the south-east (Plate 84). The top of the one to the north-west is blocked and has an inserted concrete lintel and plain surround. The one to the south-east extends to the ceiling and has a concrete sill and plain surround. The **south-east** elevation is plain with meters attached to a board (Plate 85). The **south-west** elevation is plain brick with a framed notice board attached to the north-west end.

Plate 82 (left): General view of the north-west end of the north room of the substation, Area C
Plate 83 (right): Doorway at the north-west end of the north room of the substation, Area C

Plate 84 (left): The south-east end of the north-east elevation of the north room of the substation, Area C
Plate 85 (right): General view of the south-east end of the north room of the substation, Area C

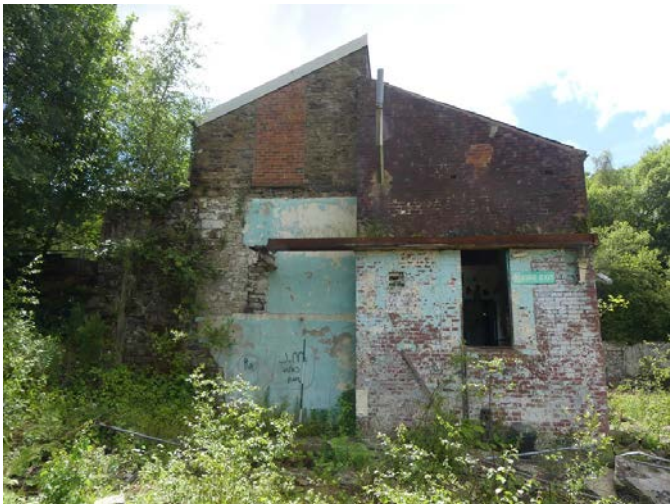
Plate 86 (left): North-east external elevation of the mill building, Area D

4.5.2 **North-east external elevation:** the south-east side has a truncated wall abutting the main building and forming part of the boundary wall to the north-east (Plate 86; Figure 10). This then comprises a wall with a mono-pitch top, with quoins on the south-east side. There is plaster over the lower part and a doorway in the upper section, extending to roof. The door has a thin stone sill/step and is blocked with brick. There is an iron girder on a bracket supporting a beam running to the north-west. The main section steps out in brick (Plate 87), again with a projecting girder supporting a beam (Plate 88) and with a bearing box on the south-east side (Plate 89) and a window/doorway to the north-west. There is a modern metal flue in the upper section.
