HODDLESDEN MILL, HODDLESDEN, DARWEN, LANCASHIRE

Archaeological Building Recording, Evaluation and Strip, Map and Record

Client: Kingswood Homes

September 2022

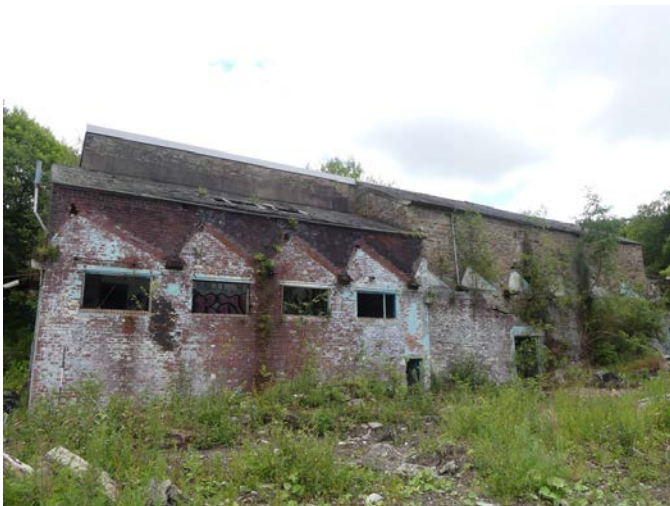
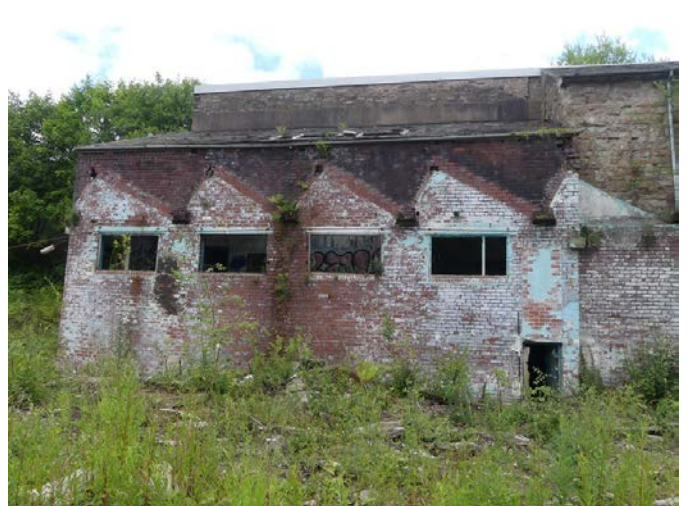
4.5.3 **North-west external elevation:** the north-east section in brick has a row of four high-level windows, with bull nosed brick sills and remains of plain timber surrounds and concrete lintels (Figure 11; Plate 90 and Plate 91). There are scars of a north-light roof above and remains of trough guttering. The doorway to the south-west end of this section houses a low plank and batten door *in situ*, but the opening was evidently originally much taller (Plate 92). There is a single random stone in the wall above and a slight step beyond. South-west of that, the lower part of the wall is brick in English Garden Bond in a ratio of five rows of stretchers to one row of headers, cladding a stone wall behind. The north-light roof scars and iron troughs continue to the south-west (Plate 93). The central double doorway has a plain surround and concrete lintel and rebuilt jambs (Plate 94). There is a further doorway at the south-west end, raised above ground level, with a plain surround and thin timber lintel.

Plate 90 (left): General view of the north-west external elevation of the mill building, Area D

Plate 91 (right): North-east end of the north-west external elevation of the mill building, Area D

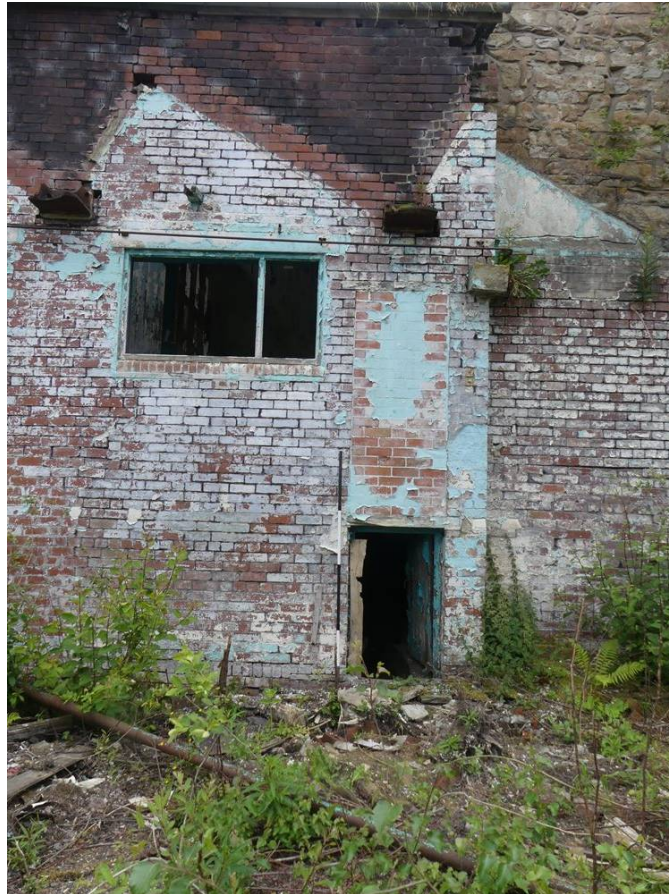
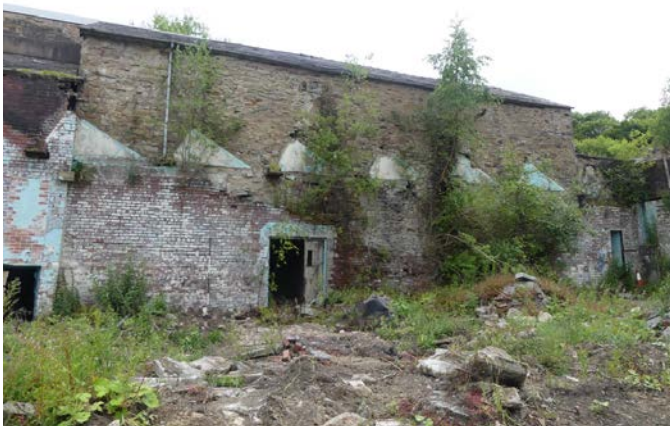
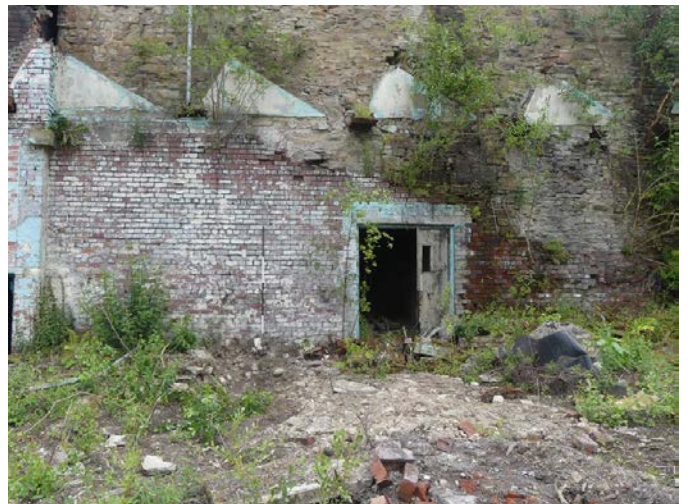
Plate 92: North-east doorway in the north-west external elevation of the mill building, Area D

Plate 93 (left): South-west end of the north-west external elevation of the mill building, Area D

Plate 94 (right): Central doorway on the north-west external elevation of the mill building, Area D

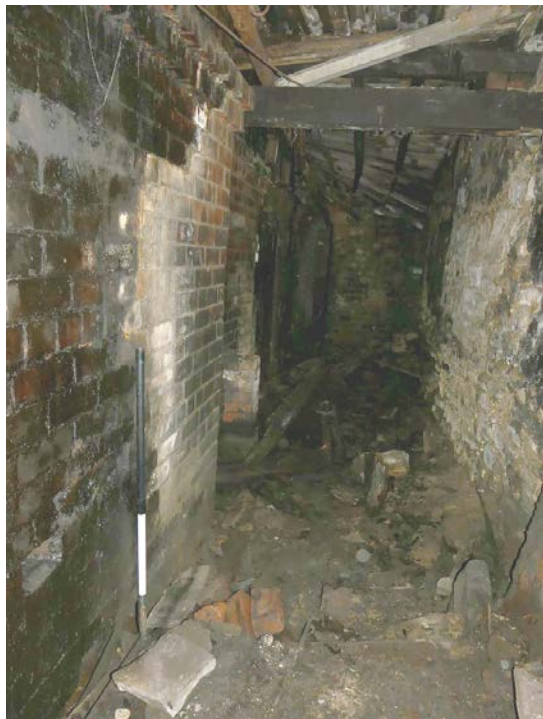
Plate 95 (left): South-west end of the south-east side of the central block of brick masonry in the north-east end room (lowe floor) of the mill building, Area D

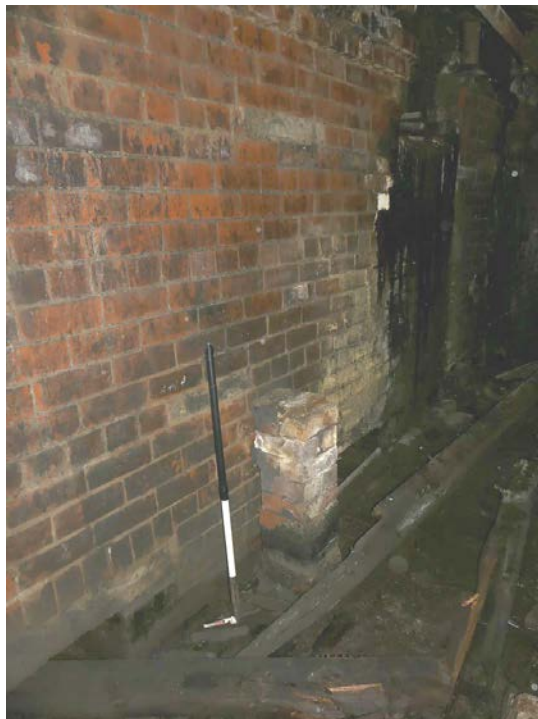
Plate 96 (right): Centre section of the south-east side of the central block of brick masonry in the north-east end room (lower floor) of the mill building, Area D

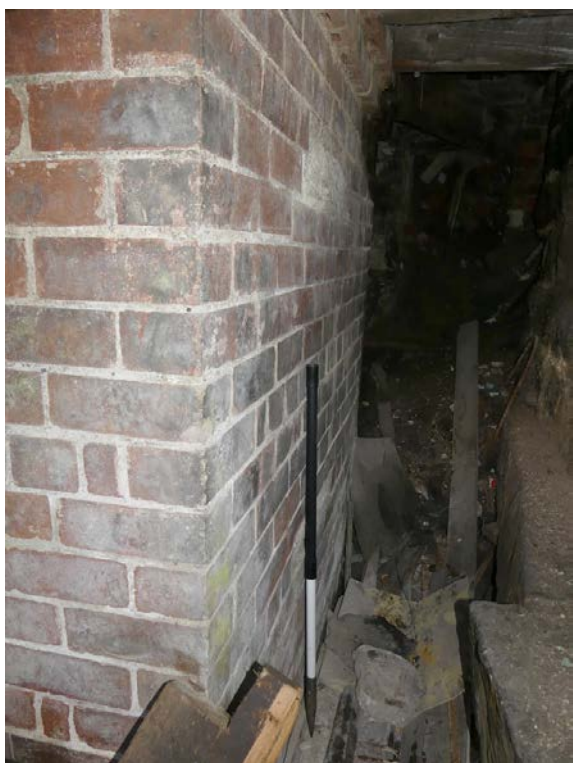
Plate 97 (left): North-east end of the brick block in the north-east end room (lower floor) of the mill building, Area D

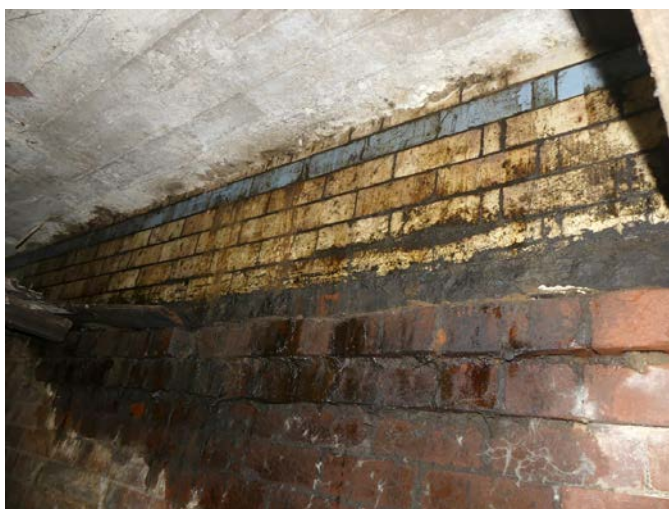
Plate 98 (right): Glazed brick in brick block in the north-east end room (lower floor) of the mill building, Area D

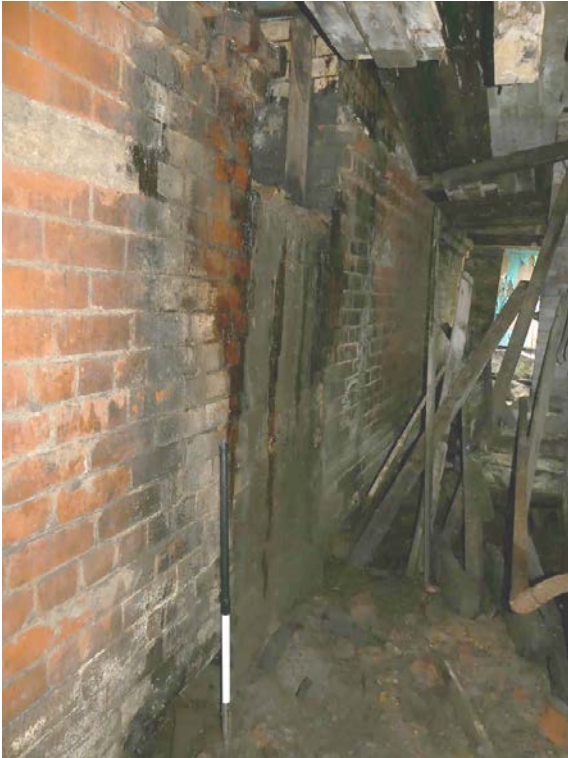
Plate 99 (left): Timber lined opening in the brick block in the north-east end room (lower floor) of the mill building, Area D

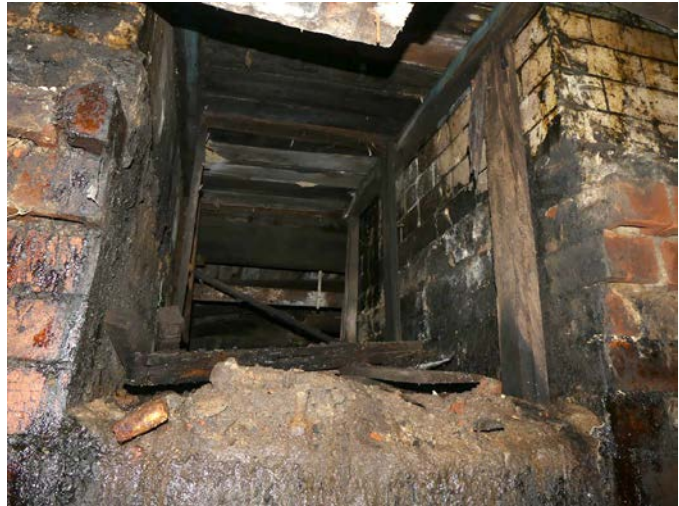
Plate 100 (right): High-up view of the timber lined opening in the brick block in the north-east end room (lower floor) of the mill building, Area D

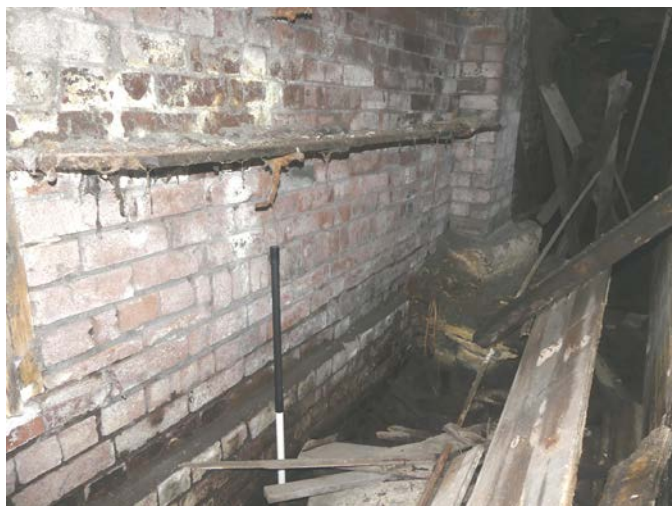
4.5.6 The **north-west** elevation has two brick pillars correlating to those on the floor above sat on large stone pads (Plate 101). The doorway at the south-west end houses a plank and batten door with chamfered jambs. The **south-west** elevation is stone on massive stone footings. There is a return on the south-east side leaving a gap to the adjoining building (Plate 103). The **south-east** elevation is stone with a rubble-filled gap on the south-west side, with brick in the south-west jamb (Plate 104). This elevation is otherwise plain apart from a brick return at the north-east end, forming a large block (Plate 105), and brick build at the south corner, in-filling a door with bull-nosed jamb on the south-west side (Plate 106). The **north-east** elevation is brick and plain apart from a ragged hole in the centre (Plate 107).

Plate 101: North-west elevation of the north-east end room (lower floor) of the mill building, Area D

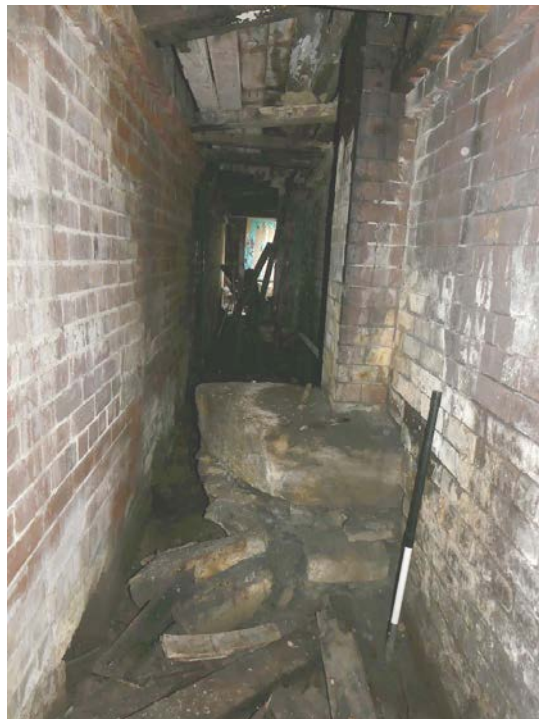
Plate 102: Pillar at the north-east end of the north-west elevation of the north-east end room (lower floor) of the mill building, Area D

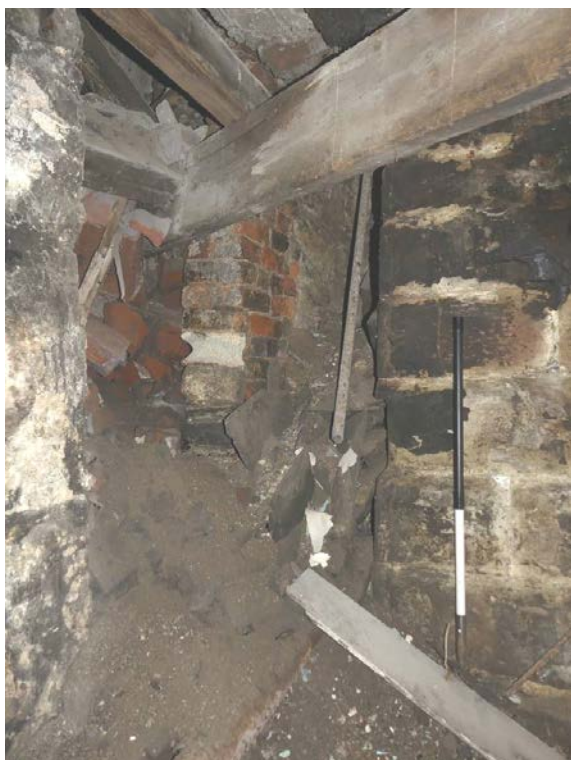
Plate 103 (left): Return on the south-east side of the south-west elevation of the north-east end room (lower floor) of the mill building, Area D

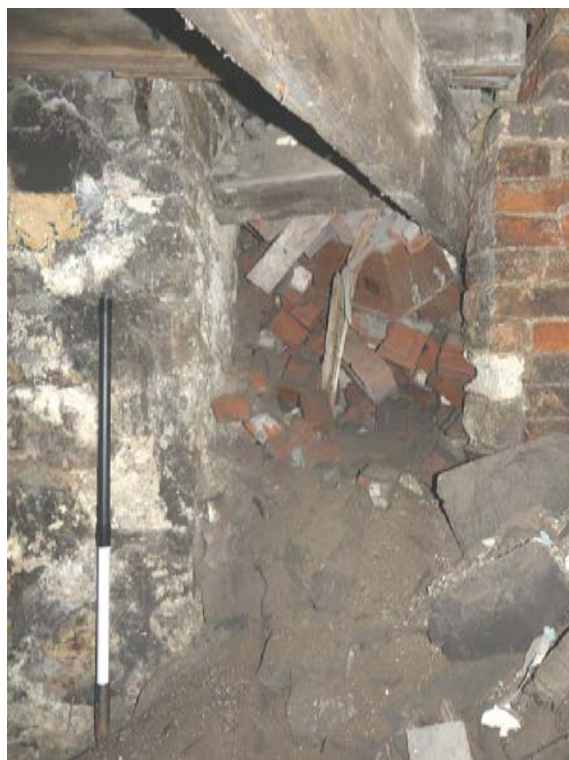
Plate 104 (right): Rubble-filled gap on the south-east elevation of the north-east end room (lower floor) of the mill building, Area D

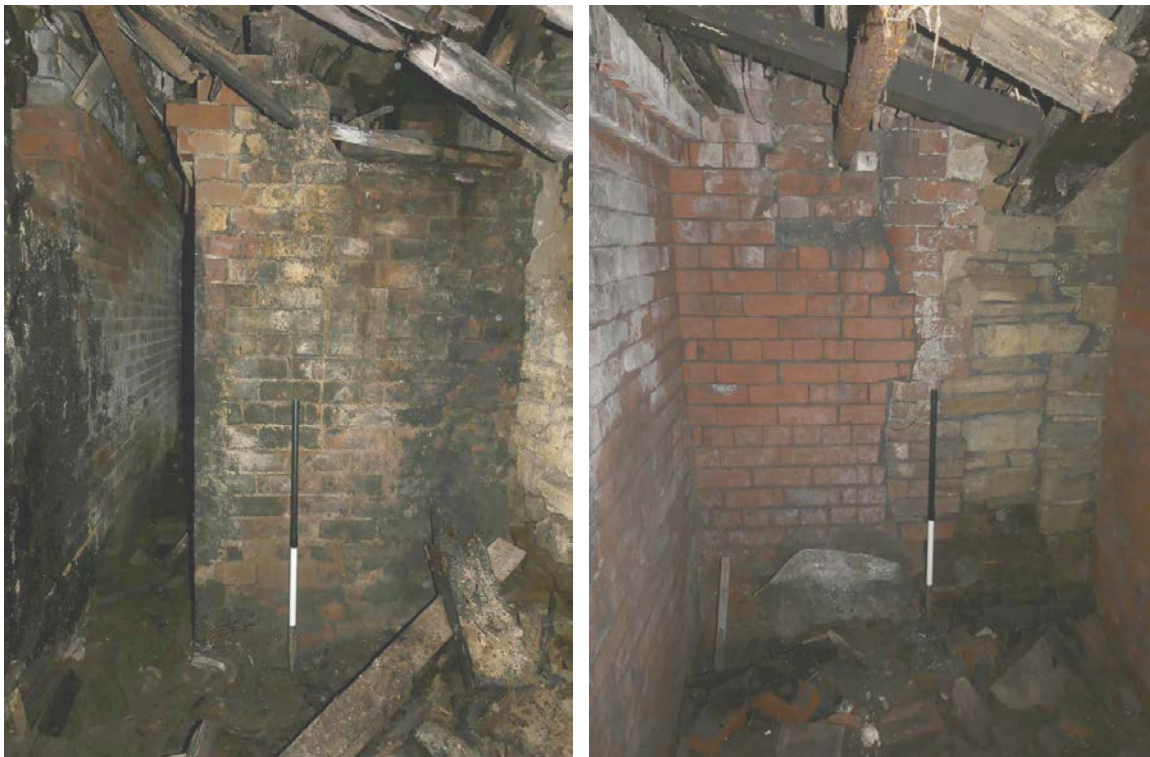
Plate 105 (left): Brick return at the north-east end of the south-east elevation of the north-east end room (lower floor) of the mill building, Area D

Plate 106 (right): Brick in-fill and blocked door at the north-east end of the south-east elevation of the north-east end room (lower floor) of the mill building, Area D

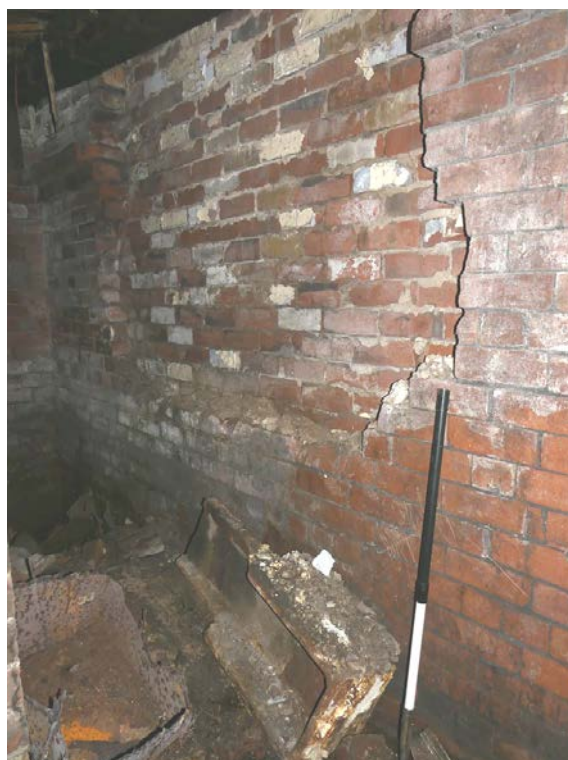
Plate 107: Ragged hole in the north-east elevation of the north-east end room (lower floor) of the mill building, Area D

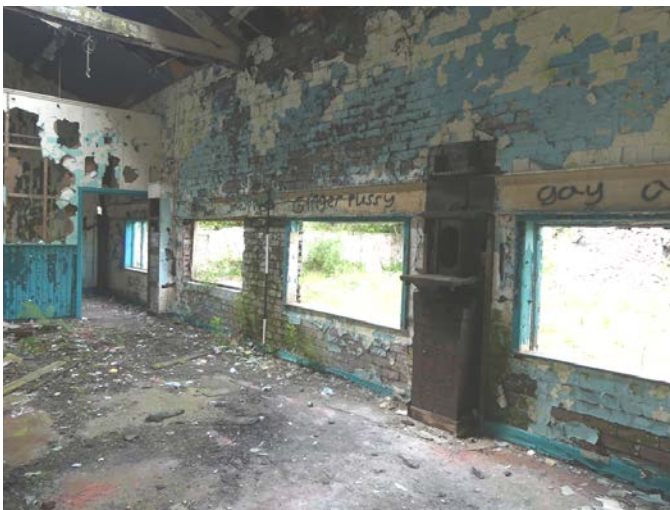
Plate 108 (left): South-west end of the north-west elevation of the north-east end room (upper floor) of the mill building, Area D

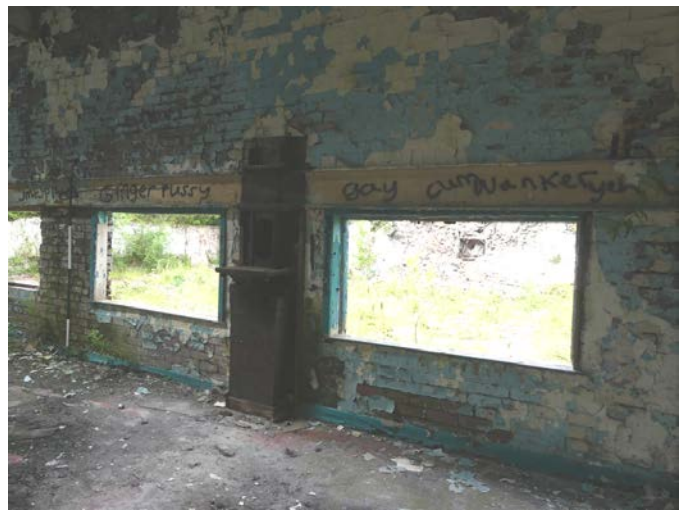
Plate 109 (right): North-east end of the north-west elevation of the north-east end room (upper floor) of the mill building, Area D

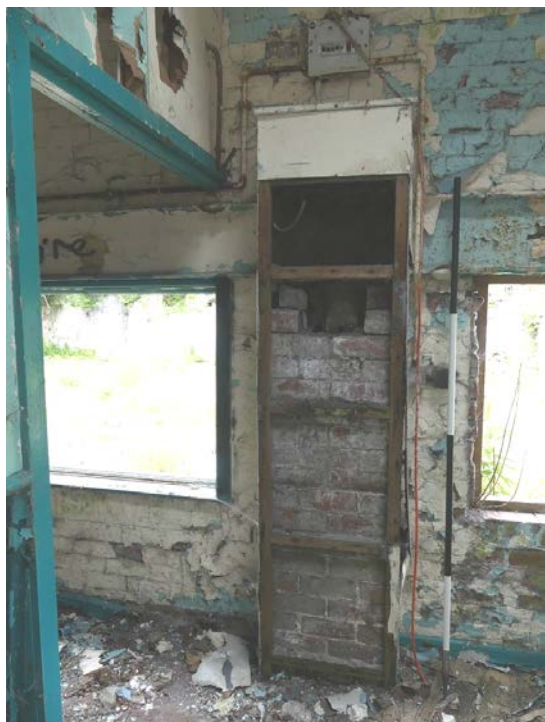
Plate 110 (left): South-west buttress on the north-west elevation of the north-east end room (upper floor) of the mill building, Area D

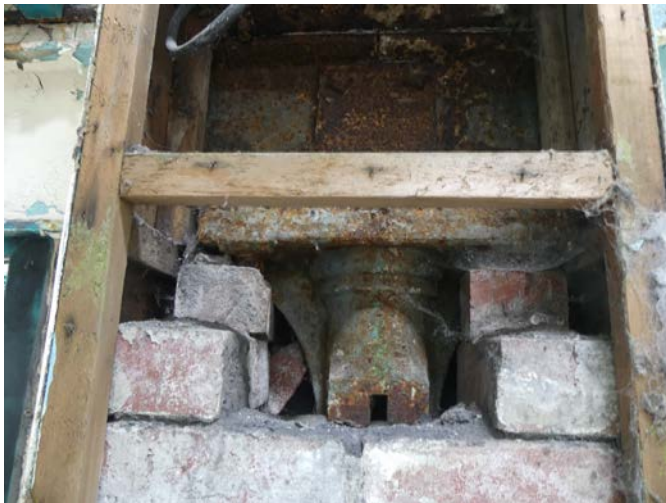
Plate 111 (right): Iron column clad round by the south-west buttress, north-east end room (upper floor) of the mill building, Area D

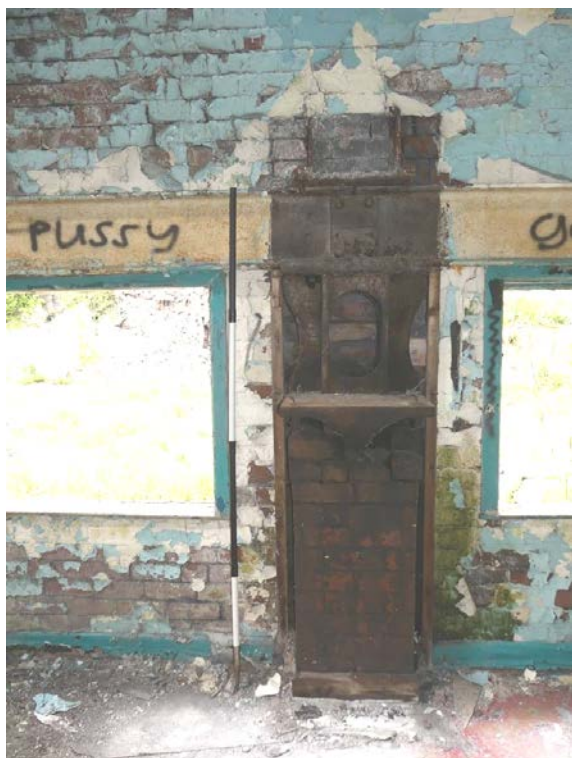
Plate 112 (left): North-east buttress on the north-west elevation of the north-east end room (upper floor) of the mill building, Area D

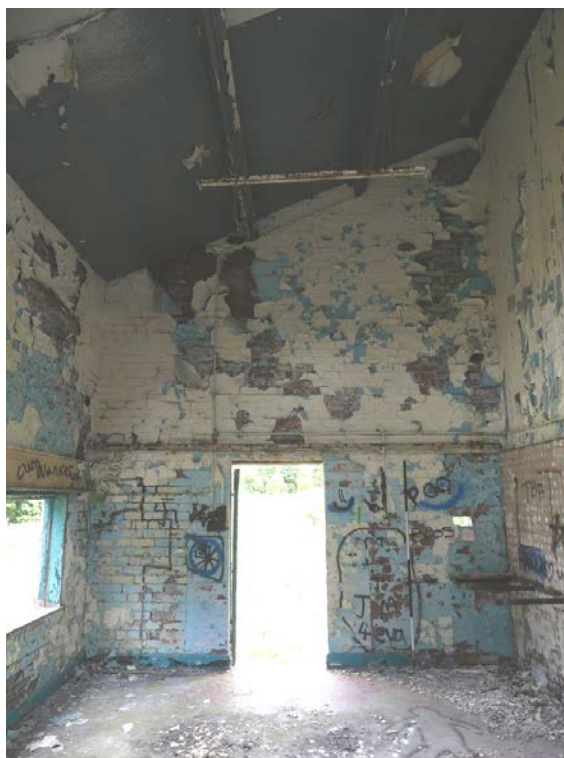
Plate 113 (right): North-east elevation of the north-east end room (upper floor) of the mill building, Area D

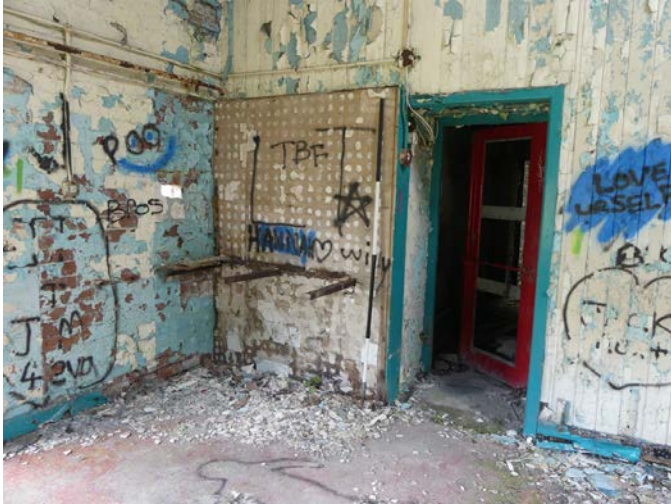
Plate 114 (left): North-east end of the south-east elevation of the north-east end room (upper floor) of the mill building, Area D

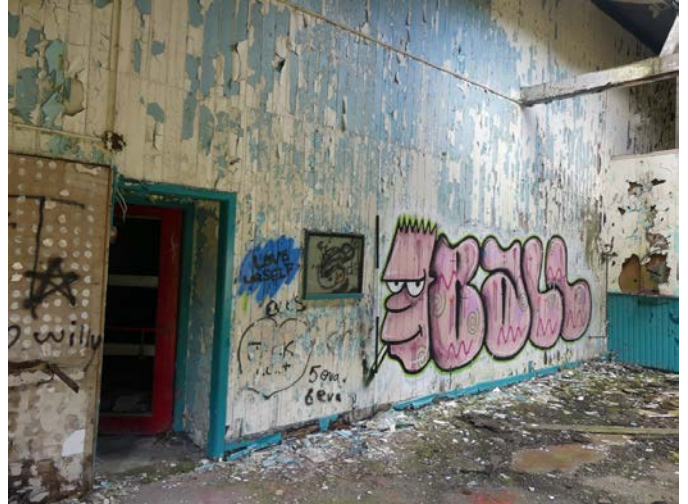
Plate 115 (right): South-west end of the south-east elevation of the north-east end room (upper floor) of the mill building, Area D

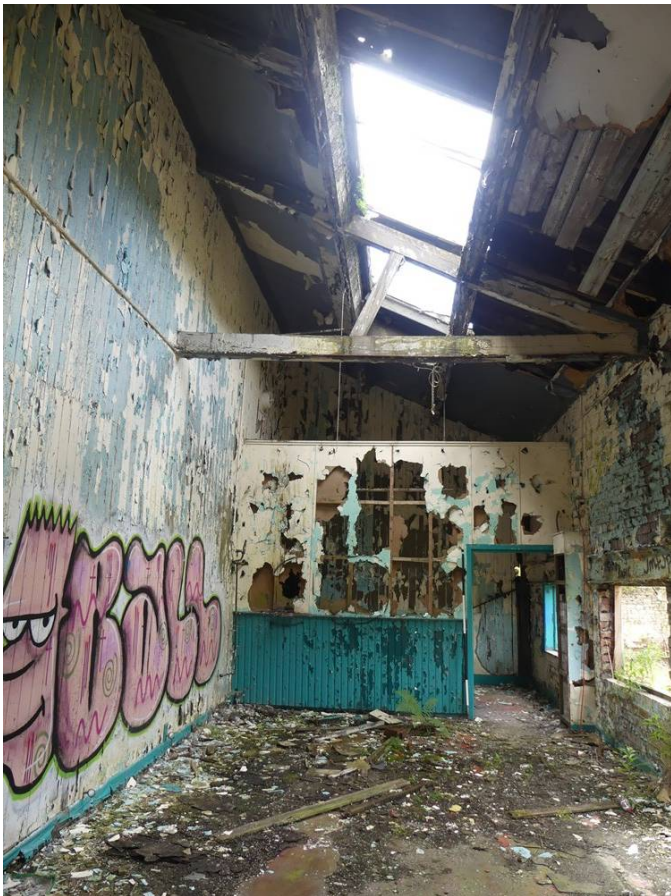
Plate 116 (left): Stud partition to the south-west end of the north-east end room (upper floor) of the mill building, Area D

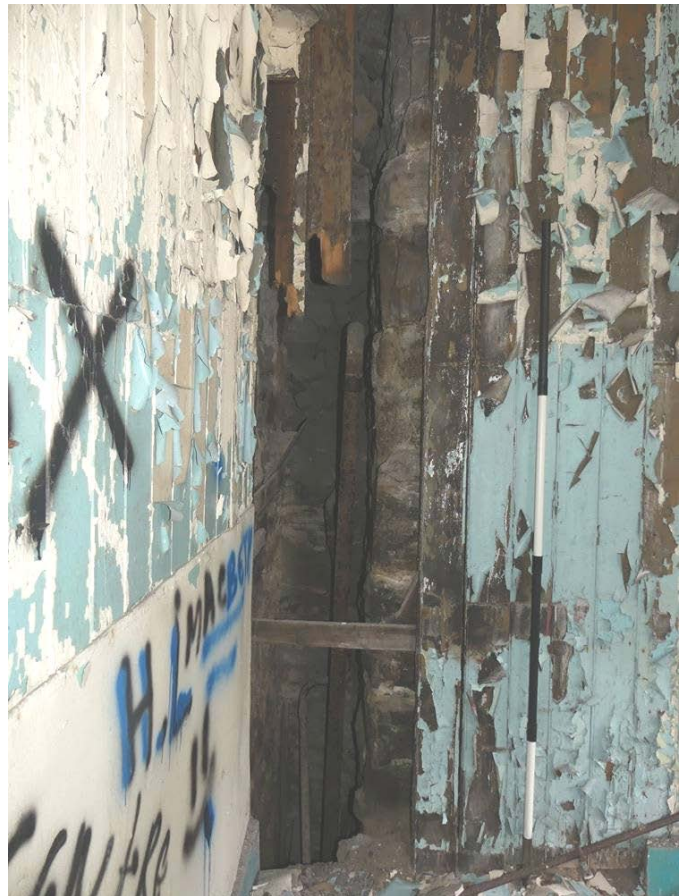
4.5.7 **Upper floor, north-east end room:** the upper floor has a concrete floor and is open to the mono-pitch roof, clad with boards, with a half-truss with angled brace. The walls are mostly painted brick with plain skirting. It is basically a single room but is subdivided on the south-west side by a stud partition (Plate 116). The **north-west** elevation has four windows, with some frame with a moulded edge remaining in the south-west one (Plate 108 and Plate 109). There is a pair of brick buttresses, one at either end of the room, the one to the south-west is clad round an iron column supporting I-beams forming lintels to the windows (Plate 110 and Plate 111). The north-east column is below a brace for the beam (Plate 112). The **north-east** elevation is plain apart from a central doorway (Plate 113). The east corner of the **south-east** elevation is clad with board and brackets for shelves and tongue and groove boards to the south-west over the rest (Plate 114 and Plate 115). The **south-west** elevation is also boarded over but there is a large void exposed on the south-east side with the corner of the building to the south-west exposed (Plate 117).

Plate 117 (right): Void to the south corner of the north-east end room (upper floor) of the mill building, Area D

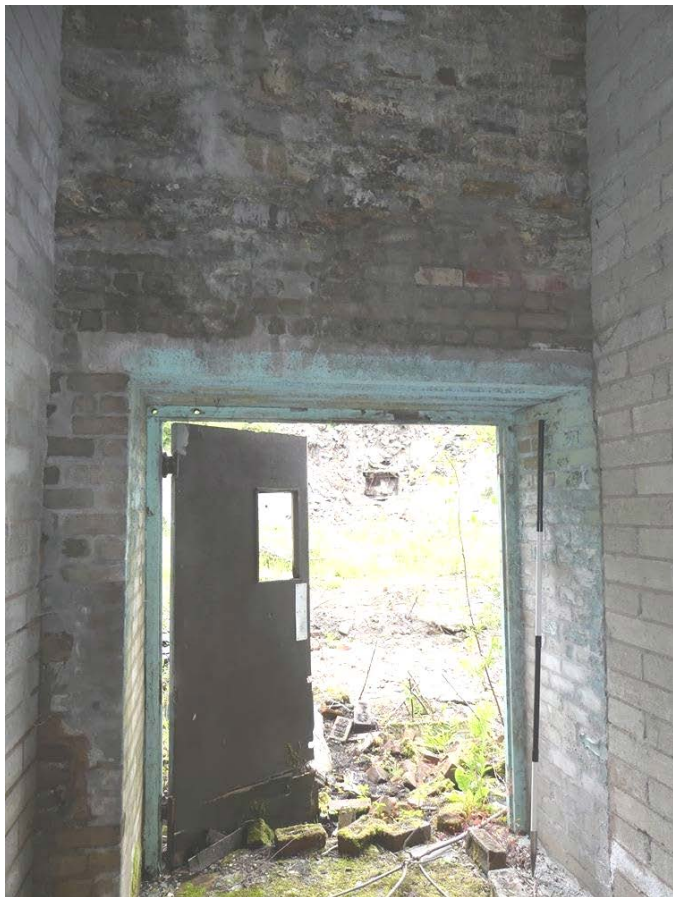
south-east ends. The **north-west** elevation is just a large doorway with a concrete lintel and rebuild over, with the remains of a 20th century double door present (Plate 118). The south-east elevation is handmade brick and the bond is not clear (Plate 119). The lower part is collapsing and includes firebricks. There is a butt joint return with old and new concrete block in the **south-east** elevation.

Plate 118 (left): North-west elevation of the centre room of the mill building, Area D

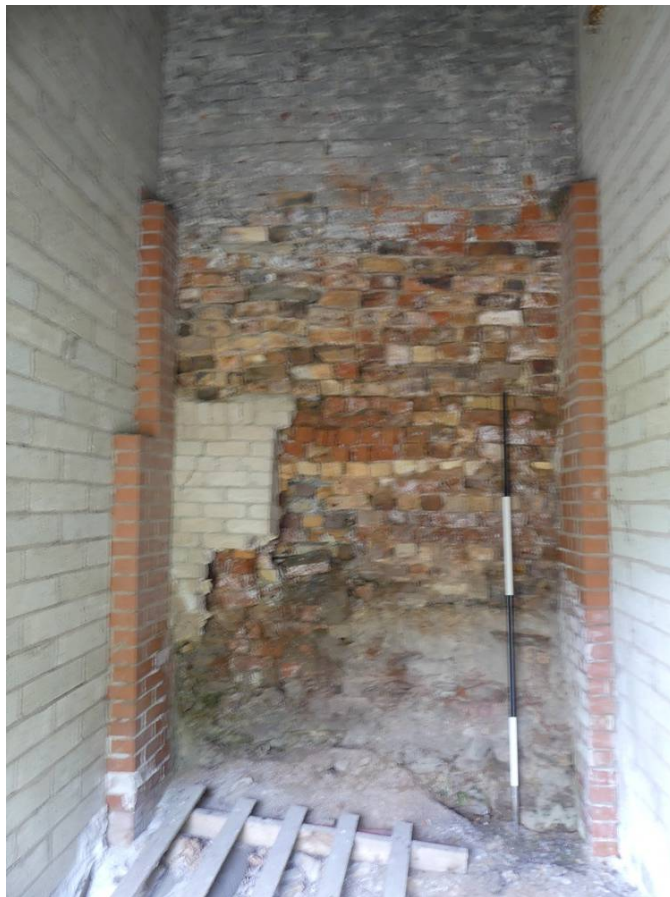
Plate 119 (right): South-east elevation of the centre room of the mill building, Area D

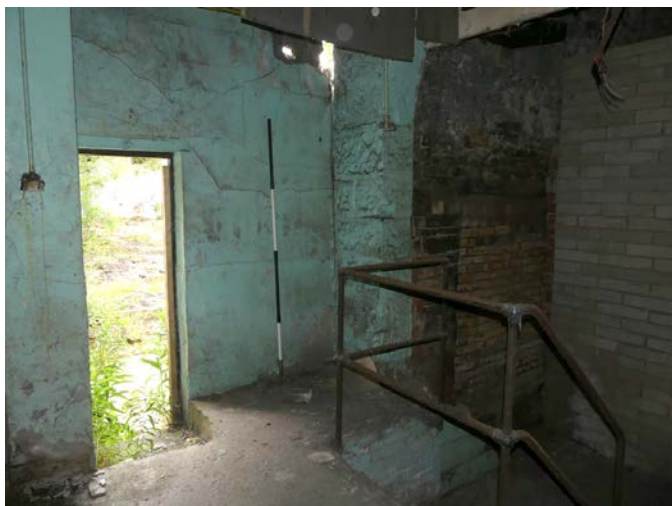
4.5.9 **South-west end room:** this room has a concrete floor and concrete steps on a concrete block going down to the north-east with an iron handrail (Plate 120). There is an inserted flat ceiling, with the roof visible above with half-trusses with angled braces as per the north-east end of the mill. There is a projecting stone column in the centre of the **north-west** elevation and plinth to the north-east (Plate 126). The elevation has some brick to the north-east side, and there is brick blocking a doorway with no lintel at that end, but the elevation is otherwise stone (Plate 121). The **north-east** elevation essentially just comprises a blocked opening, filled with concrete blocks. There is a brick column to the south-east end (Plate 122). The **south-east** elevation returns after the column and there is a further return in stone, with concrete cladding, and iron steps up to a raised area of concrete blocks at the south end of the room with metal shelving on top (Plate 123 to Plate 127). There is a blocked doorway with concrete blocks at the south-west end of the elevation, which is early brick beneath plaster (Plate 124).

Plate 120 (left): North-east end of the north-west elevation of the south-west end room of the mill building, Area D

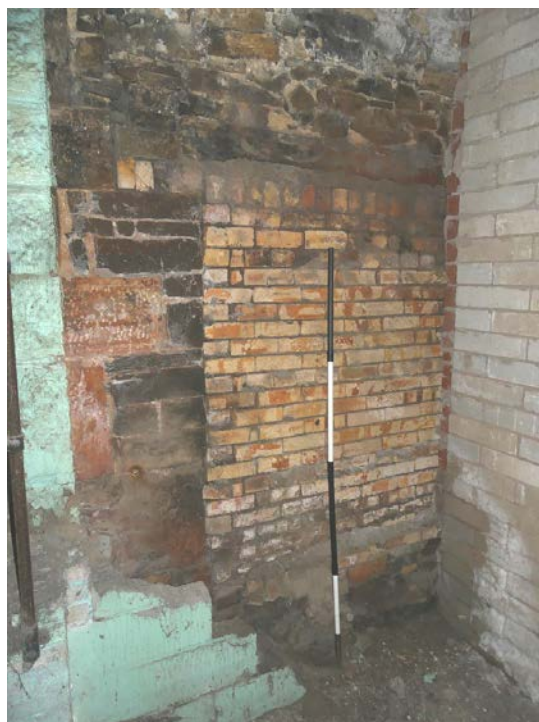
Plate 121 (right): Brick in the north-east end of the north-west elevation of the south-west end room of the mill building, Area D

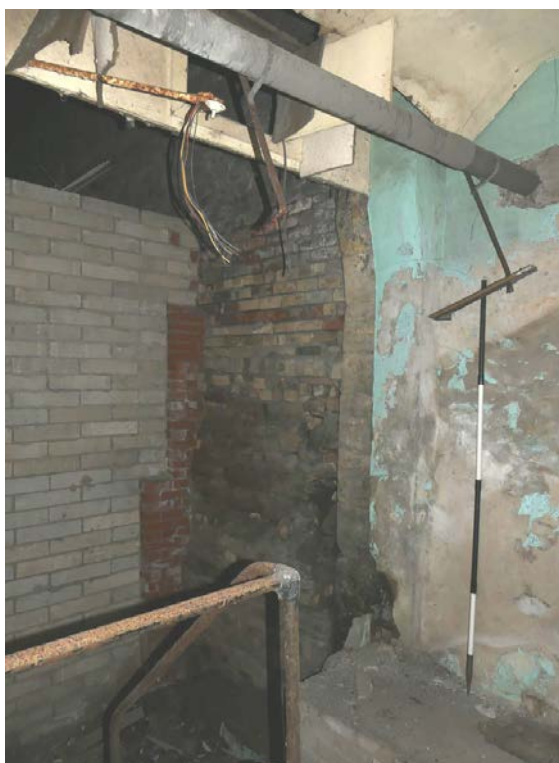
Plate 122 (left): North-east end of the south-east elevation of the south-west end room of the mill building, Area D

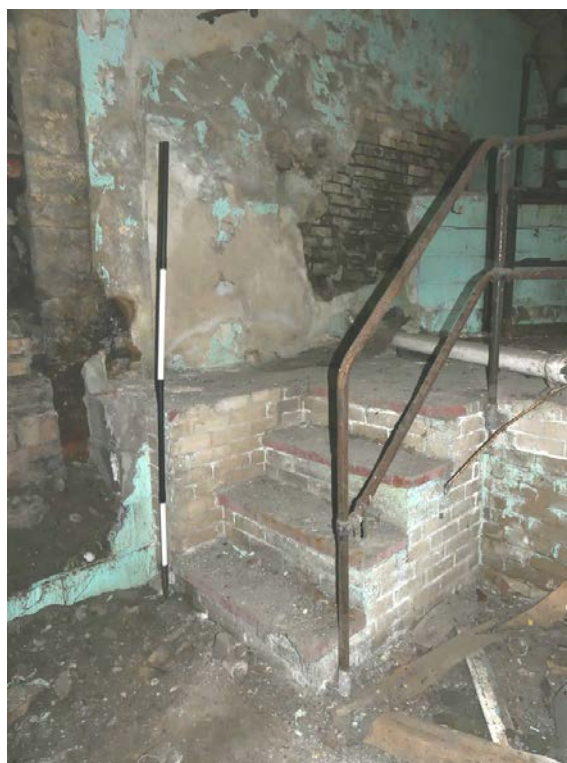
Plate 123 (right): Stairs from the north-east to the south-west ends of the south-west end room of the mill building, Area D

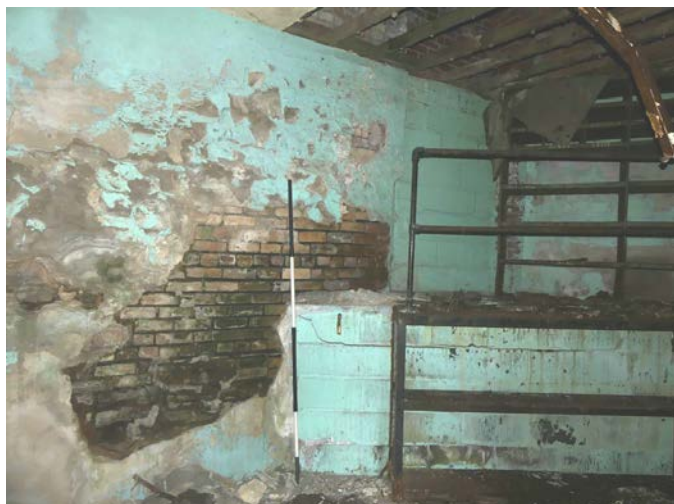
Plate 124 (left): South-west end of the south-east elevation of the south-west end room of the mill building, Area D

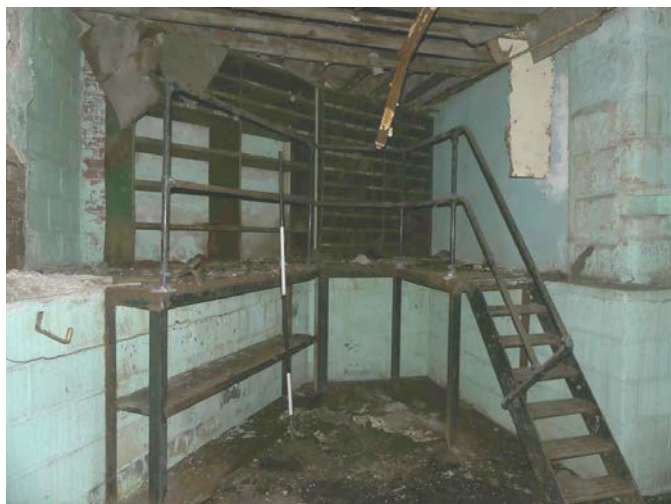
Plate 125 (right): Shelving to the south end of the south-west end room of the mill building, Area D

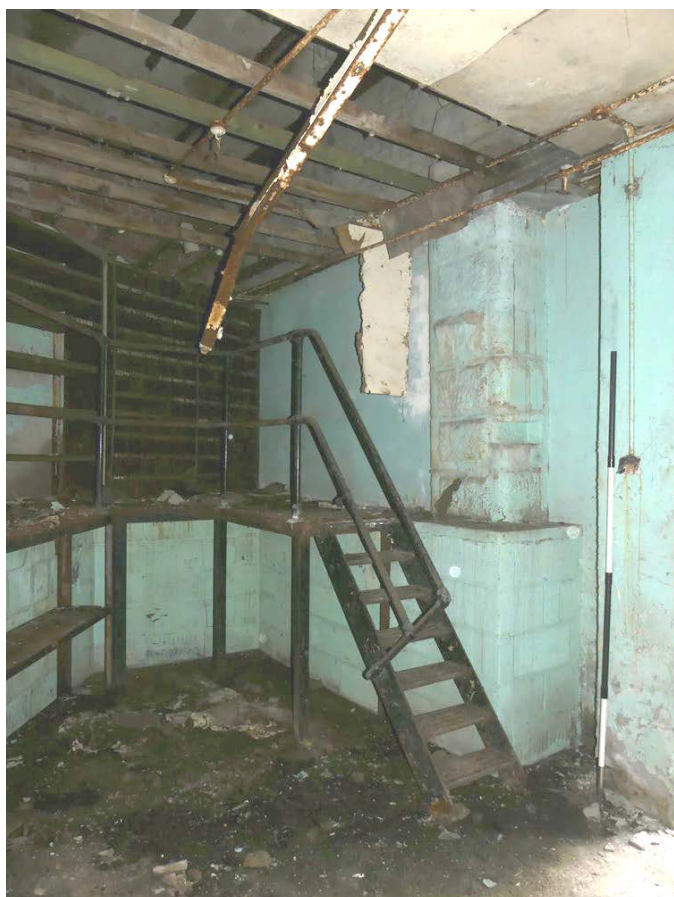
Plate 126 (left): South-west end of the north-west elevation of the south-west end room of the mill building, Area D

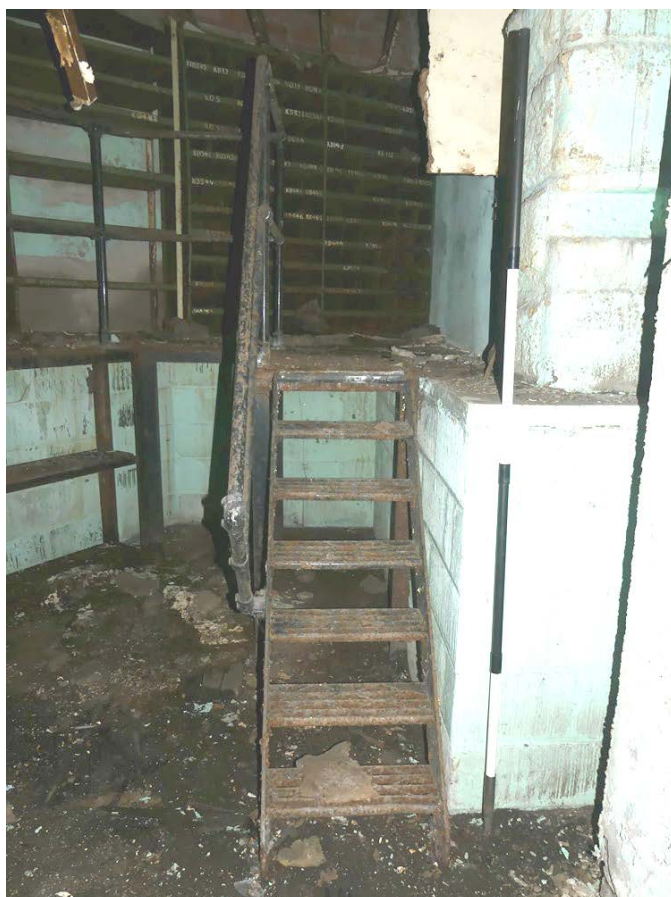
Plate 127 (right): Detail of the metal stairs to the south end of the south-west end room of the mill building, Area D

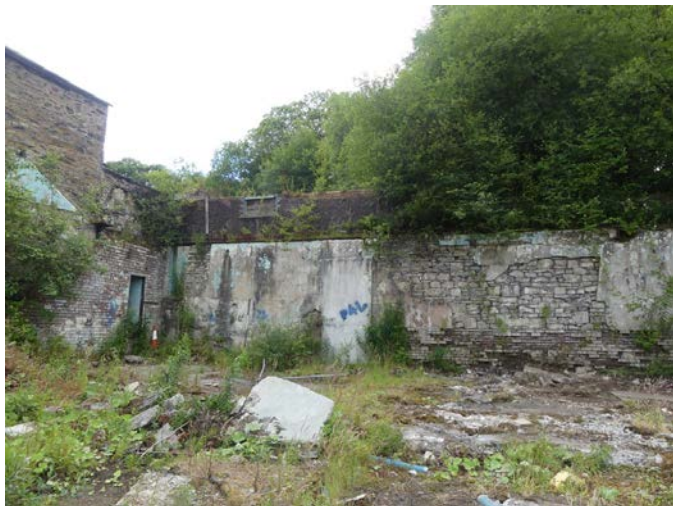
4.6.1 **South-west elevation of the courtyard (north-east facing):** this elevation is mostly of stone construction but the centre is brick, covered by remains of concrete render (Figure 10; Plate 128 to Plate 130). There is a blocked doorway with quoins in the jambs south-east of centre (Plate 131) and a high-level doorway at the south-east end. The high-level doorway has a plain surround and lintel formed by an iron plate extending the length of the wall, with a brick wall stepped back above. There is a small window on the south-east side and at least two beam girder ends projecting.

Plate 128 (left): South-east end of the south-west elevation of the courtyard/open area, Area E

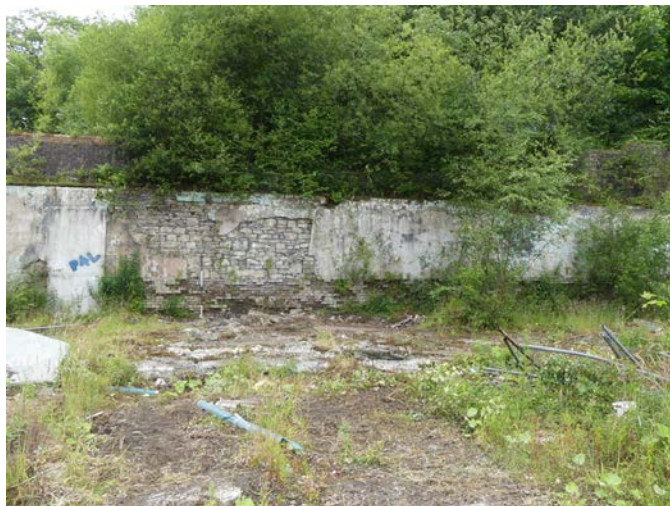
Plate 129 (right): Central section of the south-west elevation of the courtyard/open area, Area E

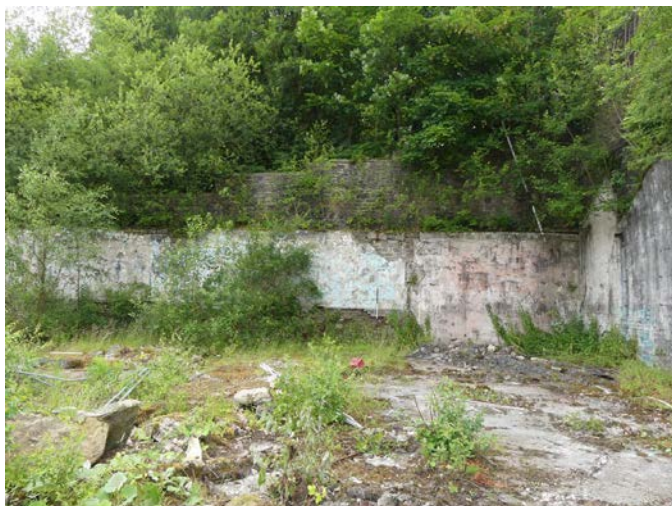
Plate 130 (left): North-west end of the south-west elevation of the courtyard/open area, Area E

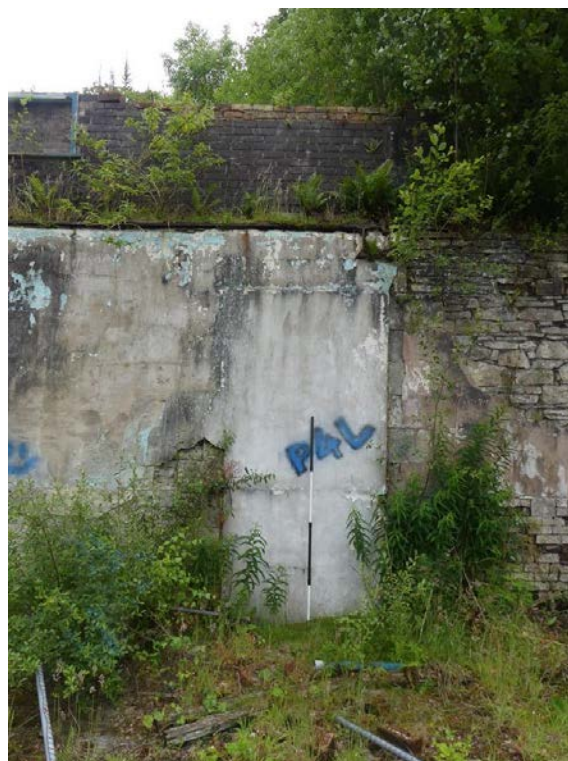
Plate 131 (right): Detail of blocked door in the south-west elevation of the courtyard/open area, Area E

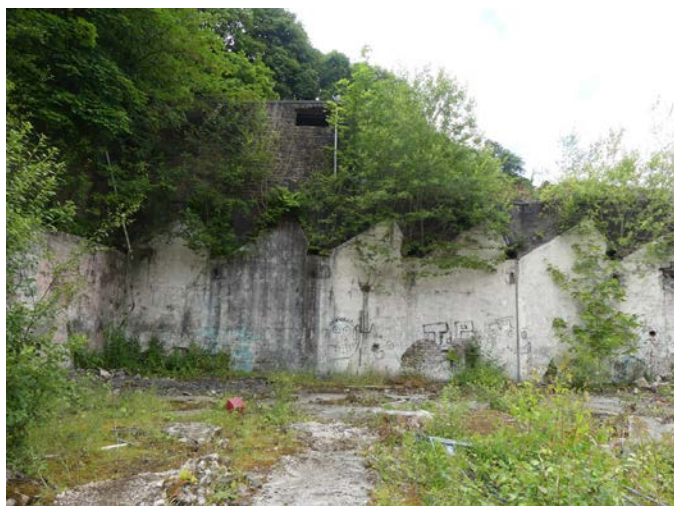
4.6.2 North-west elevation of the courtyard (south-east facing): the south-west side is covered by render but north-light roof scars leave the brickwork exposed in places (Figure 12; Plate 132). There is a high-level window from the substation (Area C) at the south-west end (Plate 134). A large area of the wall has collapsed in the centre (Plate 133). An iron structure, comprising a girder with mesh on top, is situated between two north-west/south-east wall returns within this collapsed section (see Figure 12). There is a pair of blocked bearing boxes to the north-east (Plate 135) before a return in the wall to the south-east. This return wall extended further south-east originally across what is now open area. North-east of this return is solid concrete mass retaining wall with seven concrete block buttresses (Figure 13; Plate 136 and Plate 137).

Plate 132 (left): South-west end of the north-west elevation of the courtyard/open area, Area E

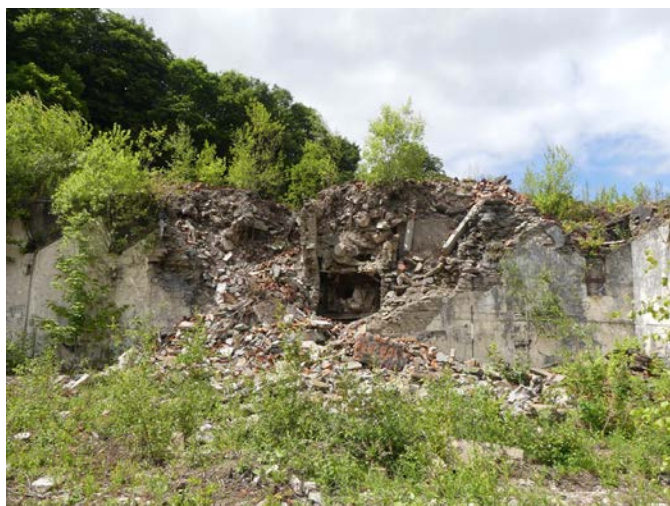
Plate 133 (right): Central section of the north-west elevation of the courtyard/open area, Area E

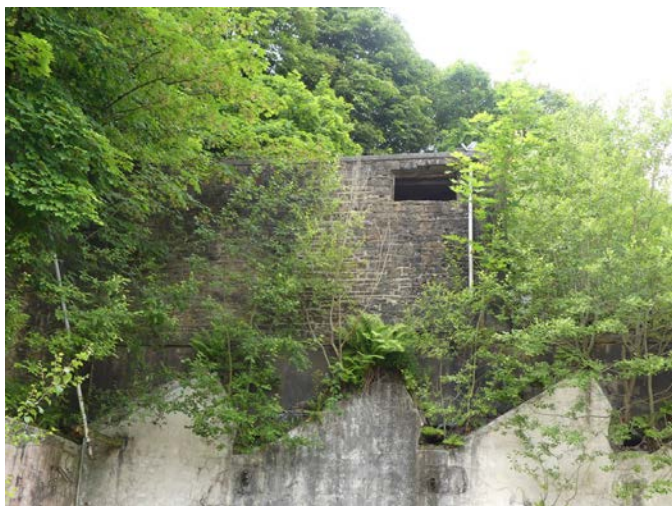
4.4.6 The **south-east** external elevation is plain stone, with some evident re-pointing, and a small high window on the north-east side (visible from Area E; see Plate 134).

Plate 134 (left): High-level window at the south-west end of the north-west elevation of the courtyard/open area, Area E

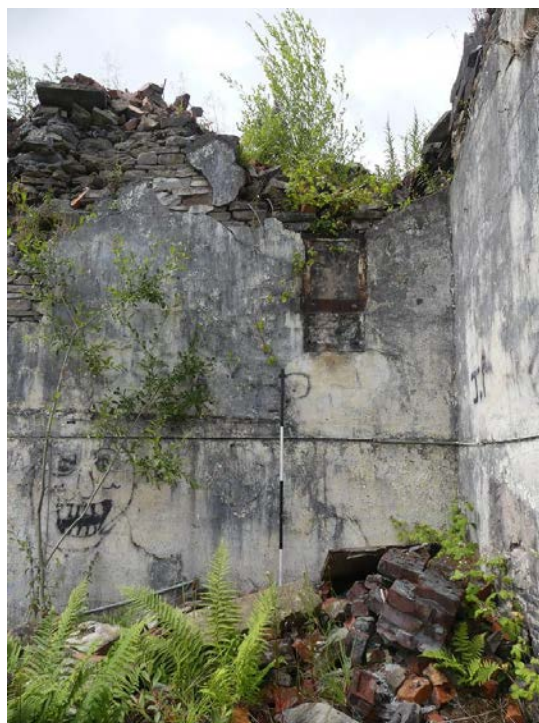
Plate 135 (right): Bearing boxes on the north-west elevation of the courtyard/open area, Area E

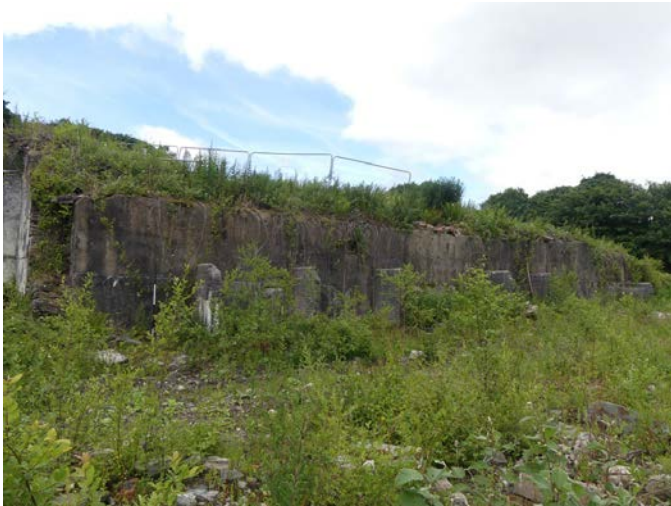
Plate 136 (left): South-west end of the concrete retaining wall to the north-west side of the courtyard/open area, Area E
