HODDLESDEN MILL, HODDLESDEN, DARWEN, LANCASHIRE

Archaeological Building Recording, Evaluation and Strip, Map and Record

Client: Kingswood Homes

September 2022

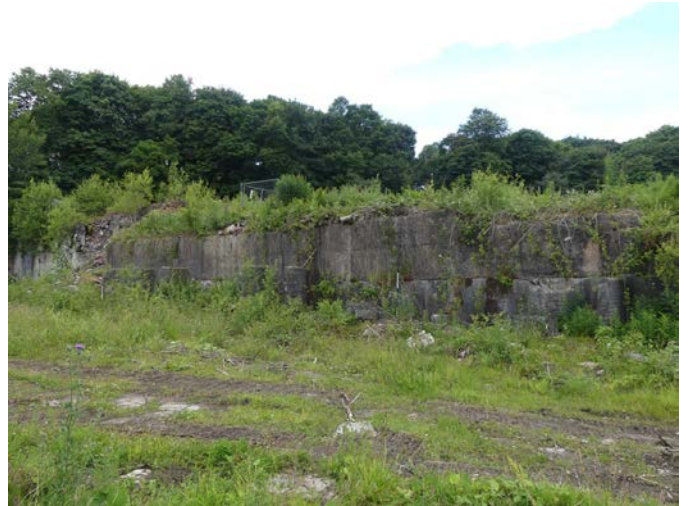
Plate 137 (right): North-east end of the concrete retaining wall to the north-west side of the courtyard/open area, Area E

4.6.2 North-west elevation of the courtyard (south-east facing): the south-west side is covered by render but north-light roof scars leave the brickwork exposed in places (Figure 12; Plate 132). There is a high-level window from the substation (Area C) at the south-west end (Plate 134). A large area of the wall has collapsed in the centre (Plate 133). An iron structure, comprising a girder with mesh on top, is situated between two north-west/south-east wall returns within this collapsed section (see Figure 12). There is a pair of blocked bearing boxes to the north-east (Plate 135) before a return in the wall to the south-east. This return wall extended further south-east originally across what is now open area. North-east of this return is solid concrete mass retaining wall with seven concrete block buttresses (Figure 13; Plate 136 and Plate 137).

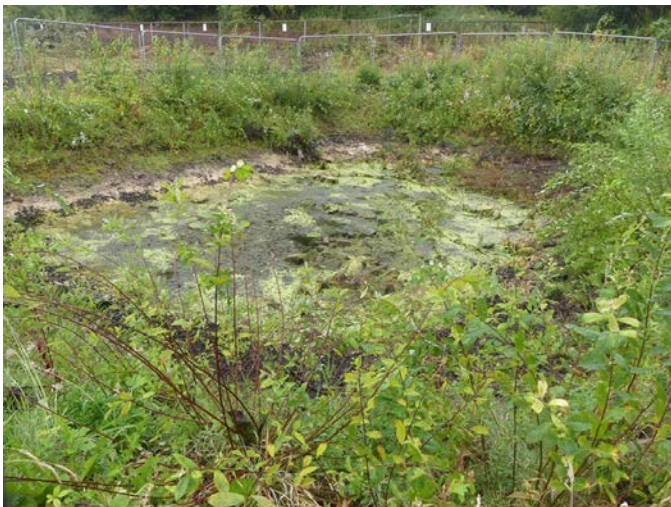
4.7.1 This area comprised a smaller rectangular reservoir or pond of brick construction but lined with concrete, the remains of another to the south, comprising part of one wall, and the mill leat running approximately north/south towards the mill buildings (Area D). The leat was constructed from stone walls with stone sett lining inside.

Plate 138 (left): The intact reservoir, viewed from the west

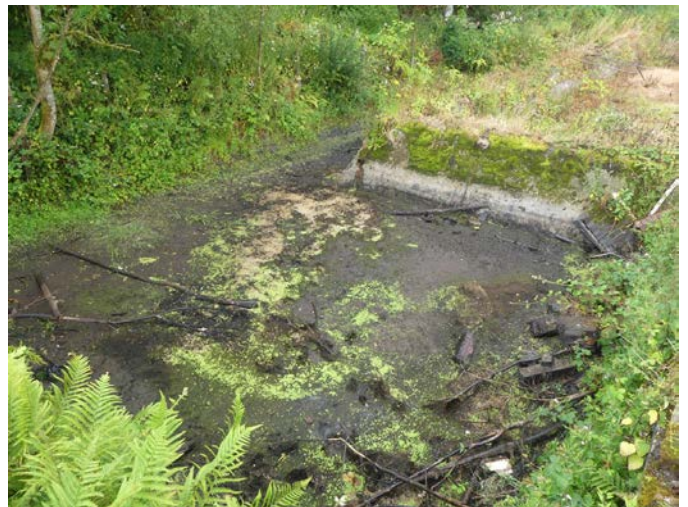
Plate 139 (right): The intact reservoir, viewed from the north-west

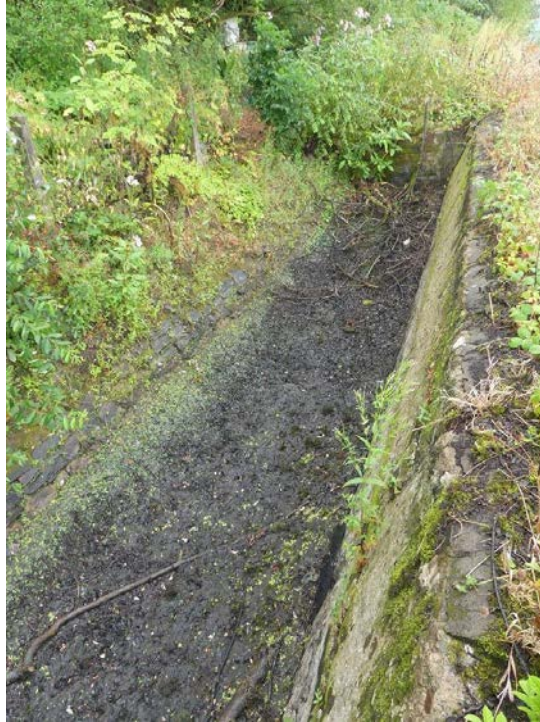
Plate 140: The leat, viewed from the north-west

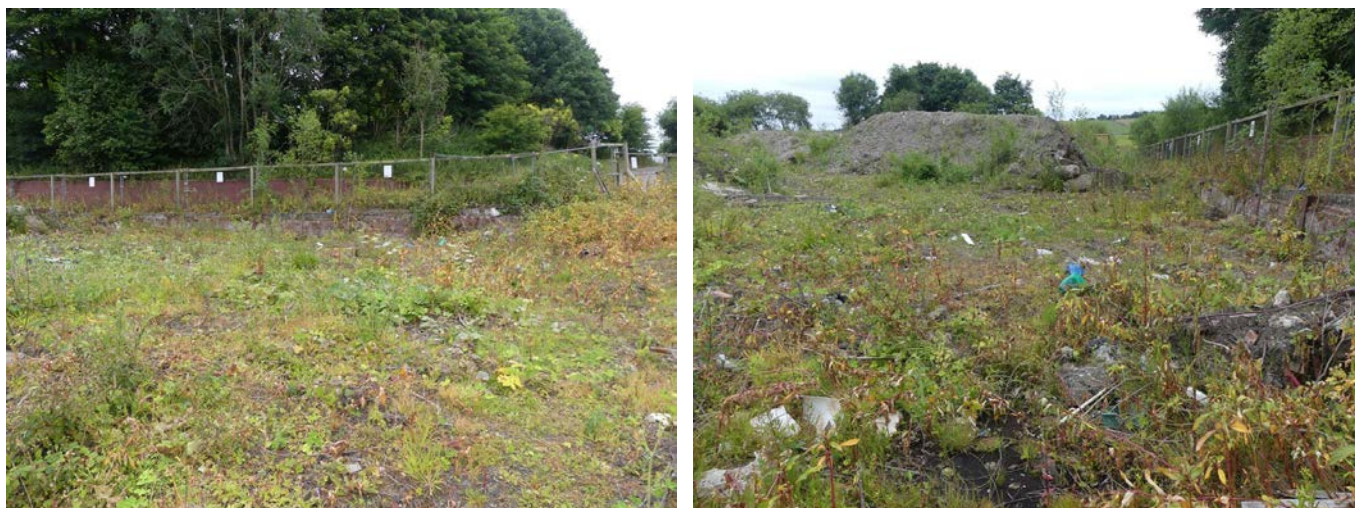
Plate 141 (left): Pre-excitation view of the location of Trench 1, viewed from the west

Plate 142 (right): Pre-excitation view of the location of Trench 1, viewed from the south-west

5.1.2 Trench 1 targeted the possible line of the mill leat and was located close to one of the boundary walls (Plate 141 and Plate 142) within the footprint of 20th century mill buildings (see Figure 3). Trench 2 and 3 were intended to cross the edge of the mill pond. Trench 2 was also within the footprint of 20th century mill buildings, but Trench 3 (Plate 143) was within the footprint of late 19th century mill buildings (see Figure 3). Trench 4 was located within what is now a large open area on the south side of the site (Plate 144 and Plate 145), which was within the footprint of the late 19th century mill buildings but also across the footprint of the earlier 19th century building. Within this area two additional small trenches were excavated, intended to reveal the extent and nature of any early remains relating to the mill site.

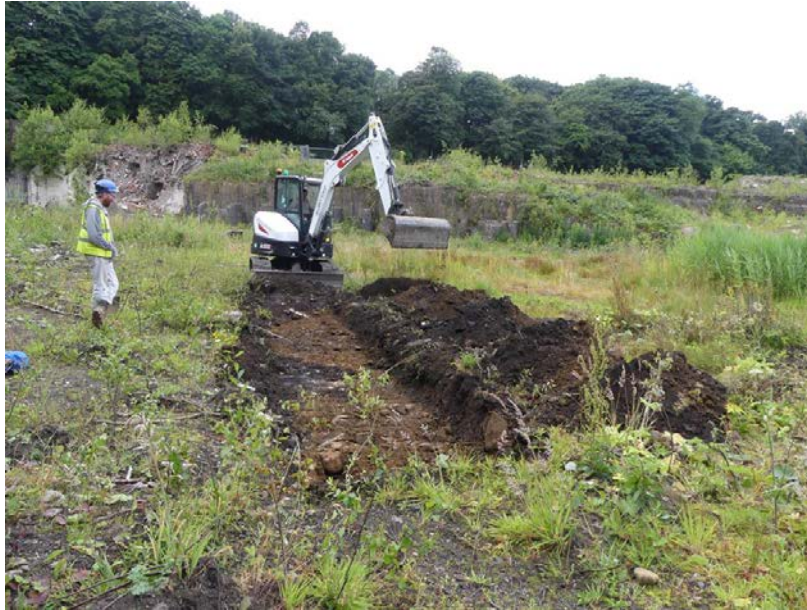
Plate 143: Working shot (Trench 3)

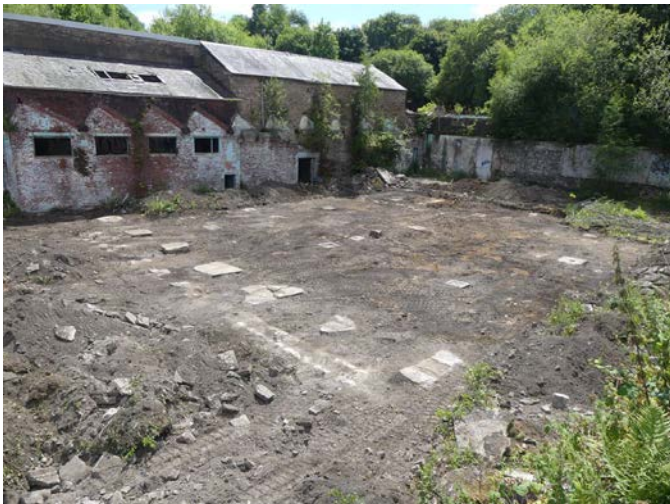
Plate 144 (left): General view of Trench 4 from the north

5.2.4 **Trench 4:** this trench comprised a larger open area (Figure 18). Across it was a 0.2m to 0.3m thick disturbed silty deposit (**400**), containing angular cobbles and boulders, concrete slabs, brick, ironwork, and modern refuse material. Below this, a sandy/ashy clay bedding material (**429**) for the former floor surface was encountered across the area, although very disturbed in places. Two test trenches were excavated through bedding material (**429**) to the natural (**435**). The natural (**435**), exposed in these additional trenches, was a mid-orange sandy clay and gritstone bedrock, with some fragmented, shale-like bedrock in the north-east trench. Across the area a range of structures were encountered. Along the north edge was a north-west/south-east aligned wall (**401**) (Plate 162 and Plate 163). Immediately to the south-west side of this wall was a stone culvert, the full extent of which was not investigated, which appeared to have been modified (Plate 164 to Plate 166). The original culvert (**433**) was constructed from smaller slabs of stone, and was partially silted-up, below a void, with a soft dark brownish silt (**434**) at the base. This had later been topped with larger and more irregular stones (**402**), bringing it up to the same level as **429**. To the south-west of that and again parallel to wall **401** was a row of pads for iron columns, each comprising a large block of roughly shaped stone (**403** to **409**; see Plate 167 to Plate 173). South-west of that and to the south-east side of the area was a group of four pads, forming a rectangle (**410** to **413**; see Plate 174 to Plate 177). These comprised smaller stones bonded with mortar rather than comprising a single large slab as elsewhere. Excavation of a trench to the west exposed three further pads (**432**; see Plate 178 to Plate 181) of a similar construction roughly in line with the northernmost of the pads in this group, which presumably formed part of the same phase of construction. The central one of this group was badly damaged and the one to the north-west was partly coloured luminous orange. West of that group of four to the south-east side and close to the centre of the area was a pad for a column or a support for a driveshaft (**414**; Plate 182), which may also date from an early phase of the mill. There were multiple additional pads for columns, all comprising dressed blocks with a square recess for the column (**426** still had the iron fixing plate *in situ*) forming three rough rows, from just north of centre, extending to the south-west end (**415** to **417**, **419** to **422**, **424** and **426**; see Plate 183 to Plate 191). To the north-west end of the centre row was a larger, roughly rectangular pad for a column or another driveshaft support (**418**; see Plate 192). Towards the south-west of the area was another north-west/south-east wall, extending across the site, with a possible gap in the centre, although this may have been due to later truncation (**423**; Plate 193 and Plate 194). To the north side and parallel to this wall was a stone culvert (**427**; Plate 195 and Plate 196), the base of which was filled with a soft silt (**430**). South of the wall and against the south-west side of the area was a large circular tank, at least 2m deep (although not fully excavated), the walls comprising well-dressed blocks in regular courses (**425**; see Plate 197 to Plate 201). One side of the feature was exposed, forming a semicircle (the remainder extended outside the area of excavation), the upper edge of which comprised yellow gritstone flags partly cut through by pad **426**. It was filled with an upper deposit of sandy clay with lots of rubble and brick (**428**), below which was a loose, dark ash and clinker deposit more than 2m thick (**431**).

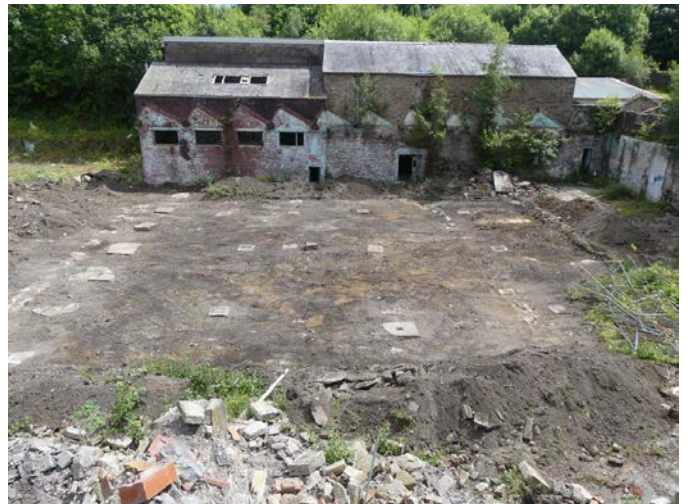
Plate 145 (right): General view of Trench 4 from the north-west

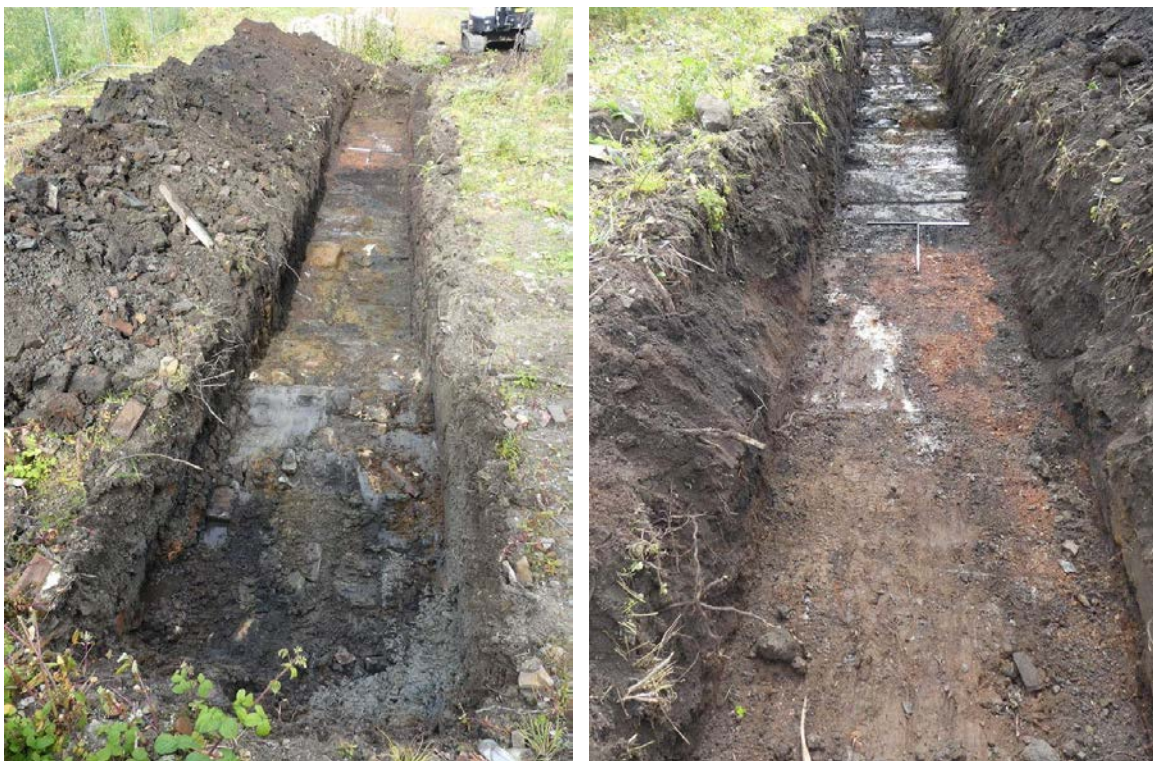
Plate 146 (left): Trench 1 viewed from the east
Plate 147 (right): Trench 1 viewed from the west

5.2.1 **Trench 1:** this trench measured c15.5m long by 1.8m wide and was aligned approximately east/west (Figure 14; see Plate 146 to Plate 150). The sandy-clay natural (**105**) and bedrock was exposed to the east end of the trench only, due to the thickness of overlying deposits, which prevented safe excavation to any greater depth (Plate 149 and Plate 150; Figure 17). The upper deposit, a layer of overburden, was a mix of brick and stone rubble in a dark brown gravelly sand matrix up to 0.5m thick (**100**). Below that, across most of the mid-section of the trench, was a loose dump of ashy sand and other lenses, including re-deposited natural (**101**), at least 0.5m thick. Towards the base of the trench, at the limit of excavation, at a depth of c1.3m, a dark grey silt deposit up to 0.1m thick (**102**) was exposed, which may have been a buried soil horizon. A firm grey clay (**103**) was exposed below the overburden at the east end. This deposit could be a clay lining to the mill leat (**104**). A slot was dug through this deposit with a machine and the bedrock exposed. The re-deposited material to the side, within **101**, perhaps formed a bank to the edge of the leat.

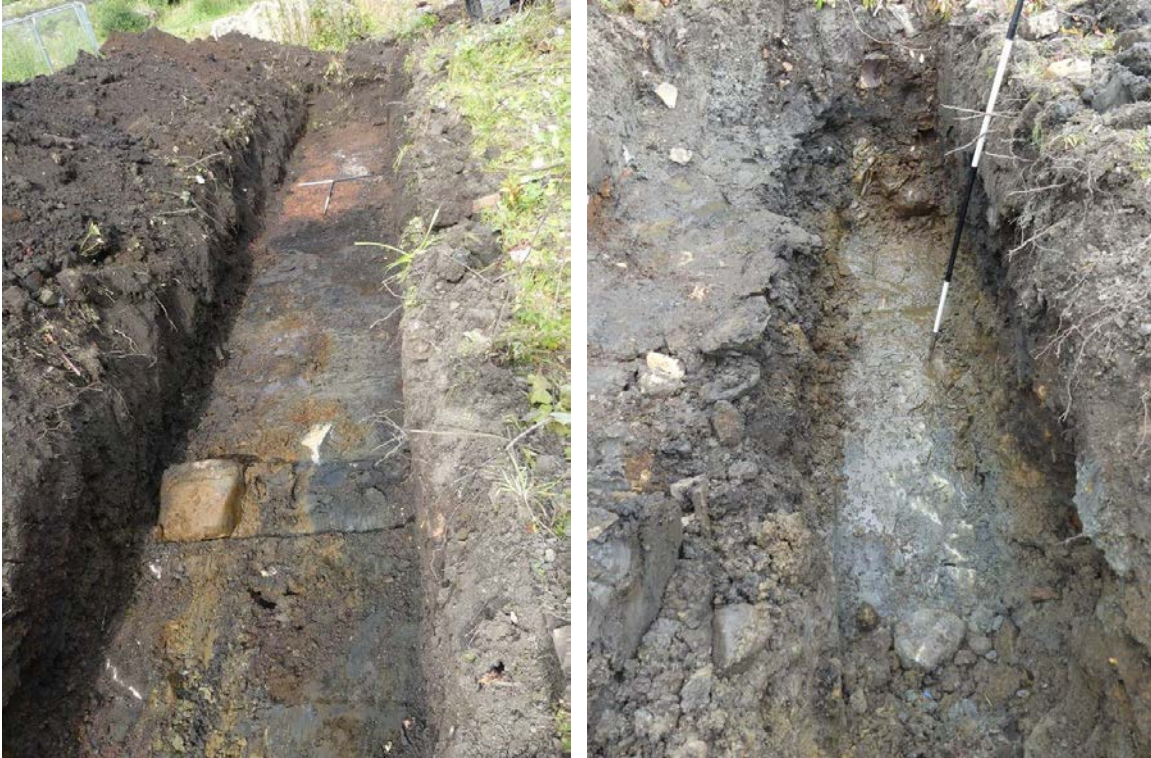
Plate 148 (left): West end of Trench 1, showing various ashy and sandy lenses within 101

Plate 149 (right): Bedrock exposed at the east end of Trench 1

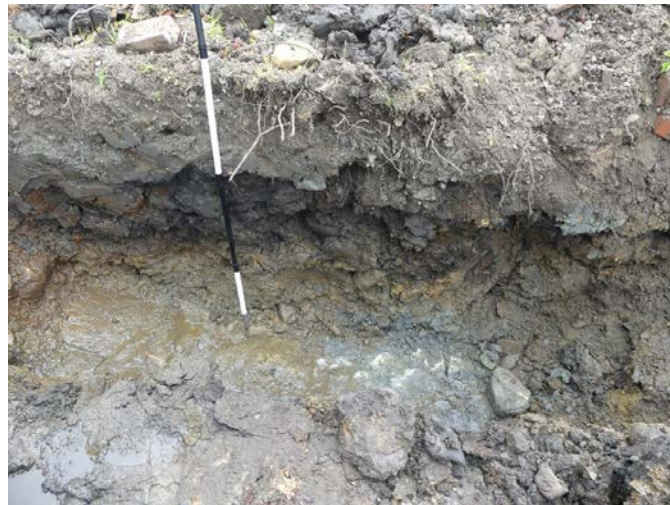
Plate 150: North-facing section of Trench 1

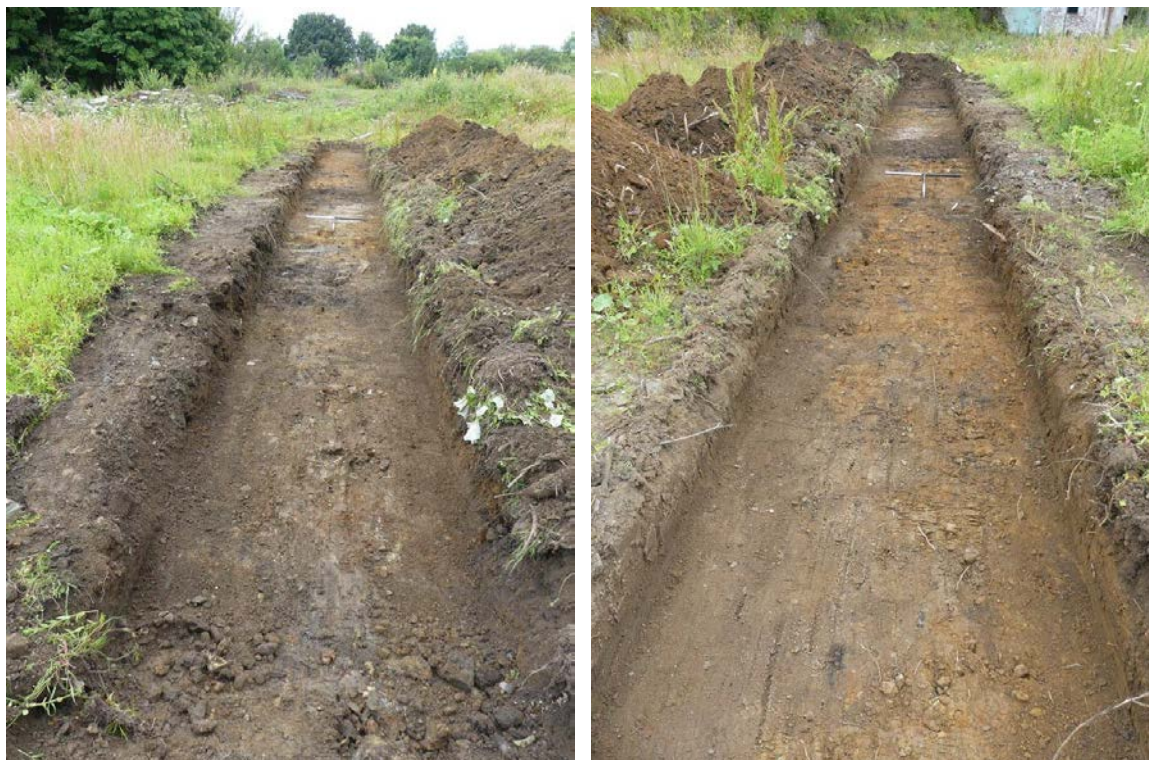
Plate 151 (left): Trench 2 viewed from the south

5.2.2 **Trench 2:** this trench was c21m long by 1.8m wide and orientated approximately north/south (Figure 15). The rooted topsoil (**200**) was a soft, pale brownish-grey silt, c0.1m thick. Below that, across the centre of the trench, was a dump of mottled dark greyish-brown angular cobbles (**201**), below which was a firm grey clay (**202**) filling a very shallow linear cut (**203**) (Plate 151). The natural (**204**) was a firm, mid brownish-orange sandy-clay, with some patches of softer sand (Plate 152).

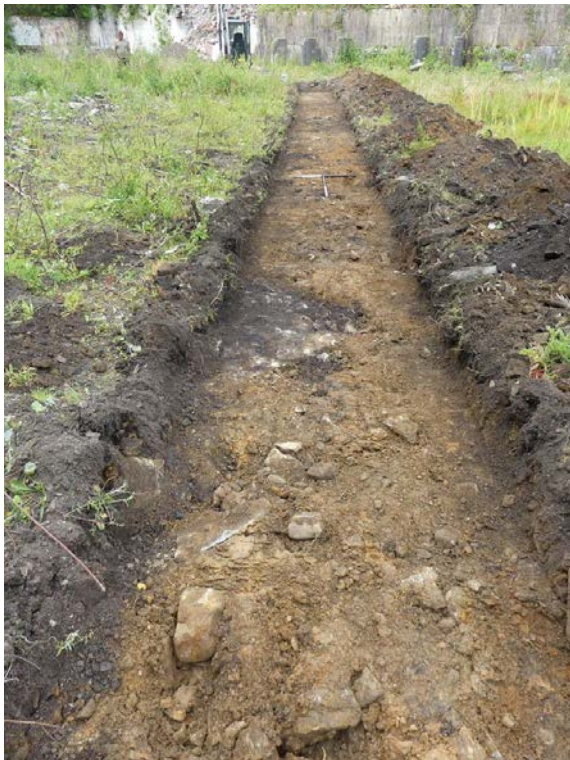
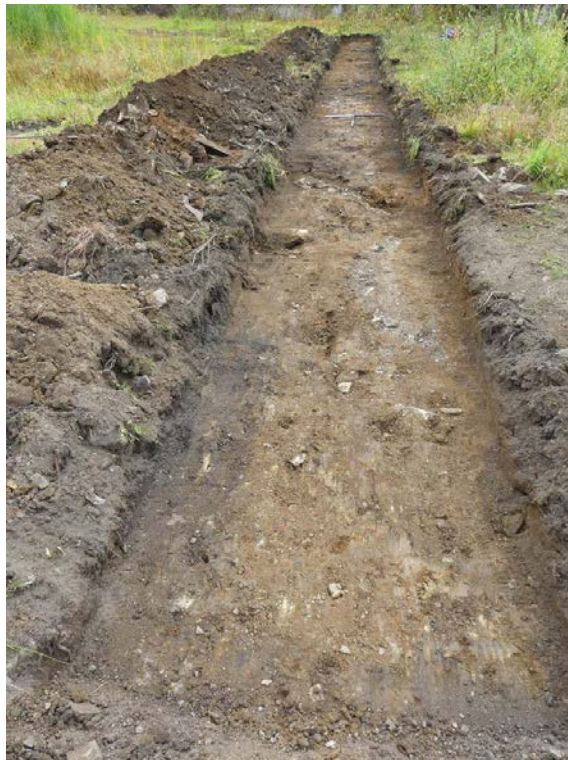
Plate 153 (left): Trench 3 viewed from the north-east

5.2.3 **Trench 3:** this trench was c30m long by 1.8m wide and orientated approximately north-east/south-west (Figure 16; Plate 153 and Plate 154). The topsoil (**300**) was a loose mid greyish-brown silt, less than 0.1m thick. Below that, at the north-east end of the trench, was a stone slab or column base (**301**), comprising rough mortared pieces rather than one large block (Plate 155). South-west of that, close to the centre of the trench on the south-east side was a partly visible pad (**306**) (Plate 156). South-west of that was a spread of pale grey clay (**302**) in a very shallow north-west/south-east cut (**303**) (Plate 157). A third stone pad (**304**) was partly visible to the south-west of this spread of clay (Plate 158). At the south-west end of the trench was a north/south aligned wall (**305**) built from angular gritstone (Plate 159 and Plate 160). The wall was in cut **308**, c0.4m to 0.5m wide and 0.4m deep, cut into the natural (**307**) (Plate 161). The deposit to the south-west of the wall towards the end of the trench may have been re-deposited natural (**309**).

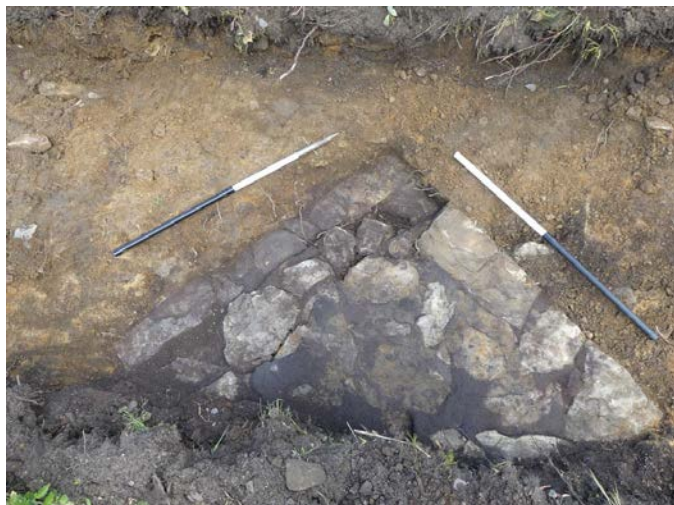
Plate 155 (left): Stone slab or column base 301

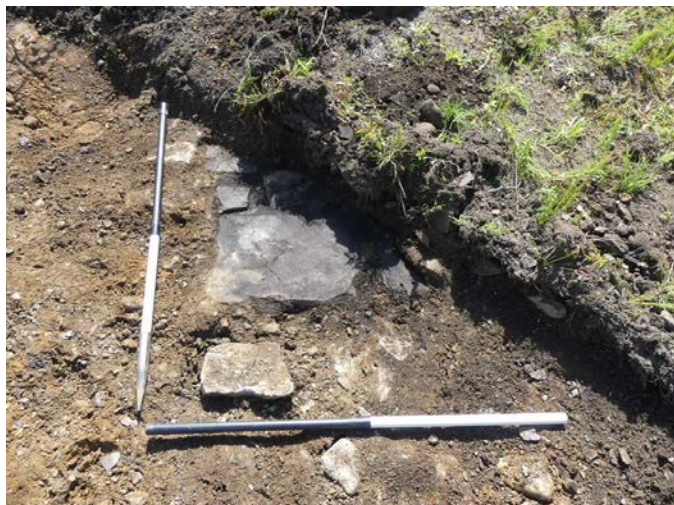
Plate 156 (right): Partly visible pad 306

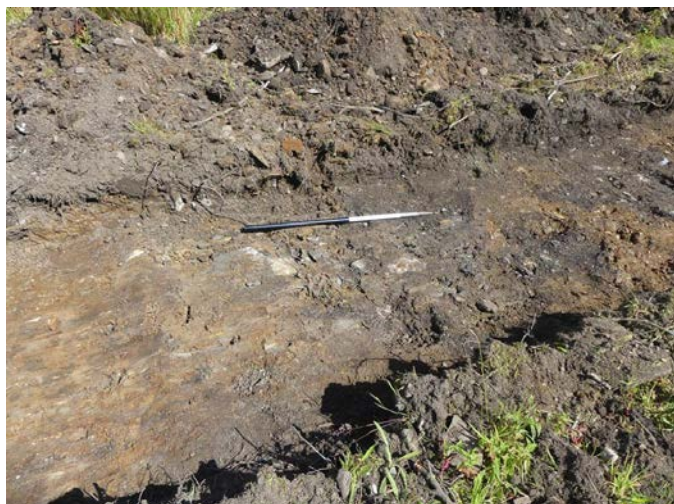
Plate 157 (left): Spread of pale grey clay (302) in Trench 3

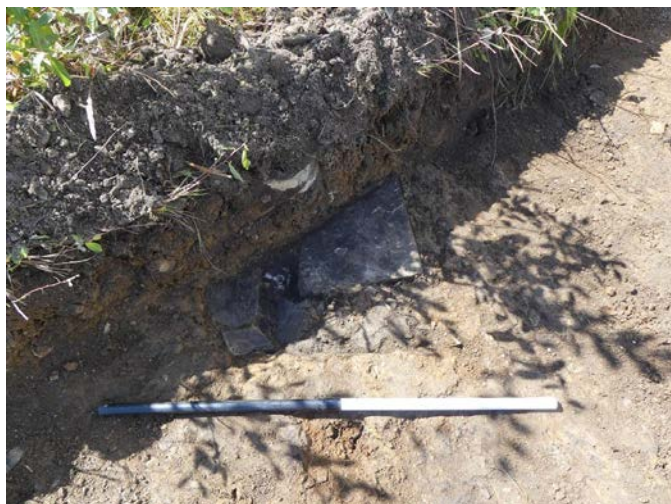
Plate 158 (right): Partly visible pad 304

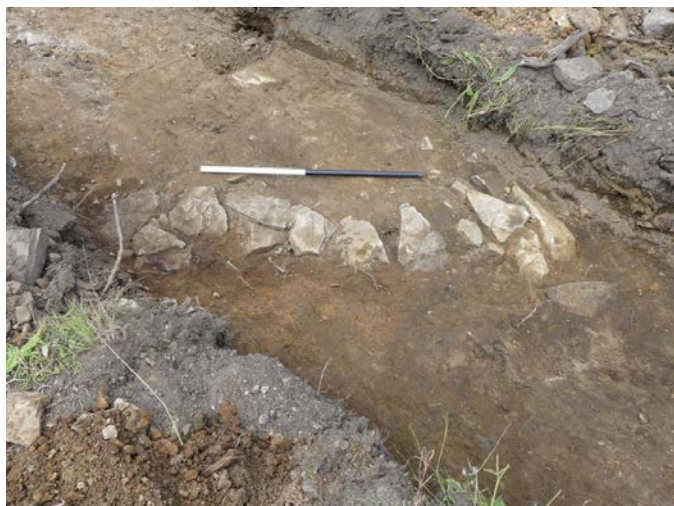
Plate 159 (left): Wall 305 viewed from the east

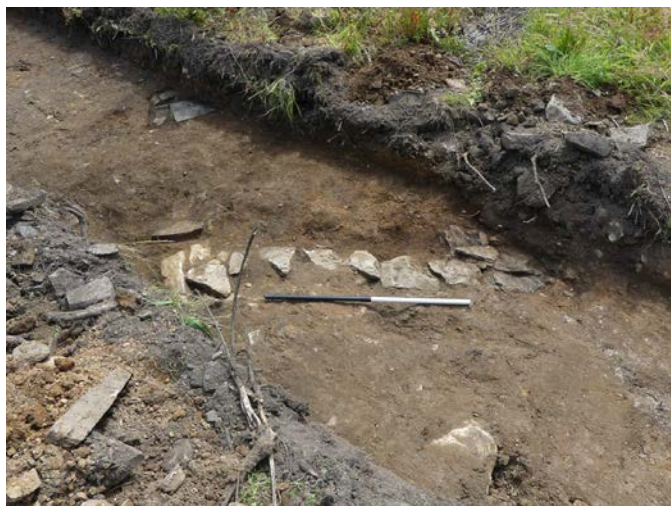
Plate 160 (right): Wall 305 viewed from the west

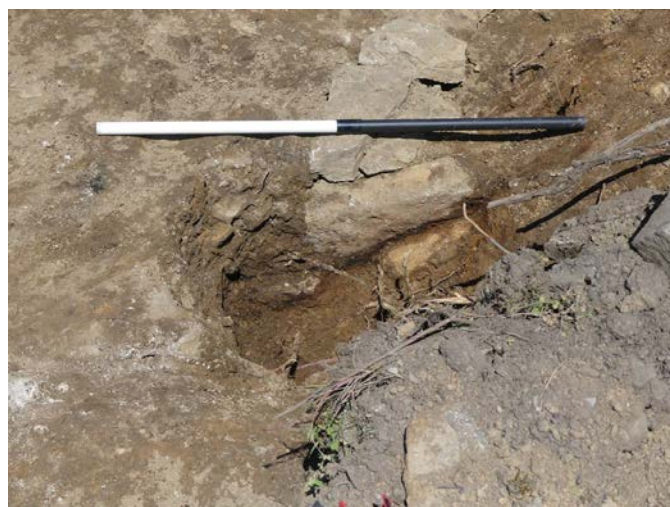
Plate 161: Slot dug through the south end of Wall 305 viewed from the south

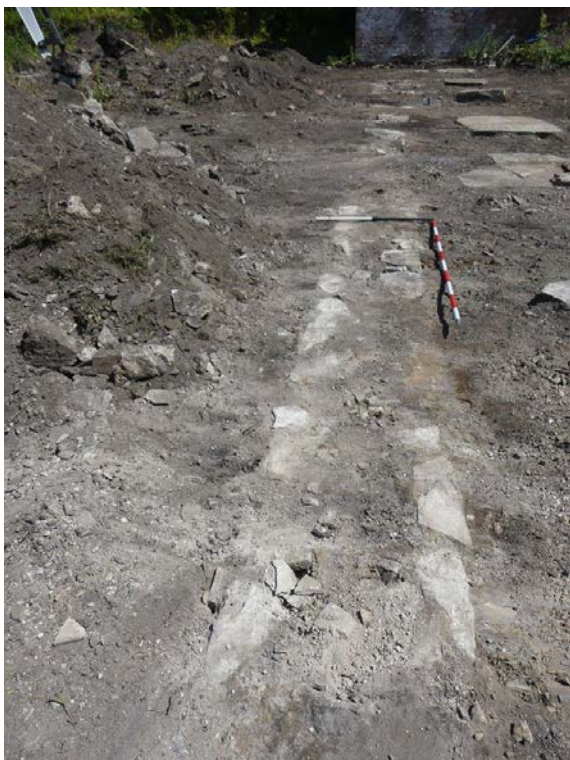
Plate 162 (left): Wall 401, viewed from the north-west

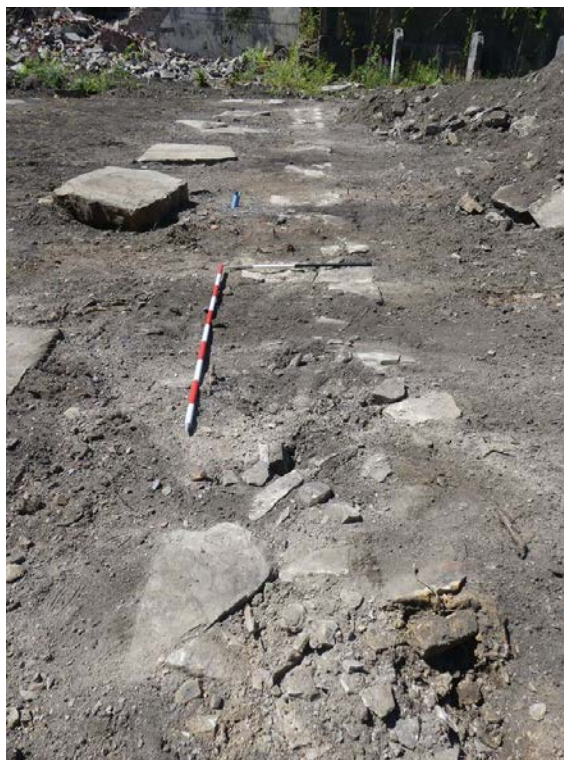
Plate 163 (right): Wall 401, viewed from the south-east

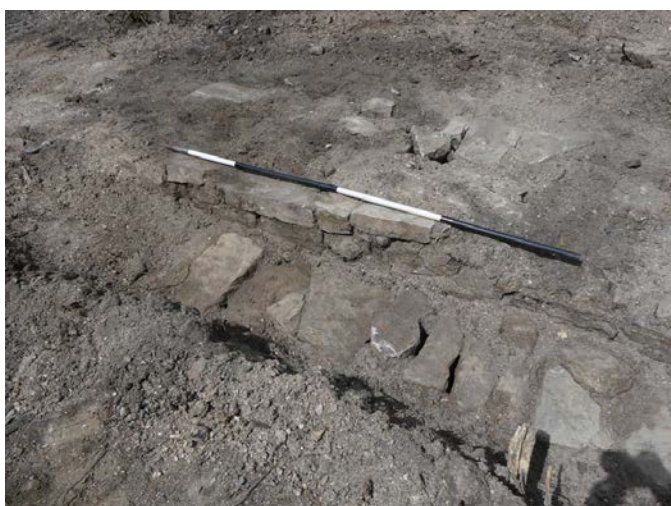
Plate 164 (left): Culvert 402 to the south-west side of wall 401

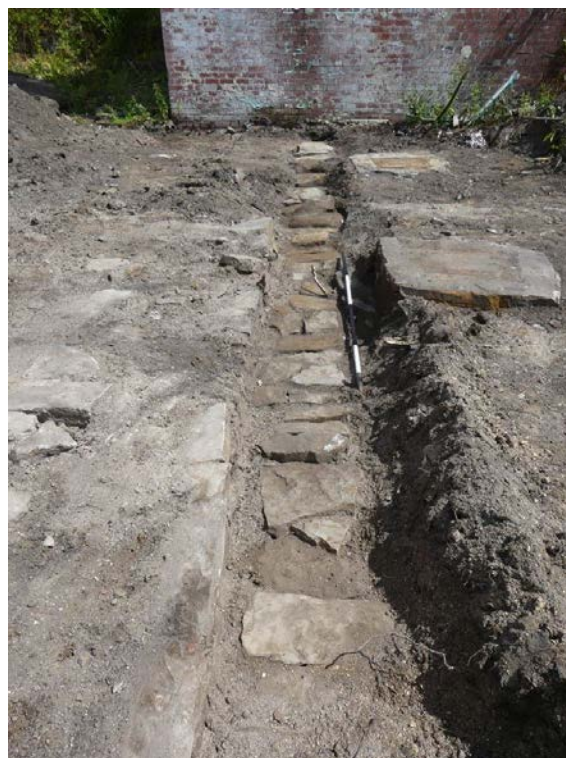
Plate 165 (right): Culvert 402, viewed from the north-west

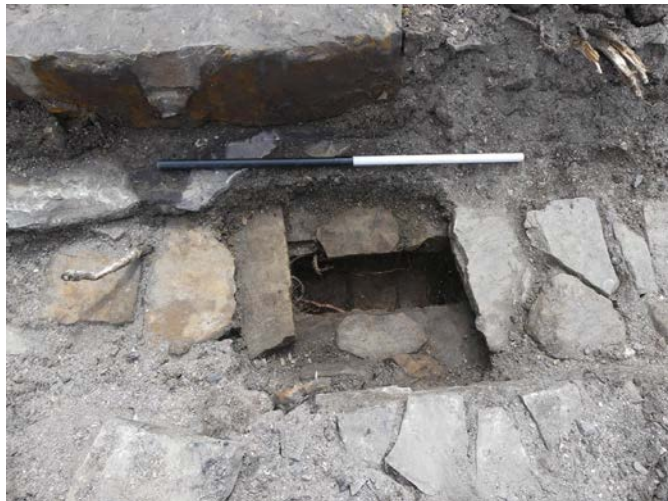
Plate 166: Capping stones removed from culvert 402, revealing the original structure 433

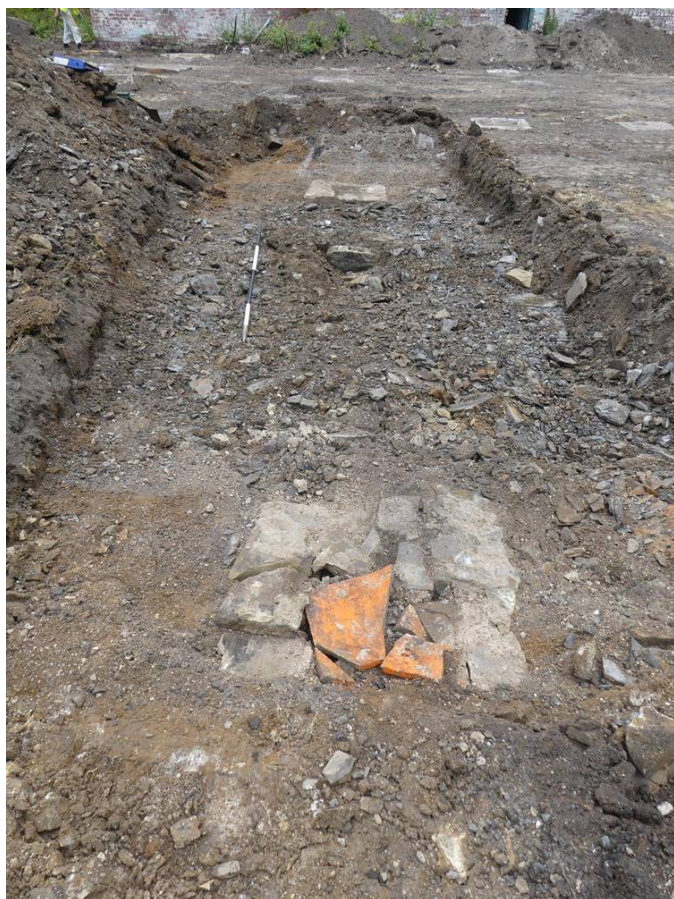
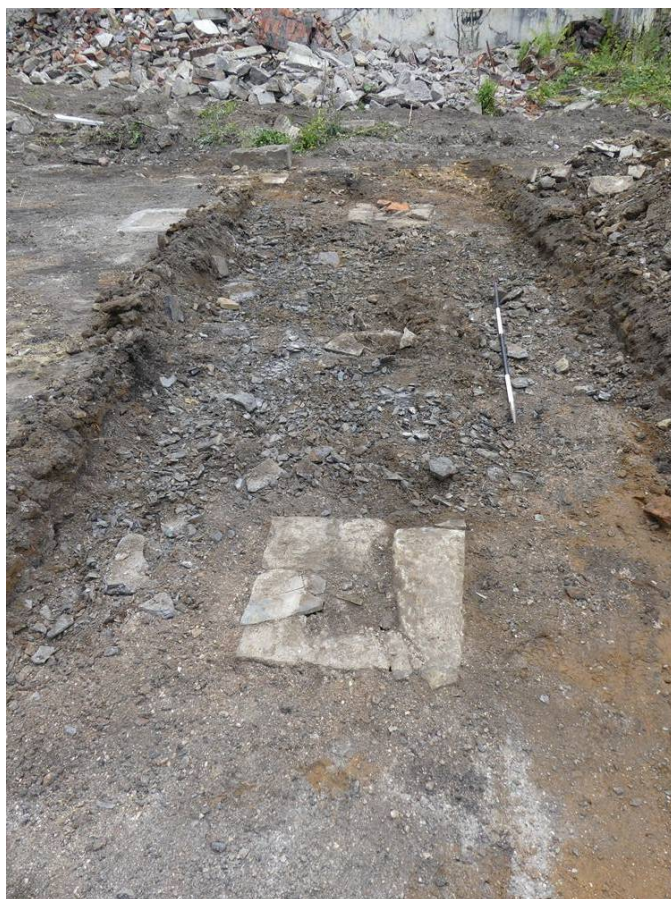
Plate 178 (left): Pads in the north-east trench (grouped as 432), viewed from the north-west
Plate 179 (right): Pads in the north-east trench (grouped as 432) viewed from the south-east

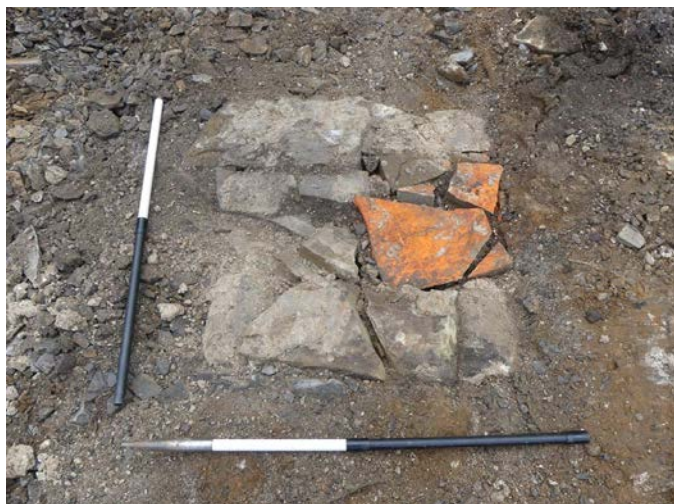
Plate 180 (left): North-west pad, part of 432

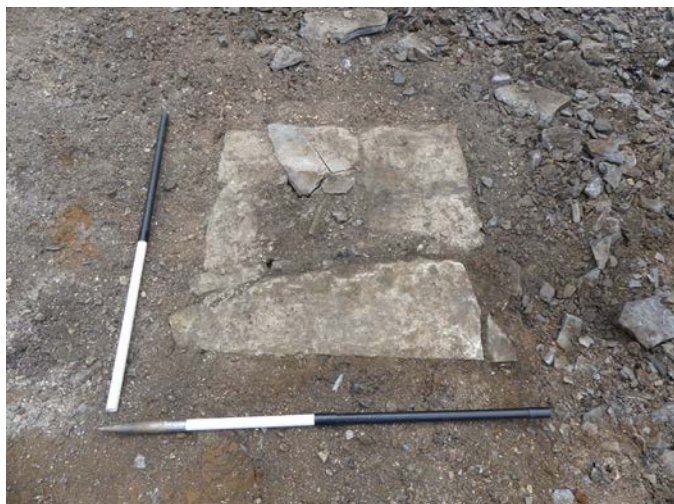
Plate 181 (right): South-east pad, part of 432

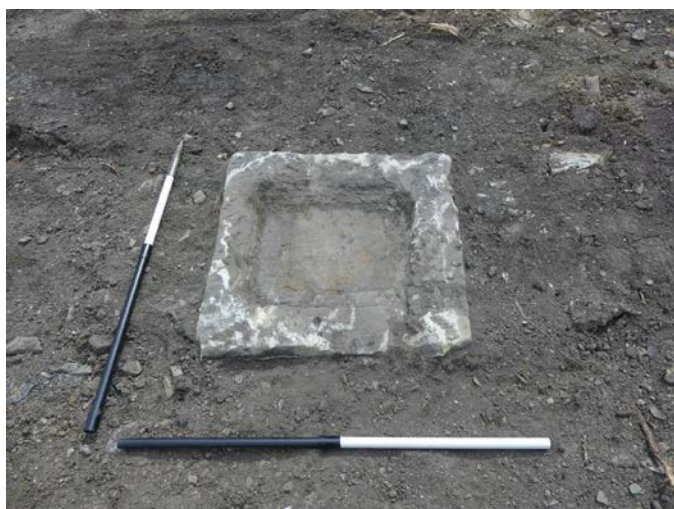
Plate 182: Pad 414

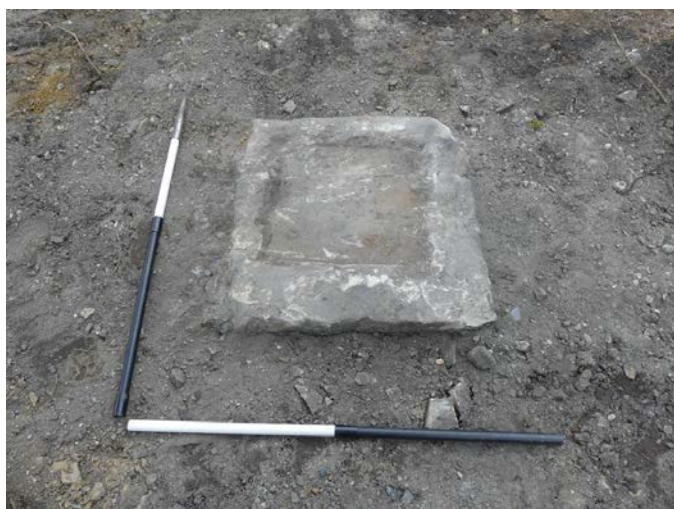
Plate 183 (left): Pad 415

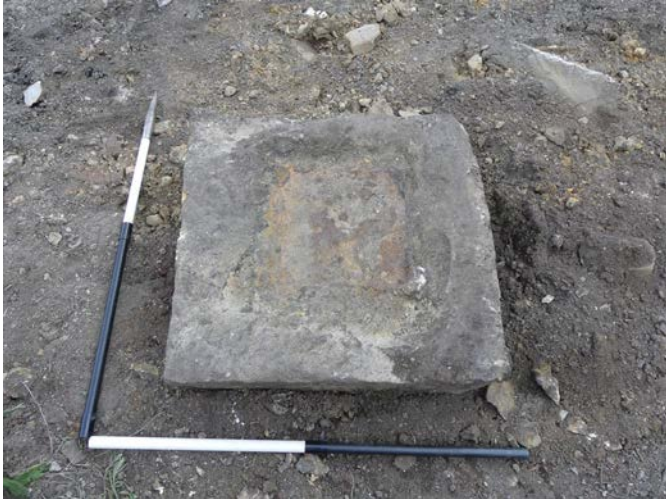
Plate 184 (right): Pad 416

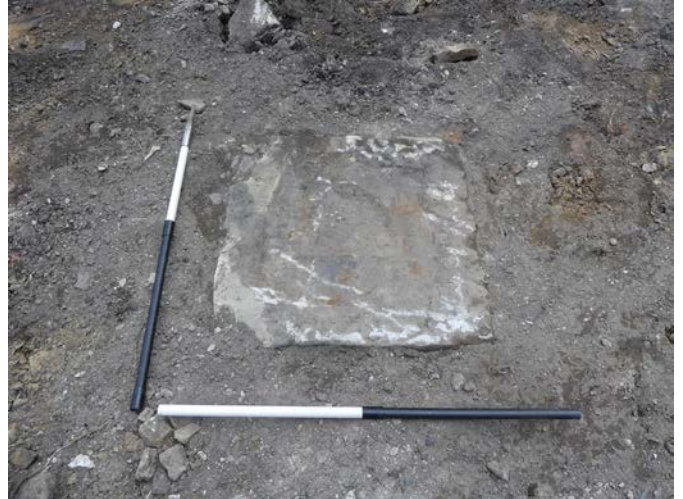
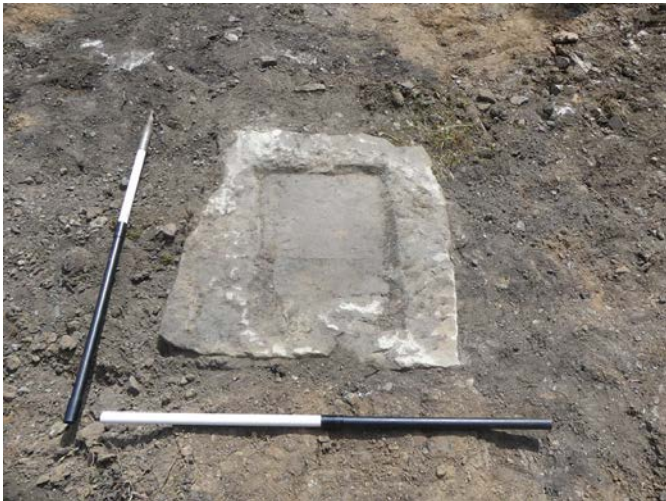
Plate 185 (left): Pad 417
Plate 186 (right): Pad 419

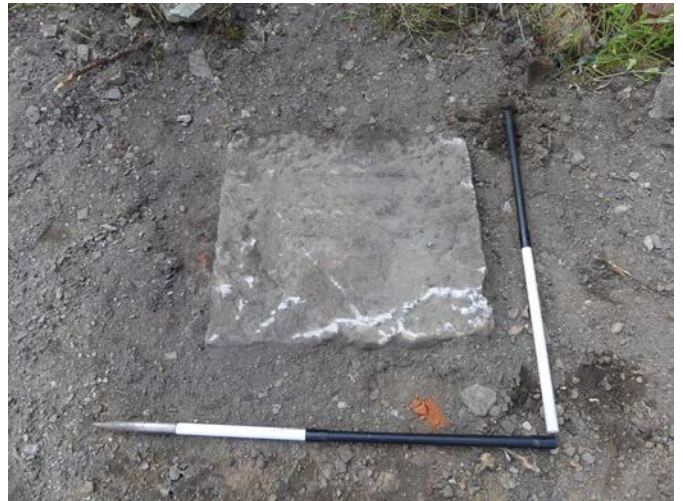
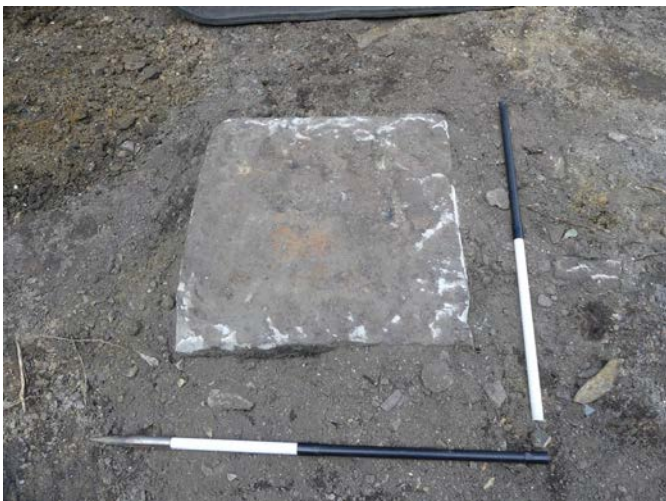
Plate 187 (left): Pad 420
Plate 188 (right): Pad 421

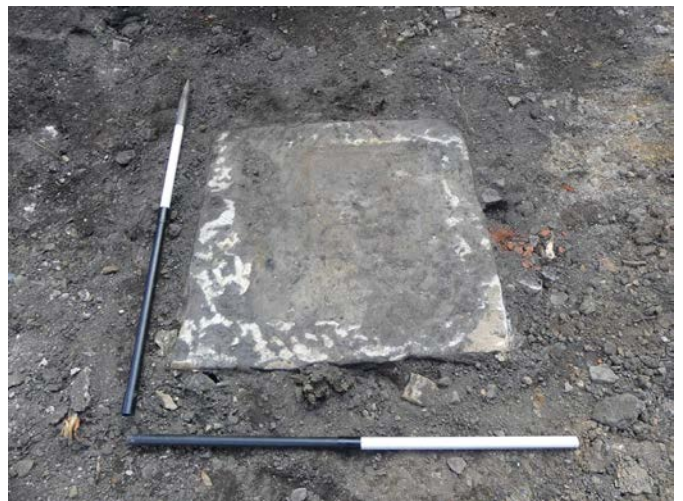
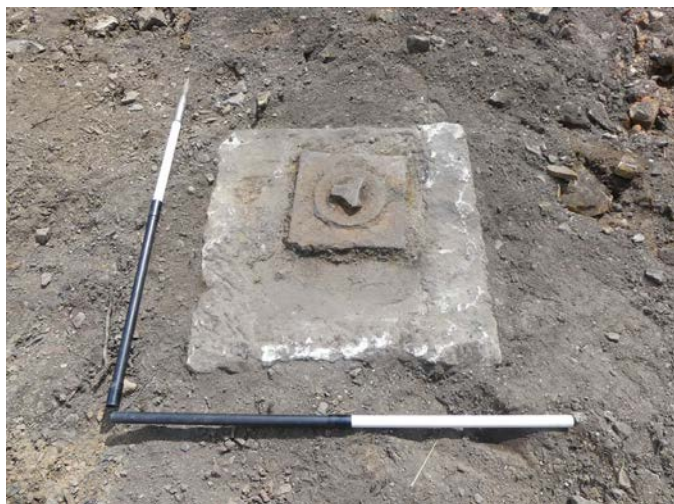
Plate 189 (left): Pad 422
Plate 190 (right): Pad 424

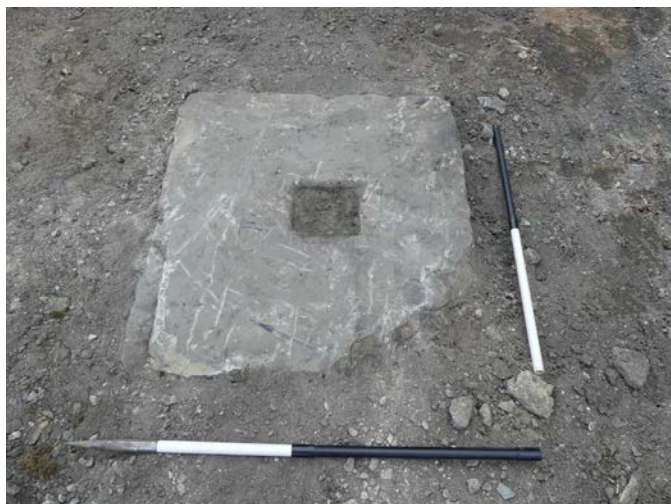
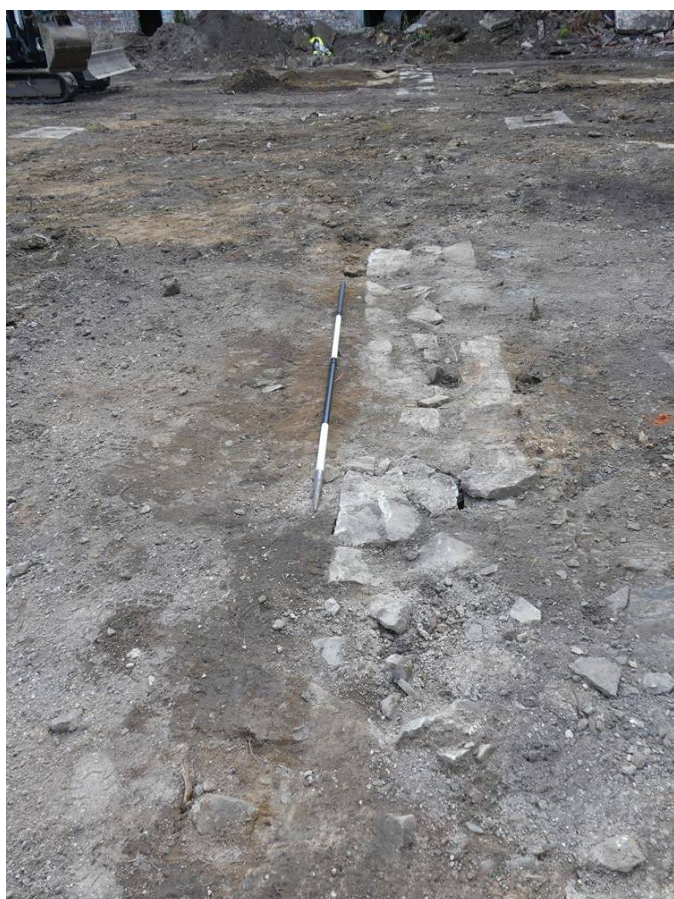
Plate 191 (left): Pad 426
Plate 192 (right): Pad 418

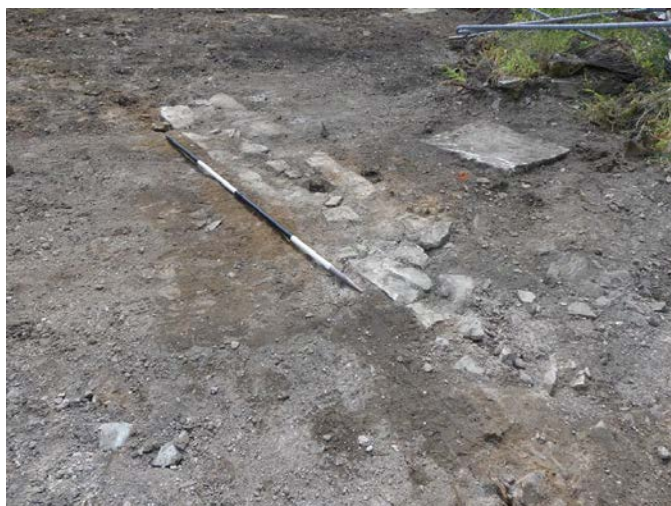
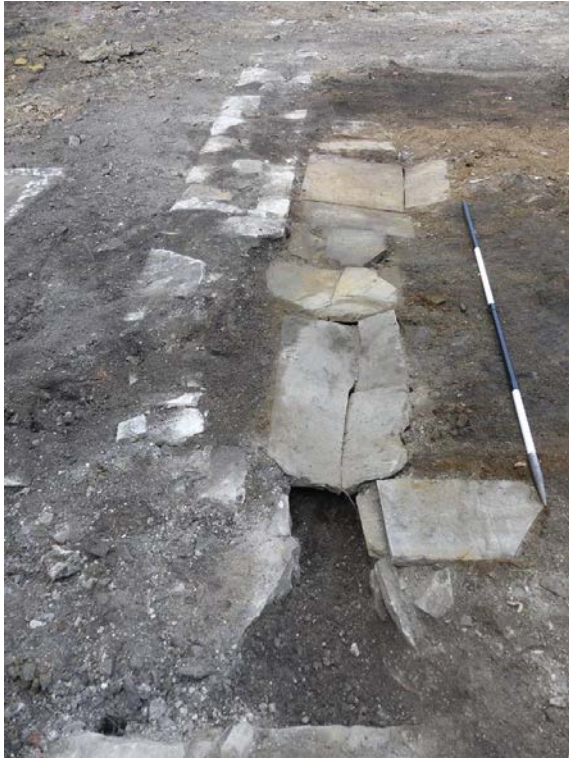
Plate 193 (left): Wall 423, viewed from the north-west
Plate 194 (right): The north-west end of wall 423

Plate 195 (left): Culvert 427 to the north-east side of wall 423

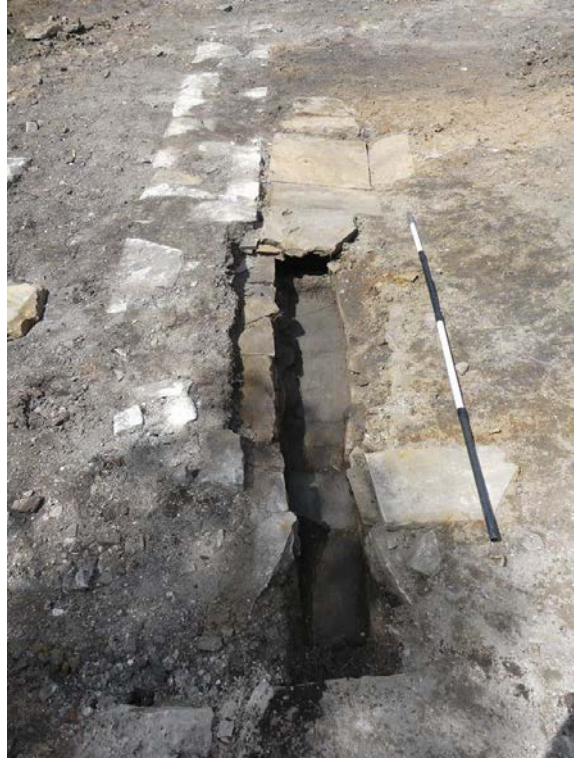
Plate 196 (right): Capping stones removed from culvert 427

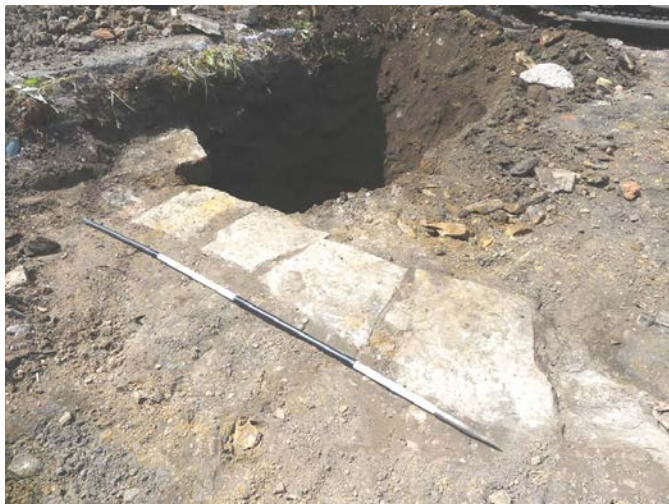
Plate 197 (left): South-east side of tank 425

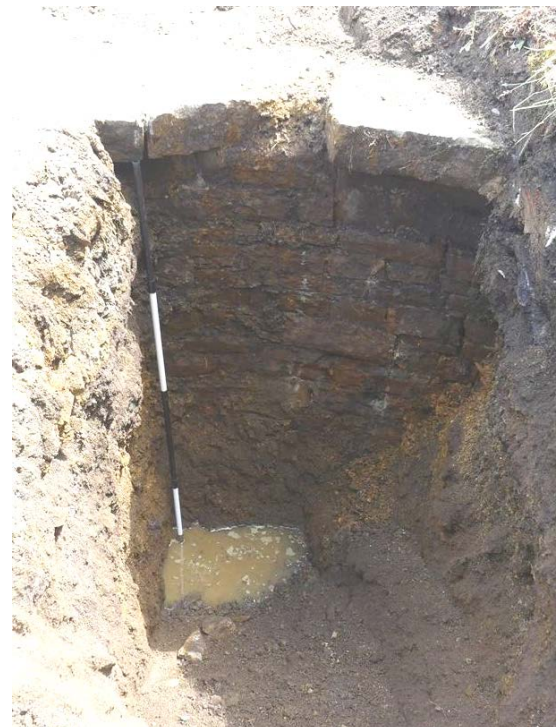
Plate 198 (right): Inside of tank 425
