HODDLESDEN MILL, HODDLESDEN, DARWEN, LANCASHIRE

Archaeological Building Recording, Evaluation and Strip, Map and Record

Client: Kingswood Homes

September 2022

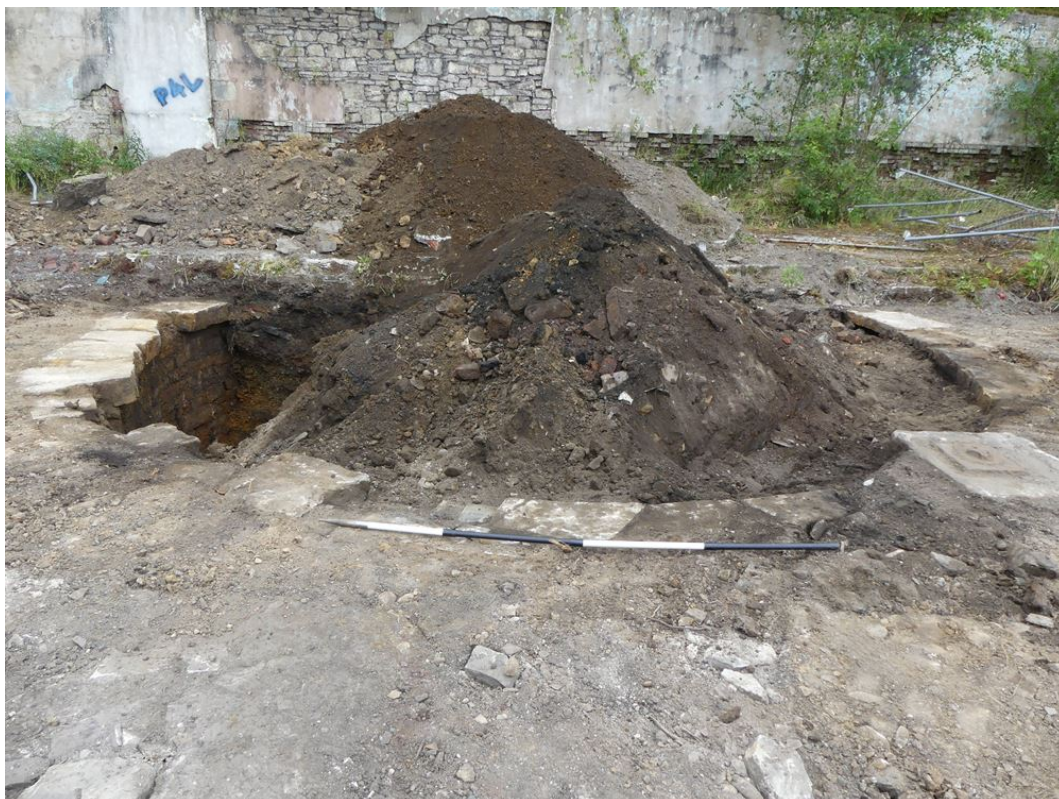
Plate 199: General view of 425 from the north-east

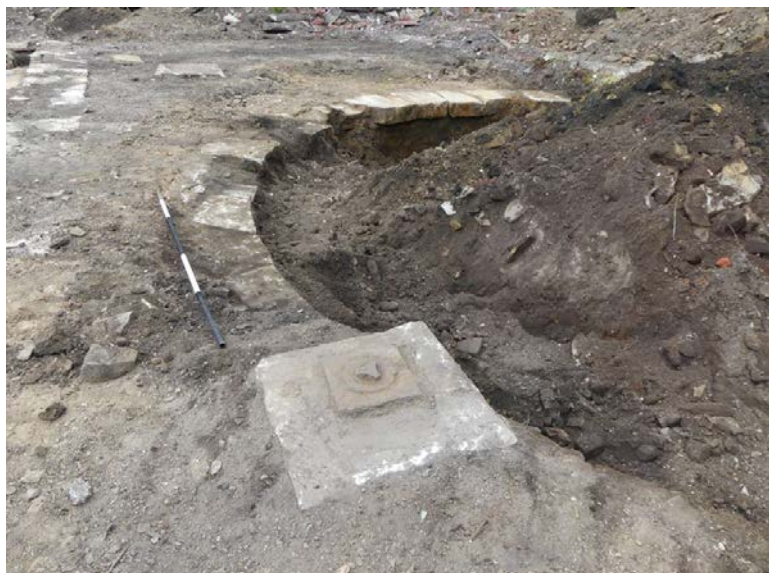
Plate 200 (left): The south-east side of tank 425, cut by pad 426

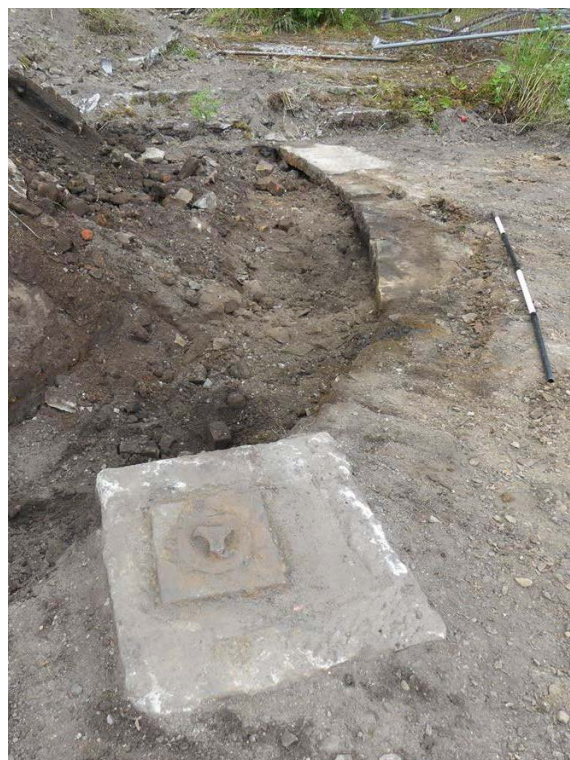
Plate 201 (right): The north-west side of tank 425, cut by pad 426
