IVY COTTAGE, DRAGLEY BECK, ULVERSTON, CUMBRIA

Heritage Assessment

January 2023

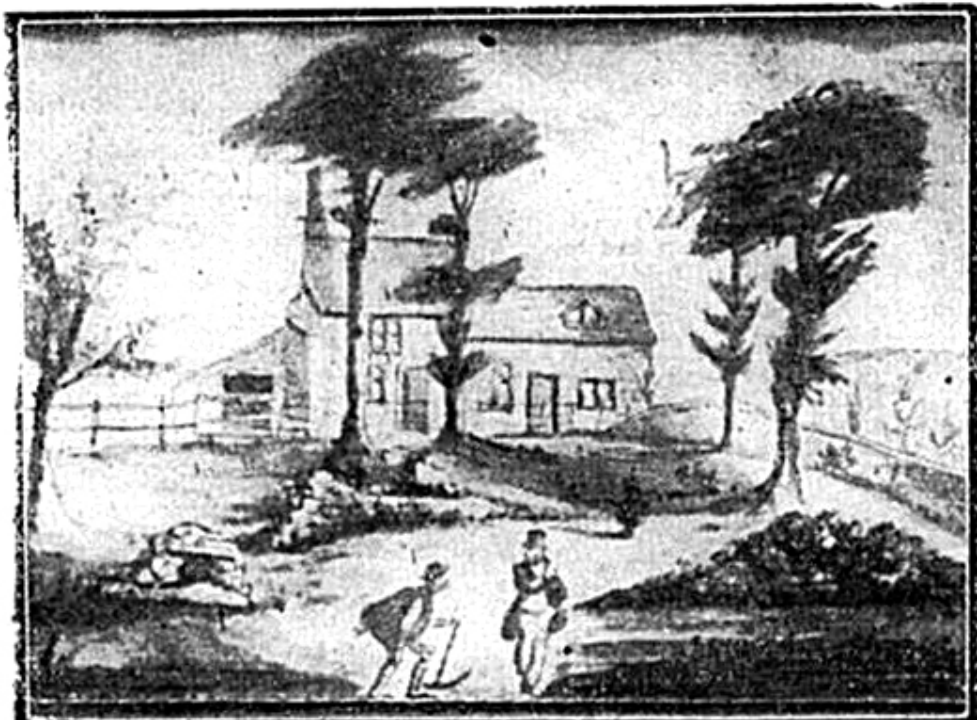
Plate 1: Illustration, 1839

3.2.3 **Illustration, 1839:** remarkably, a copy of a water colour of the building by a local artist, the Rev T Tolming, exists, entitled 'View of Mr Gilpin's Cottage, at Dragley Beck, near Ulverston'. It is not clear where the original is now but it was reported as having been given to the Town Council in 1915, by a John Cooper of Myles Close, Windermere, who was a descendant of Bernard Gilpin (Anon 1915). This shows the building very much as it is now, and evidently comprising two separate sections: the right side only single storey, the left two storeys, with a monopitch outshut on the far-left side.

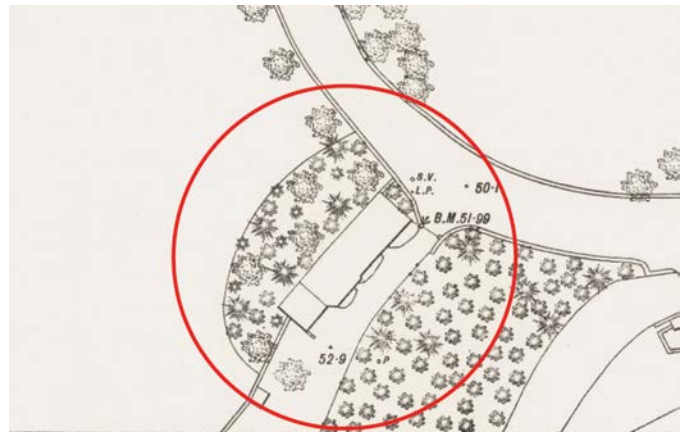
Plate 5 (right): Extract from the Ordnance Survey map of 1890

3.2.6 **Ordnance Survey, 1890:** a 1:500 edition map of Ulverston was produced in 1890, which was surveyed in 1889 (Plate 5). Ivy Cottage appears at the south edge of *Sheet 3*. The block is subdivided, with a shorter, almost square-shaped block at the south-west end corresponding with the outshut shown in the image of 1839. The wall steps out slightly to the north-east of this on the south-east elevation. There are also three features indicated on the ground in front of the building on the south-east side, although it is not clear what these are.

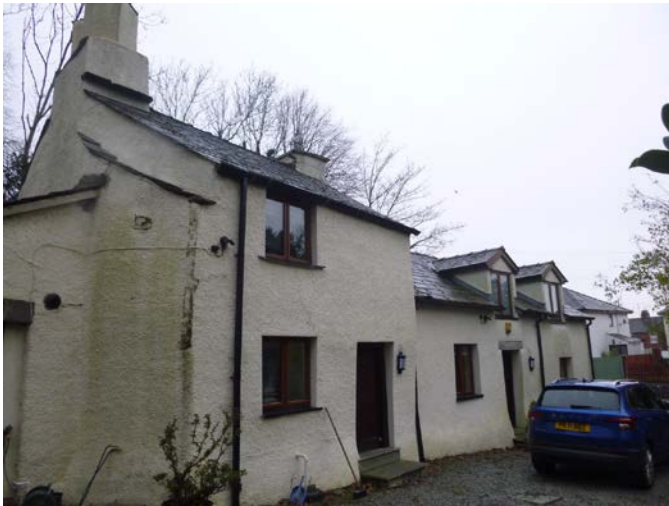
Plate 11 (left): General view of the north-east end of the front (south-east) external elevation, viewed from the south

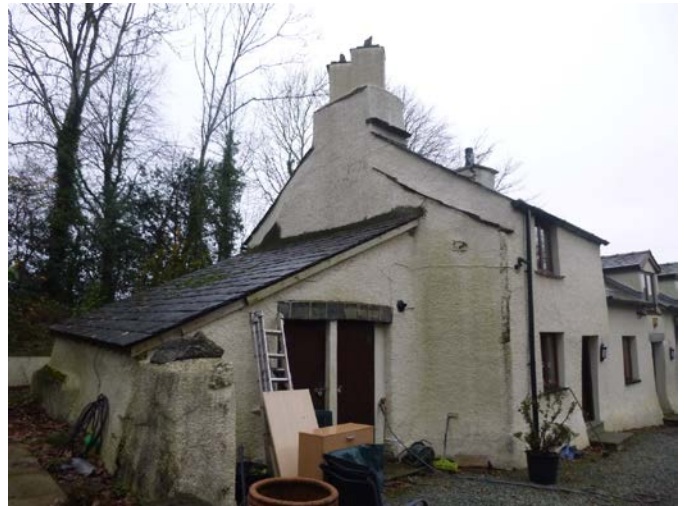
Plate 12 (right): General view of the south-west end of the front (south-east) external elevation, viewed from the south

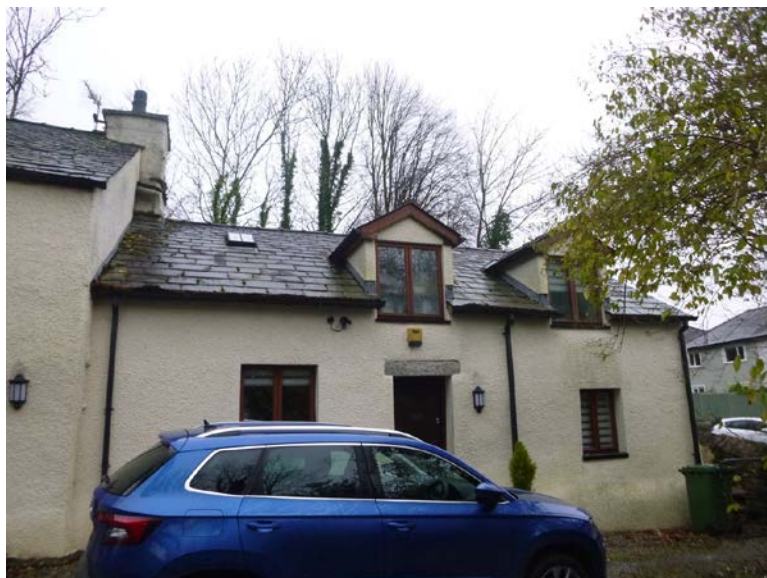
Plate 13 (left): The north-east end of the front (south-east) external elevation, viewed from the south-east

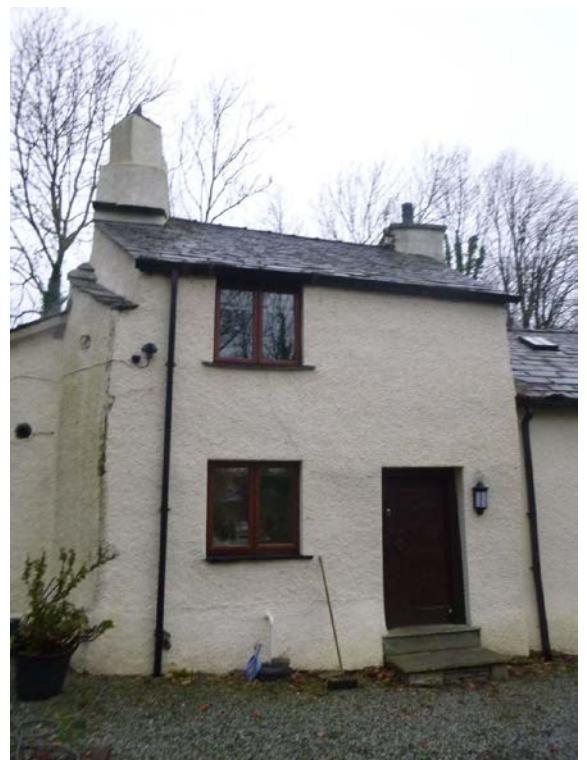
Plate 14 (right): The centre of the front (south-east) external elevation, viewed from the south-east

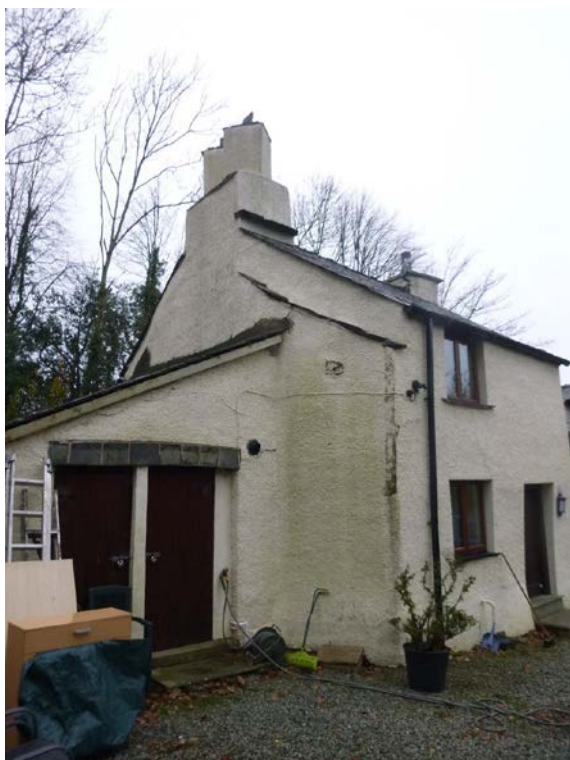
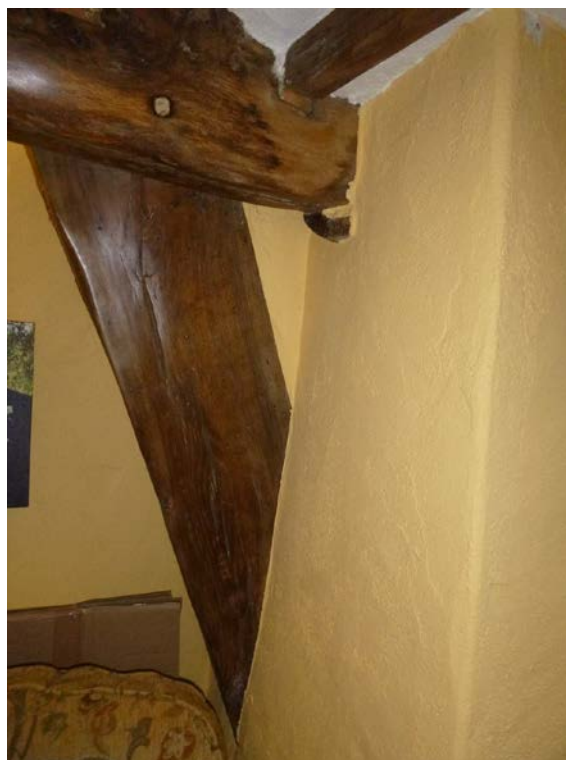
Plate 15 (left): The south-west end of the front (south-east) external elevation, viewed from the south
Plate 16 (right): The base of the south-east cruck blade in the north-east part of the cottage, viewed from the south-west

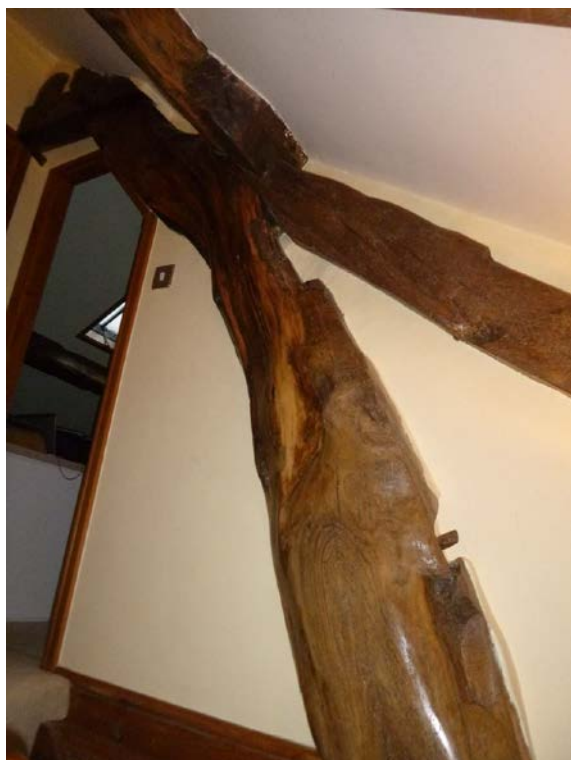
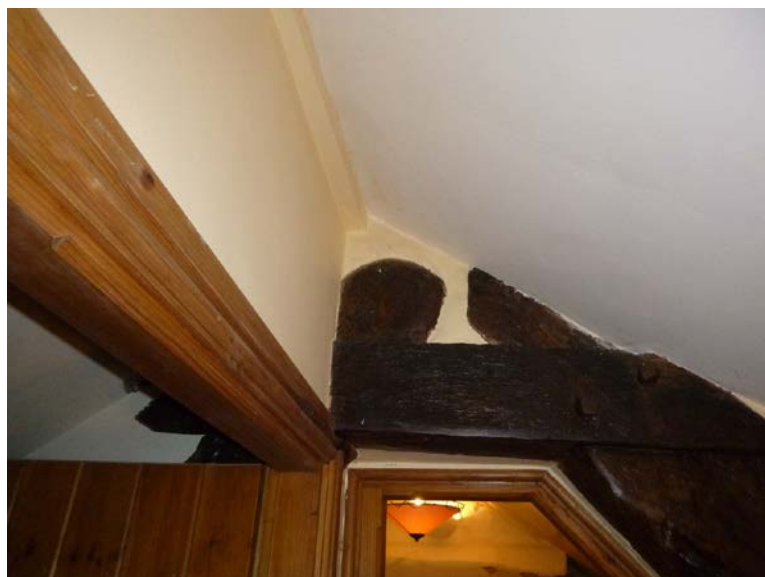
Plate 17 (left): The top of the north-west cruck blade in the north-east part of the cottage, viewed from the north
Plate 18 (right): The collar of the cruck truss in the north-east part of the cottage, viewed from the north-east

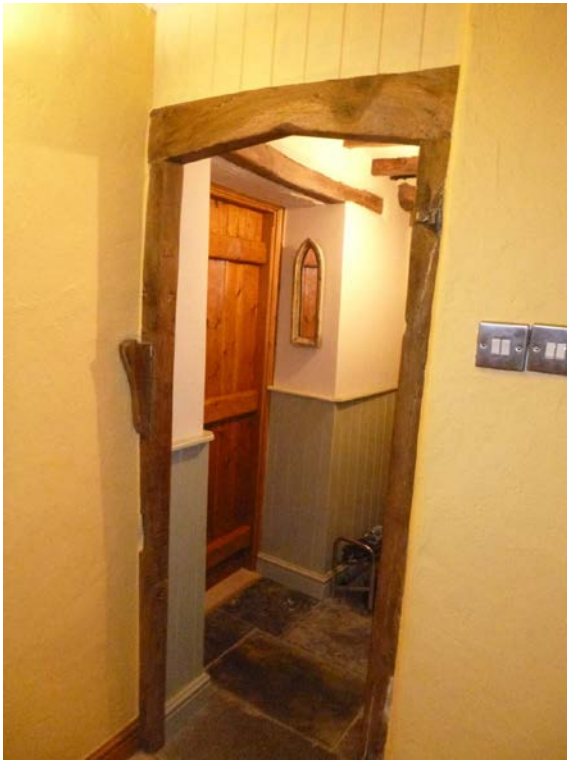
Plate 19 (left): The original doorway at the passage in the north-east part of the cottage, viewed from the west

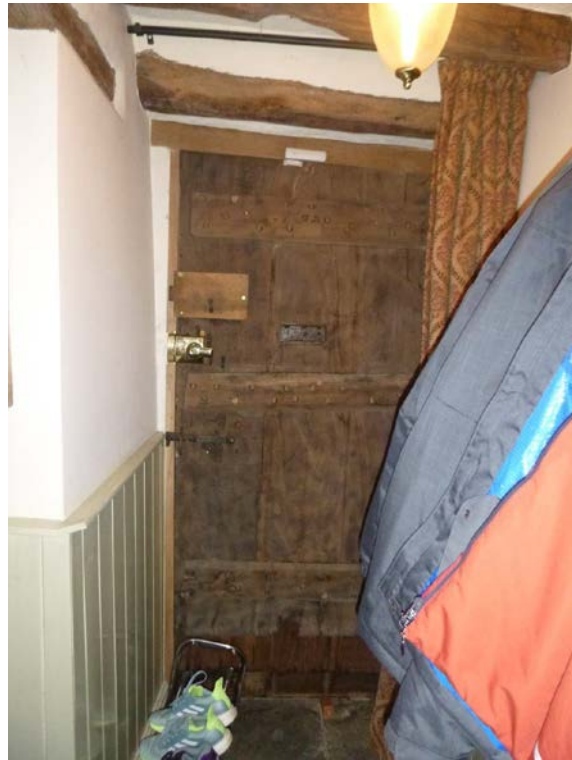
Plate 20 (right): The front door in the south-east elevation of the north-east part of the cottage, viewed from the south-west

4.3.1 It is not known at present what the proposals are, although the need to renovate the surviving front doors, which are original fabric albeit altered, is evident. There is, however, the potential for some impact on surviving historic fabric, although this has already been modified.

4.4.1 While the building is currently in a reasonably good condition and retains much of its original form and some important elements of its historic fabric, internally it has been more substantially altered and much of its historic fabric is now modified. Sympathetic renovation and alteration is certainly feasible, and, indeed, desirable in terms of repairing the two front doors.

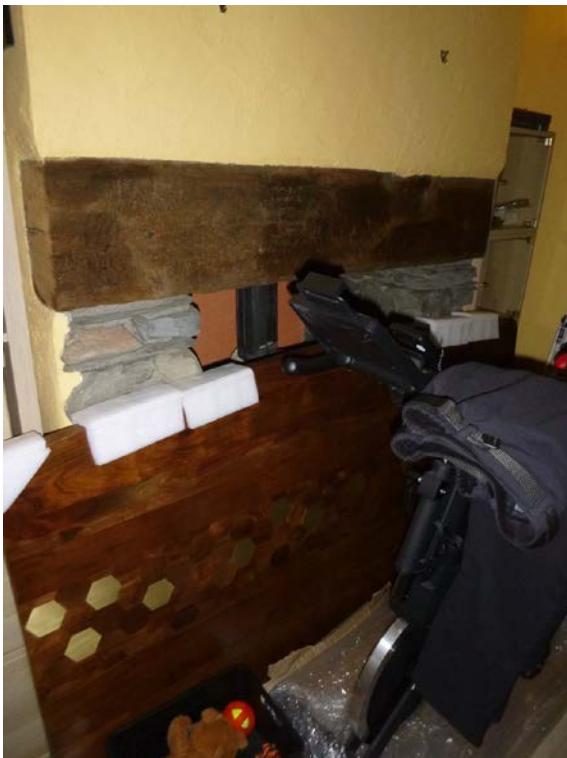
Plate 21 (left): The fireplace on the south-west side of the north-east part of the cottage, viewed from the north-east

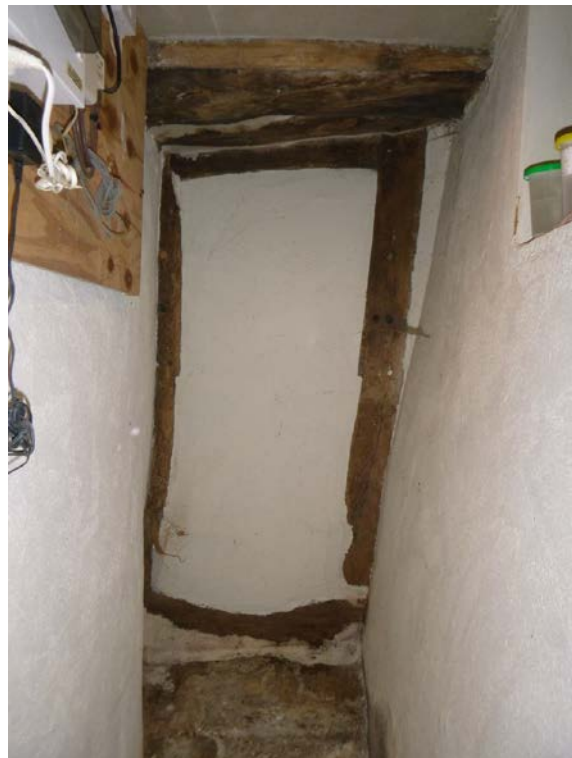
Plate 22 (right): The blocked door in the south-west side of the north-east part of the cottage, viewed from the north-east

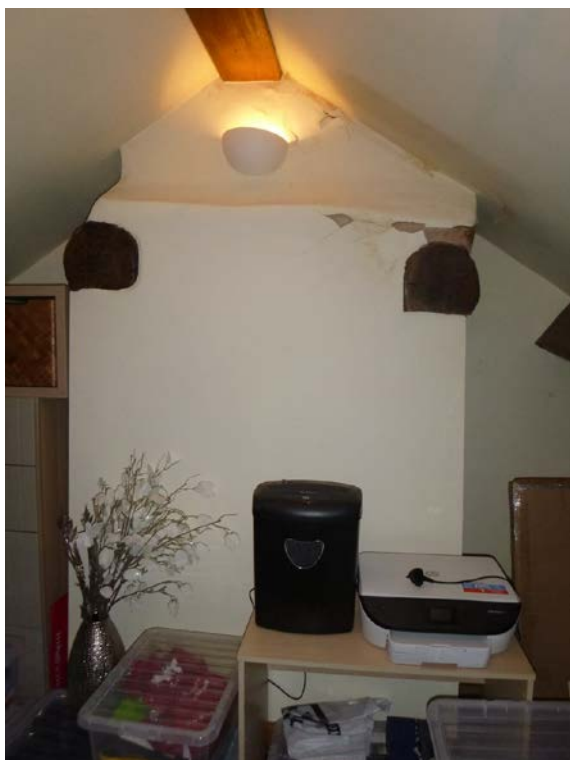
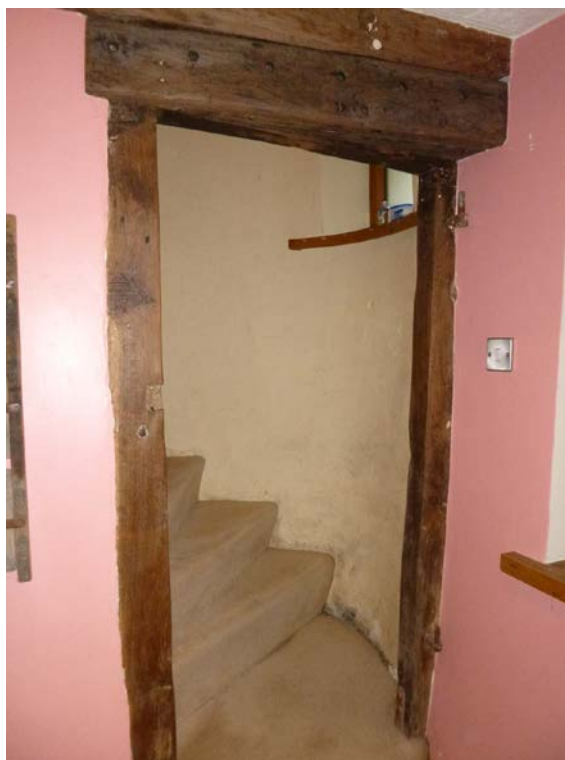
Plate 23 (left): The top of the chimney breast on the south-west side of the north-east part of the cottage, viewed from the north-east

Plate 24 (right): The original doorway at the foot of the inter mural staircase in the central part of the cottage, viewed from the east

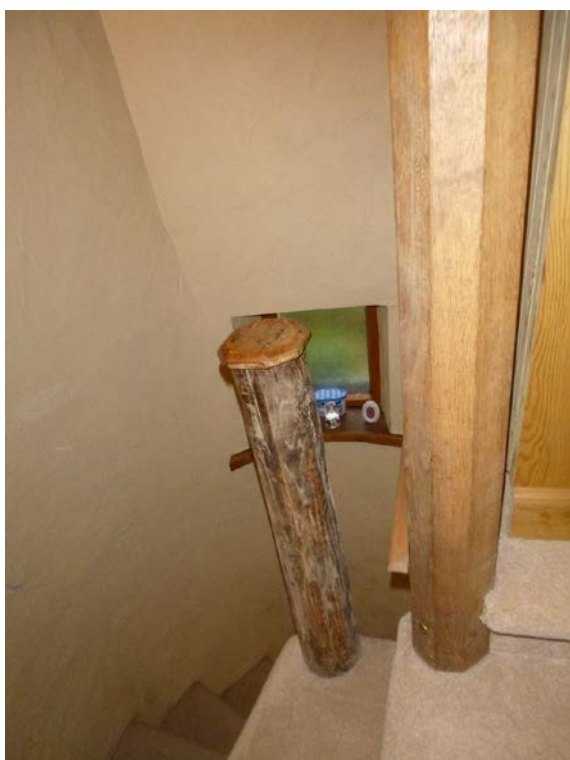
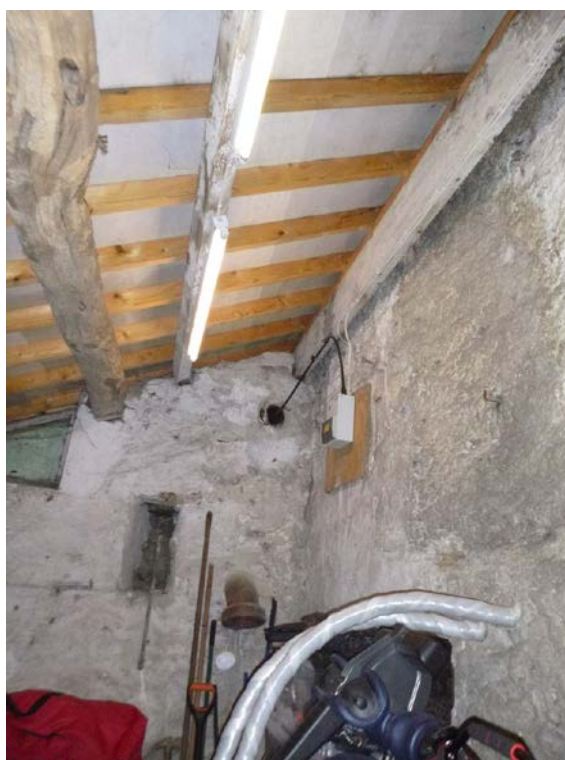
Plate 25 (left): The original octagonal newel post in the central part of the cottage, viewed from the south-east

Plate 26 (right): The interior of the outshut forming the south-west part of the building, viewed from the south-east
