LOW FLAN FARM, ULVERSTON, CUMBRIA

Archaeological Building Recording

Client: Mr J Hornby
Planning ref.:
SL/02008/841
NGR: 328751 479866

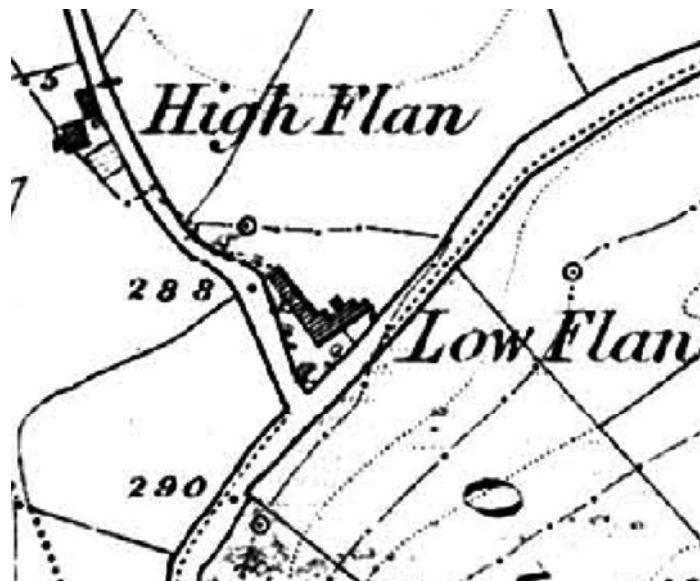
Plate 3 (right): Extract from the Ordnance Survey map of 1850

3.3.3 **Ordnance Survey 1850:** this map shows that the south-west wing has been significantly extended to the north-west, probably with additional outbuildings (Plate 3). It is otherwise not particularly detailed, although the extension to the north-west of the house is evident.

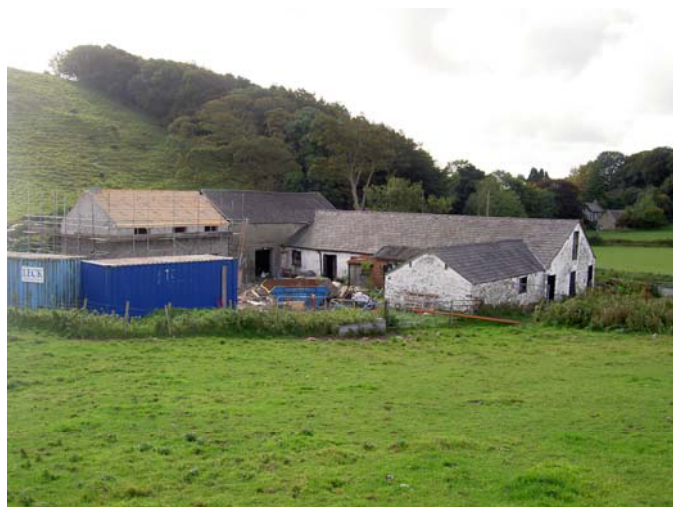
Plate 6 (left): General view of the site showing the newly built farmhouse and associated buildings to the north-west (photograph by Greenlane Archaeology Ltd)

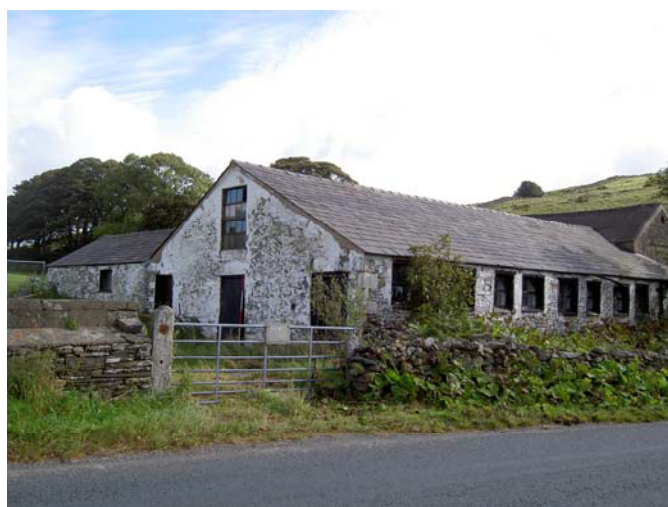
Plate 7 (right): General view of the shippon to the north-west of the farmhouse (Photography by Greenlane Archaeology)

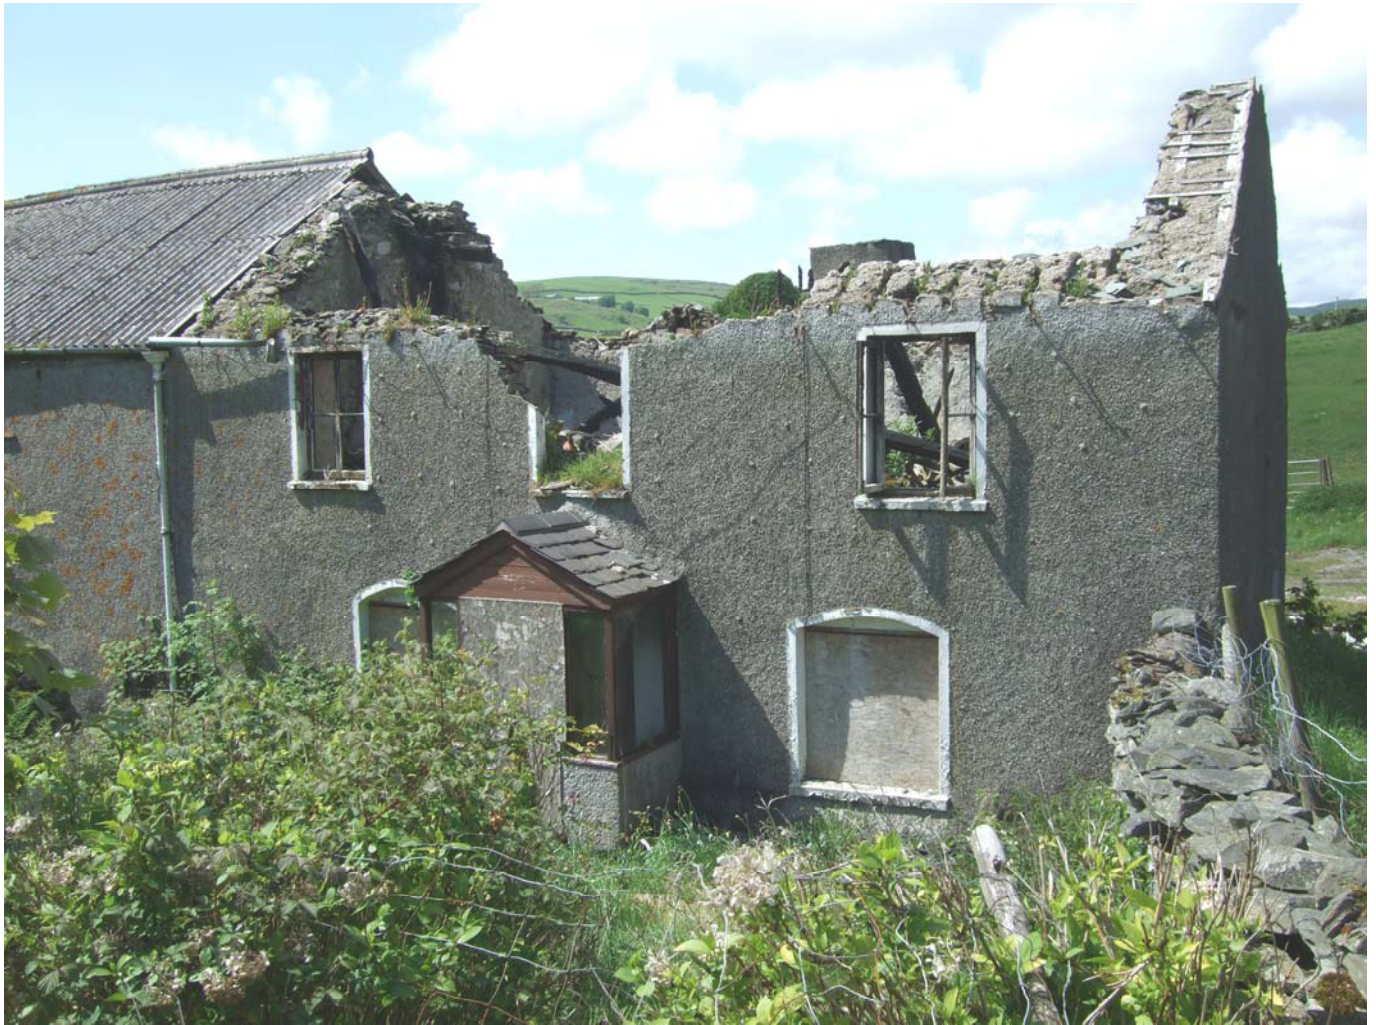
Plate 8: South-east elevation of the farmhouse (photograph by Leck Construction Ltd)

4.2.1 **South-east elevation:** this elevation comprised a porched doorway flanked by windows on the ground floor, and had three evenly spaced windows on the upper floor (see Plate 8). The porch was constructed from modern materials and its side walls had four lights in a timber frame, which sat on a low wall that had been cement rendered. The timber had been stained brown; the pitched roof was clad in grey slates capped by ceramic bonnet tiles. The ground floor windows in the main farmhouse proper were asymmetrically placed on either side of the central porch; both were identical with whitewashed

stone sills and whitewashed mortared jambs. The recent timber casements were boarded over but were evidently square in shape and they were located in surrounds with arched tops indicating the shape of the earlier windows. It was noticeable that these windows were wider than the upper windows, and perhaps wider than one might expect from a property of this date which might suggest that they had been widened or were constructed in such a fashion in order to enable more light into the ground floor rooms. The upper three windows were slightly narrower and rectangular in shape; they housed timber casements containing four-lights, which were probably side-hung and relatively modern. Once again whitewash obscured the detail of the sills, jambs and lintels. The roughcast render extended across the adjacent barn to the south-west, and so no join between these two buildings was visible. Part of the roof originally survived the fire, showing that it was finished with grey slates laid in diminishing courses set under sandstone ridge tiles. There were chimneys at each end of this elevation which were rendered, although they appeared to be constructed from stone and to be original features.

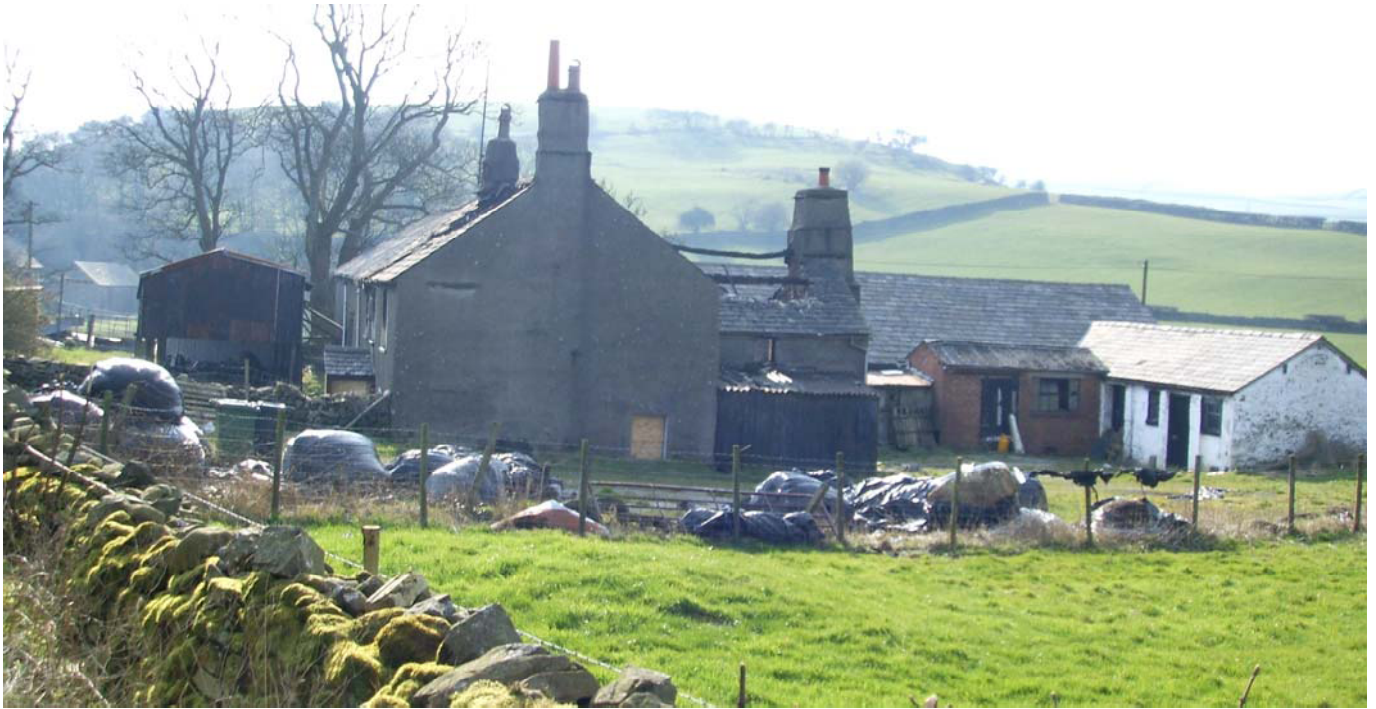
Plate 9: North-east side of farmhouse, showing wing to the rear (photograph by Dan Elsworth)

4.2.2 **North-east elevation:** this elevation comprised the gable end of the main house/range and the side of the perpendicular service wing to the rear, which was probably the kitchen (Plate 9). The gable end of the house contained a single lower floor doorway at the north-east end, which was boarded up and none of its features were visible. What appeared to be a blocked window was evident at the opposite end of the elevation at first floor level; this comprised little more than a raised area in the roughcast render with a projecting lintel above. The kitchen wing to the rear was also on two levels but was not the full height of the main house. The ground floor part of this elevation was obscured by a corrugated iron lean-to shed; a single small window aperture was visible in the centre of the upper floor, which probably related to a subsidiary bedroom. The window contained no casement, this having been destroyed by the fire. Part of the slate roof of this wing still survived and fire damaged roof timbers were evident.

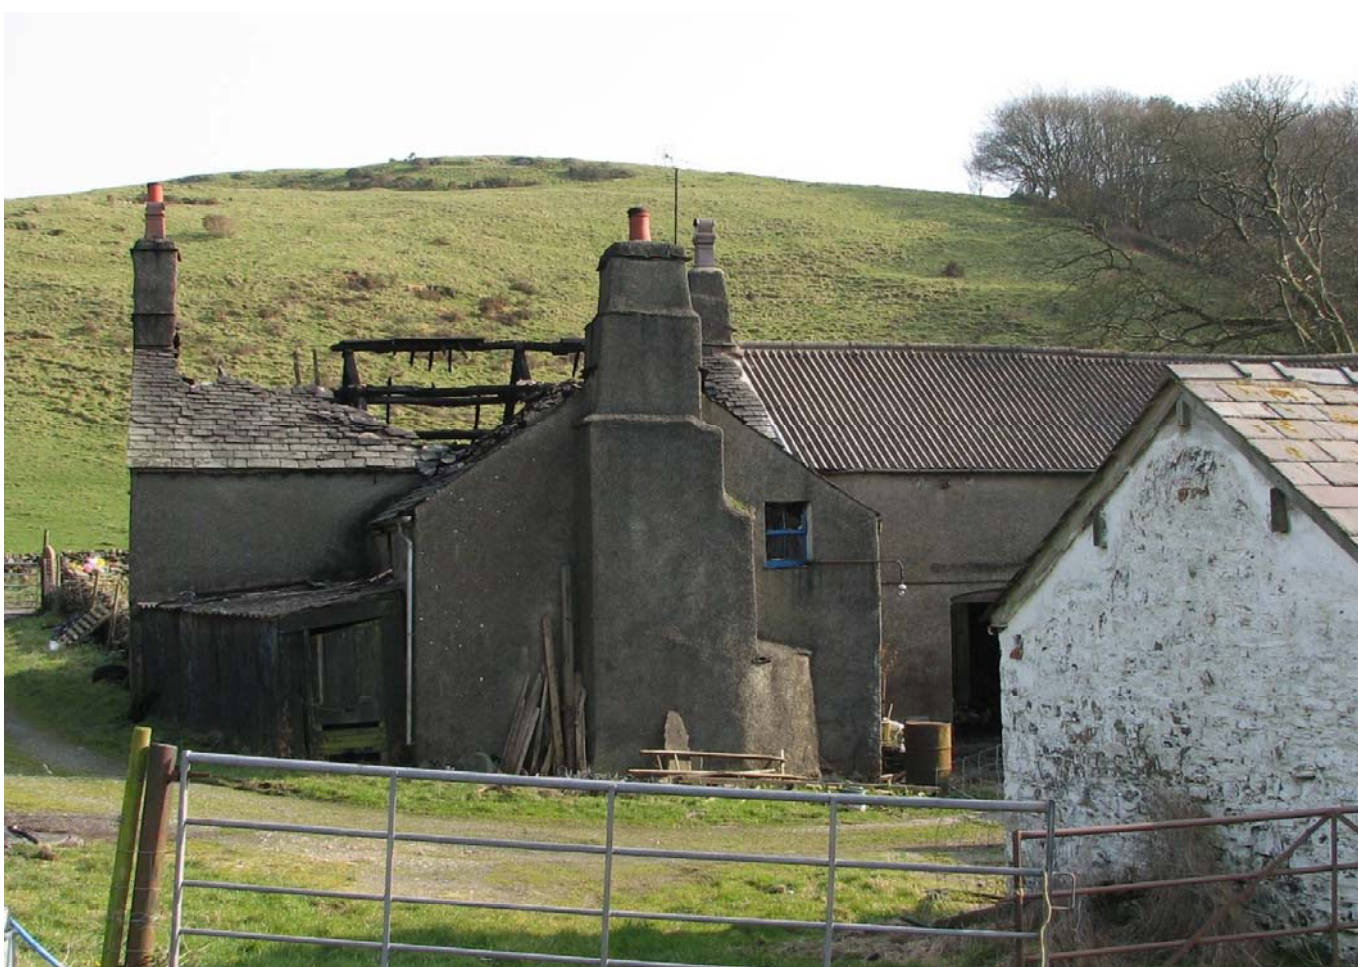
Plate 10: The farmhouse and rear wing, viewed from the north-west (photograph by Jack Layfield)

4.2.3 **North-west elevation:** this elevation comprised the gable end of the rear wing of the house and a small area of the rear of the main house to the north-east (Plate 10). The lower part of the rear of the main farmhouse was obscured by the lean-to shed, the upper part was rendered and entirely plain, and it was not possible to determine whether the main house and the rear wing were contemporary or not. The gable end of the rear wing featured a huge external chimney breast, which was considerably different to the chimneys of the main house. The width of the lower part of this breast is around 3m suggesting that the lower floor room was the kitchen and that the base of this chimney would probably have incorporated the main fireplace for cooking, a bread oven and perhaps other associated features.

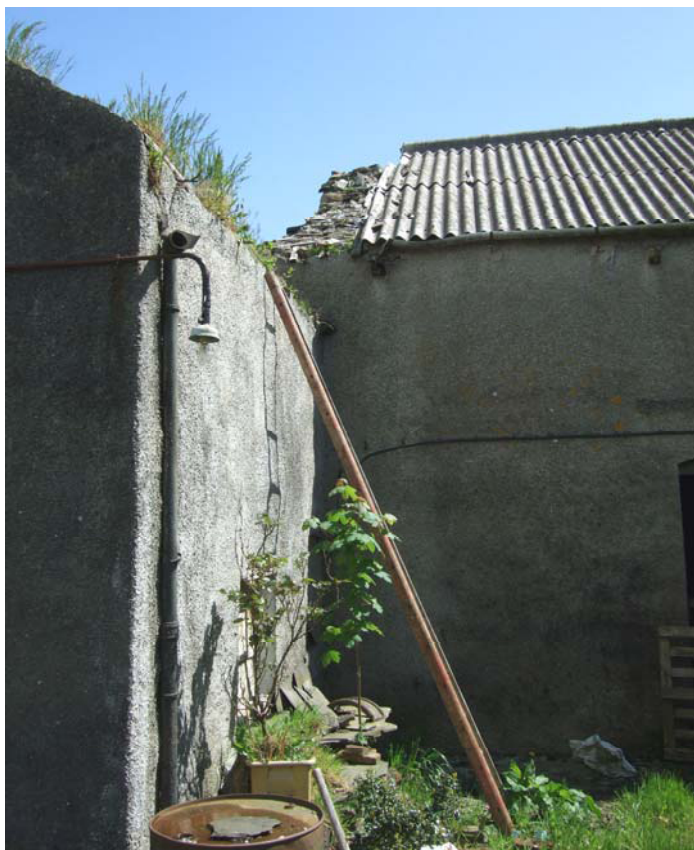
4.2.4 **South-west elevation:** this elevation comprises the side of the rear wing which was entirely plain except for a boarded window on the ground floor level. It is possible that this may have been a doorway that has been part blocked as it is considerably wider than the other windows in this part of the house. It was evident from this elevation that the rear wing was slightly lower in height than the main build (Plate 11); the solid and continuous rear wall of the main farmhouse that separates the two parts of the house also suggests that they were not contemporary.

Plate 11 (left): Oblique view of south-west side of rear wing (photograph by Leck Construction Ltd)

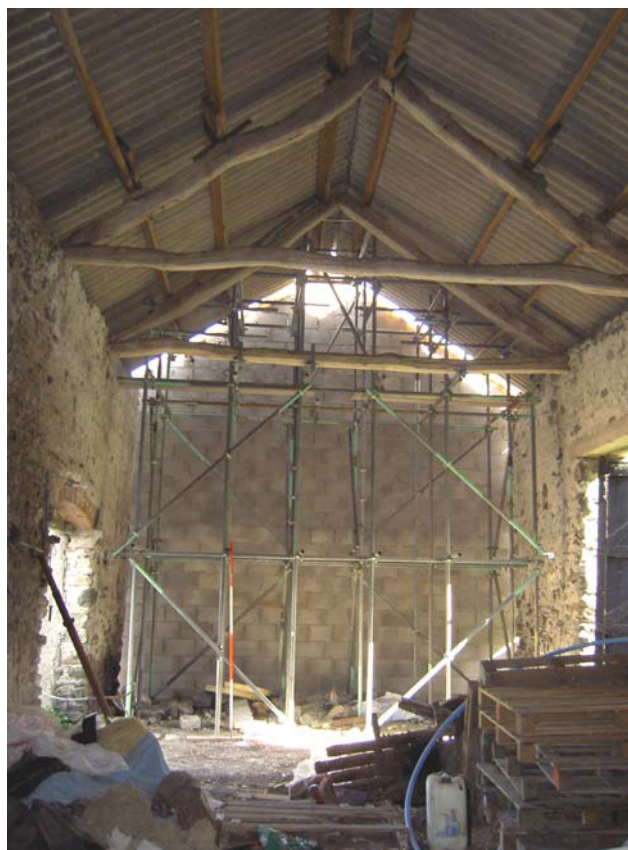
Plate 12 (right): Trusses of adjacent threshing barn, looking towards re-built farmhouse (photograph by Greenlane Archaeology Ltd)

4.2.5 Internal details: no details of the interior are available, apart from part of the roof structure. The main roof of the house was evidently originally supported by two tie-beam trusses of fairly basic form (Plate 13), similar to those present within the attached barn (Plate 12). These supported two purlins per pitch and a ridge purlin and there was evidently a partition wall below the north-east truss. The roof of the rear wing did not appear to have any trusses and it seems to have been supported by a single purlin in each pitch and a ridge purlin (Plate 9). The only other discernable internal detail of any note is the presence of what appears to have been the remains of a smoke hood on the first floor against the south-west interior wall (showing as an area of sooting in Plate 8). This is further emphasised by the evidently corbelled chimney stack, which was visible from inside the barn (Plate 14).

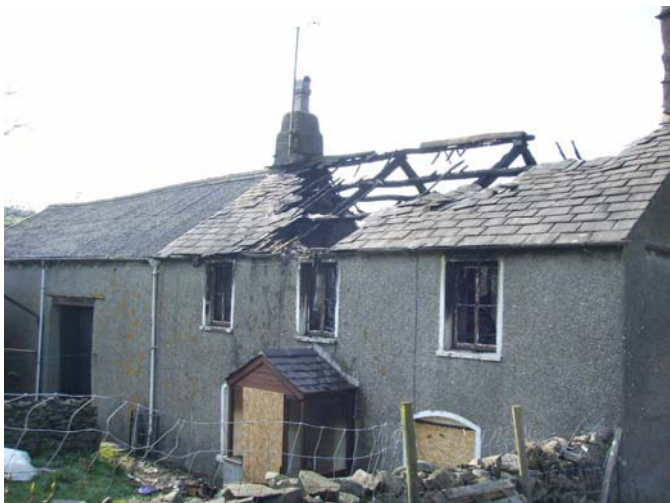
Plate 13 (left): North-west elevation, showing the roof trusses (photograph taken by Dan Elsworth)

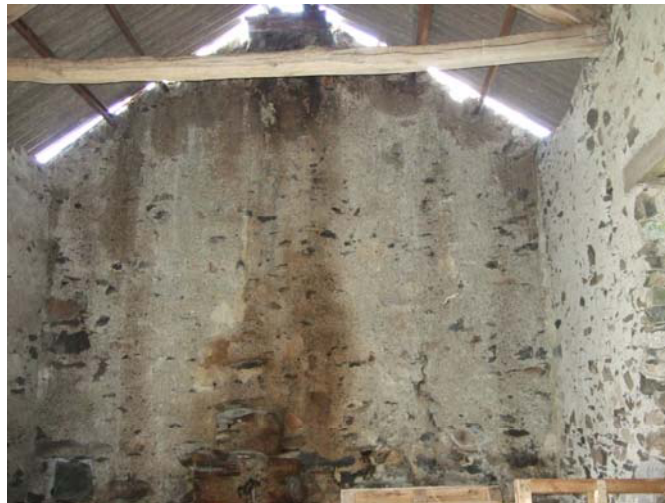
Plate 14 (right): North-east internal wall of the threshing barn, showing the corbelled chimney stack on the house (photograph taken by Leck Construction Ltd)

5.1.3 One feature that perhaps does not fit with this dating is the apparent smoke hood at the south-west end of the main farmhouse. The arrangement of the farmhouse at Low Flan Farm is fairly typical of the small 'two-unit' plan, which often had a fireplace with a smoke hood at one end and a chimney stack at the other (Brunskill 2002, 64-65). While this form has its origins in the 17th century it did continue in use approximately the end of the 18th century (*op cit*, 189). Low Flan Farm could therefore be exhibiting evidence for an earlier structure incorporated within the surviving building, but it seems more likely that the smoke hood corresponds to the late 18th/early 19th century dated already suggested.

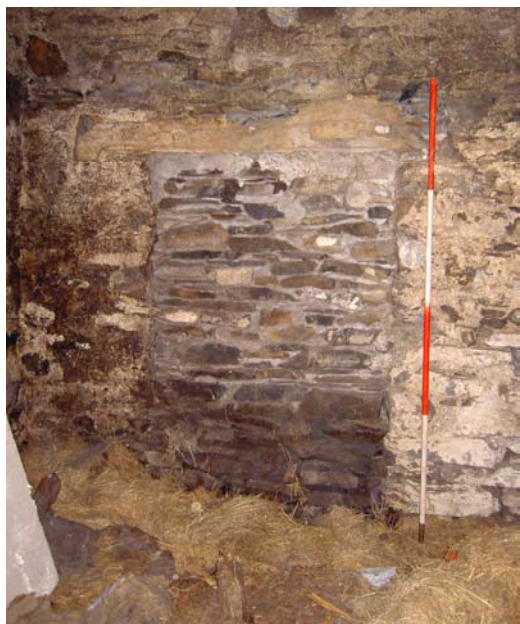
4.2.6 Other observations: although the outbuildings associated with the farmhouse were not examined in any detail the adjoining threshing barn was investigated in order to aid the interpretation of the house and the shippon and other outbuildings. The threshing barn evidently originally had a hay loft at its south-west end as there are blocked pitching doorways in both the south-east and north-west elevations. There is also a blocked doorway in the south-west end of the barn, which is remarkable because it has a re-used piece of timber forming its lintel with a neat roll moulding that curves down at the south-east end (see Plate 15 and Plate 16). The significance of this piece of timber is not clear but it has evidently come from a much earlier building, and one with some sense of ornamentation, which may link this site to the earlier property recorded as existing somewhere in the locality. It was also notable that at least one of the trusses within the barn was constructed from re-used timbers, probably parts of former cruck blades. While this is not uncommon (see Brunskill 2002, 152-153), it is reasonable to suggest that this timber might also have come from an earlier building close to or on the present site.

Plate 15 (left): Blocked doorway in the south-west end of the barn with re-used timber with moulded decoration (photograph by Greenlane Archaeology Ltd)

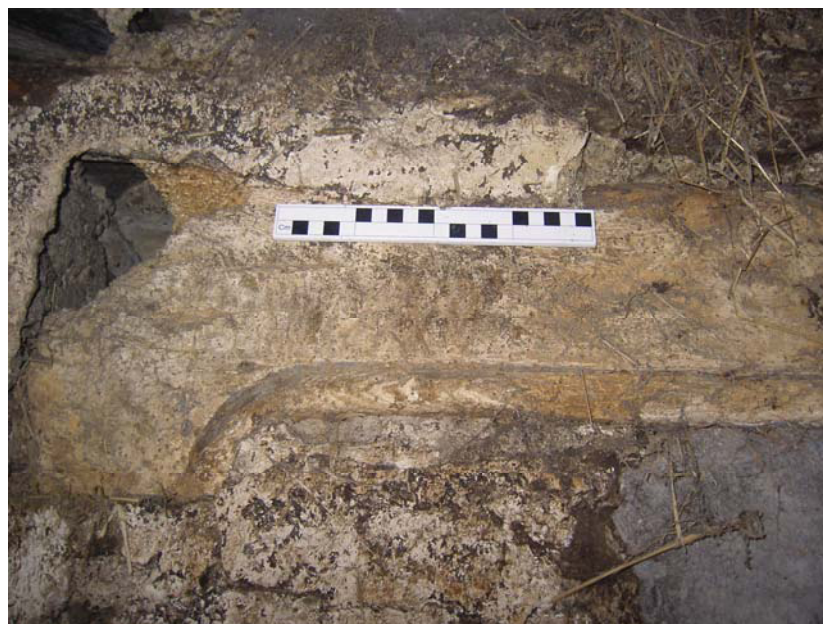
Plate 16 (right): Detailed of the re-used timber in the barn (photograph by Greenlane Archaeology Ltd)
