# SLACKWOOD FARM, SILVERDALE, LANCASHIRE

## Archaeological Desk-Based Assessment

Planning ref.:  
09/00367/CU, 09/00368/LB

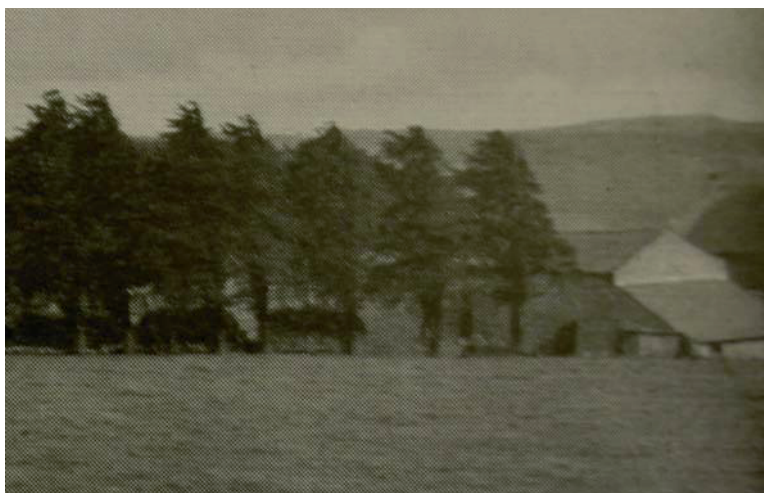
**Plate 1: Part of a photograph dated c1945 showing the west end of the north elevation of the barn (after Wood 1946)**

3.2.6 Slackwood was occupied by a number of other tenants while owned by Leighton Hall, including Douglas Fishwick, who was at Slackwood from at least 1952 and was preceded at the site by his father. Douglas and his wife, Barbara, were married in 1952 and remained at Slackwood until his death in 1976. Barbara's recollections of Slackwood are presented in *Appendix 3*; they reveal that although some additions were certainly made while she was resident, they were largely minor and comprised the addition of outshuts for storing milk, including the one on the north side of the barn, and the like. The farm was evidently still quite basic at this time, however, as it had no mains electricity or a proper bathroom, and there was an external wash house and Lister engine providing power. Many of these alterations were made during the ownership of Leighton Hall, which also oversaw the addition of the silage clamp on the north side of the barn, and the creation of the engine house and milking parlour (Richard Reynolds pers comm.) Two cowhouses were also added to the north of the barn, and from 1977 onwards a falconer was housed at the site who kept his birds in the small building adjacent to the north-west corner of the house (Richard Reynolds pers comm.). A photograph dated c1945 showing the west end of the north elevation of the barn provides some detail of the building at this time (Plate 1) – it demonstrates that the lean-to outshut against the west elevation was present by this date and that the concrete block addition to the west end of the north elevation had yet to be built, which corresponds with the anecdotal evidence that this cannot have been built before 1952 (see *Appendix 3*). There also appears to be a smaller, perhaps timber, structure in its place.

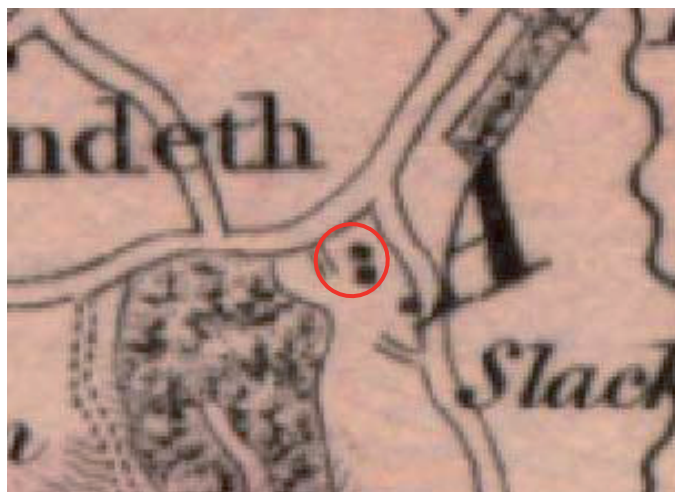
**Plate 2 (left): Extract from Hennet's map of 1830**

3.3.1 **Hennet 1830:** although Hennet's map is not very detailed (Plate 2) it does name the site and shows two buildings, which might correspond to the farmhouse and the barn to the north. A further building is shown to the south-east and there are what appear to be access tracks from the north-west and south.

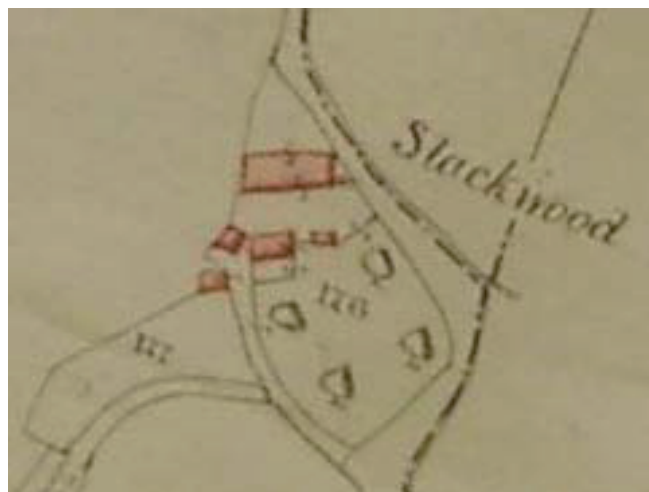
**Plate 3 (right): Extract from the Tithe map of 1846**

3.3.2 **Tithe map of 1846:** the tithe map (LRO DRB/1/195 1846) shows the positions of the farmhouse and outbuildings in detail (Plate 3). It also shows additional features for the first time, such as associated outbuildings to the east and west of the house, an area of woodland (perhaps the orchard listed in the accompanying schedule (LRO DRB/1/195 1848)) to the south, and a lane providing access to the south, which is only hinted at on Hennet's plan. Curiously the barn and house appear strangely proportioned compared to their present arrangement. The barn seems much wider on this map and the house

appears to be rectangular in plan rather than square as it is now. It is not certain if this is an accurate representation, however.
