# DAVEY'S YARD, SALTHOUSE ROAD, BARROW-IN-FURNESS, CUMBRIA

## Archaeological Building Recording

Client:  
Barrow Borough Council

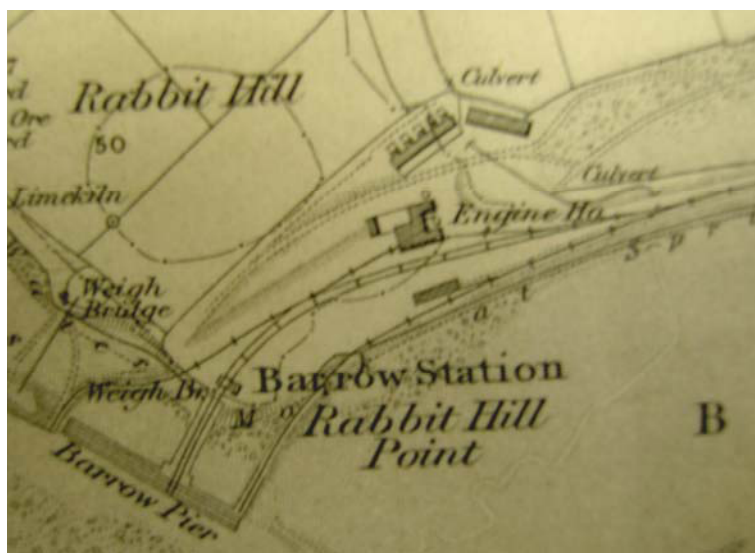
Plate 1: Ordnance Survey map 1851

3.2.2 **Ordnance Survey 1851:** this map (Plate 1) shows the location of the engine house near Barrow Station, prior to the construction of Salthouse Road, however, it is unclear whether any part or parts of these buildings are incorporated into the current site but this seems unlikely as the engine house is evidently some distance to the west of it.

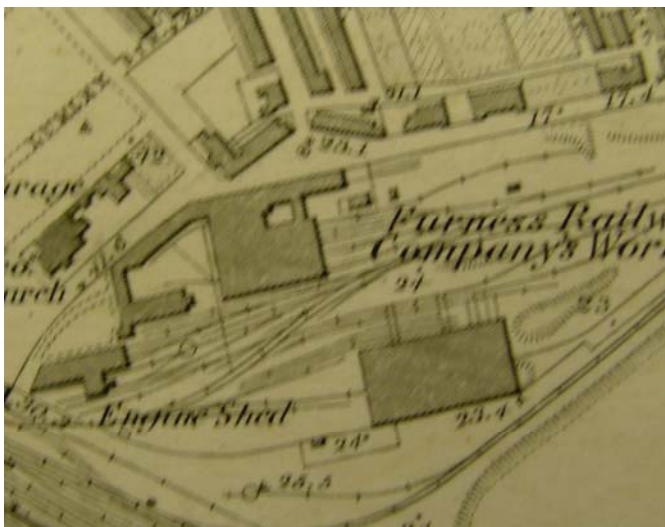
**Plate 3 (left): Ordnance Survey 1: 10,560 map c1873**

3.2.4 **Ordnance Survey 1873:** the buildings on site form a square block and the yard appears to have had additional buildings constructed to the south and west (Plate 3). The main road (Salthouse Road) is now shown to the north of the site. The yard is shown in more detail on the 1:2,500 map, with individual buildings demarcated (Plate 4), although it is difficult to ascertain which of these buildings relate to those depicted on the earlier map of 1851. There appears to be slight discrepancy with defining the western extent of the block of buildings between the two versions of this map. The 1: 2,500 map shows the western edge of the square block of buildings further to the east (more in line with the buildings on the north side of Salthouse Road); the 1: 10,560 map appears to show the western edge as being in closer proximity to the offices and engine sheds to the west.

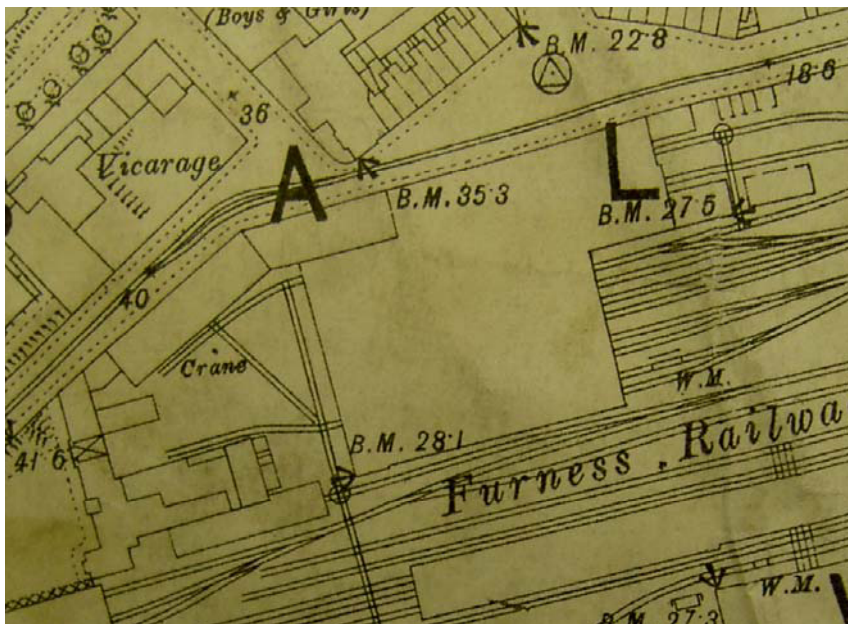
Plate 5: Ordnance Survey map 1891

3.2.5 **Ordnance Survey 1891:** the area previously marked as occupied by a crane at the north-east corner of the block of buildings in 1873 appears to have been built in by 1890 and the block of buildings has also been extended approximately in line with the one which fronted onto Salthouse Road (Plate 5). This extension possibly corresponds to the west end of Building 1. Originally, the boundary wall (highlighted in blue on Figure 1) formed the western external elevation of this block of buildings and follows the edge of the building immediately to the north and west onto Salthouse Road.

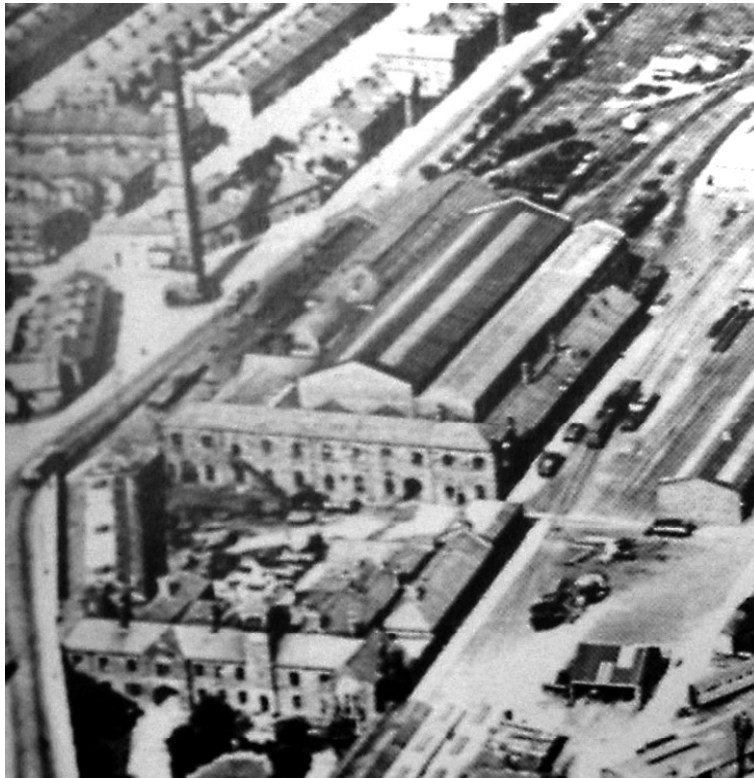
**Plate 8: The Furness Railway Company Engineering Works, c1920 (after Andrews 2003, 35)**

**3.2.8 Photograph of the Furness Railway Company Engineering Works c1920:** the arrangement of buildings to the south-east corner of the main block has again seen alteration; what was the erecting shop appears to have been extended to the east, jutting out beyond the eastern limit of the paint shop shown on the plan from 1903 (Plate 6). The western end of the block of buildings in this photograph now appears to closely correspond with the arrangement of buildings shown on Figure 1. No internal divisions have been depicted within the erecting shop on any of the earlier plans so this photograph is particularly interesting because it shows that the west elevation of the erecting shop was originally formed by three gable ends (Plate 8). Moreover, when this photograph was taken the building already appears to have been altered. The roof had been raised and now formed two separately roofed buildings; the building to the north (east end of which formed part of Building 2) spans two of the old gables and the building to the south incorporates the remaining one. The offices to the south and the fitting shop and store to the north and west are also visible in this photograph (Plate 8).

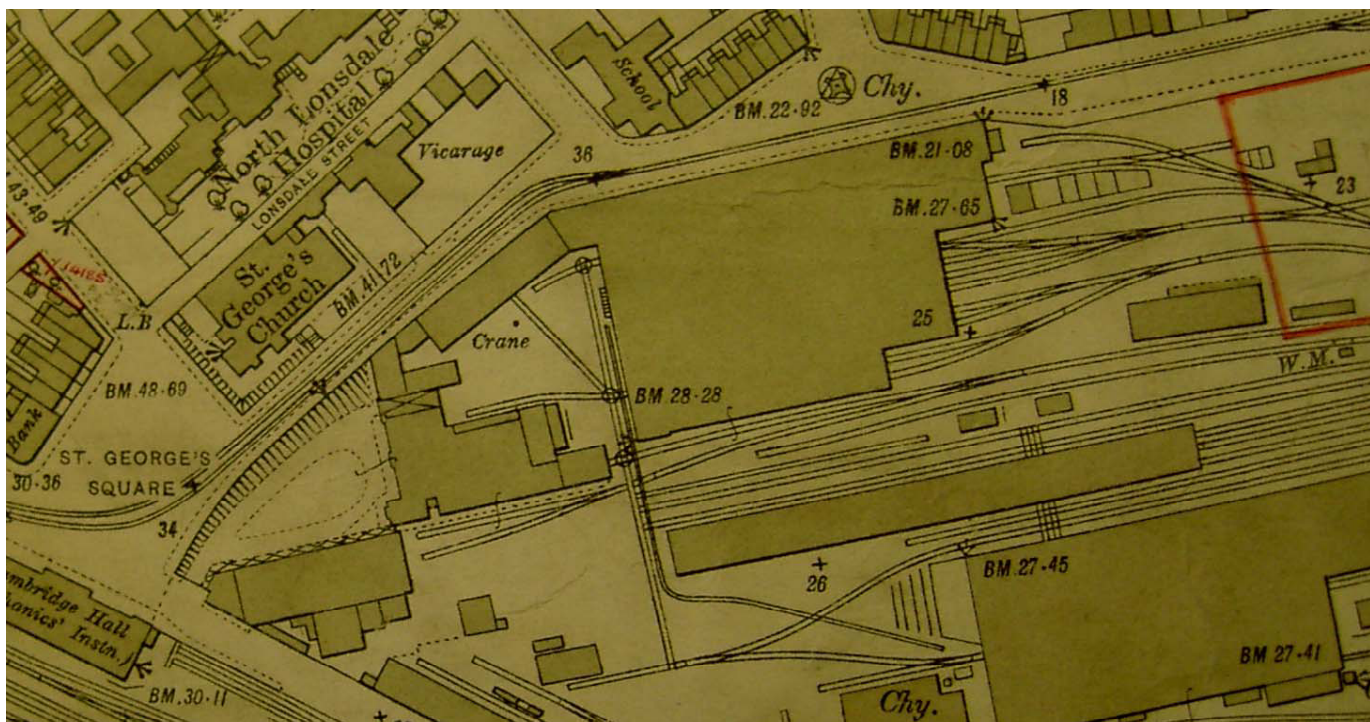
Plate 9: Ordnance Survey map 1933

**3.2.9 Ordnance Survey 1933:** this map records the layout of buildings which can be seen in the above photograph (Plate 8), with the characteristic kink to the south-east corner of the block created by Building 1 which is not aligned with the east elevations of Buildings 2 and 3. No detail is provided of the various workshops, stores and office buildings which make up the block.

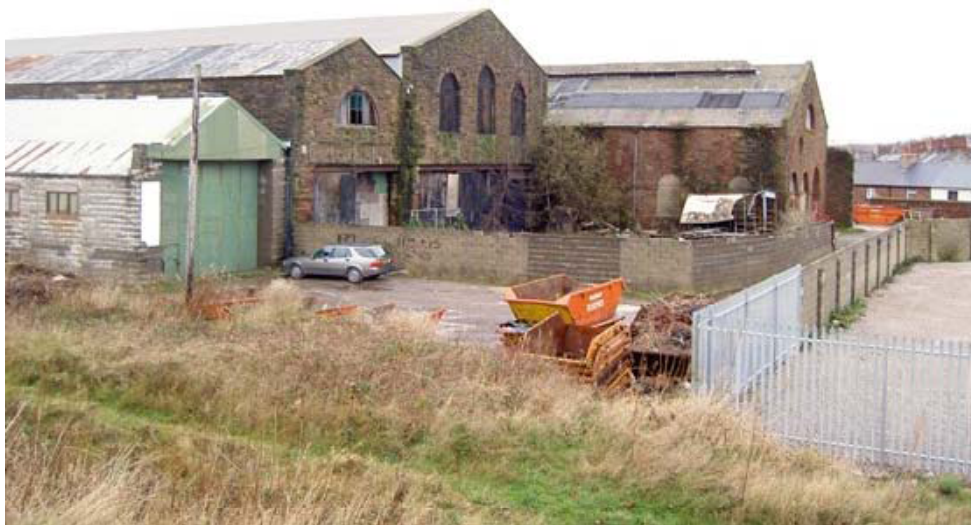
Plate 16: View of the buildings from the south-east

4.1.1 The site comprised a block of three large rectangular sheds which were orientated approximately east/west, with the north side facing towards Salthouse Road. Building 1 was slightly shorter than Buildings 2 and 3, forming a kink in the south-east corner of the block of buildings (see Figure 1). The buildings originally functioned as engine sheds and associated structures used by the Furness Railway Company, although the block was last used as a repair garage, with other commercial properties and office buildings located nearby. Internally the buildings extended over two levels but all comprised a large open space extending to the roof, with some derelict internal walls and recent concrete block additions (see Figure 2 and Figure 3), although it was evident that upper floors had previously existed in at least one area.

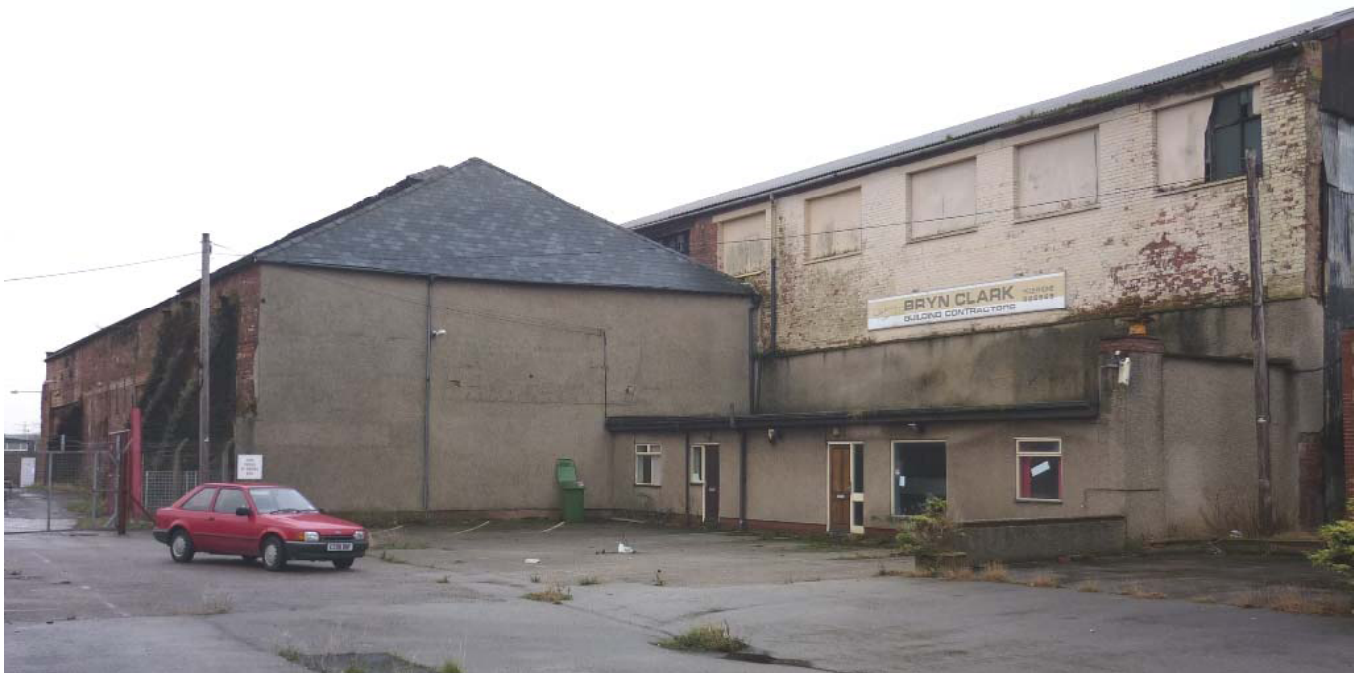
Plate 17: Oblique photograph of Building 1 and 2, viewed from the north-west

4.3.3 **West elevation:** the north side of Building 1 was finished with modern render and a hipped roof, which had been recently reslated and had modern plastic rainwater goods (Plate 17). The modern single-storey extension to this side of the building had a flat roof with a column at the north end. The west elevation of Building 2 was covered in two layers of corrugated metal sheets some of which were quite recent (Plate 19). There were also iron beams sticking through at approximately the same height as the top of the north wall and the remains of a curved roofline running through part of the corrugated sheeting (presumably indicating the location of the blister hanger mentioned in 1953 – see *Section 3.2.12*). The lower part of this elevation was partially rendered brick with ‘GARRY KENDAL/SHAUN BAYLISS/3.6.97’ scored into the render. The wall was brick built and encased iron I-beam columns. The bricks are quite rough, handmade and in laid English Garden Bond (with a ratio of five rows of stretchers to one row of headers). The elevation returns to the west, forming part of the north elevation of Building 3. The west elevation of Building 3 was not easily accessible but appeared to be constructed from brick which was built on top of an earlier and lower level sandstone gable (Plate 28).

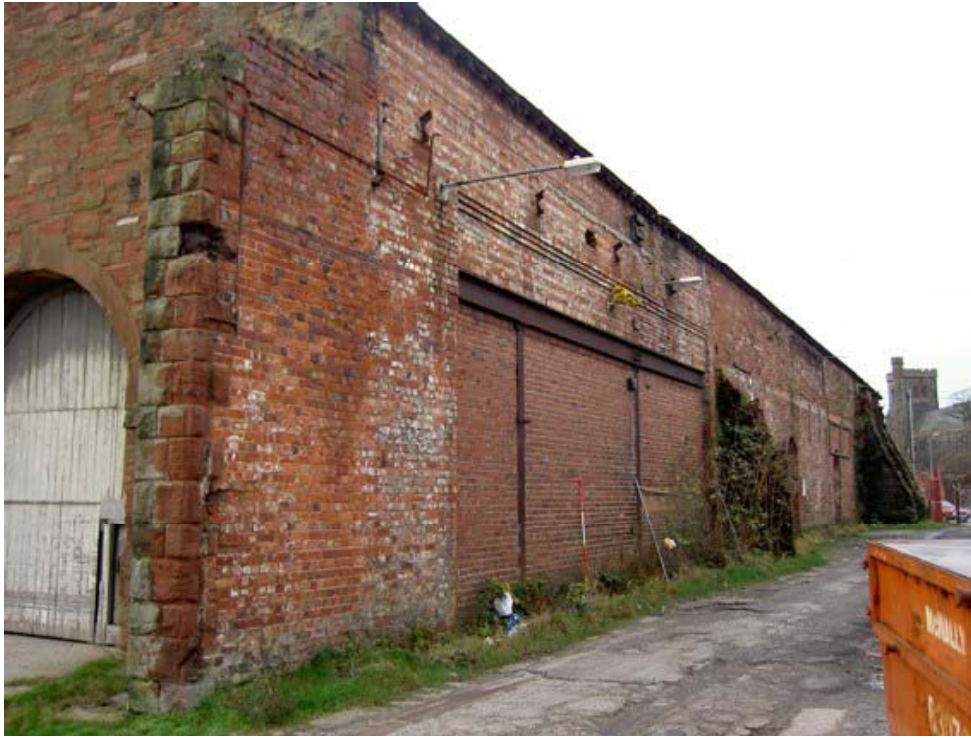
**Plate 18: North external elevation of Building 1**

4.3.2 There were three large concrete buttresses at the east end of Building 1 which supported the ends of steel I-beams (Plate 18). The bulk of the north elevation of Building 1 was randomly constructed from coursed sandstone with four courses of brick three quarters of the way up. There were five large round-headed doorways, three of which were blocked with sandstone. Two of the doorways housed modern doors and there were timber battens attached across the elevation which had presumable originally held signs. There was a section projecting northwards at the east end, with a rebated end, possibly for a door, which evidently originally extended further to the north. Beyond this, to the north the wall continues as an evident extension constructed from a steel structure, comprising a large iron I-beam with two I-beam columns bolted to it, in filled with a machine made red brick in laid in English Garden Bond (with a ratio of three rows of stretchers to one row of headers). Beyond this the rest was constructed from pale orange brick, alternating headers and stretchers. The cut ends of former steel trusses were evident below the eaves and a concrete scar denoting were the associated roof had been, as well as one end of what was possibly a horizontal girder, further indicating the former presence of another building to the north. There was also some evident rebuild in neatly dressed sandstone in the upper part of the junction between the brick extension and the stone forming the majority of the elevation. The east end projected beyond the east elevation forming a stub wall, which was constructed from brickwork but the end finished with sandstone blocks.

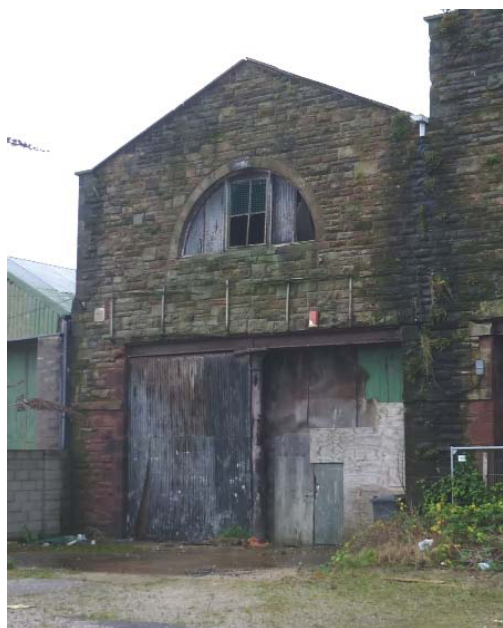
Plate 20 (left): East external elevation of Building 3

4.3.4 **East elevation:** the south end of the elevation, corresponding to Building 3, was constructed from random courses of ashlar blocks with dressed sandstone quoins at the south corner (Plate 20). There was a slight plinth at first floor level. The first floor had neat coping along the apex (apparently constructed from concrete slabs though) and a semi-circular window with a three-light casement (although originally it had more lights). The lower floor had a wide opening which was spanned by a large I-beam (possibly in two parts?), which was supported by iron columns with double flanged tops. The centre of the elevation (Building 2) was of the same construction as Building 3, but with three tall, round-headed windows on the upper floor with quoined jambs and arch, all of which were filled with corrugated sheeting (Plate 21). There was sandstone coping along the apex. The lower floor had a large opening with a massive iron I-beam (in four parts) above, supported by three flanged columns. The north end of the elevation (Building 1) was of a similar build again, but comprised less uniform blocks (Plate 22). The upper level had coping (which was thicker than that to the south) and one semi-circular window and one round window to the south. The semi-circular window was covered with boards; the round window with timber slats. The lower level had three large round-headed doorways, with a square string course. The lower part of the south doorway was partially blocked with brick to leave a small window with a sandstone lintel; the upper part was boarded up. The string course continued across the two most southerly apertures. The central doorway was blocked with brick and rendered, while the northern, and largest, doorway had a sliding door made of planks which also incorporated another smaller door. The projecting return to the east at the north end of the elevation had neatly dressed quoins.

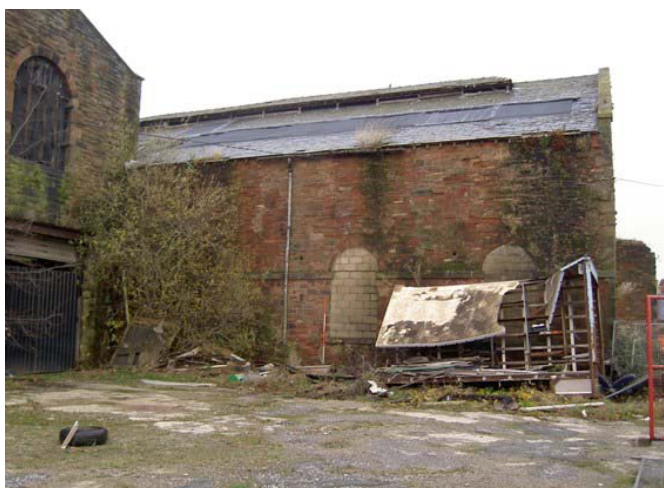
Plate 23 (right): South external elevation of Building 1

4.3.5 **South elevation:** the east end of the south elevation (Building 1) had dressed blocks in random courses, with a string course (Plate 23). There were three windows on the lower floor which were blocked with concrete blocks. The roof had further glazed areas covered with felt below the louvre and modern rainwater goods. The lower part of the rest of the elevation (corresponding with Building 3) was obscured by an adjoining building (Plate 24). At the east end the upper part was built using neatly dressed ashlar blocks and there were at least four windows on the first floor level which possibly had timber lintels. Further west the elevation was obscured by corrugated sheets and the far west end was constructed from brick with multiple round-headed windows on the upper floor. The roof of Building 3 was corrugated sheeting.

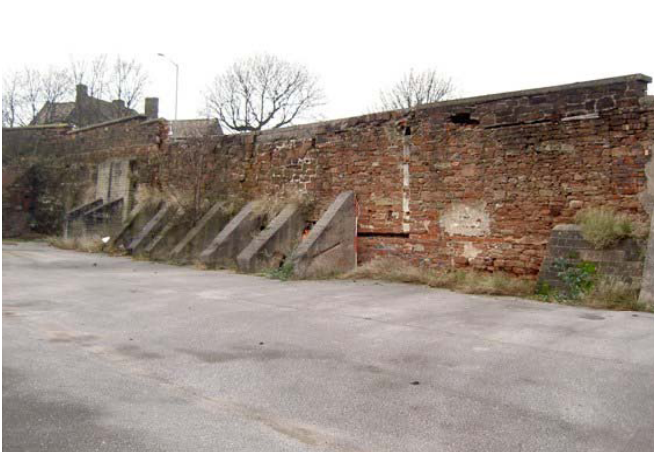
**Plate 25 (left): Buttresses against the west end of the northern boundary wall**

4.3.7 **Boundary wall** (Figure 5): the majority of the boundary wall was located to the west of the main group of buildings, with a short section to the north-west. The southern section of this boundary wall corresponds to the west wall of what were the fitting shop and offices to the south; the return to the west as well as the most northerly section of the wall formed part of the stores (see *Section 3.2.3*). There were several modern concrete buttresses against the west side of the northern section of the boundary wall, which was otherwise unremarkable although it was in poor condition and had evidently been subject to various attempts at repair (Plate 25). The east face of the western wall contained a large round-headed doorway, which had been blocked with sandstone although the original blocking had evidently left a smaller doorway that had also subsequently been blocked. The top of the wall had also been levelled with the addition of a few courses of red brick (Plate 26). The return to the east also had a large round-headed doorway that had been partially blocked to leave a smaller round-headed doorway before this was blocked with concrete (Plate 27). The subsequent return to the south had brick rebuild in at an angle at the corner, possibly forming part of a flue and there was an area of rebuild in concrete blocks at this point. There was a further large round-headed doorway after the return to the south, followed by a large number of round-headed windows across the centre of the wall the majority of which were obscured by the block of garages and were more readily visible from the west side of the wall (see *Section 4.3.6*; Plate 28).

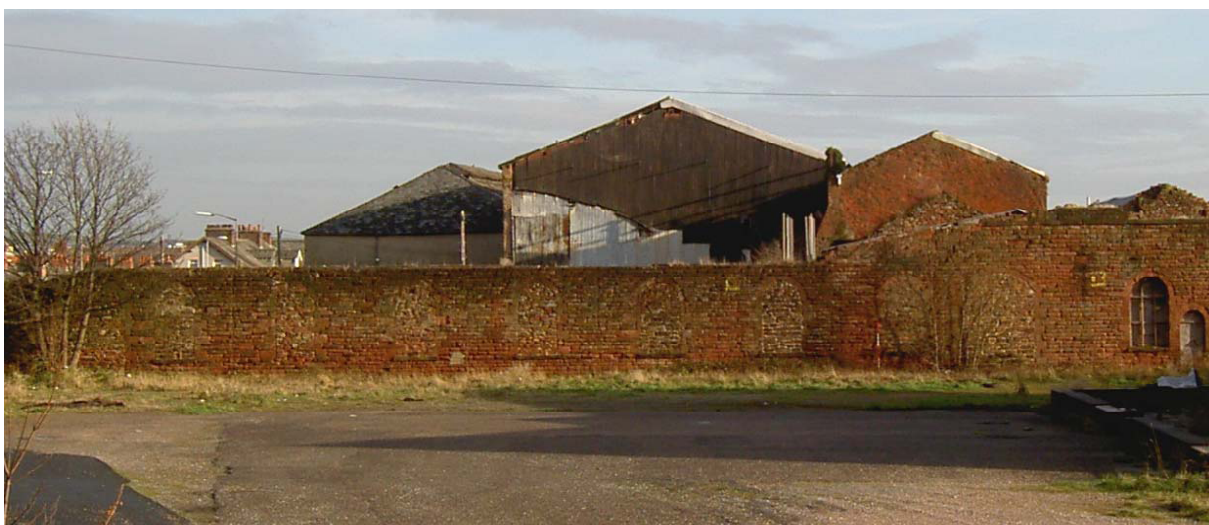
**Plate 28: West external elevation of Buildings 1-3 and the boundary wall**

4.3.8 The west side of the boundary wall was similar in appearance to the east elevation, although the north end was largely obscured by a large bank running alongside the road (Plate 28). There was the ruinous stub of a wall projecting to the west at the return, also constructed from rock faced ashlar sandstone blocks with neatly dressed quoins at the junction. There was another smaller stub of a brick wall to the east, which probably formed a drain junction, and had a large circular hole in the wall above that was filled with an iron pipe. There was a large round-headed door to the east which was part-blocked with stone to leave a smaller doorway, which had subsequently been blocked with concrete blocks. Dressed ashlar quoins were used throughout. There was then a very long return wall to the south, which was of a similar construction to the rest, and had a round-headed window and a large door at the north end and then another row of seven identical round-headed windows to the south, which were all blocked with stone, including some re-used pieces. The windows each had a sandstone sill apart from one, which was missing. Most of the wall was flat-topped and capped with concrete. The south end was slightly higher and originally might have formed the gable. This end contained another large blocked doorway and a smaller doorway, retaining its door and frame, set between two windows with the remains of nine-light casements. This door was also round-headed with an over light and a string course along the top. There was a quoined return to the east at the south end.

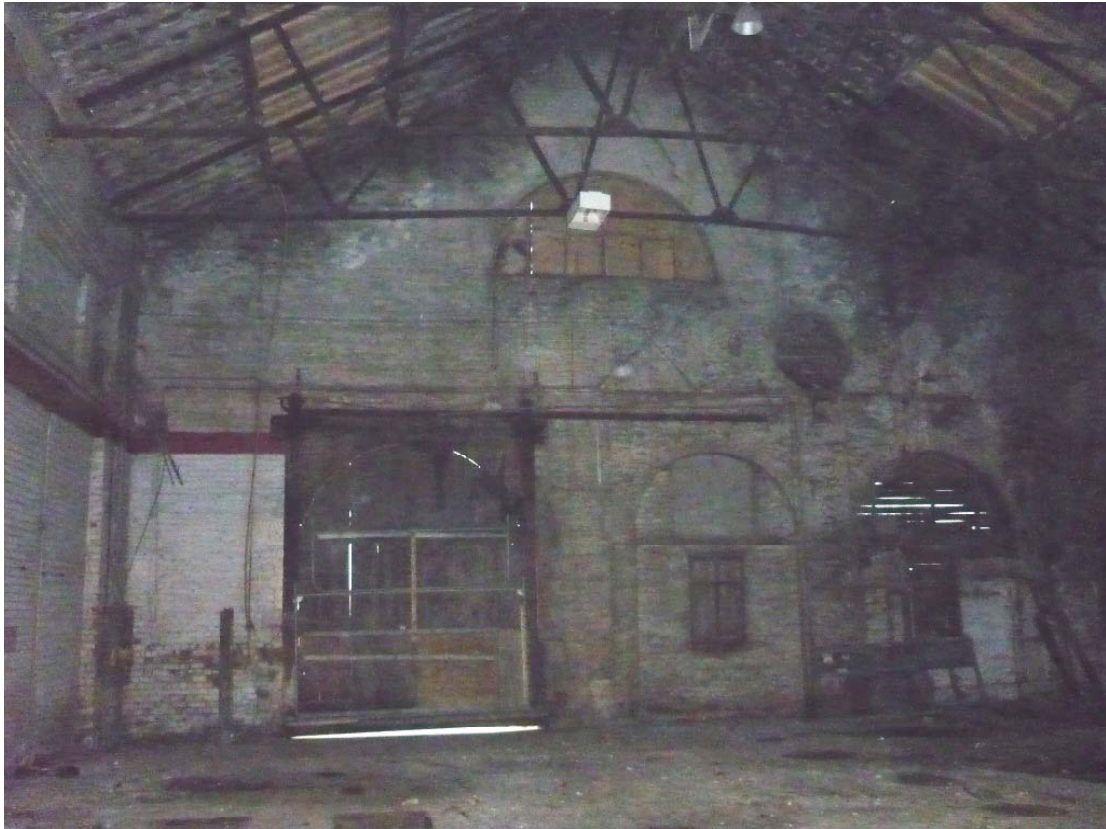
**Plate 29: Internal east elevation of Building 1**

4.4.5 **Building 1 - east elevation:** this elevation was brick built apart from the stone details around the apertures. The upper part had one semi-circular and one round window (Plate 30). The lower part of the wall had a large sliding door in a round-headed aperture to the north, and two smaller doors to the south, both of which were blocked. The more northerly of these two doors incorporated a lower four-light window and an upper opening which was blocked with concrete blocks. The south door had a lower three-light window in the upper part and a timber surround.

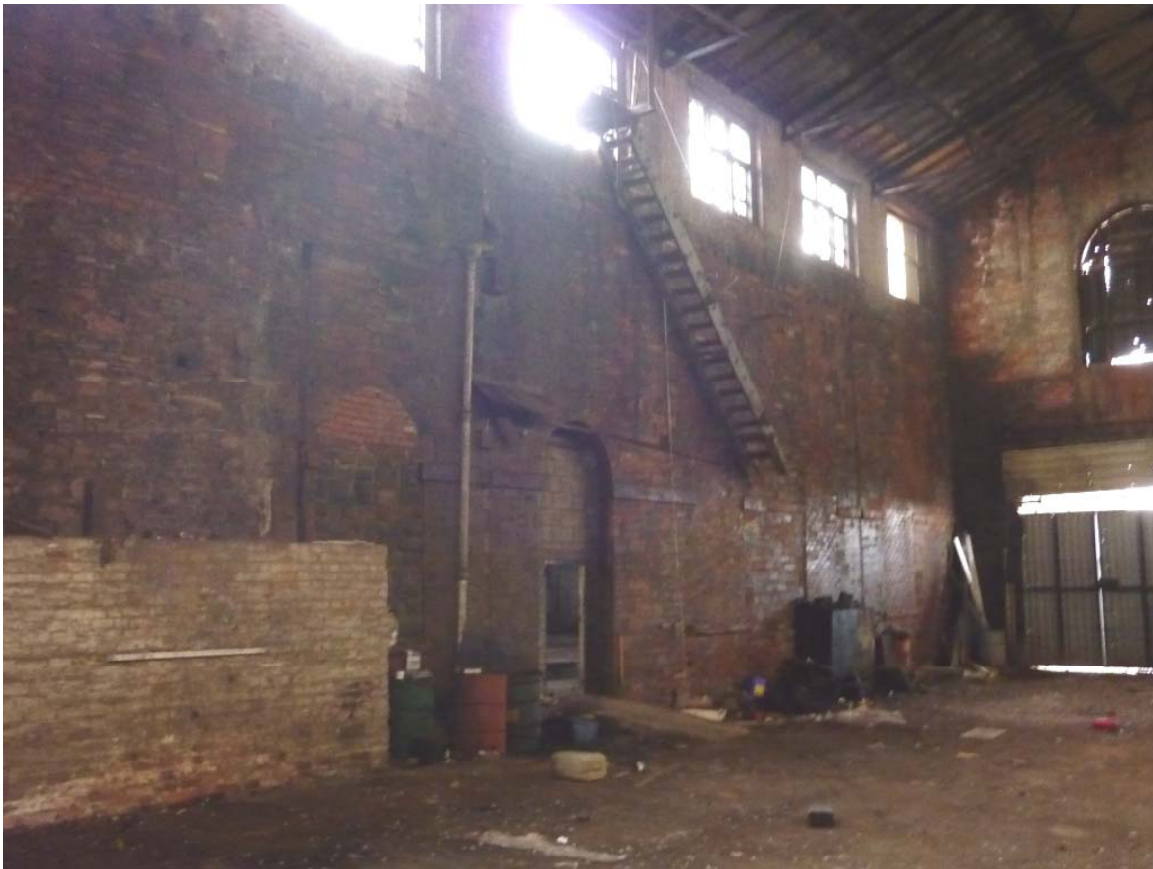
Plate 30: Ladder in the north-east corner of Building 2

**4.4.7 Building 2 - north elevation:** the lower level was built from stone, the east end using more neatly dressed blocks. There were five round-headed windows with sandstone sills, all of which were blocked apart from one, which had been partially blocked with concrete blocks and converted into a doorway with a shallow concrete ramp connecting it to Building 1. Further west much rougher stonework was used and there were at least four round-headed windows and one other large opening below an iron beam, all of which were blocked with brick. The upper level was built of brick with 12 large windows, each with eight main lights and some smaller panels within iron casements. There was a large ladder attached on the east side, leading from c3m off the ground to one of the windows (Plate 30). There was another low brick wall against this elevation (c0.5m away from it) constructed in an English Garden Bond (with a ratio of five rows of stretchers to one row of headers) and incorporating upright I-beams.

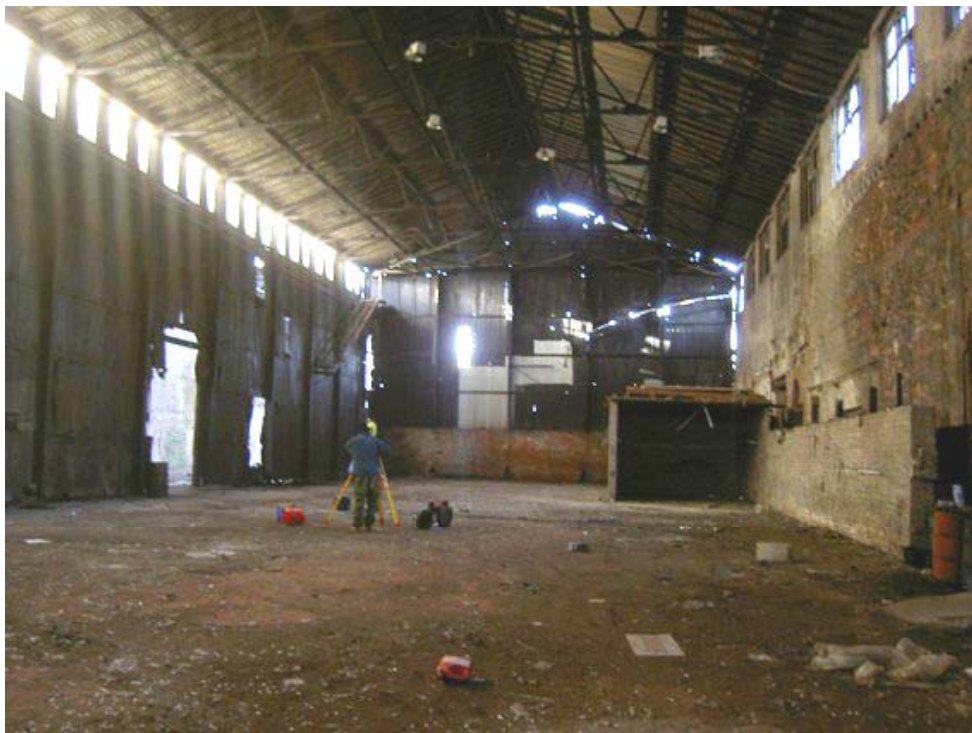
Plate 31: General view of the west end of Building 2

4.4.8 **Building 2 - west elevation:** the lower part of this elevation was constructed from brick in a stretcher bond, incorporating iron I-beam columns. The upper level comprised corrugated sheets fixed against the I-beam columns.

4.4.9 **Building 2 - south elevation:** the entire wall was constructed from corrugated sheets supported by upright I-beams (Plate 31 and Plate 32). There was a row of opaque corrugated sheets along the top forming windows, and a ladder attached at the west end similar to that to the north-east (Plate 31; see also Section 4.4.7).

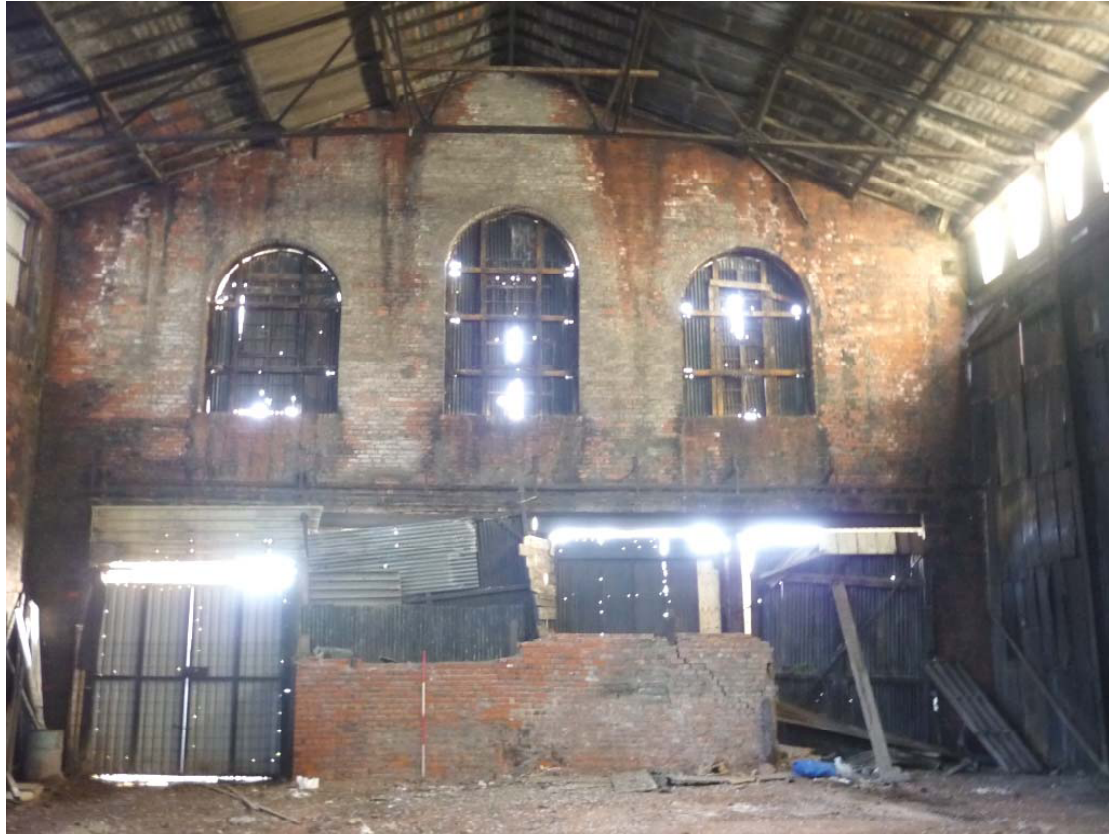
Plate 32: Internal east elevation of Building 2

4.4.10 **Building 2 - east elevation:** the lower part comprised a large opening formed by three flanged columns supporting a large iron I-beam. The north side of this opening was constructed from brick and butted the north elevation. The upper part was brick-built in English Garden Bond (with a ratio of three rows of stretchers to one row of headers). There were three large round-headed windows covered by corrugated sheeting. Against the ground floor was a short stretch of poorly made brick wall in English Garden Bond (with a ratio of five rows of stretchers to one row of headers), with a large upright iron I-beam against the north end. This was effectively ruinous along the top and at the south end and utilised hand-made brick.

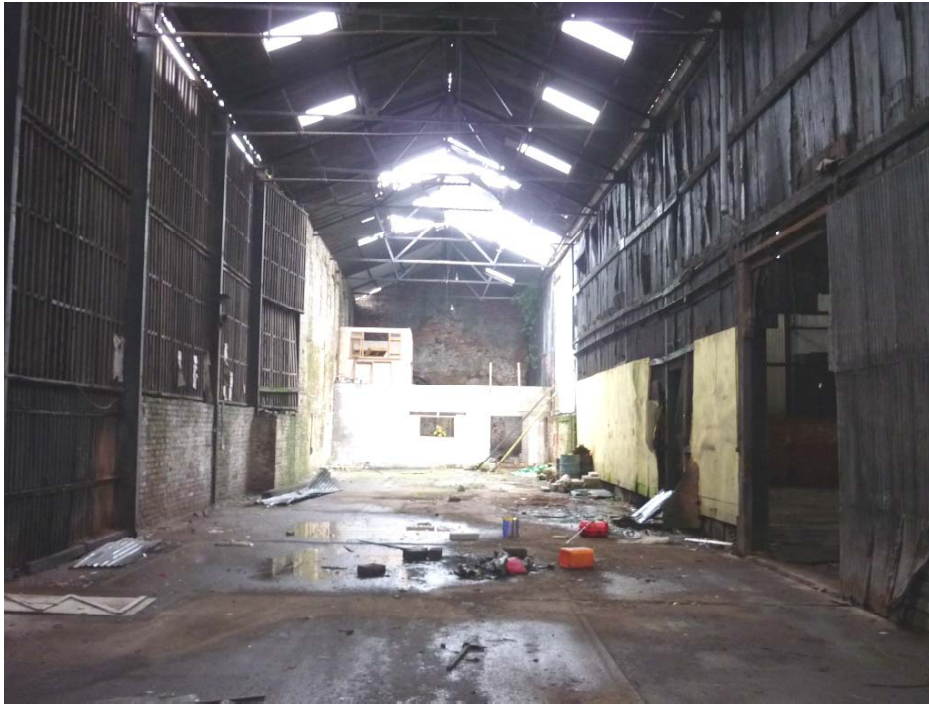
**Plate 33: General view of the inside of Building 3, facing west**

4.4.11 **Building 3 - floor and roof:** the floor was concrete and had been laid in sections (Plate 33). The roof was the same as in Building 2 (see Section 4.4.6), with 15 trusses. The four in the centre had pipe attached below.

4.4.12 **Building 3 - north elevation:** this elevation mostly comprised corrugated sheets attached to upright I-beams (seen to the right on Plate 33). There was a sliding door in the centre and the west end of the elevation had a low brick wall constructed in English Garden Bond (with a ratio of five rows of stretchers to one row of headers) clad around the iron columns with the corrugated sheets on top. There were two concrete block pillars at the west end supporting iron I-beams orientated north-south.

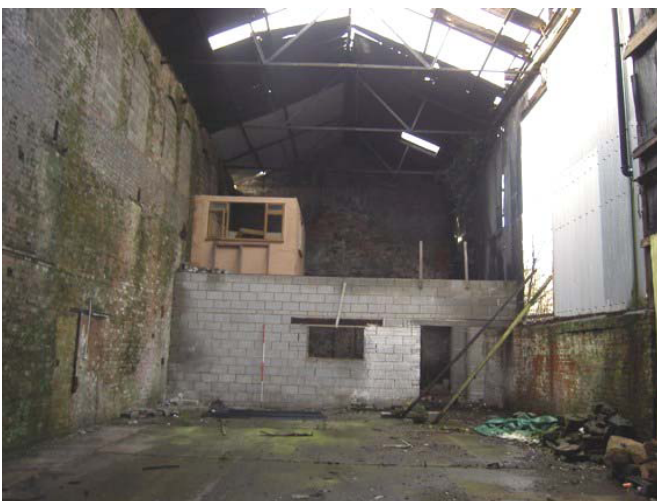
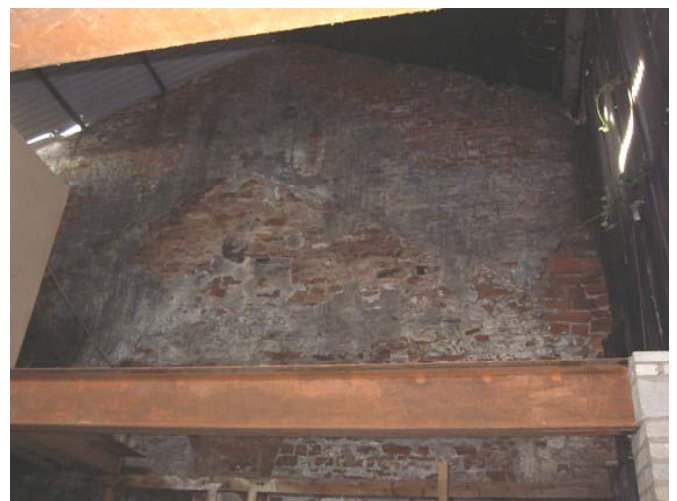
**Plate 34 (left): Detail of the west end of Building 3**

4.4.13 **Building 3 - west elevation:** the west end of the room had an inserted concrete block built wall which supported a timber floor on the south side. This wall had a single window with an iron box girder lintel, and a door to the north with a concrete lintel (Plate 34). The lower section of the west elevation proper was sandstone, and formed the gable of an earlier building, perhaps extending to the north to form a second gable (Plate 35). The sandstone section housed two large doorways with round-headed arches, both of which were blocked with stone (Plate 36), the southern one leaving a slight alcove, and there was a further recessed area on the south side. This was covered by heavy boards and blocked with brick, including some firebrick in the top which suggests that this area had perhaps incorporated a flue. The upper part of the wall had been raised in brick and this elevation was butted by the north and south elevations.

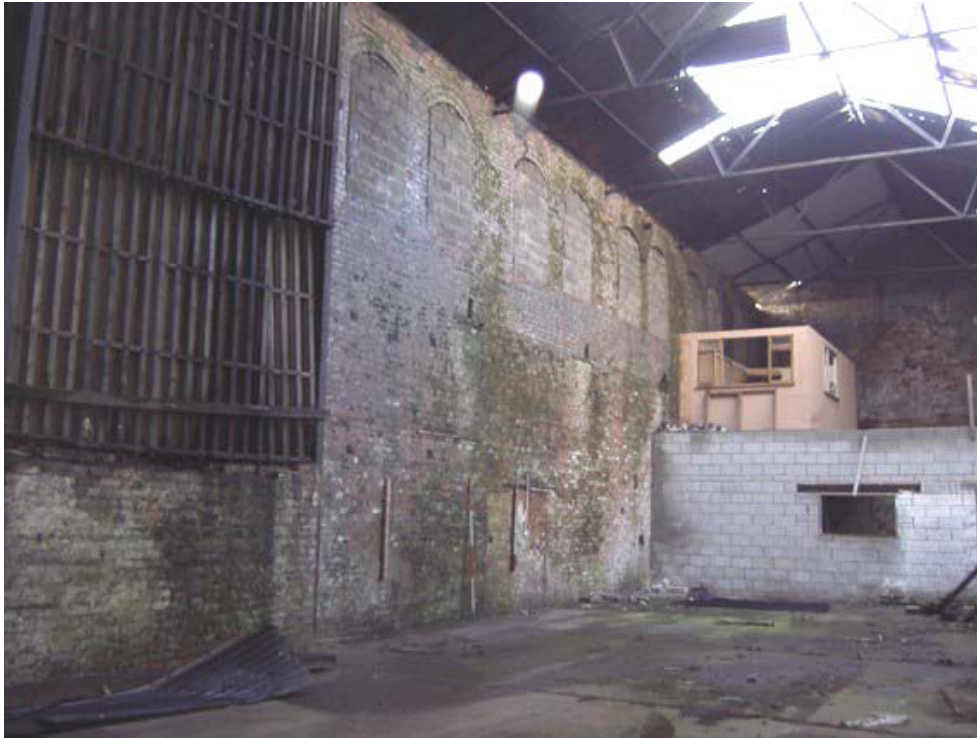
**Plate 37: Internal south elevation of Building 3**

4.4.14 **Building 3 - south elevation:** the west end was constructed from brick, in English Garden Bond (with a ratio of three rows of stretchers to one row of headers) and the upper level had nine blocked, round-headed windows (seen on the left in Plate 34; see also Plate 37). There was also the cut off end of a large iron I-beam indicating that there had originally been an upper floor at the west end of the building. The lower part of the wall had two doorways, which were blocked with brick, one round headed and the other apparently inserted beneath a brick relieving arch. There were two concrete pillars against this elevation, which supported the modern floor at the west end. There was a slight return to the east which formed a projecting section where the iron columns started (seen on the left in Plate 33). The lower level continued in brick clad around I-beam columns. There were two separate toilet cubicles with a lobby within a modern brick-built structure against the east end of the elevation. The upper section of the central part of the elevation was made from corrugated sheets clad around columns. The upper part of the east end was brick built and contained four windows, three of which had six-light iron casements.

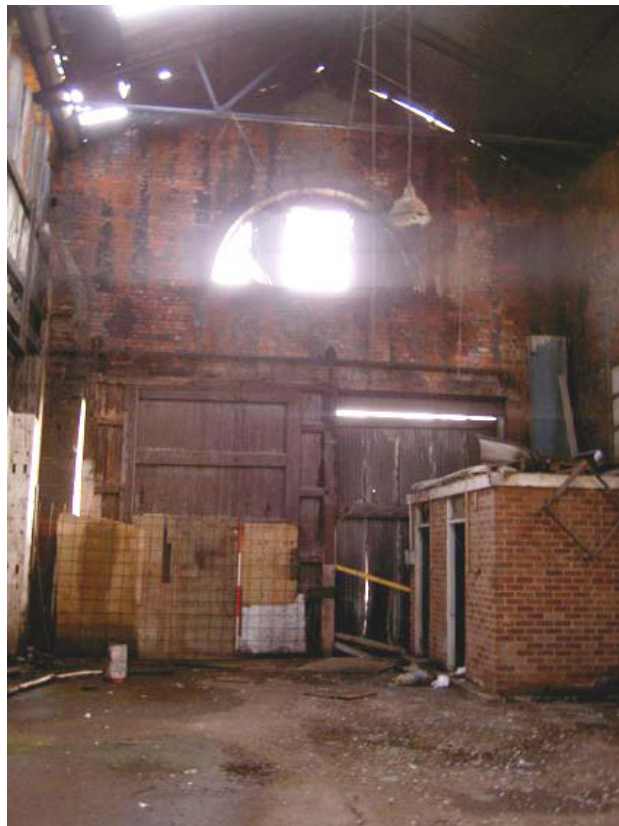
**Plate 38: Internal east elevation of Building 3**

4.4.15 **Building 3 - east elevation:** the lower part had a wide opening with stone quoins and a central round column with a flanged top. The upper part was built from brick in English Garden Bond (with a ratio of three rows of stretchers to one row of headers). There was a semi-circular window with a stone surround and the remains of a frame.
