CONISHEAD PRIORY, ULVERSTON, CUMBRIA

Archaeological On-Site Assessment

Client:
New Kadampa Tradition –
International Kadampa
Buddhist Tradition
NGR: SD 5145 9305
© Greenlane Archaeology Ltd
June 2009

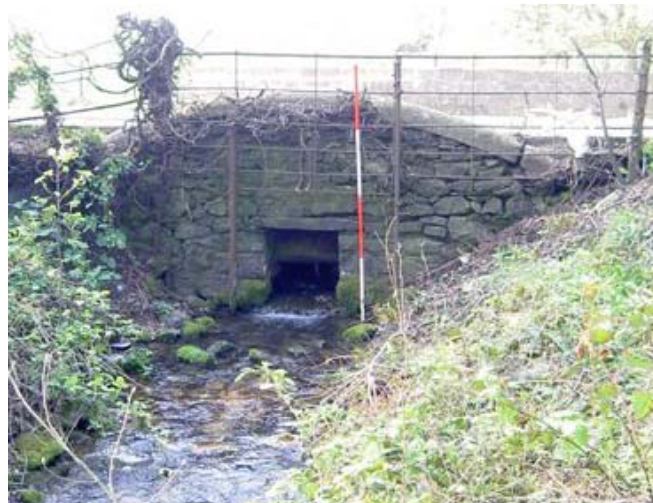
Plate 1: Culvert under the coast road at the north end of the estate (Site No. 101), looking west

Description: this culvert (Plate 1) runs under the coast road from the west side where the beck which supplies the fishpond (Site No. 112) originates. The facing of the culvert is constructed of limestone rubble with a low arched parapet 4m wide, the arch being approximately 0.5m above road level. The arch is topped with rounded coping stones.

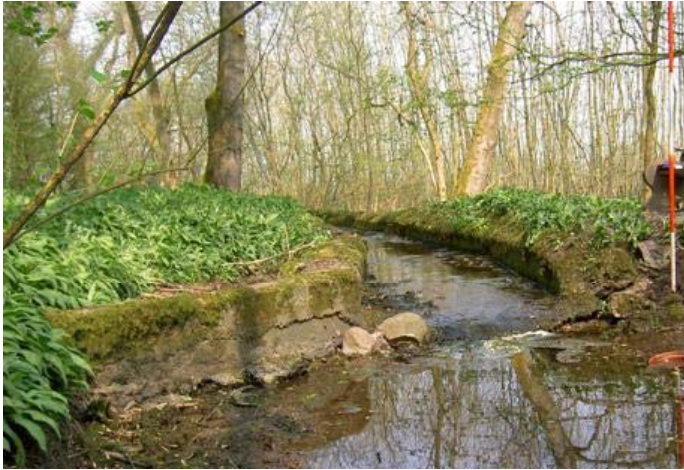
Plate 2 (left): South end of canalized section of beck (Site No. 102), looking north

Description: the beck which feeds the fishpond (Site No. 112) has been canalized approximately 170m north of the fishpond, for some 90m (Plate 2 and Plate 3). The canal has been constructed of concrete and is 1.4m wide, with the sides being 0.3m high and 0.35m wide.

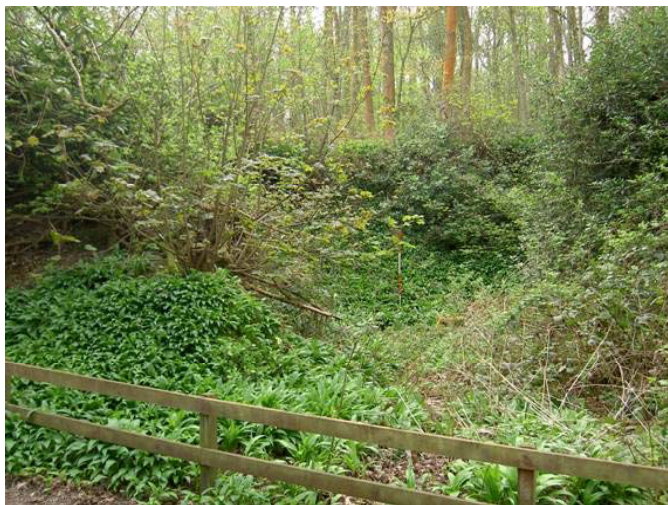
Plate 4 (left): Disused quarry (Site No. 103), looking west

Description: this feature (Plate 4), which is under dense undergrowth, is situated on the north side of Hermitage Hill, adjacent to the road running between North Lodge and Conishead Priory. The quarry, cut into the limestone bedrock of the hill, is circular in shape, approximately 15m in diameter. The west side is 4m in height and the bottom of the quarry is roughly level with the road.

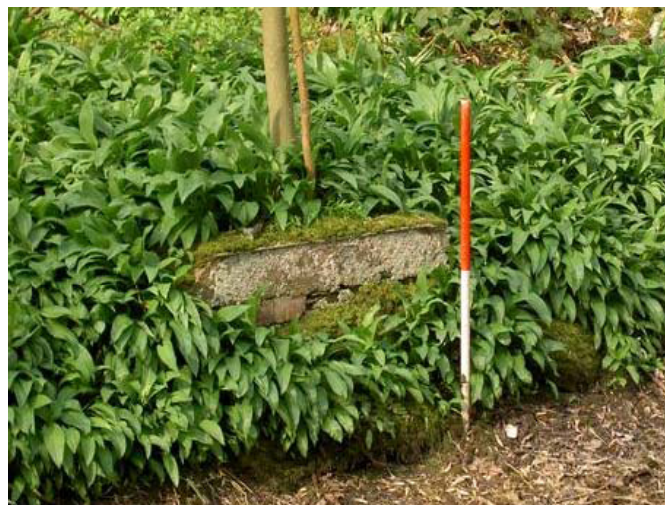
Plate 5 (right): Base of Hermitage Hill Bridge, west side (Site No. 104)

Description: site of a bridge described by the Ordnance Survey maps as a wooden bridge (1850), and foot bridge (1891). The site of this bridge is located 34m north of the fishpond across the beck. Only the brick bases on either side of the beck survive. The bases are constructed of red brick, which is capped

Plate 5). The bases are 0.5m high by 0.94m long and 0.27m deep. The span of the bridge would have been 3.4m.

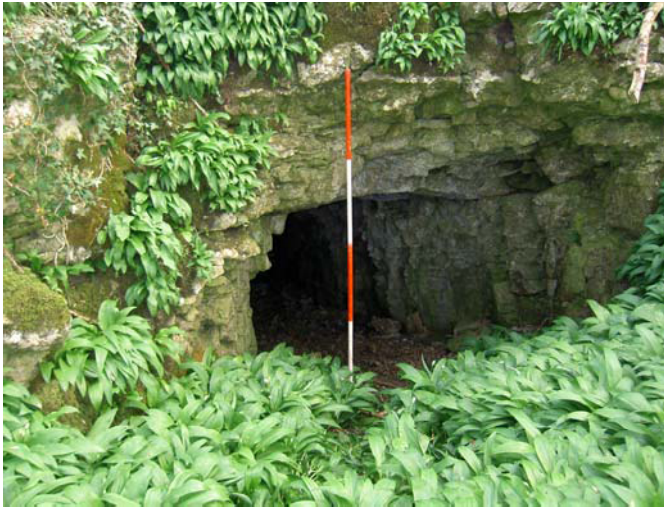
Plate 6 (left): West entrance of the Grotto (Site No. 105)

Description: this is a deep grotto just east of the remains of the hermitage (Site No. 106). The grotto is situated within an outcrop of limestone, approximately 20m square, near the summit of hermitage Hill. The grotto is roughly circular with a thick pillar of rock situated centrally, creating a doughnut shape. There is an entrance on the west, 5m in length, with a 2.5m opening which narrows to 1.9m and slopes down by some 0.5m. On the north side of the outcrop there is another entrance which is approximately 1m wide and 2m deep. On the west side of the cave is a recess 1.4m deep by 1.6m wide and 1.4m high. The width of the grotto between the outer edge and the pillar varies between 1.5 and 2m. On the south side of the grotto is a dry-stone wall approximately one metre thick by 1.3m high, leaving a small gap to the roof.

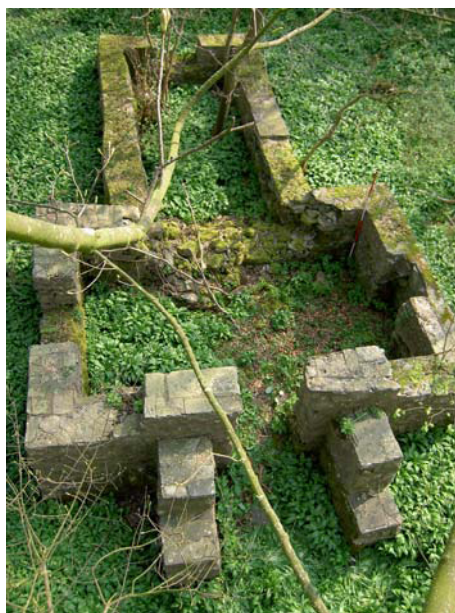
Plate 8: The hermitage (Site No. 106), viewed from the west

Description: a small building, cruciform in plan, orientated east-west, constructed of limestone rubble, with walls standing no higher than 1.5m. Some work has been done to preserve the remains as the walls have been heavily pointed with concrete and capped with roof slates. The partition wall has collapsed and shows no evidence of a doorway. There are doorways at the east and west ends of the building, with the west end having a porch. At the west end of the building on the south wall is a recess and on the opposing side is the only window left extant. The inside of the building is overgrown and no interior features are extant.

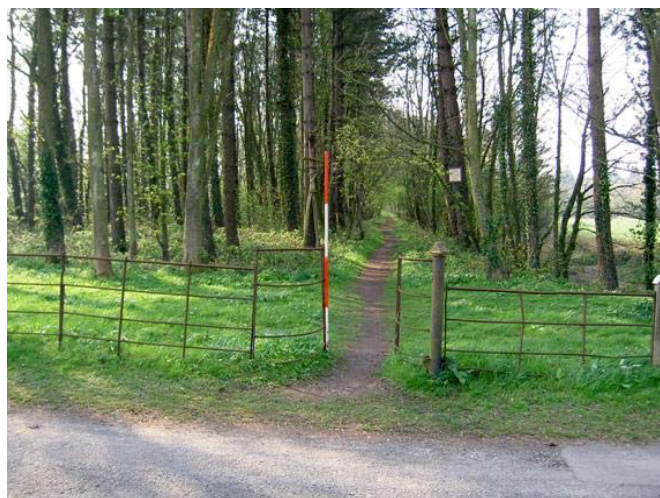
Plate 9 (left): Railway embankment (Site No. 107) taken from Priory crossing, looking south

Description: a small section of the Bardsea Branch of Furness is within the grounds of Conishead Priory, accessed by a path from the priory to the east which leads to Priory crossing. The railway had been dismantled by 1953 but the embankment is extant, approximately 200m of which is within the estate. The embankment is 40m wide and some 2.5m in height and is now covered in woodland. A path runs down the east side (Plate 9).

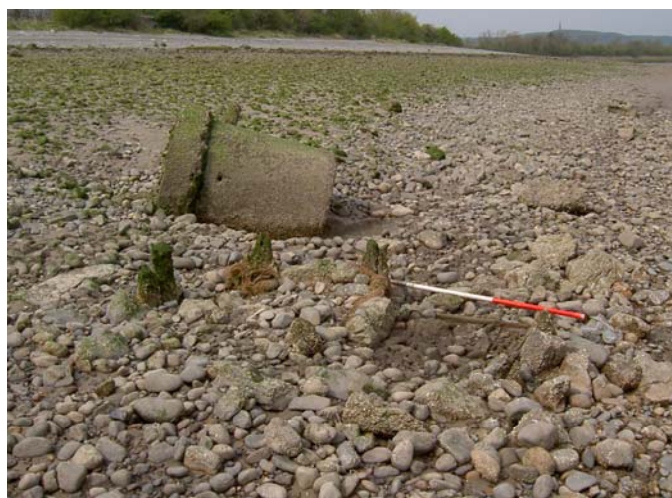
Plate 10 (right): remains of a small jetty (Site No. 108), looking north

Description: remains of a jetty (Plate 10) situated on the shore between low and high tide. The remains are 6m in length and 1m wide, comprising timber uprights and planking at the west end. This planking appears to have been the remnants of boxing which was packed with stone. On the north side are the remains of a concrete waste pipe outlet.

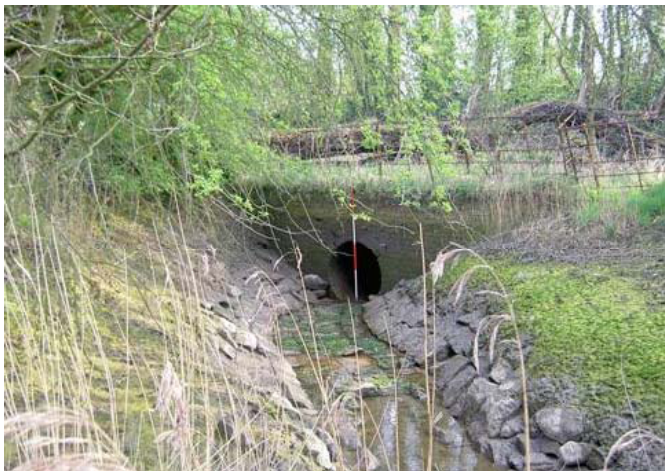
Plate 11 (left): South end of embankment culvert (Site No. 109), looking north-east

Description: this culvert is situated on the west side of the railway embankment (Site No. 107), the entrance is at the south end (Plate 11), running parallel and under the embankment before exiting at the north end (Plate 12). The culvert is circular, approximately 1.2m in diameter, and constructed of brick. The base and lower sides of the beck preceding the entrance to the culvert have been laid with large rough-cut limestone blocks.

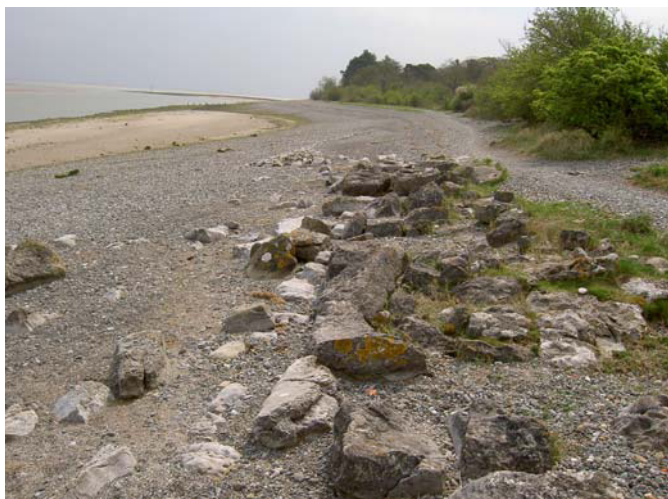
Plate 13 (left): possible remnants of breakwater (Site No. 110), looking south

Description: linear feature constructed from coarsely laid large limestone blocks and boulders running parallel with the shore (Plate 13). The feature runs for 23m and is some 4m wide before it narrows down to 0.5m wide, continuing for another 40m to the south.

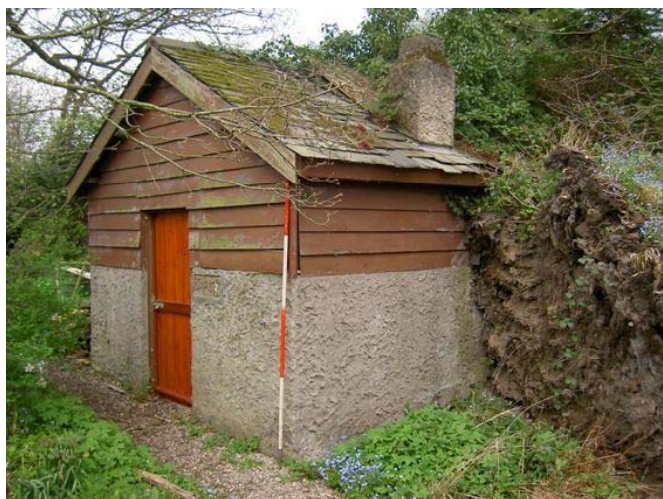
Plate 14 (right): The 'Smoke House' (Site No. 111) from the south-west

Plate 14) is situated approximately 45m east on the north side of the beck exiting the fishpond (Site No. 112). The building is square and measures 3.5m by 3.5m. Its lower half is constructed of stone walls 0.5m thick to a height of 1.3m and rendered, and the top half is constructed of timber planking. The south wall has a chimney and the gabled roof is slate with modern ridge tiles. There is a single door on the west elevation and a window on the east elevation. It is quite probable that this building is the Swiss fishing chalet which was renovated in the 1920's, although it is apparently now known anecdotally as the 'Smoke House', although the origin of this is not certain.

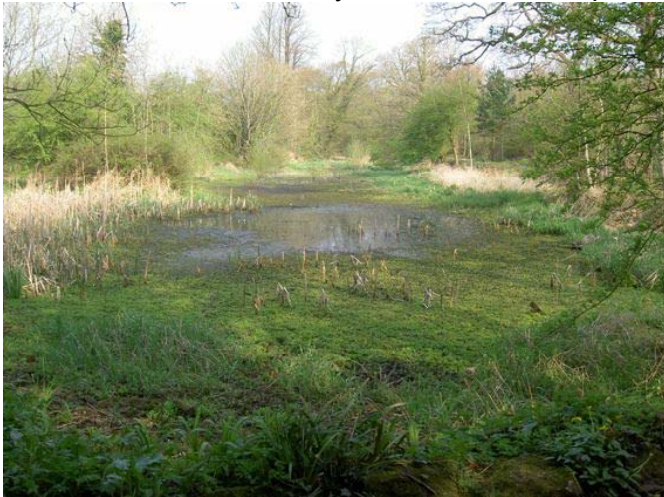
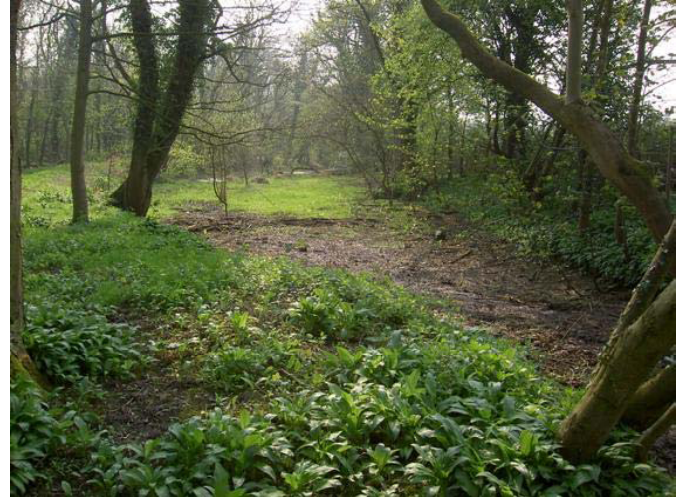
Description: the pond is approximately 130m in length with the south end widened to 25m for a length of some 50m (Plate 15 and Plate 16). The lake appears heavily silted with a depth of no more than 0.5-0.6m with saplings taking root. The lake is fed by a beck at the north end. This beck exits the pond at the south end in a westerly direction.

Plate 15 (left): Pond (Site No. 112) from the south

Plate 16 (right): Pond (Site No. 112) from the north

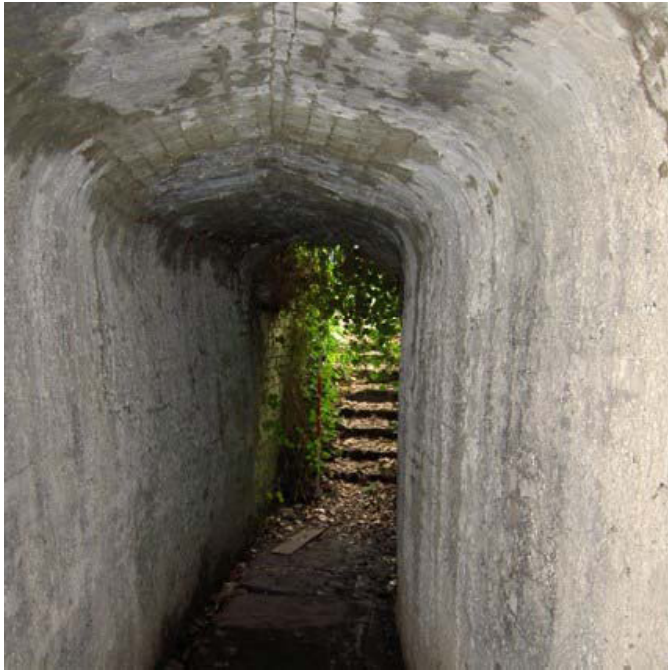
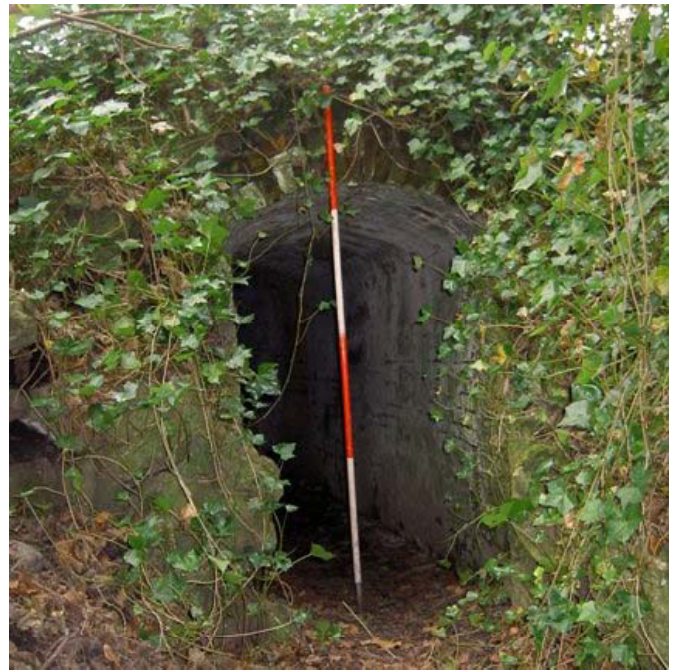
Description: this underpass runs under an estate road that runs east/west from the Priory to South Lodge. The underpass (Plate 17 and Plate 18) is of an elongated s-shape, and is orientated north to south. The underpass is 18.5m long and 1.1m wide; the construction is of red brick, whitewashed, with a flagstone floor. The roof, which has a maximum height of 2.15m, has a shallow arch. At the south end is a flight of eight limestone steps leading up to ground level.

Plate 17 (left): Brick lined underpass (Site No. 113) from the north end

Plate 18 (right): North entrance of underpass (Site No. 113)

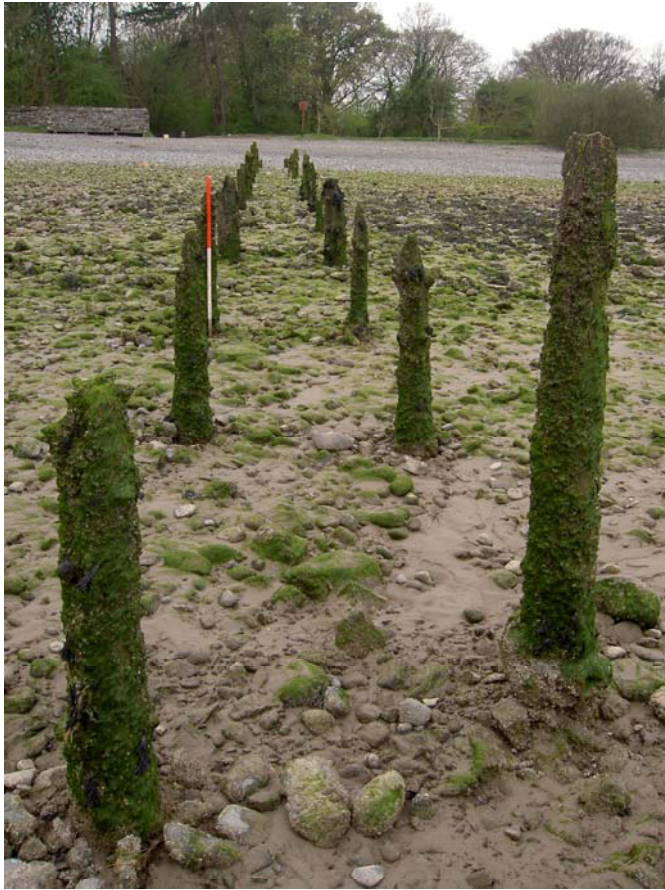
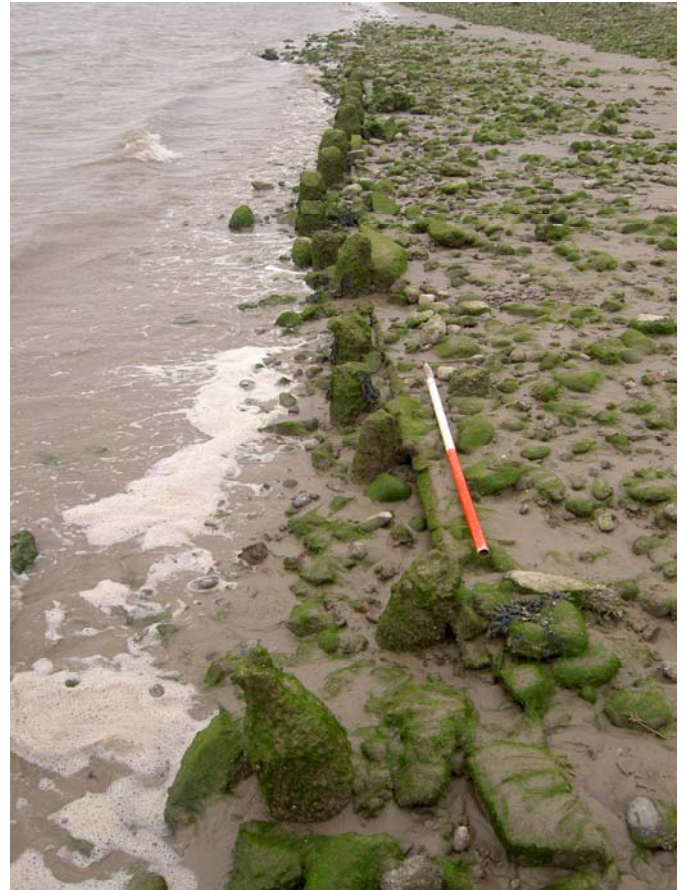
Description: remains of the timber supporting posts of a landing stage (Plate 19). This extends 35m from high to low water mark. To the south are the remains of a timber quay side (Plate 20). This feature consists of timber posts, 0.12-0.15m diameter and spaced 0.25-0.4m apart, running north to south for some 45m. Remnants of planking are attached to the shore side of the posts.

Plate 19 (left): Jetty (Site No. 114) from the east

Plate 20 (right): Timber quayside (Site No. 114) from the north

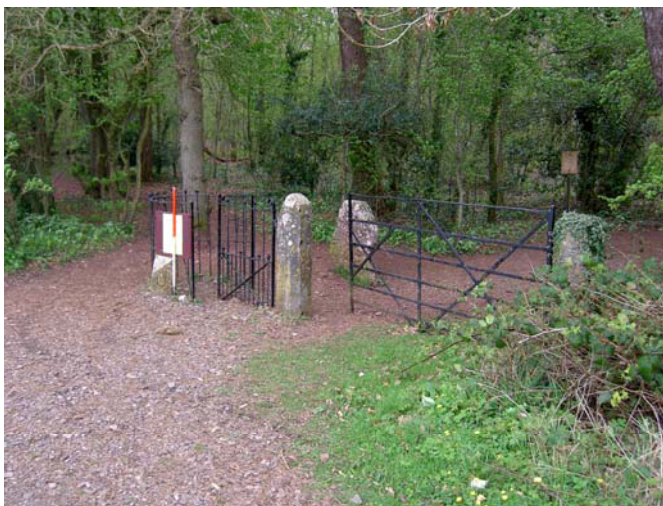
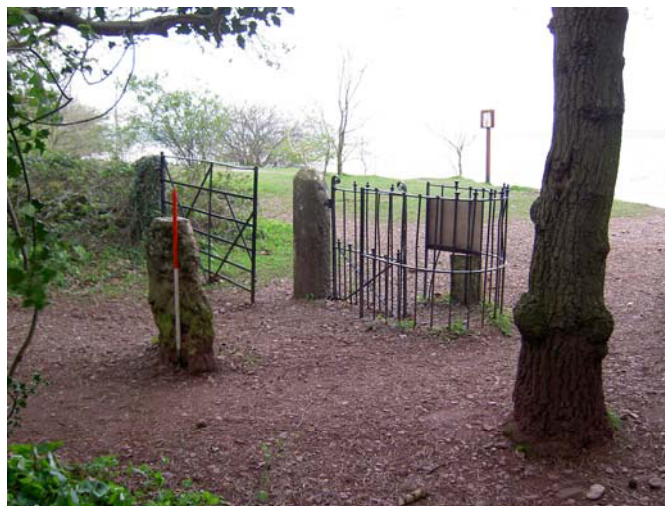
Description: both gates situated on the west boundary of Beach Wood are orientated north to south with the kissing gate to the south (Plate 21, Plate 22). Both the kissing gate and field gate are supported by two limestone gateposts. These posts are eight-sided, 1.2m high by 0.3m wide and 2.45m apart with the field gate in between. The kissing gate is hung on the south gate post and enclosed on the south side by a 'U' shaped iron railing. Set into the west side of this railing is a small marker stone inscribed with a 'U' on its north side, designating the Ulverston Parish boundary.

Plate 21 (left): Kissing gate and field gate (Site No. 115), looking south-west.

Plate 22 (right): Site No. 115, looking north-east with the parish marker (Site No. 116) in the foreground

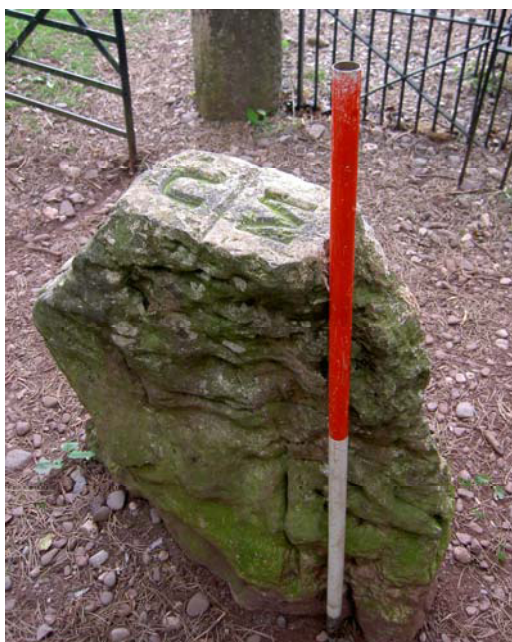
Plate 23: Parish marker (Site No. 116), from the west.

Description: this parish marker has been created from a slab of limestone shaped by water erosion, standing 0.93m in height (Plate 23). The stone has been set just to the west of the Kissing gate (Site No. 115), orientated north/south. The top has been levelled to create a small tableau on which the characters 'M' and 'U' have been cut. The meaning of the 'M' is uncertain; it may signify 'Muchland' referring to Urswick Parish to the south, although this is not an official title. The 'U' presumably denotes Ulverston Parish to the north.

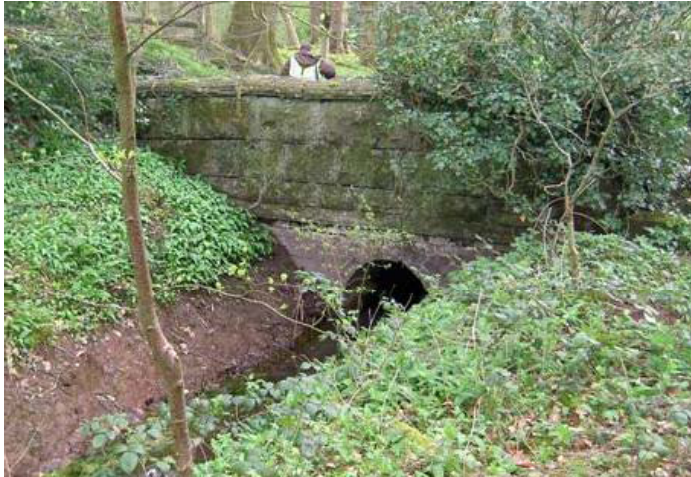
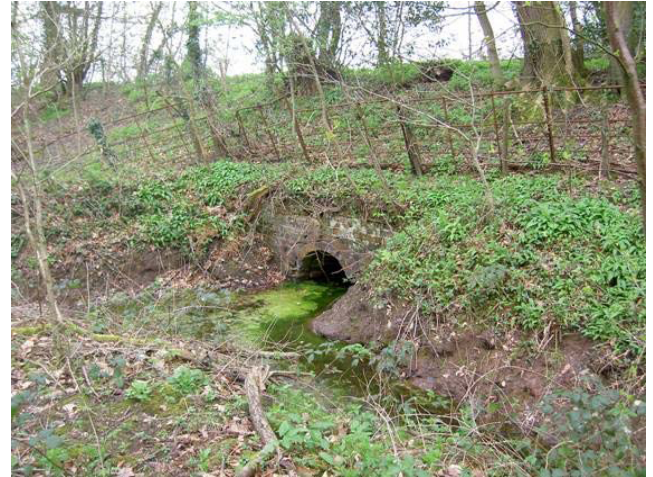
Description: this culvert runs under Red Lane (Site No. 124) on the west side of the railway embankment (Site No. 107). The culvert (Plate 24) is constructed of red brick and runs under the west walls of the underpass, the ditch continuing southwards parallel with the embankment. Just to the north of this culvert the ditch tees off to the west through a brick culvert which runs under the railway embankment, which is also constructed of brick (Plate 25).

Plate 24 (left): Culvert under Red Lane (Site No. 117), looking south

Plate 25 (right): Culvert under railway embankment (Site No. 117), looking north-east

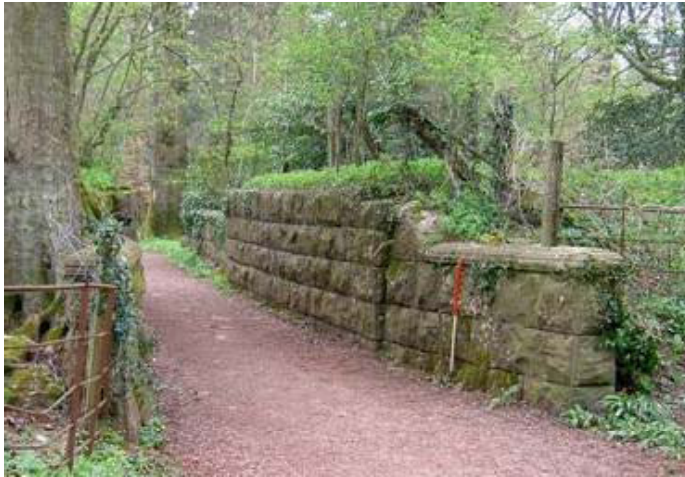
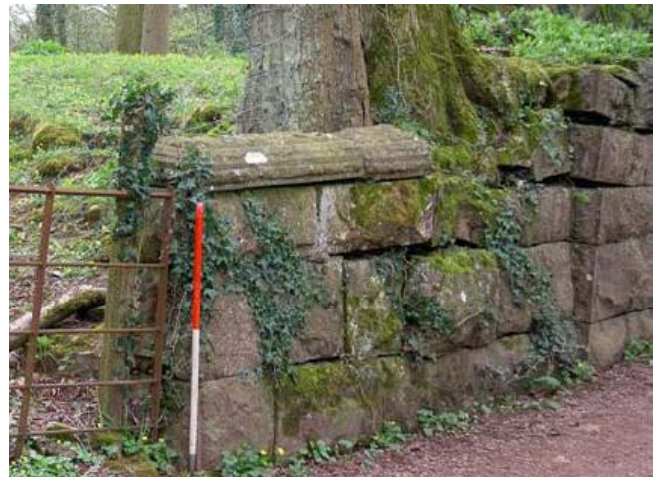
Description: the underpass (Plate 26, Plate 27), constructed of sandstone blocks, is situated where Red Lane (Site No. 124) runs across the line of the railway embankment (the continuation of Site No. 107, though not part of the Priory estate). The top of the underpass is now open and the floor has been raised to the same level as the lane. The underpass is 2.3m wide and 18m in overall length, with the section through the embankment being 7.5m long. The maximum height of the walls is 2.7m. The walls are constructed of large sandstone blocks with a rock-face finish and dressed band topped with dressed coping stones. On either side of the embankment the walls flair out slightly.

Plate 26 (left): Red Lane underpass (Site No. 118), looking west

Plate 27 (right): Detail of stonework at the east end of the south side of Red Lane underpass (Site No. 118)

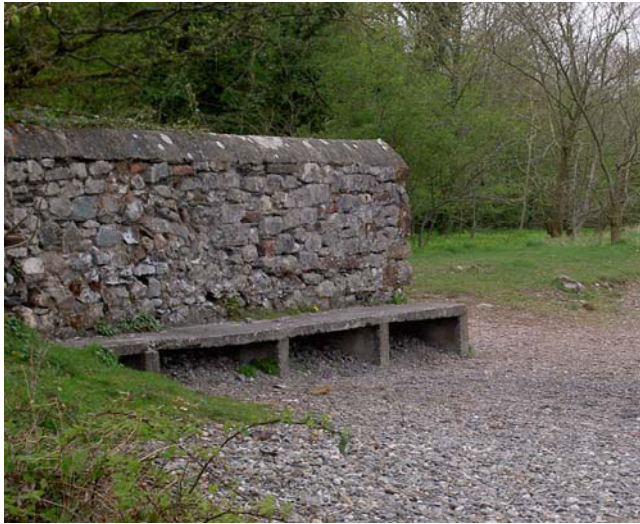
Plate 28 (left): Boundary wall (Site No. 119), from the south-east

Description: this boundary wall (Plate 28) is only 25m in length, running in a north/south direction, with the north end being some 8m west of the kissing gate (Site No. 115). The wall is 1.6m high and 0.4m thick and constructed of limestone rubble, some of it rough cut, with inclusions of brick and stone. The coping is concrete and there is a concrete bench situated on the shore side at the north end.

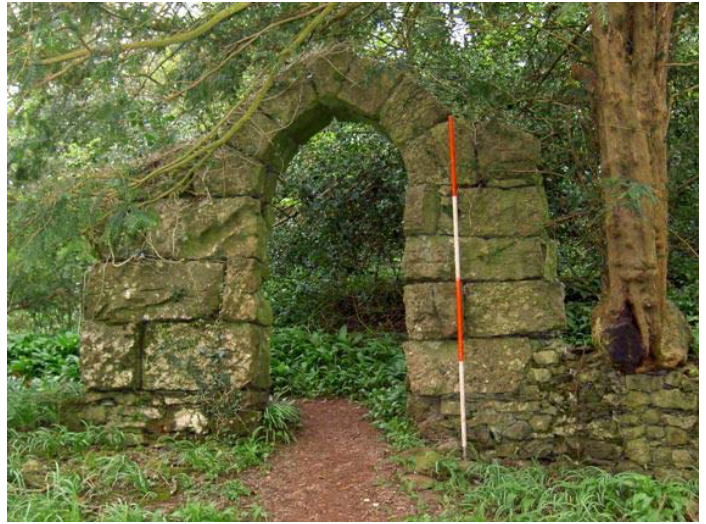
Plate 29 (right): The 'Ladies' Arch' (Site No. 120), from the east

Description: this feature (Plate 29) is a garden folly situated to the south-east of the Priory on the south side of Red Lane (Site No. 124). The archway is constructed of large rough cut limestone blocks. Overall the arch is 4.3m high by 2.55m wide, and the maximum thickness of the stonework is 0.7m. The inner arch measures 1m wide by 2.2m high. The arch rests on a low revetment constructed of limestone rubble which runs to the south-east and continues to the north, away from the arch.

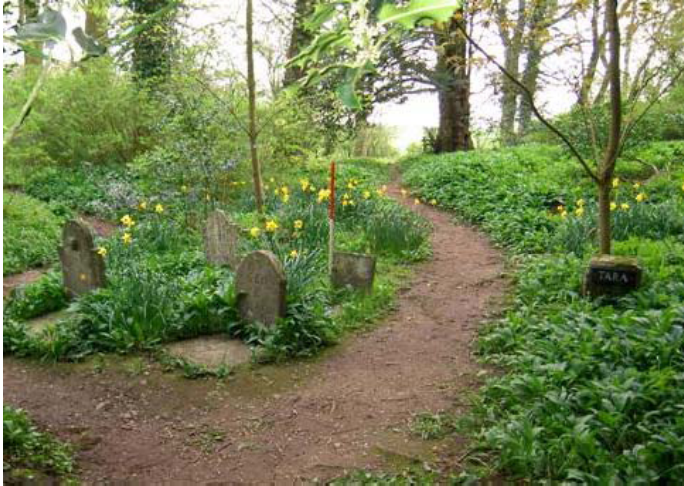
Plate 30 (left): Pets' cemetery (Site No. 121), looking north-east

Description: This group of small monuments (Plate 30), situated in the vicinity of Ladies Cottage (Site No. 122), are of pet burials, presumably dogs belonging to the estate, ranging from the 1920's to 1950's.

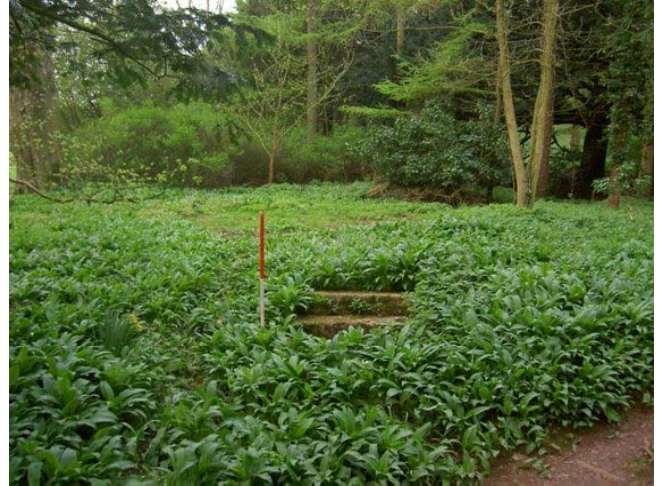
Plate 31 (right): Site of the Ladies' Cottage (Site No. 122), looking north

Plate 31) covers an area of approximately 7m by 10m just south-east of the Priory on the south side of Red Lane (Site No. 124). There used to be a summer house situated here, no longer extant, until at least the 1920's. All that remains of the building is a small flight of concrete steps and some footings of the brick walls. Just to the north-west of the site is a small mound which possibly contains debris from the demolition of the cottage.

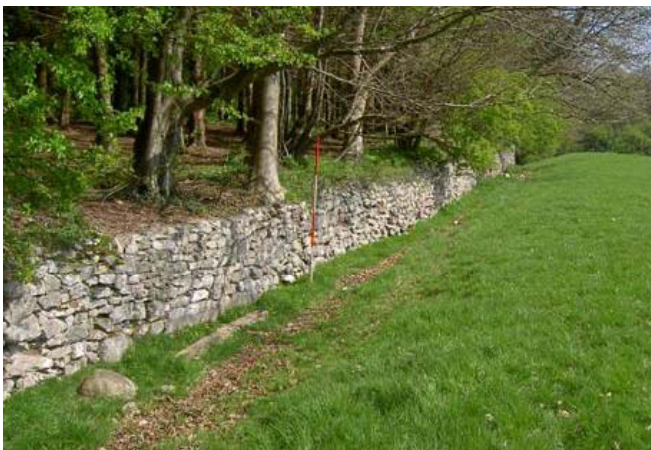
Plate 32 (left): South boundary ha-ha (Site No. 123), from the west

Description: this ha-ha (Plate 32 and Plate 33) follows the south-west side of the boundary, running southwards from the Buddhist Temple of c145m, crossing Red Lane (Site No. 124), and then turns east to run parallel with Red Lane for c145m before terminating where the boundary doglegs, just south of the site of Ladies Cottage (Site No. 122). The ha-ha has a 1.2m high stone rubble revetment on the north side; the apex of the opposite slope is some 3m distant and the base is some 1.3m wide.

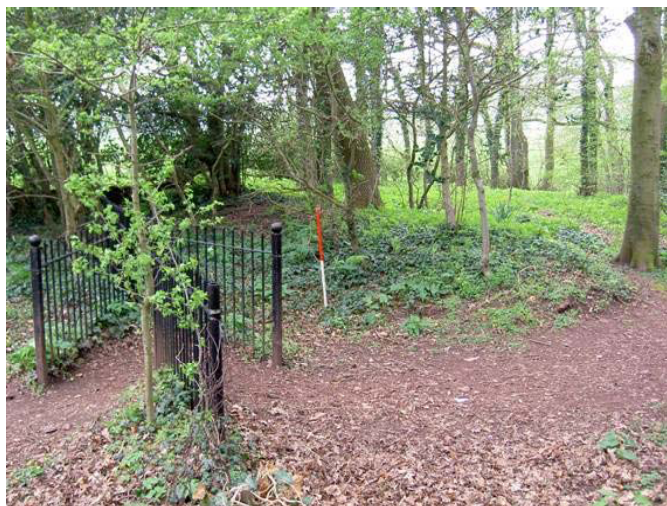
Plate 34 (left): Bank and ditch (Site No. 125), looking south-west

Description: this linear earthwork (Plate 34) is a much eroded low bank and ditch running along the west boundary of Beach Wood and the shore. The bank is approximately 140m from the south end of Beach Wood, petering out towards the north. It continues southwards along the boundary of the adjoining field. The bank is no more than 2m wide and 0.4m high with a ditch on the shore side, also 2m wide and no more than 0.3m deep. The bank and ditch are now covered by tree growth.

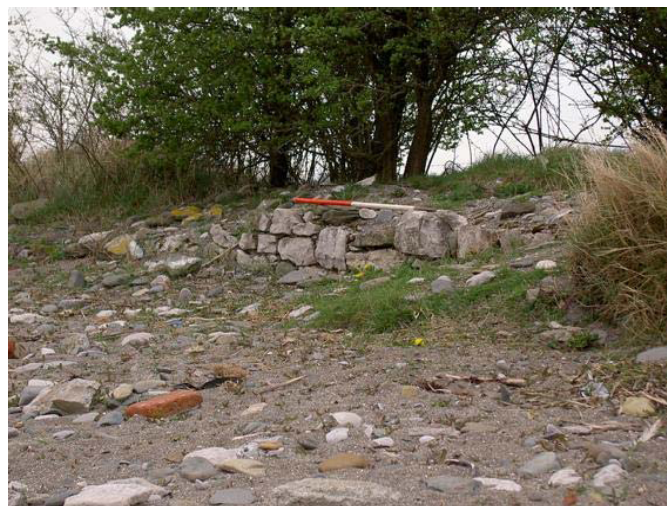
Plate 35 (right): Stone revetment (Site No. 126) at the south end of the shore, looking south-west

Description: remnant of a low revetment situated on the shore, south of Beach Wood (Plate 34 (left): Bank and ditch (Site No. 125), looking south-west Plate 35). The revetment runs north to south, 8m west of the boundary of the field south of Beach Wood. Constructed of rough cut limestone laid without mortar and no more than 0.38m high and 0.3m wide, the remains were approximately 8m in length, although the limestone debris about the area suggests it once may have been longer. It is probable that this revetment was used to prevent erosion of the path that runs between the field boundary and the shore.

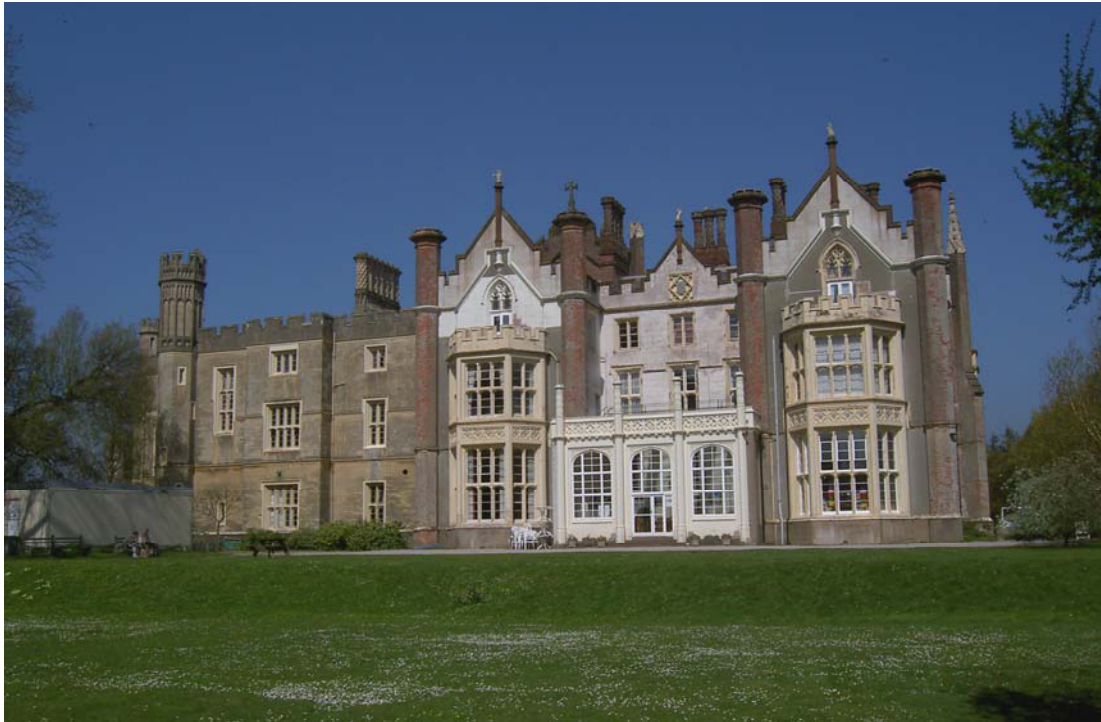
Plate 41: The two southernmost elements of the building, from the south

4.3.1 **Introduction:** this survey is only intended to provide a very general understanding of the development of the current Conishead priory buildings, and as such only six basic building phases have been identified that span the period from the start of the re-building of the property in the 1820's to the construction of the new temple in 1996. It was not possible to identify from the exterior of the building whether any of the earlier 18th century buildings have been incorporated into what is visible today; this may be a possibility if the interior of the building was to be recorded, especially in the basement areas. Recording of the internal spaces of the building would undoubtedly also reveal numerous more phases of alteration and renovation that are not evident from the outside. What follows is a summary of the six broad phases identified; reference should also be made to the phase drawing (Figure 4).

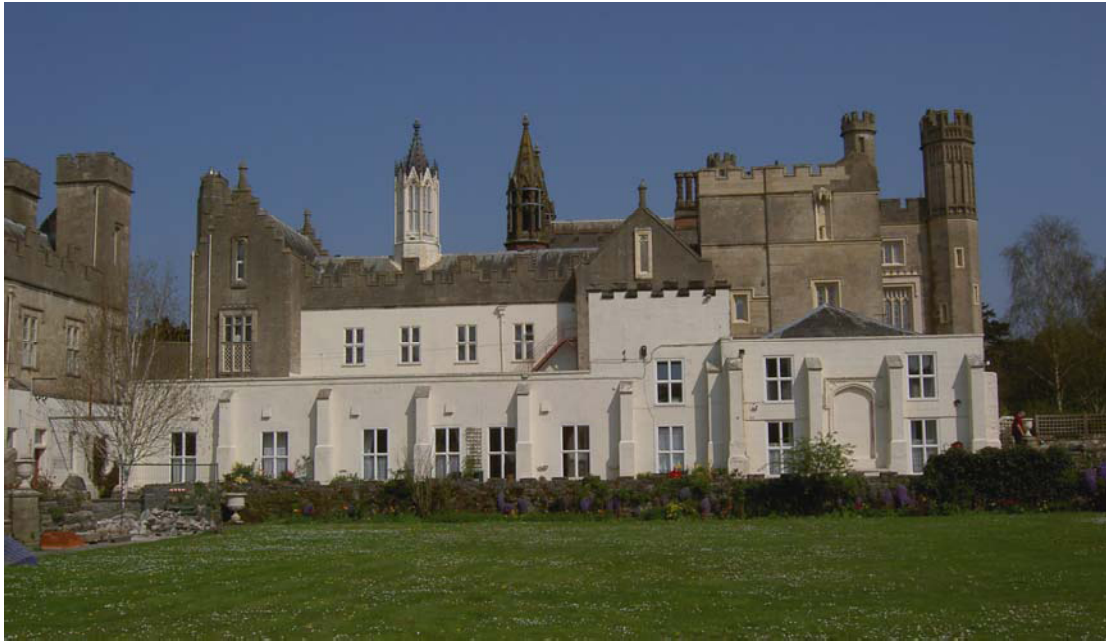
Plate 42: South part of the Priory, from the west gardens

4.3.2 **Phase 1, 1821-43:** this phase covers the majority of the current Conishead Priory buildings, the main exception being the north-eastern quadrangle that incorporates the clock tower. The majority of the structures dating from this phase are finished in un-rendered Bath stone laid as ashlar blocks and features ornamentation typical of the 19th century Gothic revival style of architecture. Such ornamentation includes pointed arches, vaulted roofs, buttresses, large windows that often have hood mouldings, and roofs with crenulated and castellated parapets and spires. An article in the north Lonsdale magazine, dated 1895 (Anon 1895, 127), comments that the work on this phase began at the west end, and was not completed even after 20 years. This statement appears to be borne out by Binns' plan of c1843 (Plate 37) which shows that while the western buildings have assumed their current form, the east entrance block had not yet been re-built. The date of Binns' plan may not be accurate, however; an illustration first published in 1831 indicates that the eastern entrance block had been completed by that date (Austin *et al* 1831). It is also conceivable that Binns' plan was carried out during the renovations while the earlier engraving illustrated the proposed outcome of the works. What is clear is that the eastern entrance block is the latest element in this phase of building, which is clearly differentiated by its use of rendered brickwork and some limestone; possibly to save money in the latter stages of a project whose total bill amounted to £140,000 (Robinson 1991, 175). It is tempting to speculate that this part of the project represents the point at which the project was taken over by George Webster, and represents a separate phase to the eastern building work. There is no definitive evidence for this, although the plans signed by Webster and apparently dated 1818 might suggest this is the case (Greenlane Archaeology 2009).

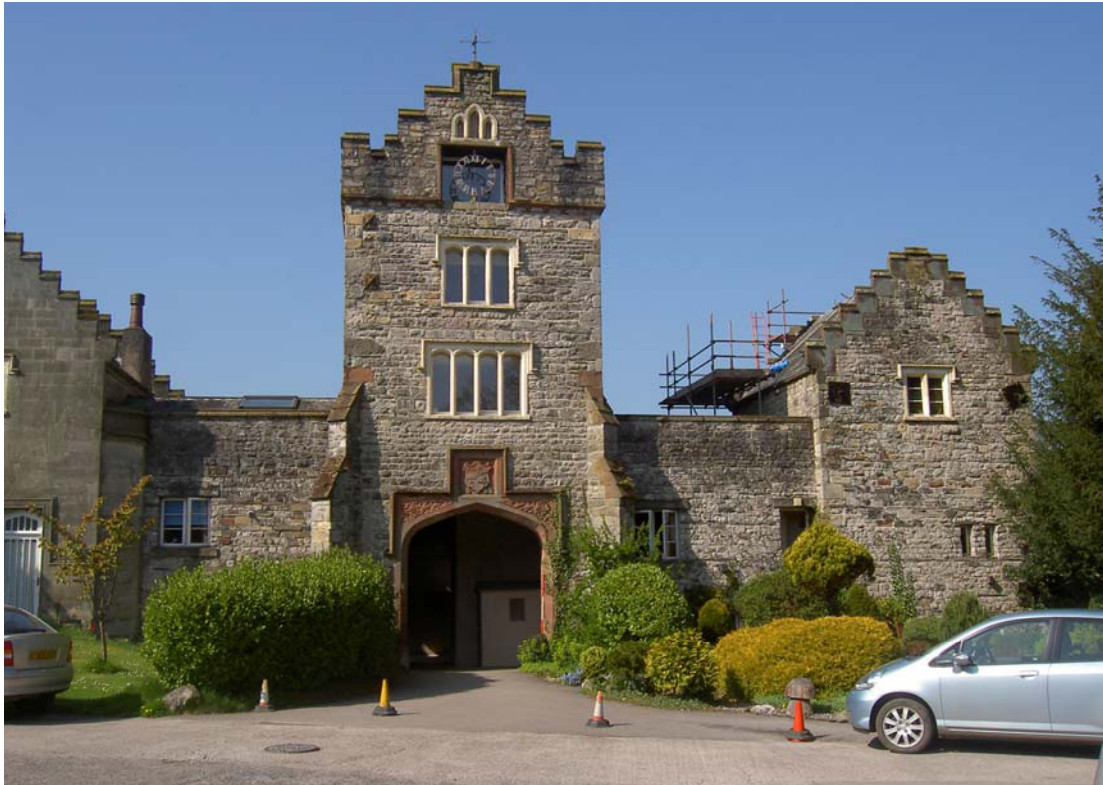
Plate 44: Phase 2 clock tower, from the east side

4.3.3 Phase 2, 1853: this secondary phase of building was carried out by Henry Askew shortly after he acquired the estate c1850; it involved the construction of the northern quadrangle including the clock tower, as well as the kitchen garden and associated glasshouses. This work is easily recognised by the use of locally sourced limestone rubble, within which some re-used sandstone has been incorporated. The buildings from this phase of development are undoubtedly more utilitarian than the main residence constructed in Phase 1. The quadrangle buildings have seen extensive modern repairs, hinted at by concrete lintels and inserted doors, prior to their recent conversion to residential quarters.

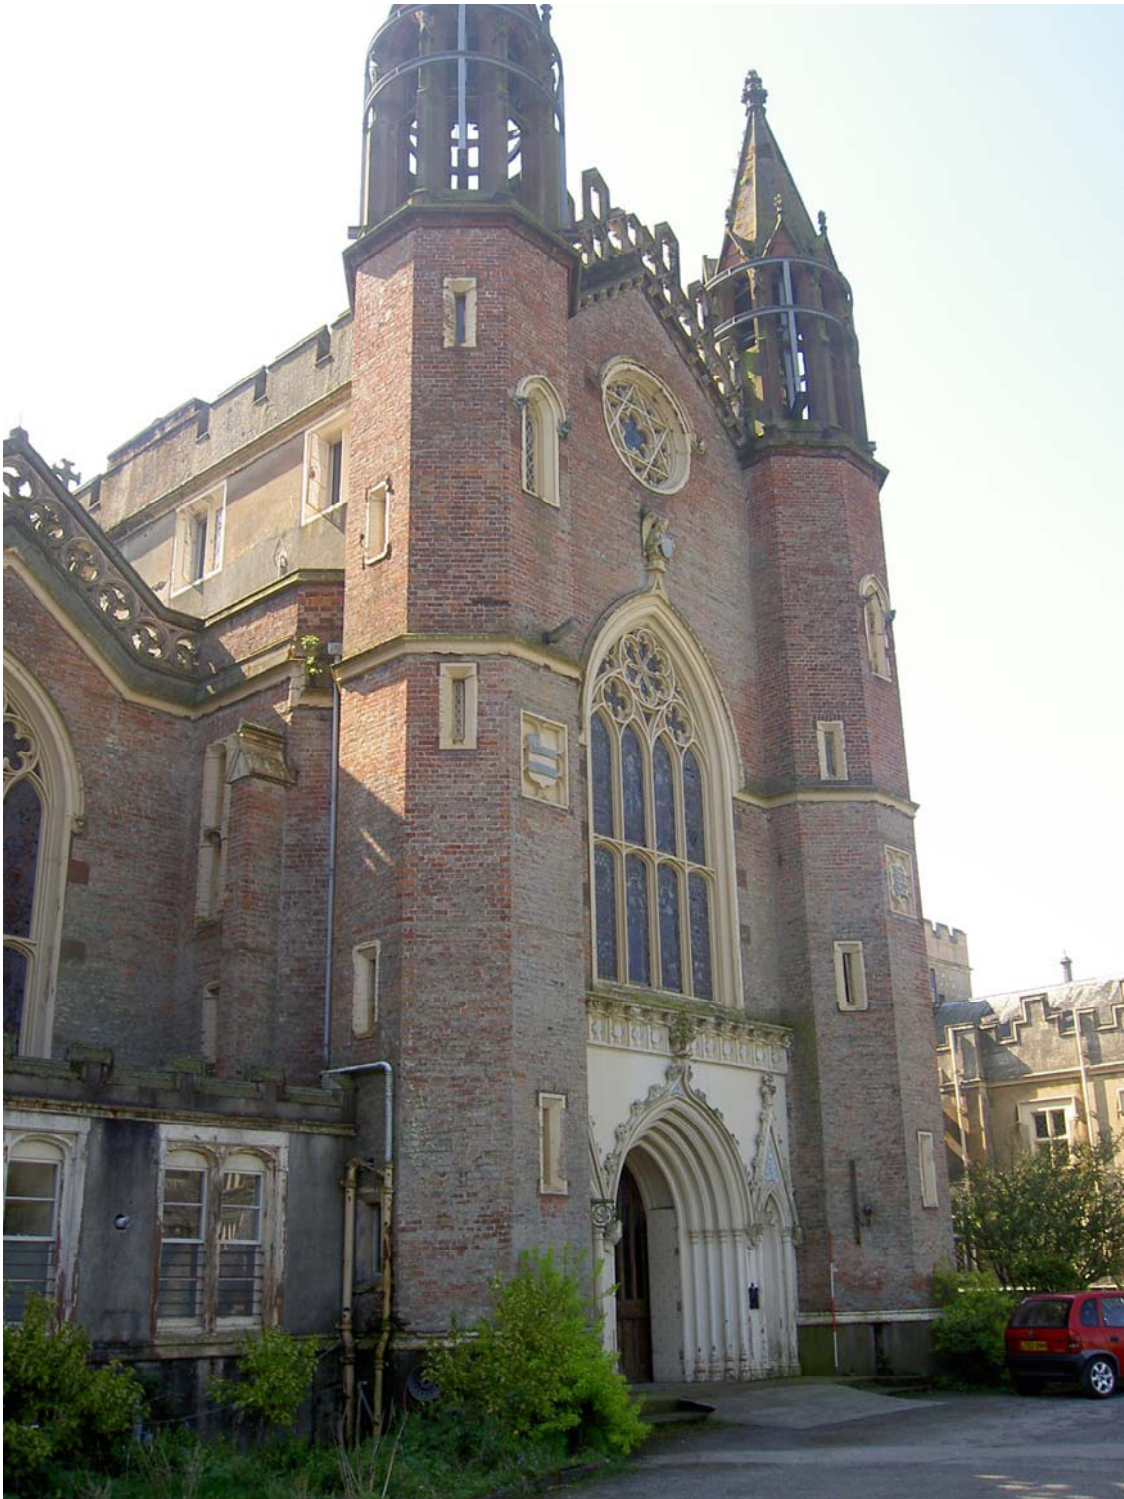
Plate 47: Phase 3 toilet block on the east side of the north entrance

4.3.4 **Phase 3, 1879-1890:** this phase involved the construction of a toilet block on the north side of the eastern entrance wing; this block appears for the first time on a map dated 1890 (Plate 40). The block is constructed from rendered brick and partly obscures the large ornate window behind it, which further suggests it is a later addition. It seems likely that the addition of the toilets probably ties in with the transition of the property to a spa hotel in 1878.

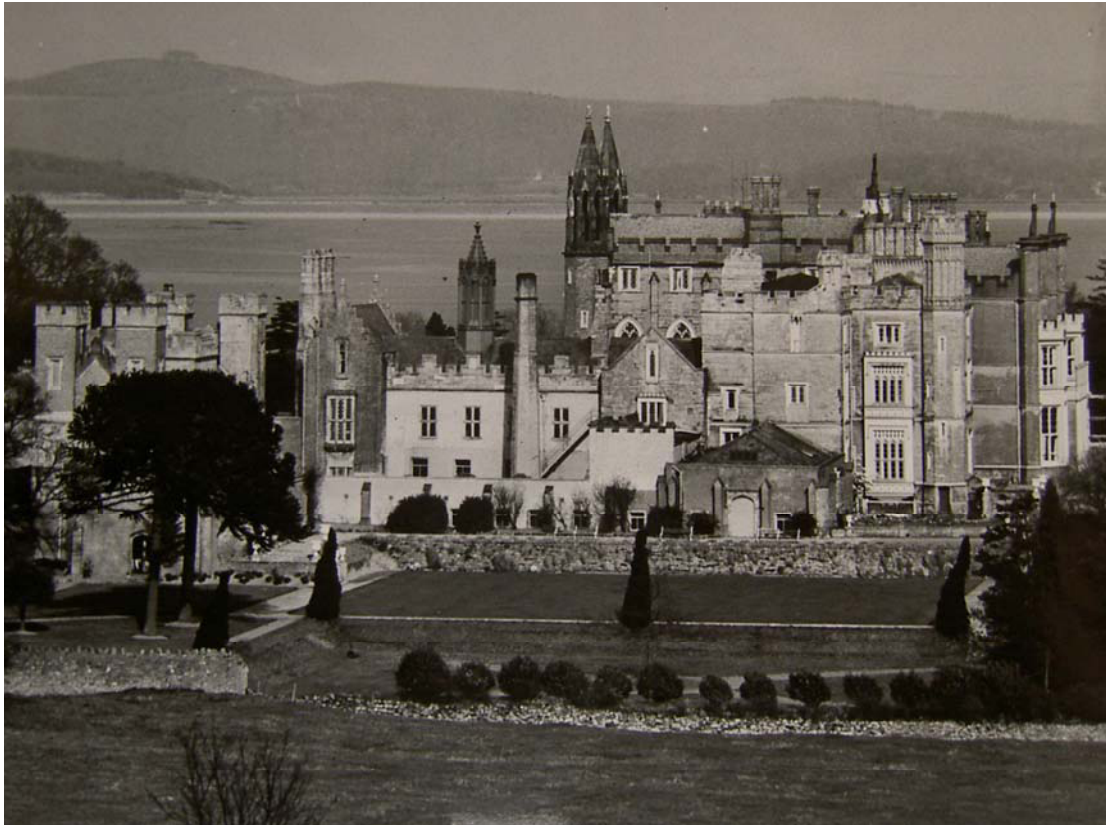
Plate 48: Phase 4 photograph showing boiler house chimney (CRO(K) WDX 427/2 1928)

4.3.5 **Phase 4, late 1920s:** this phase relates to the addition of a boiler house which seems to have been added in preparation for the conversion of Conishead priory to a convalescent home for retired miners, c1930. The boiler house was ideally located for the Turkish baths in the rooms immediately to the south. The boiler house chimney is evident in this area on plans for the convalescent home produced in 1929 (CRO(B) BDX 53/10/4 1929; see also Greenlane Archaeology 2009, 14). The boiler house chimney is also shown in a photograph which is labelled c1928 but it is more likely around 1930 (Plate 50).

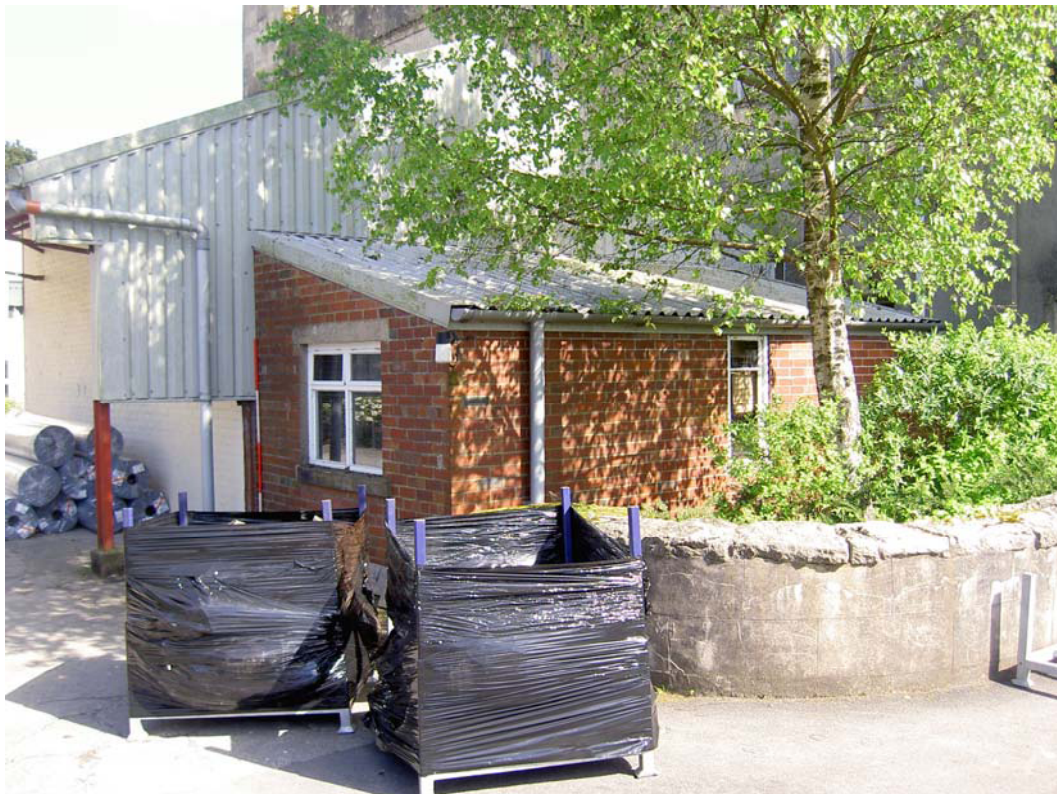
Plate 49: Brick building representing Phase 5

4.3.6 **Phase 5, post-1930s:** this is a brick building located to the north of the west wing (Plate 49) and post-dates the initial developments made to the site on its conversion to a convalescent home.
