CONISHEAD PRIORY, ULVERSTON, CUMBRIA

Archaeological On-Site Assessment

Client:
New Kadampa Tradition –
International Kadampa
Buddhist Tradition
NGR: SD 5145 9305
© Greenlane Archaeology Ltd
June 2009

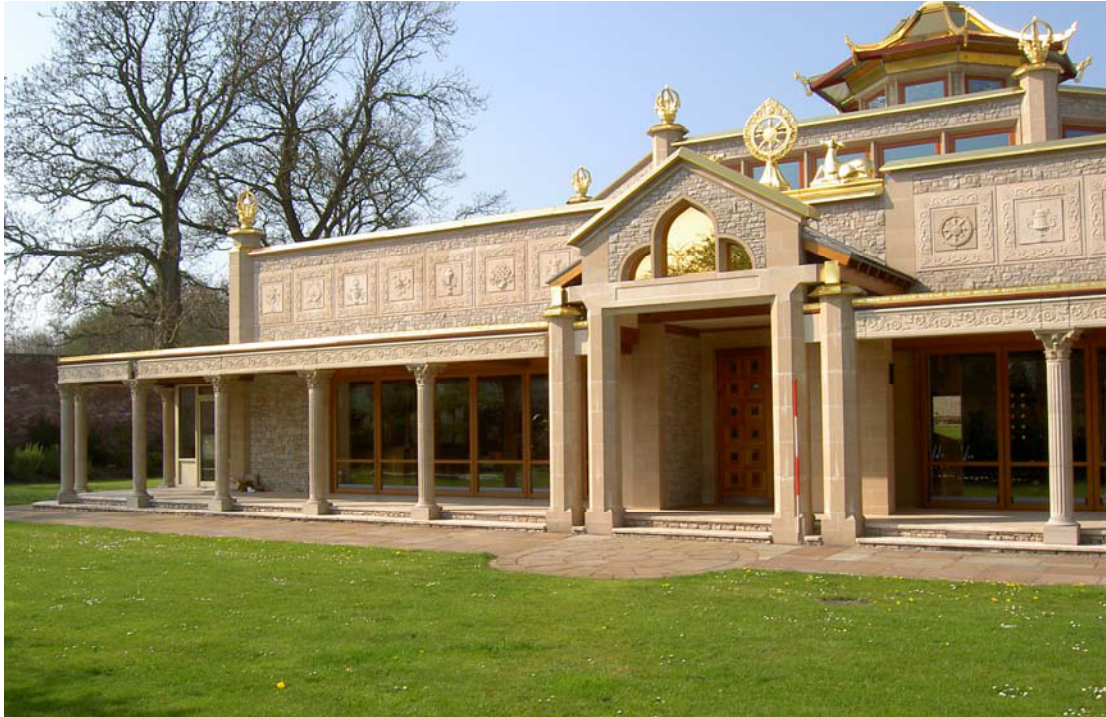
Plate 50: Kadampa temple from the south-west

4.3.7 **Phase 6, 1996:** the Kadampa Buddhist temple was constructed in the former kitchen gardens, and was opened in 1997. It is a modern design (Plate 50), intended to reflect both traditional Buddhist architectural styles and those of the earlier Priory buildings (Saunders 1996).
