Archaeological Evaluation Report

# **CROFT CASTLE WALLED GARDEN**

For The National Trust

Doc Ref: LPI240M-AER-v1.4

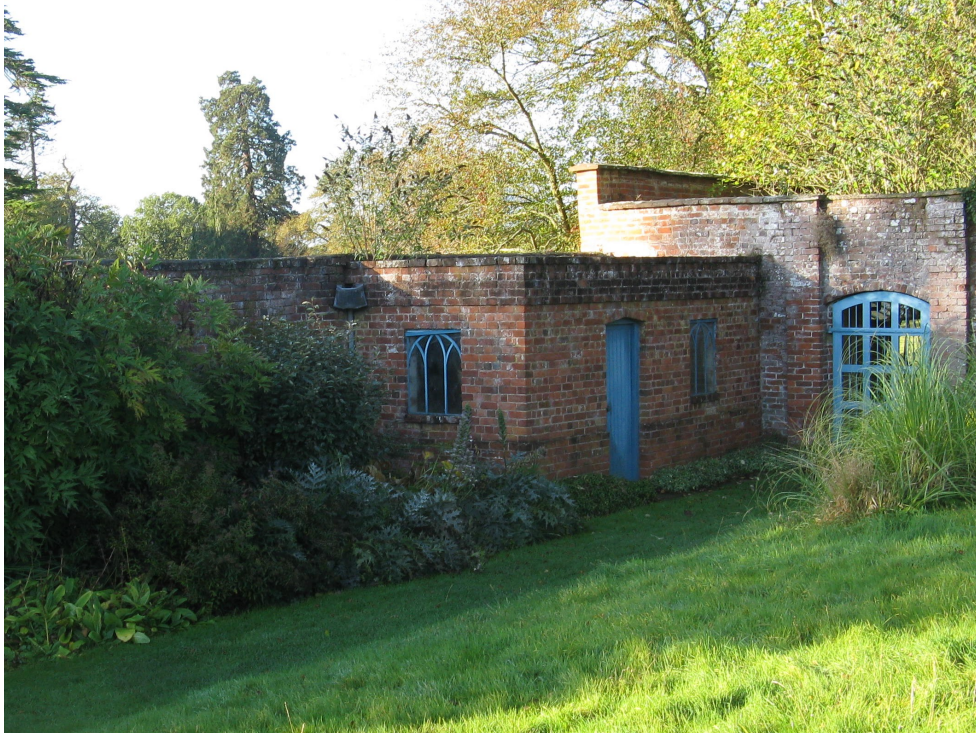
*Plate 1 - Shed (N) looking SW*

- 6.2.2. At the west end of the wall is a flat roofed brick shed (N) (PLATE 1) which continues on the other side of the west garden wall (P). The brickwork is English bond with what appears to be a mixture of new and re-used bricks with hard grey mortar. (N) butts the south garden wall and the structure is clearly a later addition to the garden. There is a blocked doorway (PLATE 2) with a wooden lintel within the shed which led through the garden wall to the shed on the west side (P). The structure is part of the glasshouse development to the south of the garden wall and may have housed boilers, although no pipe holes were noted in the garden wall.

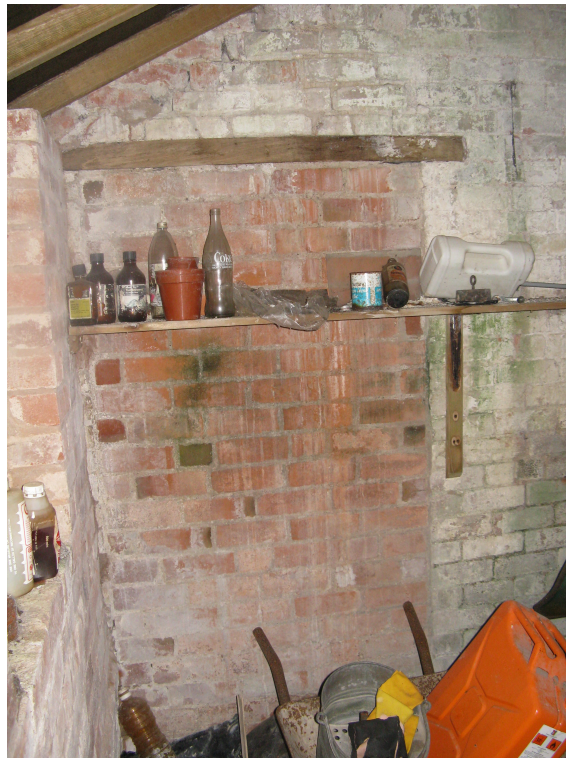
*Plate 2 - Blocked doorway in (P) looking east*

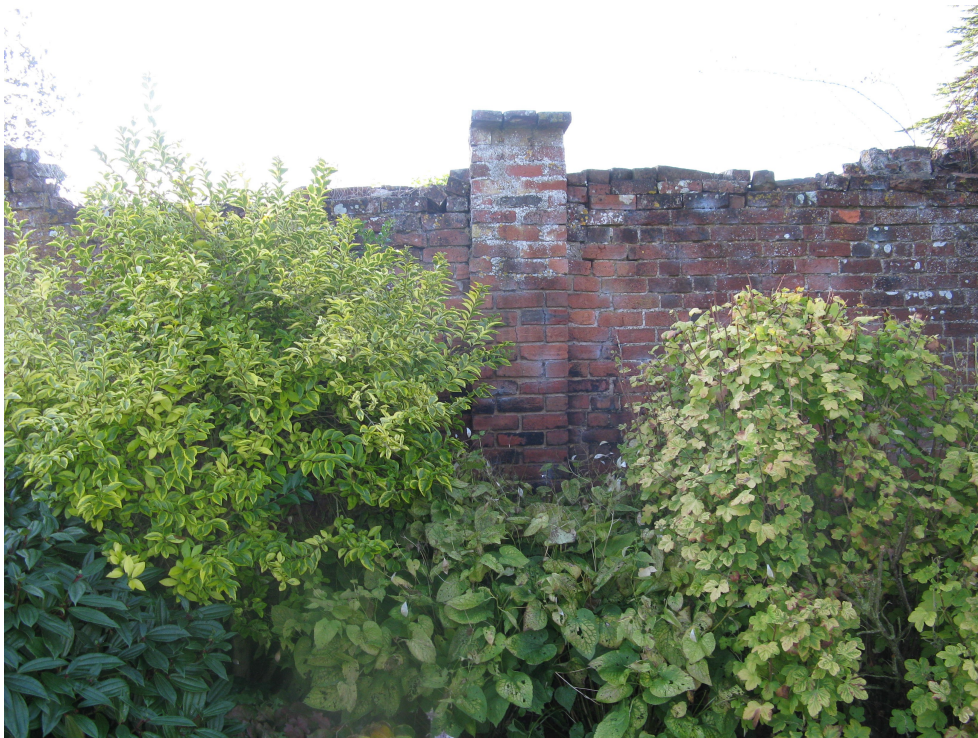
*Plate 3 - Column (Q) with damaged wall looking south*

- 6.2.3. The wall between (N) and door (S) seems to be largely original. Two brick columns (Q), each 0.47m wide, are positioned 9m apart at the west part of the wall. These match the columns on either side of door (M) in the west garden wall. This is the worst preserved section of wall and the top four courses have collapsed around the east column (PLATE 3).

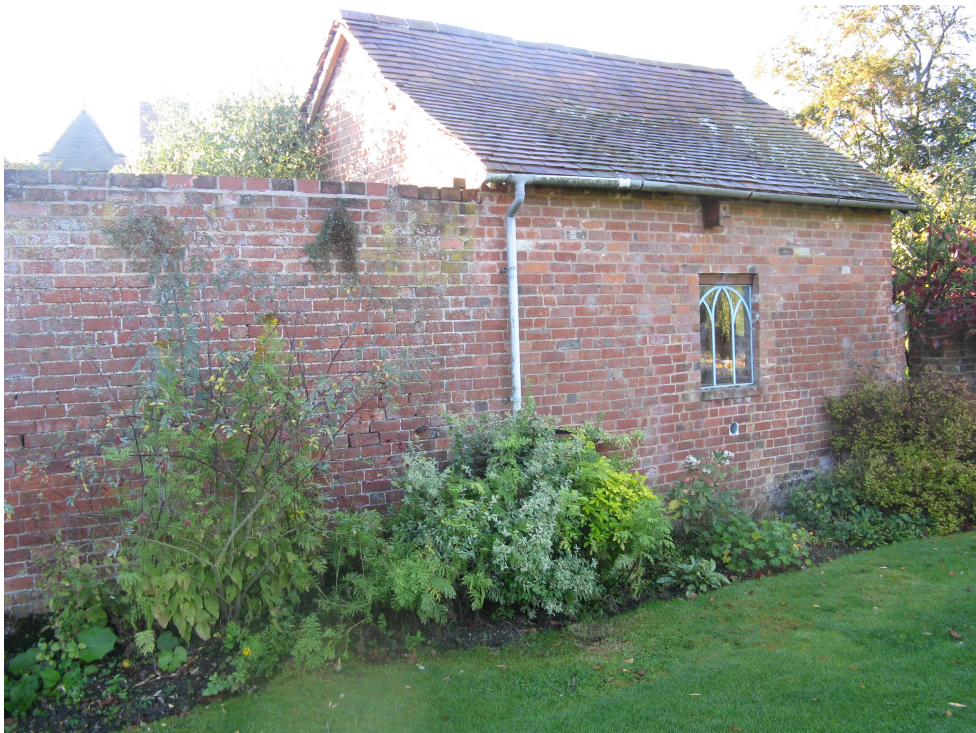
*Plate 4 - Shed (R) looking south west*

- 6.2.5. Immediately to the east of the angle on the south side of the wall is another brick shed (R) (PLATE 4) which abuts the garden wall on the south side. A building is shown here on the 1825 map (FIGURE 4) but the surviving windows are late 19<sup>th</sup> or early 20<sup>th</sup> century, the visible roof purlins are modern and the brickwork in north face is unweathered and has clearly been rebuilt. It appears to have been completely rebuilt as a part of the north forecourt development.

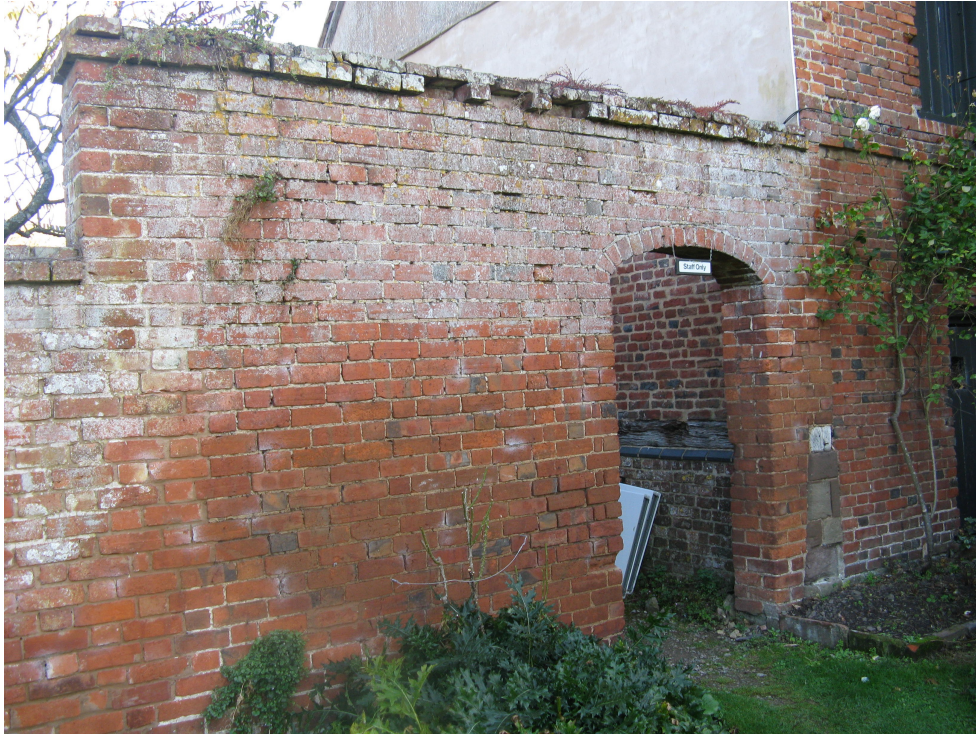
*Plate 7 - Doorway (U) east of the south east corner of the garden*

- 6.2.6. In the east corner of the wall is a single doorway (A). The path leads through the wall at this point in 1891 (FIGURE 5) and it was probably inserted when the glasshouses were built and the double door (H) opposite in the northern wall was inserted.
- 6.2.7. The east end of the southern wall continues beyond the east garden wall to where it is abutted by farm buildings. The 1825 map (FIGURE 4) shows a small building such as a shed in this area and this small section of wall is all that remains. It contains a single door with a single brick arch head (U) which differs from other doorways in the garden as the arch bricks are cut horizontal at each end of the arch. This door does not show any signs of rebuilding and the unique arch head suggests it may be the only remaining original doorway head that has not been repaired (PLATE 7).

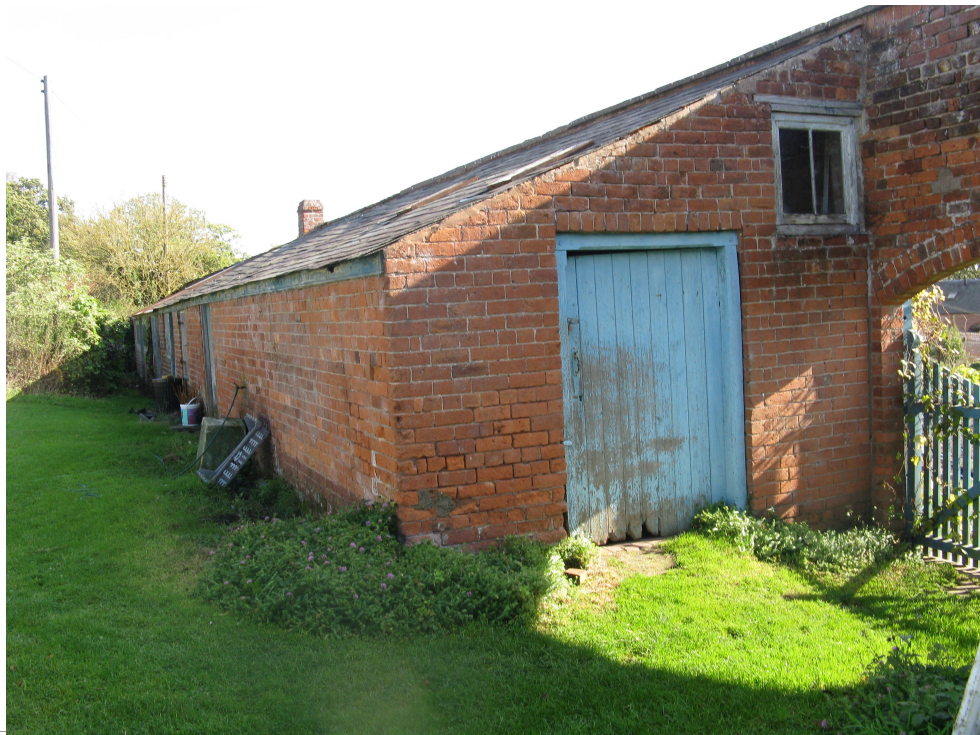
*Plate 8 - Shed (G) looking east*

- 6.4.3. On the north side of the north wall are two brick sheds (G) and a narrow boilerhouse (T). (G) has straight door lintels and a slate roof that is almost as high as the north wall (PLATE 8), indicating that the north wall must have been heightened before or during the construction of (G). (T) has a single brick arch above the door and a lower slate roof (PLATE 9). The boiler used to warm the pipes for the glasshouse is still visible in the west corner of (T). Both buildings abut the rear of the garden wall and are constructed from mid orange bricks in English Garden Wall bond three courses header, one stretcher. Both are associated with the construction of the glasshouses.

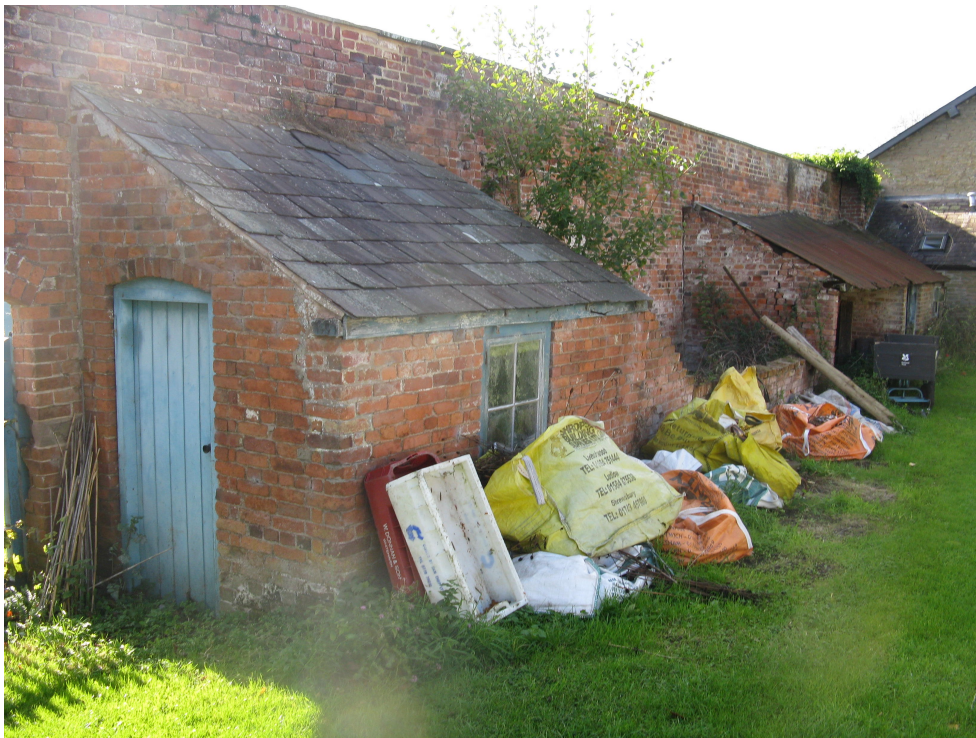
*Plate 9 - Boiler house (T) looking west*

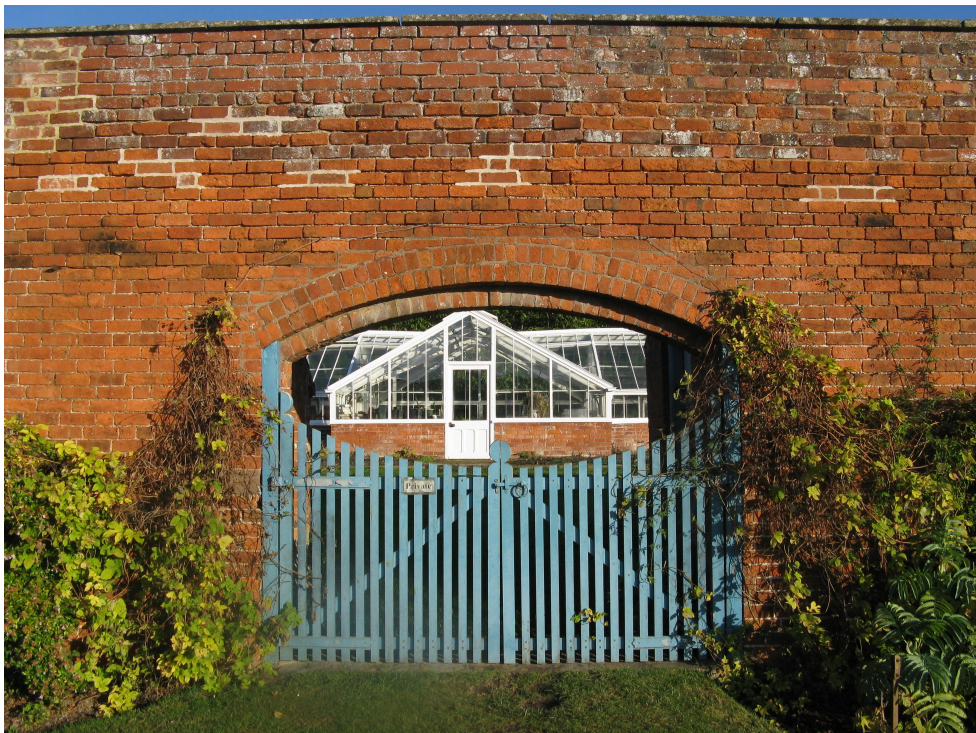
*Plate 10 - Double doorway (H) looking north*

- 6.4.4. Between (G) and (T) is a double doorway (H). It has a two brick arch head and measures 2.22m high to the bottom of the arch and 2.97m wide (PLATE 10). Path C leading to this doorway is first marked on the 1891 OS map (FIGURE 5), although the centre of (H) does not line up exactly with path C. It is possible that a doorway was inserted here when the glasshouses were built and it was subsequently widened or altered.

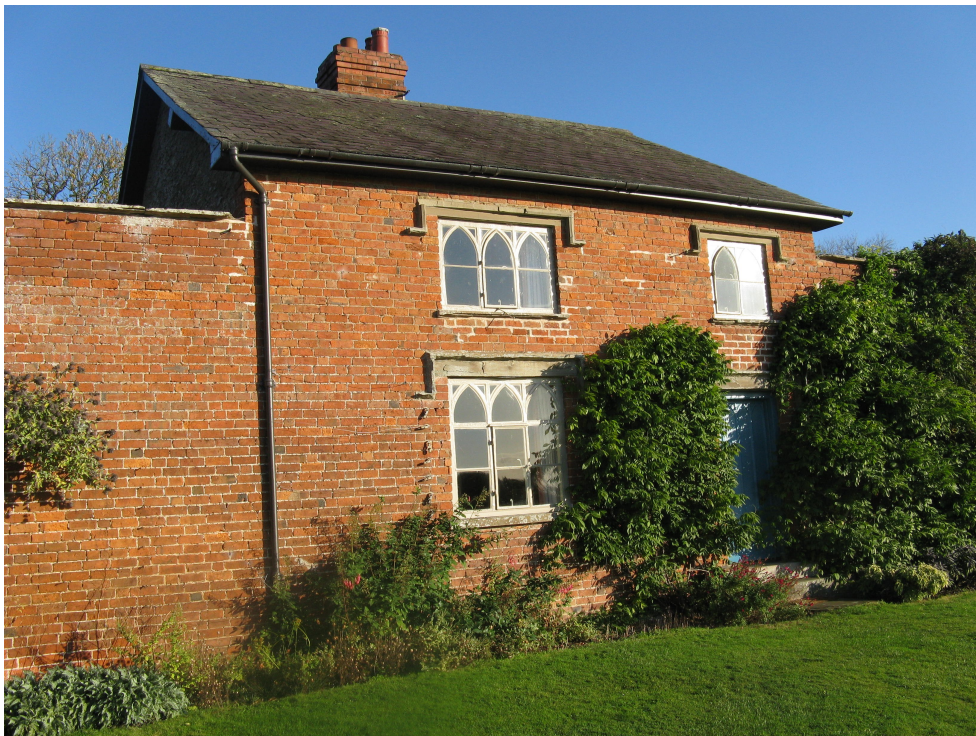
*Plate 11 - Cottage (K) looking north*

- 6.4.5. To the west of (T) is the gardener's cottage (K) (PLATE 11). It is a two storey brick cottage with a stone door lintel and stone window sills and decorative soffits. The cottage was inserted into the wall after 1839, probably as a part of the glasshouse building phase, although the brickwork, consisting of three rows of stretchers followed by a row of headers and stretchers, continues seemingly unbroken from the wall to the house and into the five courses of the

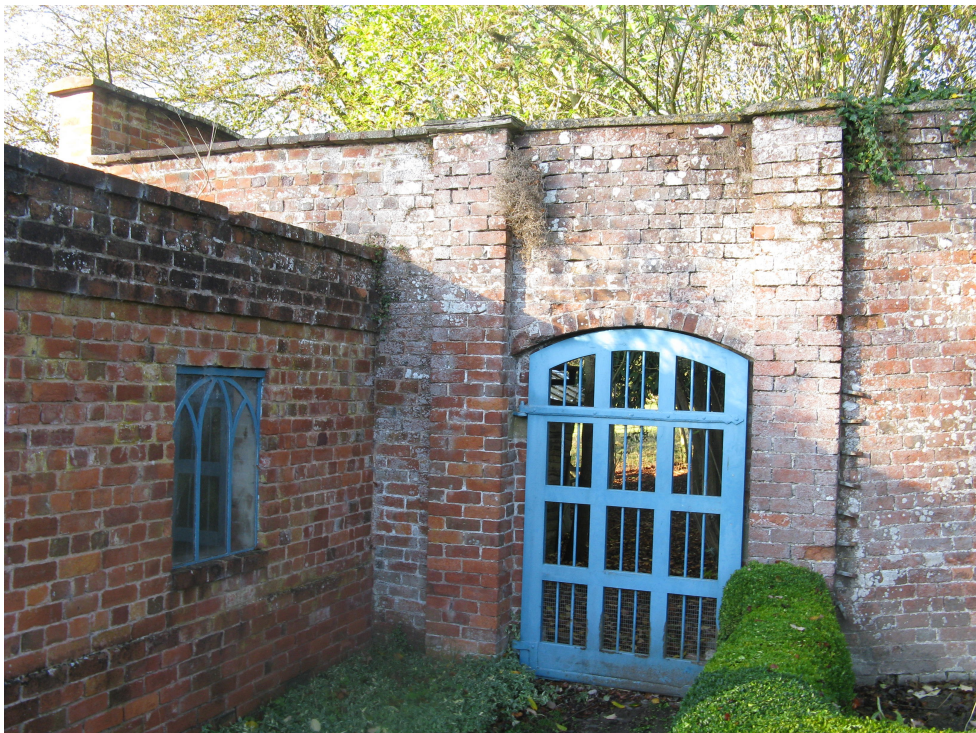
*Plate 12 - Doorway (M) looking west*

6.5.2. In the south corner is a single doorway with a single brick arch head (M) measuring 1.45m wide and 2.15m high. It is flanked by two brick columns (PLATE 12). The Tithe map (FIGURE 5) shows the path leading from the castle entering the walled garden at this point and it is likely to be the original main entrance.

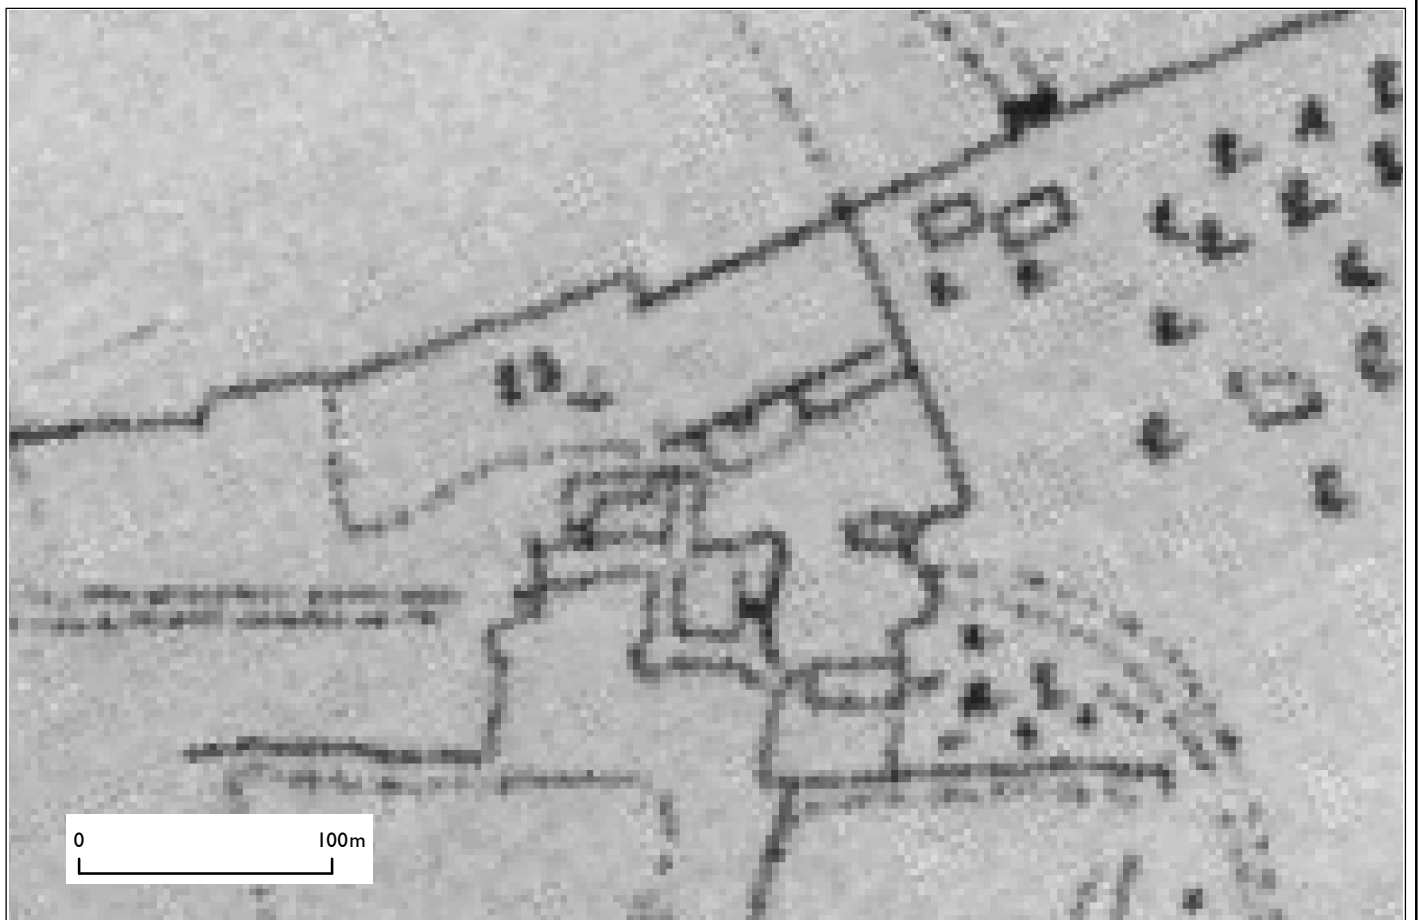
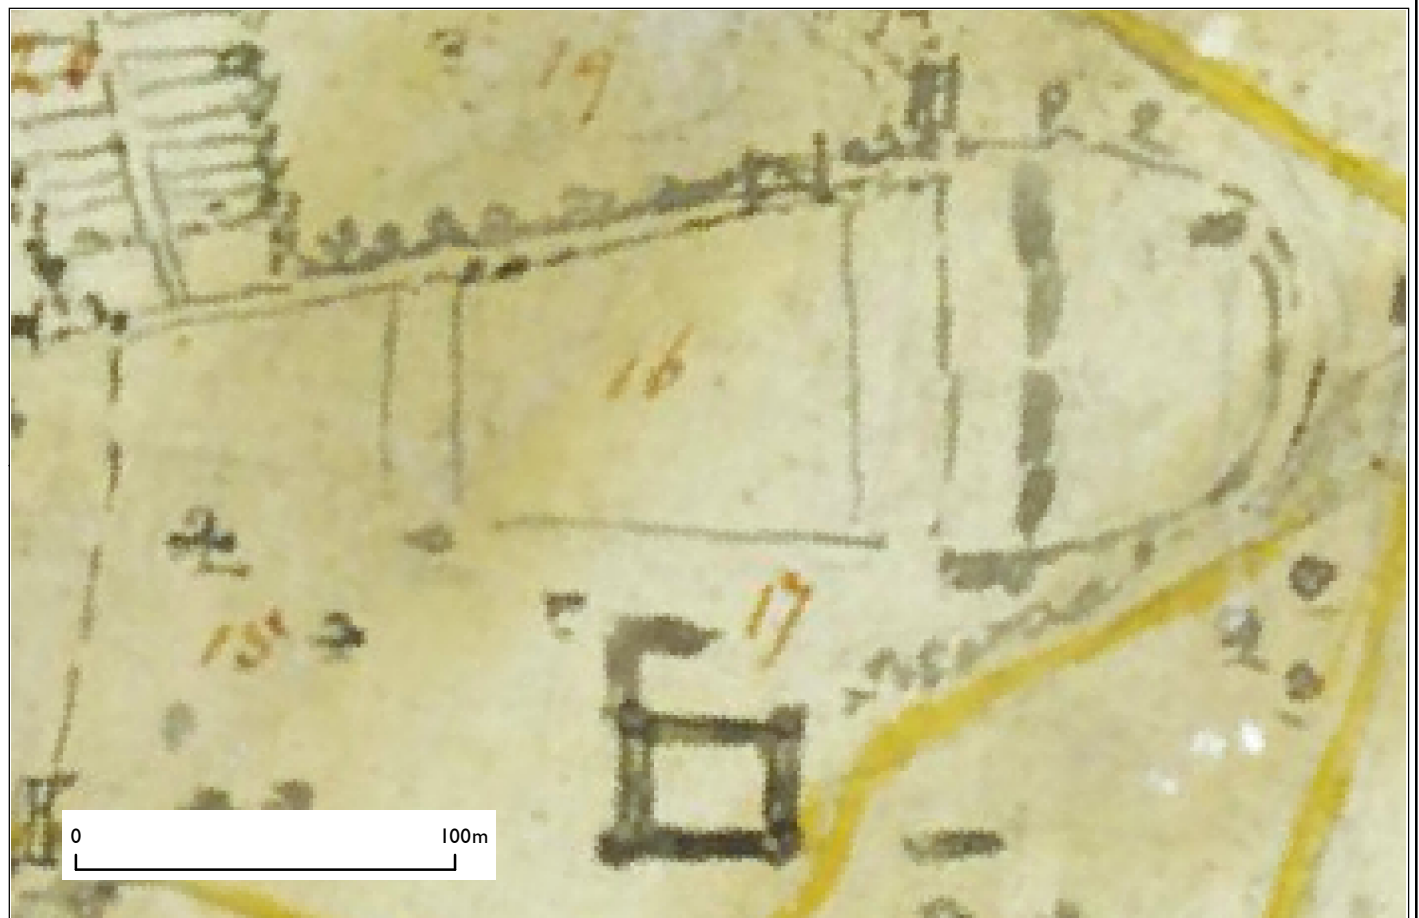
FIGURE 3 // Historic Maps

Top: Demense map 1799

Bottom: Anonymous map c.1800

5.2.1. The **1780 Davies Map** (FIGURE 3) shows an irregular field to the north of the castle with no indication of a walled garden. The **1799 Demense Map** (not reproduced) is clearly copied from the former, indicating that the garden still had not been built.

5.2.2. A **c.1800 anonymous map** (FIGURE 3) shows a very different layout around the castle. There is now a crossroads to the east of the castle and it appears that the stables have been built as well as two rows of ?buildings on the north side of the track to the north west of the castle. The area of the walled garden is shown as a rectangle with a gate in the north. The map is very roughly drawn and cannot be scaled with any accuracy, however, it is possible that the rectangle represents the walled garden.

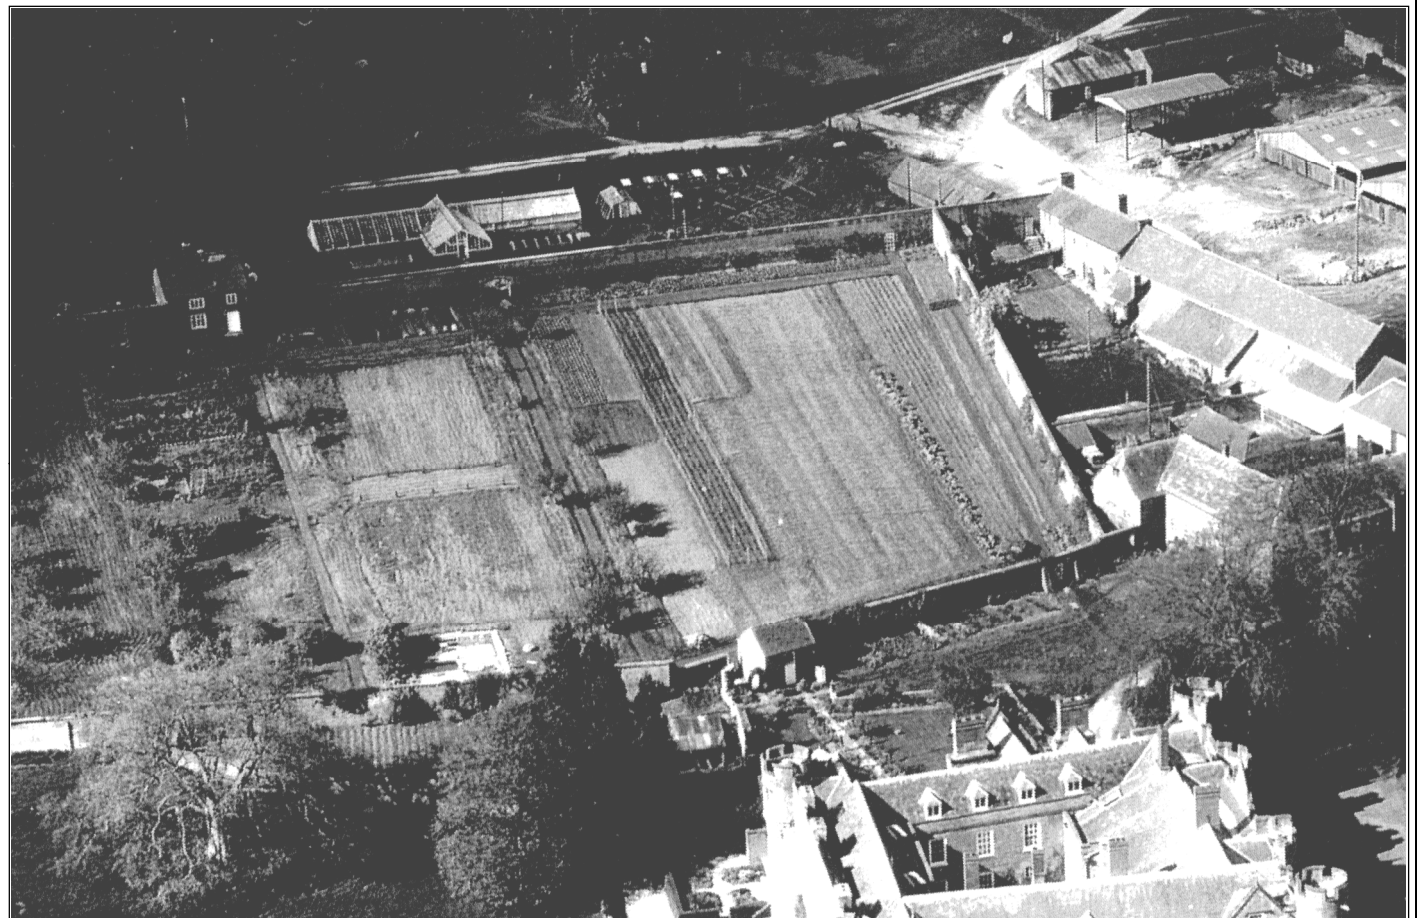
FIGURE 6 // Aerial photographs

- 5.2.7. The **1946 RAF aerial photograph** (FIGURE 6) clearly shows the garden in agricultural use. The central east west path is no longer extant and the glass houses have been demolished.

- 5.2.8. The **1974 aerial photograph** (FIGURE 6) shows the same path layout. By this time Diana Uhlman had planted the rose garden and the oval hedge feature at the centre.

Top: RAF 1946

Bottom: Oblique aerial photograph 1974
