Archaeological Watching Brief Report for land at

## ST MARY'S & ST HELEN'S CHURCH

Client:	Donald Insall Associates Ltd		
Local Authority:	Cheshire West and Chester Council		
NGR:	329140,377400		
Planning App:	11/04592/FUL		
Author(s):	B Poole		
Doc Ref:	LPI304C-AWB-vI.I		
Date:	March 12		
Site Code;	NES/NPC 12

An archaeological watching brief was carried by L-P: Archaeology, on behalf of Cheshire West and Chester Council, at St Mary's and St Helen's Parish Church, Neston. The archaeological watching brief monitored works to repair and strengthen the southern wall of the churchyard.

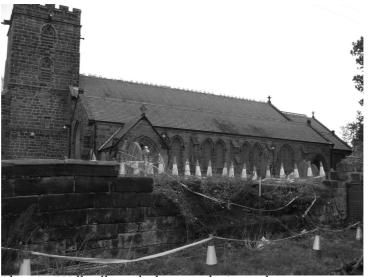
Plate 1 - Wall collapse, looking north, 1m scale

**6.3.1.** Tench 1 was located 3m west of the boundary wall for the vicarage garden and butting the southern elevation of the churchyard wall <u>100</u> (FIGURE 5). It is this area that has suffered greatest from the wall collapse (PLATE 1).

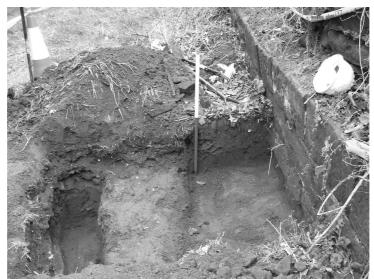
Plate 2 - East facing section of Trench 1, 1m scale

**6.3.3.** It is clear that (102) is a late Post Medieval make up layer associated with the vicarage garden, which likely dates to the late 20<sup>th</sup> century when the vicarage was built. Deposit (102) buts up against the churchyard wall <u>100</u> (PLATE 2).

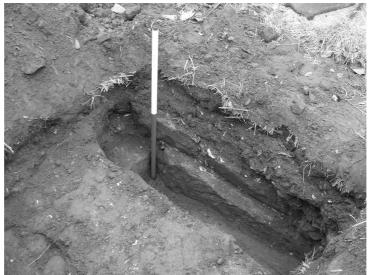
Plate 3 - Wall 104, looking east, 1m scale

- 6.3.6. Wall <u>104</u> had a similar construction form to the standing churchyard wall <u>100</u> and finds from within the construction of the wall included a Victorian penny, dated 1872, which suggests that the wall dates to the 1875 phase of construction works carried out on the site.
- **6.3.7.** Where the wall was collapsing at Trench 1 a vaulted grave, <u>108</u>, was identified (PLATE 4).

**7.4.1.** Wall 104 is thought to be contemporary with the standing churchyard wall. The presence of a dated penny, 1873, suggests that the wall dates to the 1875 repair work carried out on the church and churchyard.

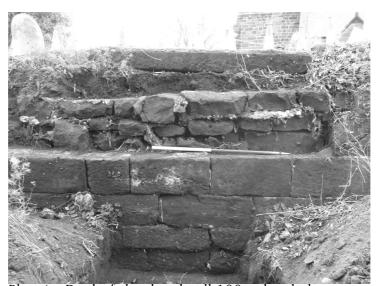
Plate 4 - Depth of churchyard wall <u>100</u> and vaulted grave <u>108</u>, looking north, 1m scale

**6.3.8.** The vaulted grave differed in construction form to the churchyard wall in that as opposed to the large ashlar sandstone blockwork of the main wall, the grave was made up of smaller, unfinished, sandstone blockwork with a hard cream to

**6.3.9.** The grave fill material (107) was a loose dark brown to black silty loam that can be seen in the upper area of PLATE 4 and is shown on FIGURE 7. The grave marker was a 0.25m thick sandstone slab 2.4m by 1.2m in size. Initially this was covered with a great deal of moss (PLATE 5).

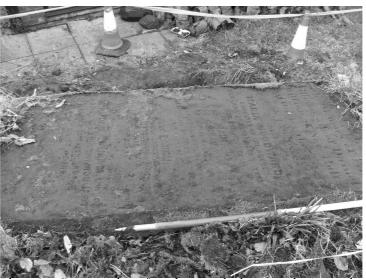
Plate 6 - Grave marker after cleaning, looking south, 1m scale

**6.3.10.** After a delicate clean, most of the moss was able to be removed to reveal a very degraded inscription (PLATE 6).

**6.3.11.**The inscription has been recorded and can be found in APPENDIX 2. The grave is clearly a family plot that was last used in 1963.

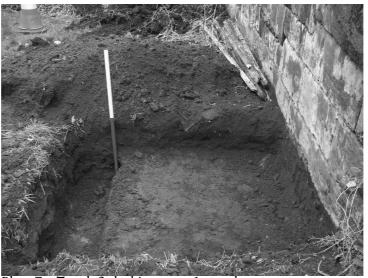
Plate 7 - Trench 2, looking west, 1m scale

- **6.4.1.** Trench 2 was located 3.4m to the west of Trench 1 and measured 1.6m by 1.4m in plan and was excavated to a maximum depth of 0.6m BGL. Trench 3 was located 3.4m west of Trench 2 and measured 1.6m by 1.3m in plan and was excavated to a depth of 0.6m BGL.
- **6.4.2.** Both trenches contained the same stratigraphic sequence seen within Trench 1 with, however wall 104 was not identified within either Trench 2 or Trench 3.
- **6.4.3.** Below a 0.05m topsoil (101), the 20<sup>th</sup> century make up (102) could be seen to be 0.4 to 0.45m thick (FIGURE 7). This in turn overlay the natural drift deposit (103) at approximately 30.05m AOD.

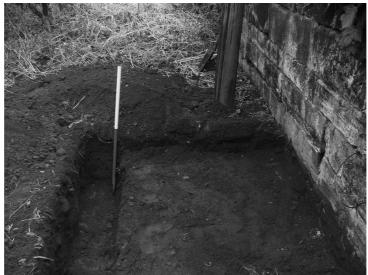
Plate 8 - Trench 3, looking west, 1m scale

**6.4.4.** At the base of Trench 3, at 29.34m AOD, the top of the natural sandstone bedrock (110) was encountered (FIGURE 8).

**6.4.5.** No features were identified within Trenches 2 and 3.

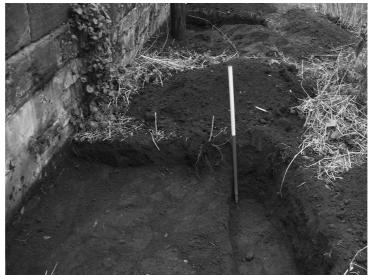
Plate 9 - Trench 4, looking east, 1m scale

- **6.5.1.** Trenches 4 and 5 contained the same stratigraphic sequence as each other (PLATE 9 & PLATE 10). Trench 4 was located 3.4m west of Trench 3 and measured 1.6m by 1.4m in plan and was excavated to a depth of 0.6m BGL. Trench 5 was located 3.4m west of Trench 4 and measured 1.6m by 1.2m in plan and was excavated to a depth of 0.6m BGL.
- **6.5.2.** The upper deposit identified in trenches 4 and 5 was a 0.45m thick loose black silt loam (106). This was a vegetable patch as many potatoes were recovered during excavation. This deposit could be seen to cut into the topsoil (101) and as such it is clear that this is a modern deposit.
- **6.5.3.** Below (106) was the 20<sup>th</sup> century make up deposit (102), which extended beyond the base of both Trench 4 and Trench 5 (FIGURE 8) at 29.48m AOD, 0.6m BGL.

**6.5.4.** No features were identified within Trench 4 or Trench 5.
