Archaeological Watching Brief Report for land at

CHESTER CATHEDRAL

Client:	Chester Cathedral
Local Authority:	Cheshire West and Chester Council
NGR:	340785,366075
Planning App:	12/02354/FUL
Author(s):	B Poole
Doc Ref:	LPI 340C-AWB-v1.2
Date:	February 13
Site Code:	CHE/116 NGS 12 & CHE/ABS 12

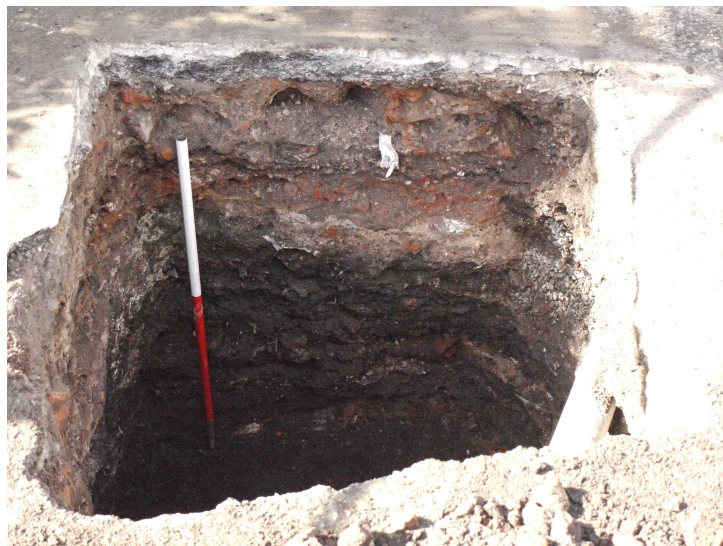
5.2.2. The uppermost deposit identified was the tarmac surface for the car park (100), which measured 0.03 to 0.05m thick. This overlay a 0.08m thick sand and gravel sub base (101), which had been severely compacted. Below (101) was deposit (102) a 0.2m thick layer of brick rubble and mortar (PLATE 1).

Plate 1 - Trench 1, looking west. 1m scale

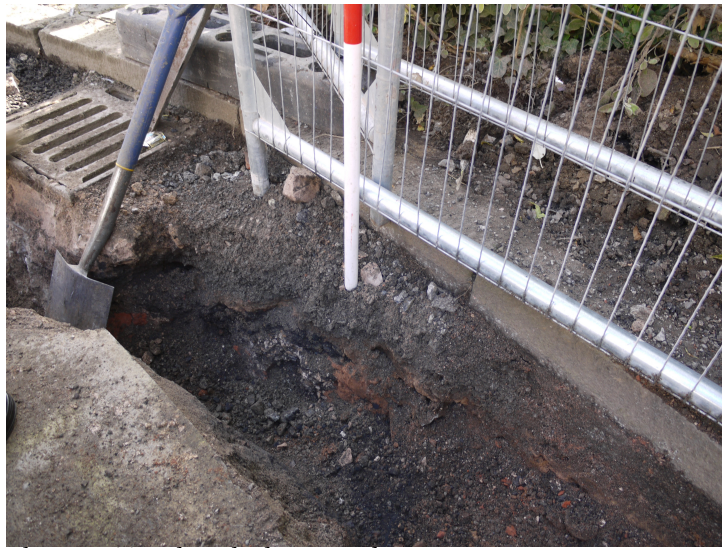
Plate 2 - Trench 3, looking north

- 5.3.3. Below the tarmac surface of the car park (100) a single deposit was encountered within Trench 3 (PLATE 2). This was the brick and mortar fill (102) seen in Trench 1.

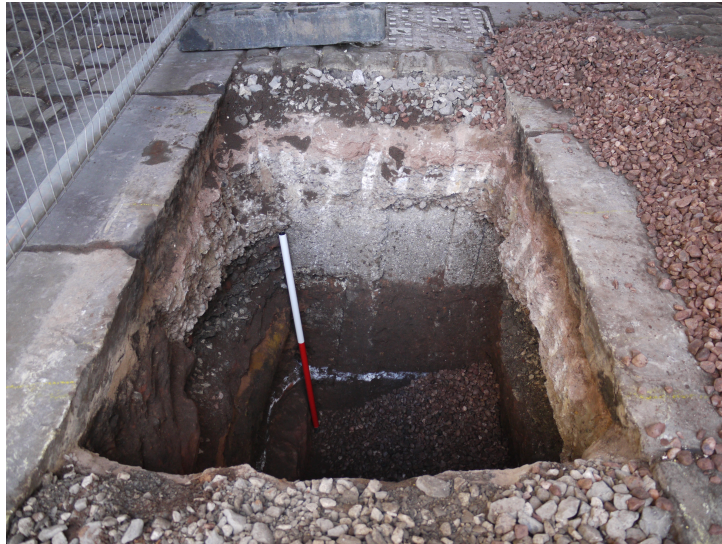
Plate 3 - Trench 4, looking east, 1m scale

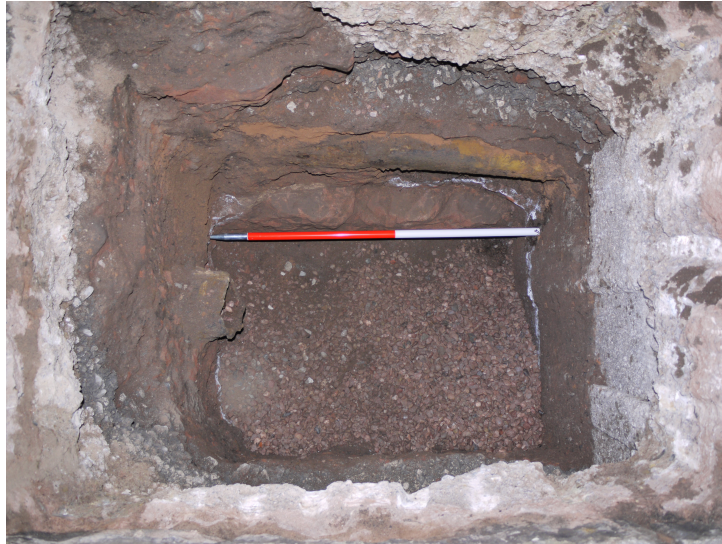
5.4.7. Although there has been a significant amount of disturbance for services in this area a sandstone structure, 206, was identified in the northern section of the trench (PLATE 4).

Plate 4 - Sandstone 206, within Trench 4. 1m scale

5.4.8. The structure is located 1.2m below ground level, at 27.99m AOD and is formed of a series of large sandstone blocks in ashlar construction running east west (FIGURE 11). The blocks have been squared off, although do not appear to be fully faced in appearance. This may indicate that these were footings of a substantial structure. Each block measures approximately 0.5m by 0.3m by 0.3m.

5.4.10. No dating evidence was recovered from the sandstone feature and as such no accurate date can be given for it. However, the location of the stonework, off centre to the standing gateway, suggests that this may represent the precursor to the 14th century gate. It is known that the standing gate replaced an earlier structure and it is possible that this sandstone feature represents *in situ* remains of the Medieval entrance to the cathedral complex. It has also been suggested, that due to the depth of the feature it may also represent a hitherto unknown Roman structure.

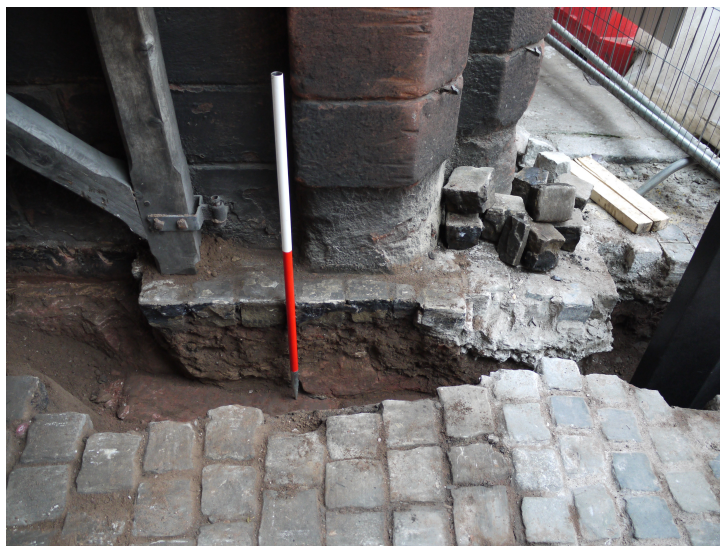
- 5.5.3. These footings comprised stepped sandstone blocks, 303 & 304, which extended from the arch base into the entrance.
- 5.5.4. Directly below the extant archway, 301, was a course of large sandstone blocks, 303. These measured 0.75m long by 0.35m high, the width was not visible as they extended back into the section (PLATE 5).

Plate 5 - Trench 5, looking south, 1m scale

- 5.5.5. These footings were of ashlar construction and of roughly finished blocks. This suggests that these were designed as foundations for the arch, which shows that the 14th century floor level of the gateway must have been approximately at its current level of 29.145m AOD.

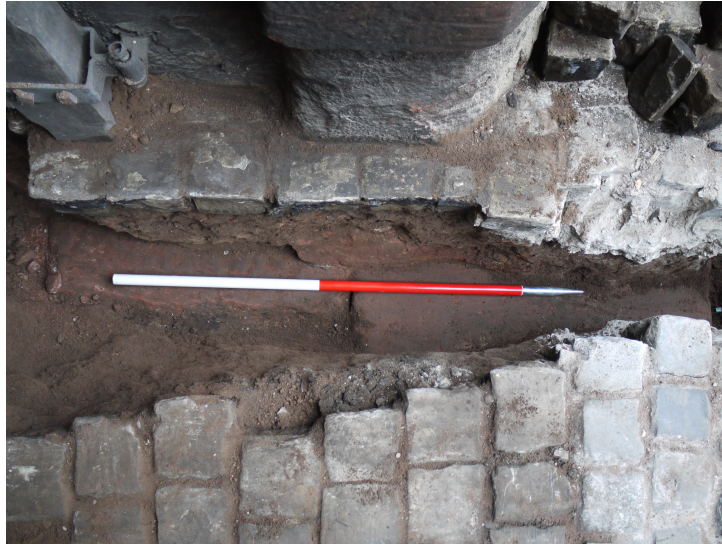
5.5.6. Below 303 a second course of foundations, 304 was identified at the base of the trench (PLATE 6). This lower course was more substantial in nature, however only the upper surface was exposed as it formed the lowest point of the excavation depth. The sandstone forming 304 measured 0.9m wide and extended 0.6m from the standing gateway, 0.45m from the edge of excavation (FIGURE 12).

Plate 6 - Sandstone foundations 304, 1m scale

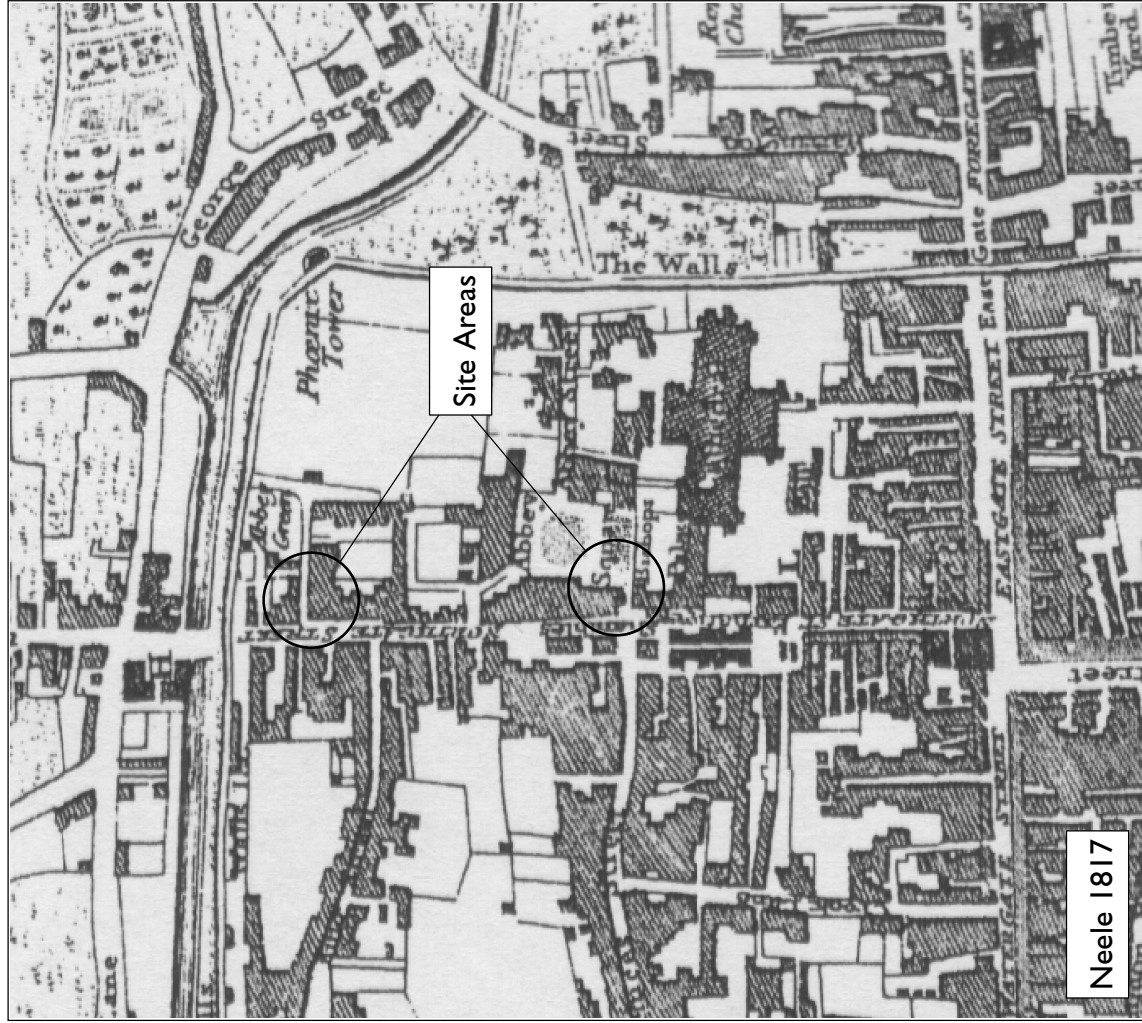
FIGURE 5 // 1817 & 1821 Maps

3.6.2. Neele's Map of 1817 and Bateman's Map of 1821 (FIGURE 5) show the development of the site area in detail, with terraced buildings leading back from Northgate Street onto the area that is now used as a car park.

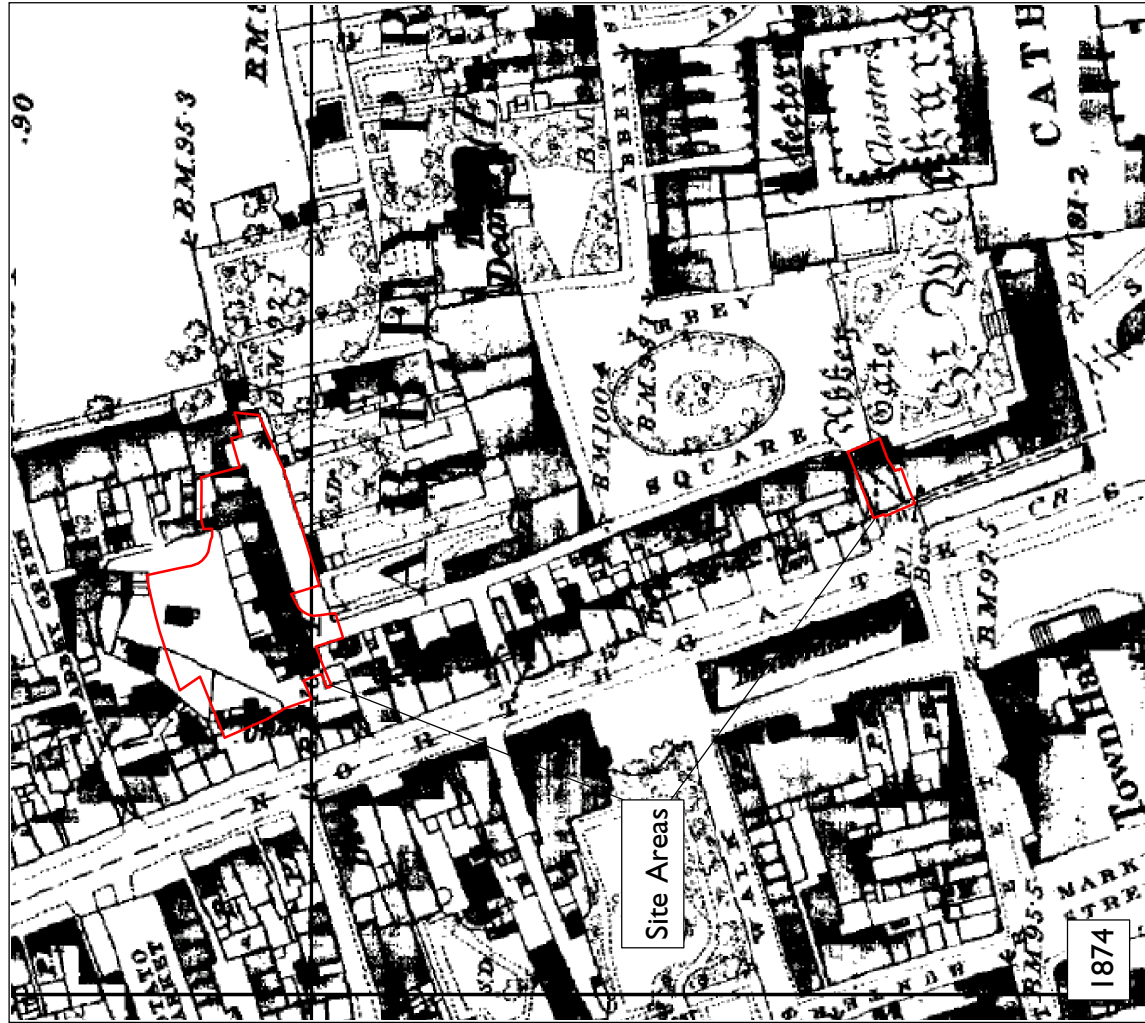
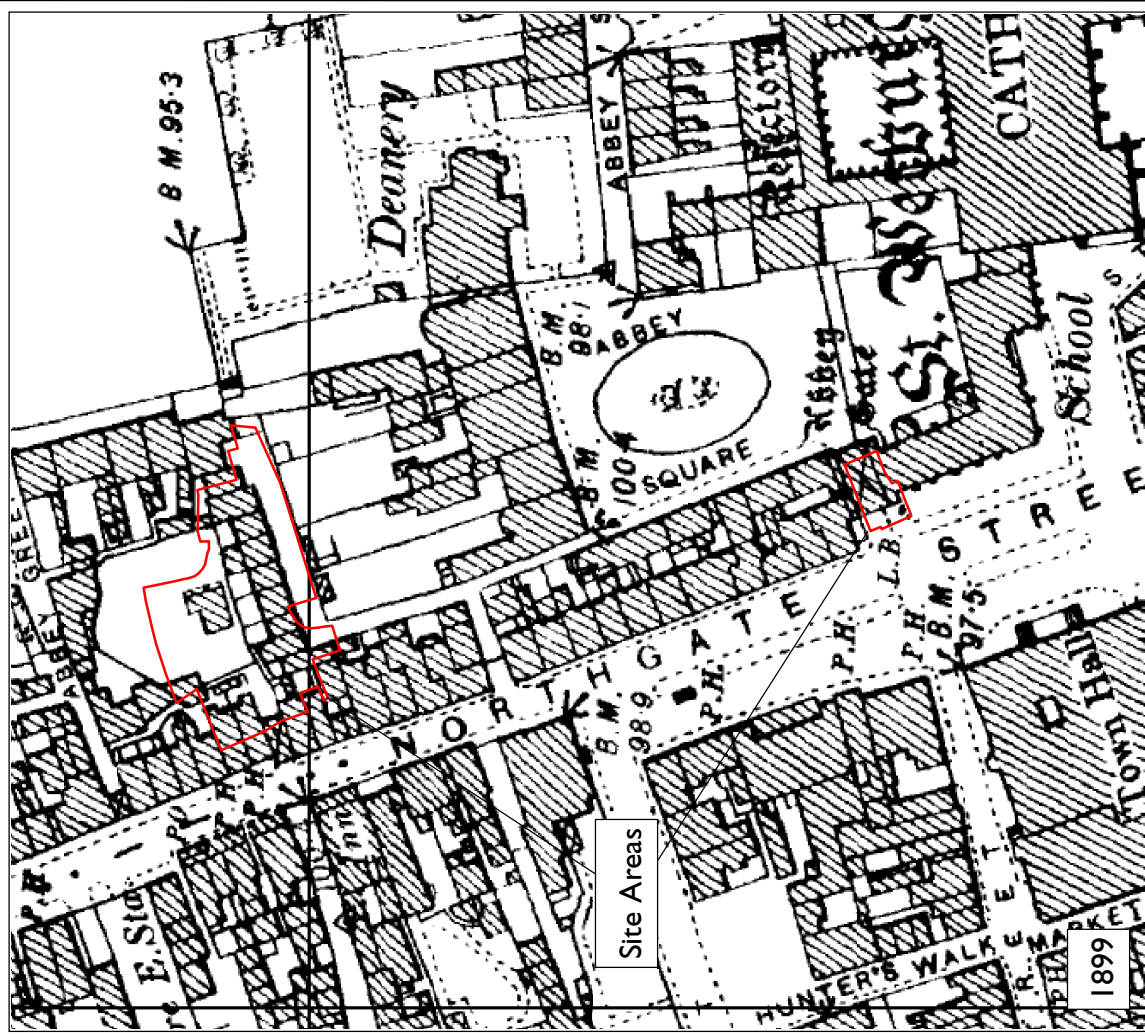
FIGURE 6 // 1874 & 1899 OS Maps

3.6.3. The 1874 Ordnance Survey (OS) map (FIGURE 6) also shows buildings extending into what is now the entrance to the car park area. The growth of these buildings can be seen on the 1899 and 1911 OS maps (FIGURES 6 & 7).

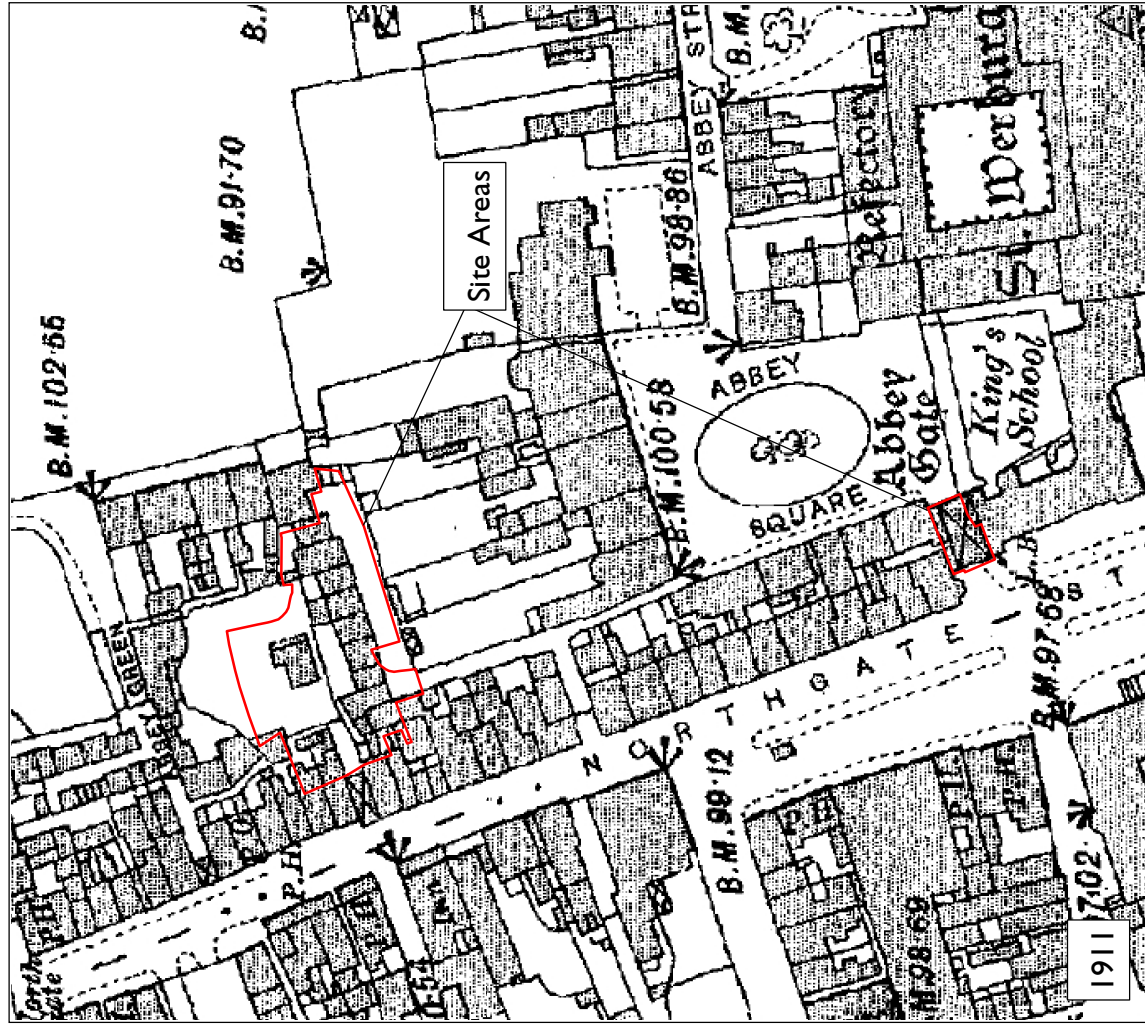
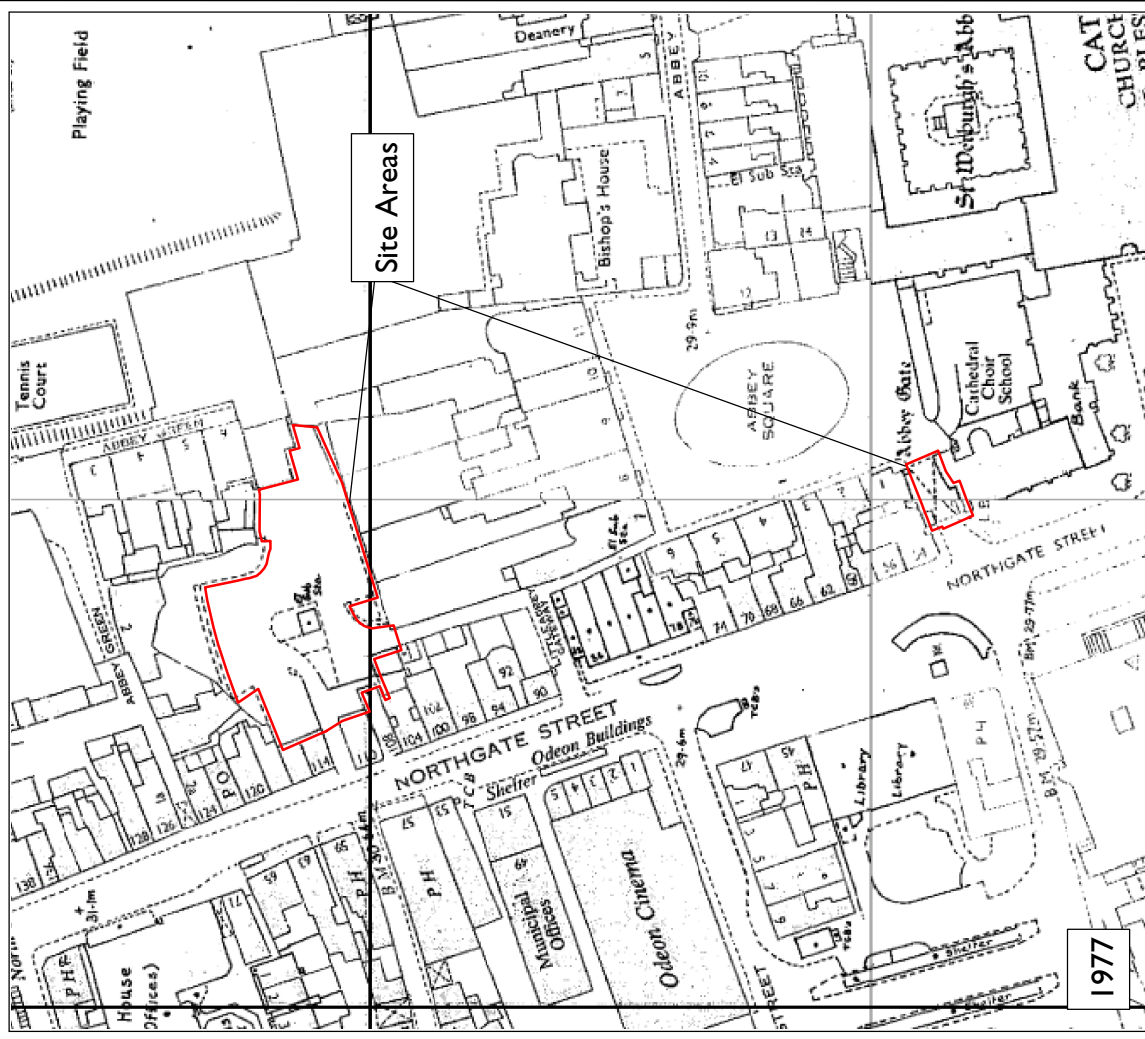
FIGURE 7 // 1911 & 1977 OS Maps

3.6.4. At some point in the late 20th century the buildings to the rear of Northgate Street were demolished and a the car park was formed. This is shown on the 1977 OS map (FIGURE 7).
