Archaeological Watching Brief Report for

ST ANDREWS CHURCH CHESTER

Doc Ref: LPI514C-AWB-v1.2

Date: May 13

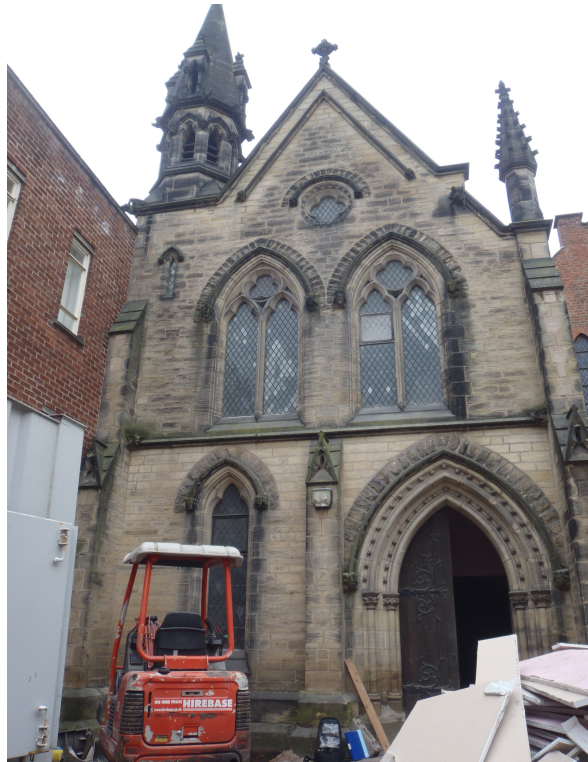
Plate 1 - ST Andrews Church, looking west

4.18. The church occupying the site (PLATE 1) was built in 1860 by JW and J Hay, with areas rebuilt by Kelly and Edwards in 1884. Originally built as a Presbyterian church it was later converted to a United Reform church. The church is shown on the first edition Ordnance Survey map of 1871. There have been no significant changes to the site since this date.

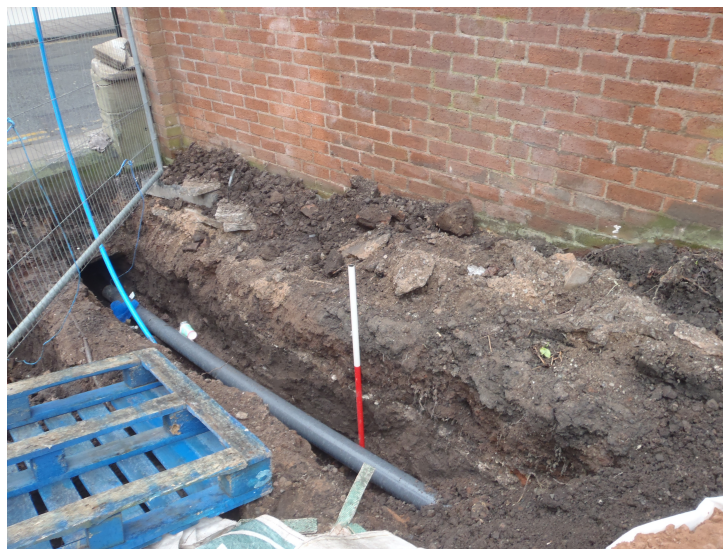
Plate 2 - Service trench 1, looking southeast, 1m scale

- 6.2.1. Service trench 1 was located along the southern perimeter of the site, measuring 25m long by 0.6m wide (FIGURE 4). The trench was excavated to a depth of 0.65m below ground level.
- 6.2.2. The eastern 19m of the trench, forming the bulk of the excavated area revealed a series of late Post Medieval layers. These are assumed to relate to the removal of the buildings that previously occupied the street frontage, until 1860.
- 6.2.3. The uppermost deposit was a 0.3m thick layer of loose dark brown sand (100) with rubble inclusions (PLATE 2). Below this was a 0.05m thick lens of mortar and sand (101), which overlay a deposit of loose dark brown silt and rubble (102). Deposit (102) extended beyond the base of the trench at 0.65m below ground level (FIGURE 5).

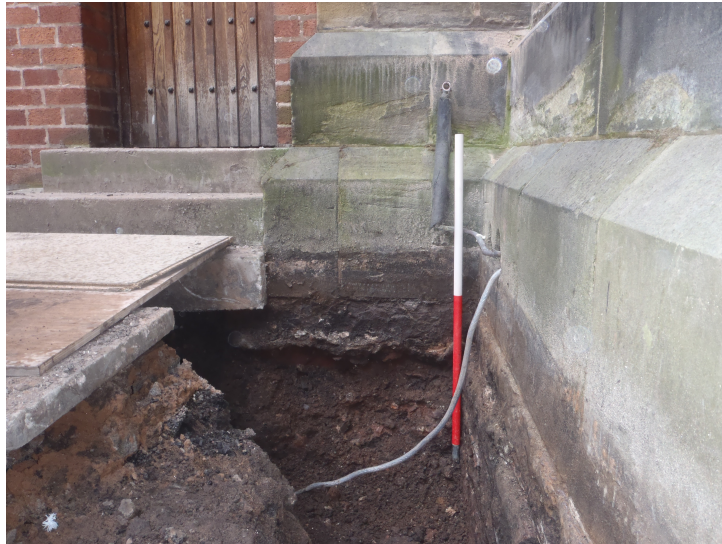
Plate 3 - North facing section, 1m scale

- 6.2.5. The wall was cut into deposit (100) and penetrated though to (102) to a depth of 0.7m below ground level. In this area the trench extended to a depth of 0.85m below ground level. Deposit (102) extended beyond the base of the trench in this area.

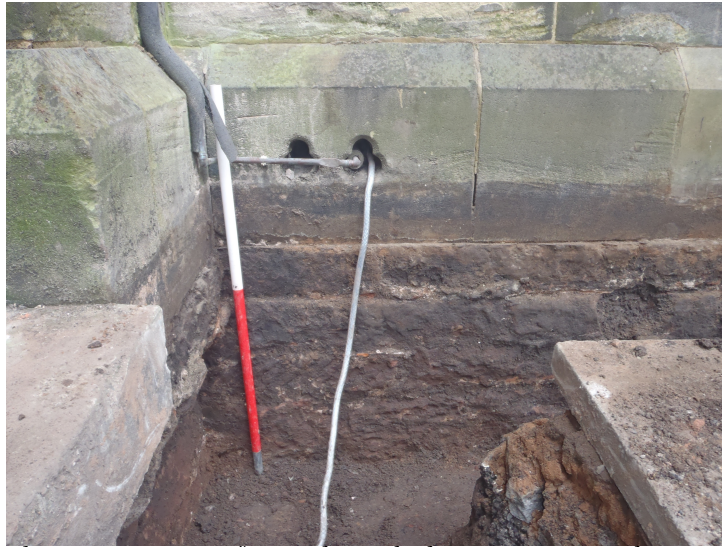
Plate 4 - Footings of St Andrews, looking west, 1m scale

- 6.2.6. At the western end of the trench the foundations for St Andrews church were exposed (FIGURES 6 & 7). Below the yellow sandstone ashlar blockwork 106, that forms the facade of the church, was a thin layer of slate (PLATE 3), dividing the yellow sandstone from the red sandstone footings 105 (FIGURES 6 & 7).

6.2.7. The footings were more uneven and roughly faced, comprising regular courses of ashlar blockwork (PLATE 4). The bottom of the footings were not exposed as the base of the trench was established at 0.65m below ground level. Deposit (102) overlay footings 105, showing that the deposits encountered during the works all post date 1860, when the church was constructed.

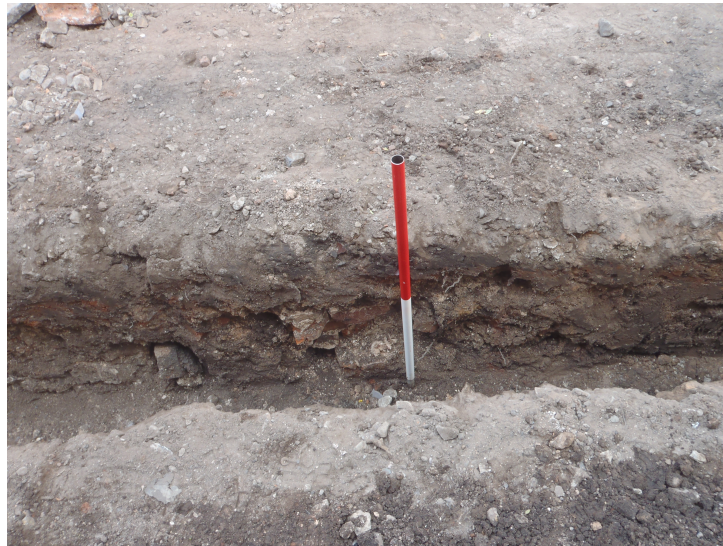
Plate 5 - Service trench 2, looking north, 1m scale

6.3.3. In the northern section of the trench, 4m from the eastern boundary of the site, evidence of a demolished wall, 107, was identified. A rough mass of sandstone and brick, 0.3m wide, sealed by (100) was recorded. This extended beyond the base of the trench. This mass was overlain by (102) and it is

thought that this represents part of a demolished structure that once fronted onto Newgate Street. A date for the wall was not determined as the excavation only revealed the southern most edge of the demolished wall and as such it was not fully excavated (PLATE 5). No finds were recovered from this structure.
