Archaeological Watching Brief Report for land at

# **HIGGINS LANE FARM RUDHEATH**

For Ripple Developments (UK) Ltd

Doc Ref: LP0693C-AWB-v1.2

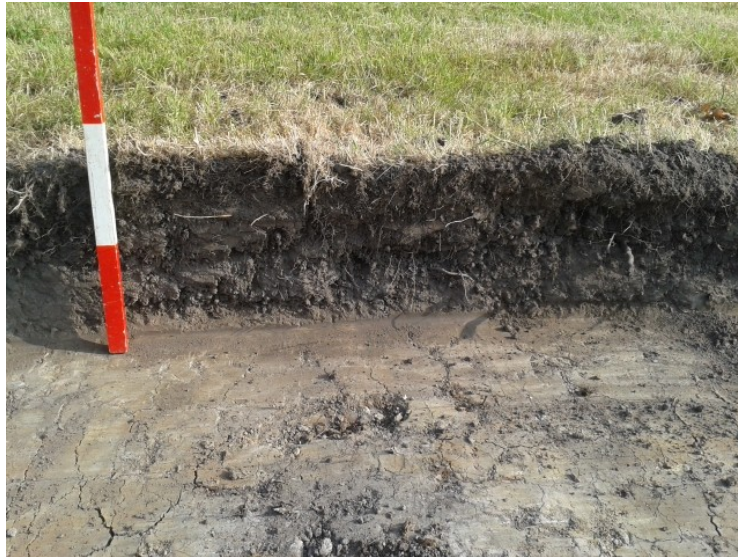
5.3.1. Initial excavations into the large car park revealed a very shallow topsoil reaching the natural boulder clay at up to 0.50m depth (FIGURE 3). Due to the compact clay, the machinist resorted to the use of toothed buckets for the majority of the car park excavations making features hard to determine. Despite this, it was clear on closer inspection of the area that very little discernible archaeology was present, aside from U-shape modern field drains, drain cut scars (PLATE 1) and a single shard of Post-Medieval 'mottled green ware' .

Plate 1: South facing section of topsoil strip, showing drains cut

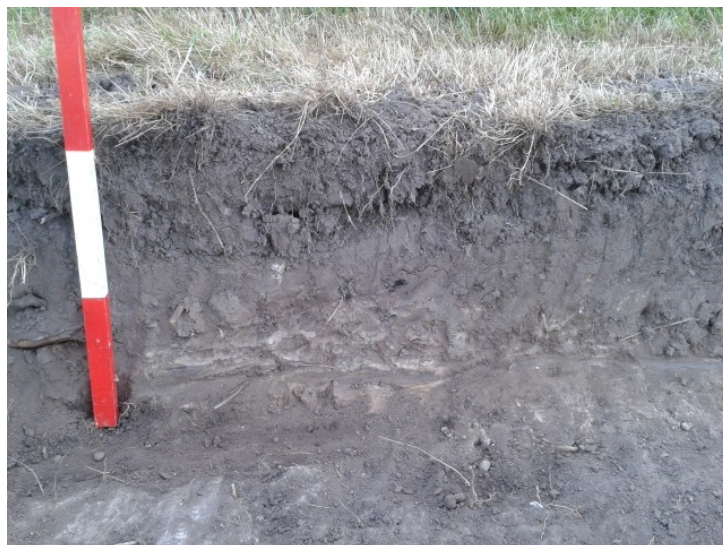
5.4.1. Area 2 was a new track and car park added to the construction plan, leading towards the farm buildings. This area revealed a similar pattern to Area 1 with field drains and cut scars and a depth to natural of up to 0.50m. However, there was also the faint presence of a former field boundary in the trench's southern portion, in this instance only visible aboveground. Scattered across this trench were some shards of post medieval pottery disturbed by machine (PLATE 2).

Plate 2: Area 2 section, looking west

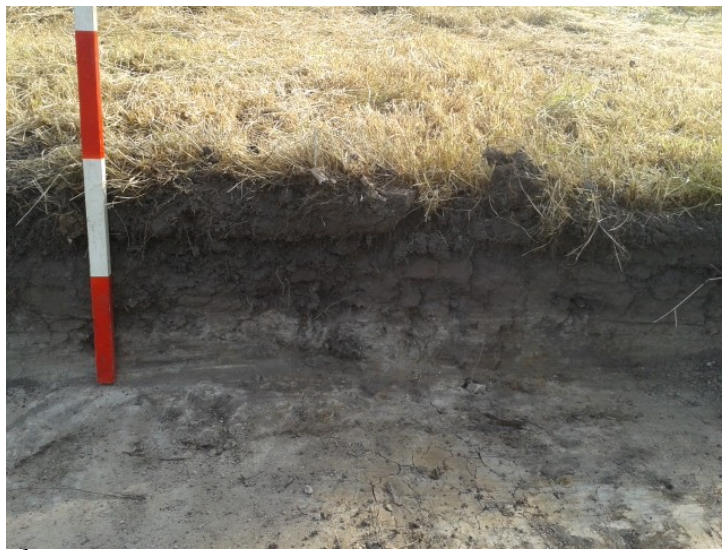
5.6.1. Area 4, the smaller car park was similar to Area 1, with a depth of up to 0.50m. This trench contained a different form of natural with inclusions of a chalky gravel. However, this was intermixed into the natural boulder clay and was likely a result of the trees surrounding the trench which had caused clear disturbance to the soils and clays (PLATE 3).

Plate 3: Area 4 section

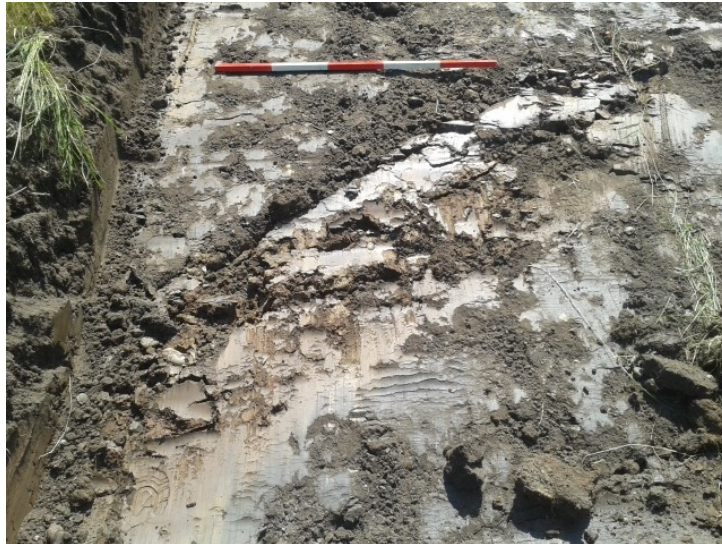
5.7.1. Area 5, connected the car parks to the marina buildings. This trench was excavated using a toothless bucket, making features easier to see. The upper section the trench (north) revealed a clear orange clay linear feature cut into the natural clay. This was part of a former field boundary still visible above ground (PLATE 4).

Plate 4: Remnant field boundary, 0.5m scale

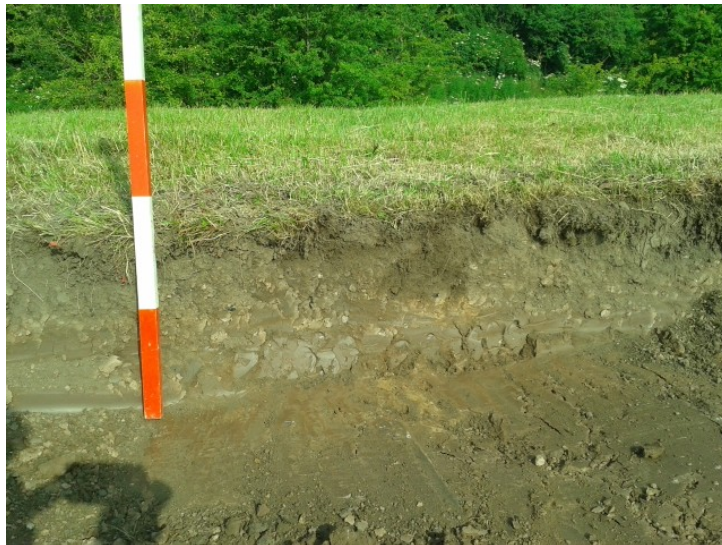
5.7.2. The remainder of the trench contained regular field drains as well as linear sand deposits. These deposits appeared to be connected to the topography on the landscape and have accumulated within depressions of the natural (PLATE 5). This is likely to be a result of the levelling on the field. Finds within this trench included a small scatter of post-medieval pottery and glass.

Plate 5: Area 5 section

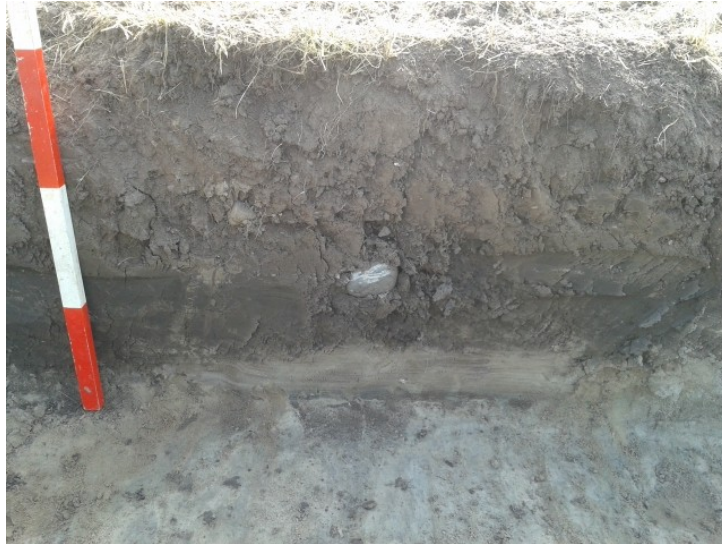
The depth of natural within this trench was up to 0.80m which is likely due to its topography at the lower end of the marina basin (PLATE 6). However, despite the sand deposits there again does not appear to be any form of notable archaeology aside from field drains.

Plate 6: Area 6 section

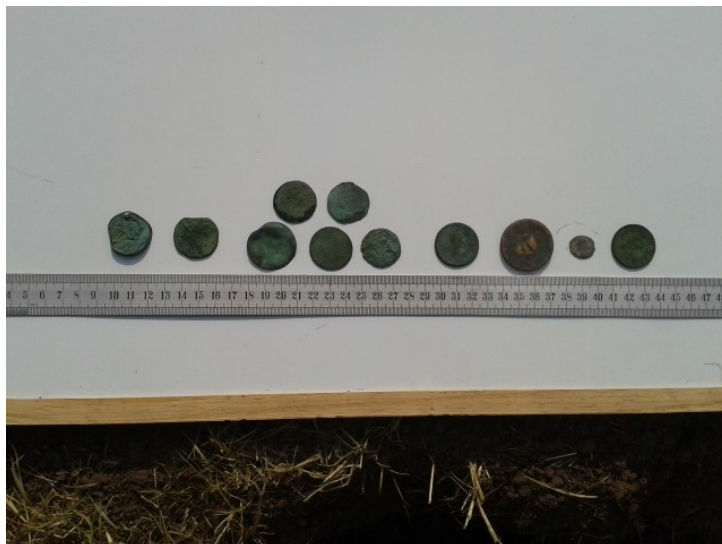
5.9. In addition to the excavations note above, the land owner over the past years, has uncovered a large quantity of copper alloy coins and objects including a small coin of what appears to be Roman origin. These finds were photographed and noted within this brief (PLATE 7).

Plate 7: Coins recovered from site by owner
