Archaeological Watching Brief Report for

ST PETER'S CHURCH LITTLE BUDWORTH

Client:	Graham Holland Associates
Local Authority:	Cheshire West and Chester Council
NGR:	359854,365368
Planning App:	12/04089/FUL
Author(s):	B Poole
Doc Ref:	LPI412C-AWB-v1.3
Date:	July 13
Site Code:	LBW/SPC 13

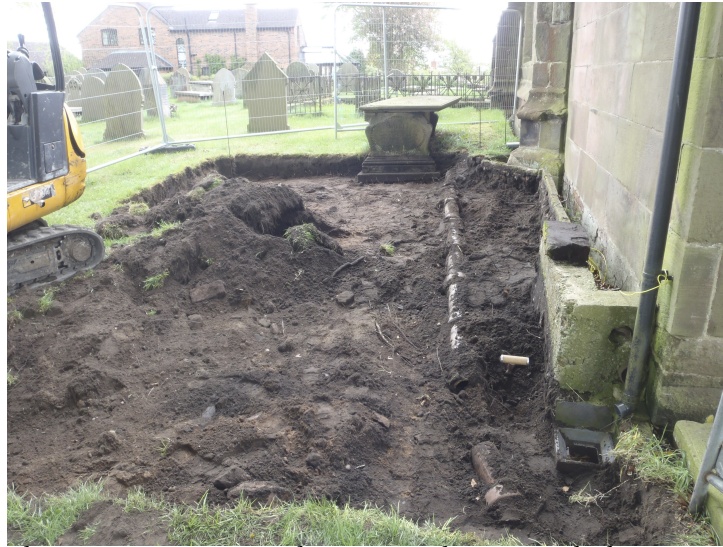
Plate 1: Excavation area during topsoil stripping, looking east

4.2. An area 2.6m north south by 2.5m east west (FIGURE 3) was stripped of topsoil prior to the excavation of strip footings (PLATE 1).

4.4. A 19th century, salt glazed, surface water drain [103] was identified running east west along the perimeter of the church, set back 0.4m from the church wall (PLATE 1). This service had been cut into the natural sand and its backfill contained a range of ceramic sherds dating from the 16th to 19th centuries. Finds included a small fragment of Cistercian ware, dating from the 16th century, and several large fragments of Black glazed ware dating from the 18th to 19th century, as well as printed blue and white ware.

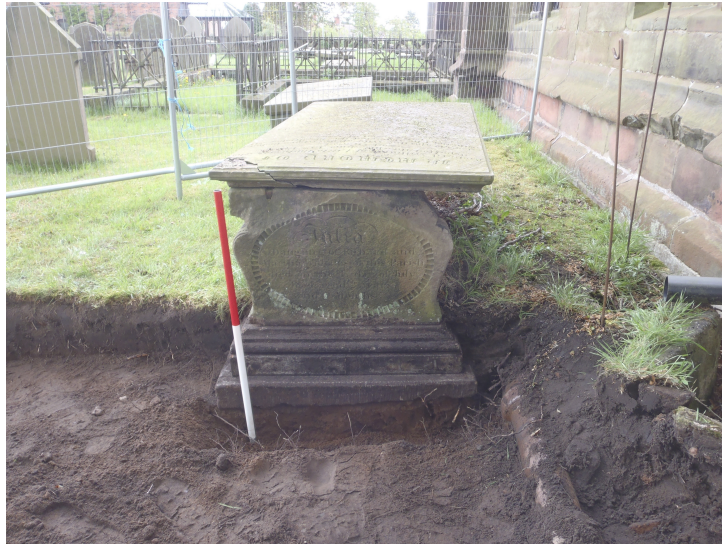
Plate 2: Table tomb in eastern section, prior to moving

4.5. At the eastern section of the stripped area a table tomb was located. This tomb dated from the 19th century and was a memorial to several members of the same family (PLATE 2).

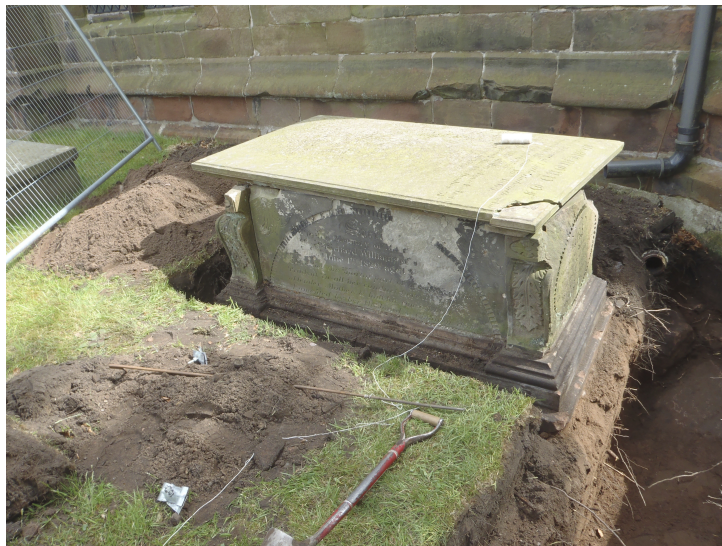
Plate 3: Table tomb after moving 0.3m to the east

4.6. A narrow, 0.3m wide, slot trench was excavated around the tomb, which was in a poor state of repair. The tomb was then slid 0.3m to the east in order to clear it of the strip footings (PLATE 3). No finds were recovered from the slot trench around the table tomb and no features were identified within the slot trench.

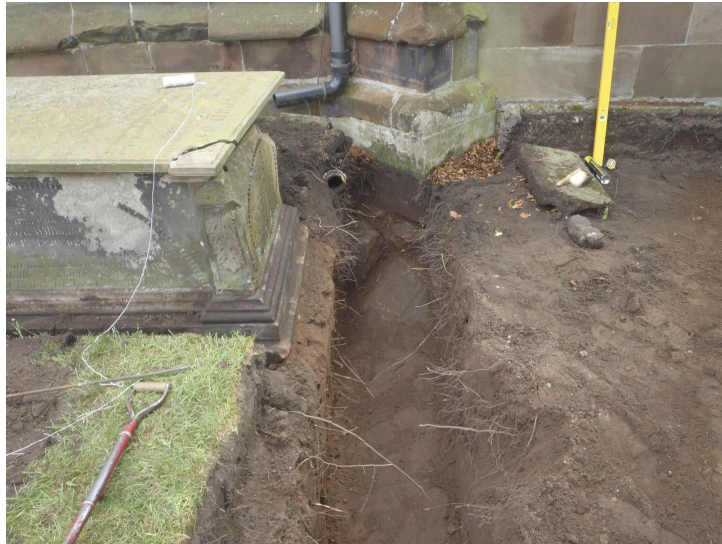
Plate 4: Southeastern extent of footings, showing bedrock beneath the church wall

4.8. In the majority of the strip footings only the natural sand (101) was present below the topsoil (100). However, in the southeastern corner of the footings, next to the table tomb, the natural sandstone bedrock (104) was encountered (PLATE 4).

4.9. It is apparent that the church has been constructed on a sandstone outcrop, whereas the graveyard appears to be within an area of sandy deposits above the bedrock.

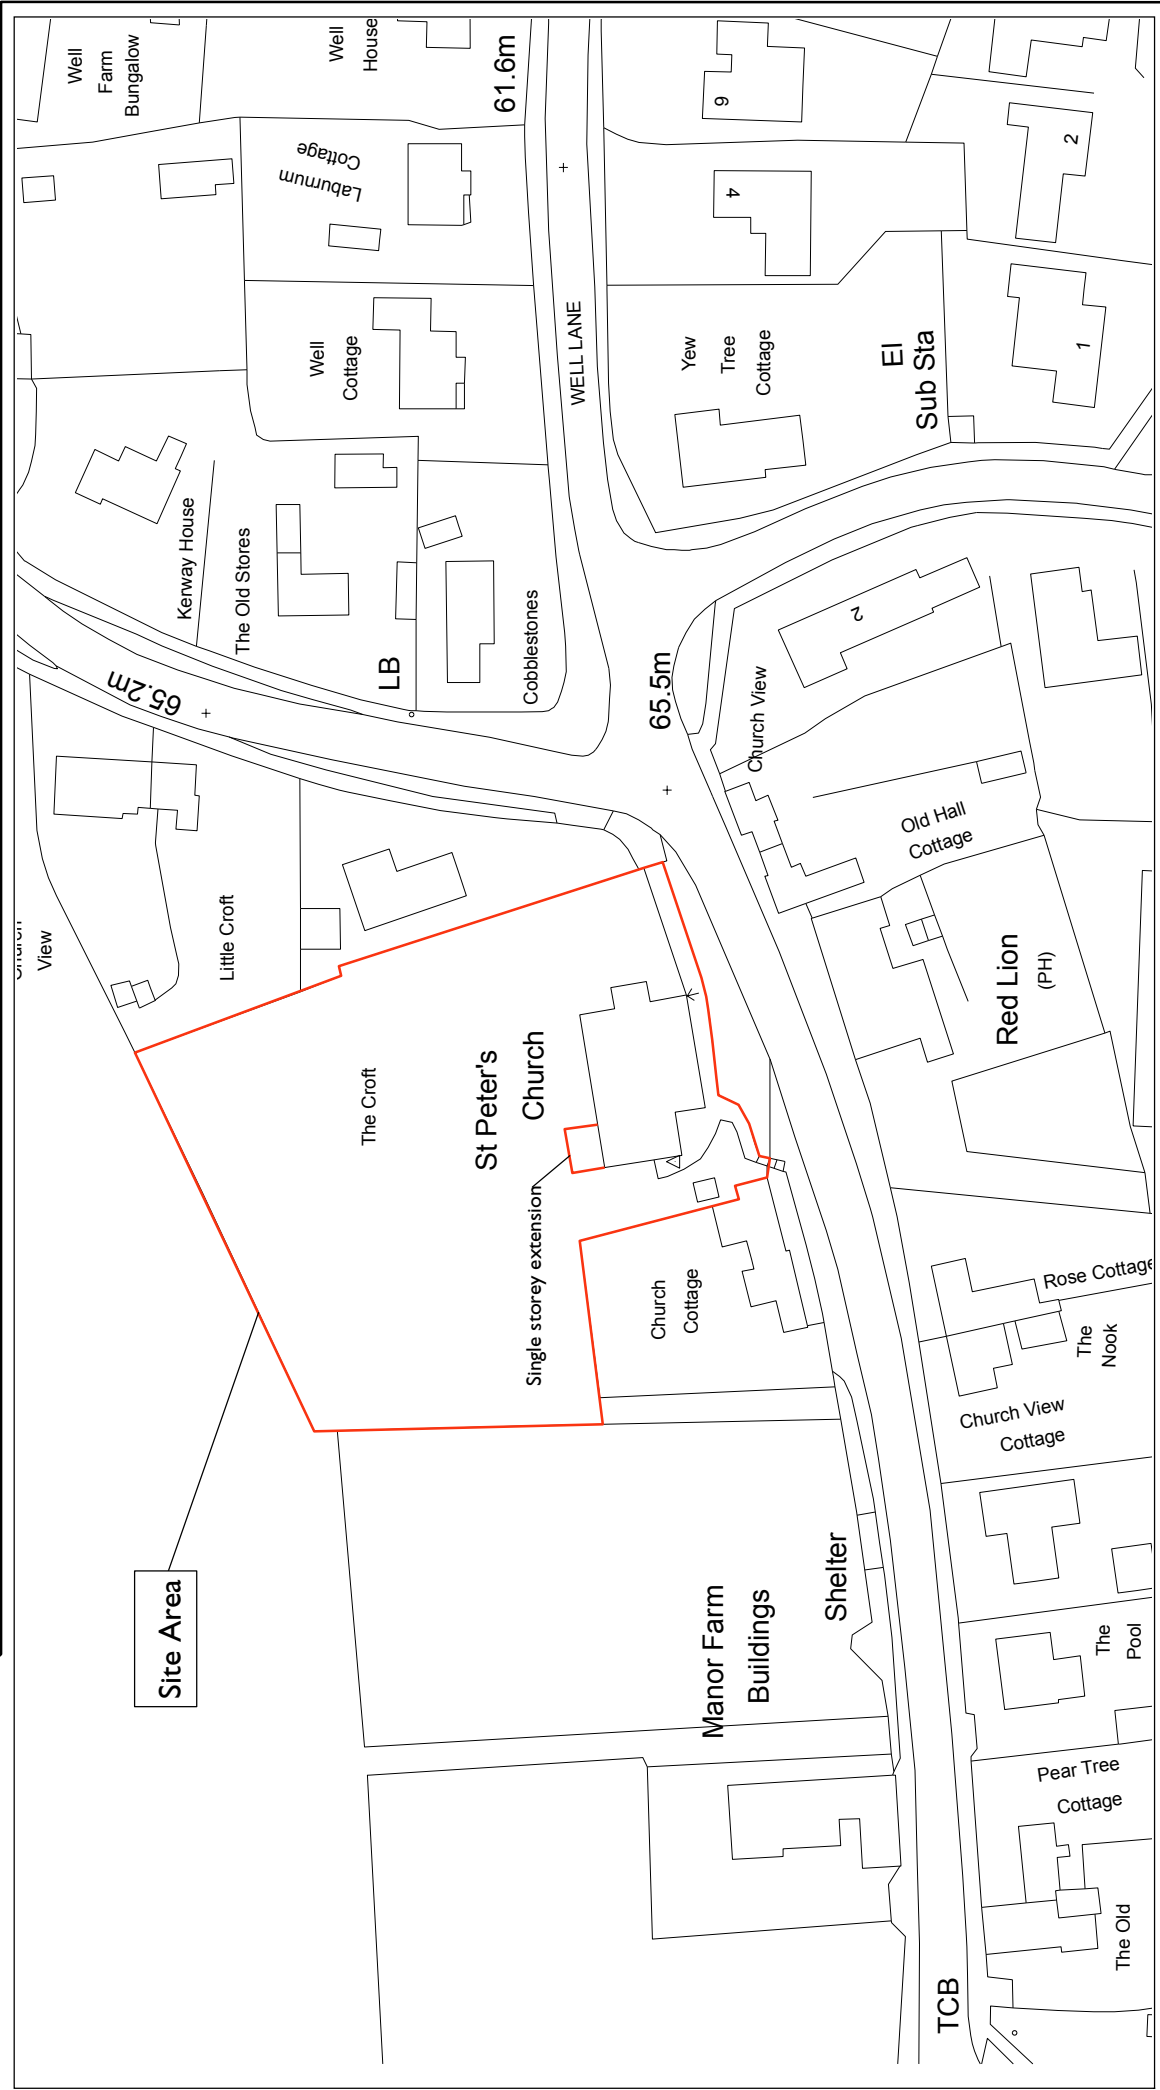
FIGURE 2 // Site Location Detail

2.9.1. The aims of the archaeological watching brief were to monitor all excavation for groundworks associated with the new extension (FIGURE 2). This is to ensure that archaeologically sensitive deposits of significance were respected and to record the character, date, type, state of preservation, and extent of any archaeological or historic architectural remains on site exposed or disturbed during groundworks.

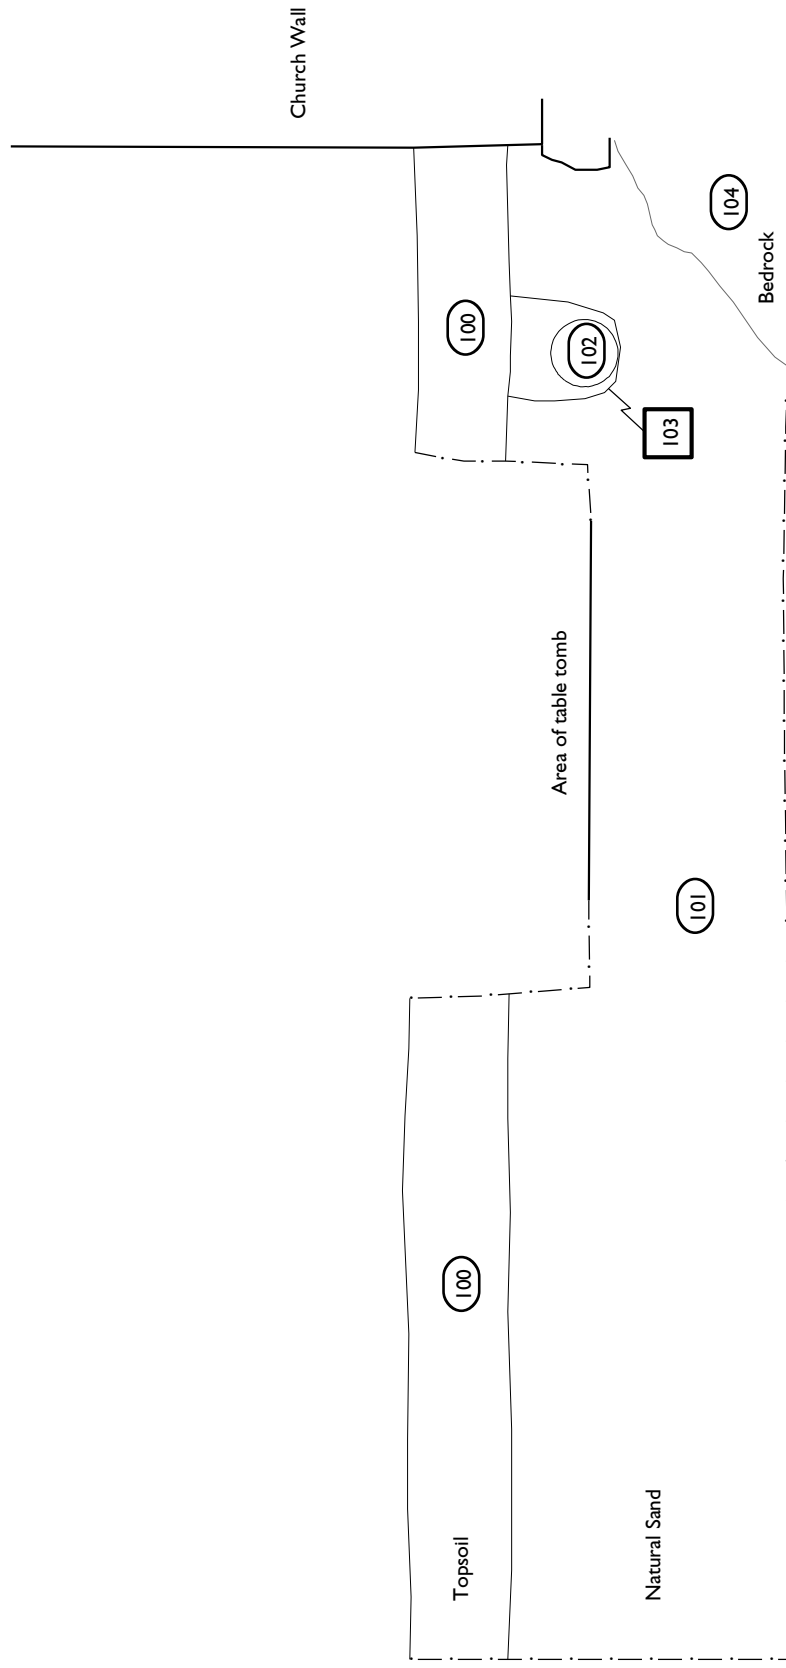
FIGURE 4 // West Facing Section

4.3. Excavation of the topsoil extended a maximum of 0.3m below ground level. Below the topsoil (100) was a loose, red, sand deposit (101). This sand was identified between 0.25 and 0.3m below ground level and was clearly a natural sand deposit (FIGURE 4).

4.7. Following the moving of the table tomb strip footings were excavated around the perimeter of the stripped area. These strip footings measured 0.4m wide by 1m deep (Figure 4).
