Archaeological Excavation Report for

ROMAN GARDENS GATE

For Cheshire West and Chester Council

Doc Ref: LPI497C-AER-v1.2

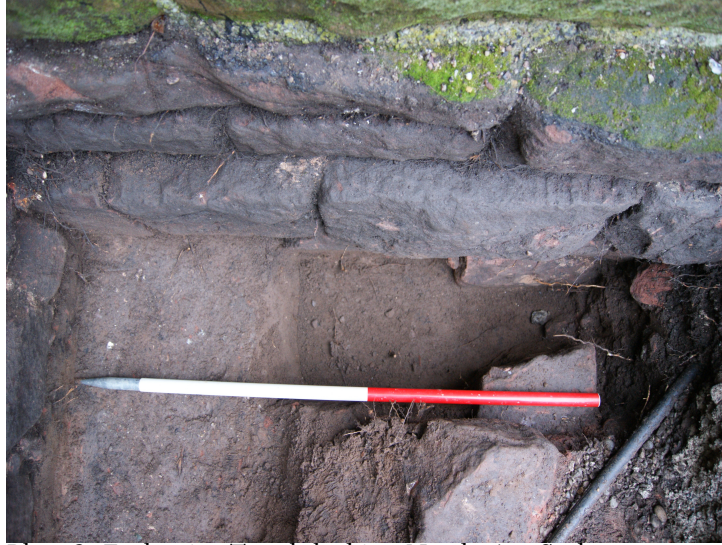
Plate 3: Evaluation Trench looking North, 1m Scale

- 4.2.3. Two small evaluation trenches were excavated against the City Walls and associated buttress in an attempt to record the depth and foundations of the walls on this side of the site (PLATE 3). The maximum depth reached during this excavation was 0.52m. The base of the wall was reached but the depth of the buttress continued below the depth of the excavation, as did the depth of

context (04).

- 4.2.1. Deposit (04) was seen to continue beneath the City Walls and is believed to provide evidence of a Victorian remodelling of this section of wall. This is likely to have included the rebuilding of a damaged area of the wall and the addition of a series of buttresses on its eastern side. This may have been necessary due to subsidence caused by the building of housing and businesses on the Park Street side of the wall, many of which had cellars which undermined the walls.
- 4.2.2. A number of services had been cut into context (04) and cast iron and lead pipes were recorded during an earlier phase of works at the site (WILLIAMS 2012). There was also a modern service trench cut into this deposit.

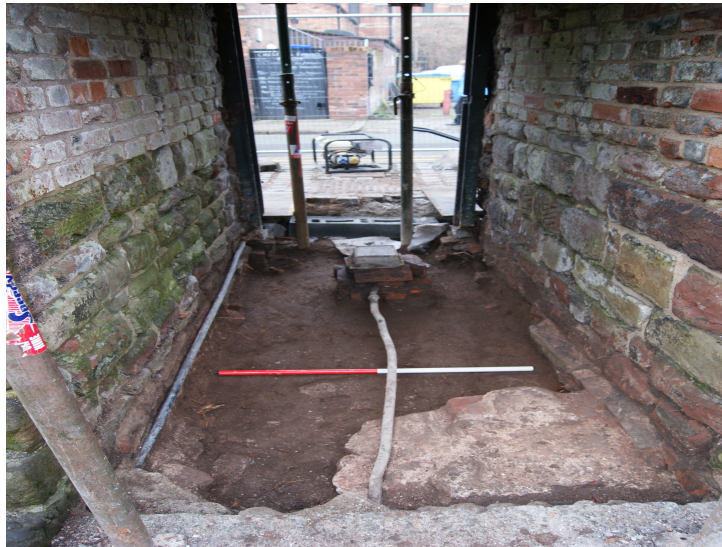
Plate 4: Passageway looking West, 1m Scale

- 4.3.1. Excavation in the passageway leading between the Roman Gardens and Park Street revealed a series of similar modern deposits to those found in the Roman Gardens. The only exception to this was the pathway surface. Whilst the surface in the Roman Gardens was of tarmac construction with associated bedding levels, squared granite setts were used on the path.

- 4.3.2. The maximum excavated depth in the passageway was 0.58m below the current ground level and at this depth the top of deposit (04) was reached.
- 4.3.3. The passageway elevations visible above ground have been described in detail elsewhere and this information will not be duplicated here. There were a number of interesting below ground architectural features noted during the course of the excavation and these are detailed below.

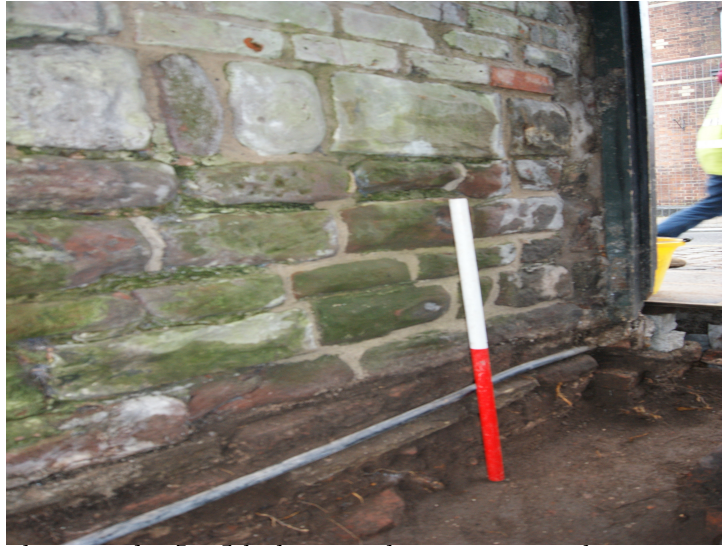
Plate 5: Ledge [01] looking South -West, 1m Scale

- 4.3.4. Two protruding ledges were recorded within the passageway. Ledge [01] protruded from the north facing eastern end of the passageway wall and was constructed using sand stone blocks and fragments of brick bonded with a lime mortar. The ledge was 1.06m in length, 0.22m - 0.34m in thickness and 0.08m in width.

- 4.3.5. Ledge [02] protruded from the south facing western end of the passageway

and was of the same construction. The ledge was 0.92m in length, 0.19m and 0.34m in thickness and 0.08m in width. It is believed that these ledges represent the surviving remnants of the original passage flooring (PLATE 5).

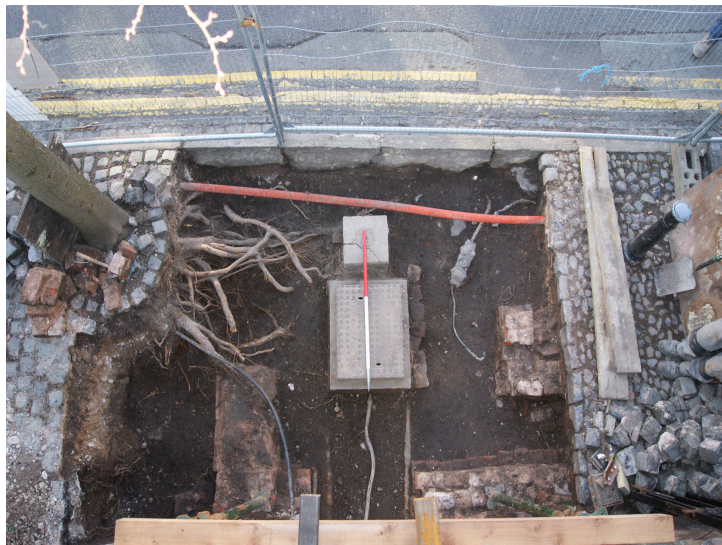
Plate 6: Western Side looking West, 1m Scale

4.4.1. Excavation on Park Street revealed the same general stratigraphy as was found in the Roman Gardens and the small square granite setts used as a surface in the passageway continued into this area (FIGURE 4). This surface was cut by a

modern linear trench running parallel with the road [08]. This trench had been back-filled with deposit (09), a mixed sandy-clay around a modern service pipe. The pipe had been covered with stone beach cobbles (FIGURE 5).

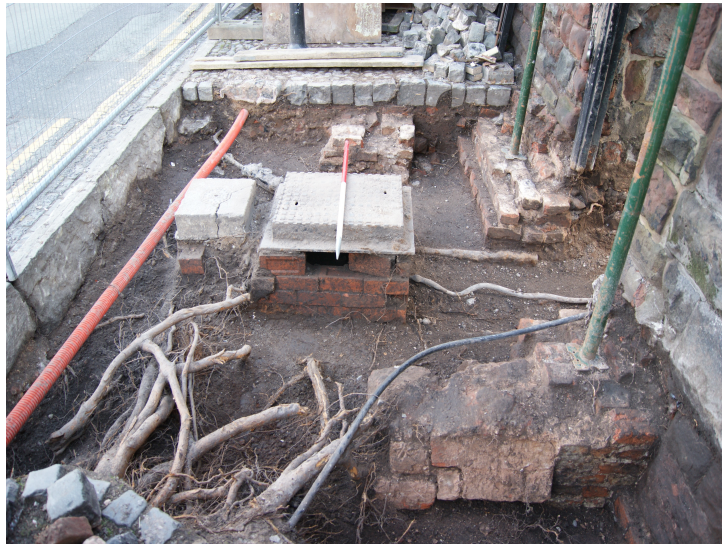
Plate 7: Western Side looking North, 1m Scale

- 4.4.2. Beneath the modern deposits context (04) was found to continue through the passageway. This deposit overlies and surrounds two roughly brick built walls. Wall [12] (PLATE 7) was aligned on a north-south axis and ran from the northern edge of the trench. Within the excavated area the wall survived for approximately 1m. It was 0.50m in width with a excavated of height of 0.45m. The wall ends approximately 1.5m from the city walls. A rubble deposit (13) which was formed from the disturbance/demolition of this wall was identified to the east of this wall.

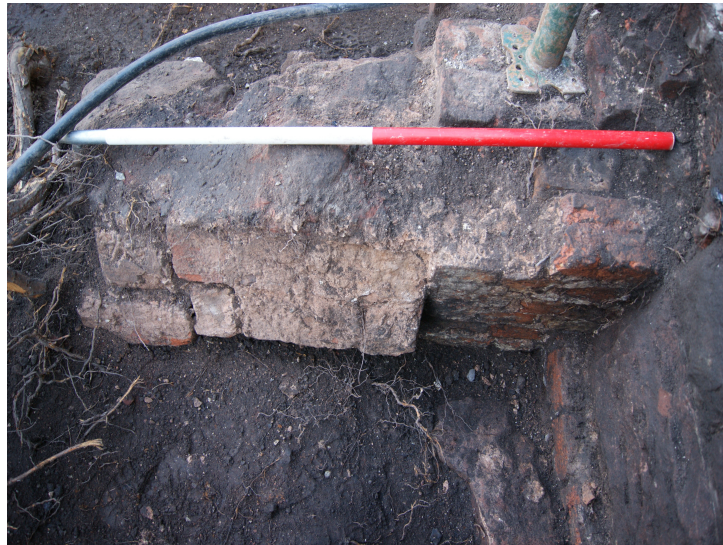
Plate 8: Wall [15], looking North, 1m Scale

- 4.4.1. The second wall, [15] (PLATE 8), was aligned on an east-west axis and ran from the south of the entrance to the City Walls passageway and ran for approximately 1.05m. The width of the wall was 0.40m and the height was 0.28m. A possible continuation of this wall was observed in the western (road side) trench section, although this area had been heavily damaged by tree roots and pipe trench [08]. The eastern end of wall [15] was formed into an arched feature (assigned context number [16]) 0.80m in length. This arched towards the southern edge of the trench and the corresponding end of the arch was not

within the trench limits.

4.4.2. Directly below the arch was a mixed clinker and charcoal deposit (17). It was unclear whether this deposit was just the fill of the area beneath the arch or if it ran beneath wall [15] itself as the deposit was only partially excavated.

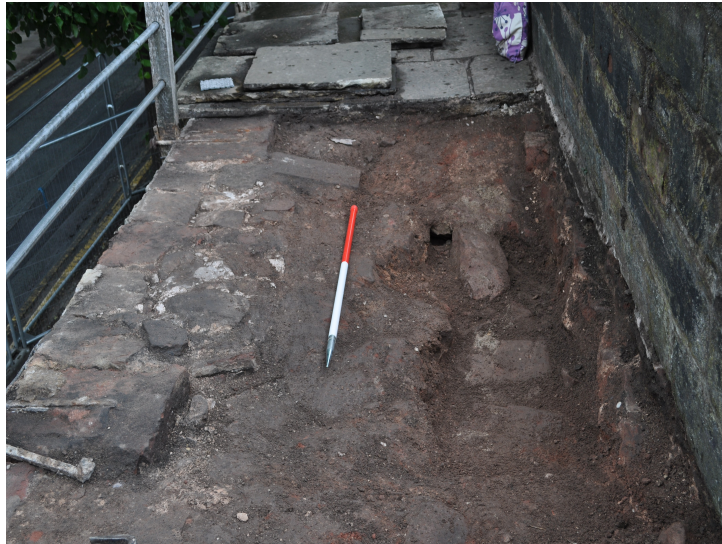
Plate 9: Wall Excavations looking North, 1m scale

4.5.2. The stone flags (PLATE 9) of the present wall walk were lifted and internal portion of the wall excavated under archaeological supervision until stable building material was encountered, to be reinforced with lime plaster, poured in to reinforce any voids.

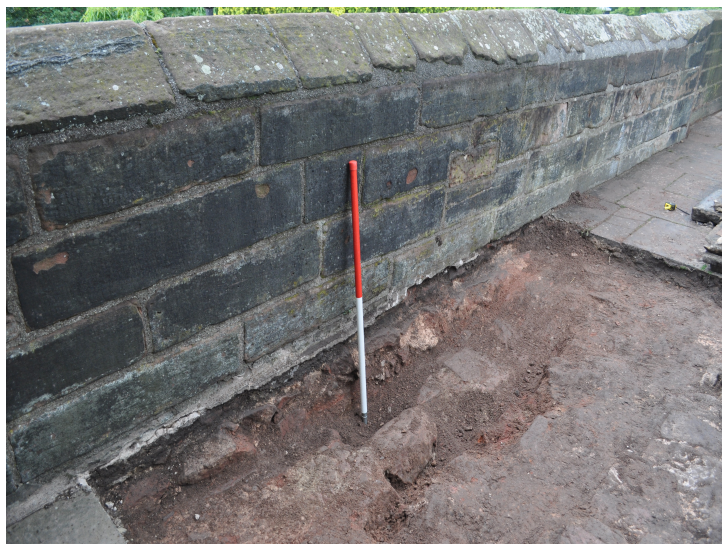
Plate 10: Section of Works looking South-East, 1m Scale

4.5.5. (104) – bedding for (103), dark brown sandy silt 0.04m thick (PLATE 10).

4.5.6. Below (103) was (101), an interior wall infill of mid pink brown silty sand

with frequent mortar and sandstone rubble up to 0.1m in diameter with finds of 18th 19th Century china and Buckley Ware. This deposit revealed further large irregular blocks of sandstone with mortar at the limit of excavations at a depth of 0.3m. A more compact rubble infill (105), comprised of irregular sandstone pieces up to 0.4m in length, was deemed solid enough for works to cease and this rubble was left undisturbed.

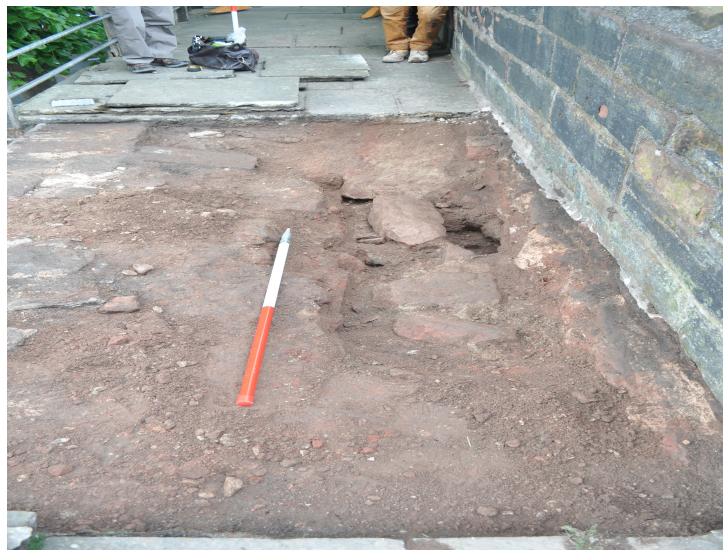
Plate 11: Full extent of works looking North, 1m scale

4.5.7. The excavations revealed the top of the western side of the sandstone City Wall construction (102), comprised sub-rectangular and irregular sandstone blocks up to 0.5m in diameter (PLATE 11).
