Archaeological Watching Brief Report

PROJECT REVOLUTION

For EDF Energy

Doc Ref: 0746C-AWB-v2.2

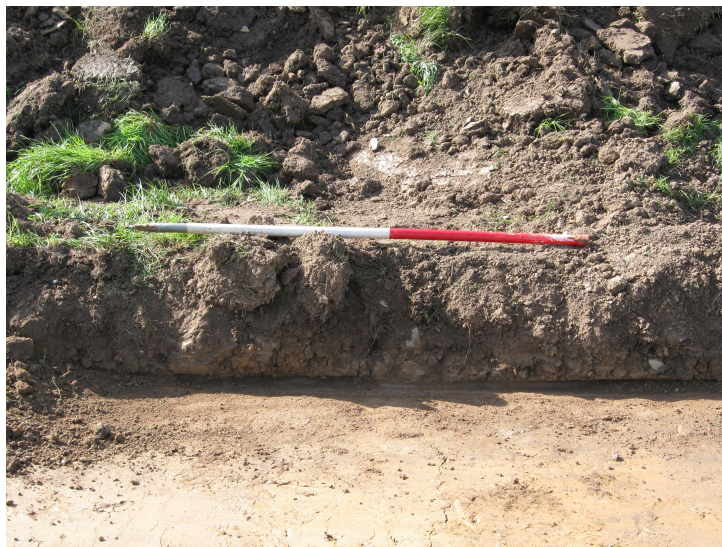
Plate i - South facing section of Pad 14, 1m scale

5.2.2. All excavations for the access roads and pads extended to a maximum depth of 0.4m below ground level (PLATE I). The upper deposit (100) was a humic loam topsoil of varying depths across the site from 0.1m to 0.25m thick. Below (100) lay a light brown sandy subsoil (101) measuring between 0.1m and 0.2m thick. This sandy subsoil sealed the natural red brown sandy clay (102).

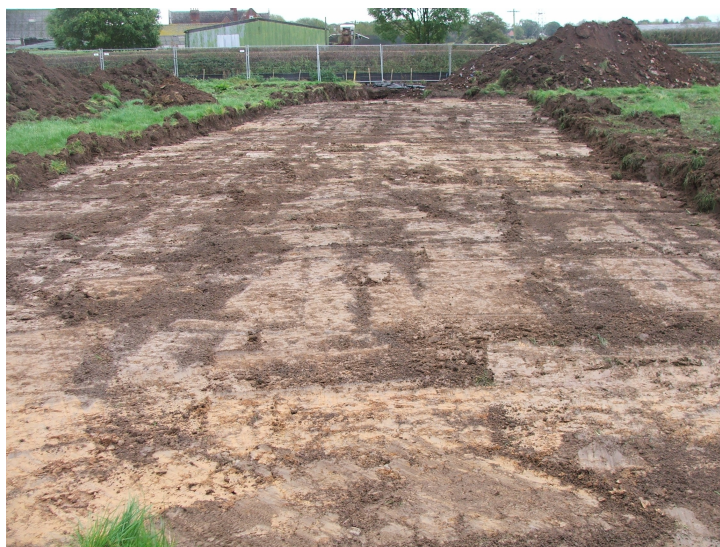
Plate ii - Well head 4, looking east

5.3.3. In the majority of well head and compound excavations no features were encountered (PLATE II), showing that the area has never been developed, and can be characterised as an agricultural landscape. However, at the northeastern corner of well head 4 a large 20th century waste pit was encountered. This measured 0.5m deep by approximately 10m in diameter. The fill was a soft dark sandy loam (103), which contained plastic and metal waste material from the local farm. This material included toys, food containers, and agricultural machine parts (PLATE III).

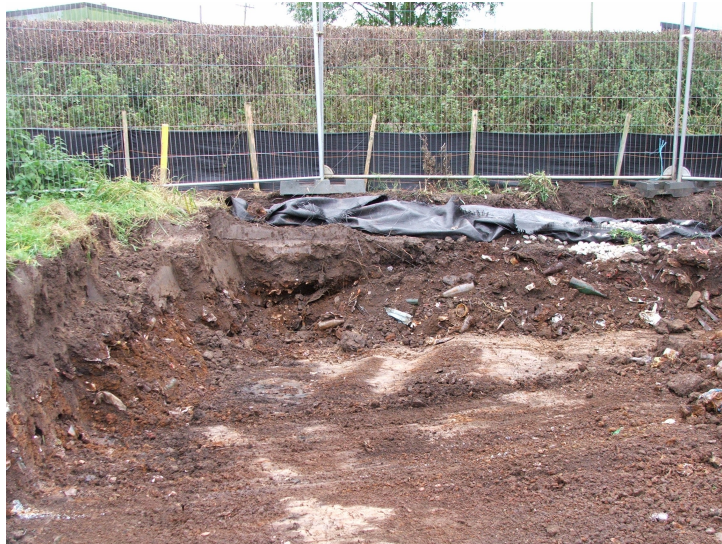
Plate iii - Northeast corner of well head 4

- 5.3.4. The location of the pit, close to Hill Top Farm, suggests that this was a waste pit created by the farm in order to dispose of its excess material.
- 5.3.5. The service excavations penetrated slightly deeper than the topsoil strip for the well heads and compounds. The services were excavated to a depth of 0.6m below ground level and showed the same stratigraphic sequence as noted above. The dark humic topsoil (100) extended between 0.2m and 0.25m thick. Underlying this was a 0.2m to 0.3m thick layer of natural sandy subsoil (101). Below (101) was the natural sandy clay (102).
- 5.3.6. No archaeological features were encountered during the works on the site.
