Archaeological Evaluation Report

SIDNEY SUSSEX COLLEGE CAMBRIDGE

Doc Ref: LPI224L-AER-v1.2

Site Code: ECB4266

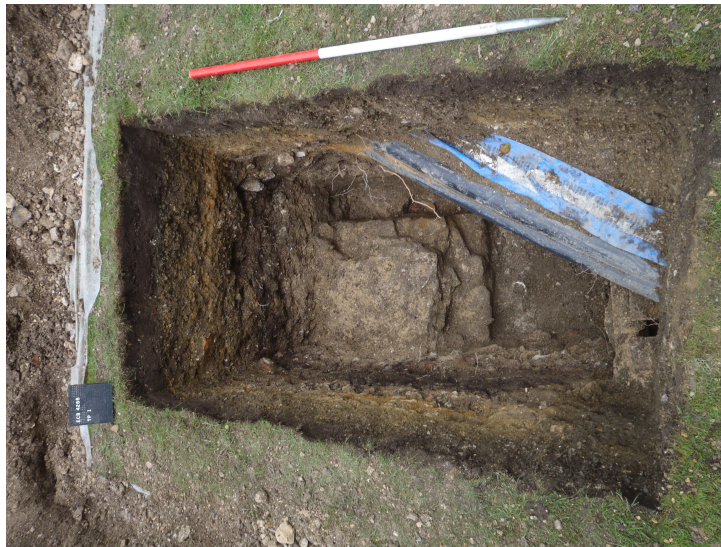
Plate 1 - Test Pit 1 General Shot

5.3.1. Test Pit 1 was excavated in the centre the terraced area of the garden (FIGURE 3). It measured 2m by 1m and reached a maximum depth 1.4m BGL where excavation ceased to the the presence of structural remains.

5.3.2. The upper deposit was a 0.18m thick topsoil (101) which sealed two service trenches [107] and [109]. However, both service trenches appeared to cut the lower portion of the topsoil suggesting the top portion of the topsoil was deliberately separated during the excavation of the service trenches and then relaid above them once backfilled.

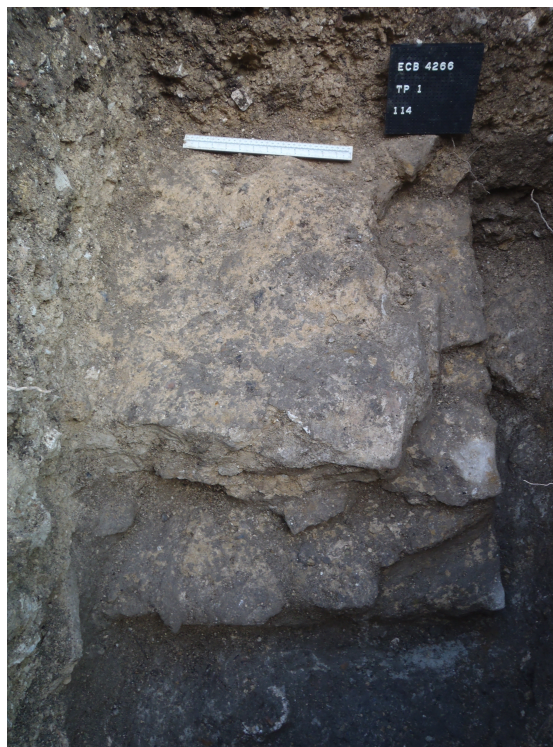
Plate 2 - Test Pit 1 Wall 114

5.3.9. A near vertical foundation cut [119] was visible in the north section of the test pit and it was filled by a thin lower grey clay deposit (116), visible in the northern and eastern sections of the test pit. The upper fill of the foundation cut was a dark grey clayey sandy silt (118) visible in the northern, eastern and southern sections of the test pit.

5.3.10. To the west of wall 114 the cut of the foundation trench [119] cut through a dark brown clayey silt (115). Below deposit (115) was a similar layer identified at the base of the trench, a dark grey/brown clayey silt (117). It is likely that (117) is a continuation of deposit (115).

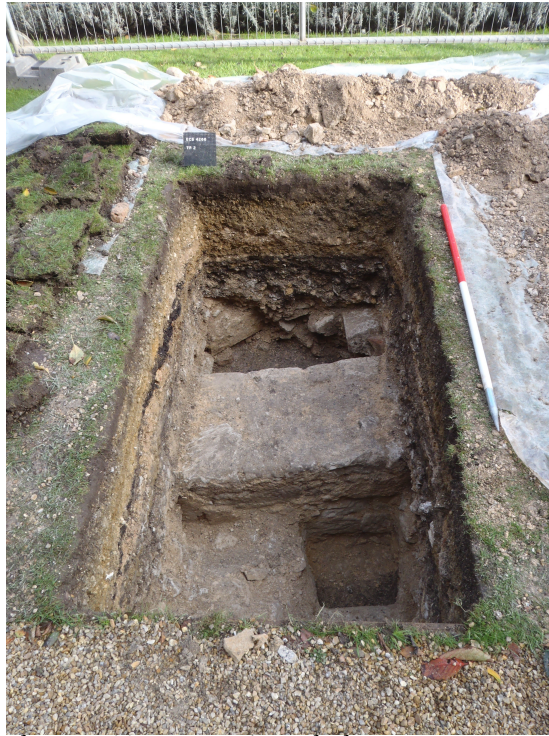
Plate 3 - Test Pit 2 General Shot

- 5.4.2. The uppermost layer identified in the test pit was the topsoil (201) which had a maximum thickness of 0.12m. This extended across the entire test pit and formed the lawn of the garden.

- 5.4.3. A series of gravel layers (220) were identified in the upper 0.5m of the test pit and were similar to the deposits identified in Test Pit 1. The uppermost gravel layer was mid grey gravel and silty sand (202). This extended across the entire test pit and was visible in all sections with a maximum thickness of 0.18m. This had a thin lens of orange sand and gravel (218), 0.04m thick, above it in the north section below topsoil (201). Below (202) was a mixed orange and grey gravel (217) with occasional mortar fragments visible in the eastern half of the test pit.

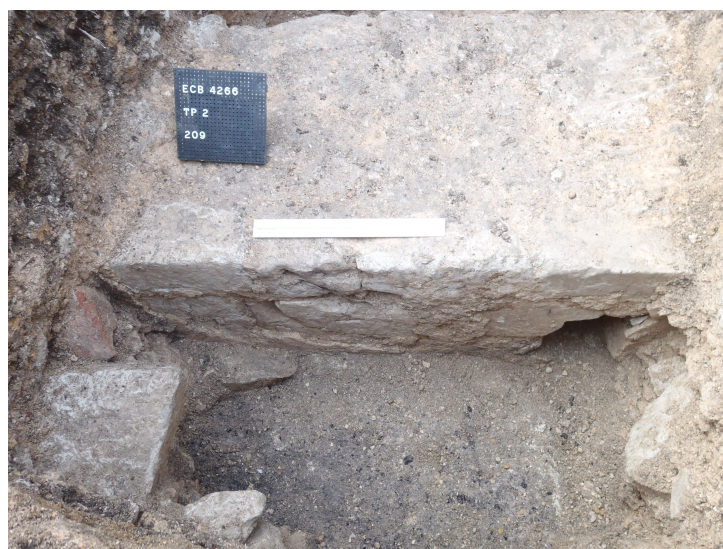
Plate 4 - Test Pit 2 Wall 209

5.4.8. Wall (209) was clunch and mortar built with trace evidence that the upper part of the faces of the wall had a mortared finish (PLATE 4). The wall survived to a height of 0.7m though due to limited excavation space it was unclear if the base of the wall was reached. The wall extended across the test pit at a slight angle and measured 0.6m wide. The wall survived to a greater depth than the wall in Test Pit 1 and had a different construction method and alignment.

5.4.9. To the east and west of wall 209 a grey clay layer was identified running up to the wall faces. To the east was (219) which was an unexcavated grey clay with a thin, 0.01m, burnt silty sand deposit (214) with frequent charcoal flecks directly above. To the west of wall 209 excavated in a small sondage against the wall was a 0.1m thick grey clay deposit (210). The two grey deposits appeared similar and both butted wall 209 but both deposits were at different depths. Deposit (219) was 1.16m BGL and deposit (210) was recorded at 1.28m BGL.

5.4.10. To the west of wall and sealed by clay (210) the cut for the foundation trench for the wall was identified [213]. The cut appeared to run parallel with the wall and had near vertical sides though no clear base was identified. It was filled by a sand and mortar fill (212) and cut through a dark grey silty clay (211) similar to (115) and (117) in Test Pit 1.

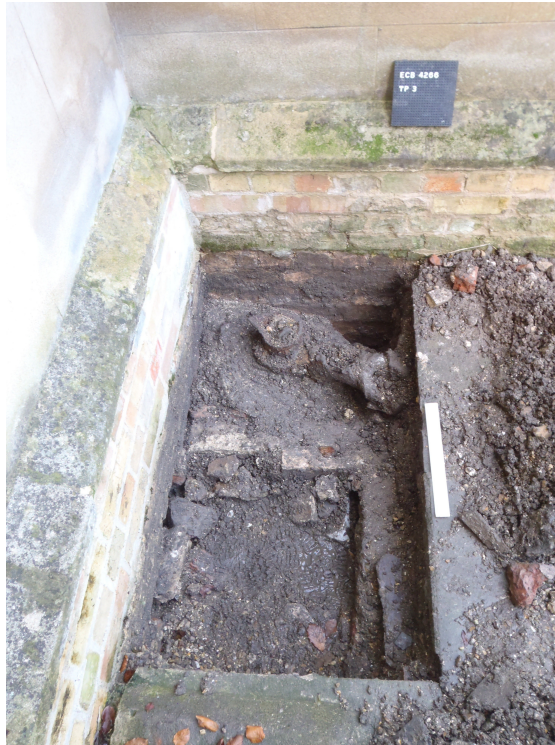
Plate 5 - Test Pit 3 General Shot

5.5.1. Test Pit 3 was excavated against the eastern wall of the college buildings in order to assess the depth and condition of the foundations for the building. Space was limited due to existing services and surfaces. The test pit measured 1.2m by 0.65m with a maximum depth of 0.6m.

5.5.2. The area of the test pit was covered in 0.04m thick flagstones (301) bedded on a cement layer (302) 0.05m thick.

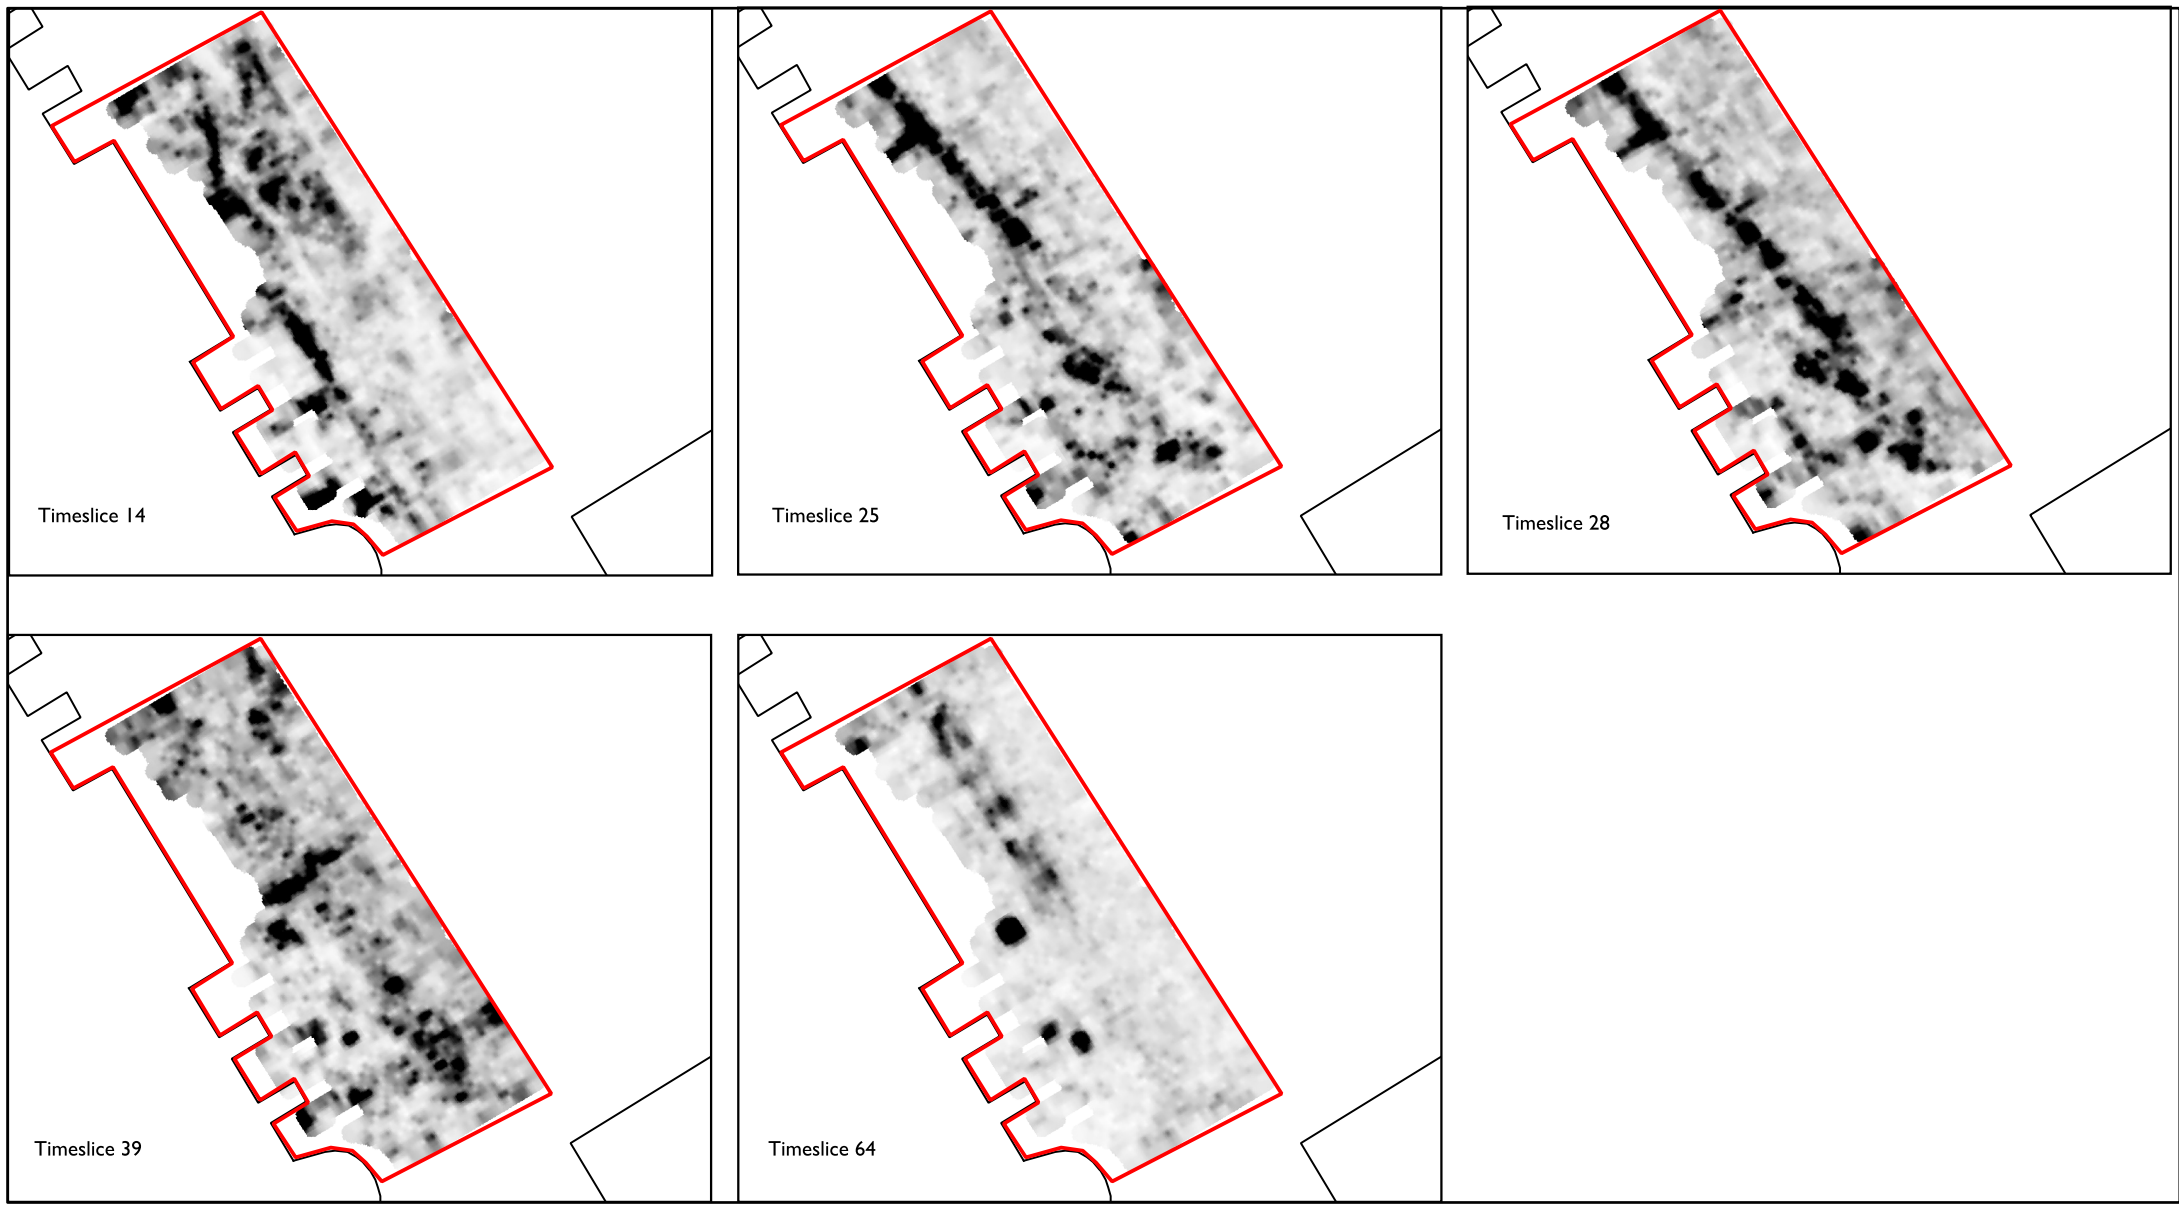
FIGURE 6 // GPR Results

with rugged terrain cart and a 500 MHz antenna. A setting of 4 stacks was used for ungained data collection with a total time window of 100 ns, was collected at a 0.25m line separation in zig-zag acquisition mode. A total area of measuring 7m by 22m was surveyed on the garden terrace.

- 4.2.10. A zero ns (time zero point) was calculated and set to 104 samples. Radargrams were then resampled and sliced at 18 samples (3.6 ns) between 104 – 500 samples.

- 4.2.12. Timeslices were then gridded using an inverse distance gridding algorithm at 0.25 cell size, with a 3 x 3 low pass filter applied to the gridded data. All timeslices were subjected to vertical interpolation and then exported for georectification in the GIS.

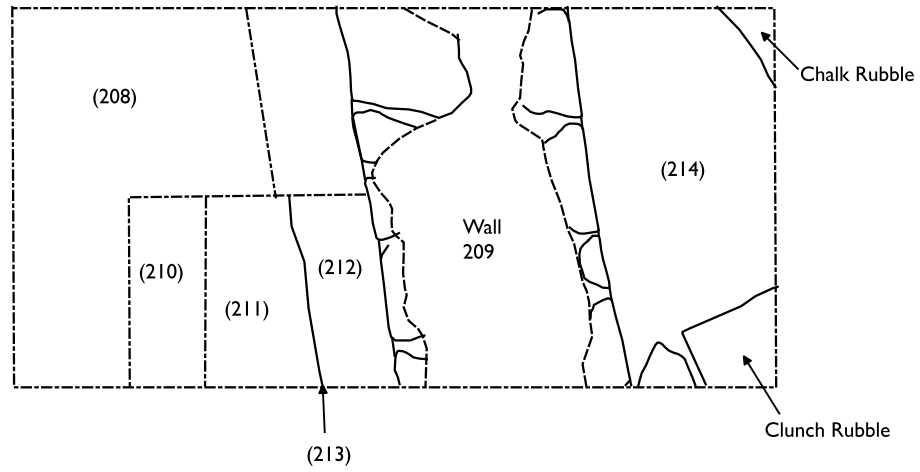
FIGURE 10 // Test Pit 2 - Plan and Sections

5.4.7. A possible demolition layer (208) was identified across the test pit and sealing wall 209. This deposit consisted of mortar and clunch rubble with some chalk fragments and sandstone roof tiles, and was similar to layer (113) in Test Pit 1.

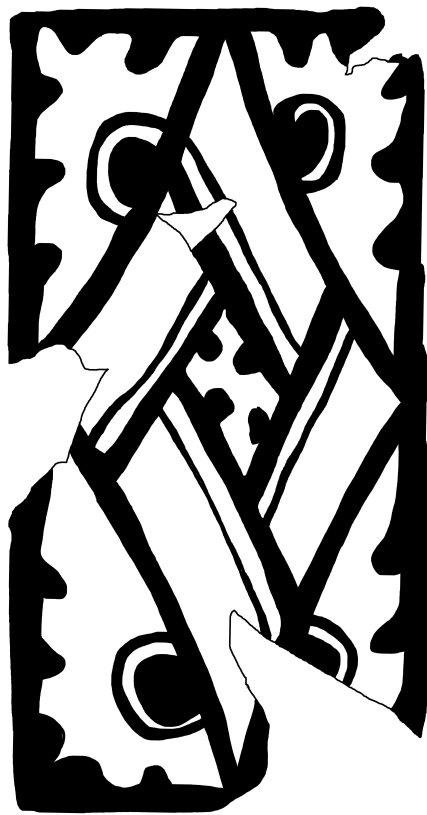
Medieval Window Glass
Context (204)
Drawn by Dr H Willmott
Scale 1:1

- 7.1. A small but significant assemblage of medieval window glass was recovered from excavations at Sidney Sussex College. Interestingly the material is similar in composition to a more extensive assemblage from previous excavations in the latter half of the 20th century, which also dates to the second half of the 14th century (SALWAY 1996). As is often typical for medieval window glass, the assemblage is in an advanced stage of decay and devitrification, and as there is little that can be done to arrest this or prevent further deterioration, this report serves as the permanent record of the finds. On its own, given the very limited size of the assemblage, little can be said about the glass contextually. Given its size and location it must derive from the earlier Franciscan friary, and presumably adorned the church or one of the other principal cloistral buildings until the Dissolution of the Monasteries in the 1530s.
