Archaeological Watching Brief Report

ROPES COURSE CONDOVER HALL

Client:	Travel Class Ltd
Local Authority:	Shropshire County Council
NGR:	349390,305690
Planning App:	14/03855/FUL
Author(s):	M. Williams
Doc Ref:	LPI713M-WBR-v3.1
Date:	March 15

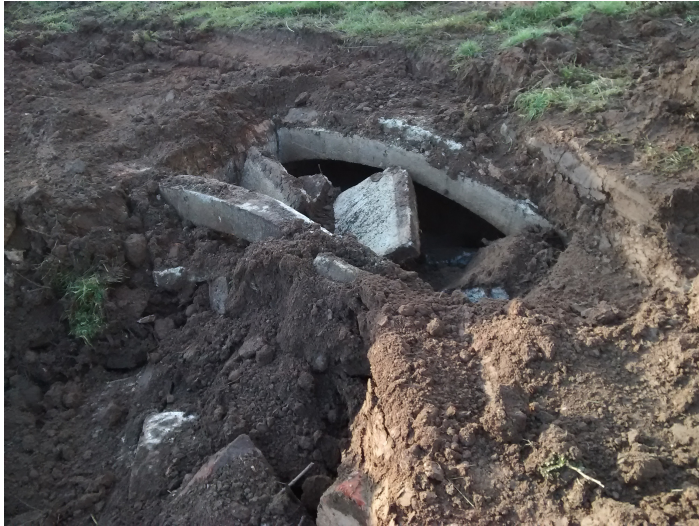
- 5.4. The western 3.50m was constructed of pre-cast concrete (07) which was partially visible in the lawn. It was filled with silt and rubble (PLATE 1).

Plate 1 - Concrete culvert (07) with rubble infill

- 5.8. The thick deposit of silt and rubble infill of the concrete section demonstrate that it

is no longer functioning as part of a drainage system.

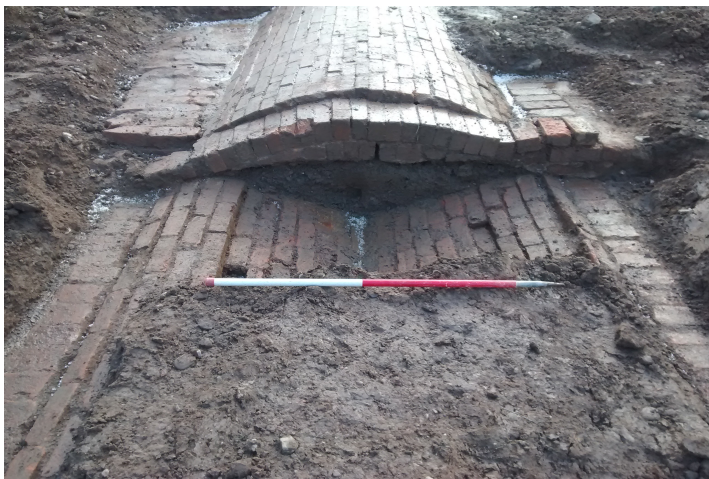
- 5.5. The central 15m consisted of a collapsed brick culvert arch 2.25m wide (03). The arch had collapsed from a single break down the axis leaving the single course of foundation bricks in place at the base of the arch (PLATE 2 and PLATE 3) which were bedded into clean yellow sand. The arch bricks measured 300mm long by 120mm wide and 70mm deep and were laid on edge to form the arch. The foundation bricks were 200mm long and laid in a single row of headers. No bonding material was used in the arch or foundation. The collapse was overlain by mid brown silt (04).

- 5.6. The western section of the culvert consisted of an upstanding arch (06) supported at the base by a mortared brick foundation (08) (PLATE 2 and PLATE 3). The arch measured 2.25m across and was constructed of bricks 300mm long by 120mm wide and 70mm deep. The foundation (08) consisted of broken bricks 120mm wide (no full length bricks were present) and was bonded by a hard pale grey sand mortar. Between the two sections was a poorly constructed single brick width arch (05) of the same type of bricks as (03).

- 5.7. It appears that the arches (03) and (06) are part of the same build. The eastern section (03) collapsed and the arch (05) and bonded foundation (08) were constructed to strengthen the remaining standing part of the culvert (06). The concrete section (07) is the latest section and may relate to insertion or replacement of the metal drain in the lawn.

Plate 2 - Culvert looking southeast showing collapse (03), arch (05) and culvert (06). 1m scale.

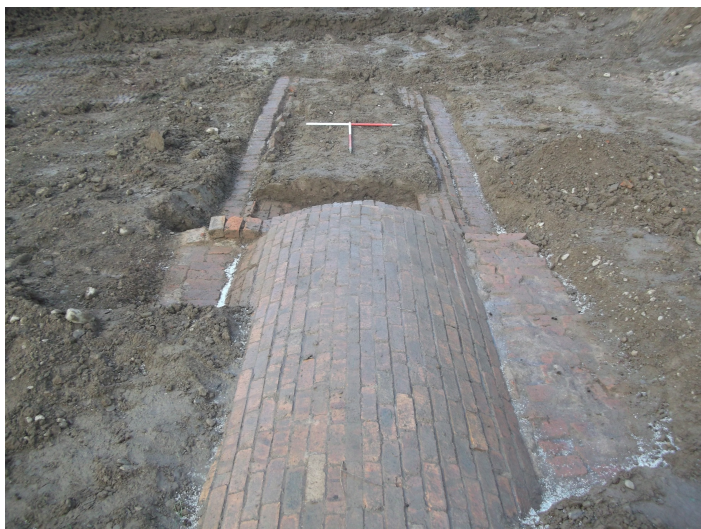
- 5.1. A plan of the stripped area is given in Figure 2.
- 5.2. The upper layer was 0.30m of loose dark brown topsoil (01). This overlay moderately loose mid grey brown sand and gravel natural geology (02) (PLATE 3) which was excavated to a maximum thickness of 0.60m.

Plate 3 - Culvert looking southeast. Natural geology to right of structure. 2 x 1m scale
