Archaeological Evaluation Report for

RIVERSIDE HOUSE PENKRIDGE

Client:	Cruden Construction Ltd		
Local Authority:	South Staffordshire Council		
NGR:	392350,314350		
Planning App:	14/01026/FUL		
Author(s):	C Matthews		
Doc Ref:	LP2060C-AER-v1.2		
Site Code:	LP2060C		
Date:	April 16

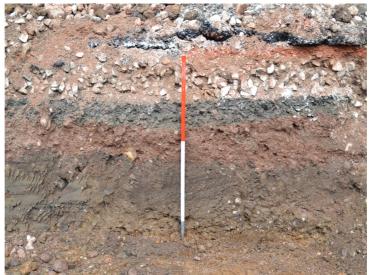
Plate 2: Trench 1 South facing section

- **5.2.3.** The centre and western extent of the trench was excavated into the modern carpark and comprised of the surface tarmac and hardcore (01), 0.14m thick, overlying a layer of crushed stone (11), 0.26m thick. Below this was a layer of grey gravel layer, approximately 0.15m thick (03). Below (03) was (04) the crushed red gravel seen at the eastern end of the trench, measuring 0.33m thick (PLATE 2).

- **5.2.4.** Below (04) was the grey silty clay with brick inclusions (05), measuring 0.41m thick in this area. This is thought to be a 20th century cultivation soil. This could be seen to overlay the natural sand and gravel (10), which extended beyond the base of the trench.

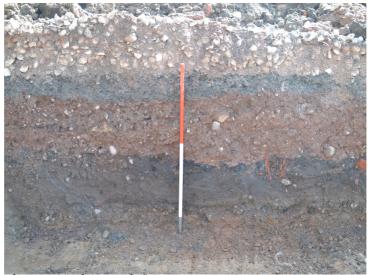
Plate 3: Trench 2 north facing section

- **5.3.3.** Below (13) was the grey silty clay (14), which could be seen to be the same as deposit (05). This is thought to be a remnant 20th century cultivation soil.
- **5.3.4.** The majority of the trench, up to the eastern extent, was excavated into the the hardcore (11), revealing similar stratigraphy to trench 1 (PLATE 3). Bellow the hardcore, which measured 0.3m thick, were two crushed stone layers, the first a crushed grey gravel (12) same as (03), measuring 0.15m thick and the second a crushed red gravel measuring of varied thickness up to 0.45m (13) could be seen to be the same as (04). This sealed a layer of grey silty clay soils (14), 0.3m thick, which were the same as (05).

5.3.5. Below this was a thin layer, 0.1m thick, of light grey silty clay (15) with rounded cobble and sub angular stone inclusions. This layer extended throughout the trench and overlay the natural sand and gravel (16) at the base of the trench.

5.3.2. The eastern extent of the trench encroached by up to 1m onto the eastern boundary turf bank and consisted of the same makeup as the excavation in trench 1, this was comprised of Turf and topsoil (02) over a redeposited clay (06) which further capped a dump of mixed 20th century organic soils, brick rubble and concrete (07).
