Archaeological Watching Brief Report

# **PRINCES DOCK LIVERPOOL**

Client:	Orion Heritage
Local Authority:	Liverpool City Council
NGR:	333676,390897
Planning App:	Pre-planning
Author(s):	N Herring
Doc Ref:	LP2447C-WBR-v1.5
Date:	October 17
Site Code:	LP2447C

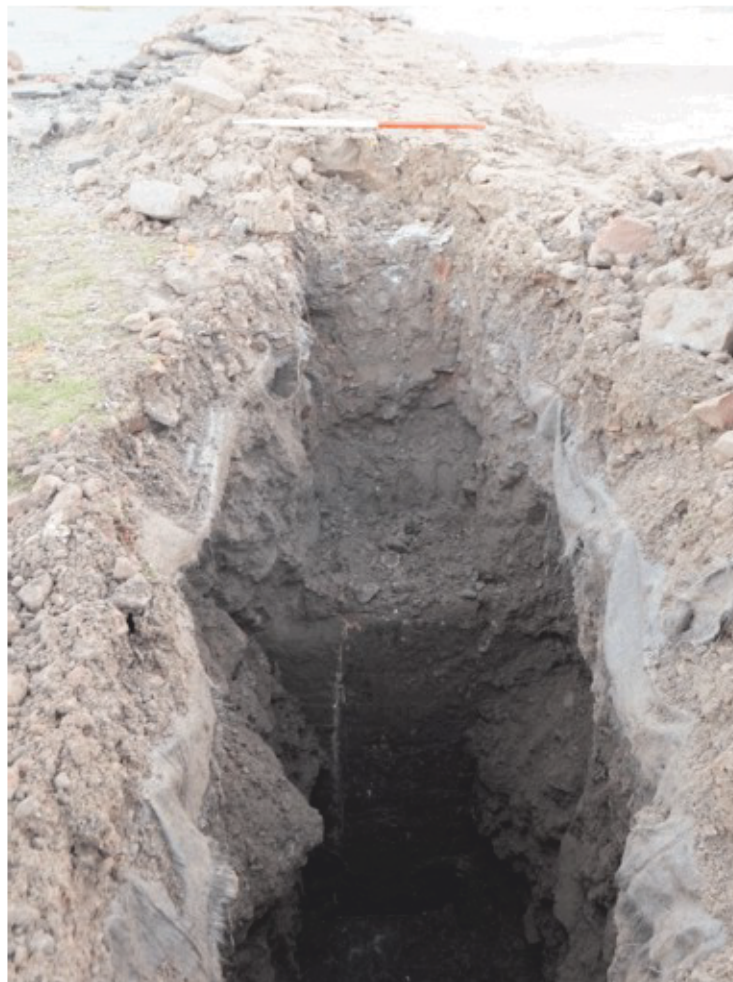
- 4.5. The southwest facing section of the wall was vertical, whilst the northeast facing section was stepped (FIGURE 8) and may have a pronounced batter, based on photographic evidence (JARVIS, 1991). Through excavation the top of the wall was exposed, seen at a width of 2m within the limits of excavation, however it is likely that the base is wider for structural support.

4.9. The deposits on the stepped southwest side of the dock wall (13), (16) and (21) were a series of dark grey-brown clayey sand, with frequent, unsorted sub-round and sub-angular fragments of red and yellow sandstone quarry waste up to 0.5m in size.

Plate 1 - The stepped north east facing section of the Sea wall in TP104B

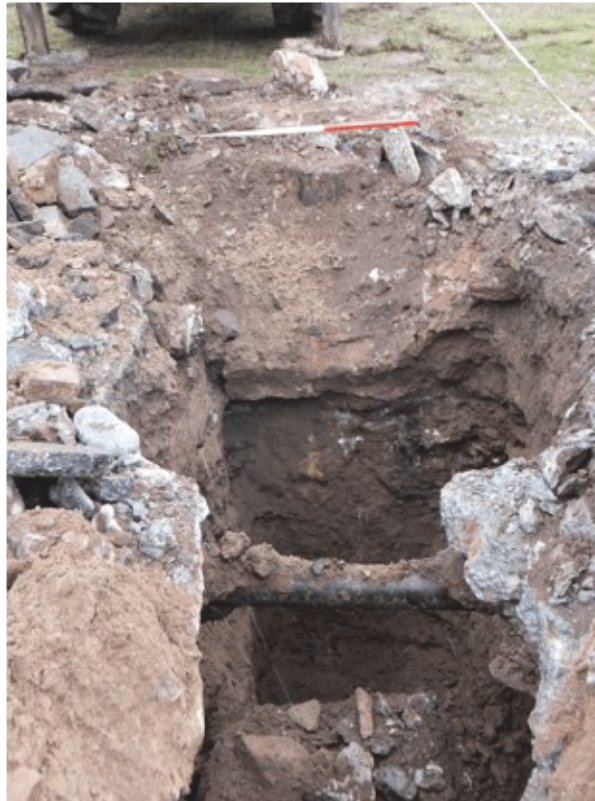
4.11. On the vertical southwest face of the dock wall, the deposits used to build up the ground level consist of crushed, fragmented sandstone (9), (14), (22) overlaying a yellow-brown sandy clay (11) and (23). In TP103 this distinction was less defined, though it became sandier towards the base.

Plate 2 - The vertical south west facing section of the Sea wall in TP104A

4.13. A 20<sup>th</sup> century metal drainage pipe (PLATE 2) aligned northwest to southeast and measuring approximately 0.20m in diameter is present within trial pit TP104A but the extent of this pipe remains unknown.

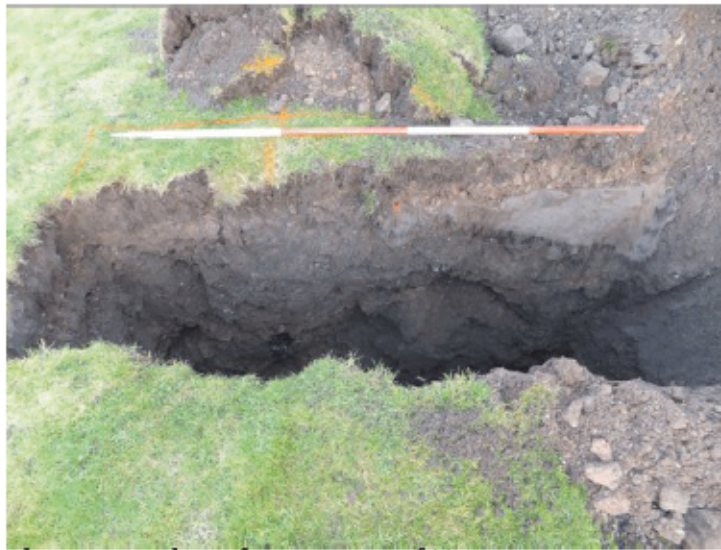
Plate 3 - Southeast facing section of TP105.

4.17. The 0.3m thick grass turf and 50mm thick tarmac were removed to expose a layer of crushed sandstone hardcore (6), with a layer of terram separating the hard core from a deposit of backfilled material for land reclamation.

4.18. The deposit is similar to that found on the southwestern side of the seawall, notably a dark grey-brown silty sand, with frequent and randomly sorted fragments of sandstone and previous building demolition waste, such as bricks, metal, and ceramic pipes, that date from the 19<sup>th</sup> and early 20<sup>th</sup> centuries. Again, it was not possible to reach the bedrock within the limits of the excavations.

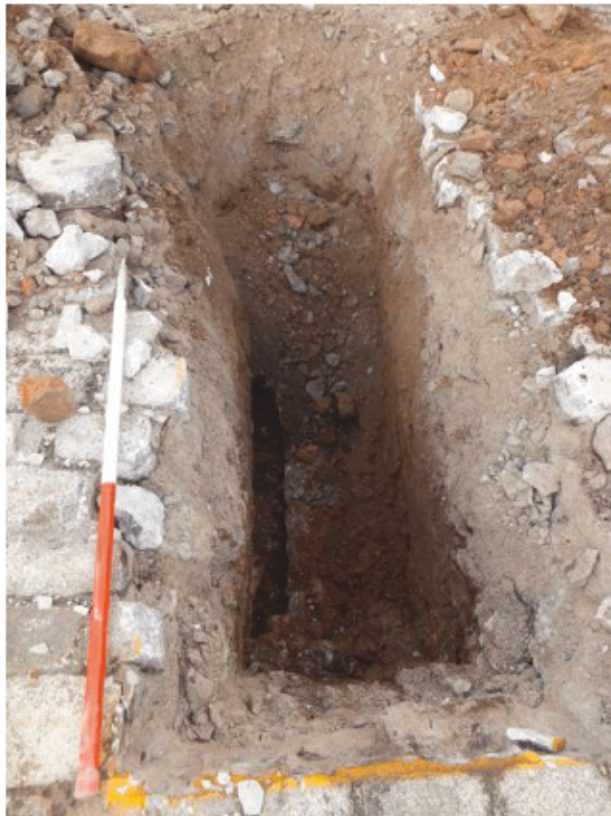
4.21. This deposit was cut by a brick culvert, which ran northwest to southeast through both trial pits. The brick culvert was constructed to 0.47m in height and was exposed by 0.44m in width within TP110. It was found in good structural condition and is likely preserved *in situ* further along its extent, which remains unknown (PLATE 4).

Plate 4 - Northwest facing section of TP110

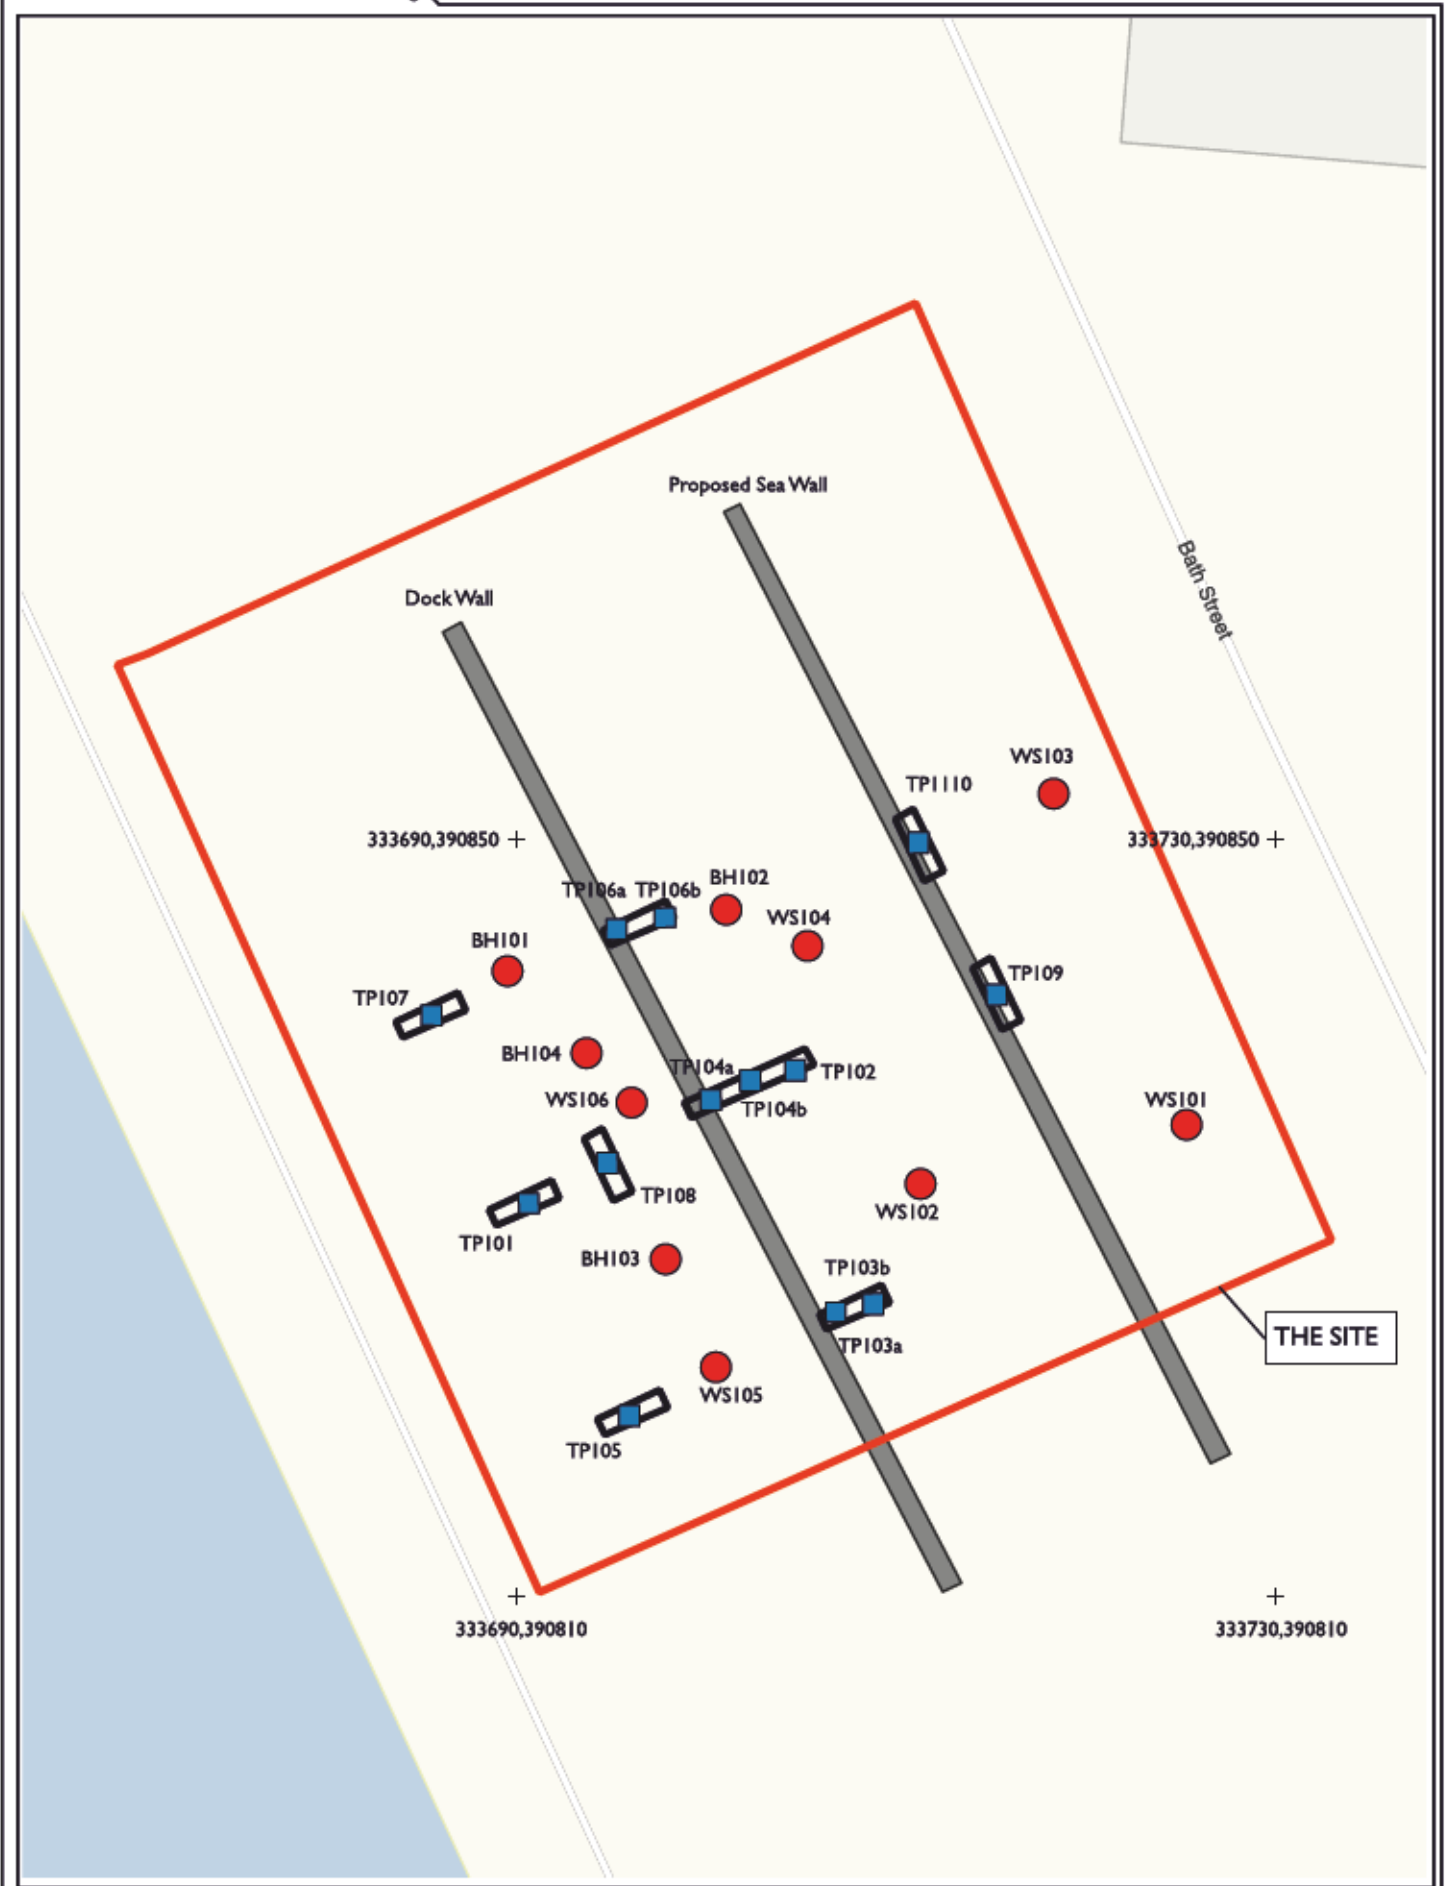
FIGURE 7 // Location of Geotechnical Trenching

- 4.2. Nine trial pits (TP) were machine excavated to the south of the red line boundary near the entrance to the site off Bath Street. Several of these trenches were subdivided into TPa and TPb (FIGURE 7). In general these trenches can be divided into three groups, as detailed below.

DESCRIPTION // Location of Geotechnical Trenching
