Historic Building Recording and Watching Brief at

**70 BIRTLES ROAD**  
**MACCLESFIELD**

For Bartholomew Homes

Date: May 2017

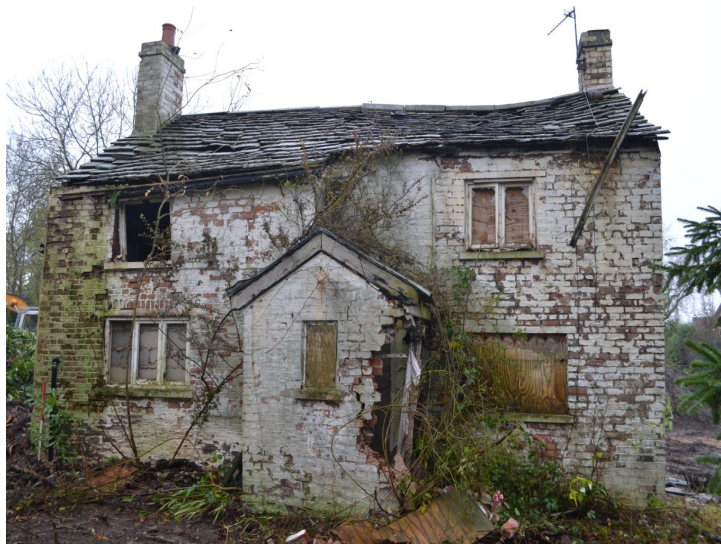
Plate 1- South facing elevation

5.3.3. The south facing elevation, forming the frontage for the property, was of brick

construction in a garden wall bond, with an irregular coursing pattern (PLATE 1). The frontage was symmetrical with two sets of wooden frame casement windows either side of a central brick porch. These windows had concrete sills and lintels, with the ground floor windows having an additional header course above them to form a second, decorative lintel.

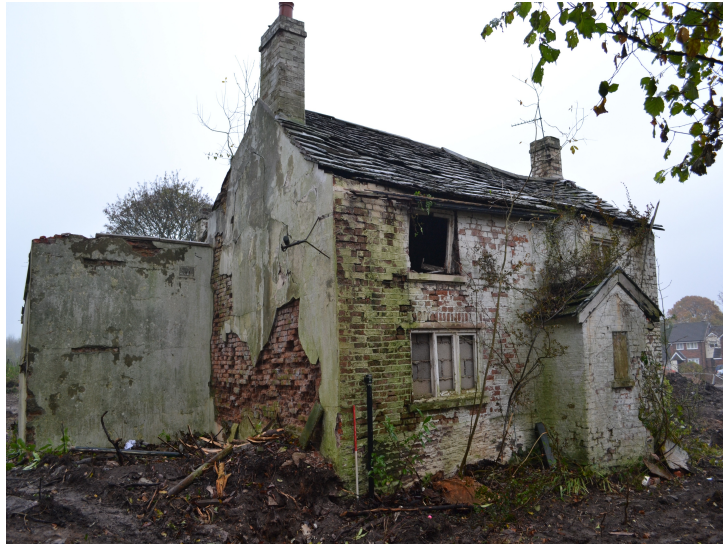
Plate 2 - Southern elevation, from the west

5.3.4. The frontage had been painted white, whereas other elevations had undergone full rendering with plaster painted white (PLATE 2). It is clear that the brick frontage is of a later date to the internal framework, dating from at least the mid to late 19<sup>th</sup> century.

5.3.5. The porch allowed access via its eastern elevation and had a single, thin upright, window light in the southern elevation (PLATE 2). The porch had a pitched roof of slate tiles, with wooden barge boards. Based on the construction detail, this was a later addition, likely 20<sup>th</sup> century in date.

5.3.6. The western elevation (PLATE 2) was of roughly coursed brick in a poor state of repair. This had been rendered and painted, likely in the late 20<sup>th</sup> century. The western elevation formed one of the gable ends of the property and had no windows or doors present.

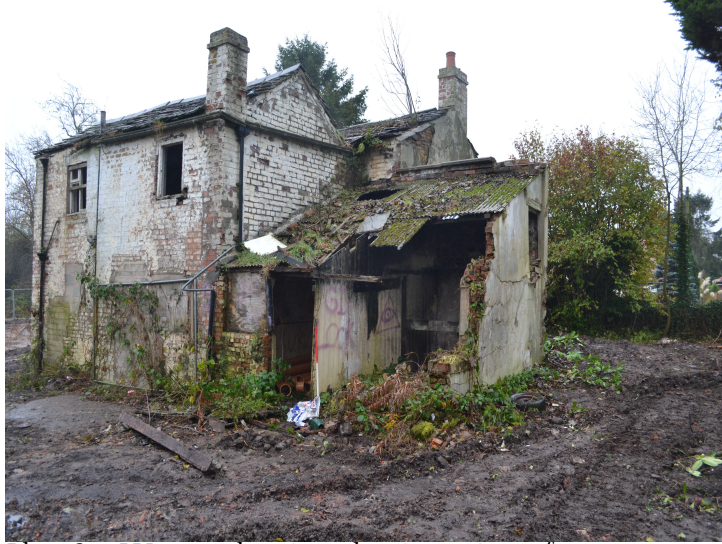
Plate 3 - Western elevation, showing twin roof structure

5.3.7. At the northwestern corner of the structure a lean-to had been added and was of a rough brick construction with corrugated metal roof. This was in such a

poor state of repair, access was not possible (PLATE 3).

5.3.8. The western elevation also clearly shows the twin roof structure, with pitched parallel roofs.

5.3.9. These two roofs show the offset nature of the footprint of the structure with the southern block extending slightly further to the west than the northern block.

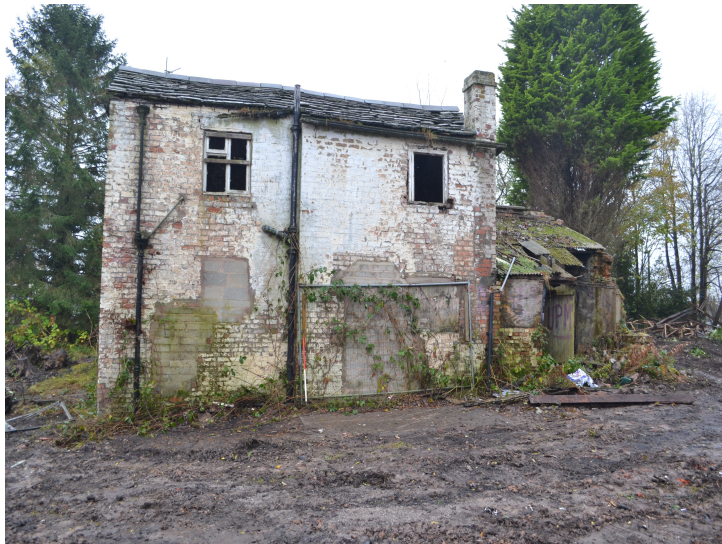
Plate 4 - Northern elevation

5.3.10. The northern elevation formed the rear façade of the building (PLATE 4).

5.3.11. The northern elevation was of a similar brick construction to the southern

elevation, in a garden wall bond, with irregular coursing. The first floor contained two equally spaced windows of wooden frames. The panes and fixings were missing from the western window. However the eastern window showed a modern casement with a small awning window at the top left.

5.3.12. At ground floor level there was clear repair work, with breeze block inserts where it is thought a door and window may have been present. This may have been done recently to secure and stabilise the structure.

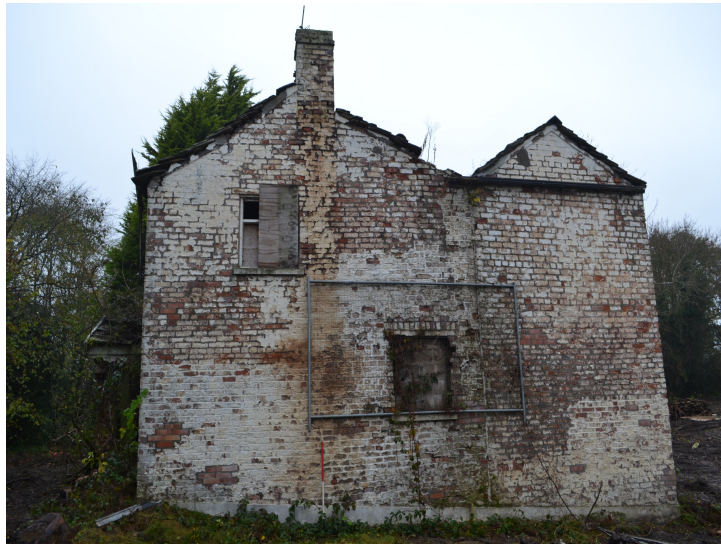
Plate 5 - Eastern elevation

5.3.13. The eastern elevation was constructed of brick in a garden wall bond and painted white (PLATE 5). This elevation shows the drop in ground level to the north.

5.3.14. The fenestration was basic, with a wooden framed window at the southern end of the first floor and a ground floor window at the northern end of the southern block. The joint of the southern and northern blocks was visible on this elevation showing that they are of different phases of construction.

5.3.15. The height of the ground floor window also shows the relative height of the internal floor level.

5.3.16. A single chimney is visible on this elevation, located on the southern block gable wall.

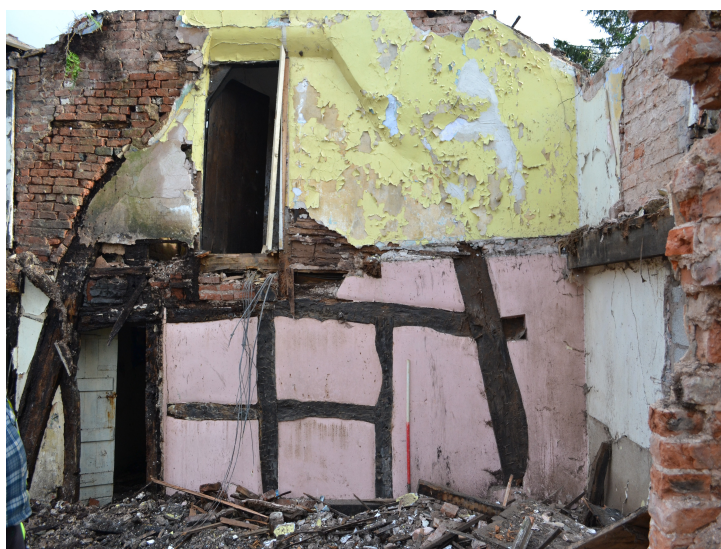
Plate 6 - Cruck frame on central wall of southern block

- 5.4.1. The interior was observed from a distance during demolition, due to health and safety concerns, which hampered recording the interior details significantly. The demolition was carried out by a mechanical excavator, once the roof had been removed by hand.
- 5.4.2. On commencement of demolition of the buildings west wall elements of the original timber frame were revealed (PLATE 6 & FIGURE 5). This comprised of a curved timber cruck frame positioned in the centre of the building. Between the cruck frame the box timber construction for the walls can be seen.

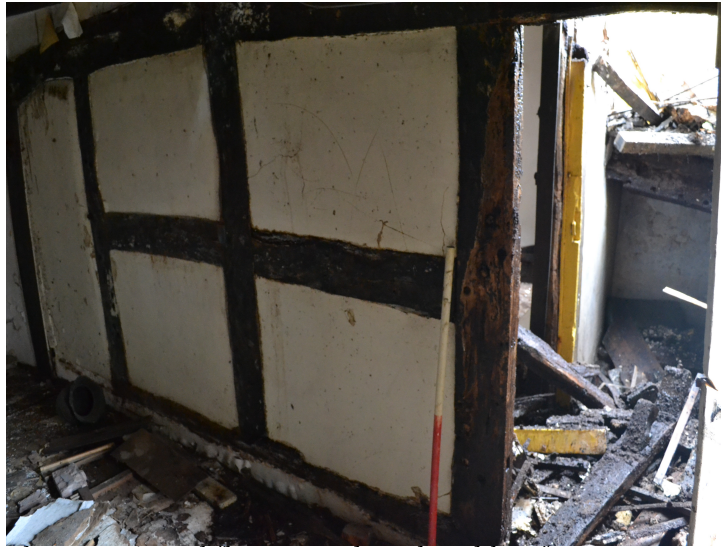
Plate 7 - Ground floor exposed cruck and box frame

- 5.4.3. The framework extended through to the ground floor, where the extent of the cruck were defined and the squared internal box frame support was still visible (PLATE 7). At first floor level a doorway was located at the southern end of the frame, which may be contemporary with the cruck. At ground floor level the doorway was located at the northern end and is also thought to be contemporary (PLATE 8).

5.4.4. The upper section of the cruck frame was sampled for dendrochronological assessment.

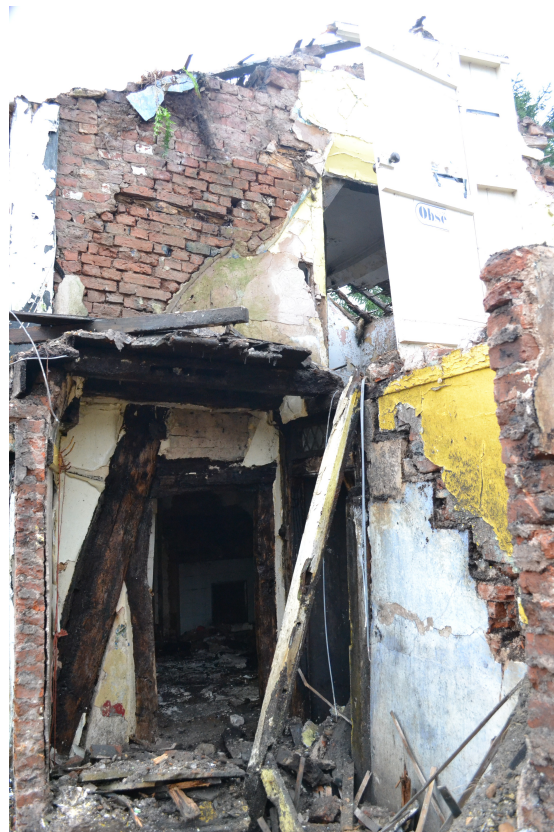
Plate 8 - Cruck frame

5.4.5. The cruck frame was the only original feature to be observed within the building and was used to divide the southern block into two rooms. All other features appeared to date to the mid 19<sup>th</sup> century and later. The cruck frame

was not present on the eastern or western elevations, suggesting that these walls were part of the later phases of construction.

5.5.1. A sample of the upper section of the cruck frame was sent to the Dendrochronological Consultancy Ltd for assessment. This sample measured 0.5m long and 0.4m by 0.3m in cross section. Unfortunately the sample was not suitable for dating purposes. Although confirmed as oak, it had less than the 50 rings required as a technical minimum. Usually specialists require at least 80-100 rings for any single timber. It was also noted that the rings were all distorted, not regular circles of consistent sizes, so it must have come from “*the knotty end of a rather twisty tree*”.

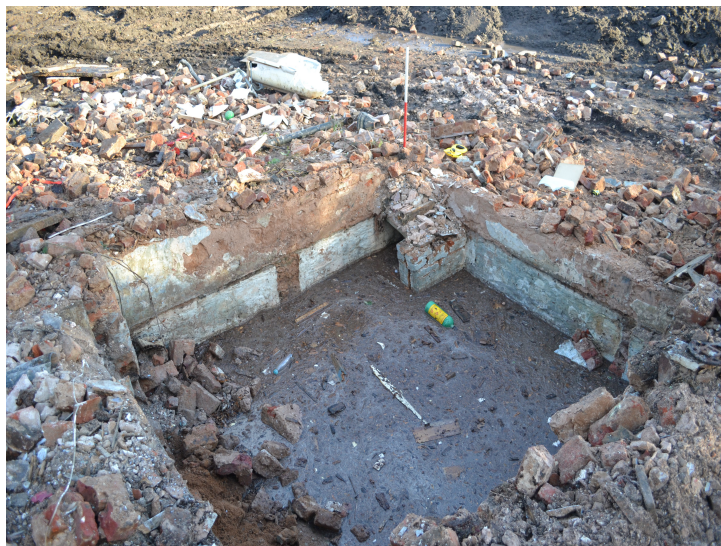
Plate 9 - Cellar below kitchen area

5.6.2. A small cellar was uncovered at the north of the property, located beneath the kitchen and measuring approximately 3m x 3m with stone shelving protruding from the walls (PLATE 9). The cellar walls were of rough brickwork and are thought to extend over 1.3m below ground level. However, the cellar was flooded with water and silt, as such it was deemed unsafe to enter so was only recorded from a safe distance (PLATE 10).

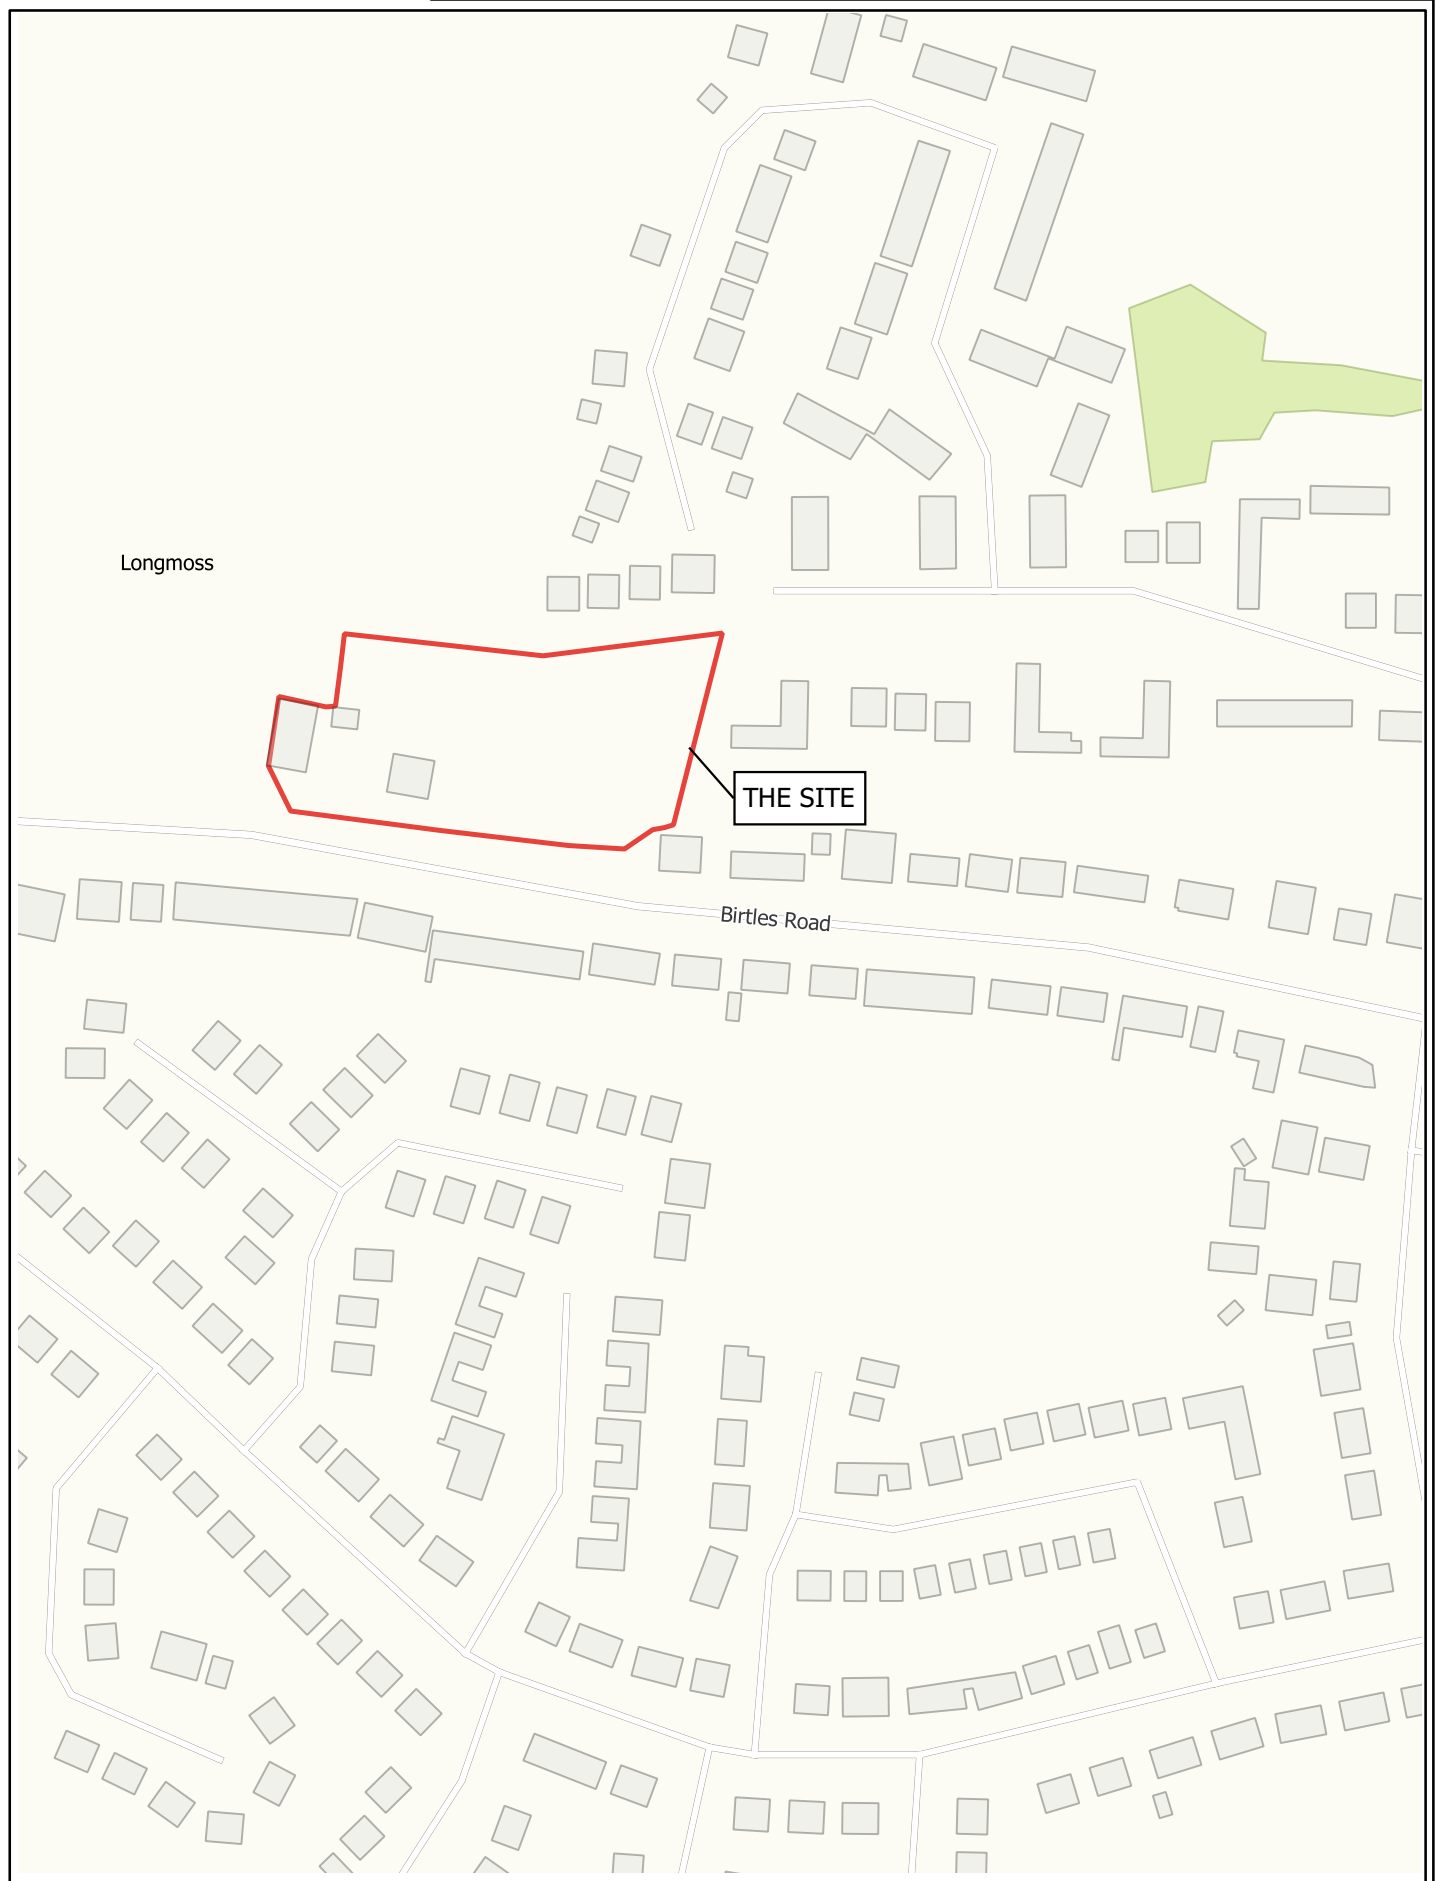
FIGURE 2 // Site Location - Detail

- 1.3. The structure lies within a small plot of land situated on Birtles Road, Macclesfield, located at NGR 388947,374233 (FIGURE 2). The house is thought to have originally dated to the early 17<sup>th</sup> century, although the house has been subject to much alteration. The earliest phase of the house is believed to have been constructed entirely from timber with a thatched roof. The house was later modified by the construction of a brick exterior and slate roof. The purpose of the building recording was to establish the presence of any features from the original phase of the building.
